# WATERSHED SCIENCE INSTITUTE WATER MANAGEMENT CENTER NRCS STATE OFFICE - OKLAHOMA

## Case Summary Report

### Applying Geomorphic Principles to Sands and Low Plasticity Silts in the Sugar Creek Watershed Project

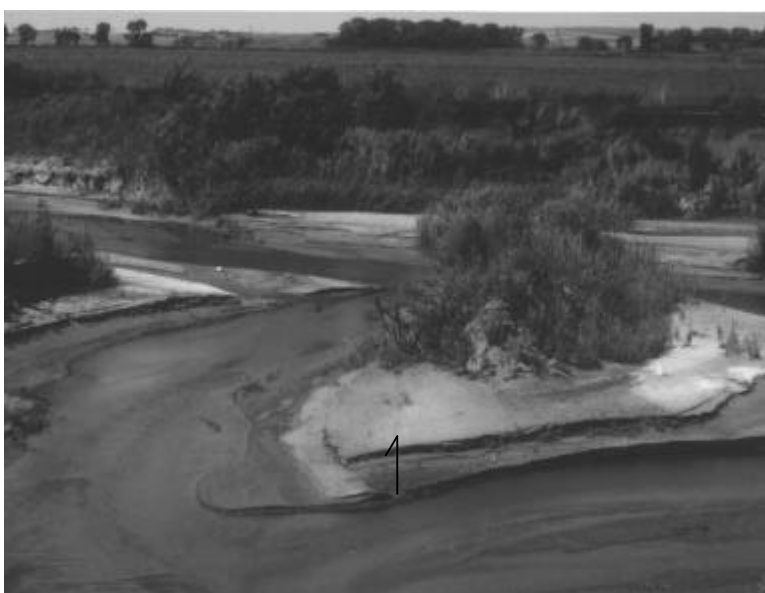
Figure 1. Sugar Creek shown 3 miles north of Gracemont illustrates extensive channel widening and readjustment. Remnants of jacks on the left side of island mark the edge of stream at some time in the past.

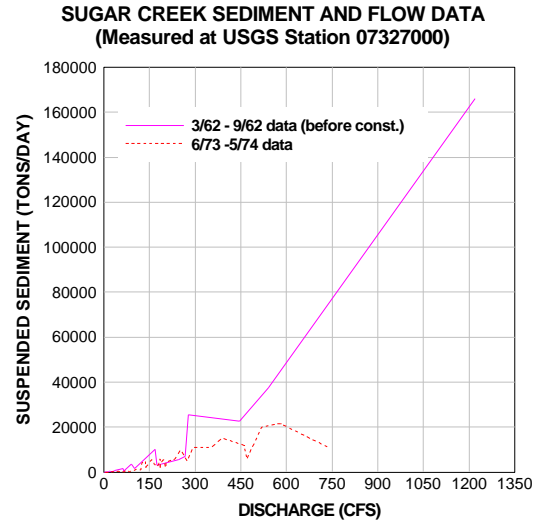
Figure 3. Suspended sediment and flow data for first and last years of gauge use.

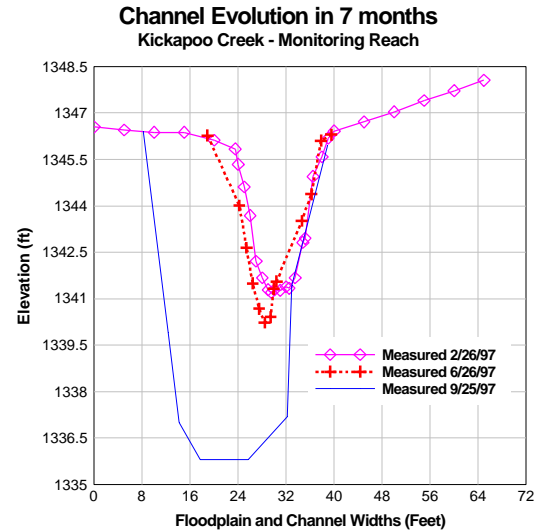
Figure 5. Changes in the Kickapoo Creek (tributary) monitoring station occurring as a head cut advanced through this area.

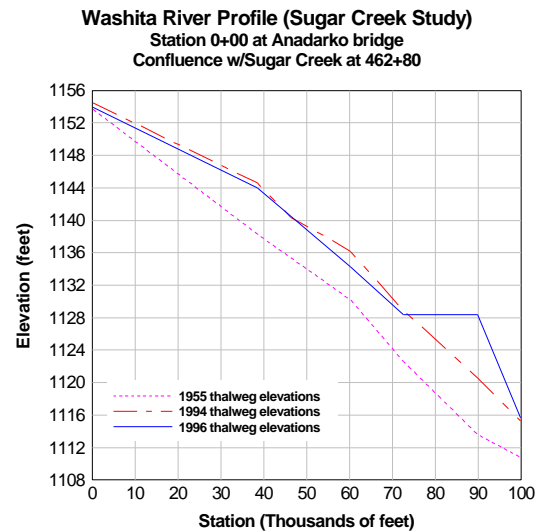
Figure 6. Historical aggradation of the Washita River near Sugar Creek since 1955.

The first level of base control for this project is Sugar Creek's confluence with the Washita River. At this location, the Washita River has aggraded approximately 7 feet from 1955 to April 1994 (see Figure 6). This aggradation extended fairly uniformly downstream to the last resurveyed cross section which is located slightly more than ten miles downstream of the Sugar Creek - Washita River confluence (measured along the stream). Indications of aggradation can be visually observed as far downstream as the H. E. Bailey Turnpike bridge which is nearly forty miles downstream of the subject confluence.

This aggradation illustrates the tremendous amounts of sediment being moved by Sugar Creek as the Washita River above and below the Sugar Creek

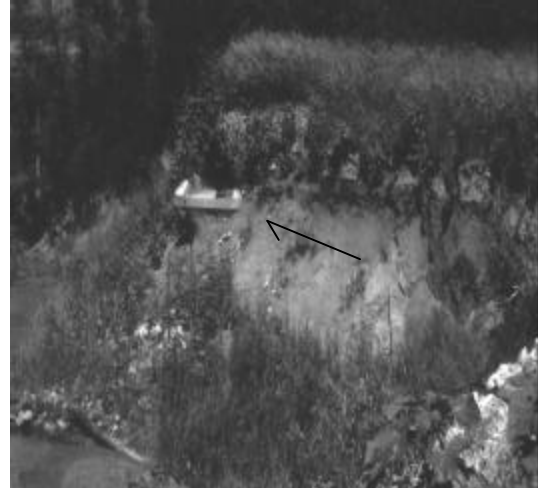
Figure 8. Note location of concrete pad for road culvert relative to current stream location and lack of vegetation in the midbank region.

Soil moisture decreases with the height of the bank so there is likely insufficient moisture in mid-bank for vegetative establishment. Moisture is actually more plentiful in the upper 4 to 5 feet of the bank because the original soil profile has remained relatively intact. Vegetation could be established in this zone. However, the ability to stabilize the banks in the near term is extremely doubtful since roots would have to extend down 20 to 30 feet to be effective. Given the instability of these banks, even the most vigorous roots could not reach these depths before the plants were severely undercut and lost (see Figure 8). Some type of slope and bank height modification consistent with the designed plan form may be necessary to facilitate vegetation over the entire bank.

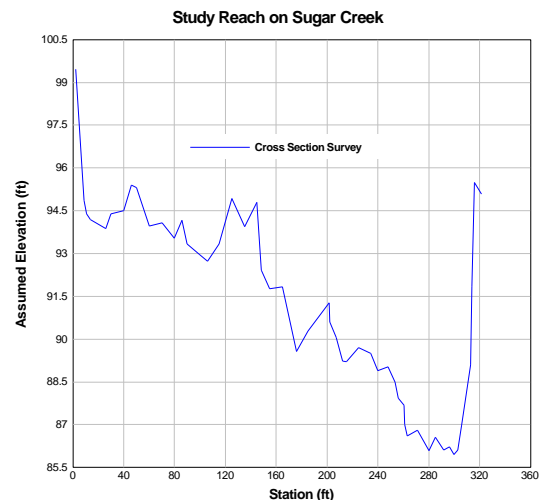
Figure 9. Low flows are typically near elevation 87. Flows will extend to near elevation 91.5 during bankfull events. Note the potential for mass wasting of the right bank.

Physical constraints in this stream system may, however, be more difficult to overcome than cultural concerns (see Figure 9). The recovery potential of “F5” systems are very poor due to very high sediment supply and streambank erosion potential (Rosgen, 1996).
