## Suitability for Construction Materials: Sand Source - Massachusetts, Connecticut, and Rhode Island (2008)

## Suitability for Construction Materials: Sand Source

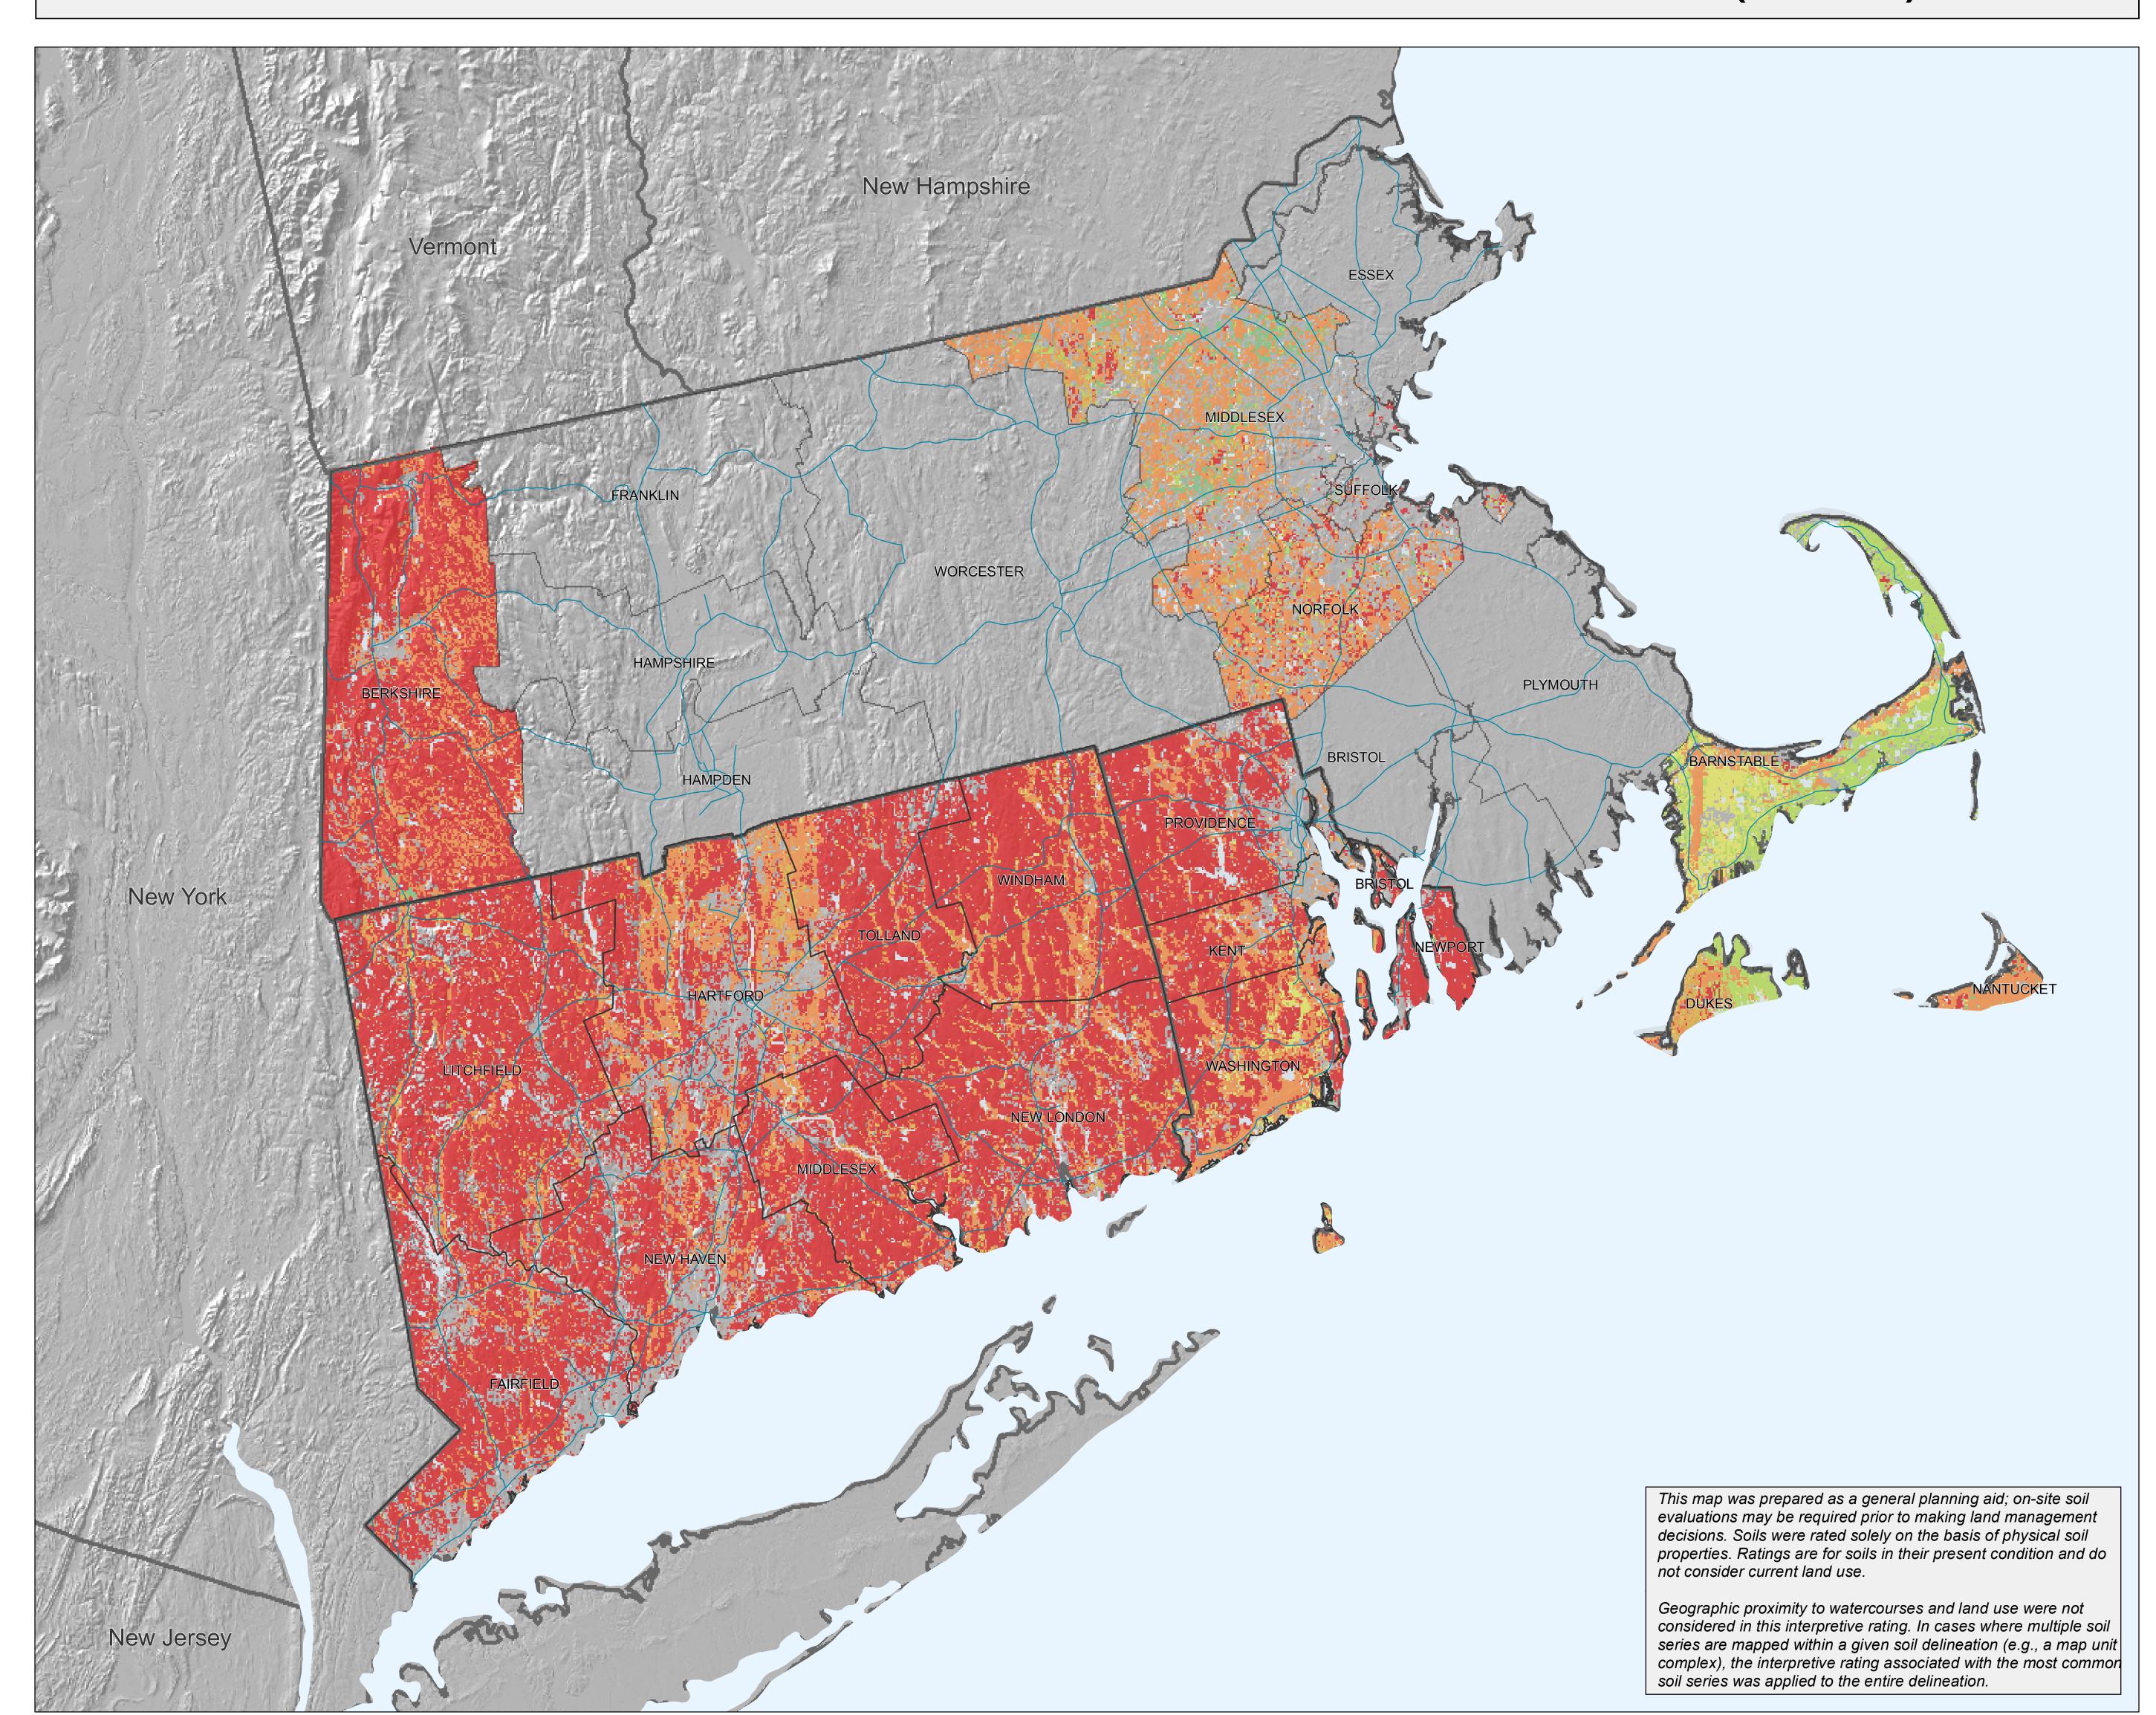
Sand is used in great quantities in many kinds of construction. Specifications for each purpose vary widely, though sand as a construction material is usually defined as particles ranging in size from 0.074 mm (sieve #200) to 4.75 mm (sieve #4) in diameter. The intent of this rating is to show only the probability of finding material in suitable quantity. The suitability of the sand for specific purposes is not evaluated. Final site evaluation and selection require an onsite inspection to determine the suitability and quality of the materials for the intended purpose. Implementation of these interpretations helps minimize the need for excessive random exploratory investigation by pinpointing potential sites.

Soils are rated and placed into sand source suitability rating classes per their rating indices. These are poor (rating index = 0), fair (rating index > 0 and < 1.0), or good (rating index = 1.0).
