Research  
Paper  
FPL-RP-556

# Field Performance of Timber Bridges

## 11. Spearfish Creek Stress-Laminated Box-Beam Bridge

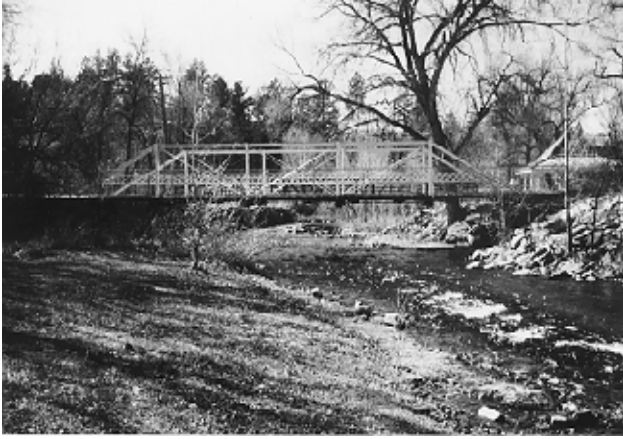
**Figure 2—Original Spearfish Creek bridge constructed in the early 1950s.**

Before replacement in 1992, the Spearfish Creek bridge was a 71-ft long, single-lane, steel pony truss superstructure on a timber substructure (Fig. 2). Initially constructed in the early 1950s, the steel trusses were badly corroded and the bridge could no longer safely carry standard highway loads. The single-lane bridge also posed a hazard to the two-way traffic flow on Canyon Street. After considering several replacement options, it was determined that a timber bridge replacement would be most appropriate for the site. The city council supported this replacement option in order to accent the natural setting of the campground and the Historic D.C. Booth Fish Hatchery.

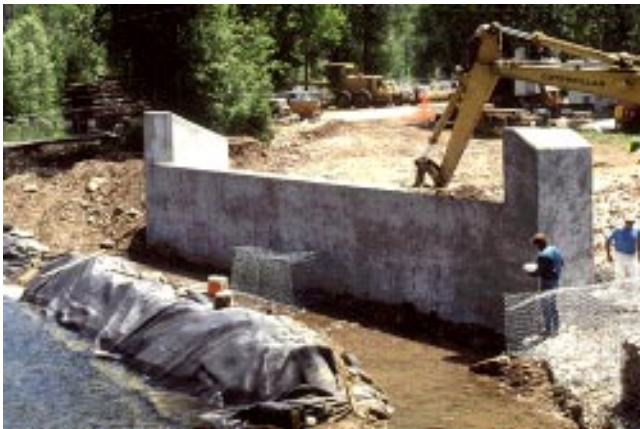
Figure 6—Construction of reinforced concrete abutments and wingwalls.

Construction of the Spearfish Creek bridge by a local contractor began in June 1992. During construction, a temporary crossing consisting of corrugated steel culverts was installed just upstream of the bridge site. The existing bridge was then removed and salvaged for use as pedestrian crossings. Following removal of the existing bridge, new reinforced concrete abutments and wingwalls were constructed (Fig. 6).

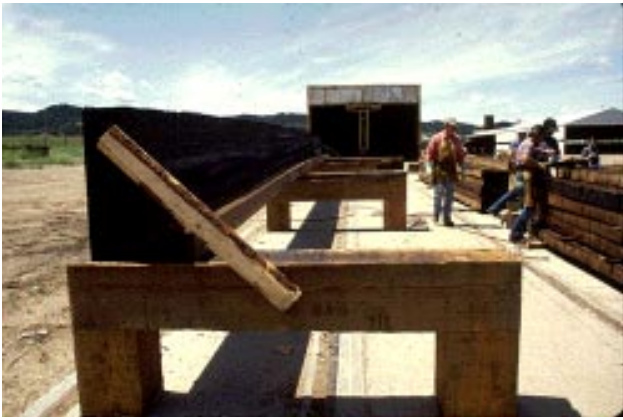
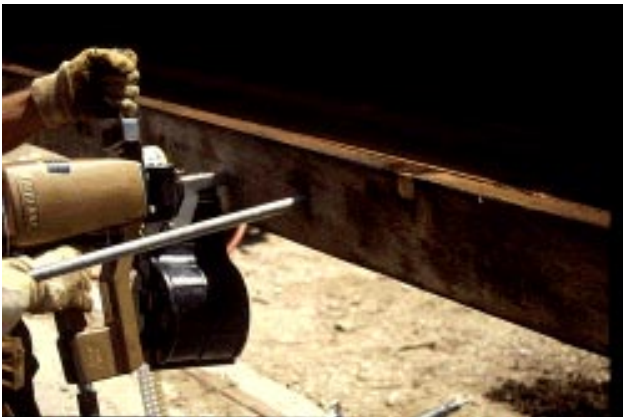
**Figure 9—Preassembly of the bridge components into modules at the fabrication plant. Temporary supports were used to align members (top); temporary dowels and nails were placed to fasten members (bottom).**

During construction of the substructure, prefabrication and preassembly of the superstructure were completed at a nearby lumber fabrication plant. After prefabrication, the bridge components were pressure treated with preservative and pre-assembly was completed (Fig. 7). To facilitate transportation and installation, the design specified assembly of the bridge into a series of six bridge modules (two exterior and four interior), to be placed side by side to form the bridge width (Fig. 8). Using this approach, the width of the glulam webs at the module interface was 5.125 in., which provided for a total web width of 10.25 in. when the modules were joined. At other locations, a web width of 8.75 in. was used. The bridge modules were assembled using nails and temporary dowels (Fig. 9), then transported to the bridge site on flatbed trailers.

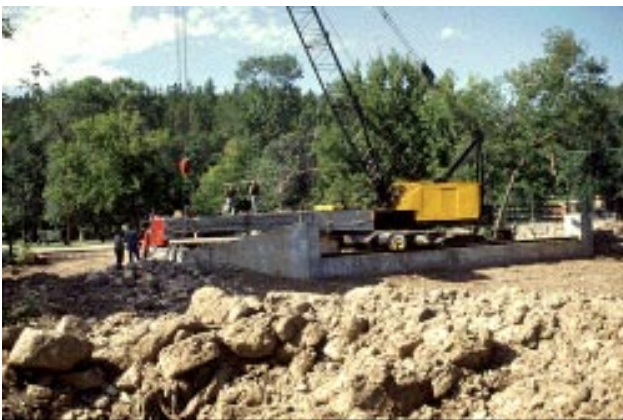
**Figure 10—Lifting preassembled bridge modules onto concrete abutments with an overhead crane.**

The bridge superstructure was installed July 27, 1992. At the bridge site, the modules were lifted and placed on the abutments by a large overhead crane (Fig. 10). Temporary dowels were removed and full-width, steel stressing bars

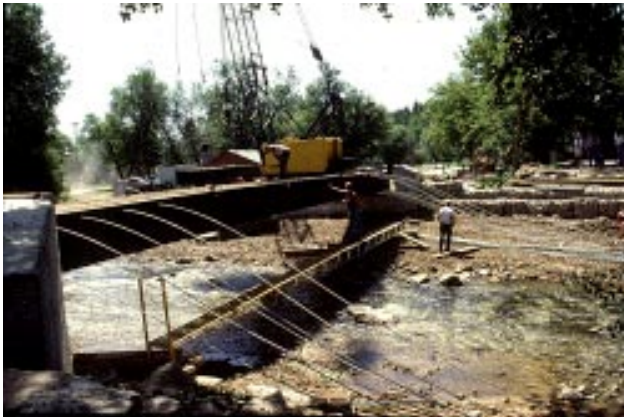
**Figure 11—Placement of full-width, steel stressing bars through prebored holes in the top and bottom flanges.**

were inserted by hand through prebored holes in the top and bottom flanges (Fig. 11). Steel anchorage plates and nuts were attached to each bar end, and the initial stressing of the bridge commenced.

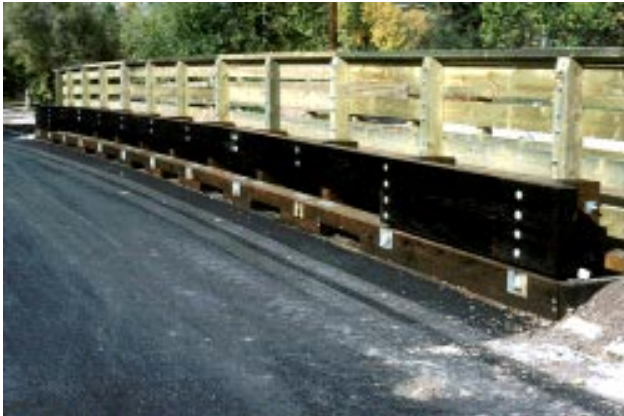
**Figure 12—The completed rail system and pedestrian sidewalk.**

installed approximately 6 weeks after bridge installation, and the railing and walkway were constructed approximately 3 months after bridge installation (Fig. 12). The completed Spearfish Creek bridge is shown in Figure 13.

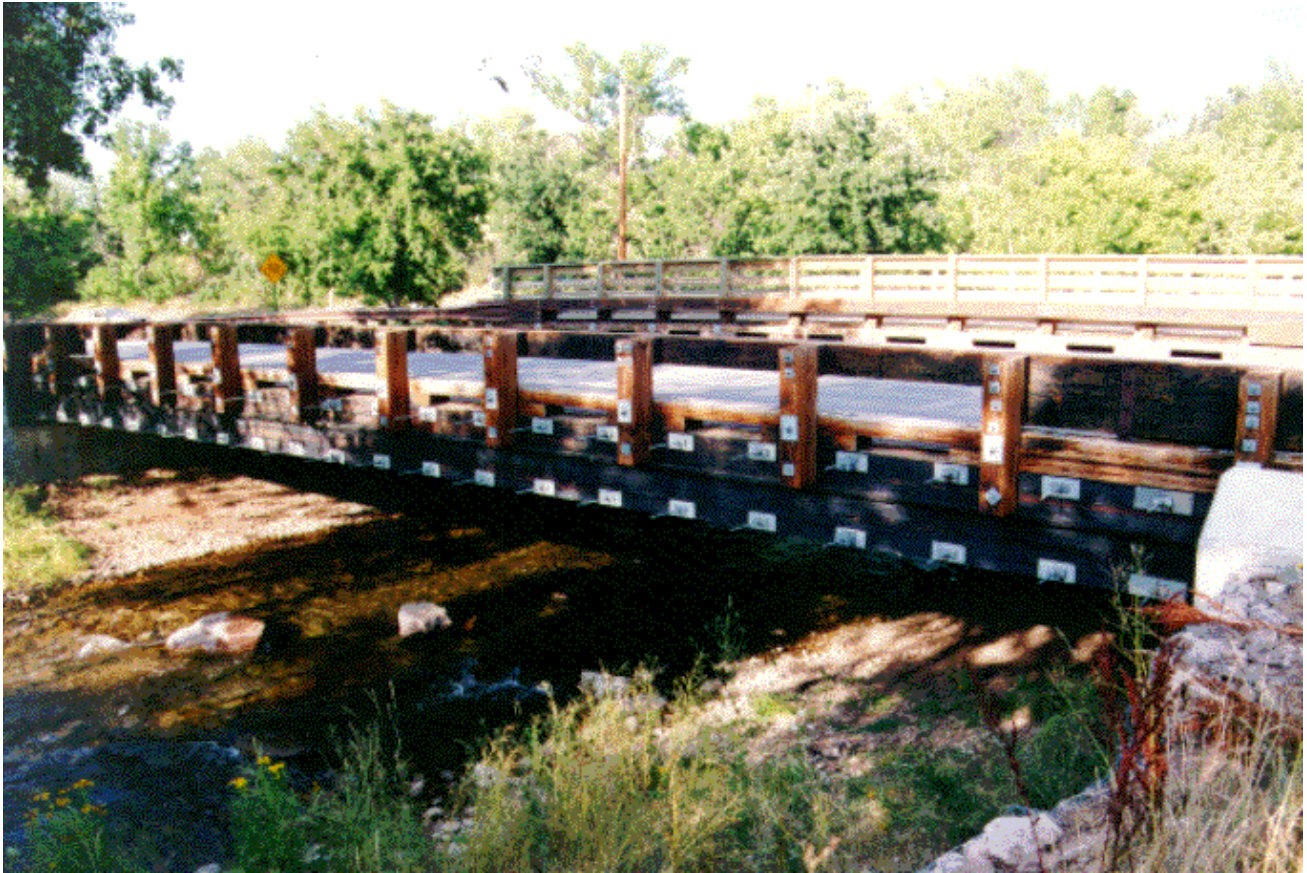
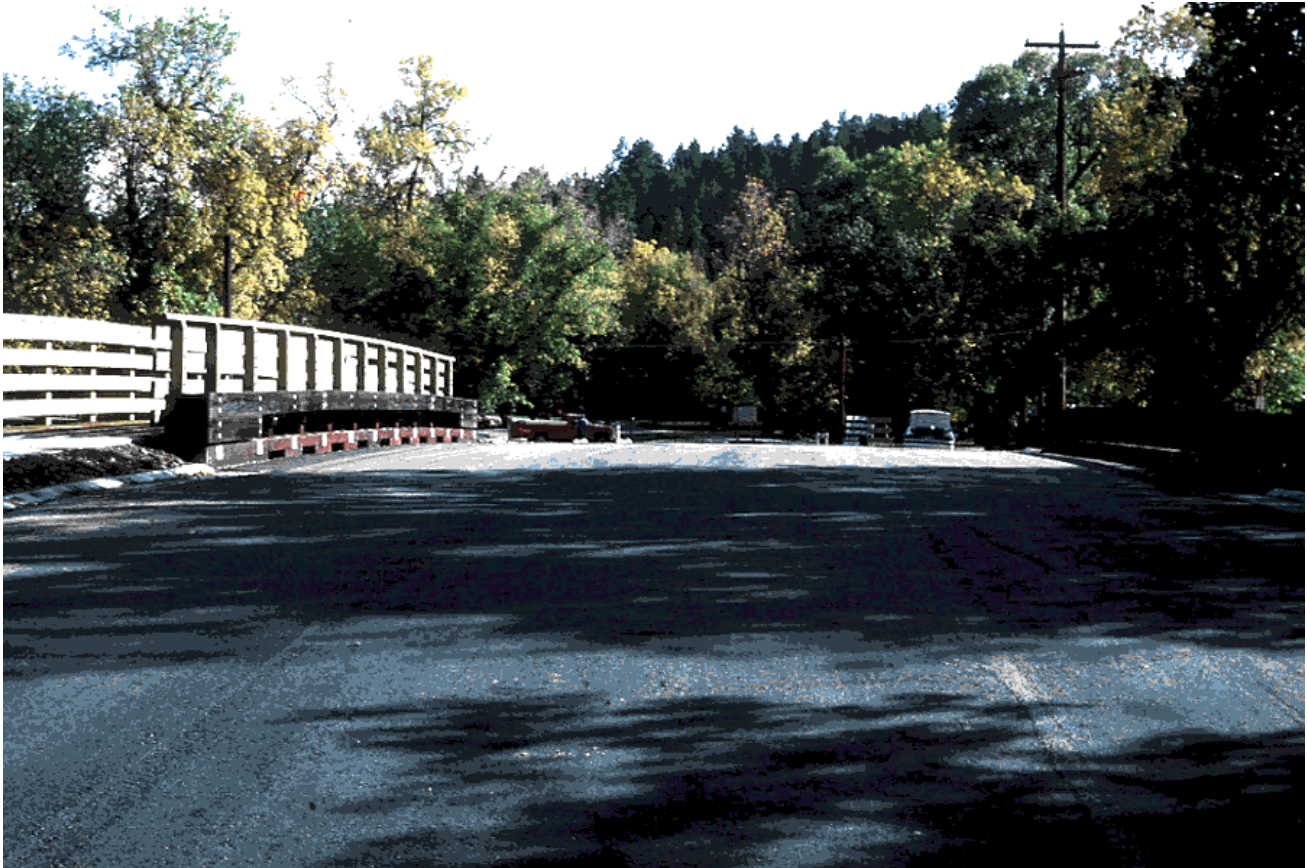
Figure 13—The completed Spearfish Creek bridge: side view (top) and end view (bottom), looking north.

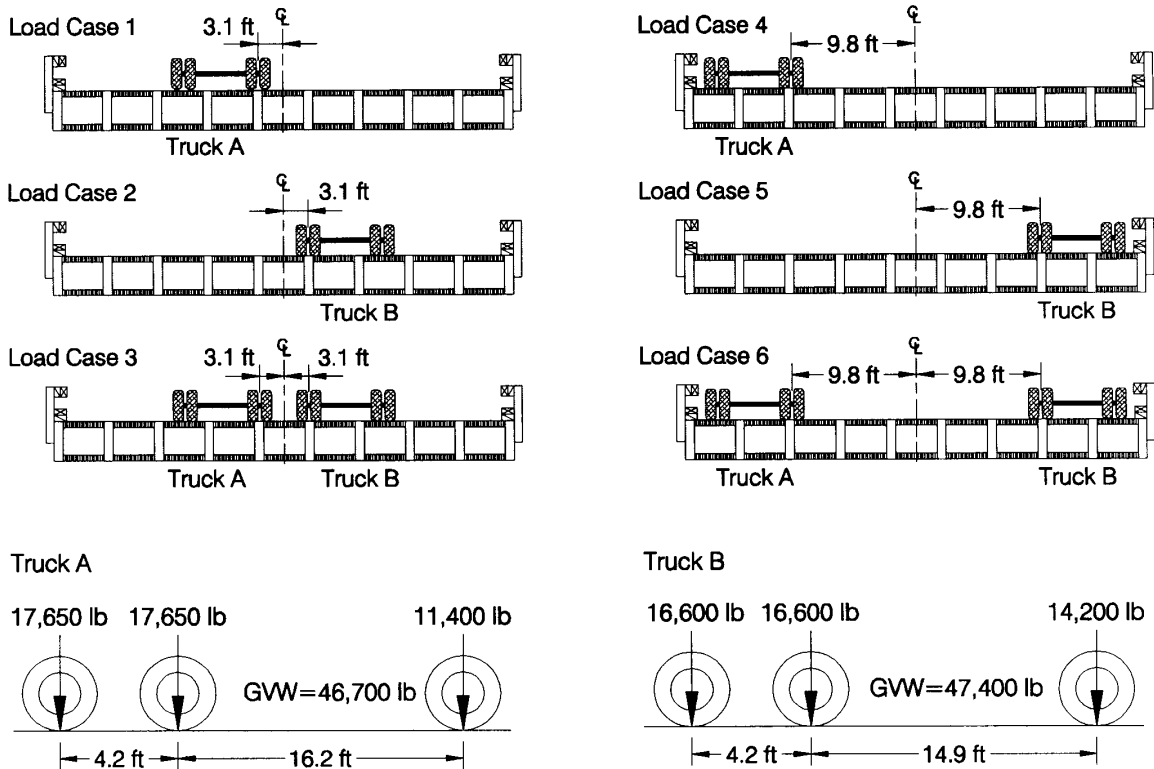
Figure 15—Load test 2 truck weights, axle spacings, and transverse load test positions.

Load test 2 was conducted August 22, 1994, and utilized six load cases and two fully loaded trucks: truck A with a gross vehicle weight of 46,700 lb and truck B with a gross vehicle weight of 47,400 lb (Fig. 15). To align the truck wheel lines directly over web members, the trucks were slightly offset in the transverse direction from the load test 1 positions. For load cases 1 to 3, the trucks were positioned 3.1 ft from the roadway centerline. For load cases 4 to 6, the trucks were positioned transversely 9.8 ft from the roadway centerline. The truck center of gravity was positioned at midspan for all load cases, and deflections were measured to within 0.04 in. Load cases 3 and 6 are shown in Figure 16.

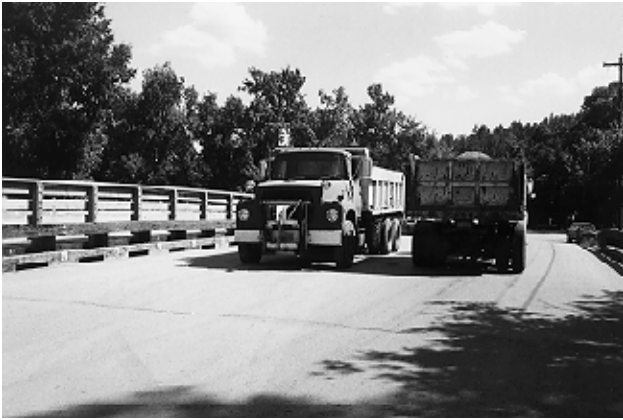
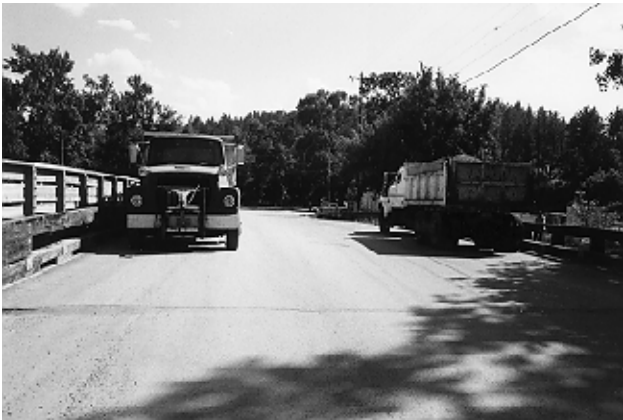
Figure 16—Load test 2 truck positions for load cases 3 and 6 (looking south).

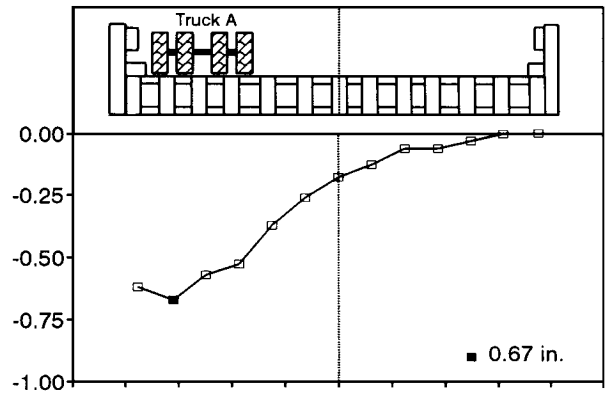
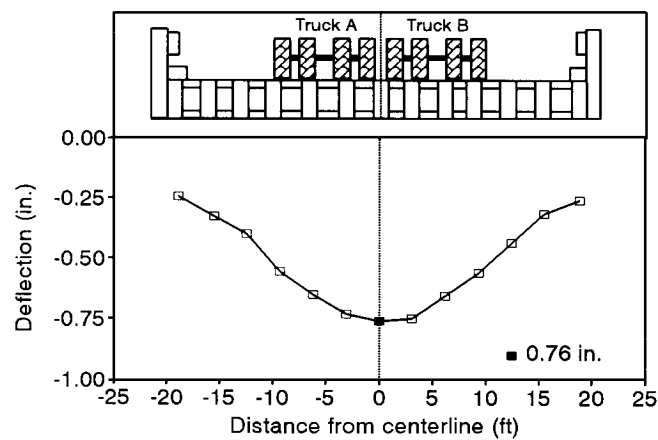
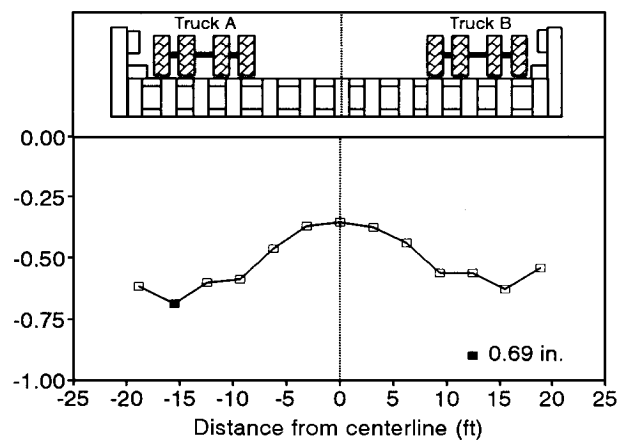
Figure 19—Load test 1 transverse deflection measured at the bridge centerspan (looking north). Bridge cross-sections and vehicle positions are presented to aid interpretation only and are not to scale.

Transverse deflections for load test 1 are presented in Figure 19. The maximum deflections for load cases 1 and 2 occurred under the inside truck wheel line and measured 0.45 and 0.5 in., respectively (Fig. 19a,b). For load case 3, the maximum deflection of 0.76 in. was at the roadway centerline and represented the largest measured deflection of all load cases (Fig. 19c). Maximum deflections for load cases 4 and 5 measured 0.67 and 0.63 in., respectively, and occurred near the outside truck wheel line (Fig. 19d,e). The maximum deflection for load case 6 measured 0.69 in. and was under the outside wheel line of truck A (Fig. 19f). For all load cases, the deflected shape of the centerspan cross-section follows the symmetrical truck positions, with maximum measured deflections for the single truck load cases occurring at the same relative positions for the two truck locations.

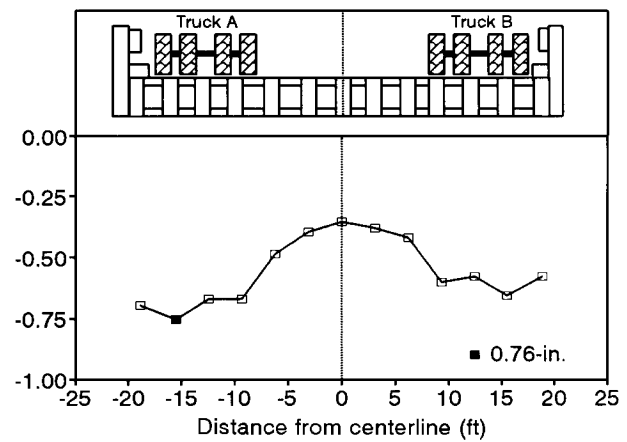
Figure 21—Load test 2 transverse deflection measured at the bridge centerspan (looking north). Bridge cross-sections and vehicle positions are presented to aid interpretation only and are not to scale.

Transverse deflections for load test 2 are shown in Figure 21. The maximum deflection of 0.51-in. for load case 1 occurred under the outside truck wheel line (Fig. 21a), and the

maximum deflection for load case 2 was 0.54 in. under the inside truck wheel line (Fig. 21b). For load case 3, the maximum deflection of 0.79 in. was measured under the inside wheel line of truck A, adjacent to the roadway centerline, again representing the largest deflection of all load cases (Fig. 21c). Maximum deflections for load cases 4 and 5 occurred under the outside truck wheel line and measured 0.74 and 0.70 in., respectively (Fig. 21d,e). The maximum deflection for load case 6 measured 0.76 in. and was under the outside wheel line of truck A (Fig. 21f).
