Research
Paper
FPL-RP-588

Field Performance of Timber Bridges

18. Byron Stress-Laminated Truss Bridge

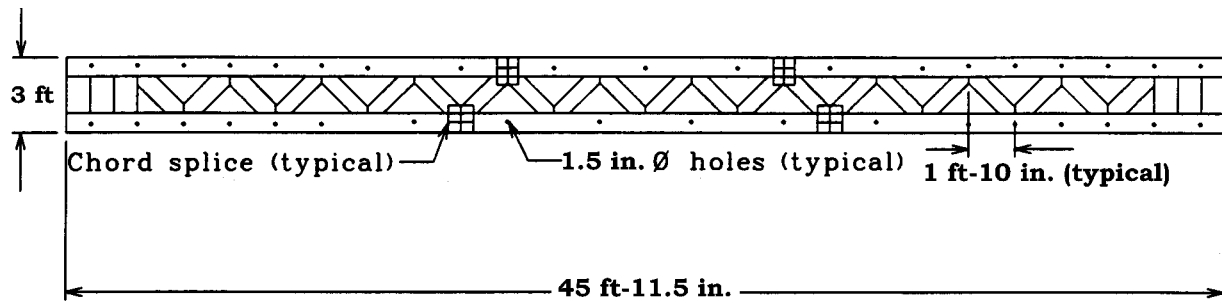
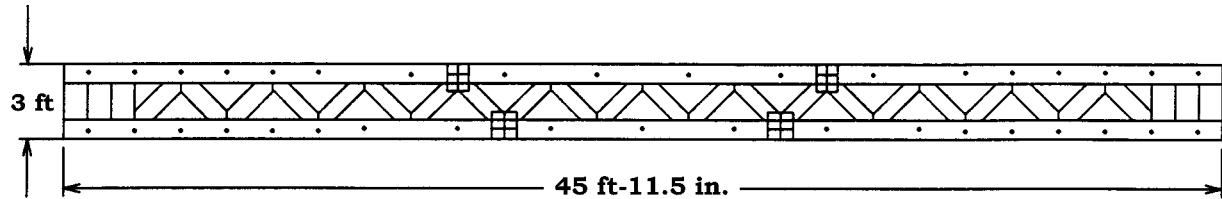
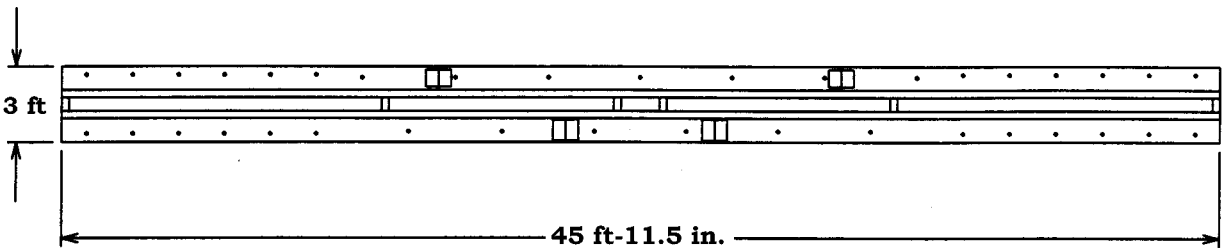
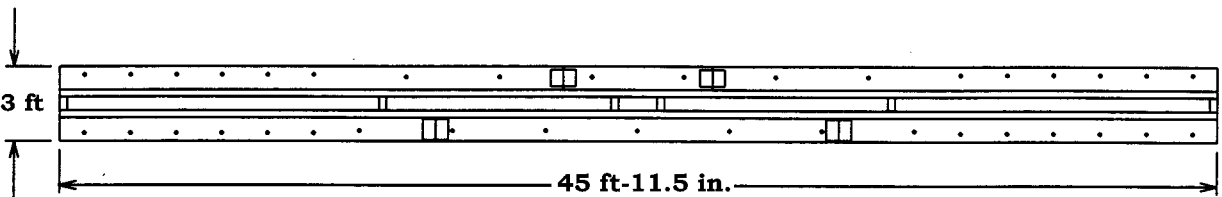
Figure 3—Profile of structural and spacer trusses.

Structural Truss Type I

Structural Truss Type II

Spacer Truss Type I

Spacer Truss Type II

Two truss configurations were used: structural and spacer. Each structural truss had 22 diagonal webs that connected the top and bottom chords. The structural trusses were placed next to the spacer trusses. The spacer trusses had deeper top and bottom chords compared with those of the structural trusses. Each spacer truss was connected with only enough metal plate connector joints and vertical webs to allow it to be handled as a single unit. The deeper chords of the spacer trusses covered the metal connector plates of the structural trusses. This detail prevented the structural truss metal plate connectors from withdrawing as result of cyclic loading and moisture and temperature changes.

The bridge was constructed from six rectangular modules. Each module was staggered by 22 in. to allow for the 18° skew. The skew required that two types of structural trusses be developed to maintain continuous web openings across the bridge for the prestressing rods. These structural trusses differed in the origination of the diagonal webs. For Type I trusses, the diagonal webs started from the top chord, and for Type II trusses, the webs started from the bottom chord. These two truss types were alternated from module to module.

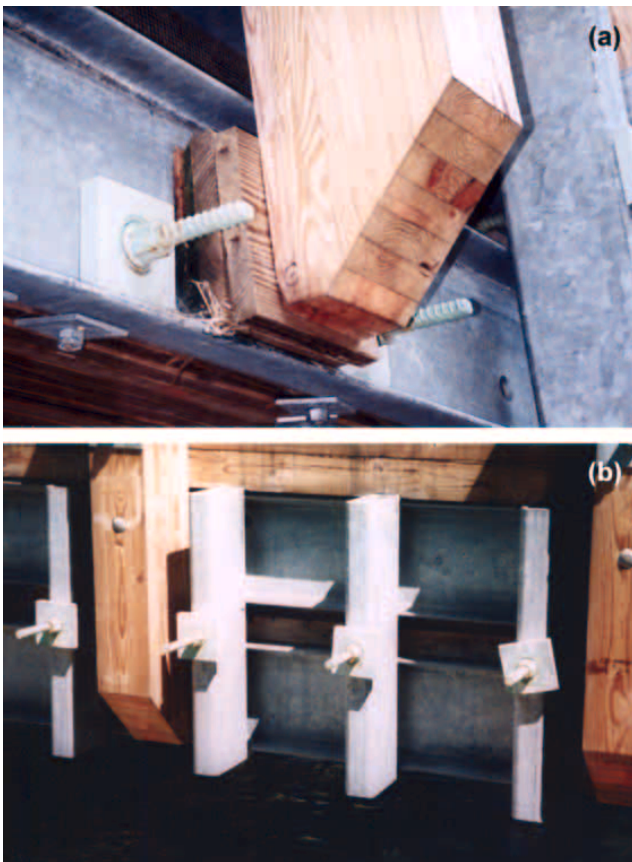
Figure 5—Anchorage system for Byron bridge: (a) continuous steel channel and discrete plate bar configuration; (b) continuous steel channel and vertical structural tube bar configuration.

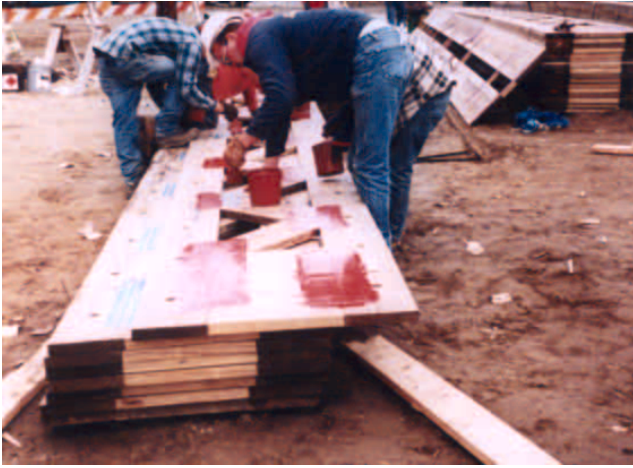
Figure 6—Brush painting of galvanized metal plate connectors of each truss at site for additional protection from corrosion.

The CCA-treated trusses were fabricated in Biddeford, Maine, and transported to the bridge site on a flatbed trailer in bundles banded together with light metal straps. Before the bridge was assembled, the galvanized metal plate connectors of each truss were brush painted at the site with an epoxy-based paint for additional protection from corrosion (Fig. 6). After the paint dried, the trusses were placed by crane onto temporary supports to form mini-modules (Fig. 7).

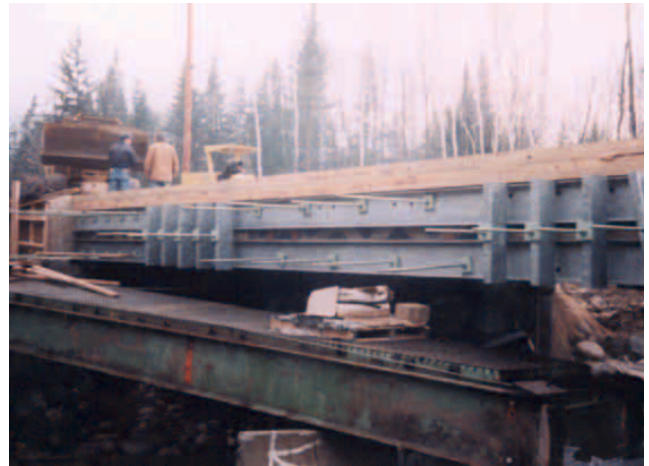
Figure 9—Installation of stressing system.

The mini-modules consisted of 10 to 12 trusses and were formed by nailing structural trusses to spacer trusses. Figure 8 shows the assembly of a mini-module at the bridge site. After the trusses were nailed together, the mini-modules were again banded together with light metal straps. The mini-modules were lifted by a crane and placed side by side to form the bridge deck. They were positioned to form six rectangular modules to account for the 18° skew. To hold the trusses in position, several steel bars were inserted through holes in the chords as the modules were assembled. After all the modules were assembled, the remaining steel stressing bars were inserted through predrilled holes in the truss chords and through some web openings. Steel bearing channels were installed on the edge of the bridge, followed by the structural tubes, anchor plates, and nuts (Fig. 9).

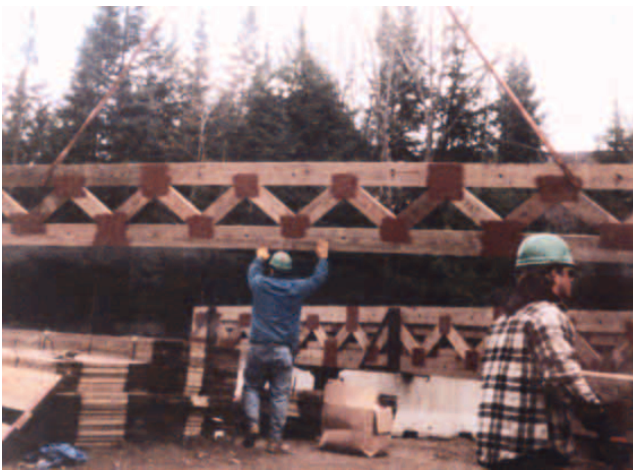
Figure 7—Placement of painted trusses onto temporary supports for formation of mini-modules.

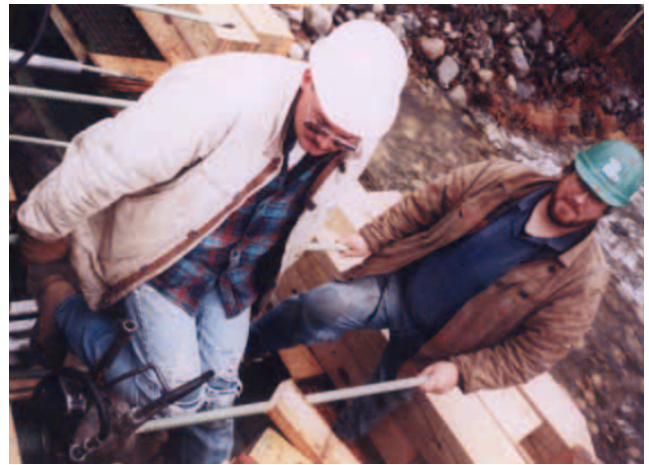
Figure 10—Tightening of stressing bars during stressing.

sequentially, beginning at one end of the bridge (Fig. 10). This procedure was repeated until the bars held the desired stress of 63 lb/in². The bars were retensioned at 1 week, 6 weeks, 9 months, 22 months, and 54 months after installation to the full design stress of 125 lb/in² using the same procedure.

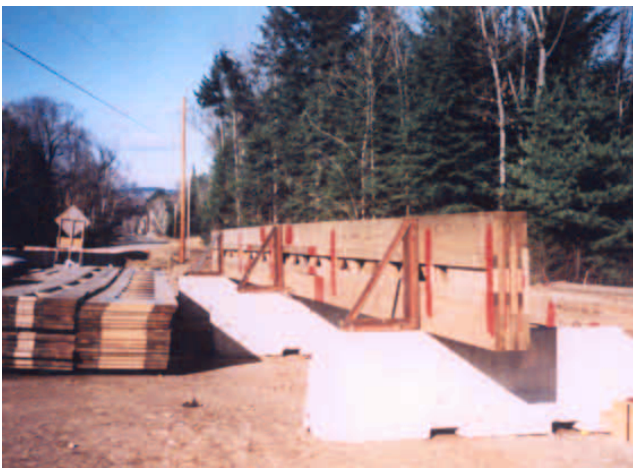
Figure 8—Preassembly of laminations into mini-modules at bridge site.

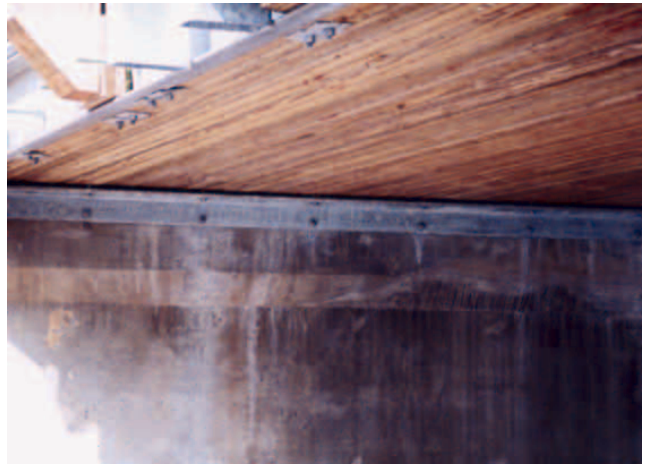
Figure 11—Superstructure was attached by bolting steel angles to sides of abutments, then bolting bridge to steel angles.

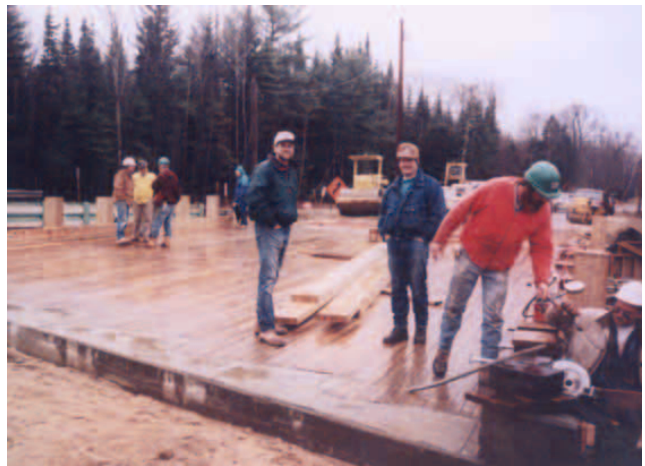
Figure 12—Bridge after construction of backwalls and installation of rail post and curb.

After the superstructure was attached, construction of the concrete backwalls was completed. The glulam curb and rails were installed shortly after the backwalls were poured (Fig. 12). To protect the bridge from moisture, one coat of adhesive primer was painted directly onto the deck, followed by the installation of two layers of self-sealing waterproof membrane. The waterproof membrane was wrapped over the backwalls to completely seal the top surface of the structure from moisture (Fig. 13). The bridge was paved with a 1-in. leveling course and a variable thickness bituminous pavement, measuring 3.5 in. at the crown and 1.5 in. at the curb. The completed Byron bridge is shown in Figure 14.

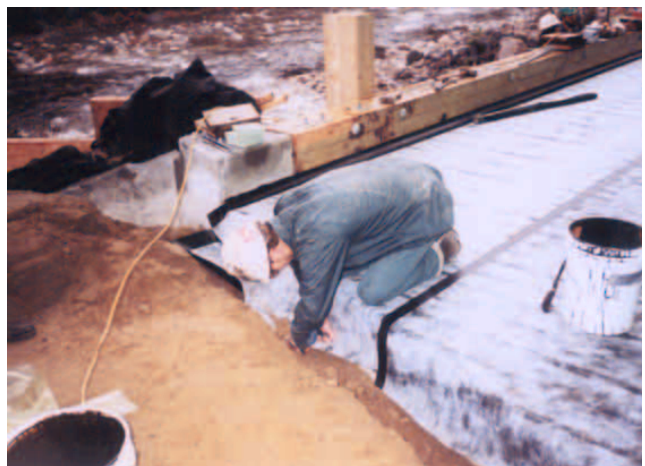
Figure 13—Installation of waterproof membrane.

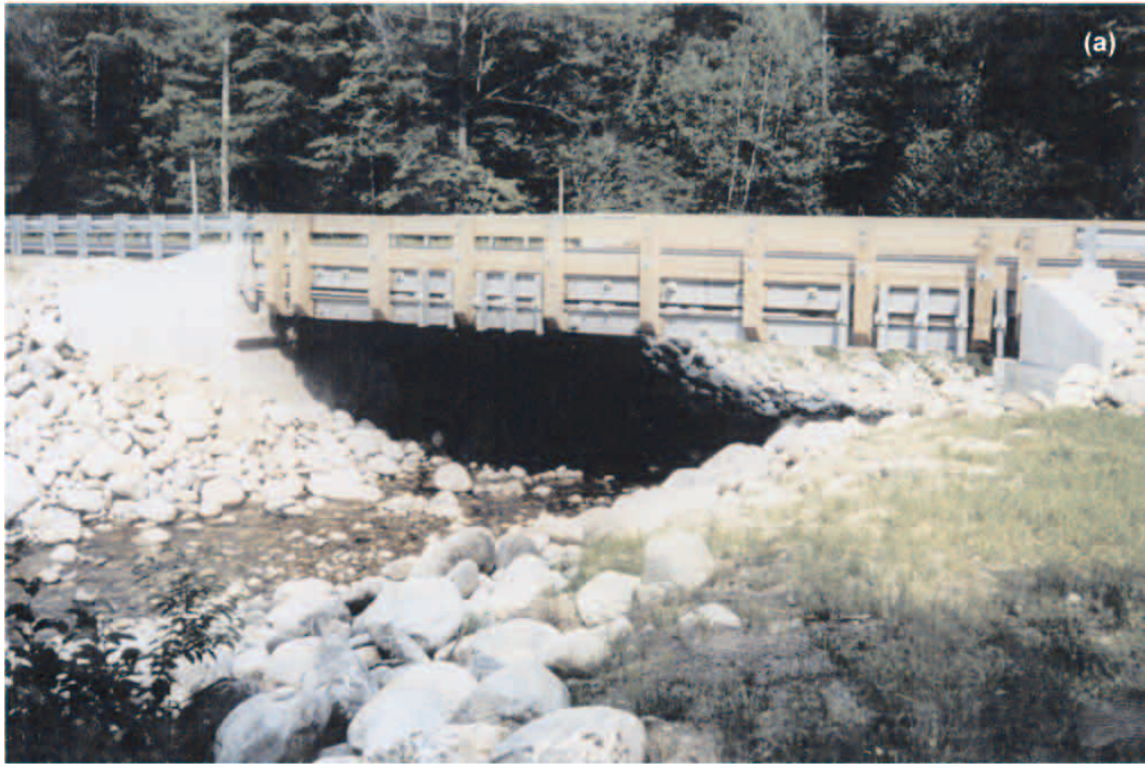
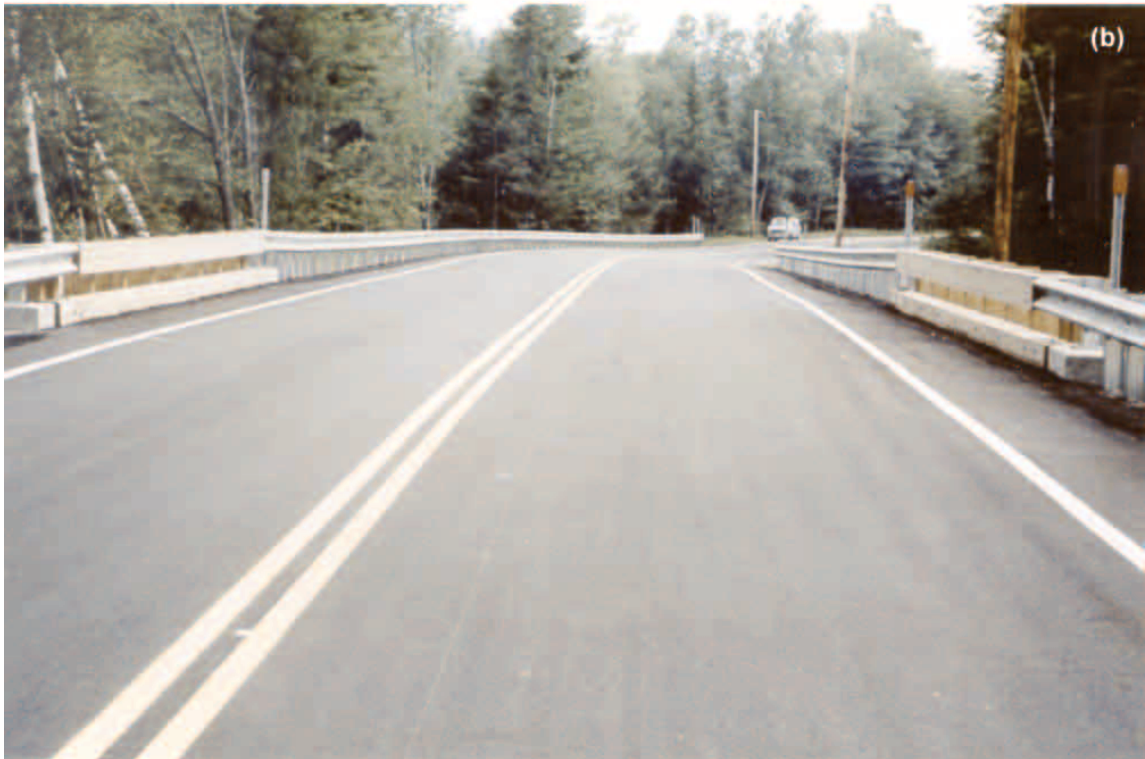
Figure 14—Completed Byron bridge: (a) profile of completed bridge (looking east); (b) completed bridge just after paving (looking south).

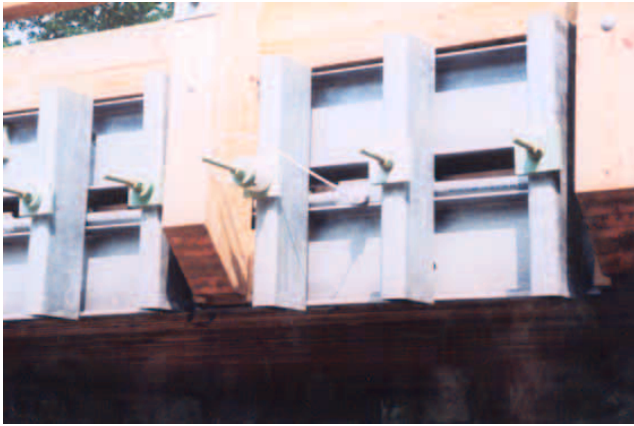
Figure 15—Load cells were installed on stressing bars to monitor changes in bar tension.

During the scheduled retensionings, bar force was measured with calibrated steel load cells developed at the University of Maine (Fig. 15) and with a hydraulic jack. The load cells were installed on six bars prior to the initial construction stressing. Load cell measurements were obtained using a computer-controlled data acquisition system. Strain measurements were converted to units of bar tensile force by applying a calibration factor to the strain reading. Bar force measurements were also obtained from five bars prior to each retensioning by noting the jack pressure required to move the anchorage nut away from the anchorage plate of each bar. The jack pressure was converted to bar force by applying a laboratory calibration factor to the pressure value.

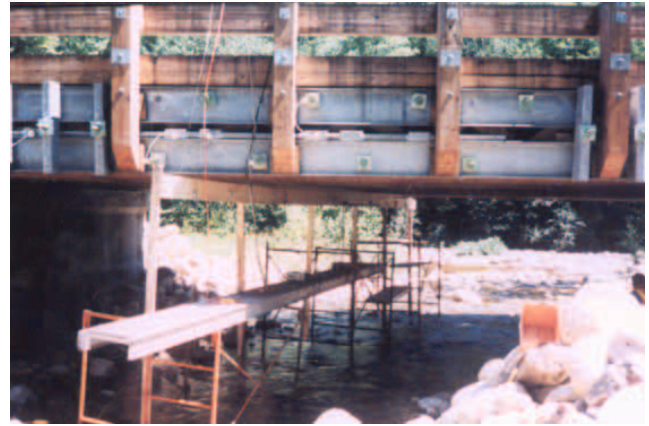
Figure 16—Bridge deflections of load tests 1 and 2 were measured using displacement transducers attached to a wood beam supported by scaffolding.

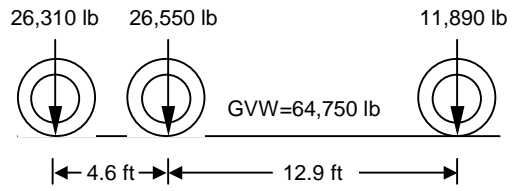
Figure 17—Truck weights, axle spacings, and transverse load test positions for load test 1.

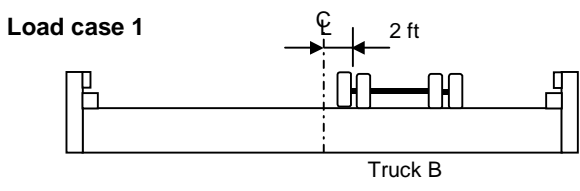
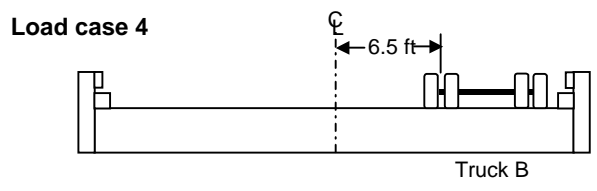
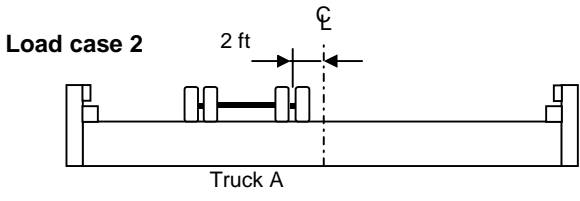
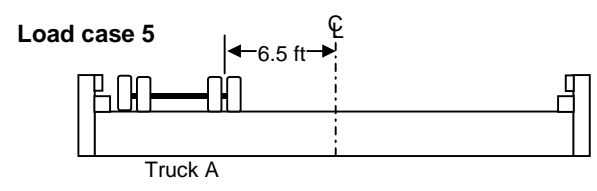
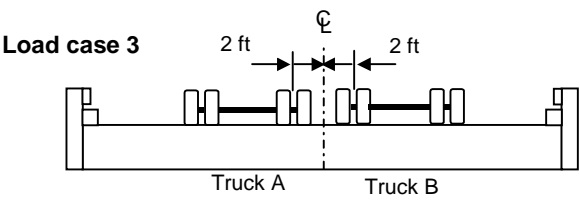
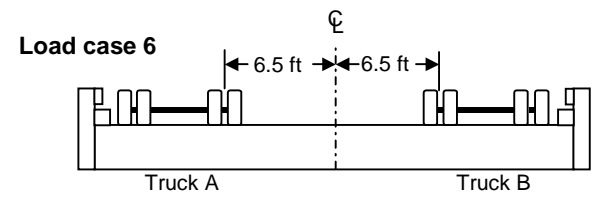
Figure 18—Truck weights, axle spacings, and transverse load test positions for load test 2.

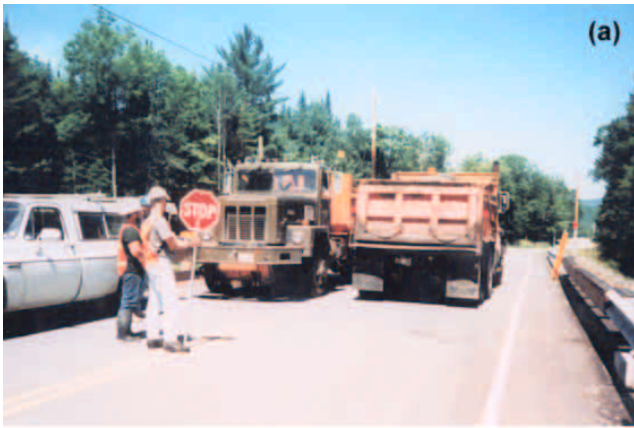
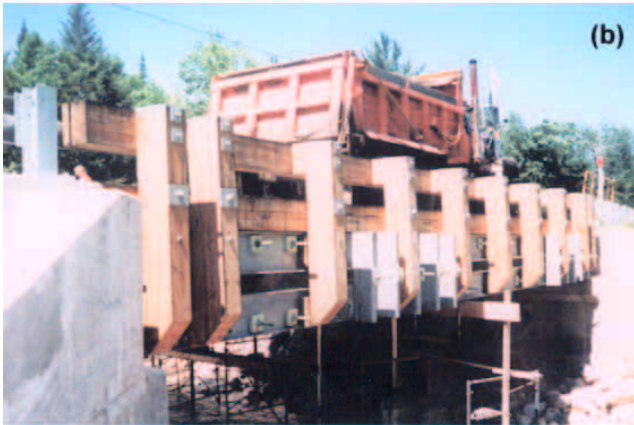
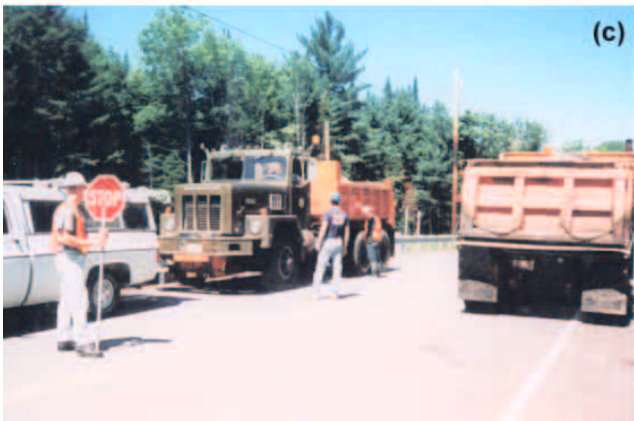
Figure 19—Truck positions for load test 2 for three load cases (looking north): (a) load case 3, (b) load case 4, (c) load case 6.

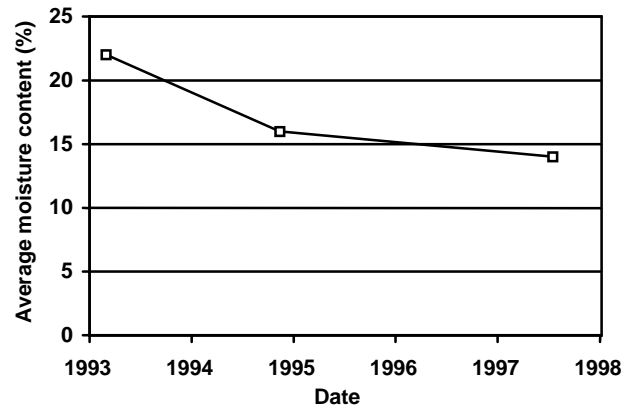
Figure 20—Average trend in wood moisture content.

The average trend in wood moisture content is presented in Figure 20; measurements were taken in September. When monitoring was initiated, average wood moisture content was approximately 22%. After 20 months of service, moisture content decreased to 16%, and after 53 months, it stabilized at approximately 14%. Moisture content measurements and visual inspections of the wood indicated that the waterproof membrane and pavement crown were effective in protecting the bridge from water.

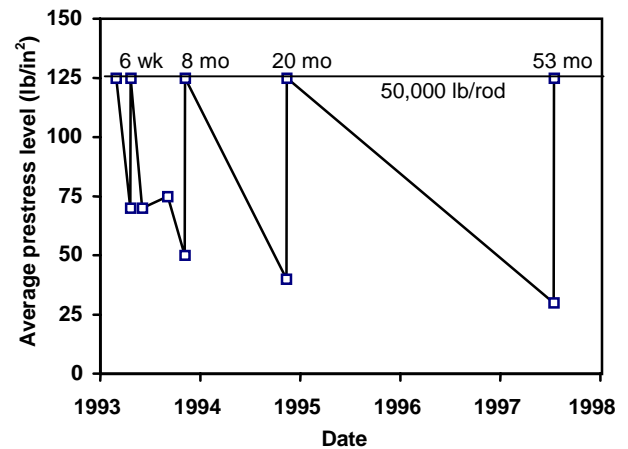
Figure 21—Average trend in prestress level of bar force.

The average trend in bar force is shown in Figure 21; measurements were taken in September. For stress-laminated structures to perform efficiently, adequate bar force must be maintained to prevent interlaminar slip. The bar force was expected to decrease after construction as a result of the combined effects of a decrease in wood moisture content, stress relaxation, and seating of the metal plate connectors. Therefore, the bridge was retensioned to the full design value
