Protecting and Enhancing River and Stream Continuity

River and Stream Continuity Partnership

River & Stream Continuity Project

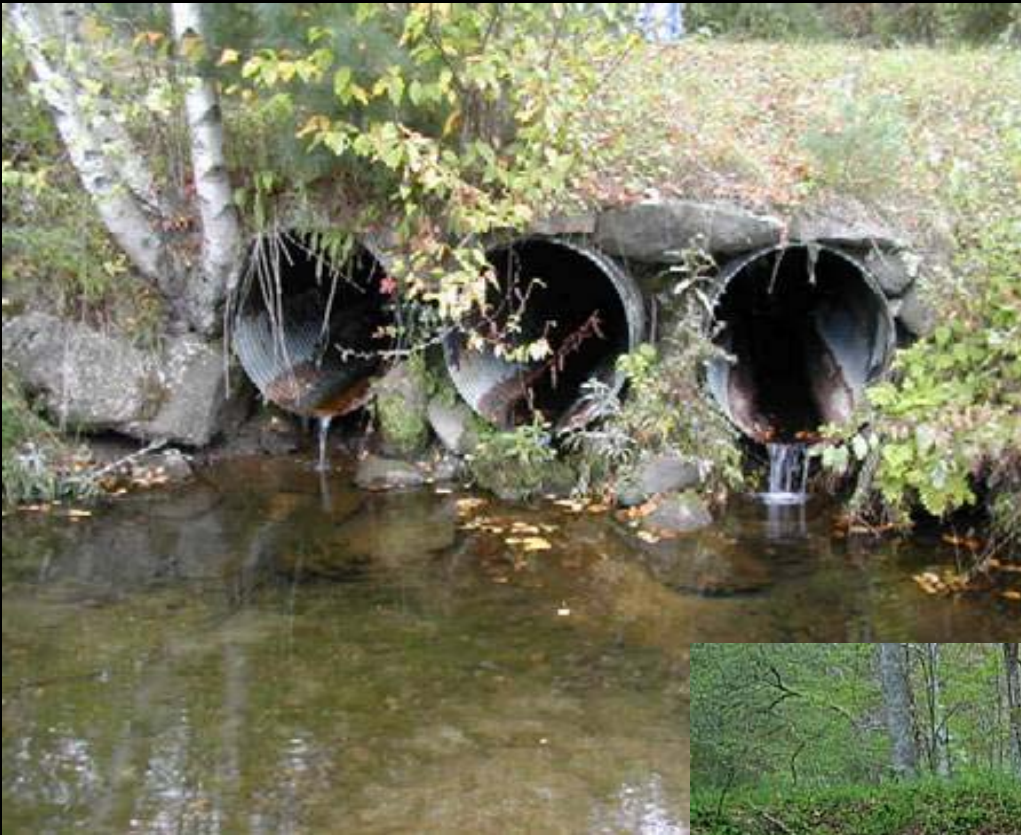
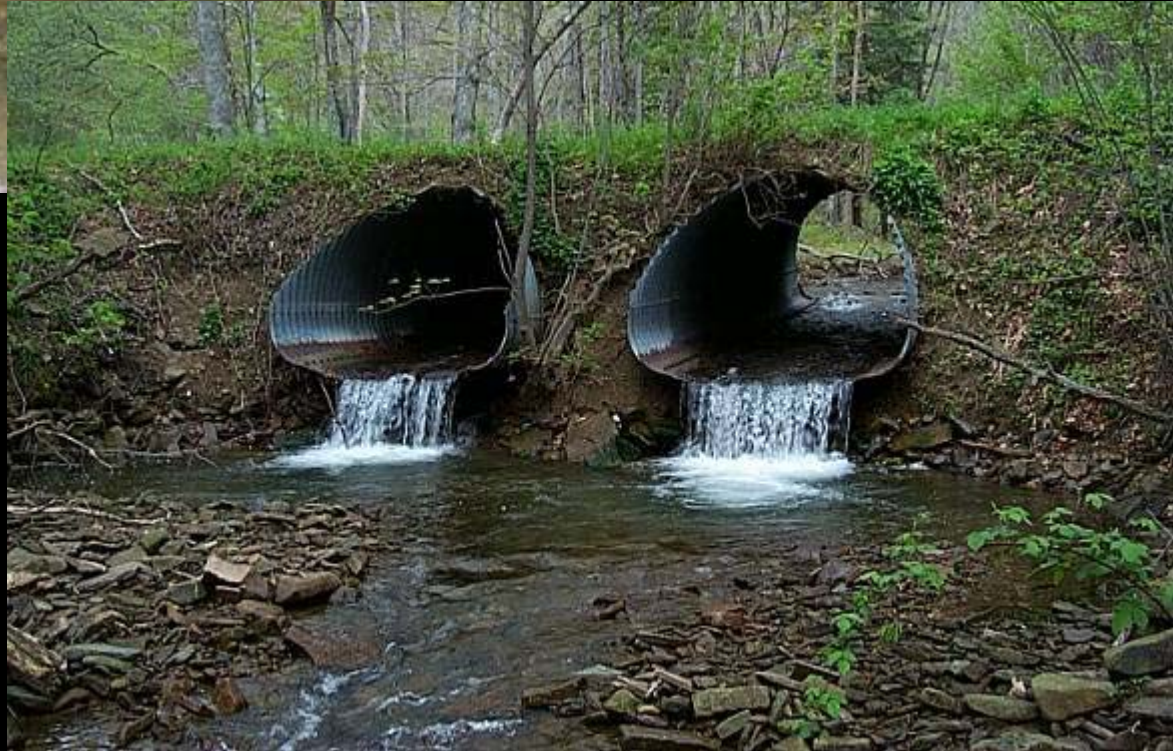
Inlet Drop

Outlet Drop (Perching)

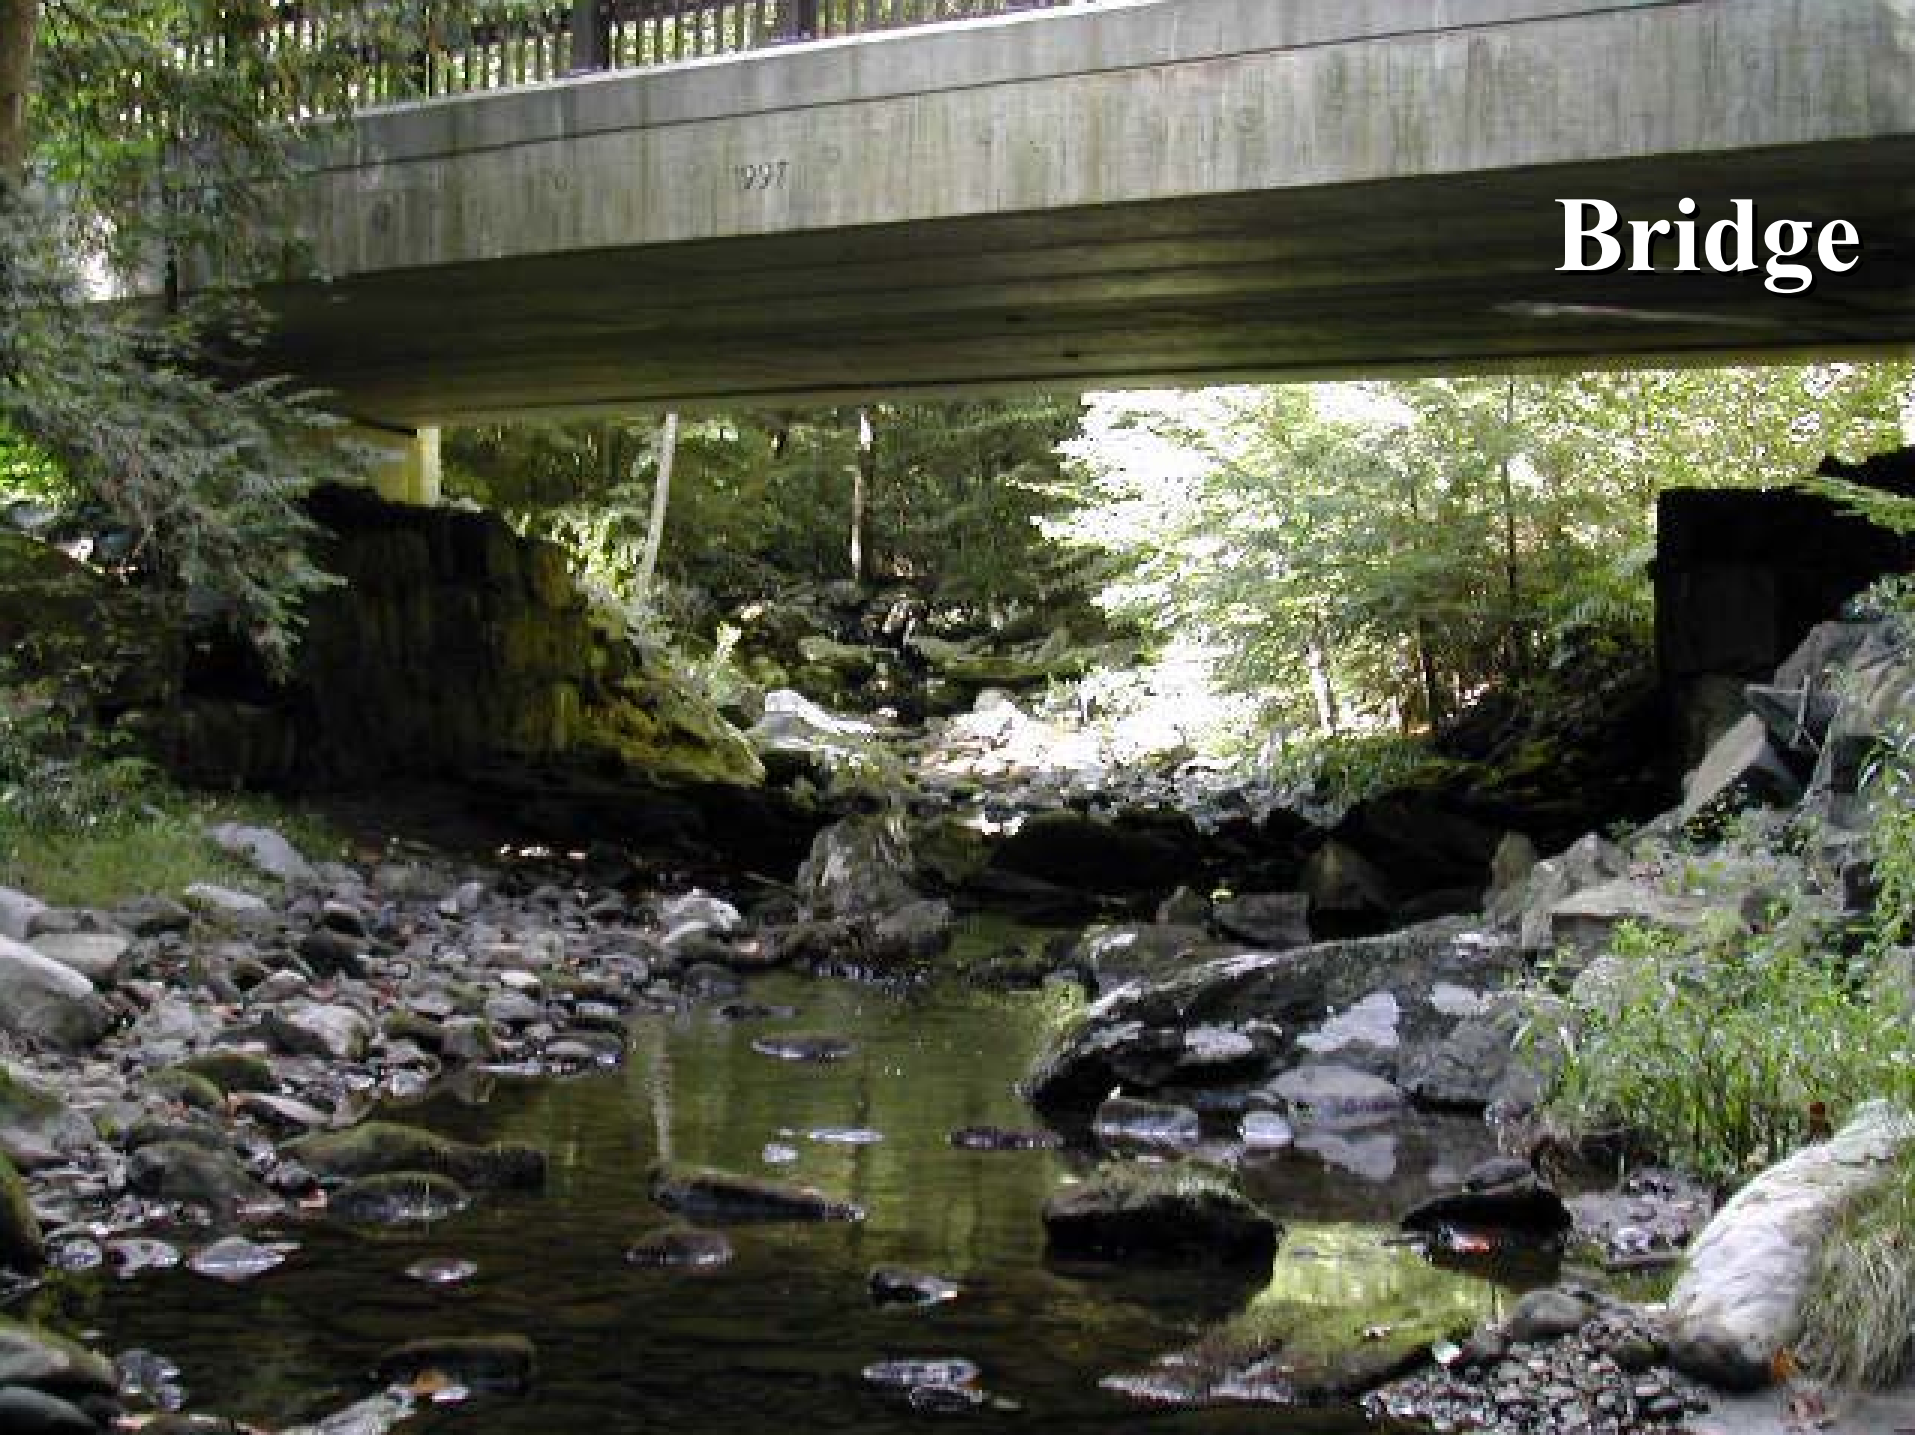
Bridge

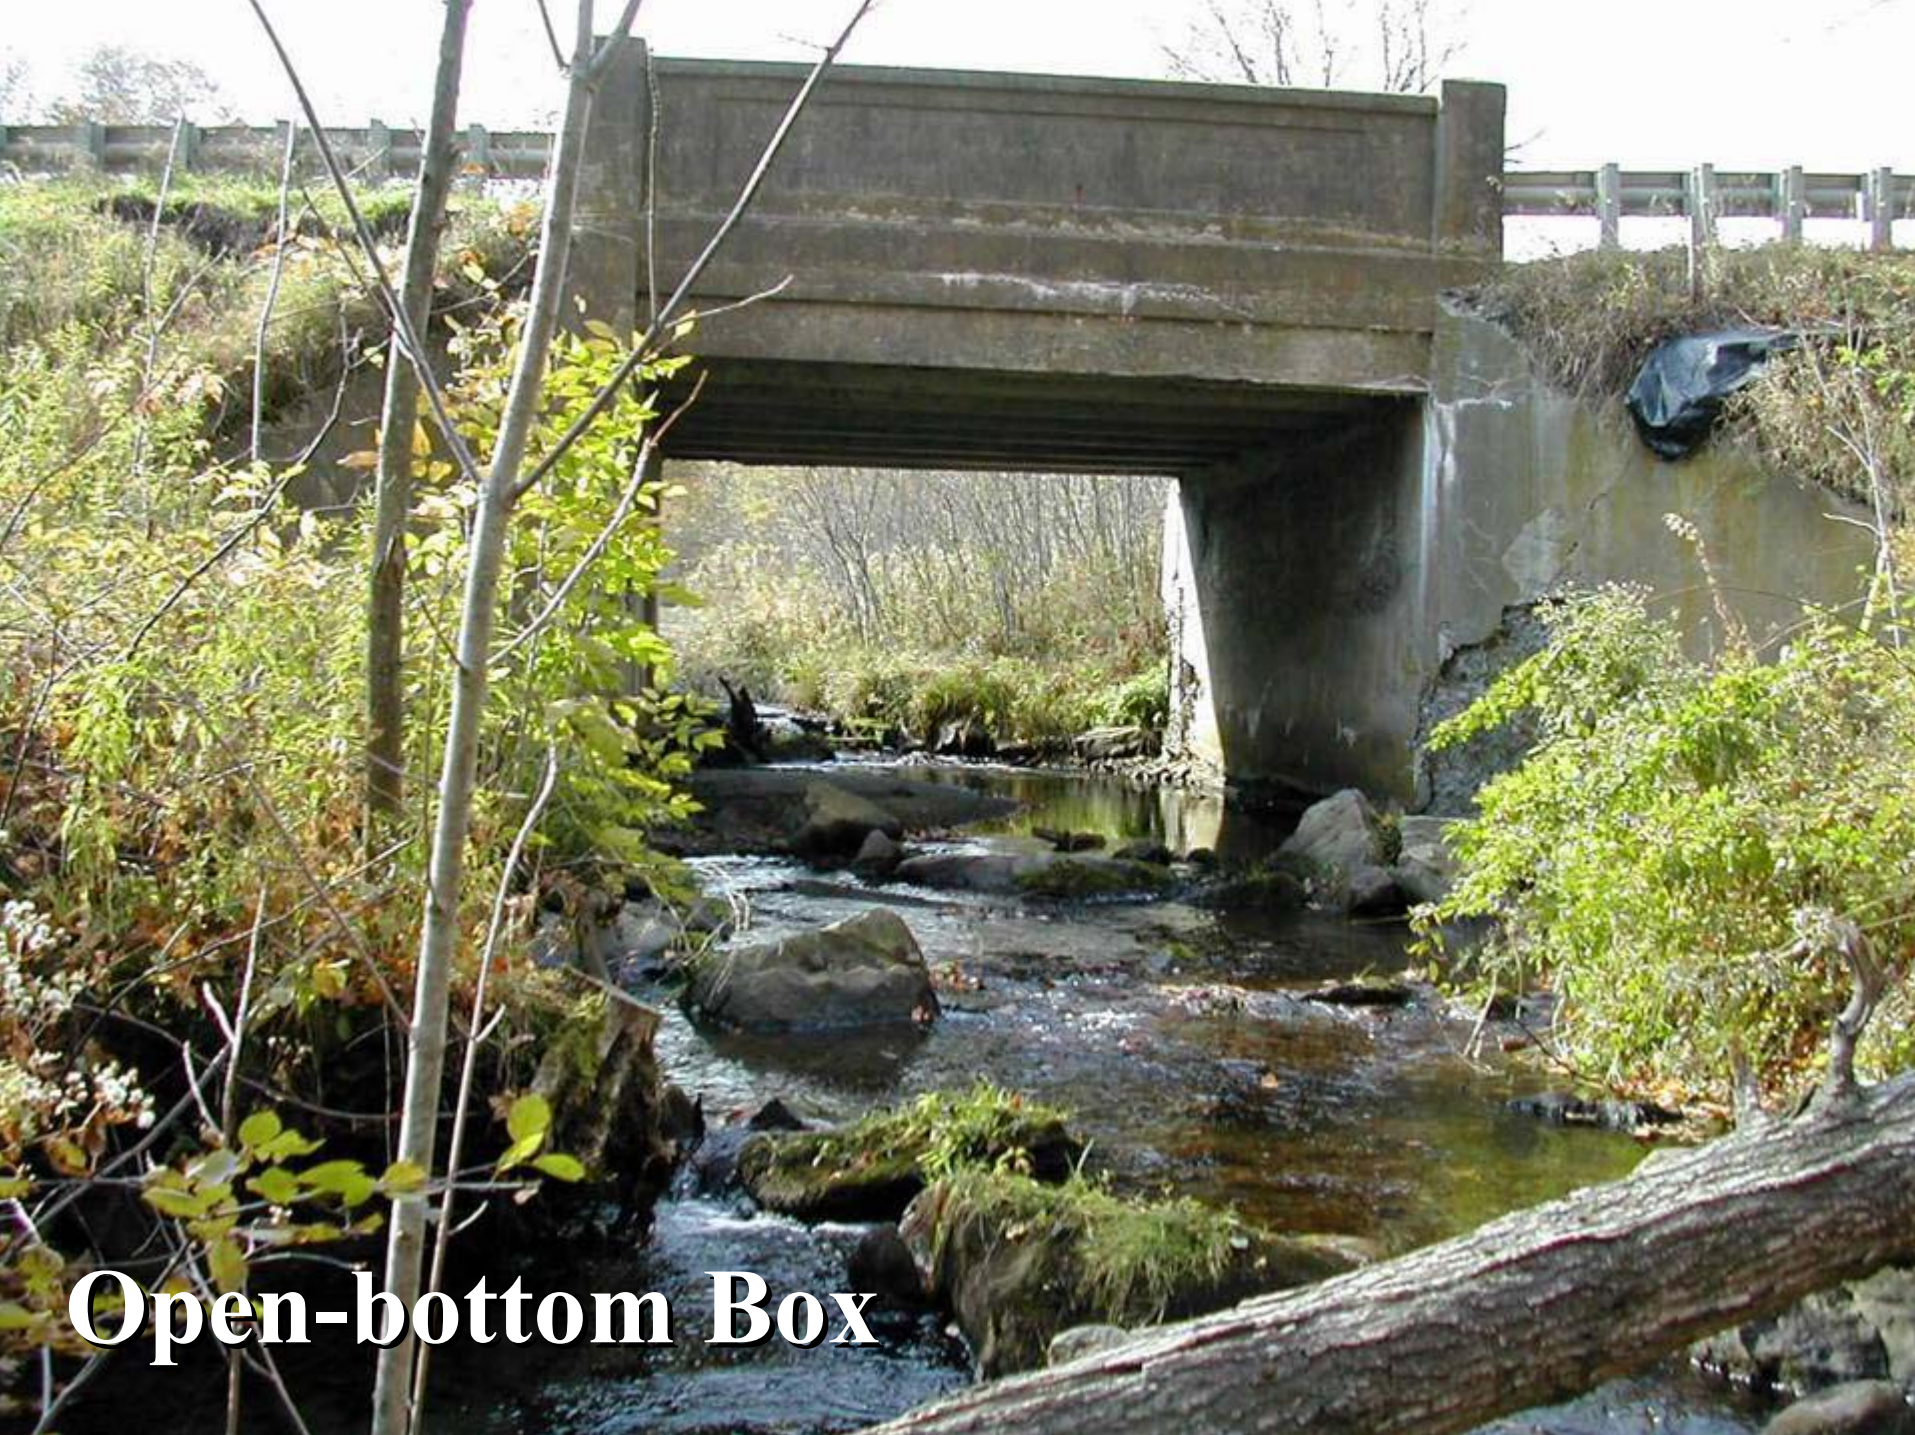
Open-bottom Box

Open-Bottom Arch

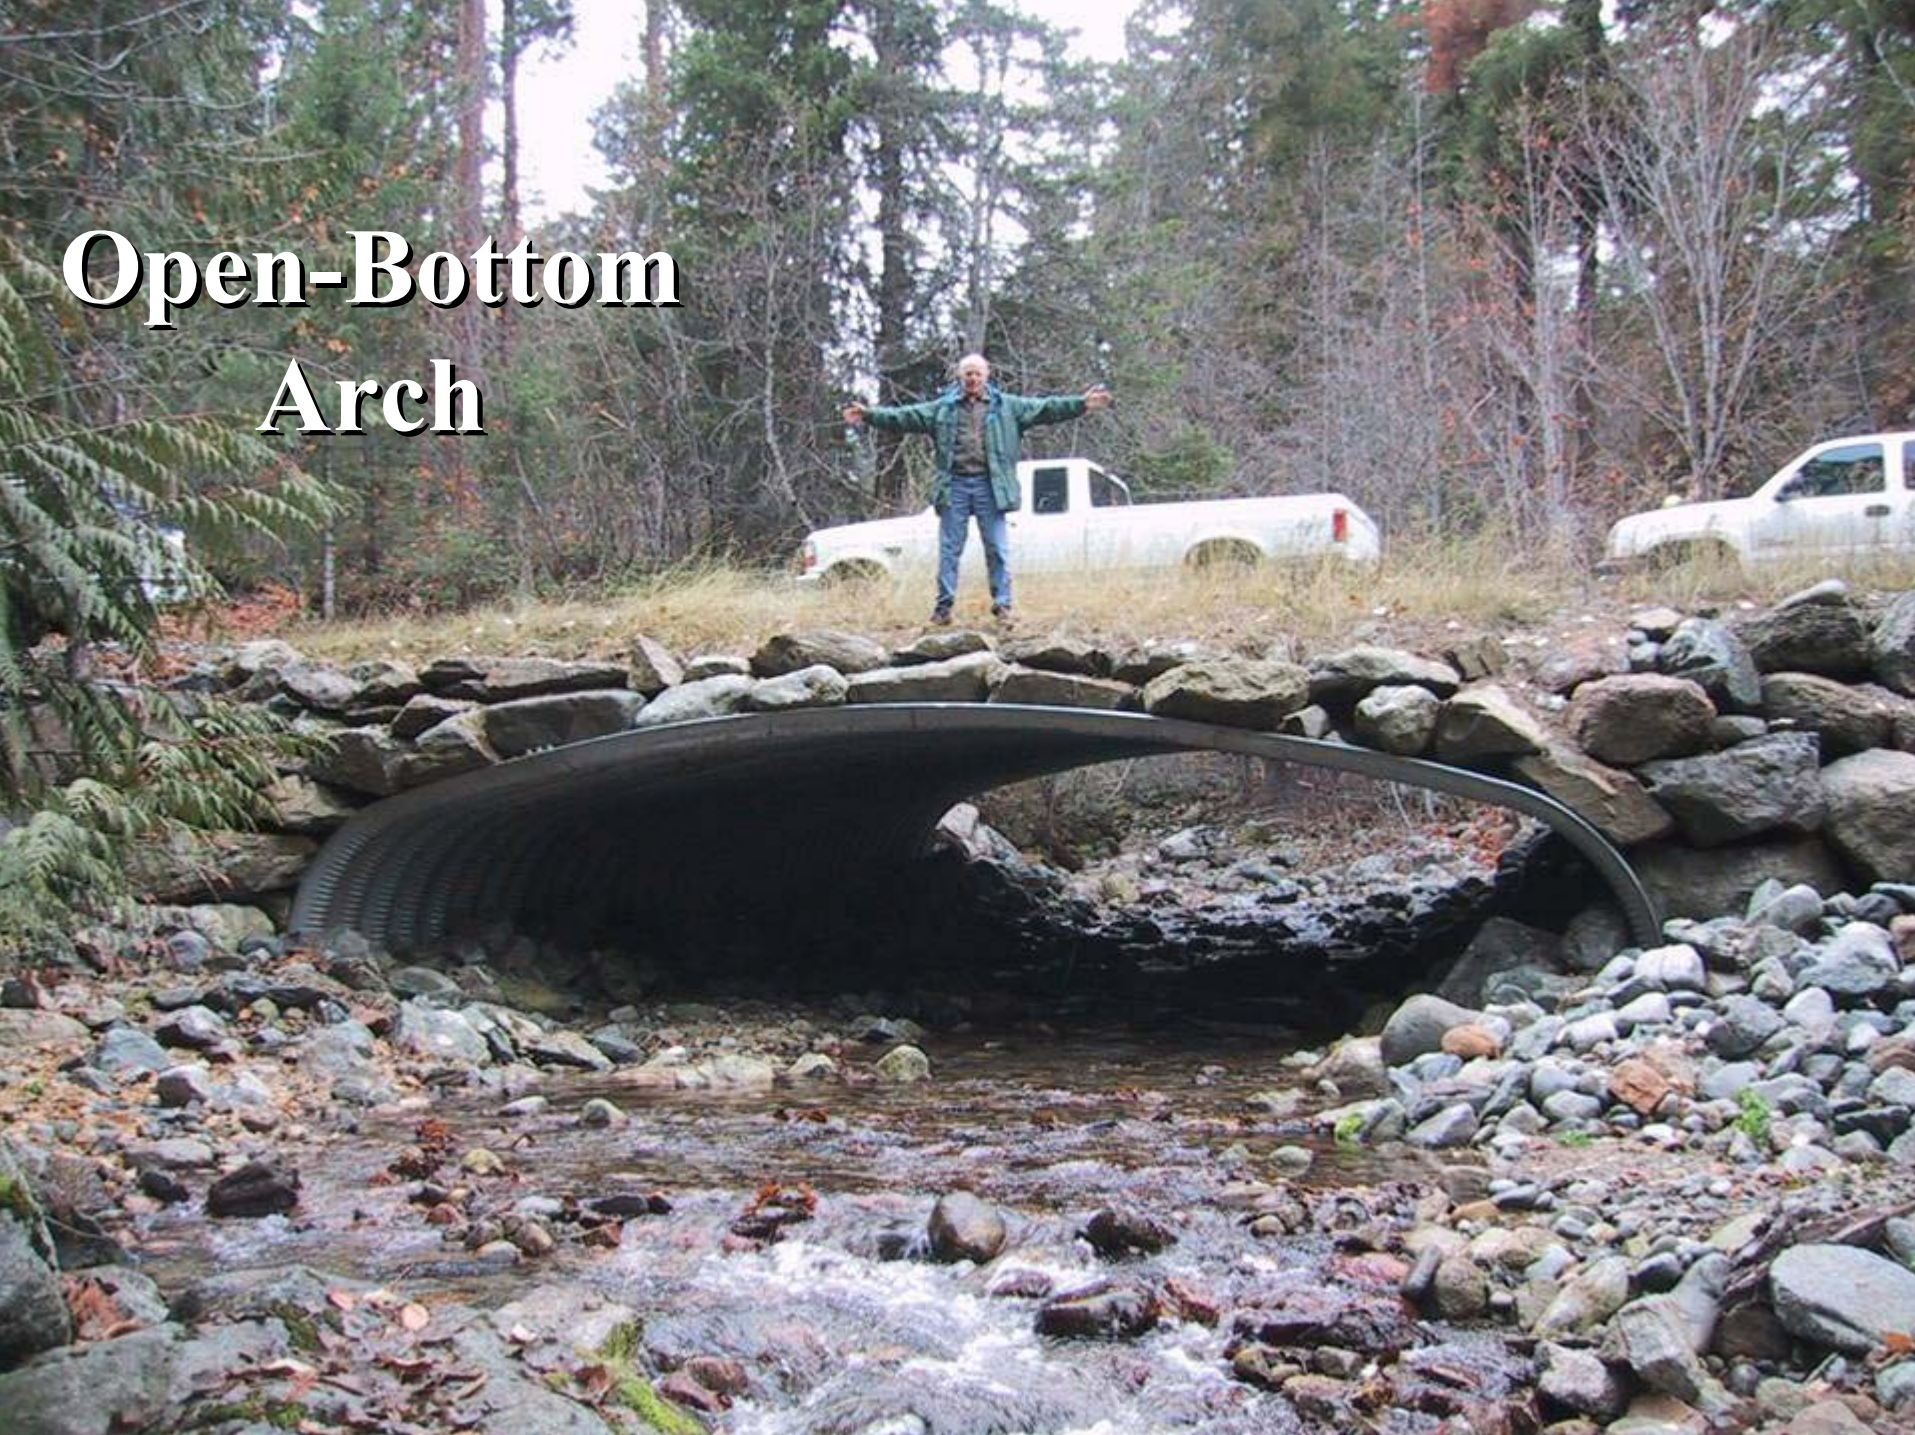
Stream Simulation Culvert

- **Bridge span preferred**
- **If a culvert then embedded ≥ 2 foot; ≥ 1 foot and 25% for corrugated round culverts**
- **Natural bottom substrate within culvert (matching upstream and downstream substrates)**
- **Spans channel (1.2 x bankful width)**
- **Designed to provide water depths and velocities at a variety of flows that are comparable to those found in upstream and downstream natural stream segments (e.g. low flow channel)**
- **Openness ratio ≥ 0.25 (calculated in meters)**
