ERDC/EL SR-00-11

# **Status of Waterhyacinth/Hydrilla Infestations and Associated Biological Control Agents in Lower Rio Grande Valley Cooperating Irrigation Districts**

September 2000

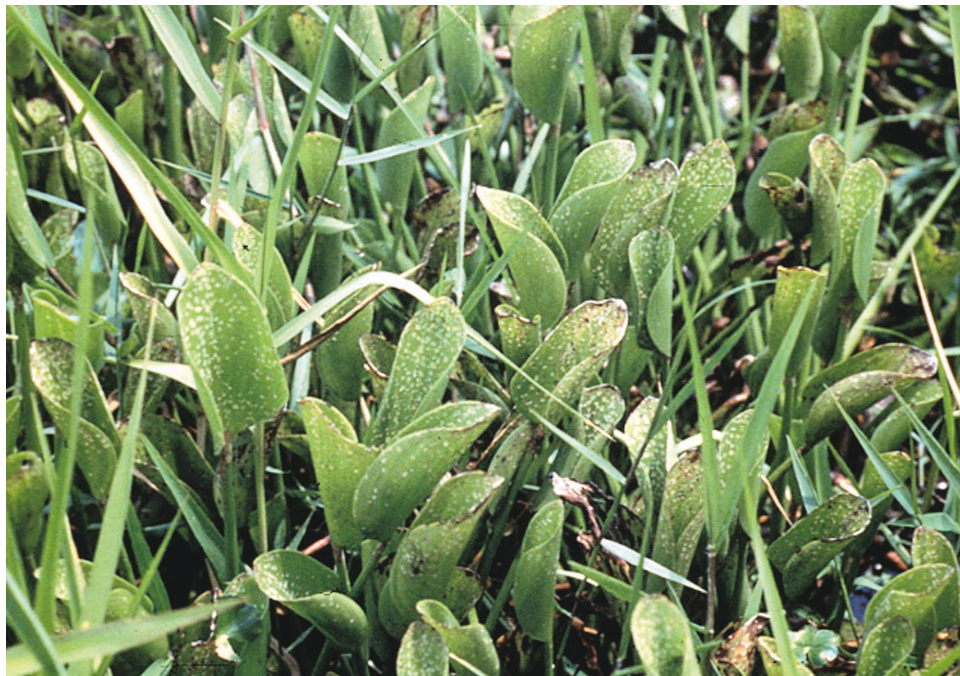
Figure 4. Waterhyacinth highly stressed by the feeding action of *Neochetina* spp. Note the large number of feeding scars, smaller stature of the plants, curled leaves, lack of flowering, and the presence of other plant species encroaching into what is typically a monotypic infestation of waterhyacinth

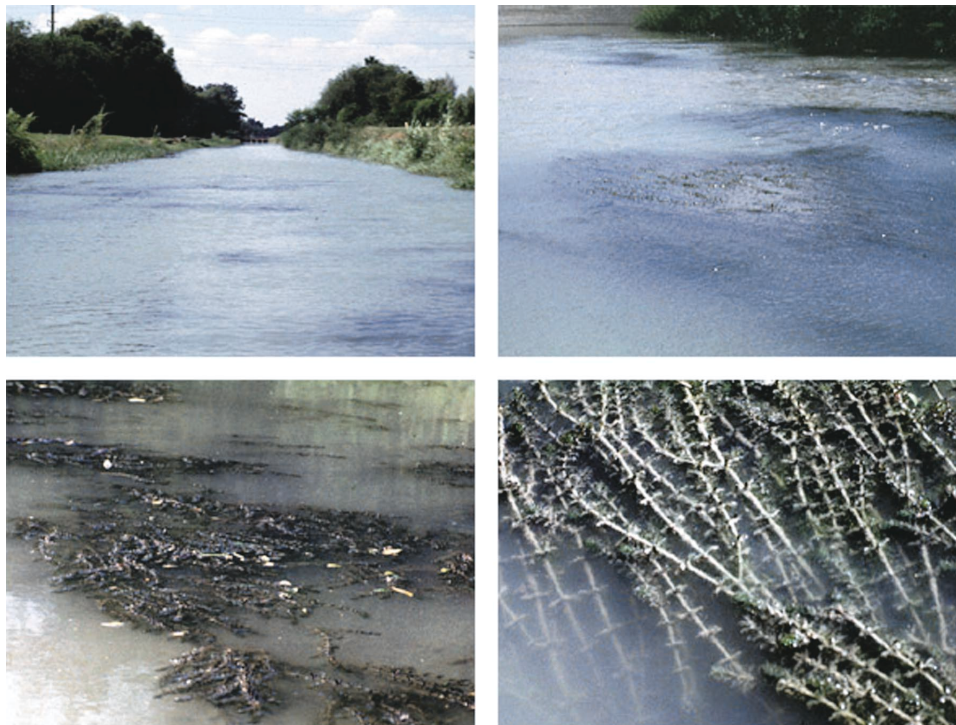
Figure 12. One of the main canals of the Hidalgo County Irrigation Water District No. 1 near Mission, TX. Hydrilla at this site was found scattered throughout the canal system in small clumps. Hydrilla appeared very healthy with long stems that trailed on the surface with the water flow. Hydrilla in some areas appeared as larger infestations where the individual clumps had begun growing together

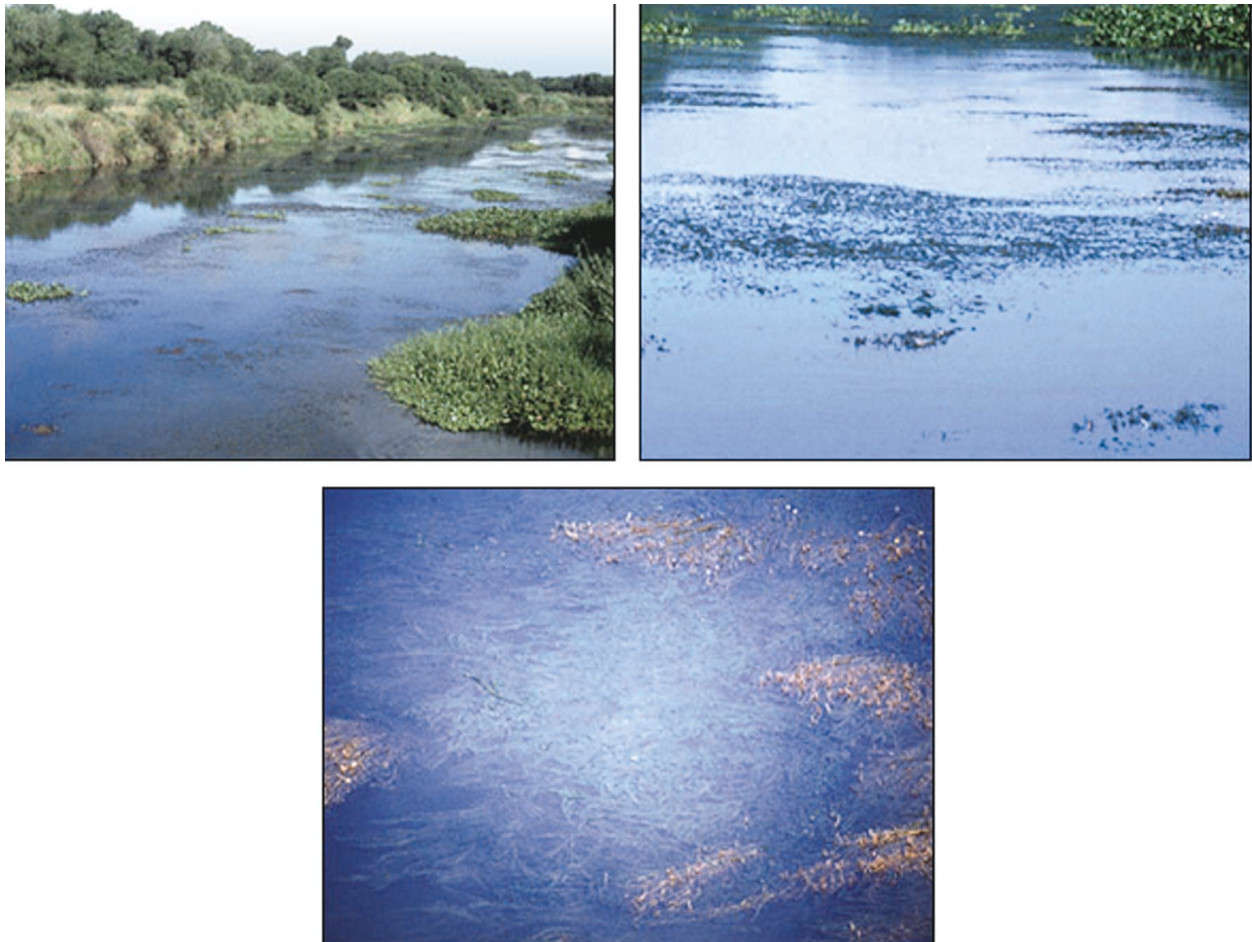
Figure 13. Series of views of the Cameron County Irrigation District No. 6 Pumping Station located directly on the Rio Grande. Waterhyacinth was present in distinct clumps, but the infestation never extended across the entire river (top left). While some feeding damage by *Neochetina* spp. was observed, it was mostly minimal throughout the site. This site, located near a weir, had increased water flows in the general area. This may have precluded the accumulation of waterhyacinth except directly on the rocks composing the weir, which tended to trap and hold the waterhyacinth. Hydrilla infestations were large at this area and tended to completely cover this section of the river (top left, top right). While the hydrilla appeared healthy, there were areas where native species were encroaching into the mat. For example, the lower photograph shows significant coverage of *Heteranthera dubia* (water star grass) encroaching into the hydrilla infestation

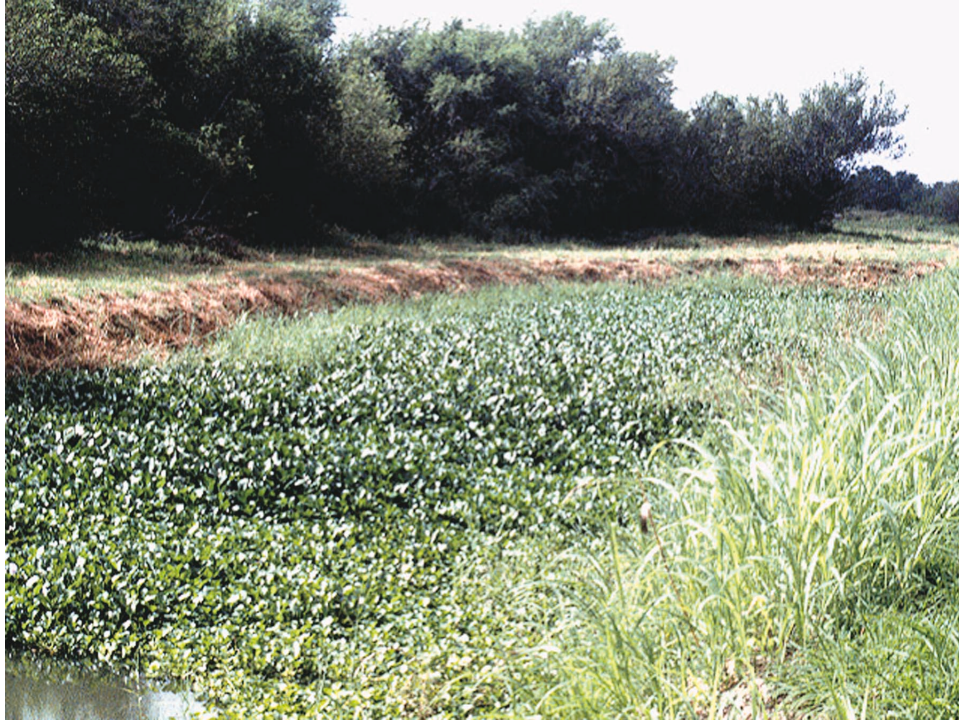
Figure 14. Canal leading away from the Cameron County Irrigation District No. 6 Pumping Station. Note the large waterhyacinth infestation completely covering the canal. While some areas of the canal were open, a majority was completely covered. The waterhyacinth at this site was very healthy with only minimal damage from biological control agents. Limited encroachment by other plant species was observed at this site

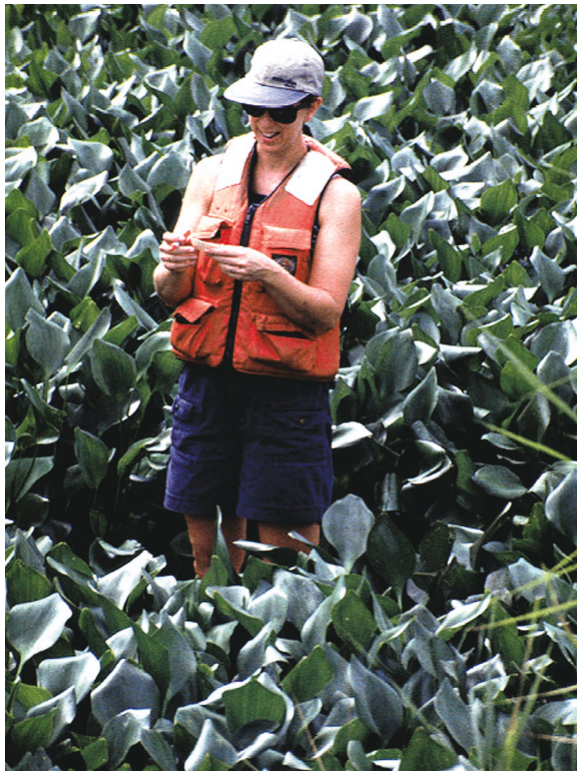
Figure 15. Close-up view of canal at Cameron County Irrigation District No. 6. Note healthy plants with only limited feeding damage by *Neochetina* spp.

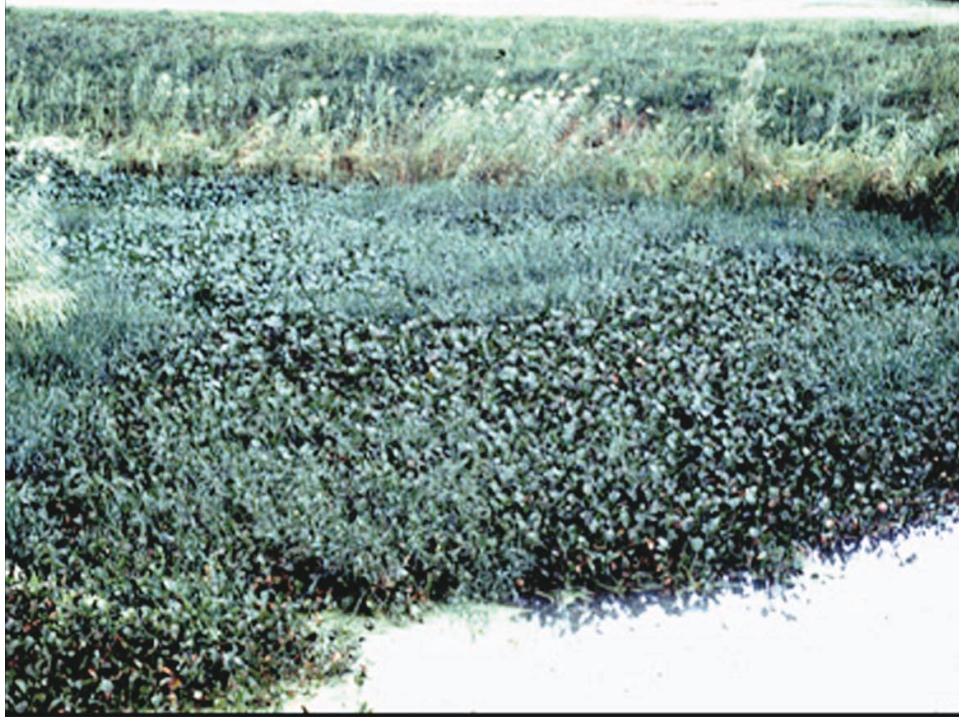
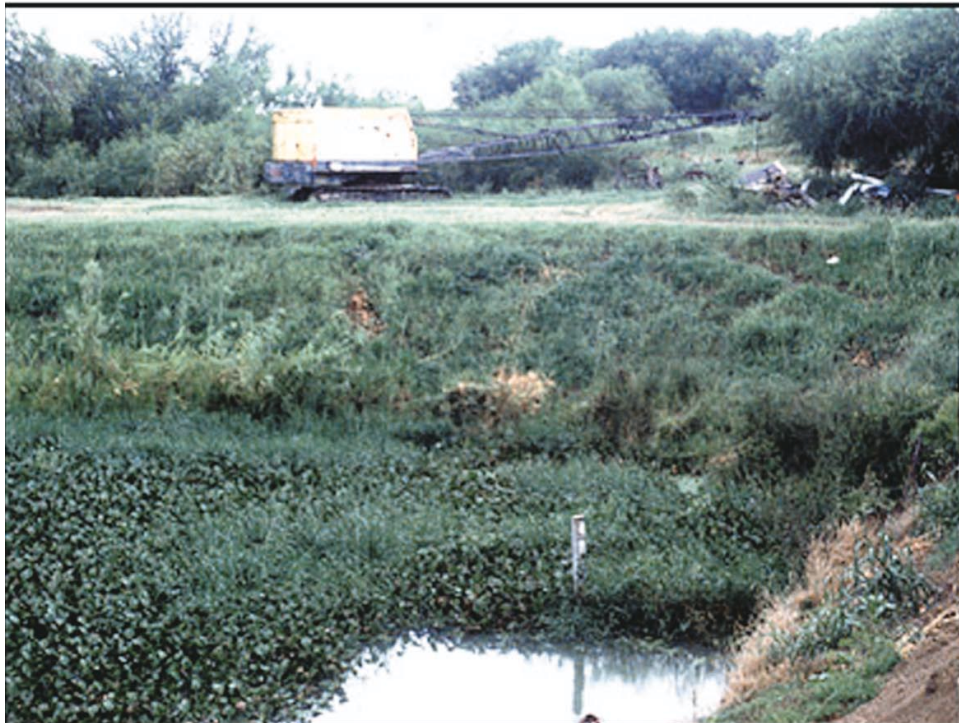
Figure 16. Composite view of the La Feria Irrigation District. These photographs were taken on the canal leading from the Rio Grande to pumping station. Note the extensive infestation, which is apparently stressed by the feeding action of *Neochetina* spp. as indicated by the browning and curling leaves and the presence of other plant species encroaching into the infestation

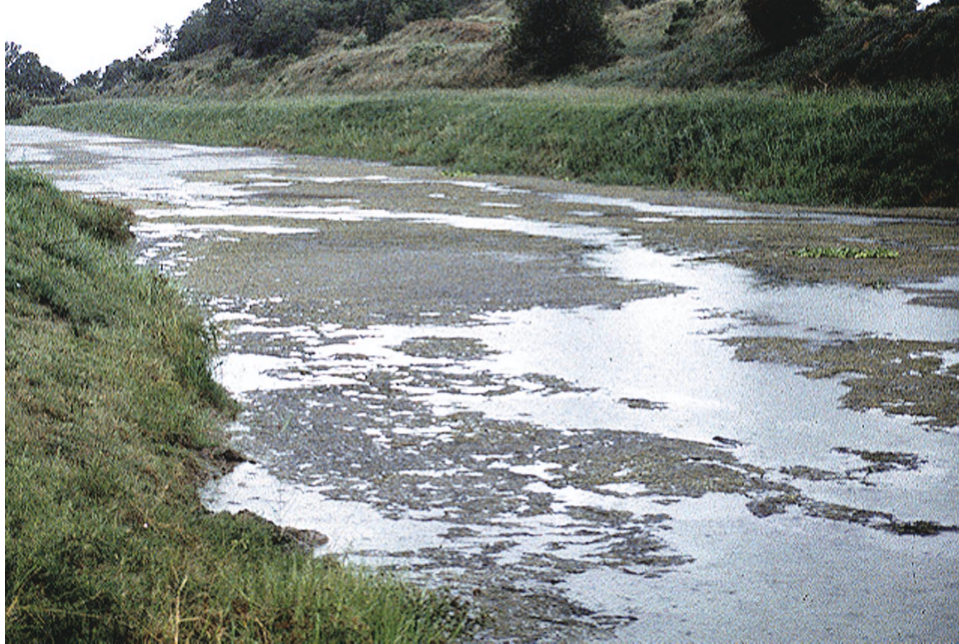
Figure 17. Canal leading from the Rio Grande to the Harlingen Irrigation District (Cameron County) No. 1 Pumping Station. Minimal waterhyacinth was present at this site and most of the plants appeared stressed. While an extensive hydrilla infestation appears present, closer inspection revealed it was mainly algae covering what had probably been an infestation. Reasons for the hydrilla disappearance are unknown

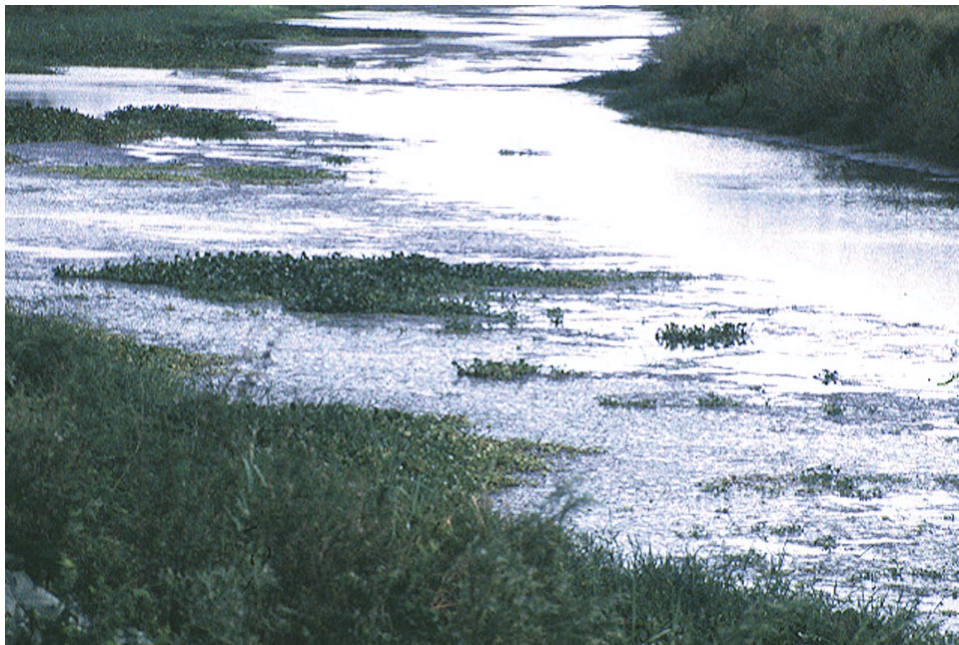
Figure 18. Canal leading from the Rio Grande to the pumping station of Cameron County Irrigation District No. 2. Similar to the Harlingen Irrigation District Cameron County No. 1 Canal (Figure 17), the waterhyacinth was highly stressed and the hydrilla infestation was minimal and mainly covered with copious quantities of algae

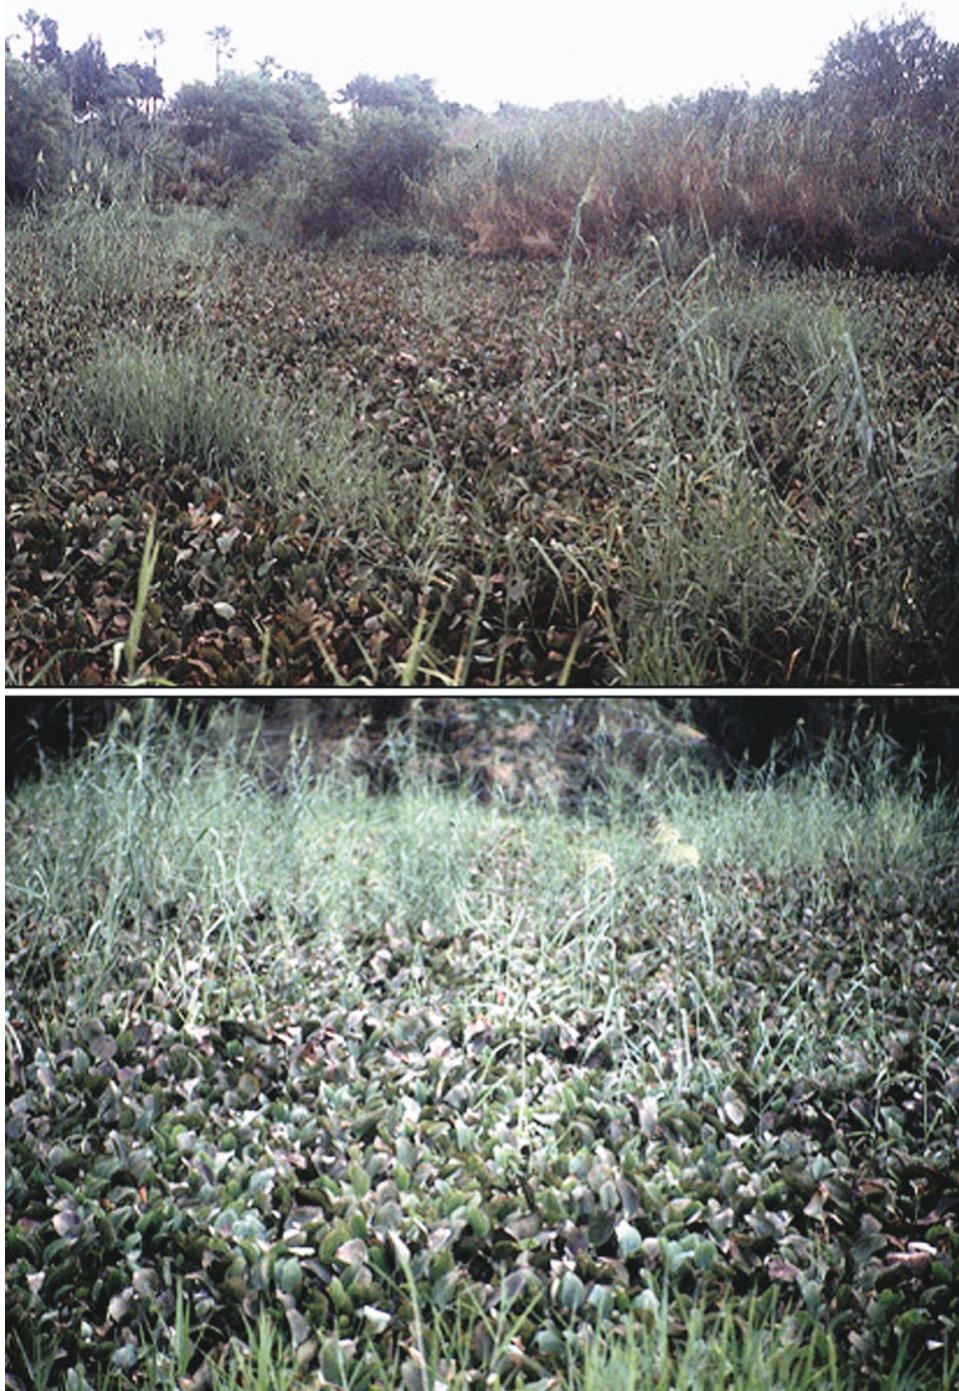
Figure 19. Composite view of an extensive waterhyacinth infestation on the Rio Grande adjacent to the River Bend Golf Course. While the waterhyacinth completely choked the river at this point (top), the plants appeared highly stressed by the feeding action of the insects and in numerous areas large populations of other plant species were observed encroaching into the mat (top, bottom). The plant species most commonly seen within the mat was another introduced species, *Arundo donax* (giant reed), which was commonly observed along large stretches of bank

River Bend Golf Course (Figure 19)	Site was located directly on river adjacent to golf course. Mechanical control of waterhyacinth and hydrilla had been accomplished at this site in prior years.	Large infestation of waterhyacinth was present and completely choked the river. Plants appeared highly stressed with limited flowering. Encroachment into the mat by other plant species, mainly <i>Arundo donax</i> , was observed.

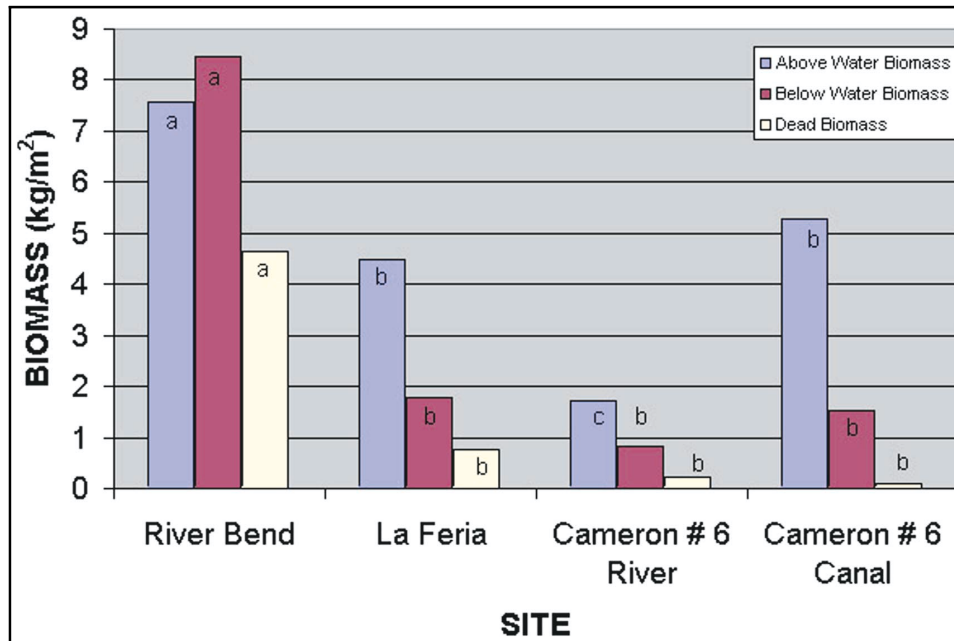
**Waterhyacinth.** Biomass of waterhyacinth samples varied significantly from site to site (Figure 20). Highest total biomass (i.e., above, below, and dead biomass per  $m^2$  combined) was found at the River Bend Golf Course site ( $20.67 \text{ kg}/m^2$ ) with the lowest observed at Cameron No. 6 River site ( $2.74 \text{ kg}/m^2$ ). Total biomass differences in this case were almost eight-fold higher for the River Bend Golf Course site relative to that found at the Cameron No. 6 River site. Examining each of the separate biomass partitions (i.e., above water, below water, and dead material) reveal that at most sites quantity of each partition on a per  $m^2$  is similar. The only exceptions occurred at the River Bend Golf Course site where significantly higher biomass occurred for all partitions relative to the other sites. In addition, significantly lower above-water biomass occurred for the Cameron No. 6 River site, as well.

Figure 20. Total amount of above, below, and dead biomass per  $m^2$  at each of the four sites surveyed for waterhyacinth on and adjacent to the Rio Grande. Means which are significantly different at  $p < 0.05$  are marked by different letters within a biomass partition (above water biomass –  $df = 3, 11, F = 12.58, p = 0.0007$ ; below water biomass –  $df = 3, 11, F = 7.35, p = 0.0056$ , and dead biomass –  $df = 3, 11, F = 9.94, p = 0.0018$ )

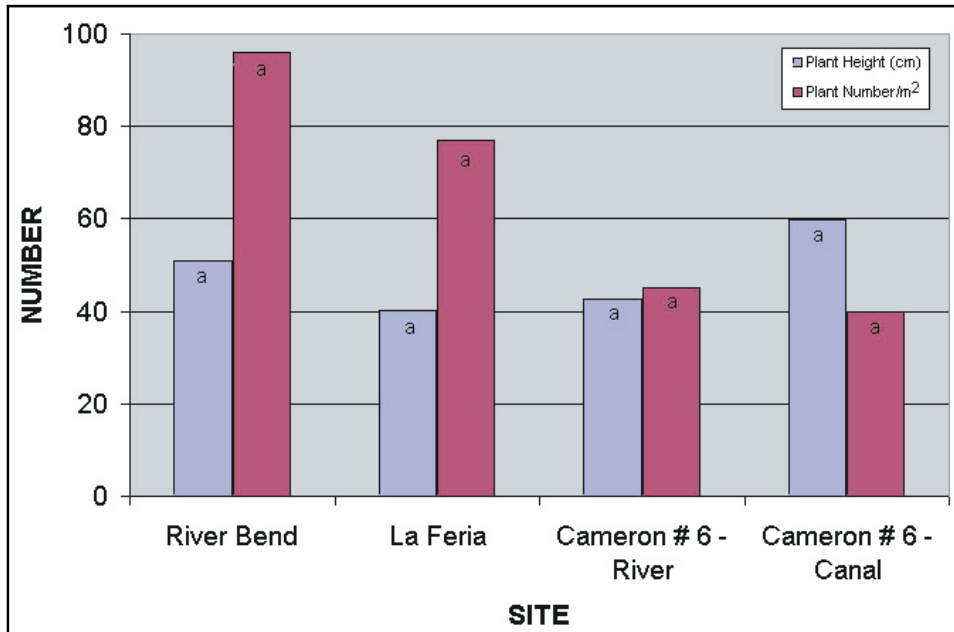
Other plant parameters were similar for each site and included plant height, plant number (Figure 22), leaves per plant, and number of flowers per  $m^2$  (Figure 23). Of these four plant parameters, significant differences were observed for leaves per plant only. Plant height ranged from 40 cm at the Cameron Irrigation District No. 6 River site to a high of about 60 cm at the Cameron Irrigation District No. 6 Canal site. Plant number per  $m^2$  was also similar across sites and ranged from 40 plants/ $m^2$  at the Cameron Irrigation District No. 6 Canal site, to 96  $m^2$  at the River Bend Golf Course site. Repeating this sampling with higher sample sizes may have revealed the presence of more significant differences.

Figure 22. Plant height (cm) and number of plants per m<sup>2</sup> for waterhyacinth sampled at four sites on and adjacent to the Rio Grande. Means for each parameter followed by different letters indicate significant differences at p < 0.05 level (Plant height – F = 2.16, df = 3, 11, p = 0.1507, Plant number – F = 2.82, df = 3, 11, p = 0.0880)

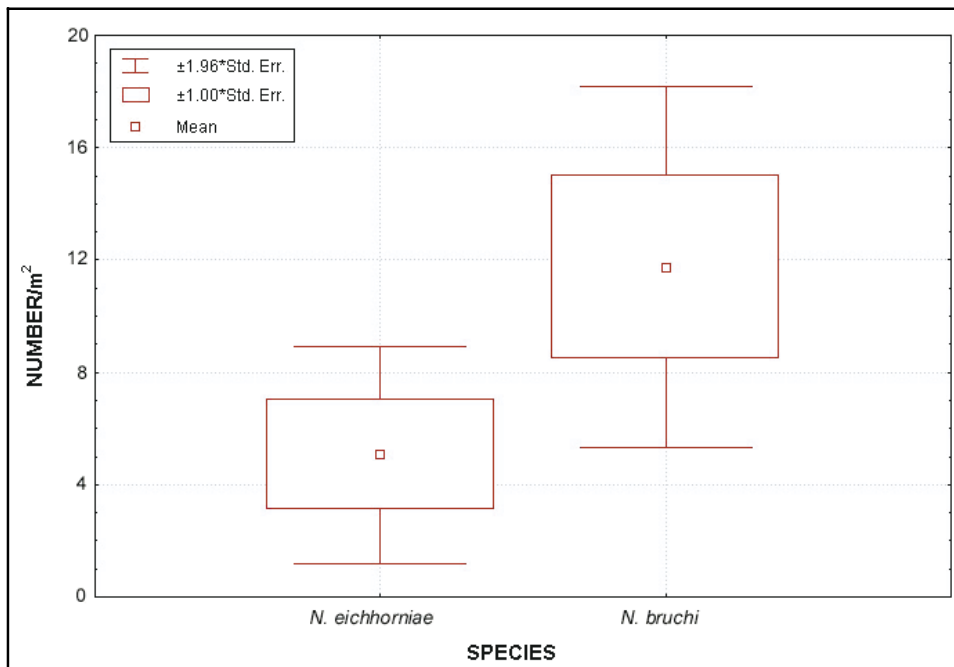
Two species of introduced biocontrol agents of waterhyacinth were also commonly observed at most of the sites sampled. The insect agents included *N. eichhorniae* and *N. bruchi*, the mottled and chevroned waterhyacinth weevils, respectively. Numbers of each of the species were statistically similar but over two-fold higher means were observed for *N. bruchi* (11.7/m<sup>2</sup>; Figure 24). Statistical differences in the number of each species may be detected by taking a larger number of replicates at each site. Finding such high numbers of *N. bruchi* was unusual as most waterhyacinth sites sampled in Texas typically contain only *N. eichhorniae*, with only limited numbers of *N. bruchi* (personal observations). No *S. albiguttalis* were observed. *Sameodes albiguttalis* was probably present as well but is typically found in higher numbers during the early spring regrowth period when the plants are growing more laterally to fill up sites opened during the winter die-back period. Plants in this stage of growth typically have enlarged petioles for floatation, which is a more ideal larval feeding site for *S. albiguttalis* than plants without enlarged petioles.

Figure 24. Mean number of each species of *Neochetina* spp. per m<sup>2</sup> collected from sites on and adjacent to the Rio Grande. No significant differences were detected ( $F = 3.04$ ,  $df = 1, 28$ ,  $p < 0.0922$ ). Please note, however, means were higher for *N. bruchi* and the p level is less than 0.10

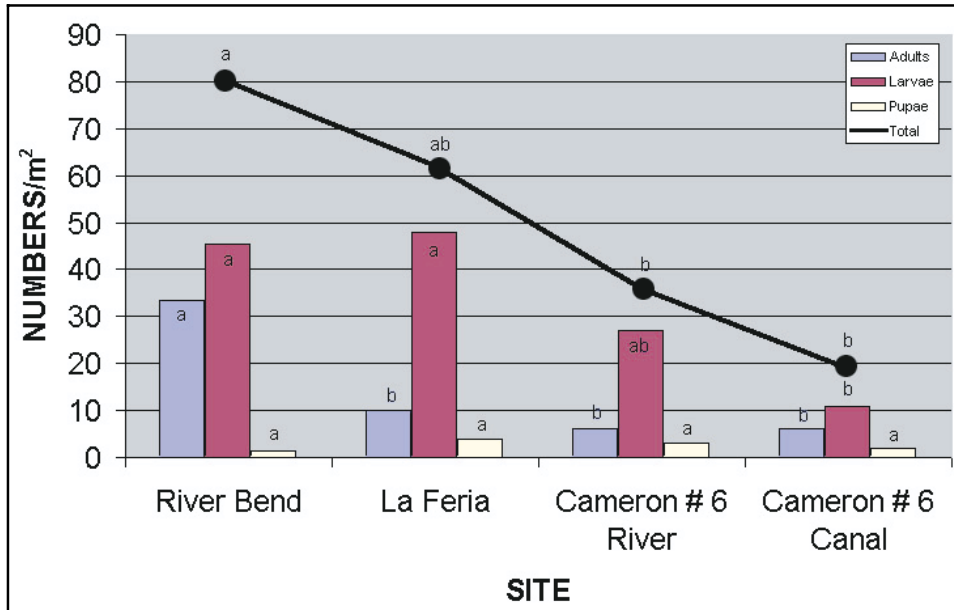
Of the four sites sampled, total number of all life stages of both *N. eichhorniae* and *N. bruchi* differed considerably from site to site (Figure 25). For example, highest numbers were observed at the River Bend Golf Course site with 80 individuals/m<sup>2</sup>. This was followed by the La Feria site (ca. 60 individuals/m<sup>2</sup>), Cameron No. 6 River site (36 individuals/m<sup>2</sup>), with the lowest amount observed at the Cameron No. 6 Canal site (19 individuals/m<sup>2</sup>; Figure 25). Numbers of adult and larval stages also varied from site to site. Highest numbers for both stages were observed for the River Bend Golf Course site; the lowest, at the Cameron No. 6 Canal site.

Figure 25. Total number of all life stages of *Neochetina* spp. and number of adults, larvae, and pupae on a per m<sup>2</sup> basis for waterhyacinth sites on and adjacent to the Rio Grande. Means followed by different letters are significantly different at  $p < 0.05$  level (Total/m<sup>2</sup> –  $F = 5.80$ ,  $df = 3, 11$ ,  $p = 0.0126$ , Adults/m<sup>2</sup> –  $F = 4.16$ ,  $df = 3, 11$ ,  $p = 0.0338$ , Larvae/m<sup>2</sup> =  $5.67$ ,  $df = 3, 11$ ,  $p = 0.0135$ , Pupae/m<sup>2</sup> –  $F = 0.32$ ,  $df = 3, 11$ ,  $p = 0.8090$ )
