**US Department of the Interior
National Park Service
National Center for
Preservation Technology and Training
Publication No. 1996-06**

PROTECTIVE GLAZING STUDY

National Preservation Center

March, 1996

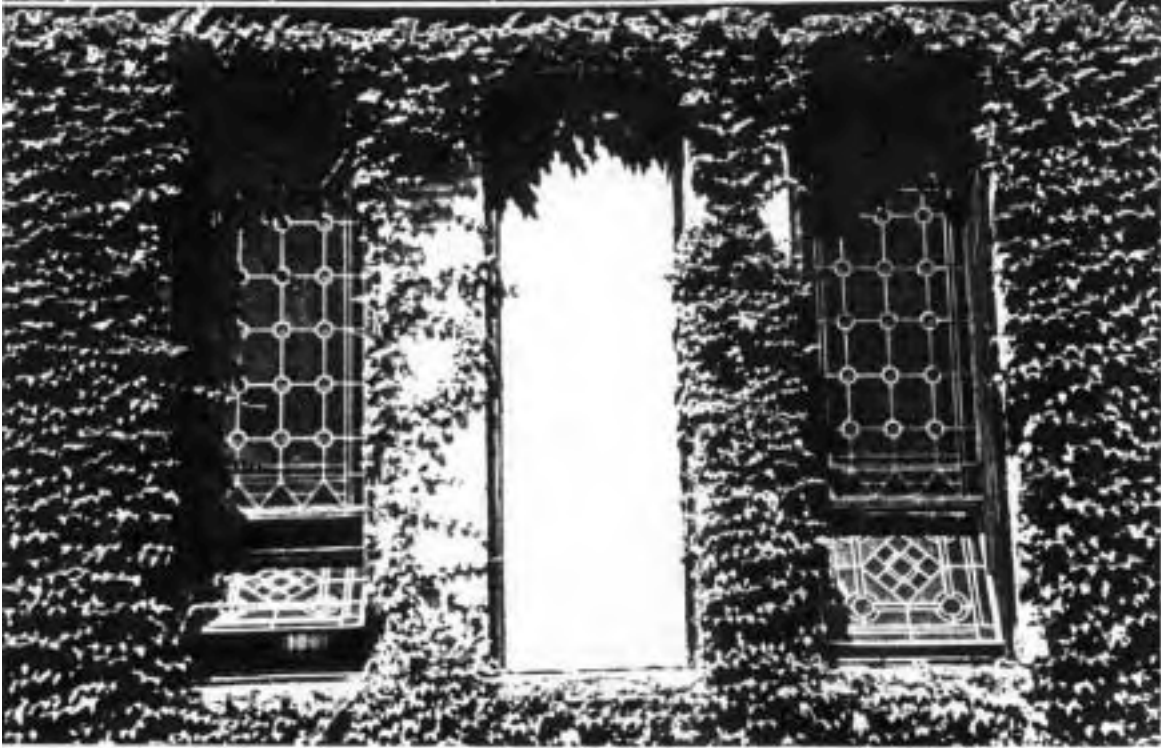
Fig 1. Most of the windows were tested in direct sunlight.

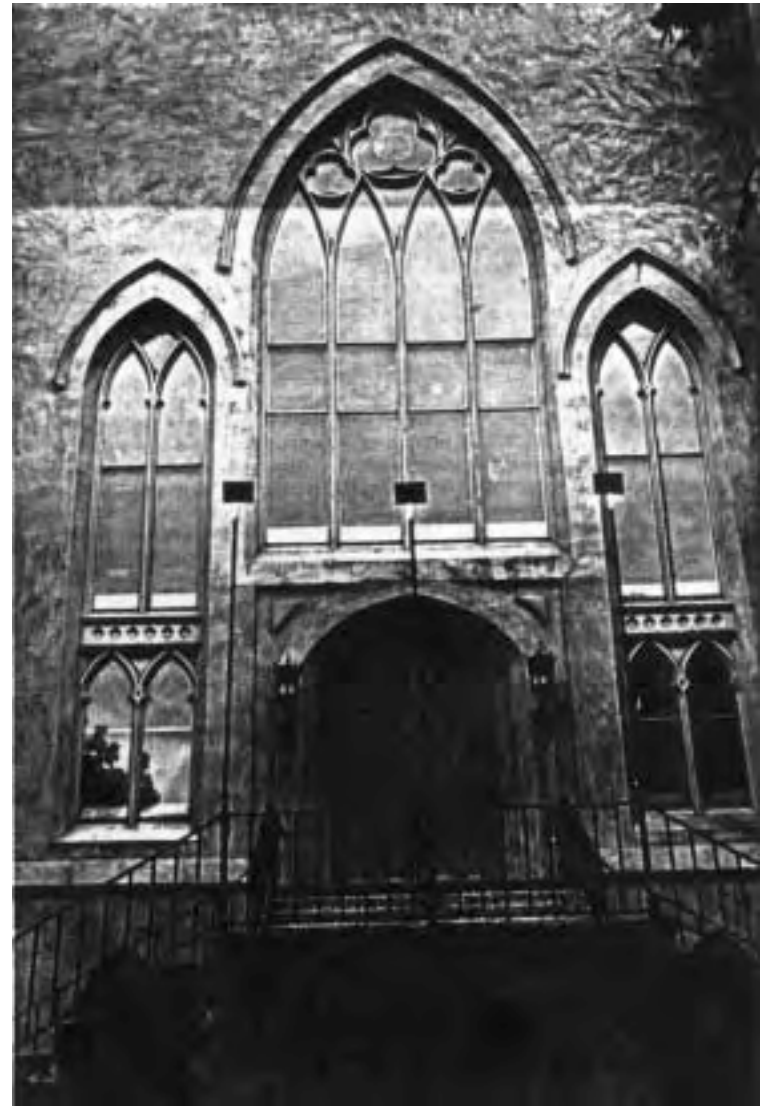
Fig 8. PG can be integrated with the original tracery.

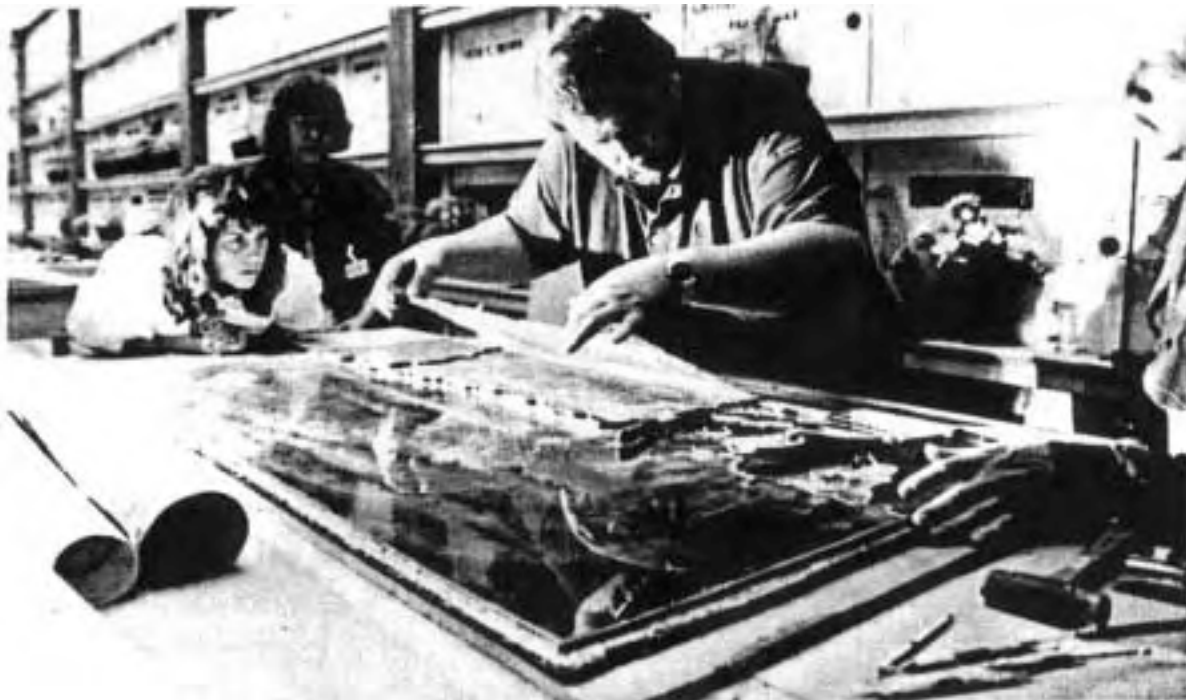
Fig 10. A large piece of glass is removed from a plated Tiffany window.

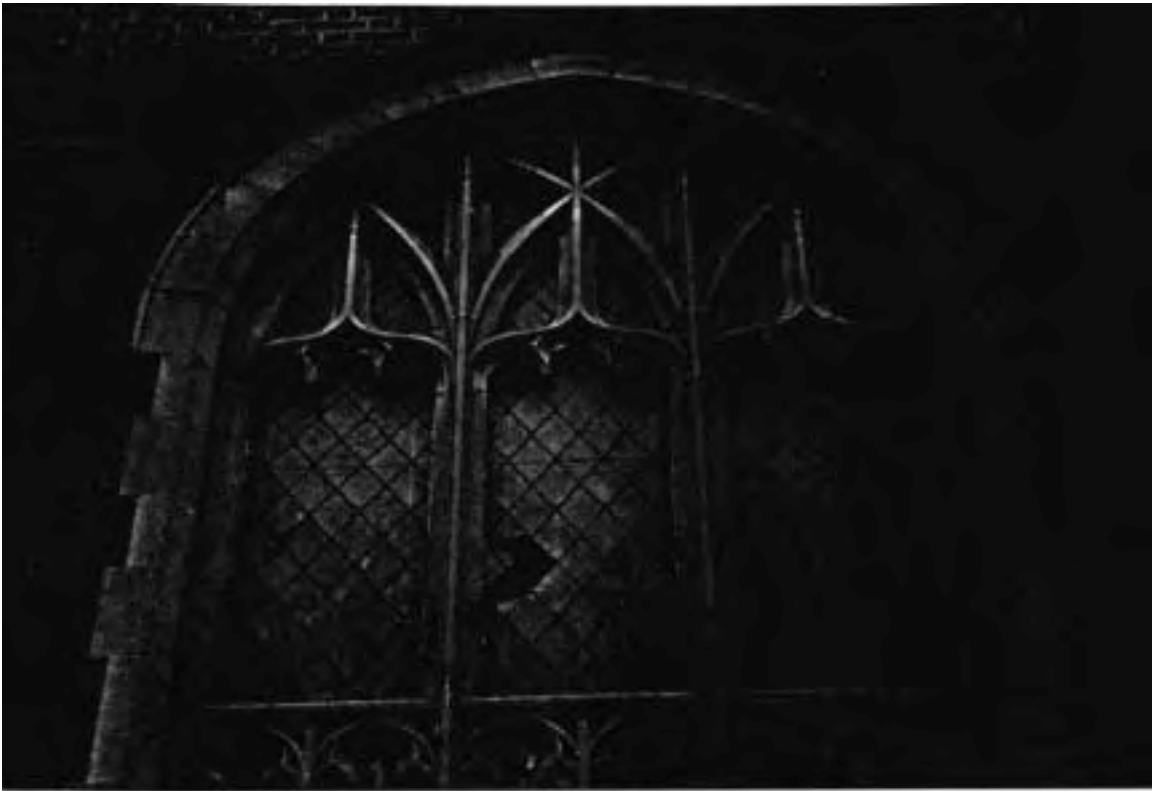
Fig 11. 1922 diamond-pane windows became PG for stained glass installed later.

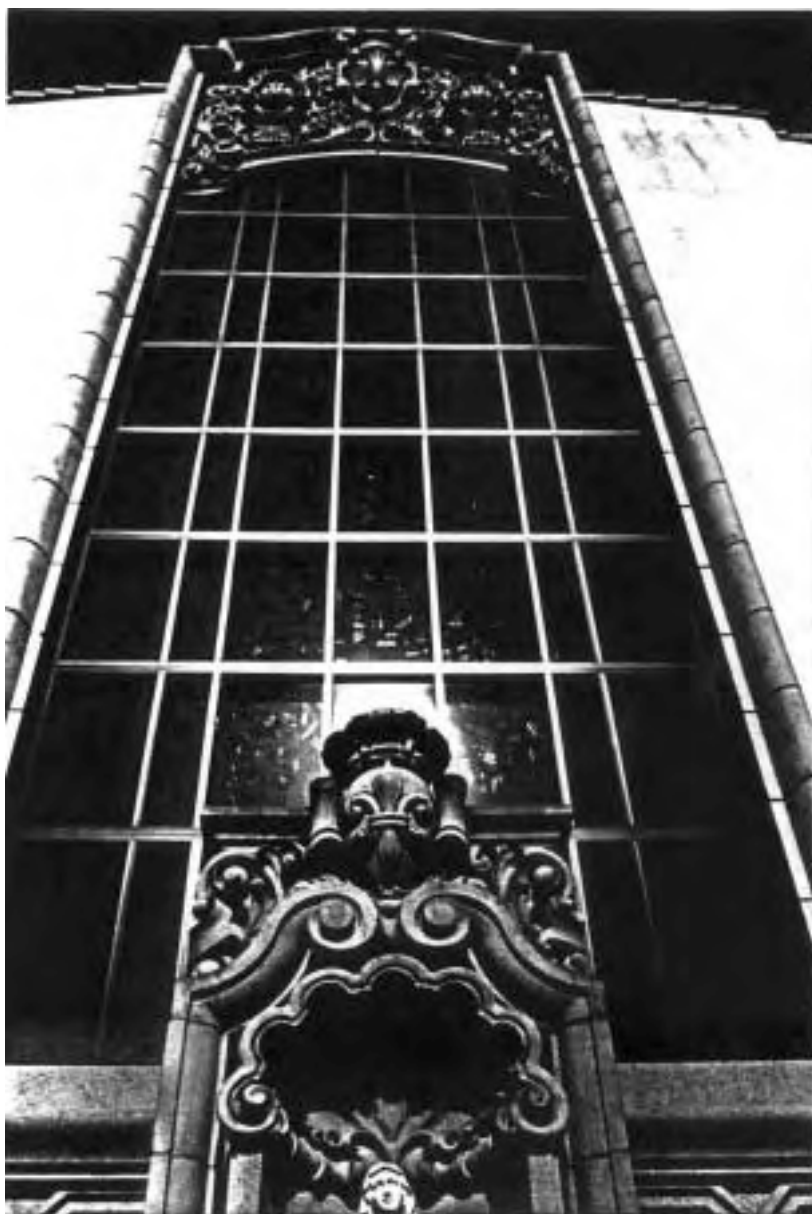
Fig 16. PG was installed over slab glass in 1993 on this church in Phoenix, AZ.

Methods of producing stronger glass evolved in the years leading up to, during, and immediately after W.W.II. Even leaded glass was not spared as super stained glass, called “Dalle De Verre,” was developed in France in 1937. Eventually dubbed “faceted” or “slab” glass in America, such windows can be more than 1” thick and were originally set in a hard cement matrix (now epoxy). Generally less expensive and much stronger than leaded glass, slab glass has grown in popularity since its introduction in the U.S. in the 1940s. Ironically, despite its wall-like strength, PG has been installed in recent years over several slab glass installations in the U.S. [Fig 16.]!

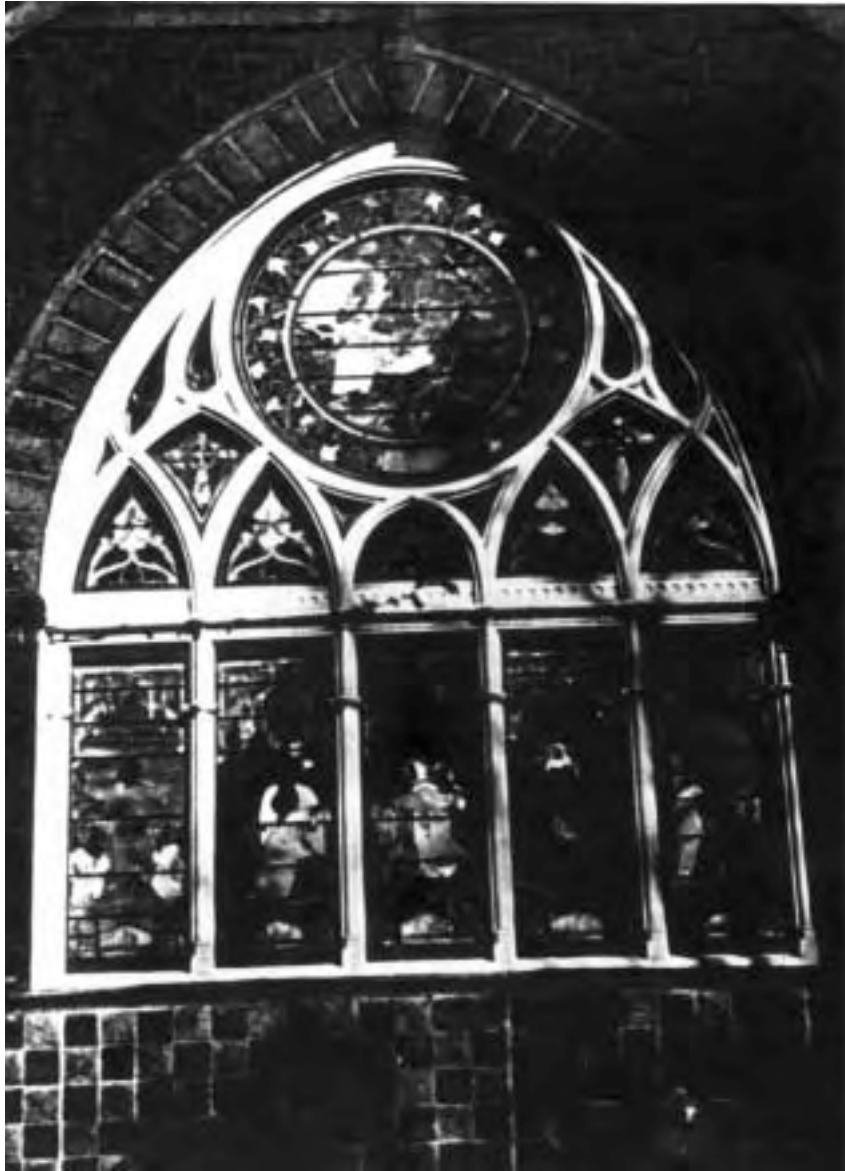
Fig 21. Opalescent glass adds color to the exterior.

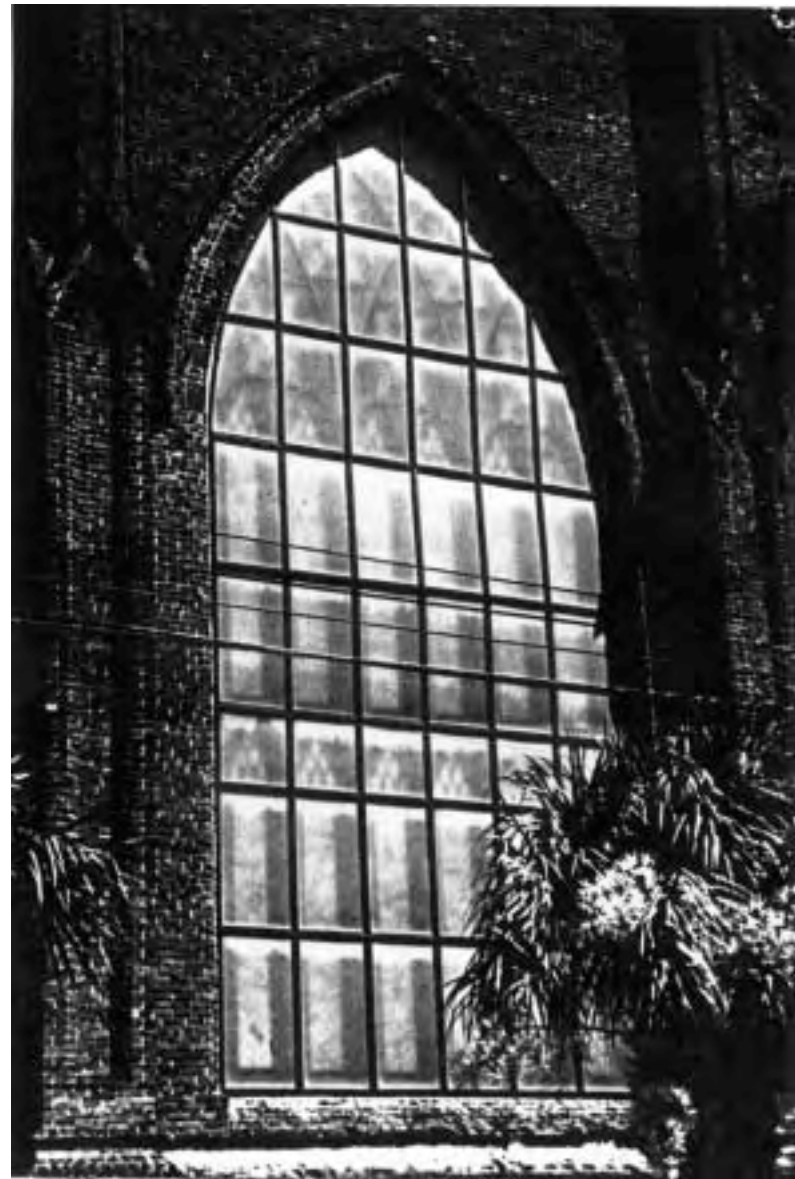
Fig 24. The delicate tracery of this window is completely hidden

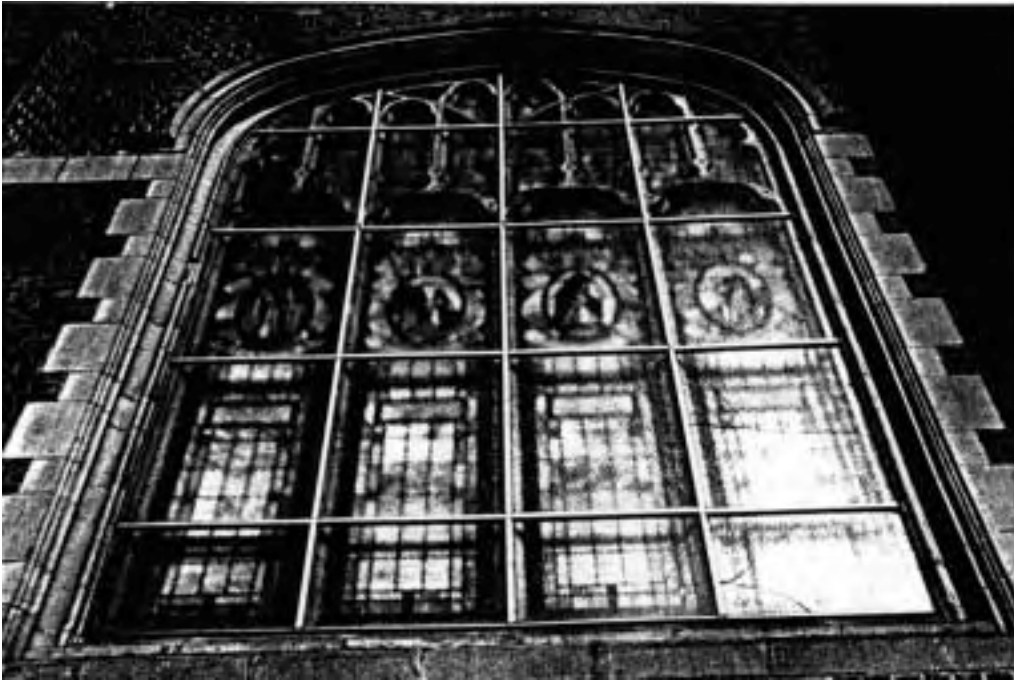
Fig 27. The art glass in this installation is blurred by glare and textured PG.

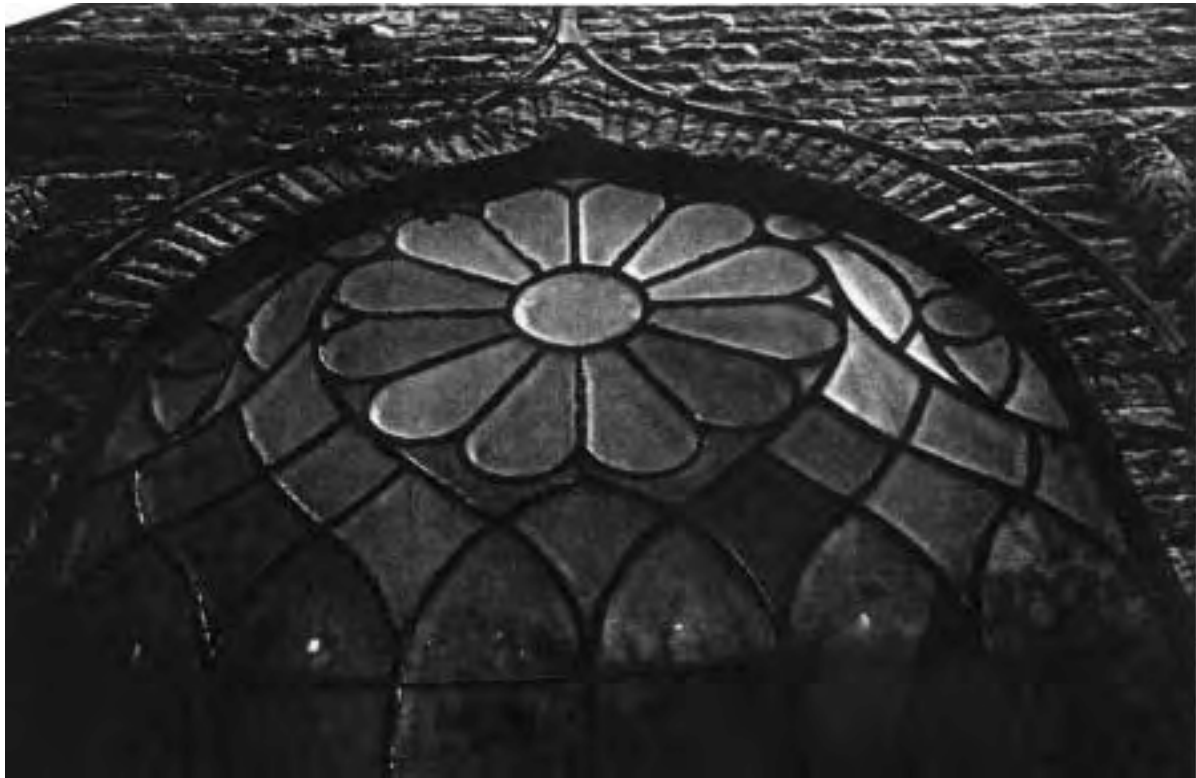
Fig 28. This PG needs maintenance, but the muntins conform to the tracery.

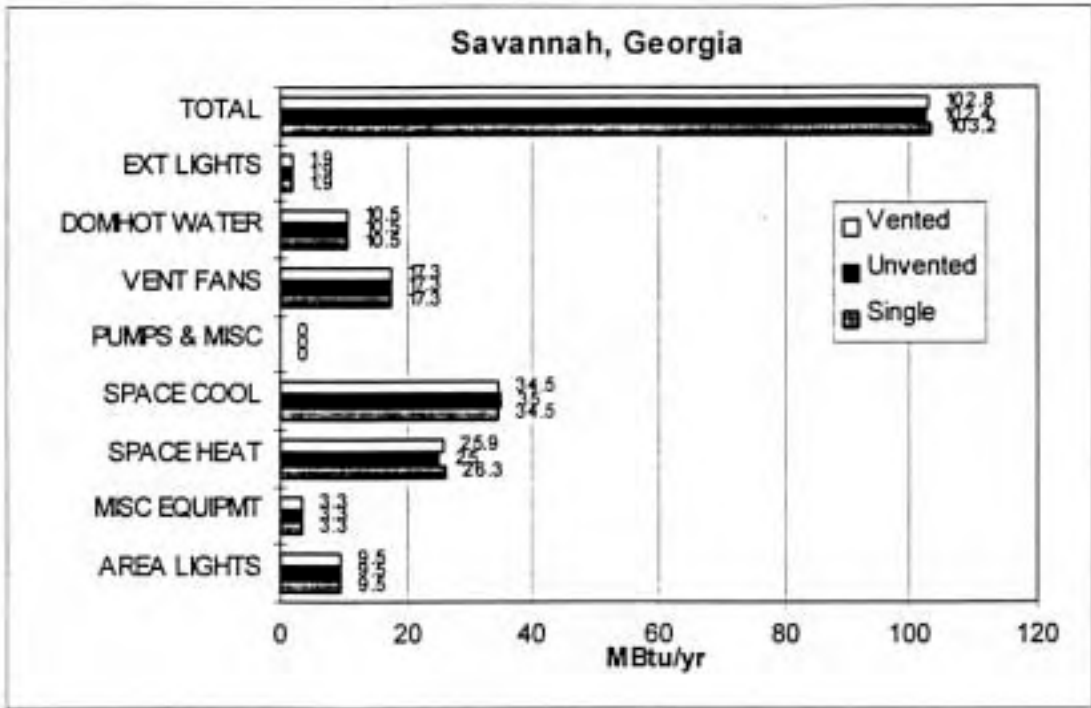
Figure 7 Comparison of end-use categories for Single, Unvented, and Vented glazing options.

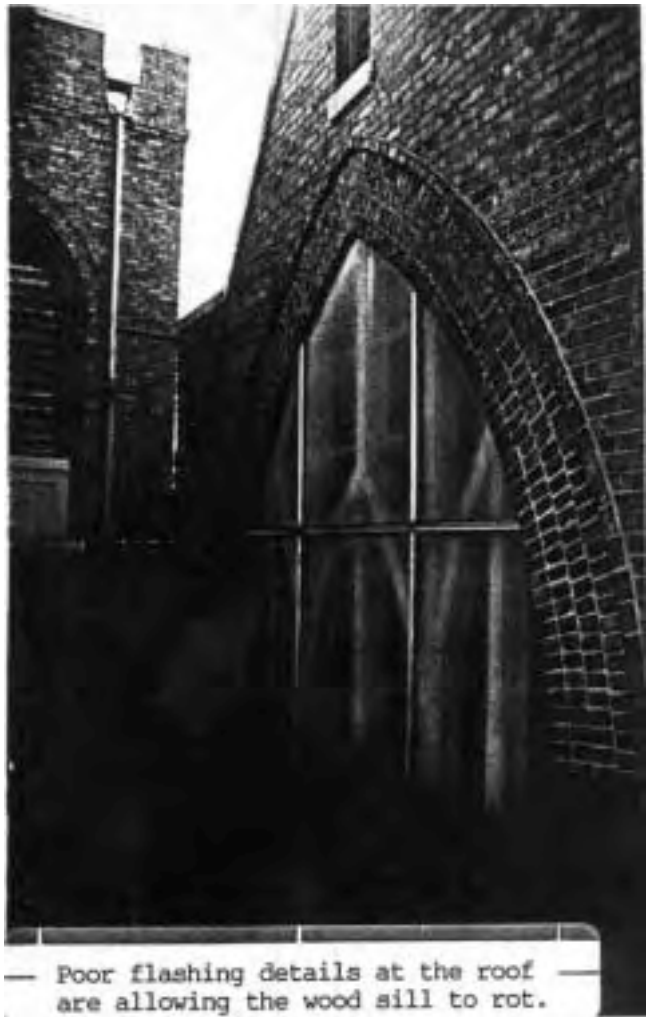
- Poor flashing details at the roof are allowing the wood sill to rot.

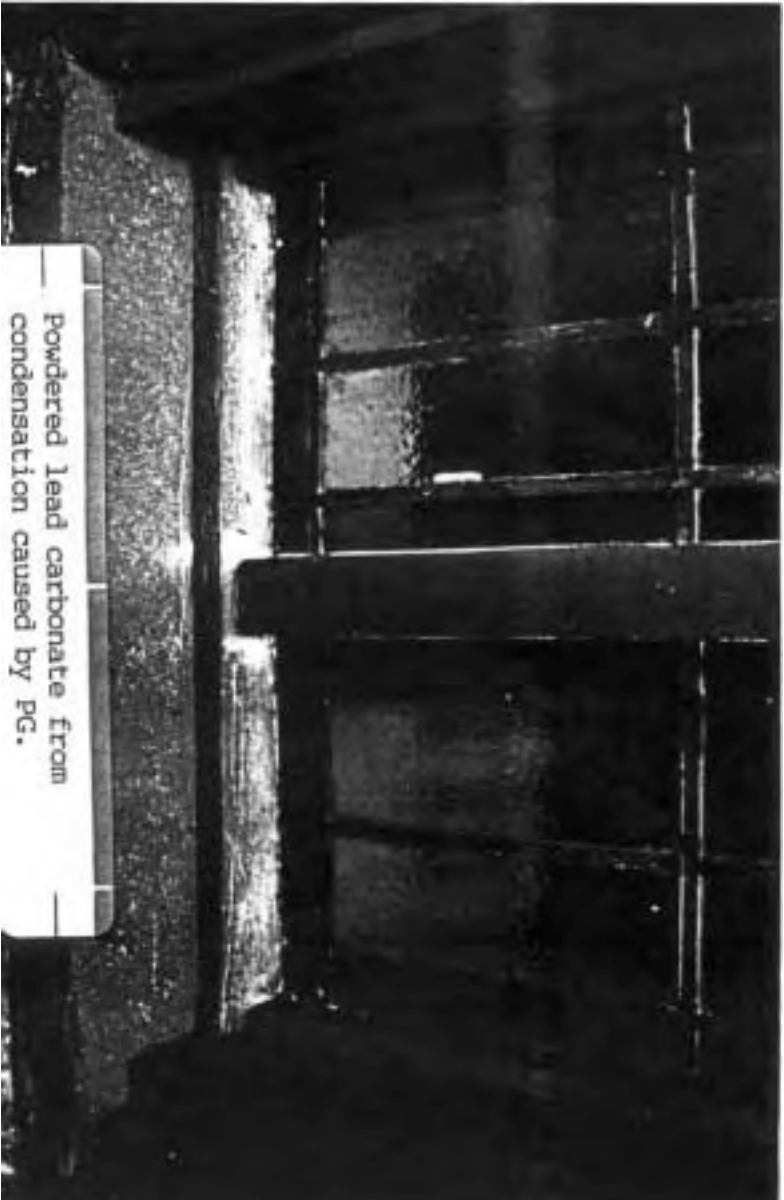
White lead carbonate is oxidizing on the lead comes from condensation.

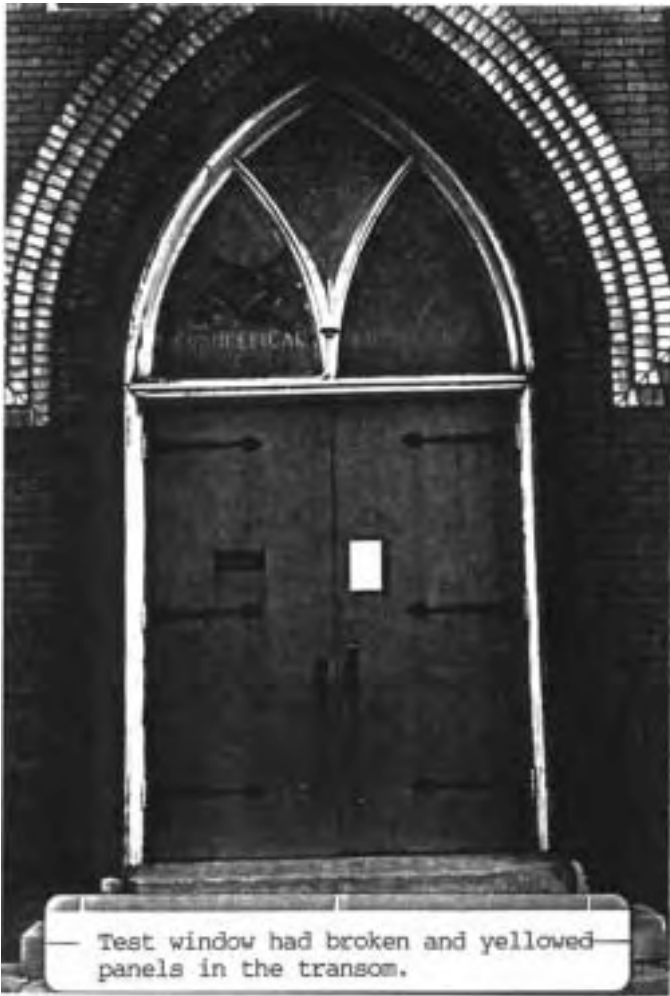
Test window had broken and yellowed panels in the transom.

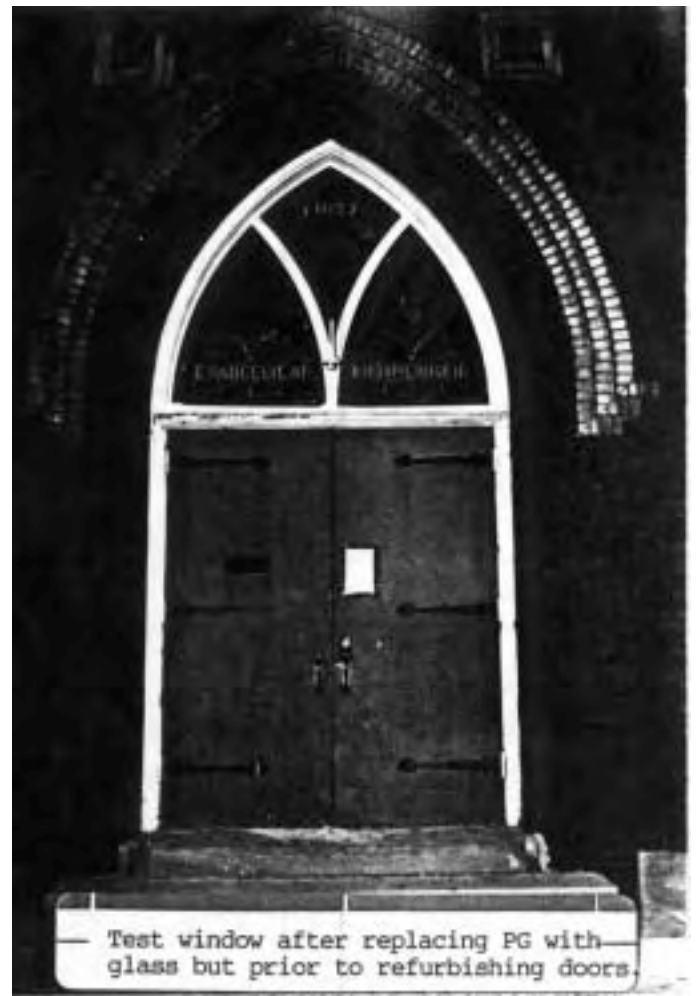
Test window after replacing PG with glass but prior to refurbishing doors.

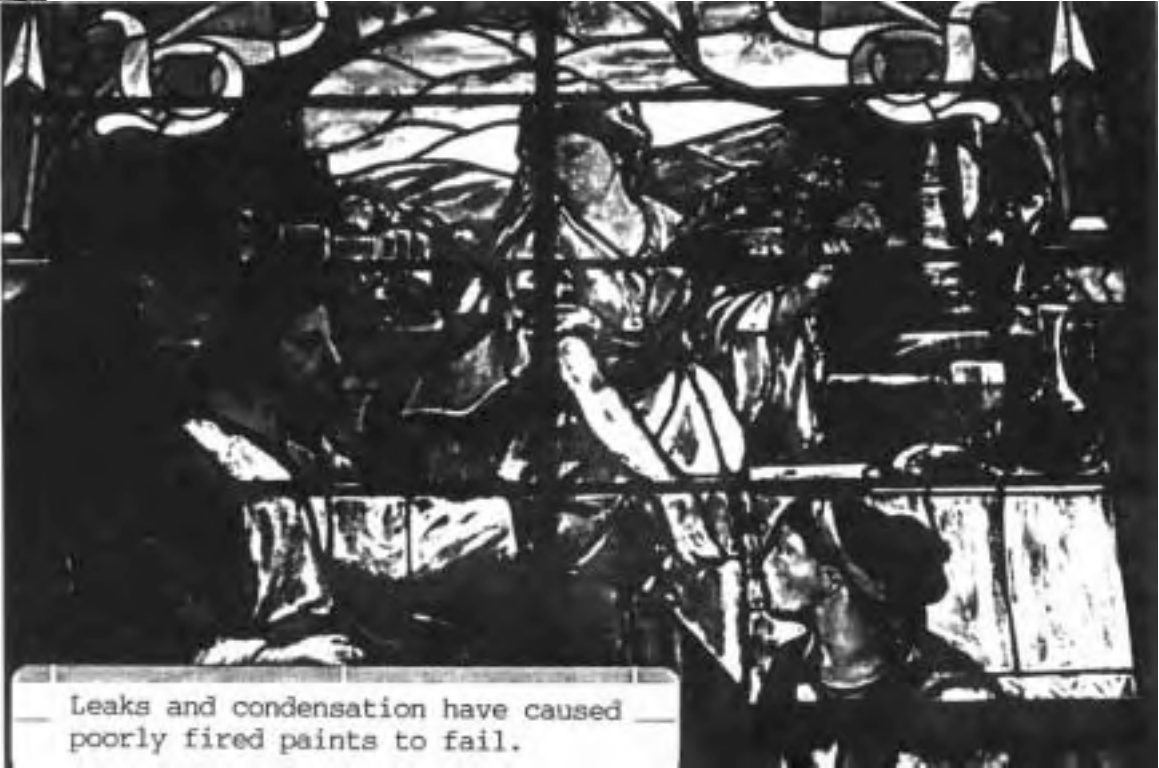
— Leaks and condensation have caused poorly fired paints to fail. —

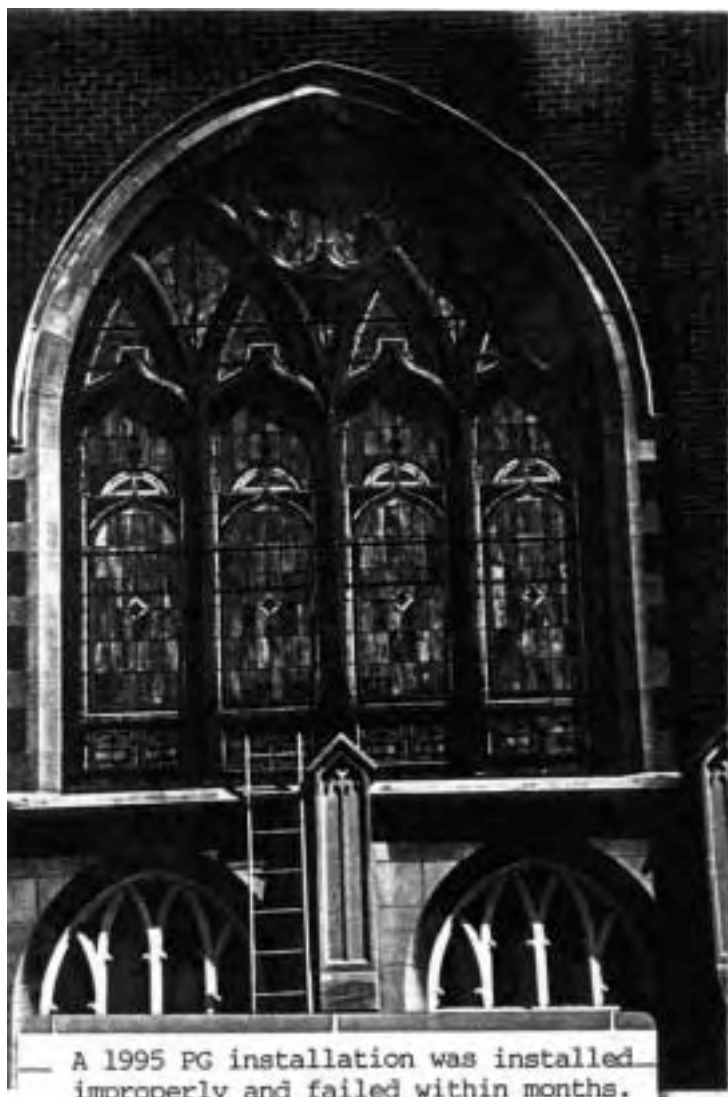
A 1995 PG installation was installed improperly and failed within months.

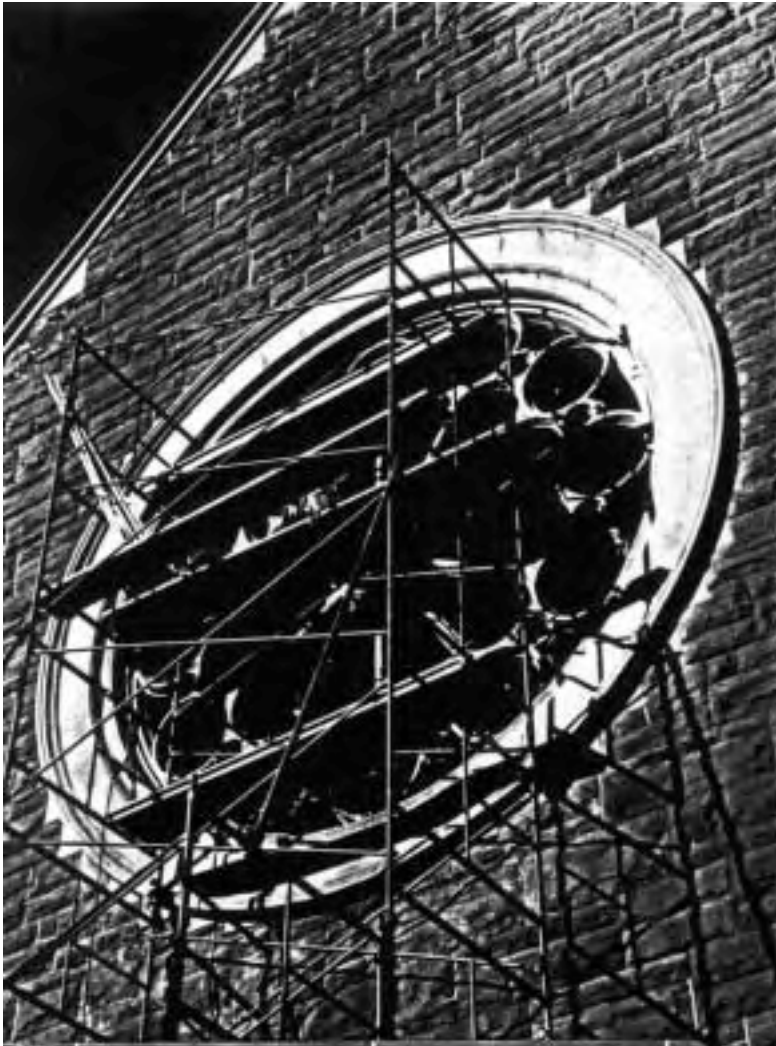
All the stained glass was removed to restore the frame.

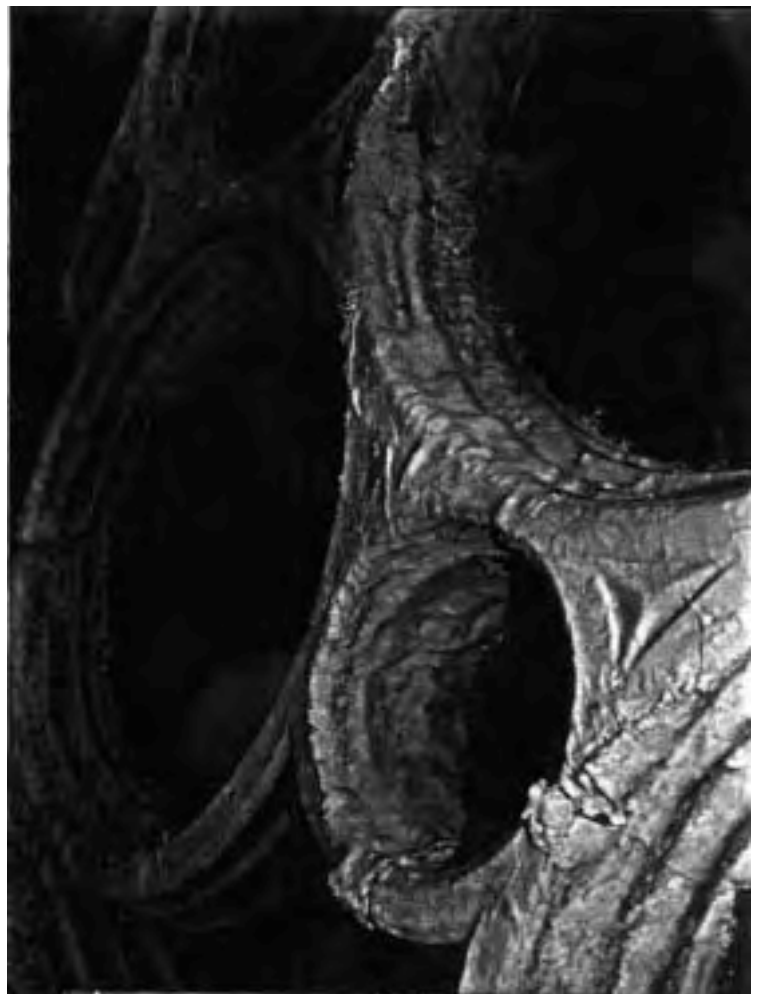
Prior to covering the window with PG the studio made repairs with bondo!

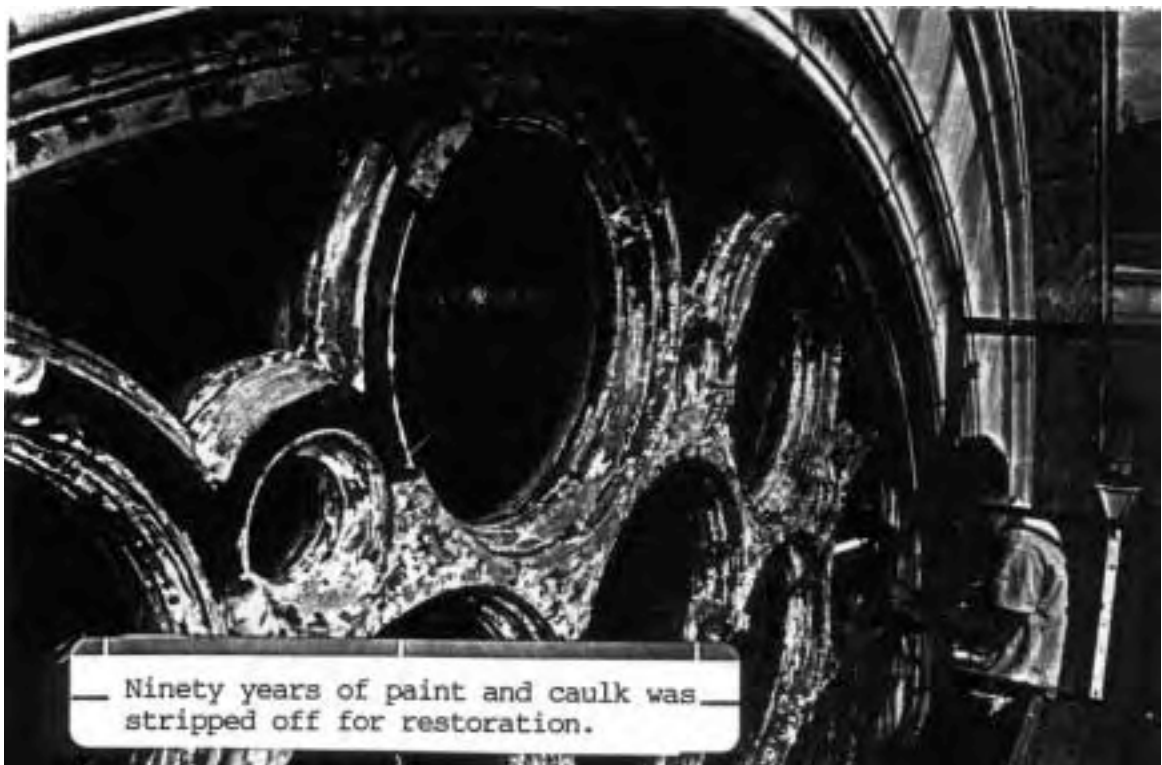
Ninety years of paint and caulk was stripped off for restoration.

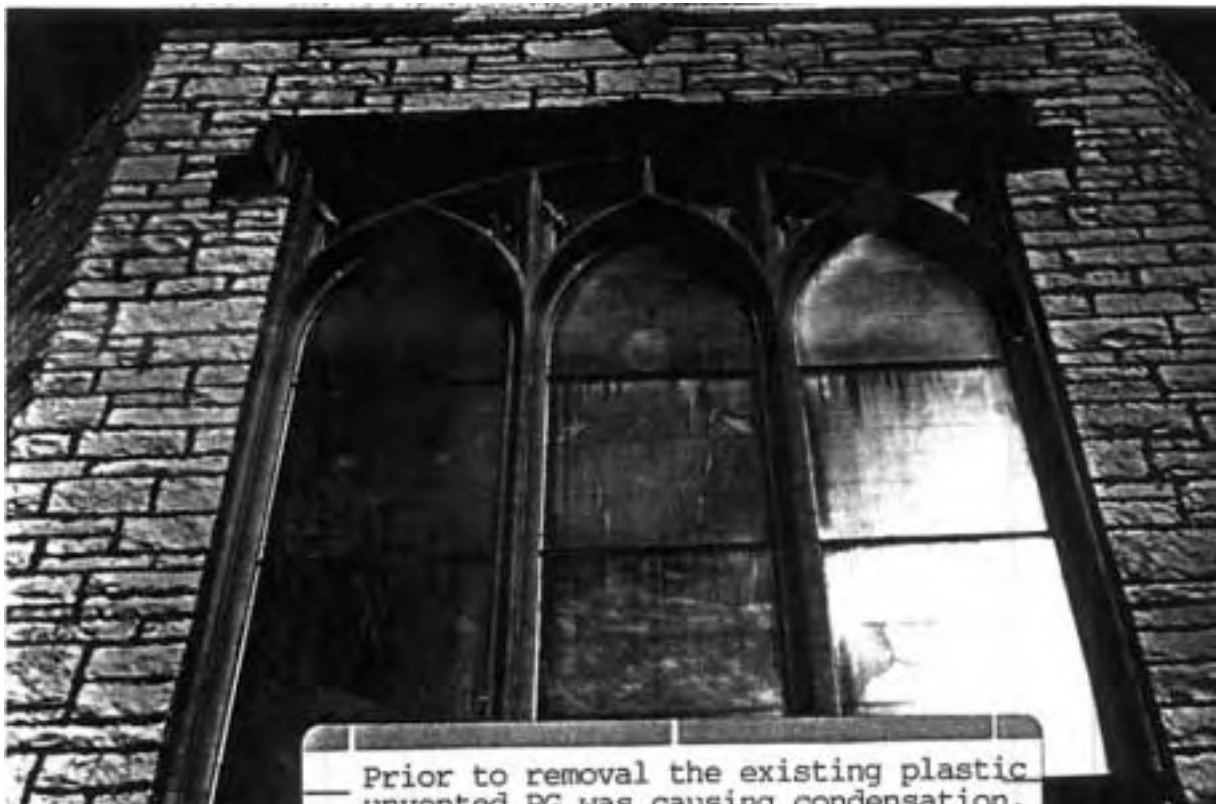
Prior to removal the existing plastic invented PG was causing condensation.

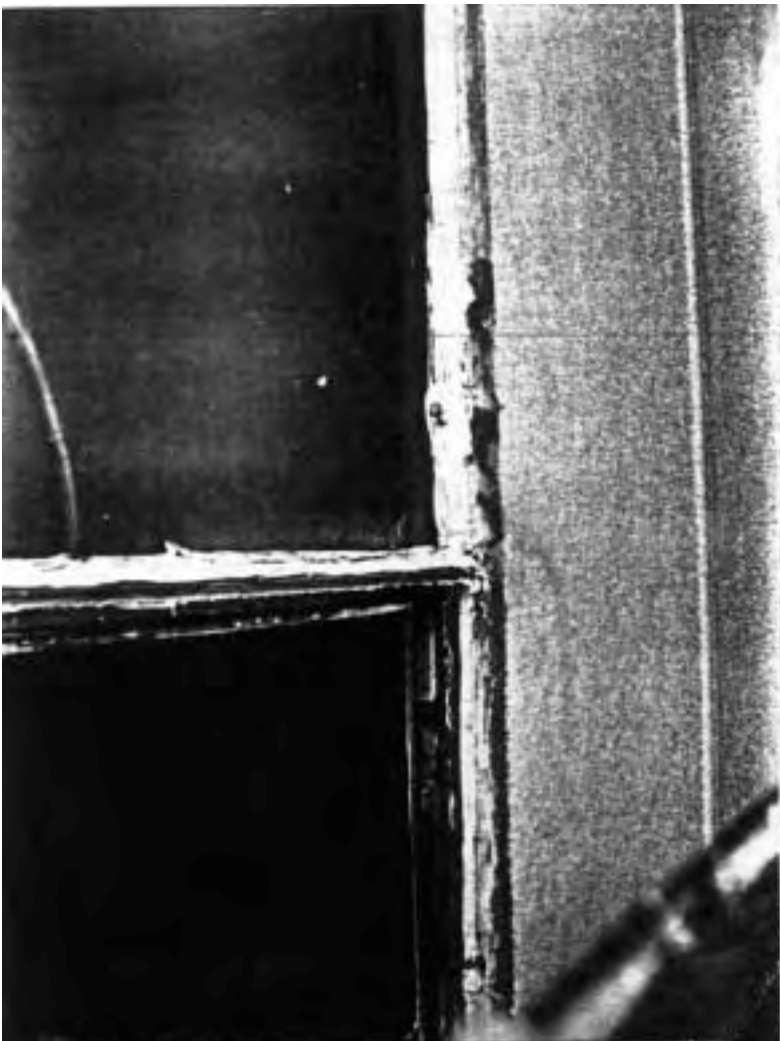
Sealants had been applied poorly on the existing PG.

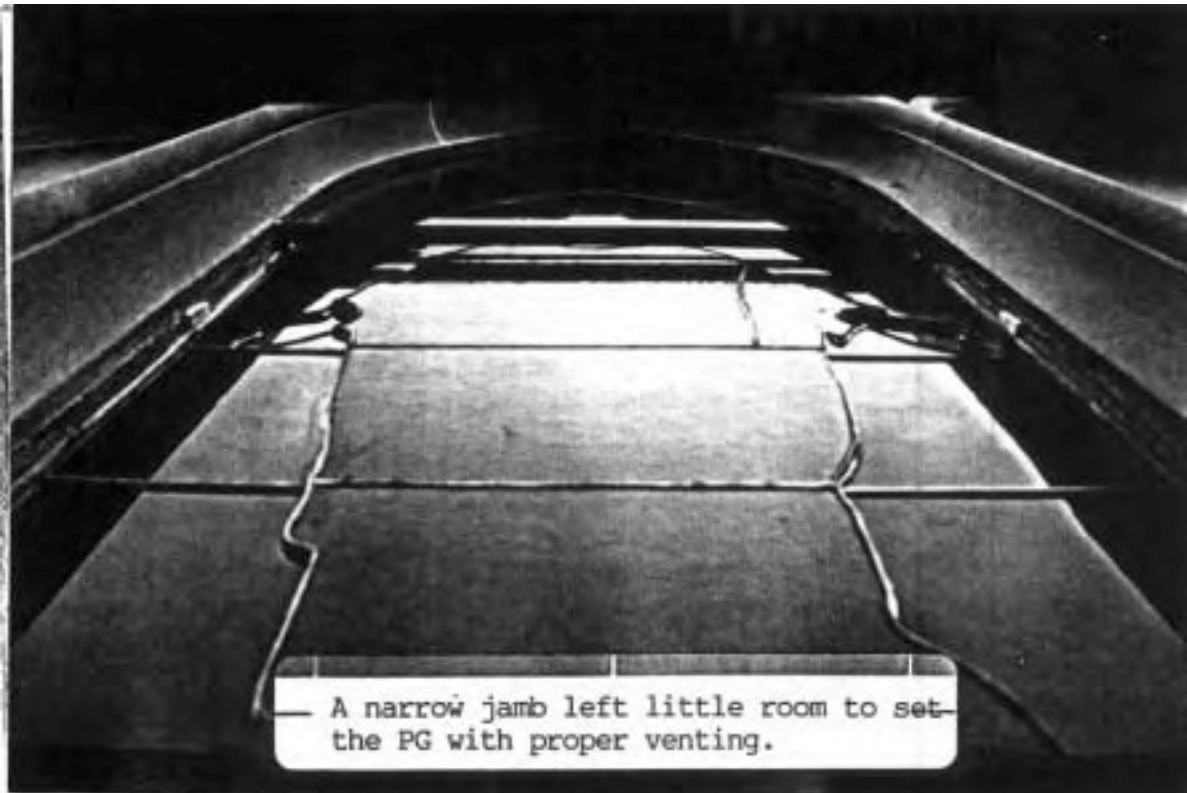
A narrow jamb left little room to set the PG with proper venting.

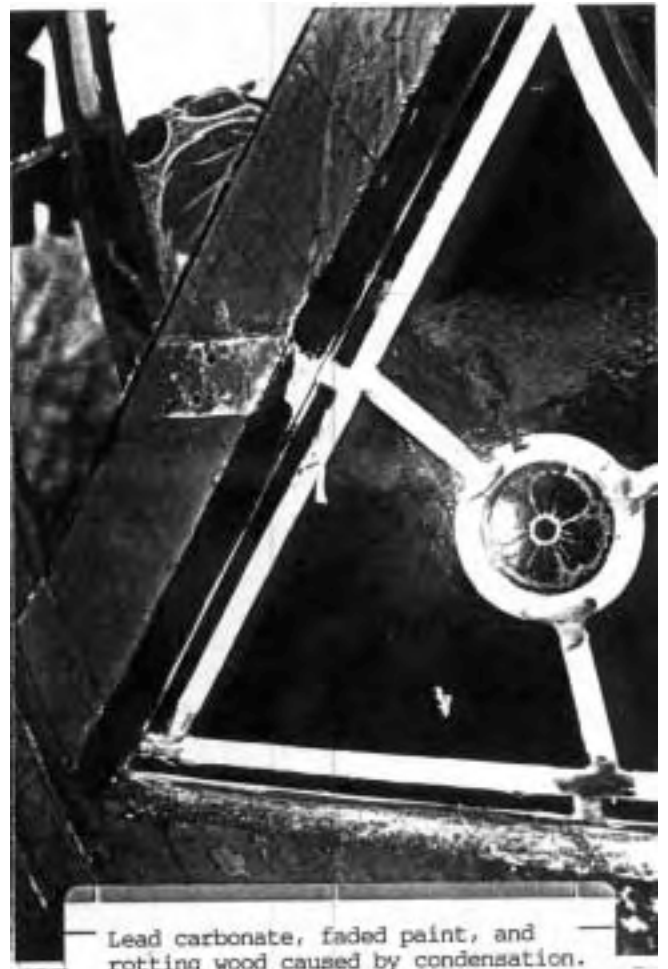
Lead carbonate, faded paint, and rotting wood caused by condensation.

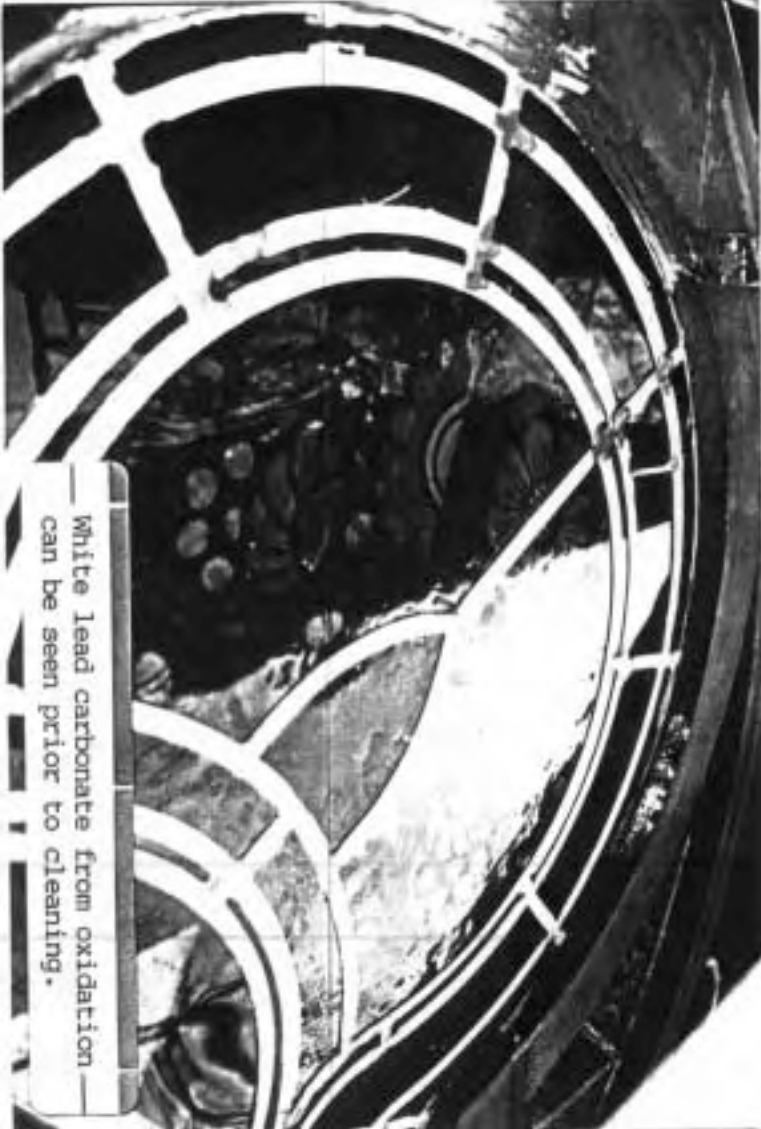
— White lead carbonate from oxidation —
can be seen prior to cleaning.

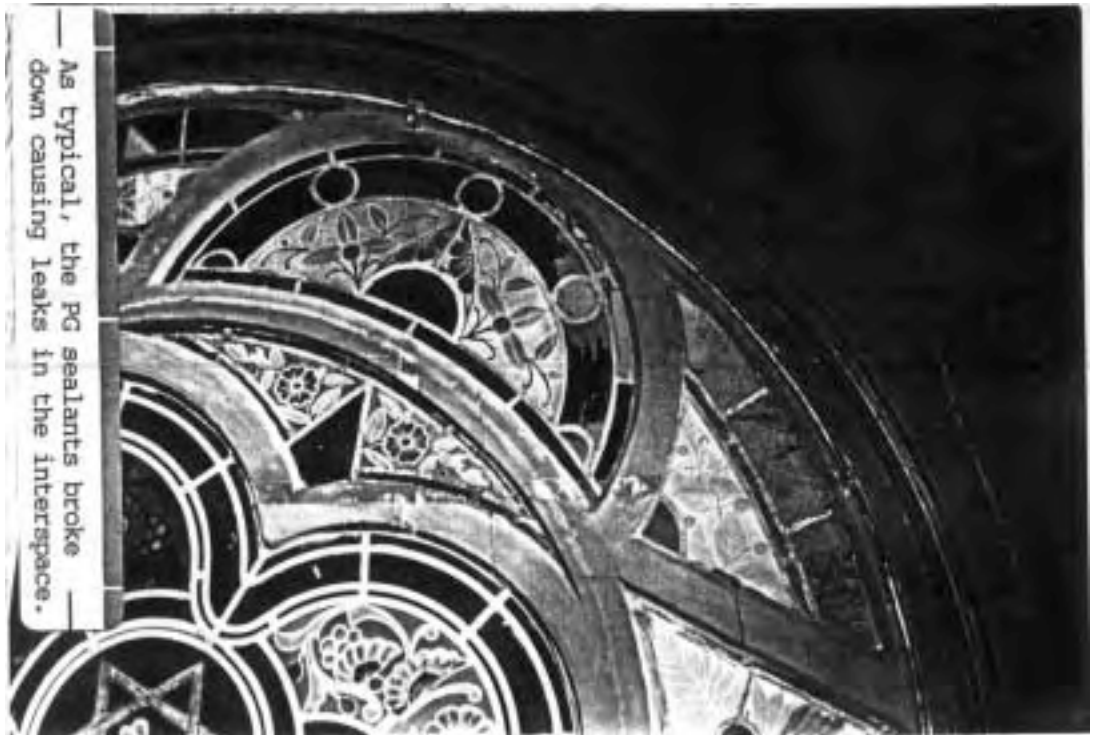
— As typical, the PG sealants broke —
down causing leaks in the interspace.
