**Applying Infrared Thermography for the Purpose of  
Identifying Concealed Wood Framing Member Type and  
Subsurface Anomalies with Intended Application Towards  
Historic Structures**

**University of Kentucky, College of Design,  
Department of Historic Preservation**

**Grant #: MT-2210-06-NC-10**

Final Report was Submitted August 24, 2008

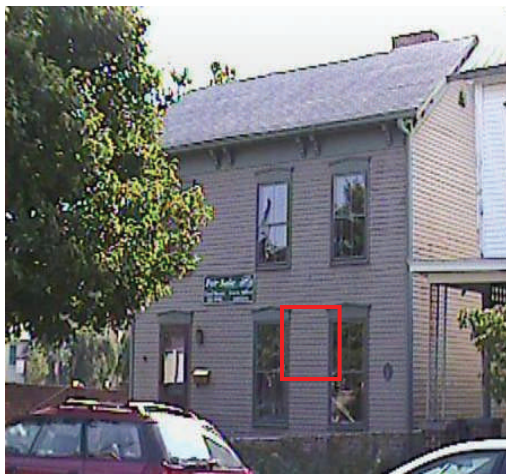
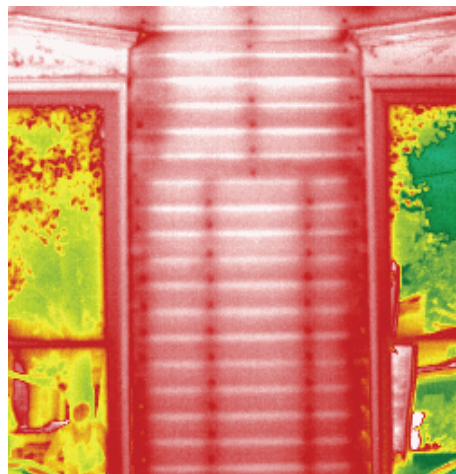
**Fig. 1 & 2:** Digital picture of an early 19<sup>th</sup> century frame structure in Lexington, Ky. (top). The red box indicates where the infrared picture (bottom) was taken. Note the identification of an otherwise unsuspected framing system. (Photos by John Liebertz, 2007)

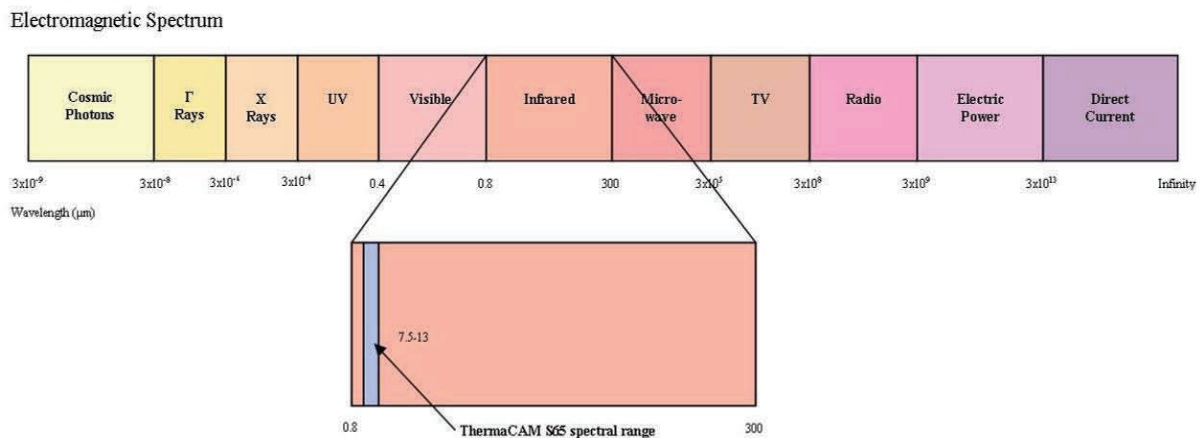
**Fig. 3:** An illustration of the electromagnetic spectrum showing infrareds relationship to other spectral ranges. The infrared camera used to conduct this research has a spectral range between 7.5-13  $\mu\text{m}$ 's as noted by the light blue band and black arrow. (Illustration by author, 2007)

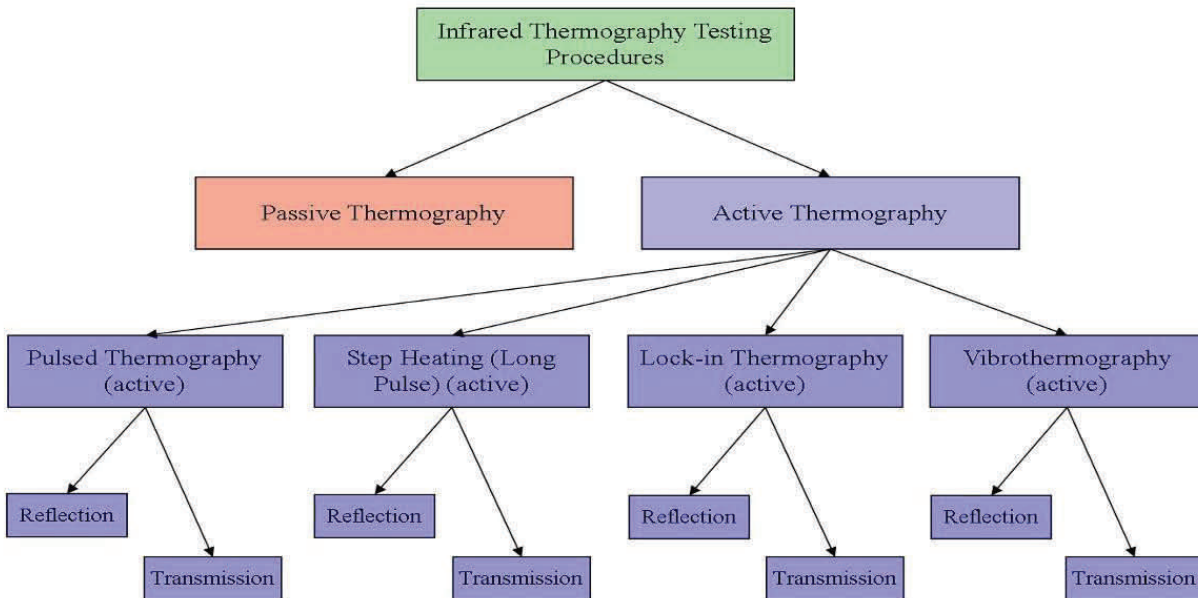
**Fig. 4:** Various infrared thermography testing procedures exist, each with advantages and disadvantages. The illustration above shows these procedures beginning with the two main methods, passive and active thermography and ending with the two types of heating methods, reflection and transmission. (Illustration by author, 2008)

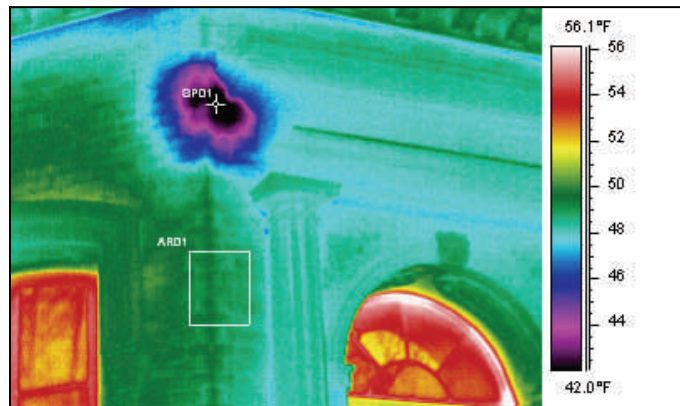
**Fig. 5:** IRT image of Ashland Estate, Lexington, Kentucky (ca. 1854) indicating a thermal anomaly (dark area) on the brick facade. The thermal gradient between the temperature of the center of the anomaly and the average temperature of sound brick directly below registered a  $\Delta T$  value of 9°F. The area when checked with a moisture meter was well above comparative levels. Passive thermography was used to detect this anomaly. (Photo by author, 2007)

Although passive thermography typically produces qualitative data the process has proven extremely effective in detection of moisture and the identification of concealed structural elements within historic buildings (fig. 5 & 6).

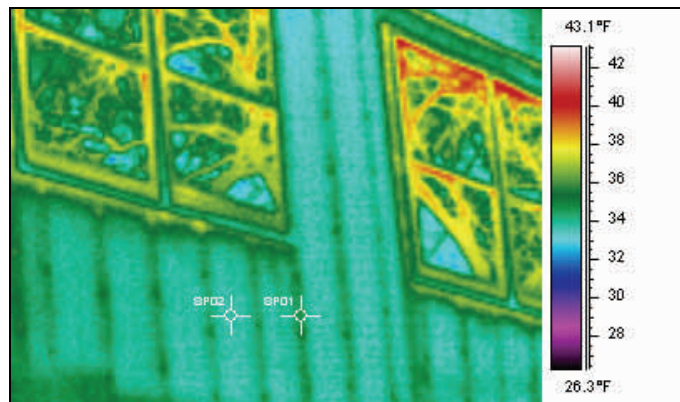
**Fig. 6:** This IRT image, taken on a cold night (28°F), shows the wood frame structural system below 1/4" masonry siding on a ca 1958 rancher. Although no active measures were taken to heat this facade the interior of the structure was heated to 68°F creating a thermal gradient of 40°F, thereby enhancing the contrast between the thermal bridges, the studs, and the insulated wall cavities. The  $\Delta T$  value between the stud (34.8°F) and the wall cavity area (33.8°F) was 1°F. (Photo by author, 2007)

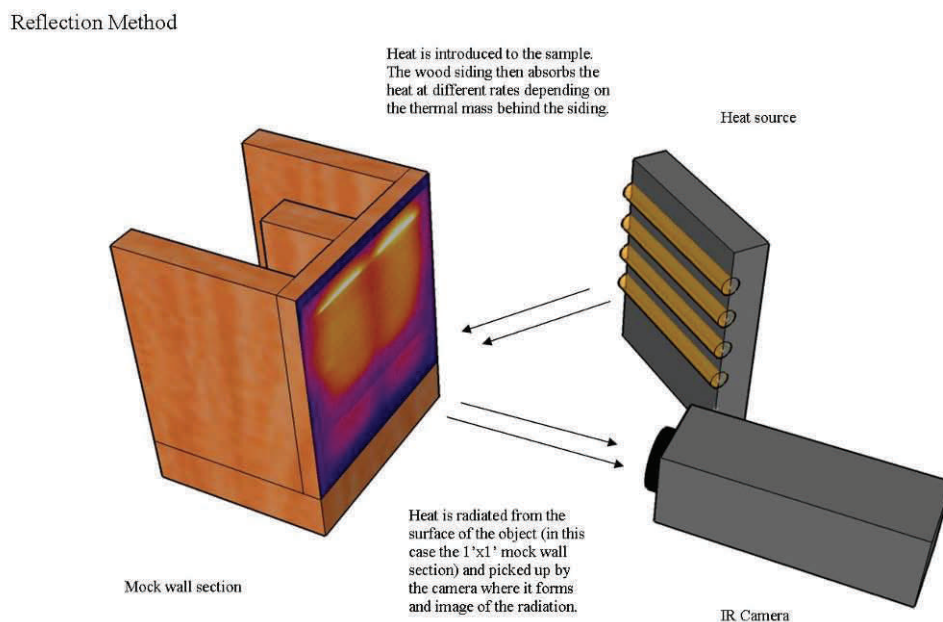
**Fig. 7:** A schematic showing the arrangement of the heating apparatus, the IR camera and the mock wall section during an active thermographic test that is using the reflection mode. Note the off centered position of the heating apparatus, ideally another unit would be placed on the opposite side of the IR camera to promote even heating. (Illustration by author, 2008)

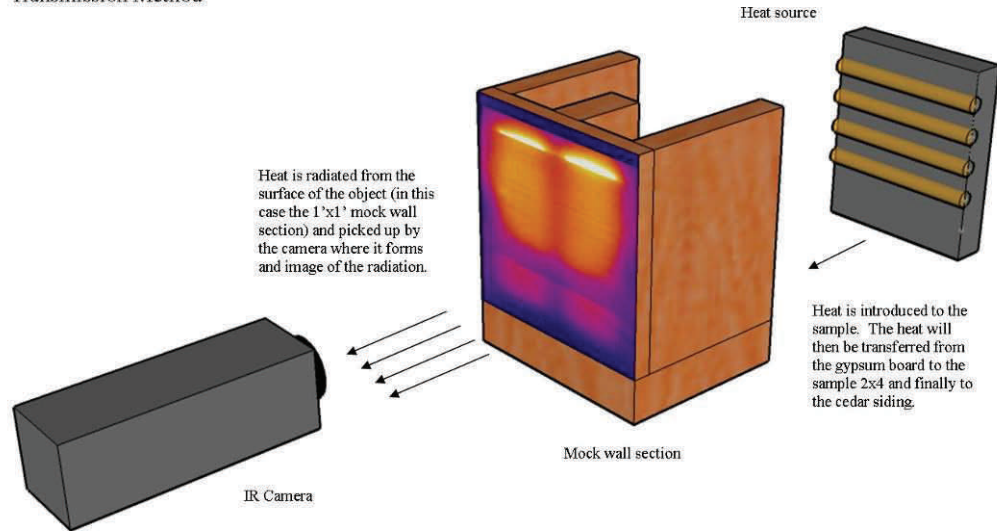
**Fig. 8:** This schematic depicts the transmission mode also in conjunction with active thermography. Note the placement of the heating apparatus on the opposite side from the IR camera. While this method can take longer to produce results it provides the most consistent and even heating of the object. (Illustration by author, 2008)

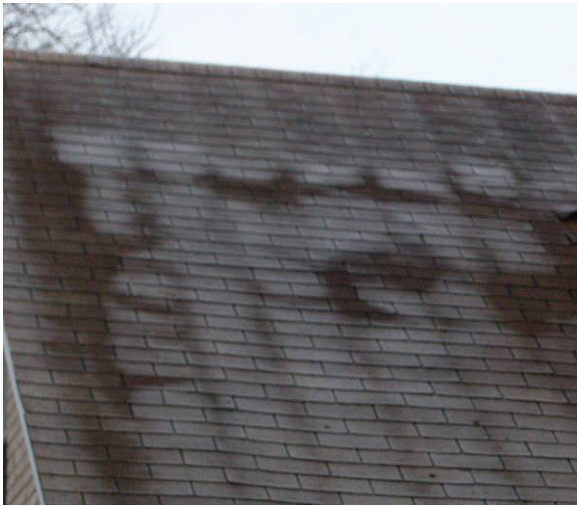
**Fig. 9:** A thermal bridge, such as the rafters in this photograph, act as a better thermal conductor than the surrounding materials, in this case fiber glass wool insulation. IRT can help make this differences visible without the need for a cold frosty morning. (Photo by author, 2007)

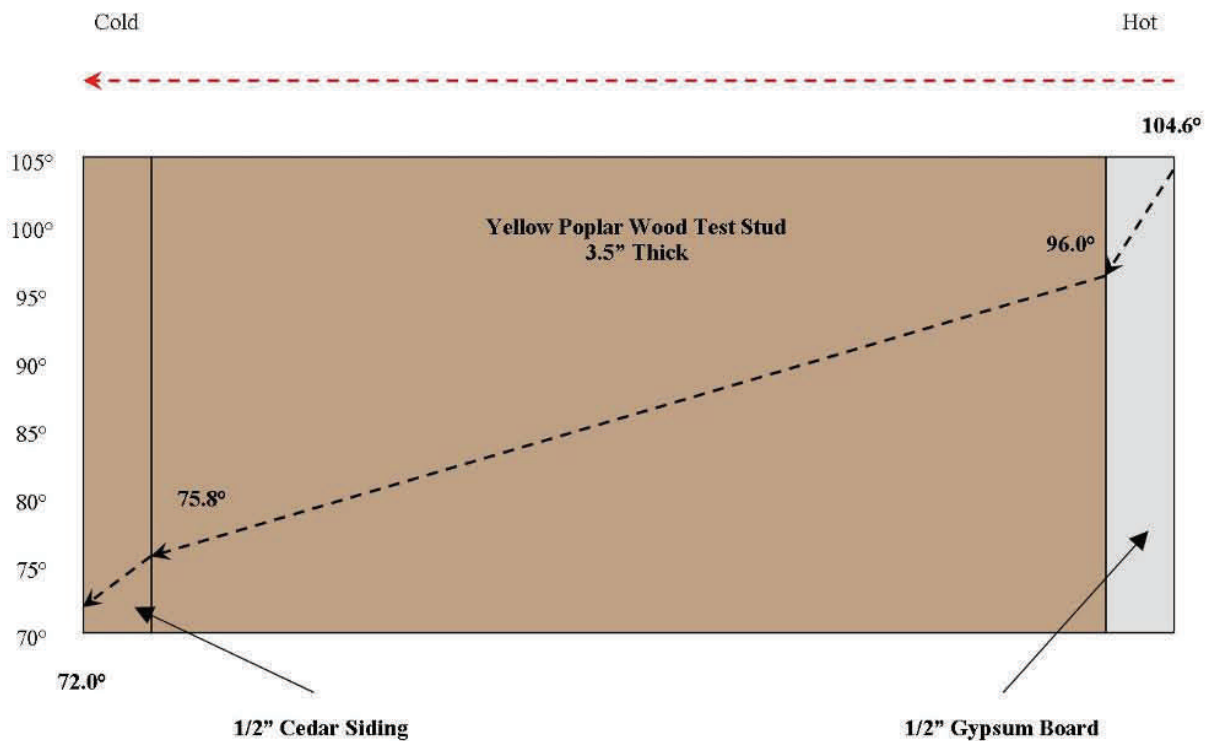
**Fig. 10:** Illustration showing the thermal transfer and decline as the heat pulse propagates through various materials. Easily discernable is the difference in thermal conductivity ( $k$  values) between the gypsum board and the wood materials. (Illustration by author, 2008)

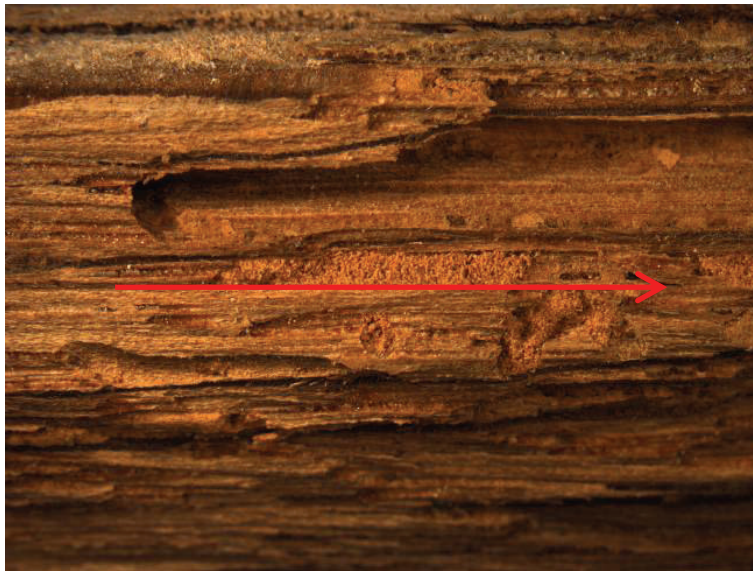
**Fig. 11:** 7x magnification of wood indicating the distinct grain direction (red arrow). (Photo by Liz Boyer, 2008)

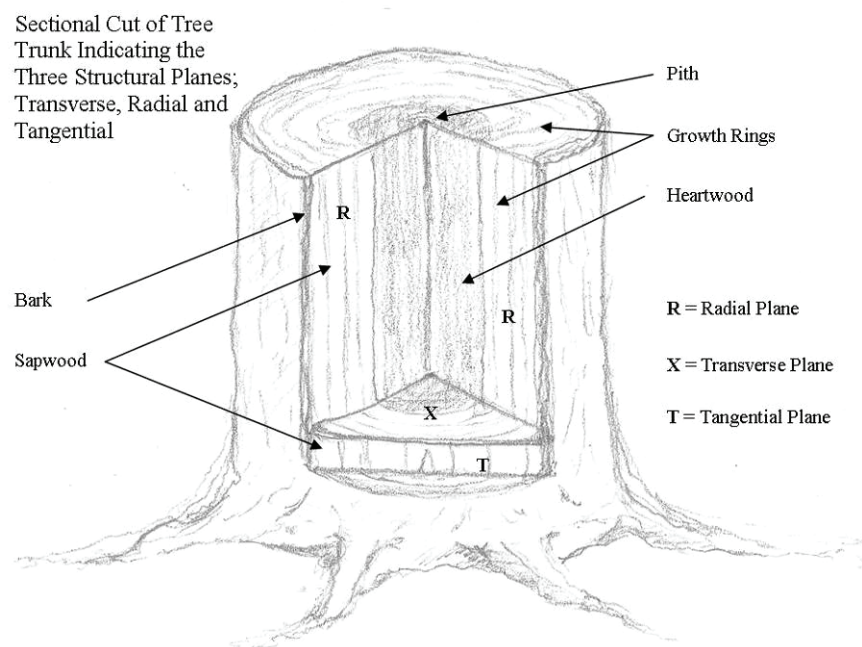
**Fig. 12:** Illustration showing the various wood planes within the context of a tree trunk. Note how the growth rings create different visual patterns on the wood depending on the cut. (Illustration by author, 2008)

One of the primary cells in coniferous tissue is the tracheid. Parenchyma cells and epithelial cells also can be found but are too few in number to greatly influence a woods thermal conductivity. Tracheids come in two forms, with the denser, and therefore higher  $k$  value, of the two found in latewood. Latewood tracheids are characterized by small cellular diameters, a somewhat flattened shape and slightly thicker cellular walls whereas earlywood tracheids have larger cellular diameters, a rounder shape and thinner cellular walls.<sup>33</sup> Observing trachied diameters can also be useful in species identification as certain species have specific diameter sizes. This diameter size can also be used as an indication of the woods potential  $k$  value, as there is a correlation with density. However, it is important that only the diameters of the transverse plane (**fig. 12 & 13**) be examined when making comparisons.<sup>34</sup>

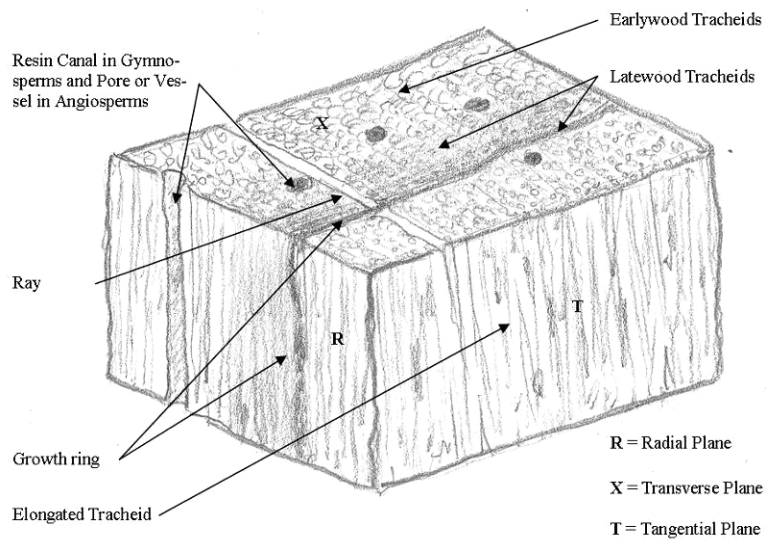
**Fig. 13:** Illustration showing the magnified composition of a coniferous wood. Visible under x25 magnification are tracheids, resin canals and rays. Also note how the wood planes correspond to the cellular orientations. (Illustration by author, 2008)

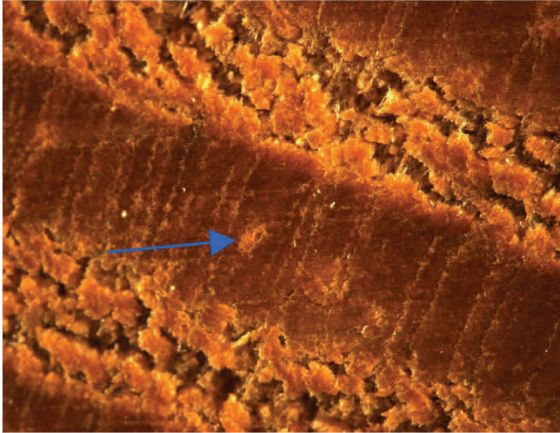
**Longleaf Pine (SYP):** x40 magnification showing the resin canals (arrow) as well as the clear latewood and early wood distinction.

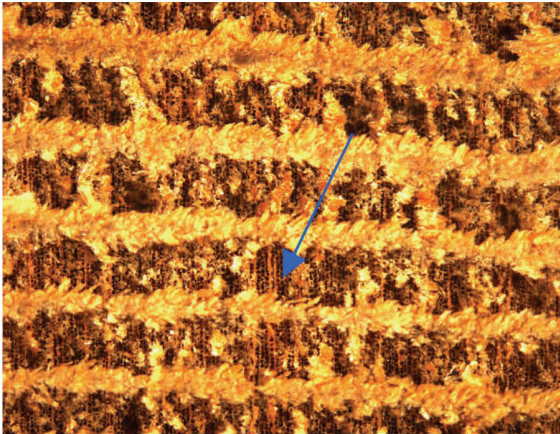
**Western Red Cedar:** Cedar sample under x40 magnification showing clear earlywood and latewood distinctions as well as tracheids (arrow).

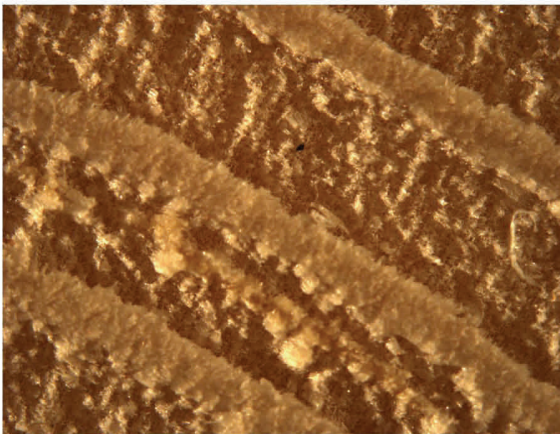
**Spruce-Pine-Fir:** Although noticeable earlywood and latewood this particular sample exhibits little color distinction. Tracheids are visible but small.

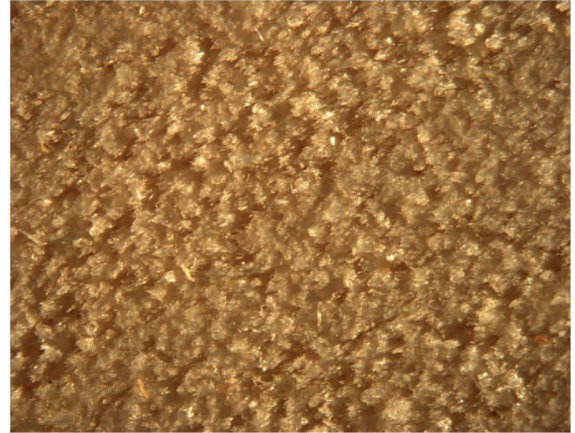
**Yellow Poplar:** x40 magnification, notice the “even” grain of the sample. Pores are too small to be clearly visible under this magnification.

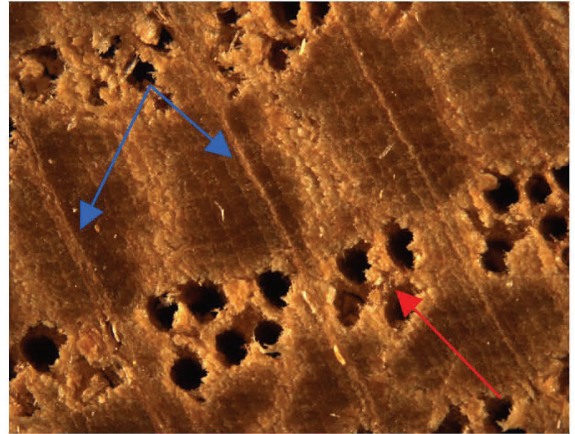
**Red Oak:** x40 magnification with pores (red arrow) and rays (blue arrow) clearly visible. Oak is known for its large pores.

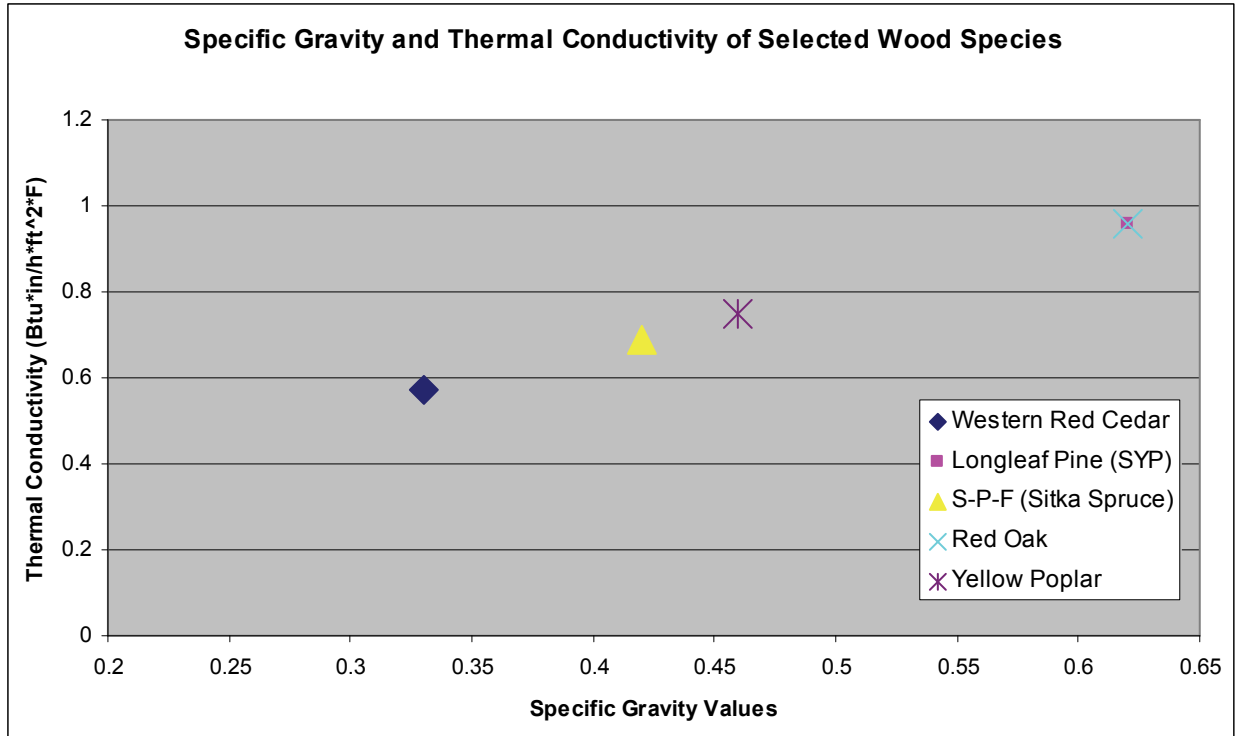
**Chart 1:** A chart showing the correlation between density (specific gravity) and thermal conductivity of wood species used during testing. (Chart by author, 2007)<sup>40</sup>

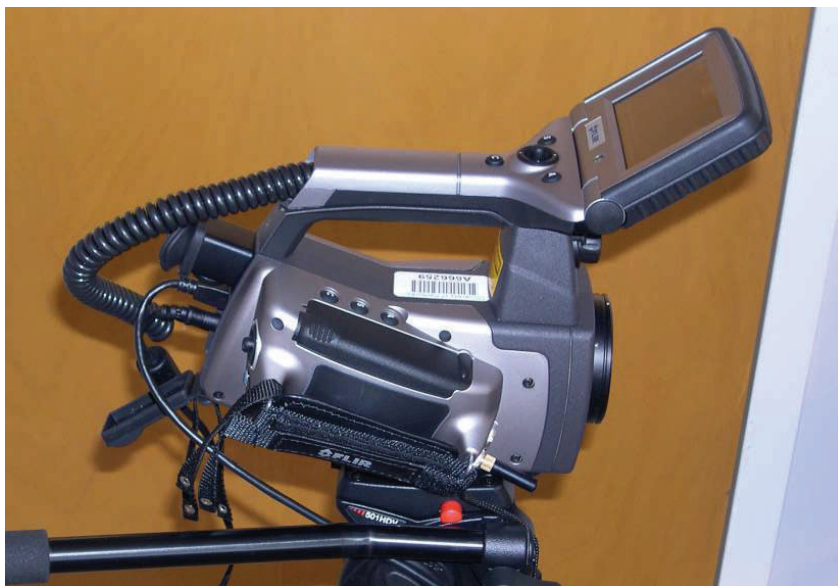
**Fig. 16:** Photo showing the ThermaCAM S65 HS mounted on a tripod for stationary viewing. Note the LCD screen for easy viewing and the straps for portability in the field. (Photo by author, 2007)

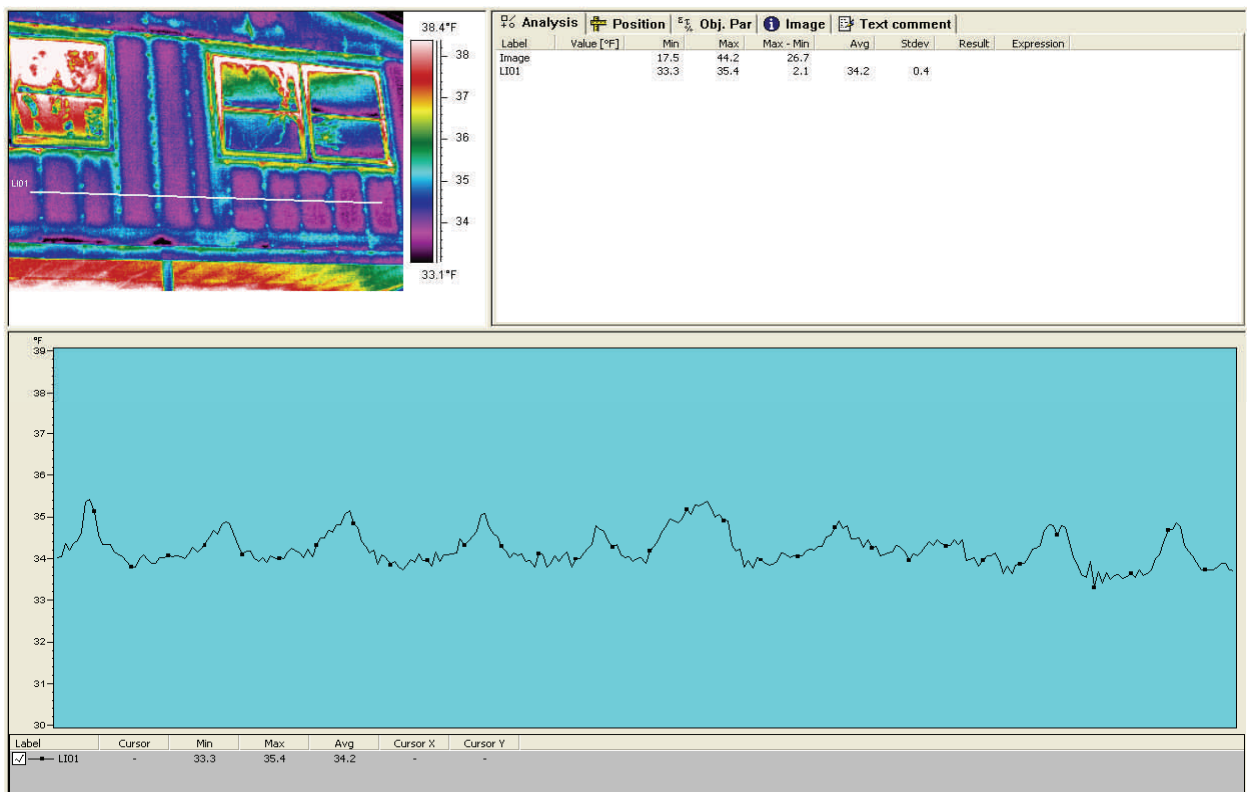
**Fig. 17:** Screen image of FLIR's ThermoCAM Researcher Pro 2.8 SR-2 showing a profile analysis using a line across the IR image. The profile clearly shows the location of the studs and resulting temperature differences. (Photo by author, 2007)

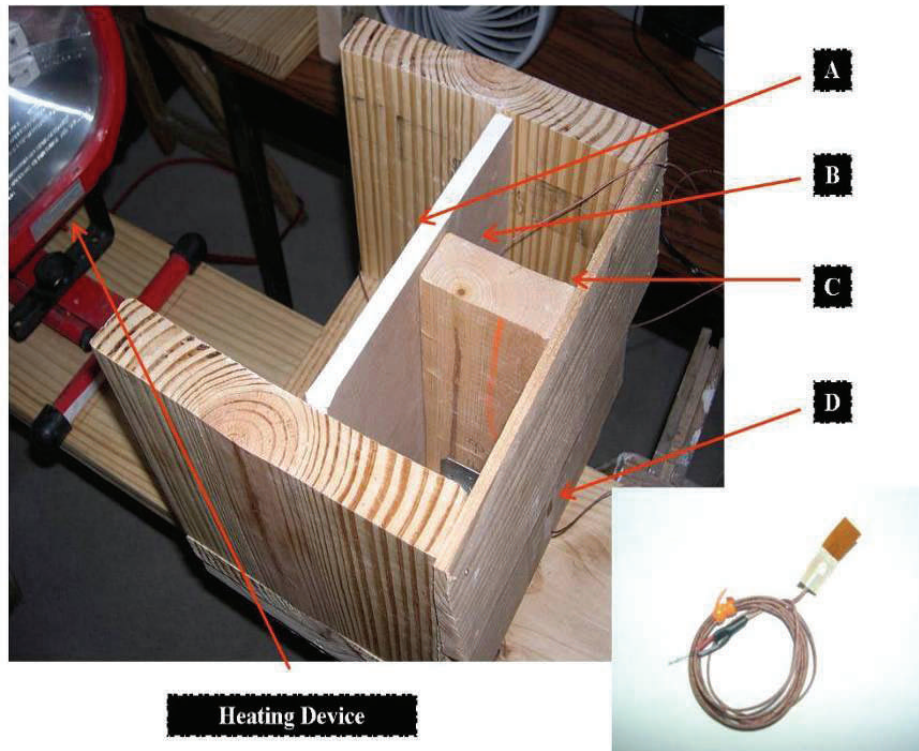
**Fig. 18:** Photograph showing the small mock wall section in relation to the heating device. Each notation, A, B, C and D all used type E thermocouples as represented in the inset picture. The adhesive end (red circle) was attached in all these locations and measured the temperature as heat propagated through the wall section. (Photo and annotations by author, 2008)

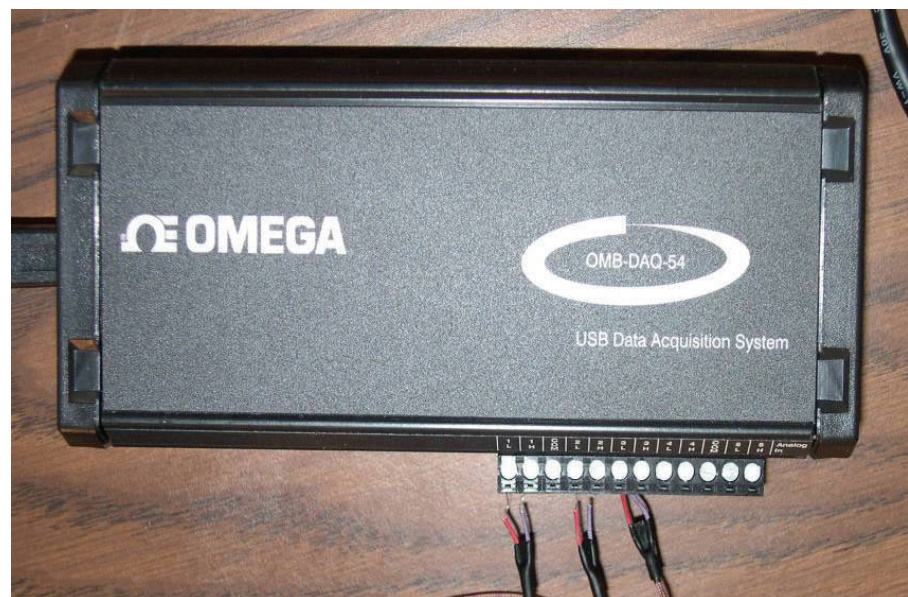
**Fig. 19:** Omega data acquisition unit (OMB-DAQ-54) used to acquire temperature readings throughout the mock wall section. Type E thermal couples were used in conjunction with this unit with measurements taken every 7.5 seconds. The thermal couple terminals are located at the bottom right of the unit. (Photo by author, 2007)

While thermocouples were used to obtain temperature data the OMB-DAQ-54 (**fig. 19**) was used to translate and store temperature values. This data acquisition unit manufactured by Omega instruments provides terminals for up to five thermocouples to be employed at the same time as well as a USB connection to a computer. Corresponding software logs the information from the thermocouples, displaying the information in real time as a temperature or stores it in a

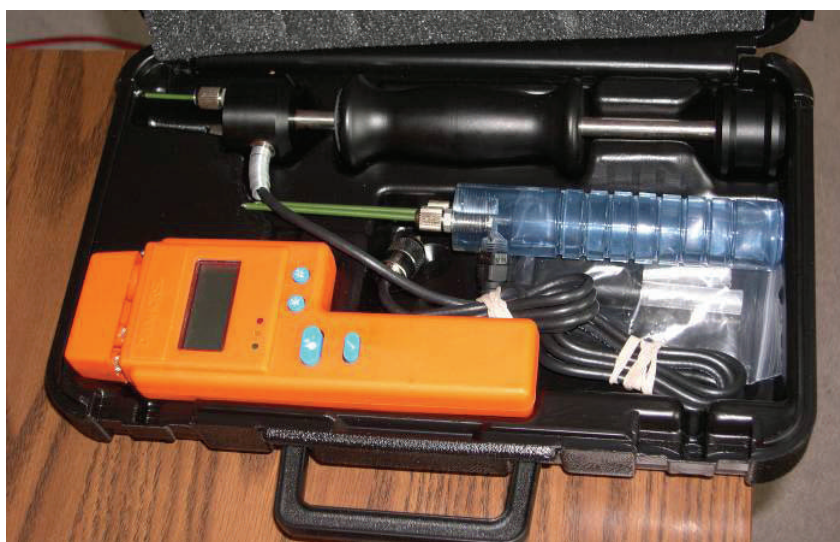
**Fig. 20:** Picture of the Delmhorst BD-2100 unit (orange) and accompanying pin set. The pin in the middle is used for deep wood penetration and is insulated on all sides so that the reading obtained is only from the tips of the pins. (Photo by author, 2007)

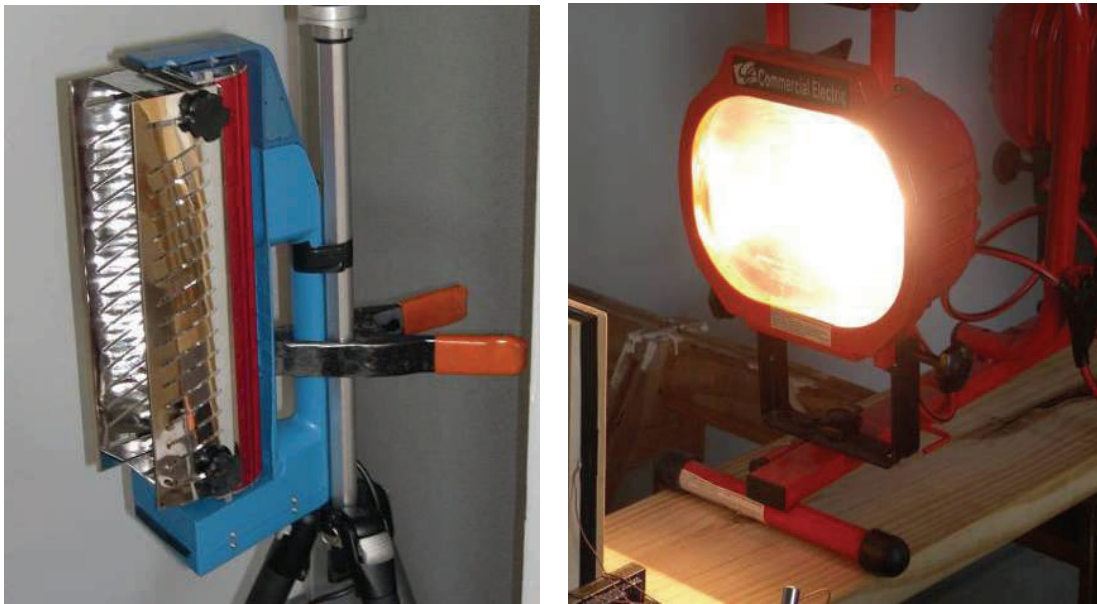
**Fig. 21-22:** Photographs showing the IR heat lamp on the left and the 300 watt type J lamp on the right. While the IR lamp posed a fire hazard the 300 watt lamp was able to be left unattended as temperatures never approached the threshold for thermal degradation. (Photo by author, 2007)

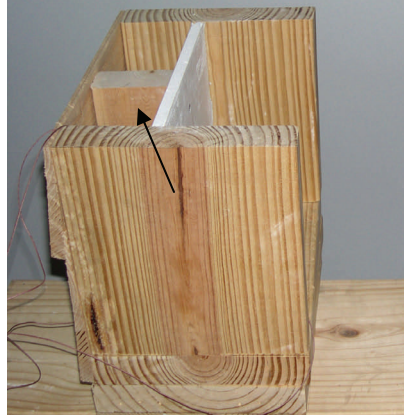
**Fig. 23:** Photograph showing one of the small 1'x1' wall sections. Clearly visible is the gypsum board (right), stud (arrow) and cedar siding (left). (Photo by author, 2008)

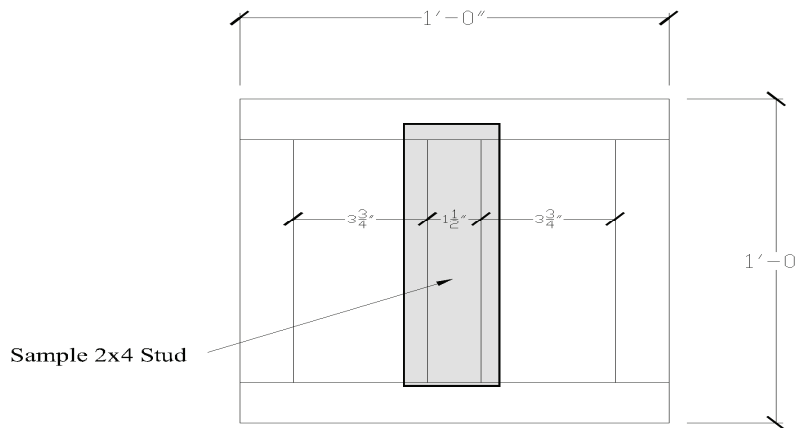
**Fig. 24:** Illustration showing the dimensions of the small 1'-0" x 1'-0" wall section from the front minus the cedar weatherboard siding. The grey box highlights where the sample stud is relative to the wall cavities (either side measuring 3.75") and the sides of the wall section. (Illustration by author, 2007)

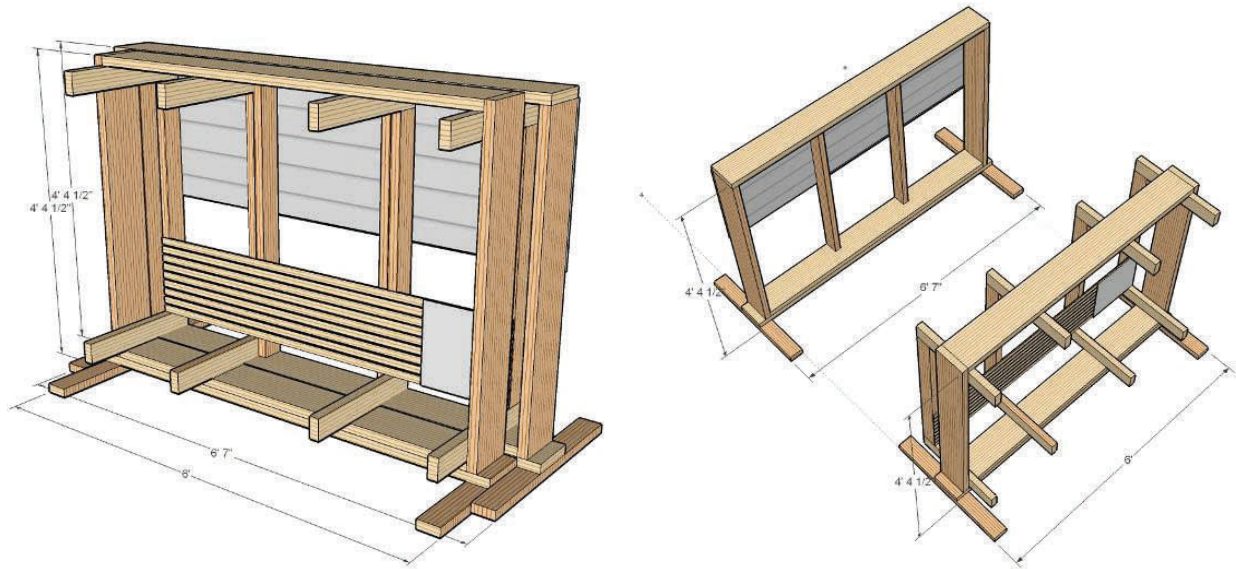
**Fig. 25 & 26:** Illustration showing how the large mock wall sections various “modules” came together (left image). The illustration on the right shows the unit housing the samples and siding (upper left) as well as the unit with the drywall (lower right). Placed together the sections formed a closed wall section with the sample studs in the middle. During construction the design was adjusted so that the studs from the drywall module did not come into contact with the sample studs. Instead of the 1’-11” on center spacing of the studs originally planned, spacing was changed to 10 ½” on center. The units were placed on casters so that they could simply be rolled apart when interchanging sample studs. (Illustrations by author, 2007)

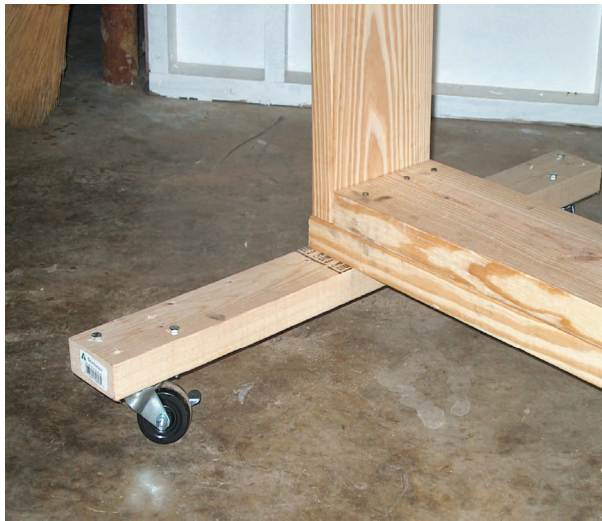
**Fig. 27:** Photo showing the casters used to wheel the larger wall sections into testing positions. The casters could also be locked to prevent sliding in transition or movement during testing. (Photograph by author, 2007)

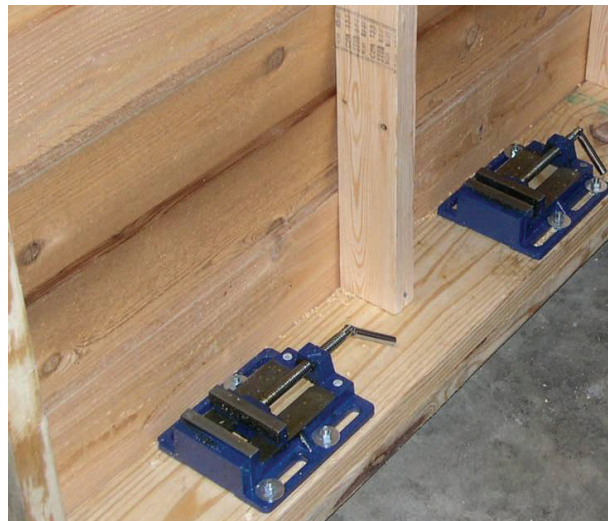
**Fig. 28:** Photo showing the clamps used to secure sample studs in the large mock wall section. Due to adjustability various sized wood members could be used. (Photograph by author, 2007)

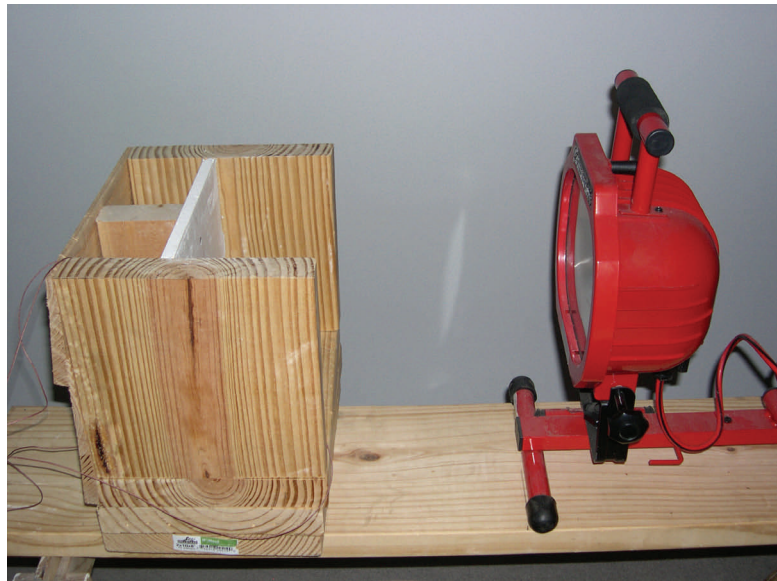
**Fig. 29:** Photo showing the placement of the 300 watt halogen lamp heat source fifteen inches from the gypsum board of the 1' x 1' mock wall section. The IR camera would be five feet to the left facing the sample and the lamp. (Photograph by author, 2007)

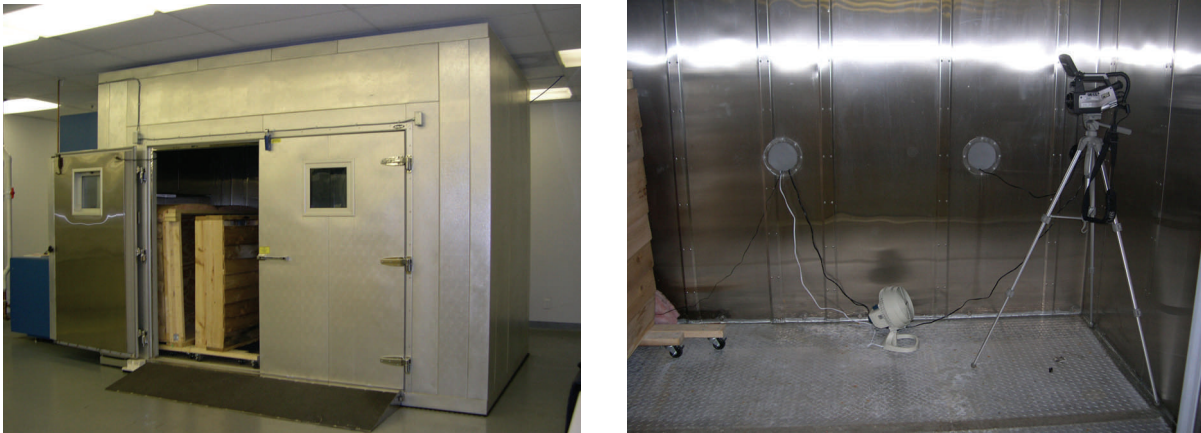
**Fig. 30 & 31:** Two images showing the environmental chamber at ESSC, Cincinnati, Ohio, used for testing the large wall sections. The two doors and ramp (left image) allowed the wall sections be we easily placed within the chamber. The interior of the chamber (right) shows the camera and the wall section (extreme left of the image). Note the wires passing out through the two holes (center), these connect the heating apparatus, thermocouples and IR camera to the computer outside the chamber. (Photo by author, 2007)

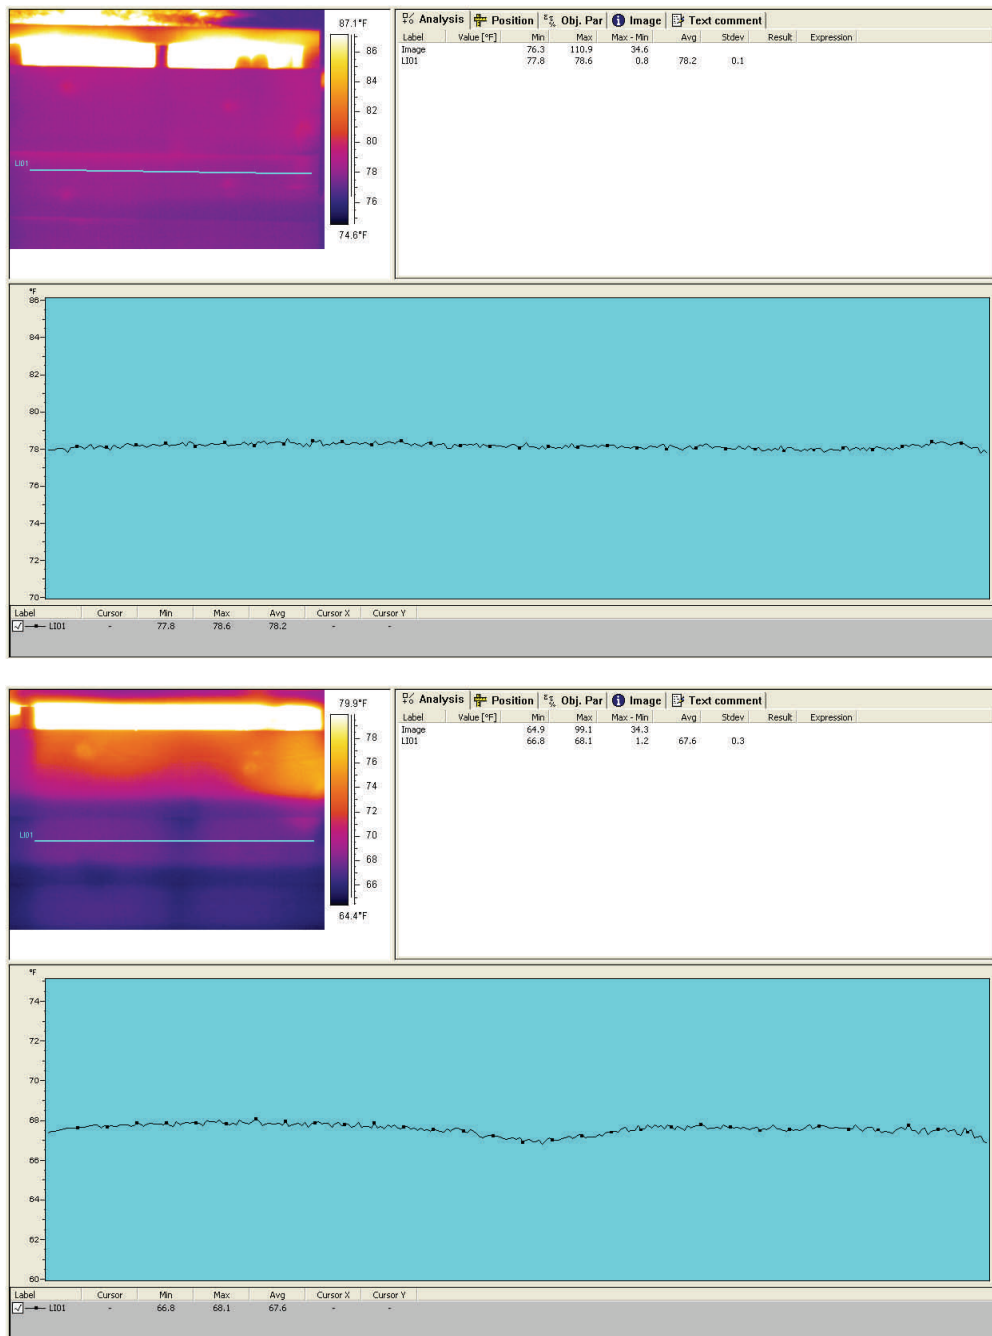
**Fig. 32:** Both images are of the large wall sections tested in the ESSC environmentally controlled chamber. However the top image shows the thermal profile of the siding's surface after 30 minutes of heating where the temperature of the chamber has been maintained at 55°F. Note the consistent coloration of the woods surface indicative of an even temperature. The profile created by the line analysis also shows little change. This can be compared to the lower image that ceased environmental control after materials had reached 55°F. Note the obvious thermal differences in the image as well as the profile, the dip noting where the stud is located. (Images by author, 2007)

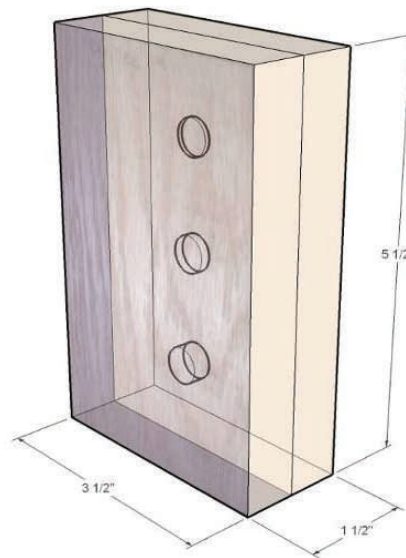
**Fig. 33:** Illustration showing the size of the wood sample used for deterioration analysis. Note the drilled holes. From top to bottom in terms of below surface depth/depth of simulated deterioration; 0.50”/0.25”, 0.63”/0.13”, 0.69”/0.06”. (Illustration by author, 2007)

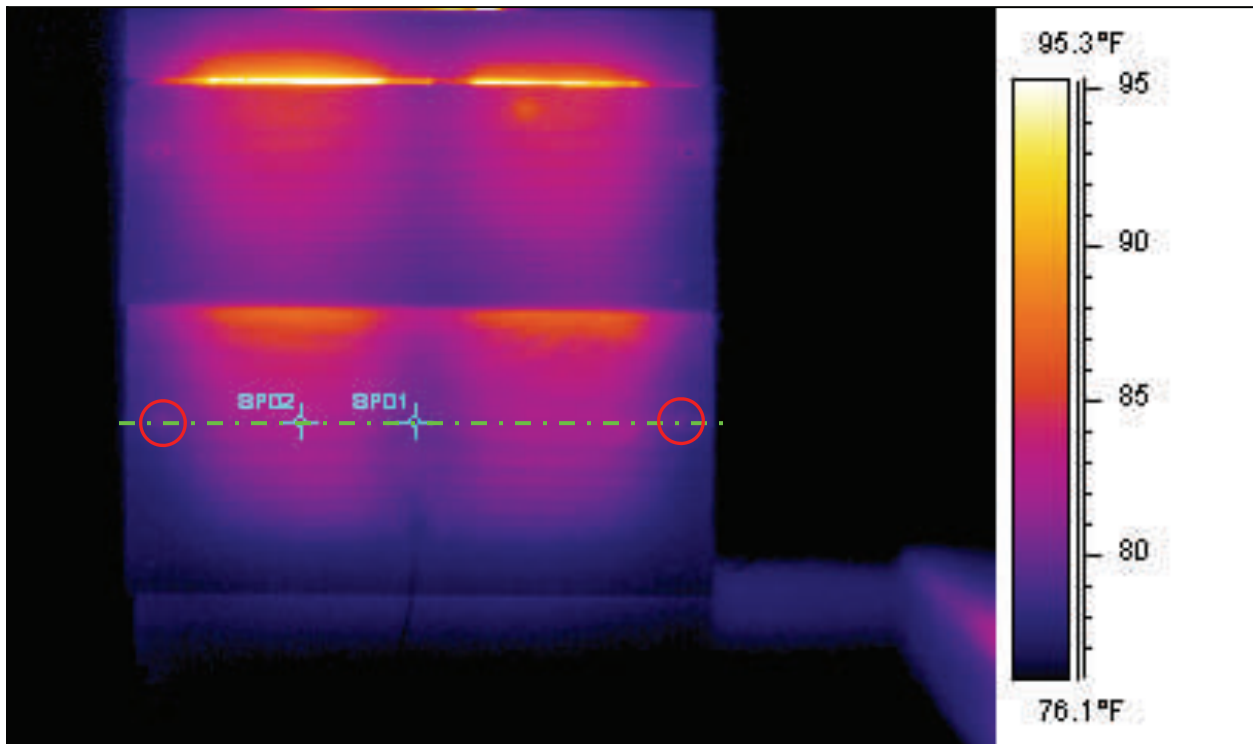
**Fig. 34:** IR image of the 1' x 1' mock wall section. Note the placement of the two spot analysis tools on the same x-axis (dashed green line). If you look closely you can discern two small thermal anomalies (red circles), these are the nail holes used to align the spots on the IR image. The spots are then moved along this x-axis (dashed green line) until the highest and lowest temperatures are located. (Image by author, 2007)

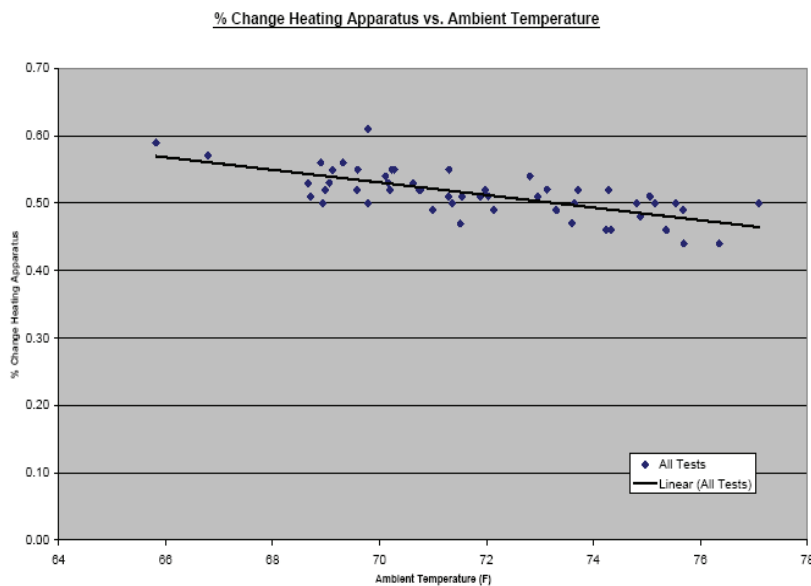
**Chart 2:** Chart 2 shows the affect that ambient air temperature has on the percentage increase of the heating apparatus used. As you can see the cooler the ambient temperature the higher percentage change in temperature increase. (Chart by author, 2008)

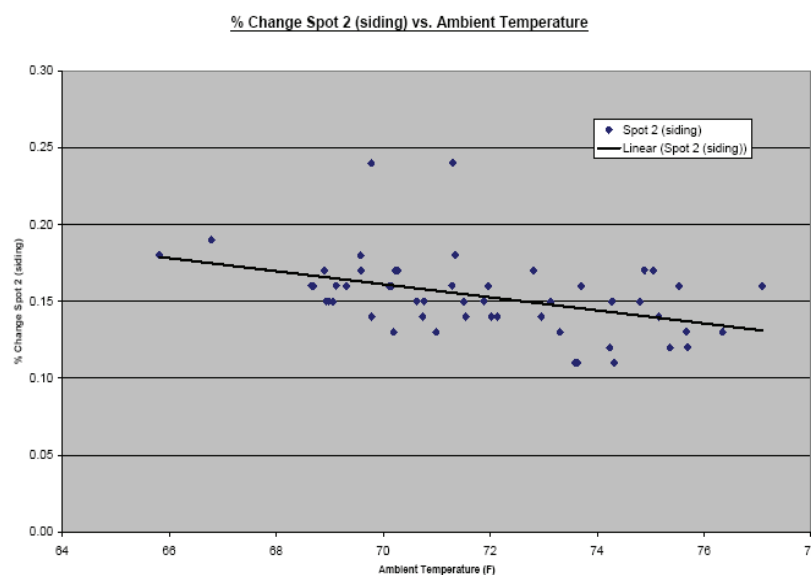
**Chart 3:** Chart 3 shows the ramifications of this by comparing the ambient temperature to the percentage change in one of the spots used for analysis. Again the cooler the temperature the greater percentage change. This makes IRT comparisons difficult when looking at temperature as a function of time therefore the percent changes of both spots were analyzed as functions of each other. Because spot 2 was always measuring the same variable any variations in linear slope were caused by spot 1 which analyzed the sample stud + the siding. (Chart by author, 2008)

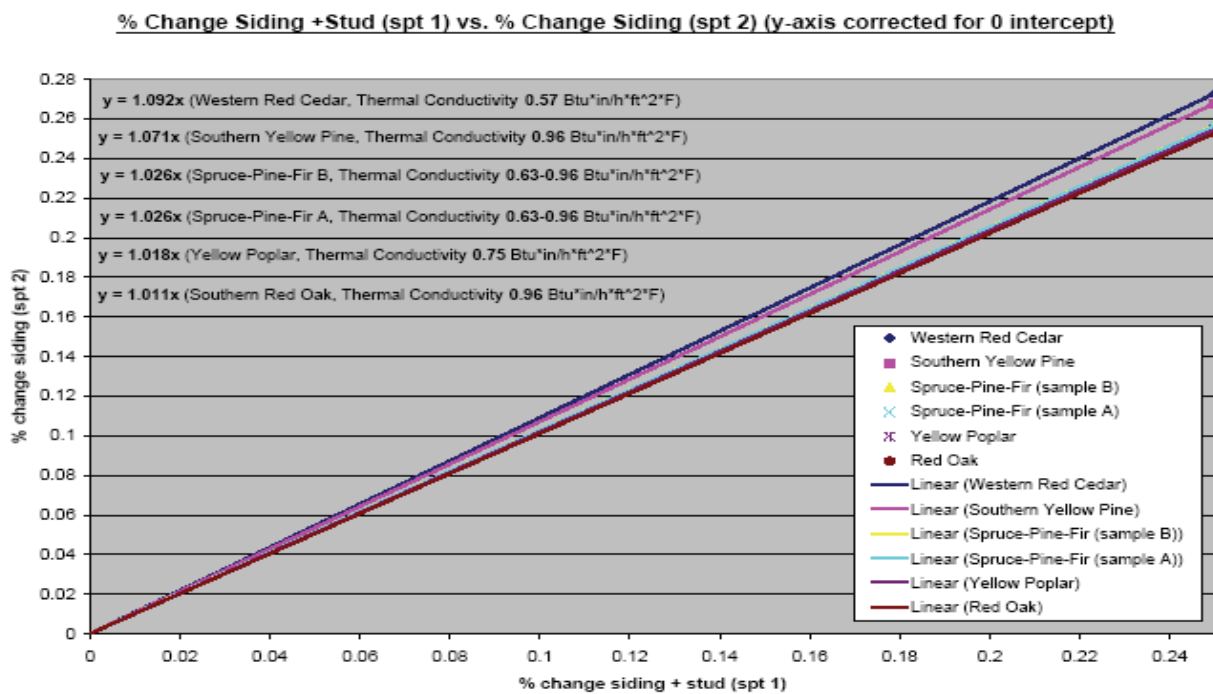
**Chart 4:** This graph plots the percentage changes of spots 1 & 2 of the small wall sections in a semi-controlled environment as they relate to each other over 240 minutes. Trendlines are used to help distinguish species as there is initial overlap when looking at scatter plots. However, linear variations become more pronounced the larger the percentage values. (Chart by author, 2008)
