**Applying Infrared Thermography for the Purpose of  
Identifying Concealed Wood Framing Member Type and  
Subsurface Anomalies with Intended Application Towards  
Historic Structures**

**University of Kentucky, College of Design,  
Department of Historic Preservation**

**Grant #: MT-2210-06-NC-10**

Final Report was Submitted August 24, 2008

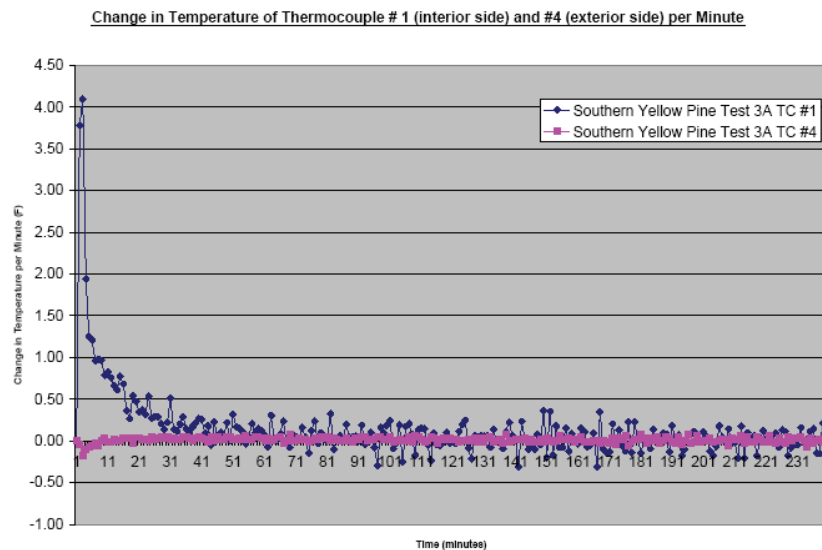
**Chart 6:** While temperature change per minute is consistent on the observed side of the wall section (chart 5) when the temperature increase is viewed in entirety its easy to observe that the first 75 minutes produce the steepest linear slope in terms of temperature gain, resulting in a temperature change of almost 4.5°F. The remaining 165 minutes only manages a temperature gain of 3.5°F. (Chart by author, 2008)

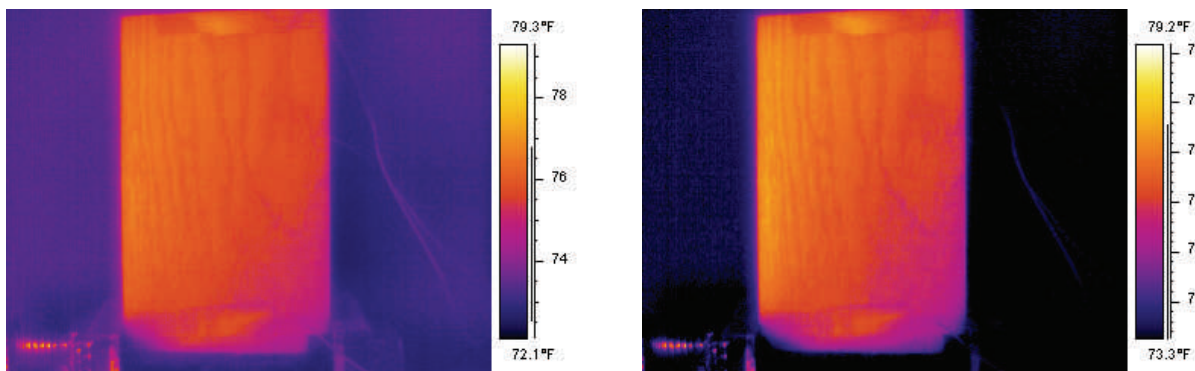
**Fig. 35 & 36:** The image on the left is the Red Oak sample after 20 seconds exposure to the 1100 watt IR lamp. The image on the right is the same sample in another test after 30 seconds exposure time. Note that the wood grain is clearly visible in each image however there are no indications of the three areas of simulated deterioration present below the woods surface. (Images by author, 2008)

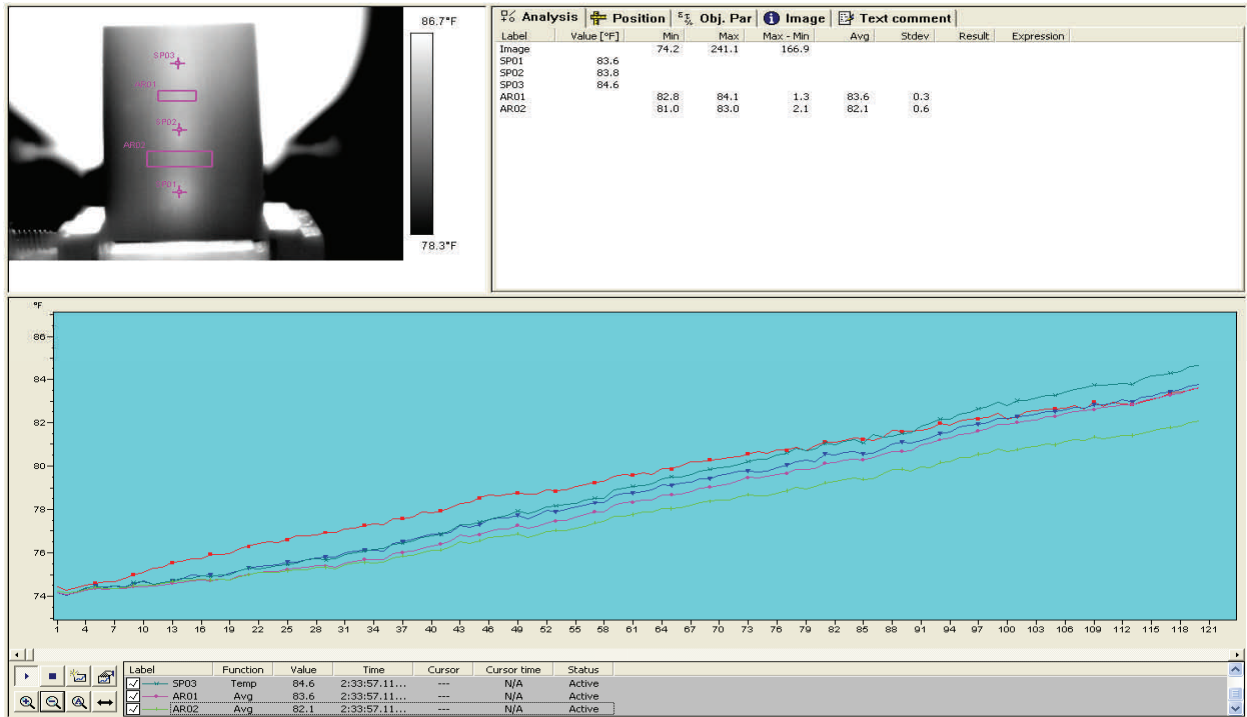
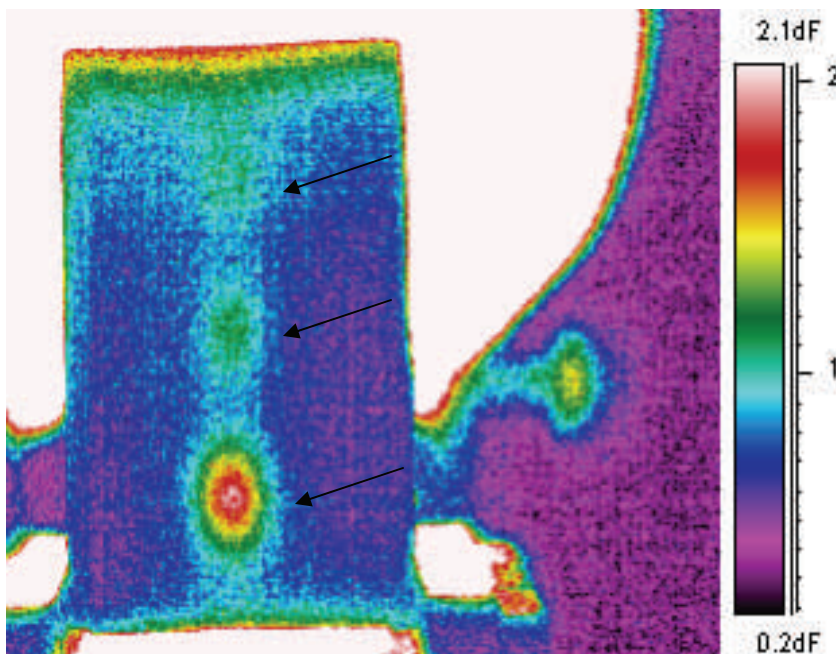
**Fig. 37 & 38:** The top image shows the plot results after a 10 minute test. Note the placement of the spots over the areas of simulated deterioration with spot 1 being situated over the shallowest area of deterioration at only 1/8". Note also how all three spots in the plot graph separate from the boxed areas (average temperature of sound wood) increasing in temperature considerably faster. The x-axis values should be multiplied x5 to determine actual time in seconds. The image on the left is the result of determining the temperature difference between the first and last IRT images, note the three distinct areas of deterioration. (Images by author, 2008)

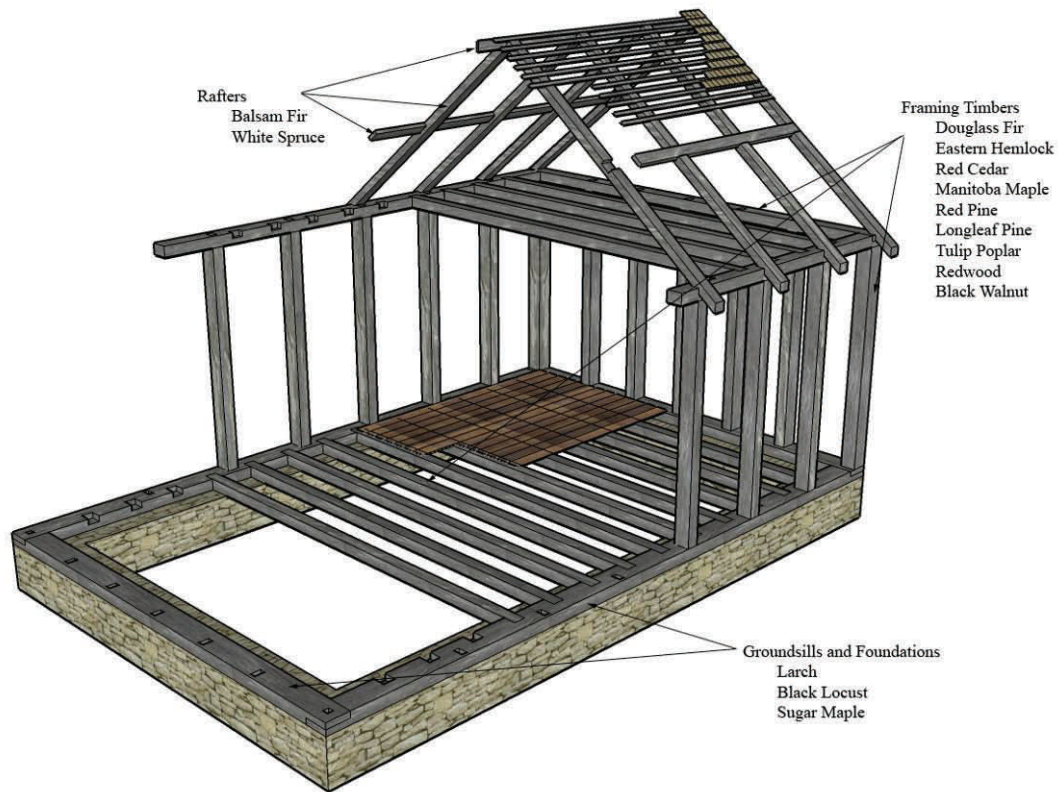
**Fig. 39:** This illustration is of a typical brace frame structure common during the period between the late 18<sup>th</sup> century and mid 19<sup>th</sup> century. Structural members varied in size, corner posts often much larger than studs and joists. Different species were often used in different structural capacities based on certain characteristics; these are noted on the drawing. (Illustration by author, 2008)

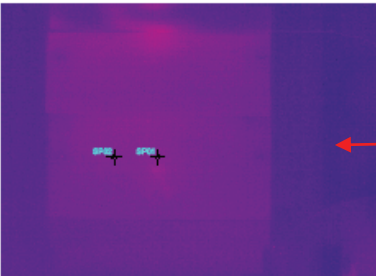
**Fig. 40**

**Database**  
**Active Infrared Thermography**  
**Step Heating (Long Pulse) Thermography Testing**  
**Wood Species Identification**  
**Small 1'x1' Wall Sections**  
**Semi-Controlled Climate**  
**Test Results**  
**H(3-26-08(1'x1')Poplar-A-T(LP)-300wHB-240-00-01**

Test #/Sample	1A
Date	3/26/2007
Wood Moisture (%)	<6%
Emissivity	0.655
Camera Distance	5ft
Atmospheric Temperature (°F)	71.88
Reflected Temperature (°F)	71.98
Relative Humidity (%)	22%
TC #1 -TC #4 (heated—non heated side)	0.04
ΔT TC#1heated side (final)	36.47
ΔT Spot 1(final)	9.01
ΔT Spot 2(final)	10.76
spt 2 - spt 1(final)	1.77
% change spt 1 (final)	0.12
% change spt 2(final)	0.15
% change TC#1 heated side (final)	0.51
Final Temperature TC#1 (heated side)	108.35

Inclusion within any database first requires that testing be consistent and therefore proper procedure for inclusion should follow ideal protocols outlined in the methodology section. Proper labeling is also required so that relevant files can be viewed and easily retrieved as the database grows. The information required on each sheet relates to parameters and results used during this research and so more specifically applies to determining wood type rather than deterioration or other characteristics. However, the general model can be adapted to apply to other IRT techniques and investigations. Proper formatting of data is noted on the template page and mainly involves conversion to Excel. Specific information regarding the database template is noted below as annotations on an image of the template. The subsequent pages show one link chain from the databases homepage to actual testing results. Green objects are typically the objects linking the pages together.

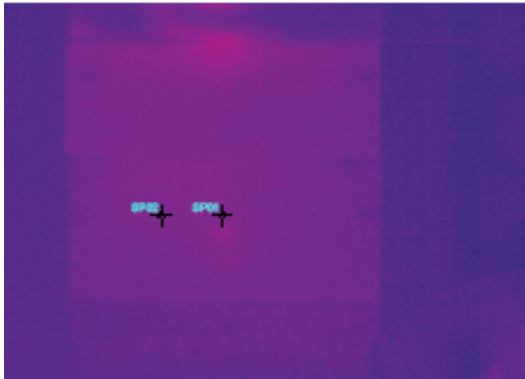
**Database**  
**Active Infrared Thermography**  
**Step Heating (Long Pulse) Thermography Testing**  
**Wood Species Identification**  
**Small 1'x1' Wall Sections**  
**Semi-Controlled Climate**  
**Test Results**  
**H(3-26-08)(1'x1')Poplar-A-T(LP)-300wHB-240-00-01**

Test #/Sample	1A
Date	3/26/2007
Wood Moisture (%)	<6%
Emissivity	0.655
Camera Distance	5ft
Atmospheric Temperature (°F)	71.88
Reflected Temperature (°F)	71.98
Relative Humidity (%)	22%
TC #1 -TC #4 (heated—non heated side)	0.04
ΔT TC#1heated side (final)	36.47
ΔT Spt 1(final)	9.01
ΔT Spt 2(final)	10.76
spt 2 - spt 1(final)	1.77
% change spt 1 (final)	0.12
% change spt 2(final)	0.15
% change TC#1 heated side (final)	0.51
Final Temperature TC#1 (heated side)	108.35

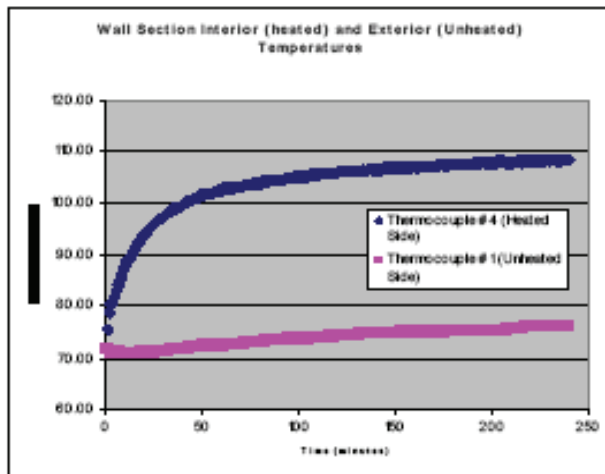
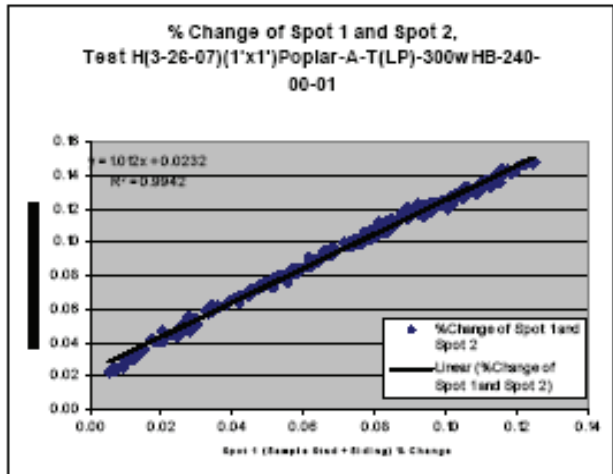
Fig. 48: This is the results page annotated previously. More specific information can be gathered from the downloads.

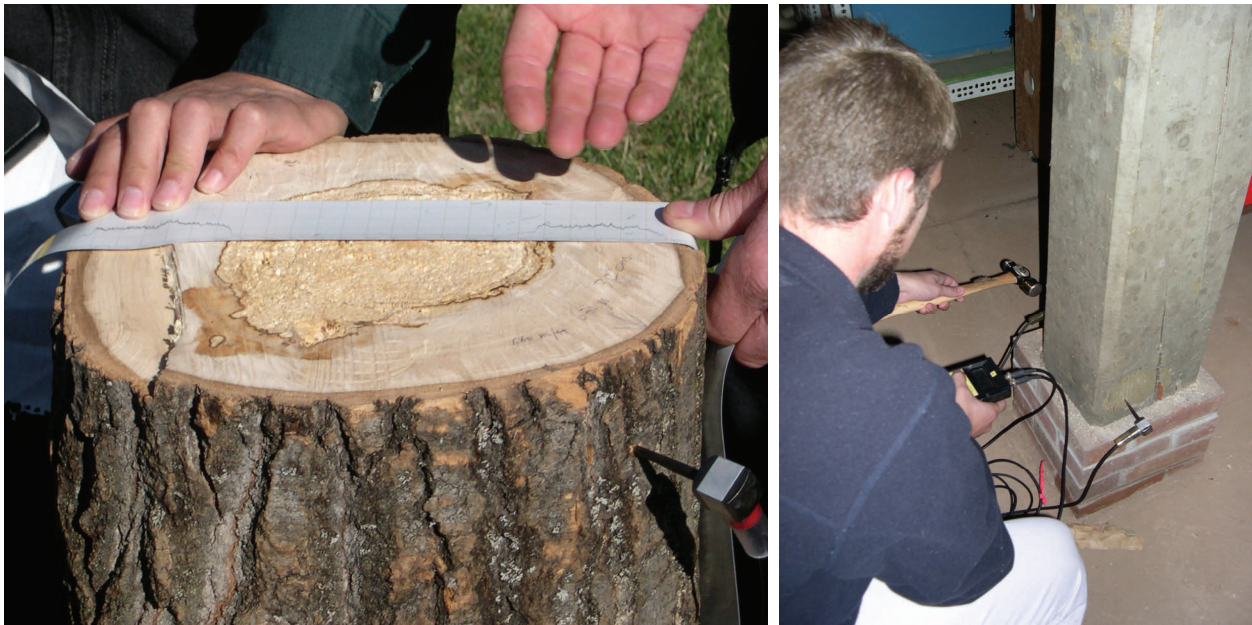
**Fig. 49 & 50:** Image B (left) shows the results of a resistance drilling test chart where a 3mm drill bit measures for wood density variations, note the paper as it measures density in a 1:1 ratio with the center or “rotten” portion of the stump showing as the dip in the readings. This device is not a truly a NDE tool it is minimally invasive to the point that it has little or no visual affect. Image 50 (right) shows the author using an impulse velocity tool which qualitatively determine areas of decay based on the transmission of waves through a wood. (Photo 49 by author and photo 50 by Danae Peckler, 2007)

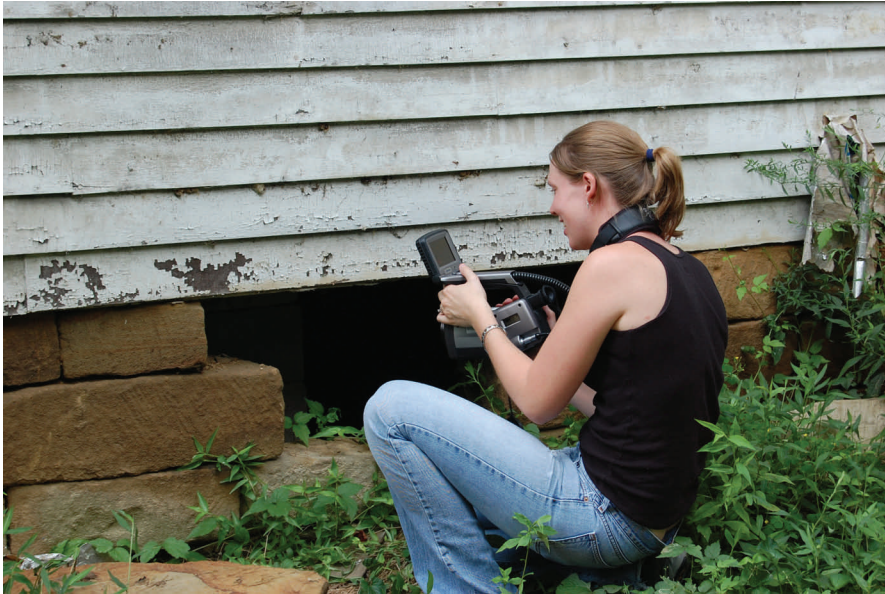
**Fig. 51:** Figure 51 shows University of Kentucky research assistant Laura Everdale using the IR camera to investigate a frame structure in Manchester, Kentucky. The IR camera helped provide information about the frame structure of the building as well as areas of moisture infiltration. (Photo by author, 2007)

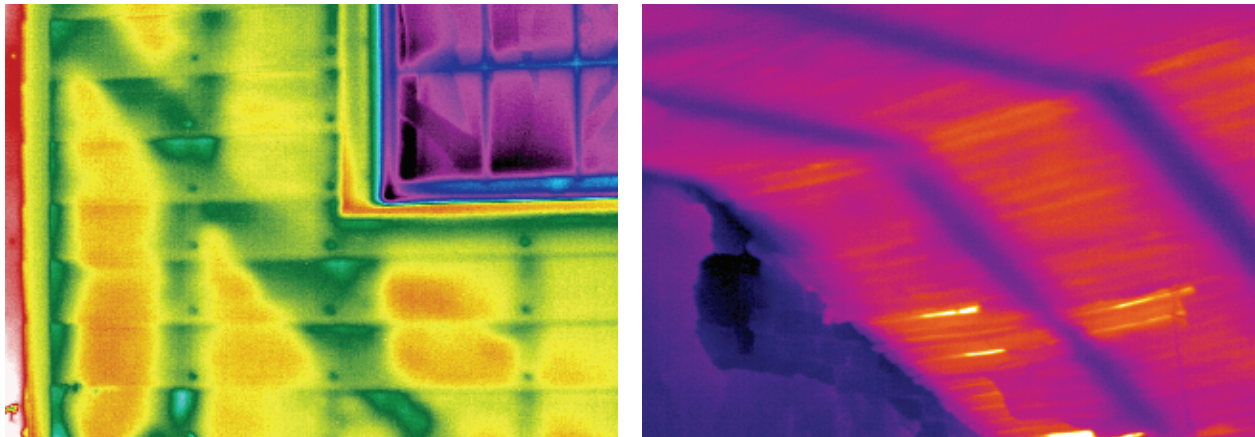
**Fig. 52 & 53:** Figure 52 (left) shows the down bracing of an early 19th century structure in downtown Lexington, Kentucky. Notice the difference in size between the studs (vertical members) and the down brace itself. Figure 53 (right) shows collar ties and rafters located in the attic of the early 19th century Green River Inn located in Greensburg, Kentucky. These structural elements are located behind a layer a 1/4" of plaster and a layer of wood lathe, however the wood members are still clearly discernable. (Left photo by John Liebertz, right photo by author, 2007)

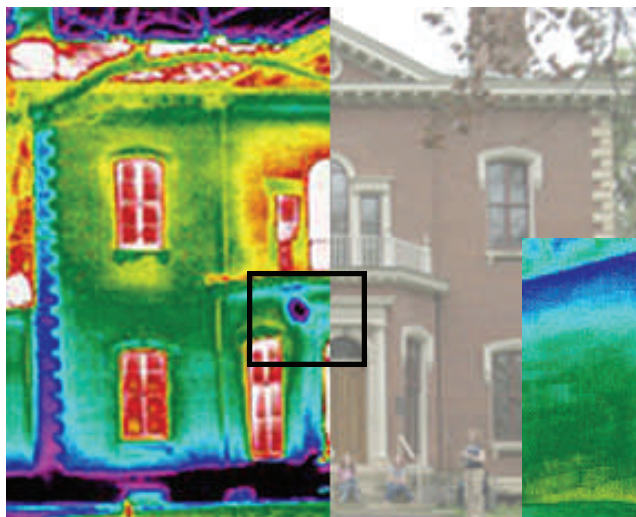
**Fig. 54:** Figure 54 shows the historic Henry Clay estate located in Lexington, Kentucky as 1/2 IR image and 1/2 regular photograph to indicate what variations appear when using IRT. Note the dark spot (box). (Photo by author, 2007)
