Research  
Paper  
FPL-RP-536

# Field Performance of Timber Bridges

## 2. Cooper Creek Stress-Laminated Deck Bridge

The Cooper Creek bridge was constructed in February 1992, in Centerville, Iowa. The bridge is a two-span, continuous stress-laminated deck structure 42-ft long and approximately 26.5-ft wide. The bridge is unique in that it is one of the first known stress-laminated timber bridge applications to use eastern cottonwood. The performance of the bridge was monitored continuously for 28 months beginning at the time of installation. Performance monitoring involved gathering and evaluating data relative to the moisture content of the wood deck, force level of the stressing bars, vertical creep, and behavior of the bridge under static-load conditions. In addition, comprehensive visual inspections were conducted to assess the overall condition of the structure. Based on field evaluations, the bridge is performing well with no structural or serviceability deficiencies.

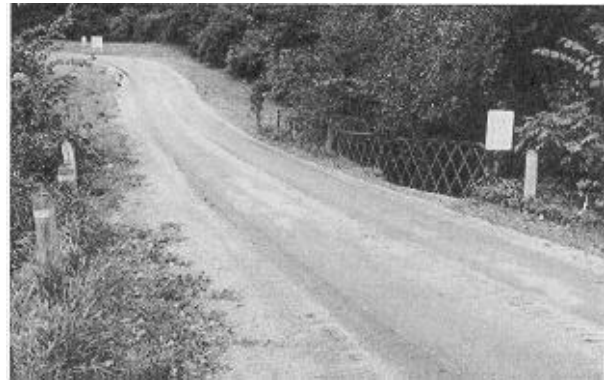
Figure 2—Original Cooper Creek bridge constructed in the 1940s.

The original Cooper Creek bridge was constructed in the 1940s and consisted of steel stringers with a concrete deck supported by concrete abutments (Fig. 2). Inspection of the bridge in the mid-1980s indicated that the concrete deck was in poor condition and steel stringers were badly corroded. Replacement of the bridge, along with another bridge in the reservoir area, was subsequently included within a large waterworks project at the Centerville reservoir. This project was made possible through a grant from the Chariton Valley Resource Conservation and Development Council (RC&D) to the State of Iowa and was initiated to improve the city's water supply system. In the initial stages of the project, both bridges were scheduled to be constructed using reinforced concrete. However, information obtained through the TBIRC prompted the Chariton Valley RC&D to change the Cooper Creek bridge to a timber structure using the relatively new stress-laminated deck design concept. A timber bridge was considered the best option by the RC&D because of the opportunity to use native Iowa materials and the aesthetics of a timber bridge would blend well into the natural park setting.

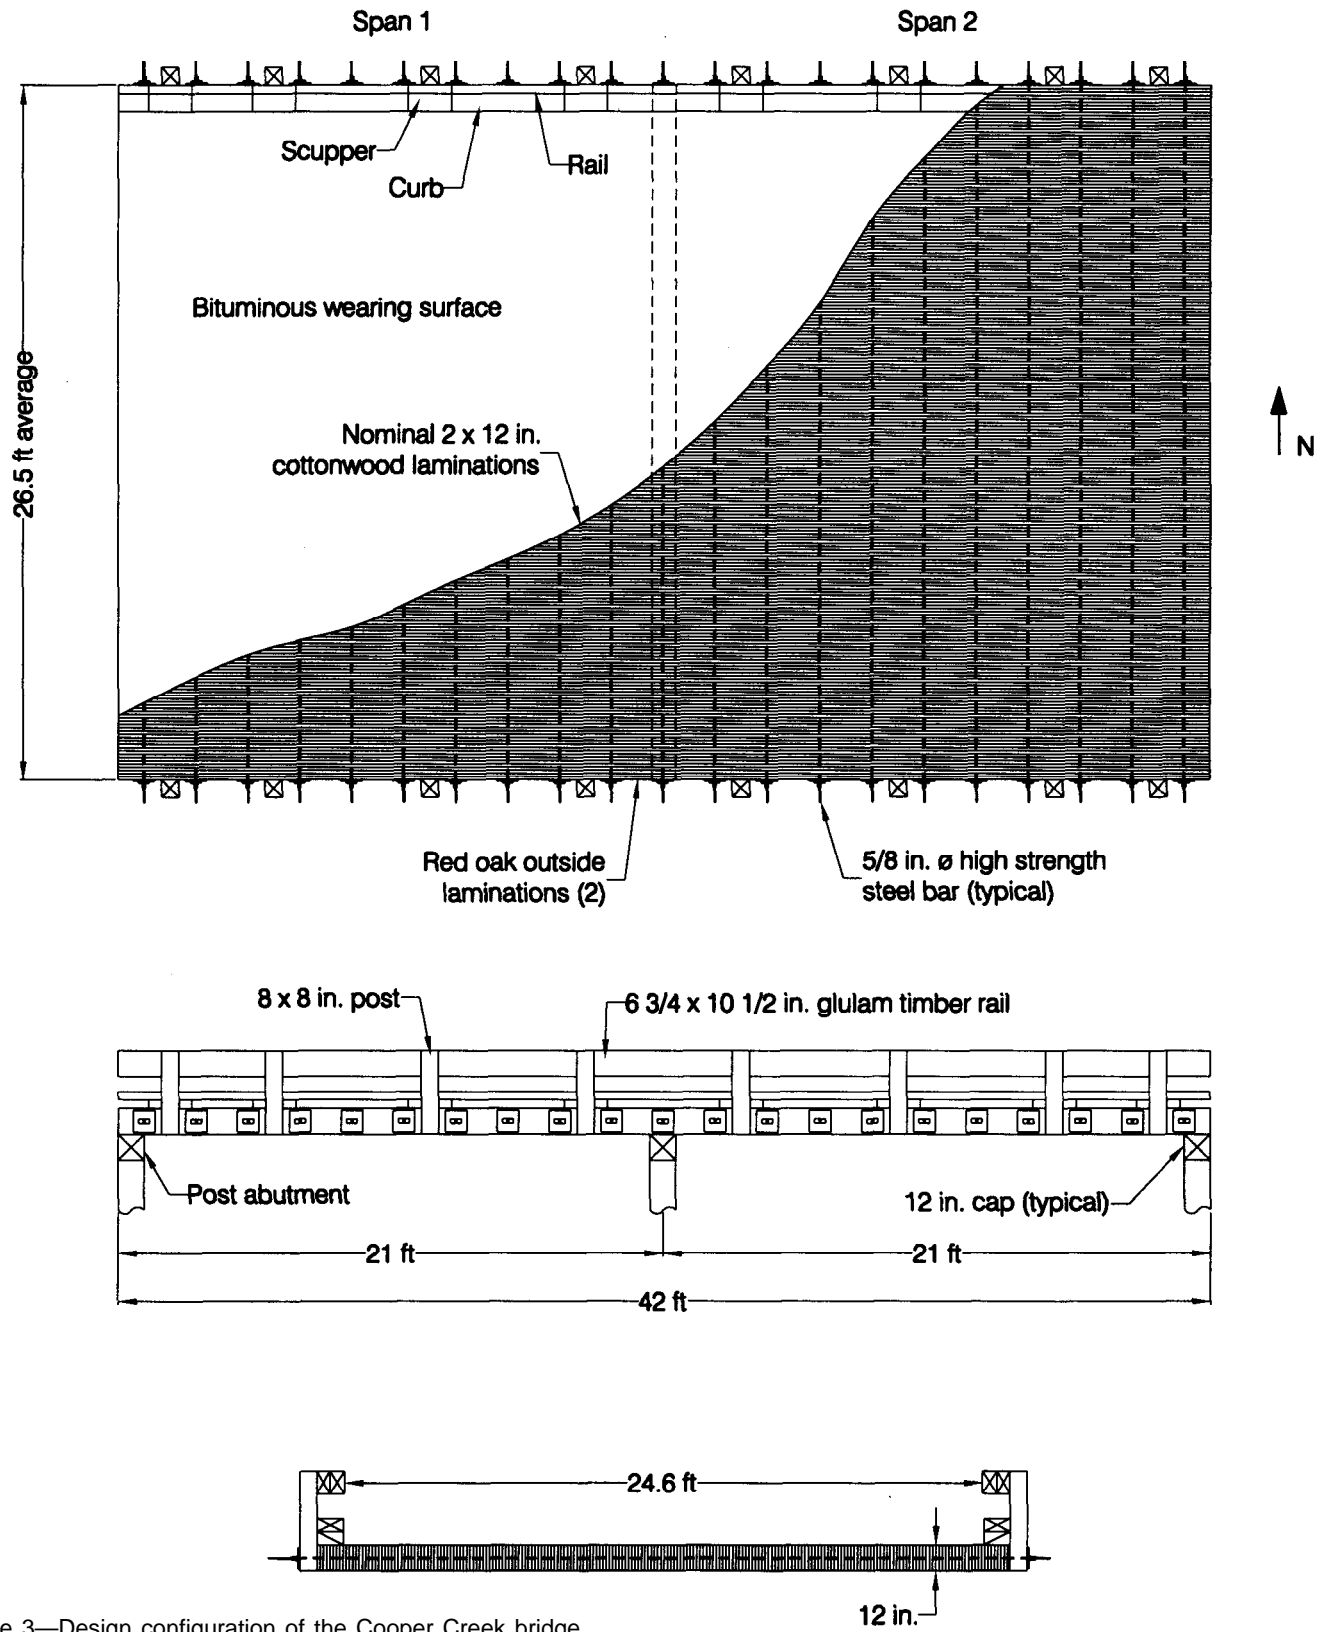
Figure 3—Design configuration of the Cooper Creek bridge.

Given the required bridge length and limitations on material size, a two-span continuous structure with equal span lengths was selected for the final design (Fig. 3). The layout of the bridge laminations was based on available lamination lengths of 4 to 18 ft in 2-ft increments. To meet span requirements for the continuous deck, a butt joint frequency of 1:4 at a 4-ft spacing was used (Fig. 4). As in most stress-laminated timber bridge decks, it was anticipated that bridge stiffness rather than strength would control the design. After adjusting tabulated design values for wet-use conditions and other applicable modification factors required by AASHTO, it was determined that a full-sawn deck 12 in. thick would meet design requirements if visually graded No. 1 lumber was used. Using this configuration, the design live-load deflection for HS 20-44 loading was 0.52 in., or 1/473 of the bridge span. A check of bending stress indicated that the applied stress of 931 lb/in<sup>2</sup> was less than the allowable 968 lb/in<sup>2</sup>.

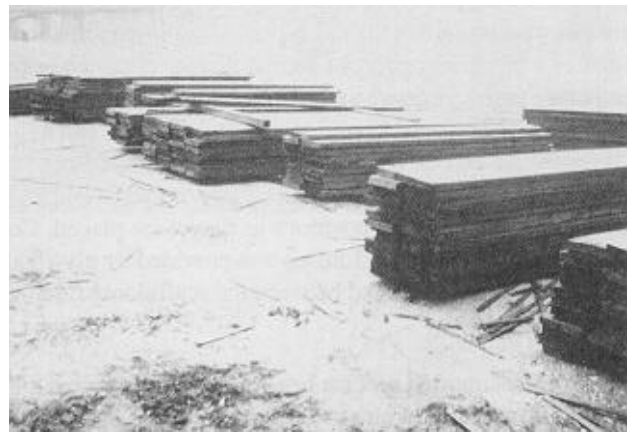
Figure 6—Eastern cottonwood laminations stacked at bridge site prior to construction.

Superstructure construction began with delivery of the bridge laminations and other materials to the bridge site. The bridge laminations arrived in banded bundles and were stacked approximately 200 ft from the substructure (Fig. 6). The laminations were prefabricated at a local mill in Centerville and sent to a pressure-treating facility in Nebraska for the creosote treatment. Inspection of the laminations at the site indicated that the material had not been surface planed to a uniform thickness, and measurements of lamination ends indicated a range in thickness of 1-3/4 to 2-3/8 in. This

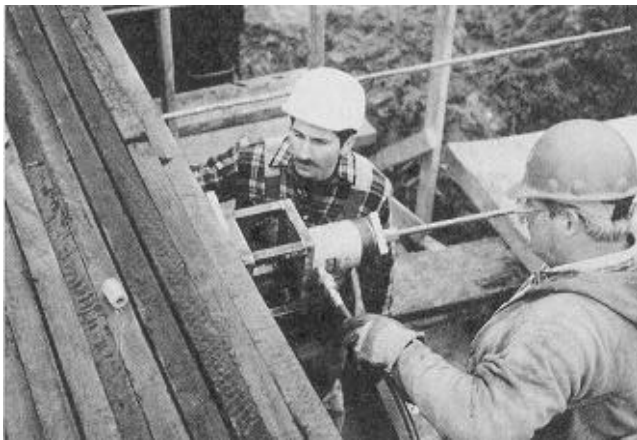
Figure 9—Bar tensioning bars using a single hydraulic jacking system.

Initial stressing of the bridge occurred immediately after all laminations were in position and steel plates and nuts were placed on stressing bar ends. Bar tensioning was accomplished with a single hydraulic jacking system consisting of a hydraulic pump, a hollow core jack, and a stressing chair (Wacker and Ritter 1992) (Fig. 9). During the stressing operation, one pass with the stressing equipment involved tensioning the first bar at an abutment, then sequentially tensioning all other bars along the bridge length. Prior to beginning the stressing, visual inspection of the deck indicated gaps between the laminations at several locations as a result of warp in the laminations. To minimize deck distortion across the bridge width during stressing, bar force was applied gradually over several passes. During the construction process, a total of six passes were completed. The first pass tensioned bars to 25 percent of the design level and was intended to bring all laminations into direct contact. The second pass brought bar force to 50 percent of design. The remaining four passes were at the full design level and were required to bring all bars to a uniform tension. Between the first and final stressing, the deck width narrowed approximately 1 in. as a result of the compression introduced between the laminations.

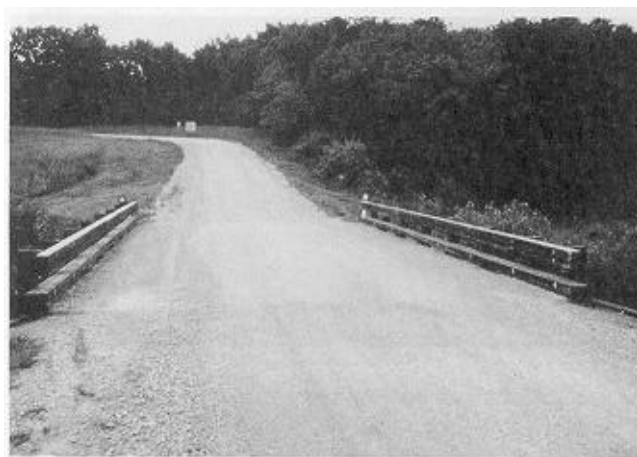
Figure 10—Completed Cooper Creek bridge.

Following initial stressing, the bridge was restressed several times, and the timber railing and asphalt wearing surface were placed. The bridge stressing followed an accelerated procedure that has not been widely used. It is general practice in stress-laminated deck construction to stress the bridge three times: at the time of initial construction, 1 week later, and 6 to 8 weeks after the second stressing (Ritter 1990). The Cooper Creek bridge was stressed four times: at construction and at 4, 7, and 14 days after construction. This accelerated procedure was completed because of limitations on equipment availability and opportunities to evaluate bar force loss using an alternative stressing sequence. Following the final stressing, the timber curb and rail system were installed. Placement of the asphalt wearing surface occurred approximately 4 months later in early July 1992. The completed bridge is shown in Figure 10.

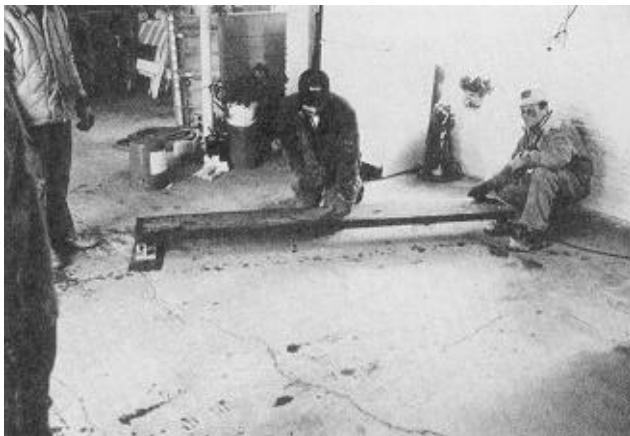
Figure 11—Measurement of bridge lamination MOE using the transverse vibration technique. Measurements were taken in the garage of the Centerville Water Department adjacent to the bridge site.

At the time of the Cooper Creek bridge design, eastern cottonwood was not widely used for structural applications, and verification of the assumed design MOE was considered necessary. To measure actual lamination MOE values, portable equipment was taken to the bridge site and a group of laminations was tested just prior to bridge construction using the transverse vibration method (Ross and others 1991). Using this method, laminations are placed flatwise on instrumented supports and impacted to induce a transverse vibration (Fig. 11). Based on the vibratory response, the natural frequency of the lamination is measured and converted to MOE. For the Cooper Creek bridge, 50 laminations were tested using this method: 10 each in lengths of 8, 10, 12, 14, and 16 ft.

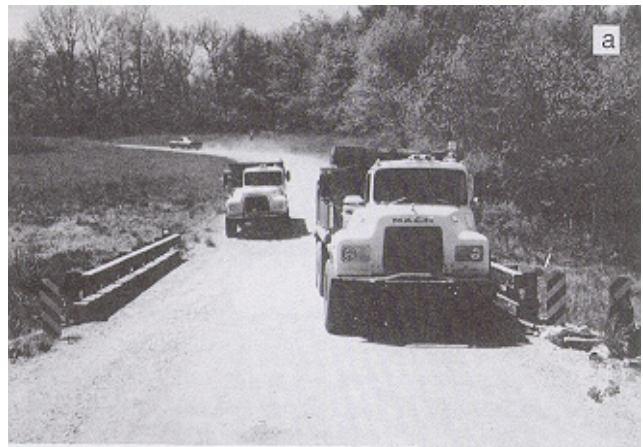
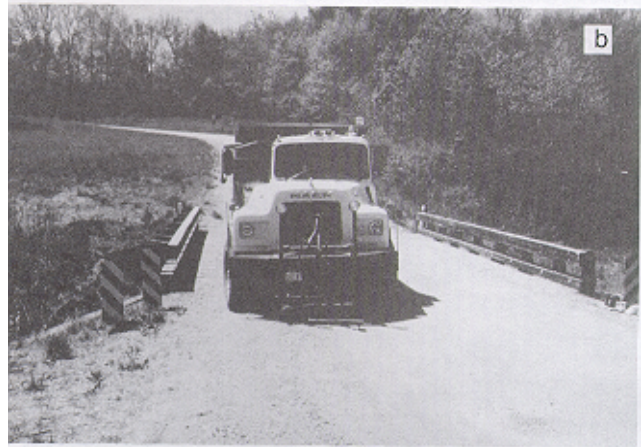
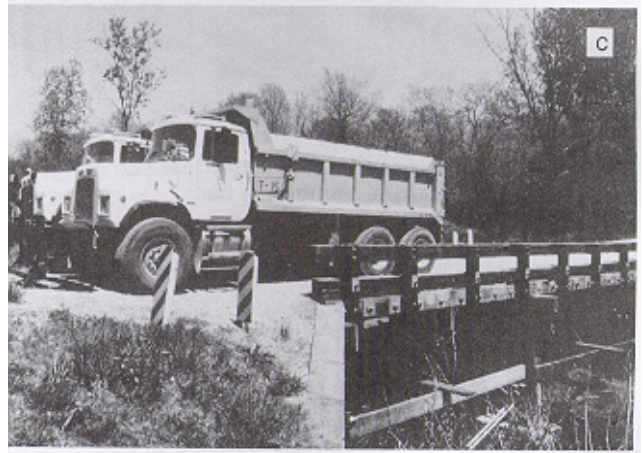
Figure 13—Load test truck configurations and axle loads. The transverse vehicle track width, measured center-to-center of the rear tires, was 6 ft.

Two trucks were used for load testing: truck T15 with a gross vehicle weight of 49,200 lb and truck T18 with a gross vehicle weight of 50,000 lb (Fig. 13). Each of the two spans was tested separately using designated positions in the longitudinal and transverse directions to produce the maximum live-load deflection in accordance with AASHTO recommendations (AASHTO 1989). Longitudinally, the trucks were positioned so that the transverse span centerline bisected the rear truck axles and the front axles were off the span. On span 1 (west), the trucks were facing west; span 2 (east), the trucks were facing east. Transversely, the trucks were positioned for three different load cases (Fig. 14). For load case 1, truck T18 was positioned in the north lane with the center of the inside wheel line 2 ft from the bridge centerline. For load case 2, truck T15 was positioned in the south lane with the center of the inside wheel line 2 ft from the bridge centerline. For load case 3, both trucks were positioned on the span in the positions used for load case 1 and 2. The three load cases are shown in Figure 15.

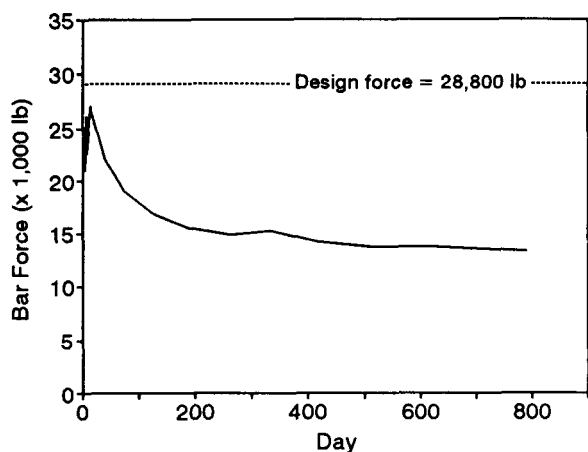
Figure 17—Average trend in bar tension force obtained from load cells installed on four stressing bars.

The average trend in bar tension force measured from the load cells is shown in Figure 17. As indicated on the left side of Figure 17, the first three stressings ranged from 10 to 15 percent below the design level. The final stressing was approximately 6 percent below the design level at 27,000 lb., or 94 lb/in<sup>2</sup> interlaminar compression. After the final stressing, the bar force decreased rapidly during the first 100 days to a level of 16,800 lb, or 50 lb/in<sup>2</sup> interlaminar compression. For the remainder of the monitoring period, the bar force gradually decreased to a level of approximately 13,400 lb, or 46 lb/in<sup>2</sup>.

The loss in bar force for the Cooper Creek bridge is likely the result of stress relaxation in the wood laminations as a result of the applied compressive force. The slight decrease in average lamination moisture content also contributed to wood

shrinkage and a minor loss in bar force. Although the bar force decreased approximately 50 percent during the monitoring period, it did not drop below acceptable levels. However, it was probable that the gradual decrease would continue, and the bridge was restressed at the conclusion of the monitoring period.

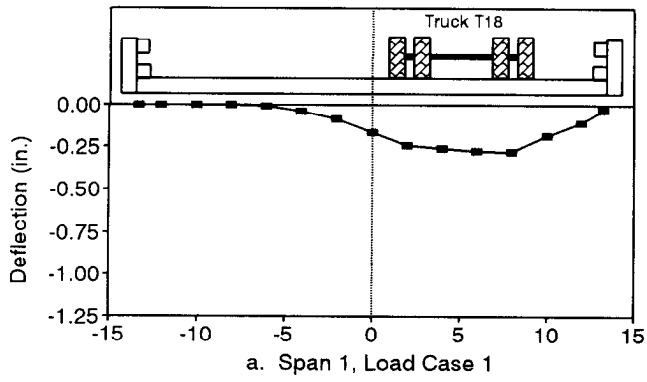
Figure 18—Transverse deflection for the Cooper Creek load test, measured at the bridge centerspan (looking west). Bridge cross-sections and vehicle positions are shown to aid interpretation and are not to scale.

Transverse deflection for span 1 and 2 are shown in Figure 18. For span 1, load case 1 resulted in a maximum deflection of 0.28 in. under the outside wheel line nearest the north deck edge (Fig. 18a). The maximum deflection of 0.26 in. for load case 2 was measured under the outside wheel line nearest the south deck edge (Fig. 18b). For load case 3, the maximum deflection of 0.36 in. occurred under the inside wheel line of truck T18, 2 ft from the span centerline (Fig. 18c). As could be expected for the same loading on similar spans, the results for span 2 were similar to those for span 1. Load case 1 resulted in a maximum deflection of 0.27 in. under the outside wheel line nearest the north deck edge (Fig. 18d). The maximum deflection of 0.26 in. for load case 2 occurred under the outside wheel line nearest the south deck edge (Fig. 18e). For load case 3, the maximum deflection of 0.35 in. occurred under the inside wheel line of truck T18, 2 ft from the span centerline (Fig. 18f).
