Research
Paper
FPL-RP-555

Field Performance of Timber Bridges

10. Sanborn Brook Stress-Laminated Deck Bridge

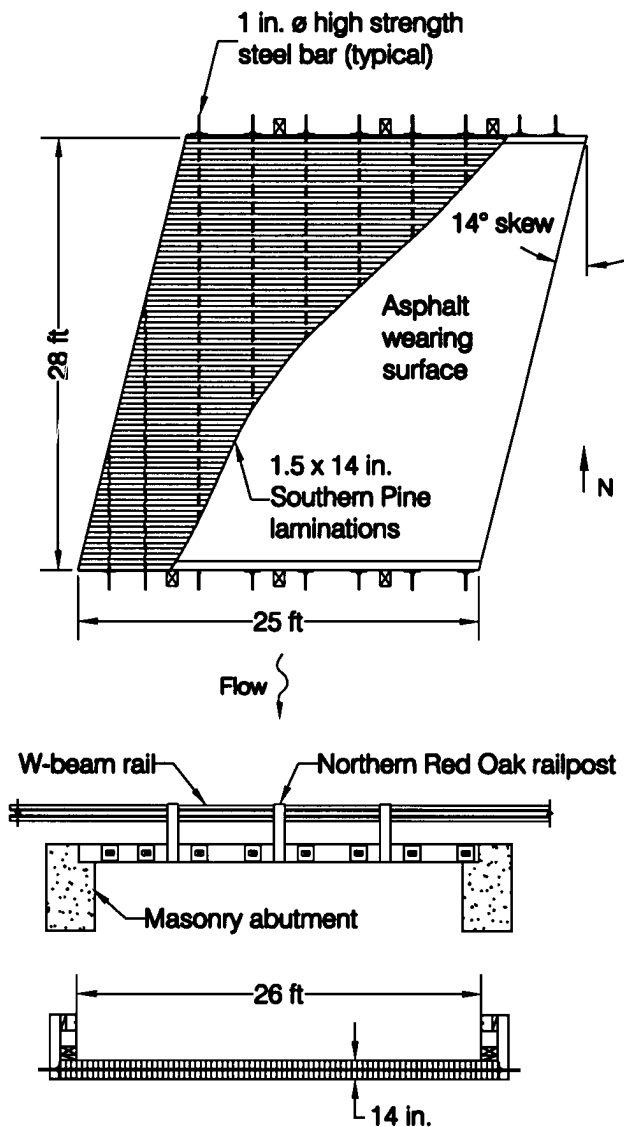
Figure 2—Design configuration of the Sanborn Brook bridge.

The bridge was designed for American Association of State Highway and Transportation Officials (AASHTO) HS 25–44 loading (AASHTO 1983), resulting in a deck geometry 25 ft long and 28 ft wide, with a deck thickness of 14 in. and a skew of 14 degrees (Fig. 2). It was the original intent of New Hampshire DOT to utilize a local species, such as red maple, Hem-Fir, or Eastern Spruce, as the lamination material. However, these local species were unavailable in the size necessary for the project; therefore, Southern Pine Grade No. 2 and better was substituted as the lamination material. Butt joints in the deck laminations were placed in every fourth lamination transversely with a 4-ft longitudinal spacing between butt joints in adjacent laminations (Fig. 3). The bridge rail system was designed to meet AASHTO static-load requirements and consisted of a W-beam mounted on timber posts. All lumber components were treated with pentachlorophenol in heavy oil in accordance with American Wood Preservers' Association Standard C14 (AWPA 1990).

The stressing system for the Sanborn Brook bridge was designed to provide a uniform interlaminar compressive stress of 100 lb/in², which corresponds to a design bar force of 55,000 lb. High strength 1-in.-diameter stressing bars, complying with the requirements of ASTM A722 (ASTM 1988), were spaced 39.5 in. on-center. The anchorage system was composed of discrete steel plates and is illustrated in Figure 4. To provide protection from deterioration, all steel components were galvanized and an asphalt wearing surface was specified.

The as-built configuration of the Sanborn Brook bridge varied slightly from the design configurations in Figure 2. After the final stressing, the average out-to-out bridge width measured 27.7 ft, and the bridge length measured 24.9 ft. The bridge span, measured center-center of bearings, was 24.1 ft. The completed bridge is shown in Figure 6.

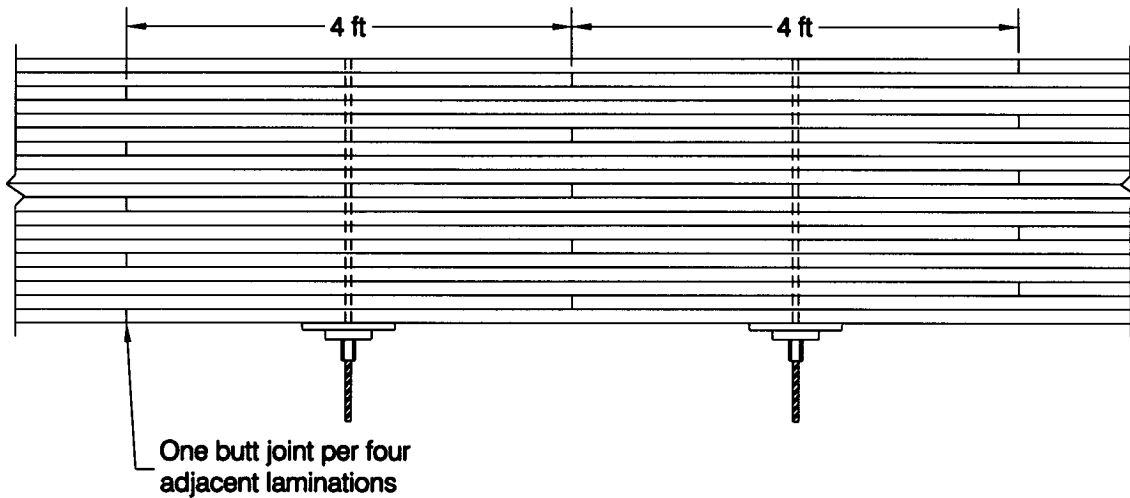
Figure 3—Butt joint configuration used for the Sanborn Brook bridge. Butt joints were placed transverse to the bridge span in every fourth lamination. Longitudinally, butt joints in adjacent laminations were separated by 4 ft.

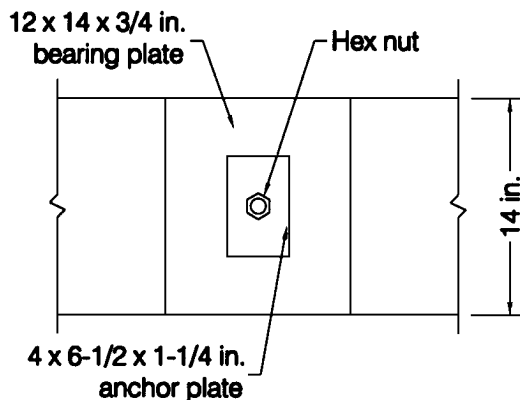
Figure 4—Discrete plate anchorage system.

The stressing bar anchorage system performed as designed with no signs of distress. There was no indication of the discrete plate anchorage crushing into the outside laminations and no measurable distortion of the bearing plate. However, the exterior laminations, when viewed from the underside of the deck, appeared distorted and wavy, curving away from the deck between the discrete anchorages (Fig. 26). This distortion does not appear to have affected the performance of the deck and is not typical of stress-laminated bridges. The exposed steel stressing bars and hardware showed no visible signs of corrosion.

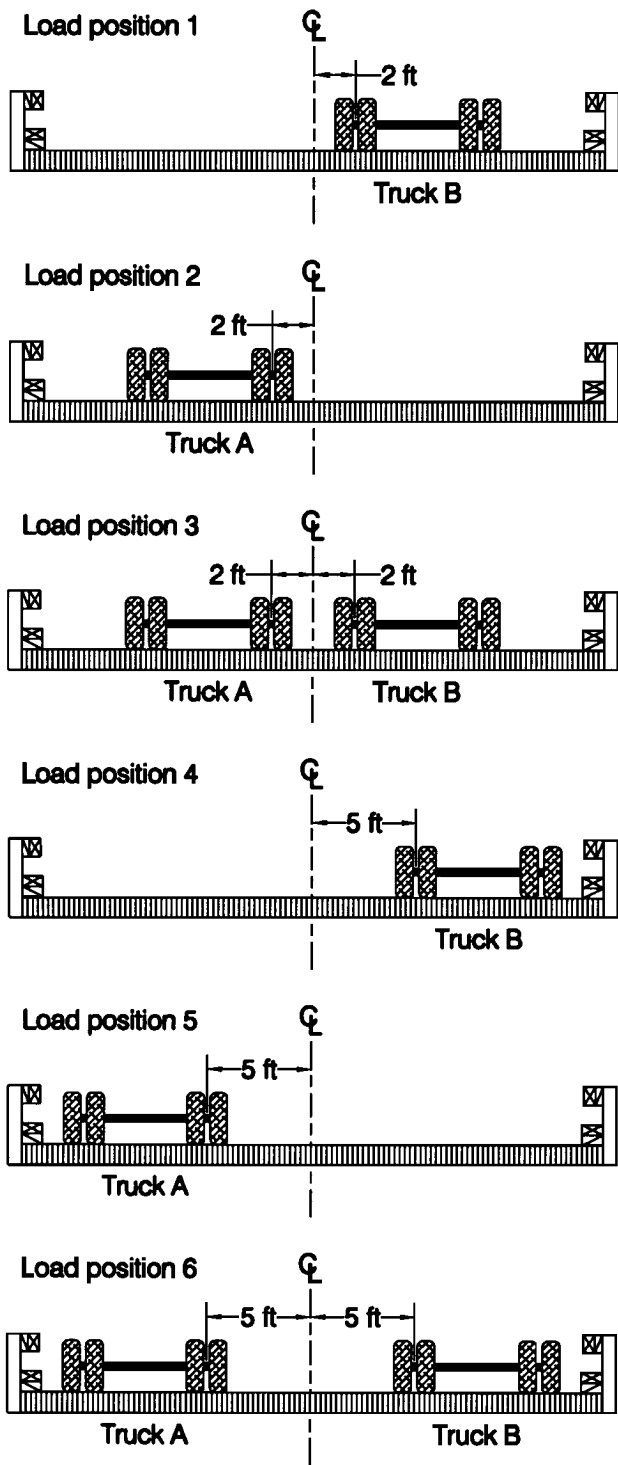
Figure 11—Transverse load positions used for both load tests (looking east). Trucks A and B were in the north and south lanes, respectively.

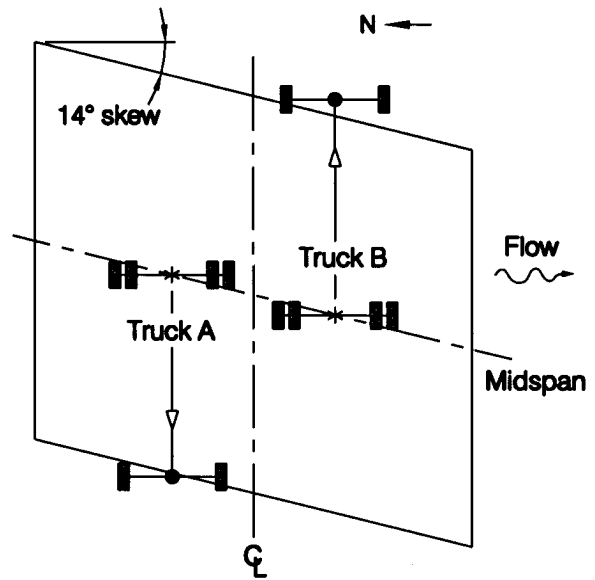
Figure 12—Typical configuration of longitudinal vehicle placement for load test 1. For all positions, the rear axle of each truck was centered at the skewed midspan.

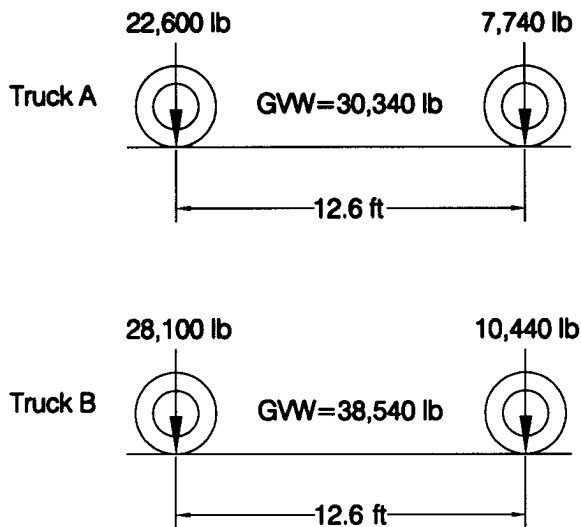
Figure 14—Load test 2 vehicle configurations and axle loads. (Lighter axle is vehicle front.) The transverse vehicle track width for both vehicles, measured center-center of the rear tires, is 6 ft.

The second load test was conducted June 23, 1993, approximately 21 months after bridge installation. At the time of the test, the interlaminar compression was 39 lb/in². Two test vehicles were used: truck A with a gross vehicle weight of 30,340 lb and truck B with a gross vehicle weight of 38,540 lb (Fig. 14). The six transverse load positions (Fig. 11, 15) and measurement method were identical to those employed during load test 1. Values were read to the nearest 0.04 in., and the measurement accuracy is estimated to be ±0.02 in. Longitudinally, the vehicles were positioned with the rear axle centered along the nonskewed midspan of the bridge, perpendicular to the roadway (Fig. 16).

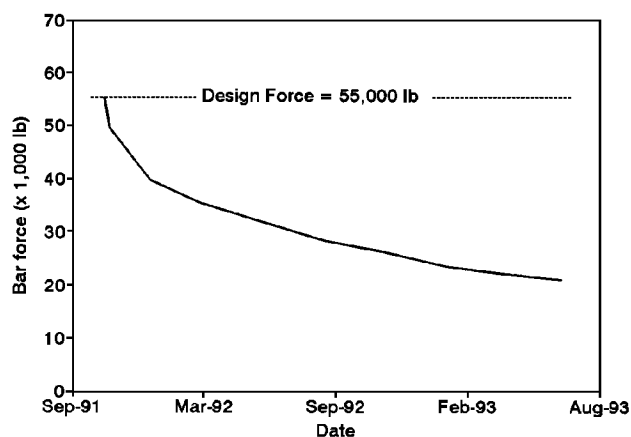
Figure 17—Average trend in bar force.

The average trend in bar force, beginning at the time of the third bar retensioning, is shown in Figure 17. The third retensioning, which occurred in October 1991, was to the design force of 55,000 lb. Immediately following the retensioning procedure, the force began a rapid decline that continued about 3 months. The time-related rate of bar force loss then decreased and remained approximately linear for the remainder of the monitoring period. In June 1993, at the conclusion of monitoring, the bar force had decreased to approximately 21,300 lb, 39 percent of the design force.

The bar force loss is attributed to stress relaxation of the lumber laminations caused by the applied compressive force and enhanced by the high moisture content. Although the bar force decreased approximately 60 percent during the

monitoring period, it did not fall below acceptable levels. Because the decline in bar force was expected to continue as a result of further stress relaxation and an eventual decrease in the moisture content, the bridge was restressed at the conclusion of the monitoring period to the full design force.

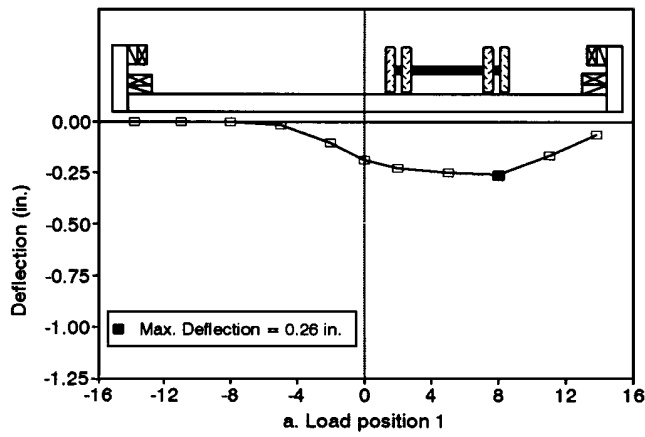
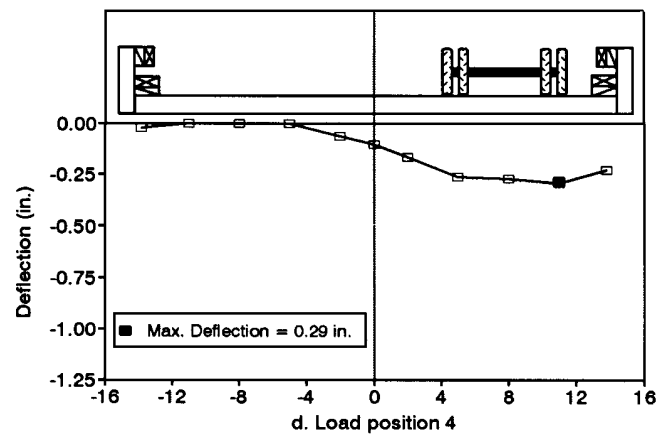
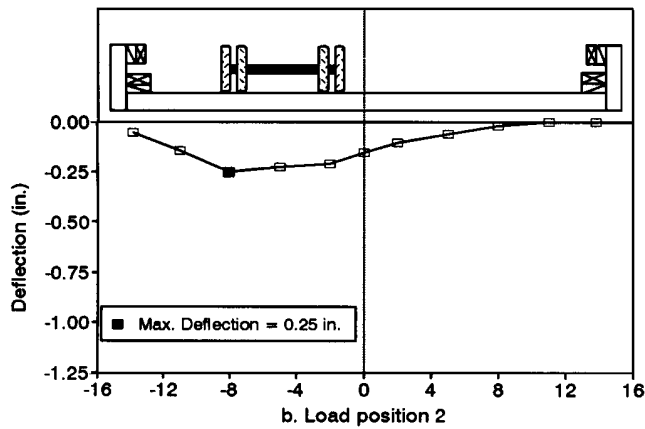
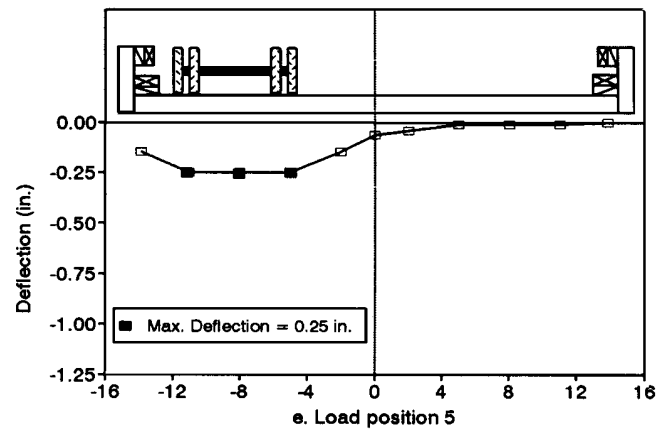
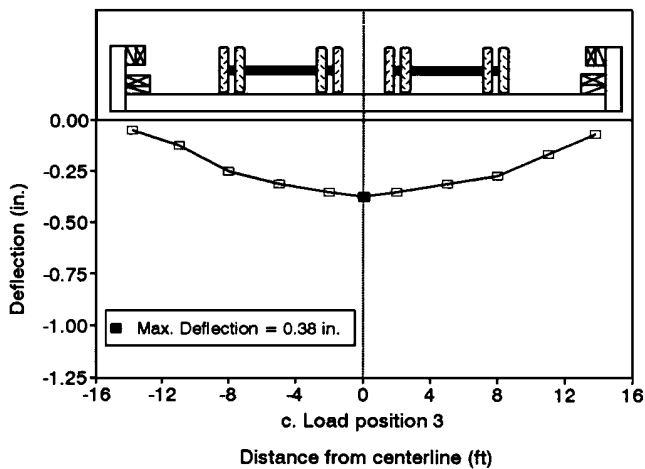
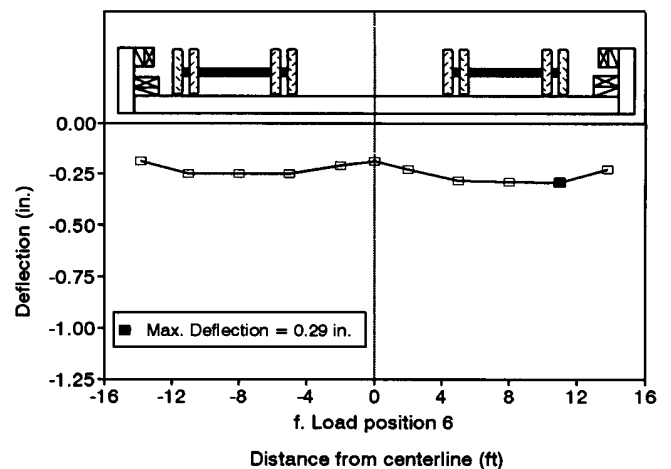
Figure 18—Transverse deflection for load test 1 (looking east), measured at the midspan of the bridge. Bridge cross-sections and vehicle positions are shown to aid interpretation and are not to scale.

Transverse deflections for load test 1 with the locations and magnitudes of the maximum measured deflections are shown in Figure 18. For each load position, the deflections are typical of the orthotropic plate behavior of stress-laminated bridges (Ritter and others 1990). The maximum deflection resulting from load position 6 occurred beneath the outside wheel line of the heavier truck (Fig. 18f). Load position 3 caused an absolute maximum measured deflection of 0.38 in. at the bridge centerline (Fig. 18c). Except for load position 5, the load positions involving one truck resulted in a maximum deflection under the outside truck wheel line (Fig. 18a,b,d). For load position 5, the maximum measured deflection occurred at three locations, one of which was under the outside wheel line (Fig. 18e). Although it is likely that minor differences existed between these three points, it is not possible to make a more accurate assessment, given the relatively small magnitude of deflections and the accuracy of the measurement method.

Assuming linear elastic behavior, uniform material properties, proper vehicle placement, and accurate deflection measurements, the summation of the deflections resulting from two individual truck loads applied separately should equal the deflection resulting from both trucks applied simultaneously. This is illustrated in Figure 19, where the sum of load positions 1 and 2 and load positions 4 and 5 are compared with load positions 3 and 6, respectively. The plots are similar with minor variations that are within the accuracy of the measurement methods, indicating that the bridge behavior under the applied loads is within the linear elastic range.

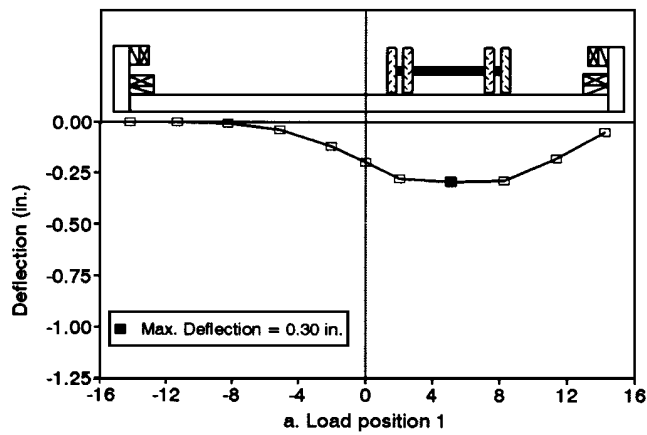
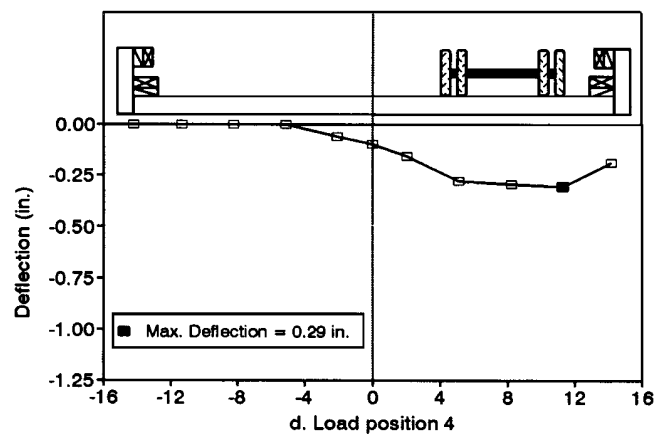
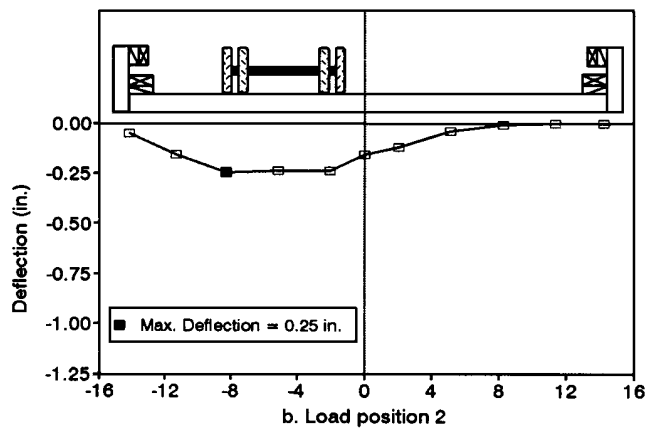
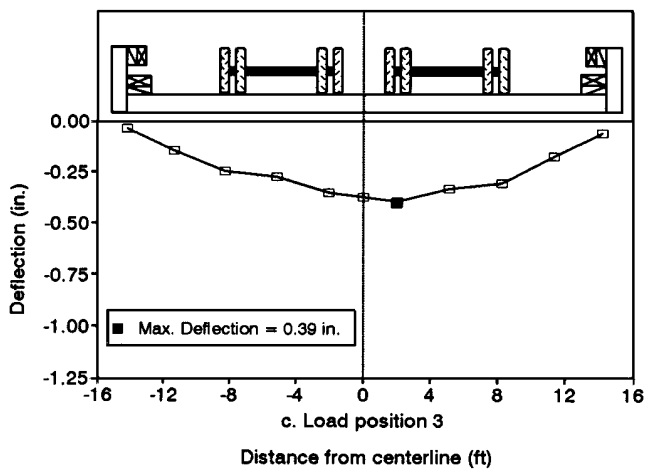
Figure 20—Transverse deflections for load test 2 (looking east), measured at the midspan of the bridge. Bridge cross-sections and vehicle positions are shown to aid interpretation and are not to scale.

Transverse deflections for load test 2 are shown in Figure 20. As with load test 1, the plots are indicative of orthotropic plate behavior (Ritter and others 1990). For load position 6, the maximum deflection occurred beneath the outside wheel line of the heavier truck (Fig. 20f). The absolute maximum measured deflection of 0.39 in. occurred at the data point immediately to the right of the bridge centerline during load position 3. For load positions 1 and 2, the maximum deflections occurred between the truck wheel lines and under the outside truck wheel line, respectively (Fig. 20a,b). The maximum deflection for load position 4 occurred under the outside wheel line, and the maximum deflection for load position 5 occurred at the three locations indicated (Fig. 20d,e). A single maximum point cannot be identified for load position 5 for the same reasons as indicated in load test 1.

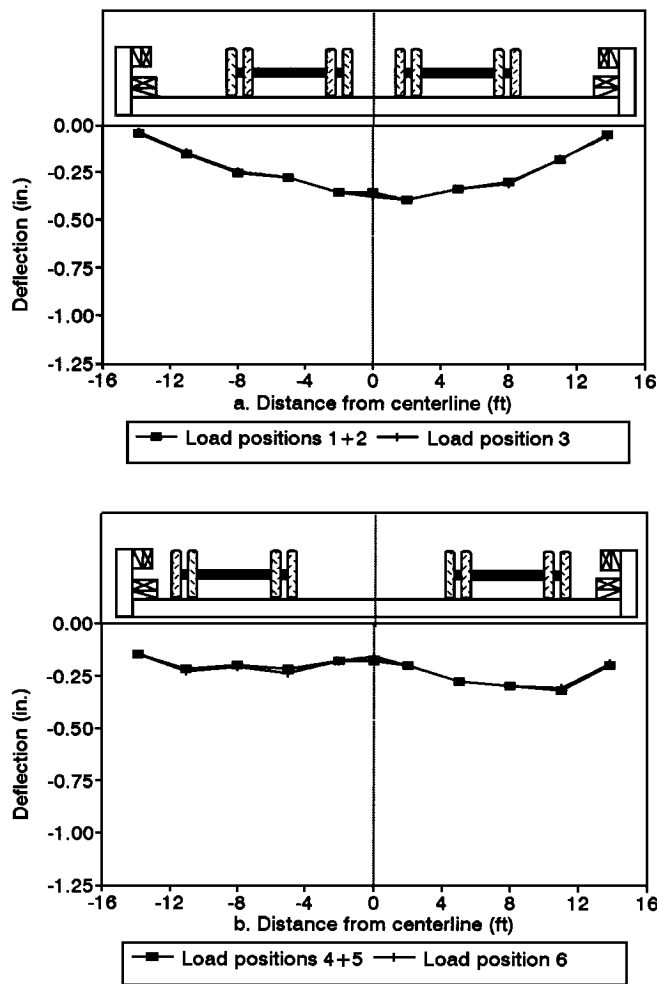
Figure 21—Transverse deflections for load test 2 (looking east), measured at the midspan of the bridge, comparing the sum of measured deflections from load positions 1 and 2 and load positions 4 and 5 to load positions 3 and 6, respectively. Bridge cross-sections and vehicle positions are shown to aid interpretation and are not to scale.

As illustrated with the measured deflections of load test 1, the summation of deflections resulting from two separately applied truck loads should equal the deflection of both trucks applied simultaneously, if uniform material properties, proper vehicle placement, and accurate deflection measurements are assumed. This is illustrated in Figure 21, where the sum of load positions 1 and 2 and load positions 4 and 5 are compared with load positions 3 and 6, respectively. The plots are virtually identical, with slight variations well within the accuracy of the measurement methods, indicating that the bridge behavior is within the linear elastic range under the applied loads.

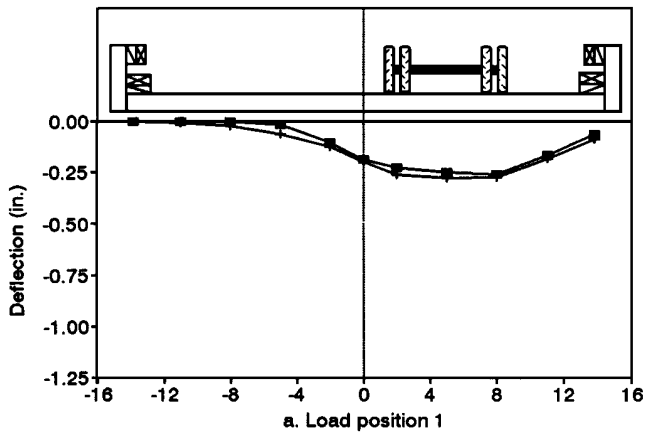
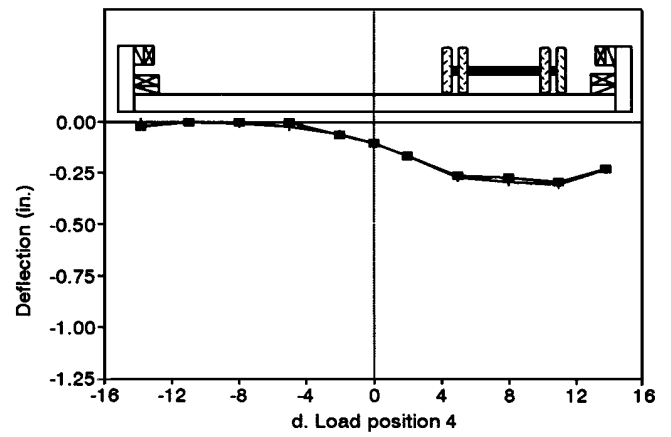
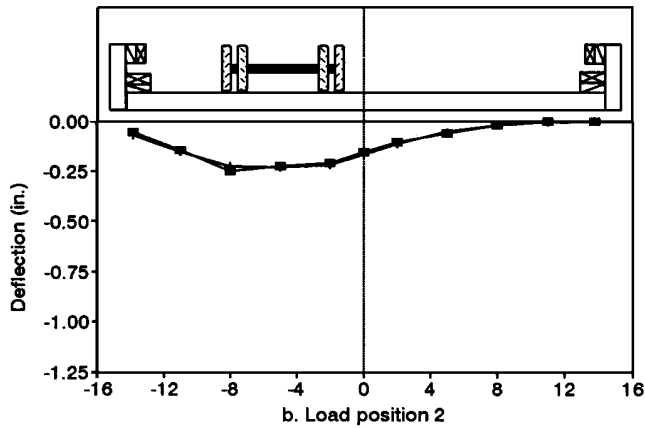
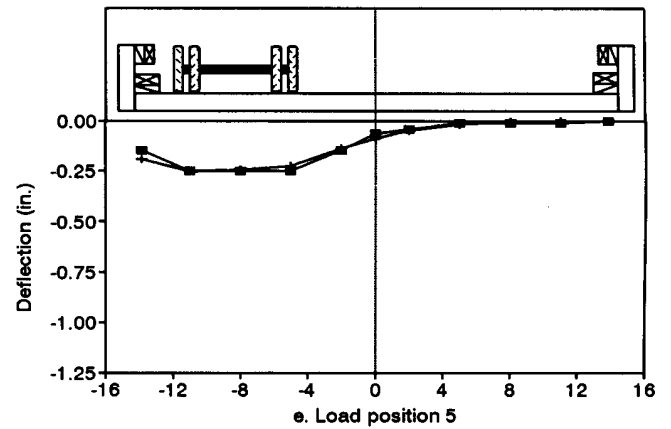
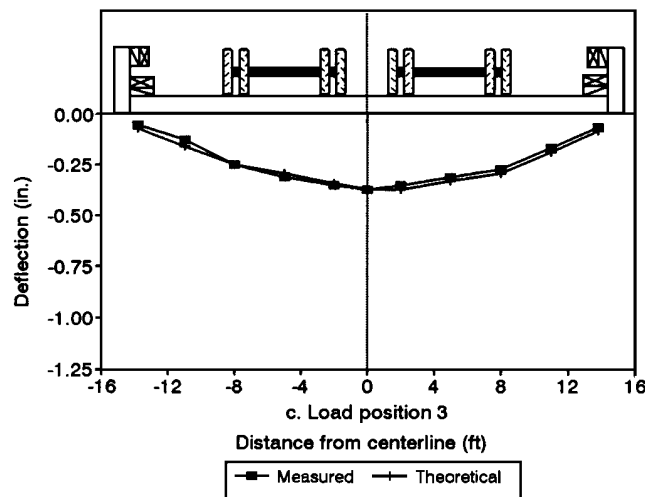
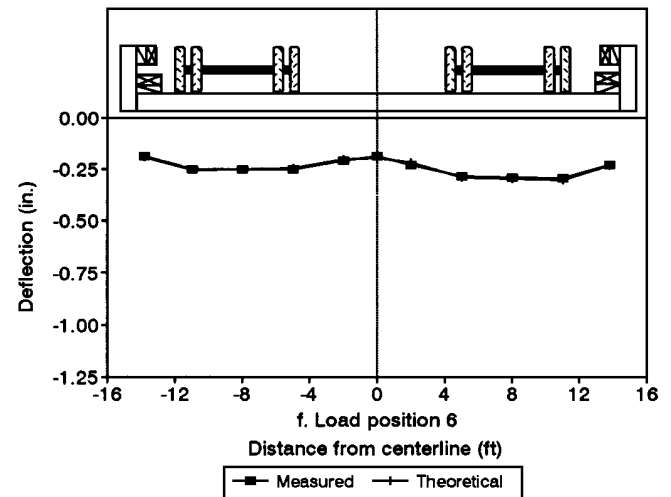
Figure 22—Comparison of the measured deflections for load test 1 (looking east) with the theoretical bridge response. Bridge cross-sections and vehicle positions are shown to aid interpretation and are not to scale.

Comparisons of the measured load test deflections to the theoretical bridge response are shown in Figures 22 and 23. As shown, the theoretical bridge deflection, based on orthotropic bridge behavior, is very close to that measured. Employing the analytical parameters used to determine the theoretical bridge response for each load test, the theoretical deflection for AASHTO HS 25–44 loading is shown in Figure 24. Based on this analysis, the theoretical maximum AASHTO HS 25–44 static deflection occurs at centerline when two HS 25–44 trucks are placed centrally on the bridge (load position 3), with the rear axles centered about the skewed midspan (Fig. 24c). The resulting deflection is 0.68 in. or approximately 1/425 of the bridge span for load test 1, and 0.74 in., approximately 1/391 of the bridge span for load test 2.

Assuming constant bridge properties, the same theoretical bridge deflection would be expected for both load tests, because the same AASHTO HS 25–44 loading is applied in each case. However, for stress-laminated bridges with butt joints, it is known that a decrease in interlaminar compression results in a decrease in longitudinal bridge stiffness (Oliva and others 1990). The interlaminar compression decreased from 96 lb/in² at the time of load test 1 to 39 lb/in² at the time of load test 2, resulting in an approximate 9-percent decrease in longitudinal bridge stiffness. This change in stiffness resulted in a slightly greater deflection for load test 2 compared with that for load test 1.

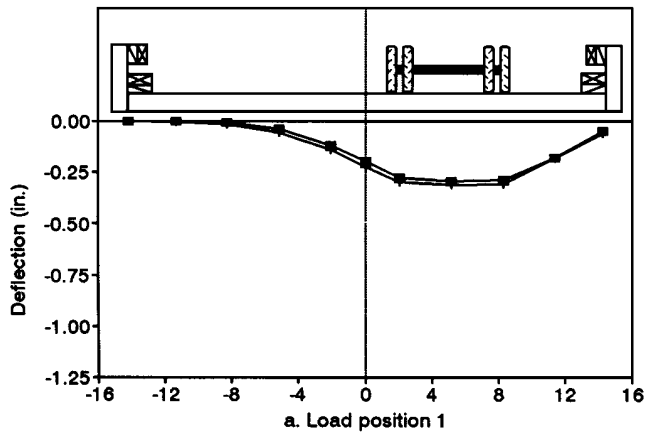
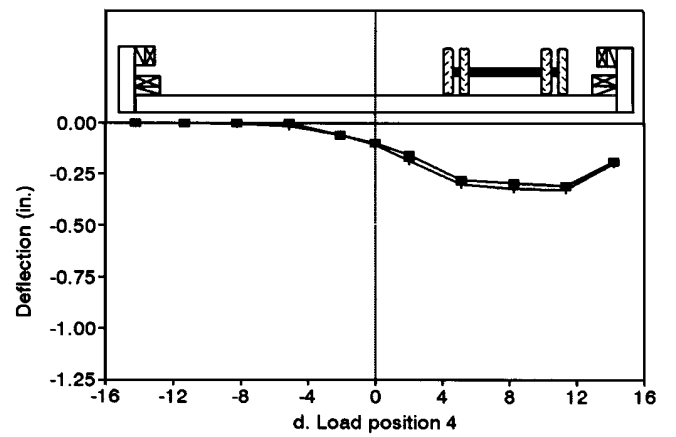
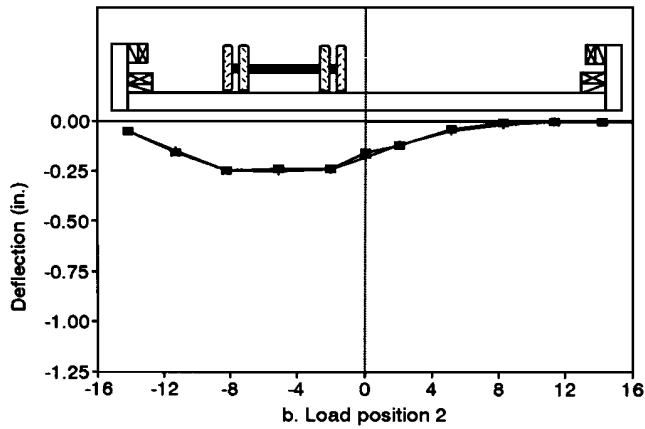
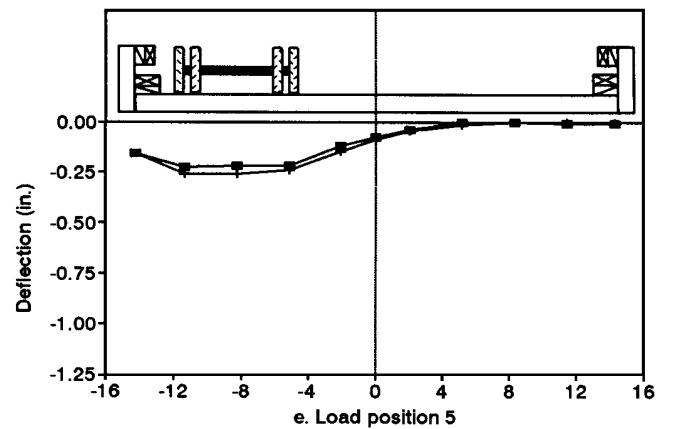
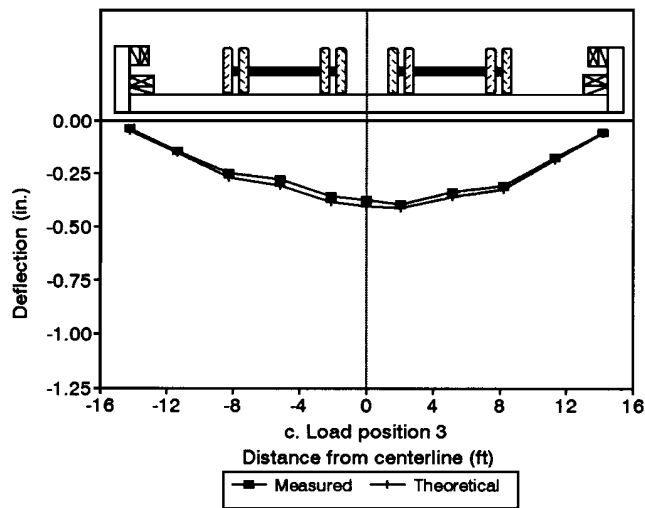
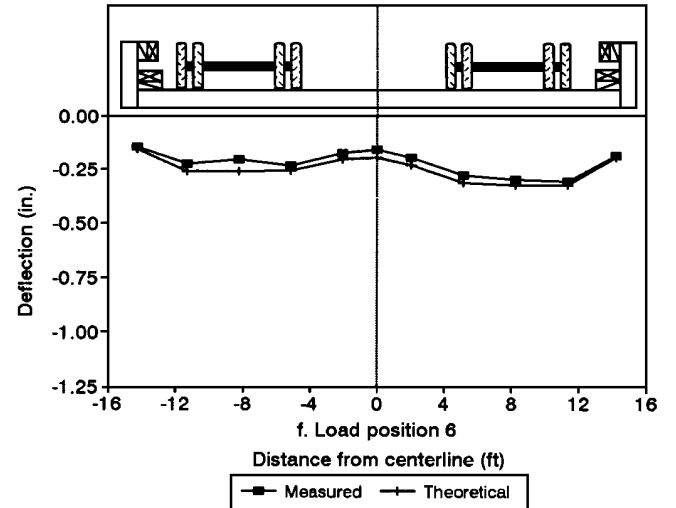
Figure 23—Comparison of the measured deflections for load test 2 (looking east) with the theoretical bridge response. Bridge cross-sections and vehicle positions are shown to aid interpretation and are not to scale.

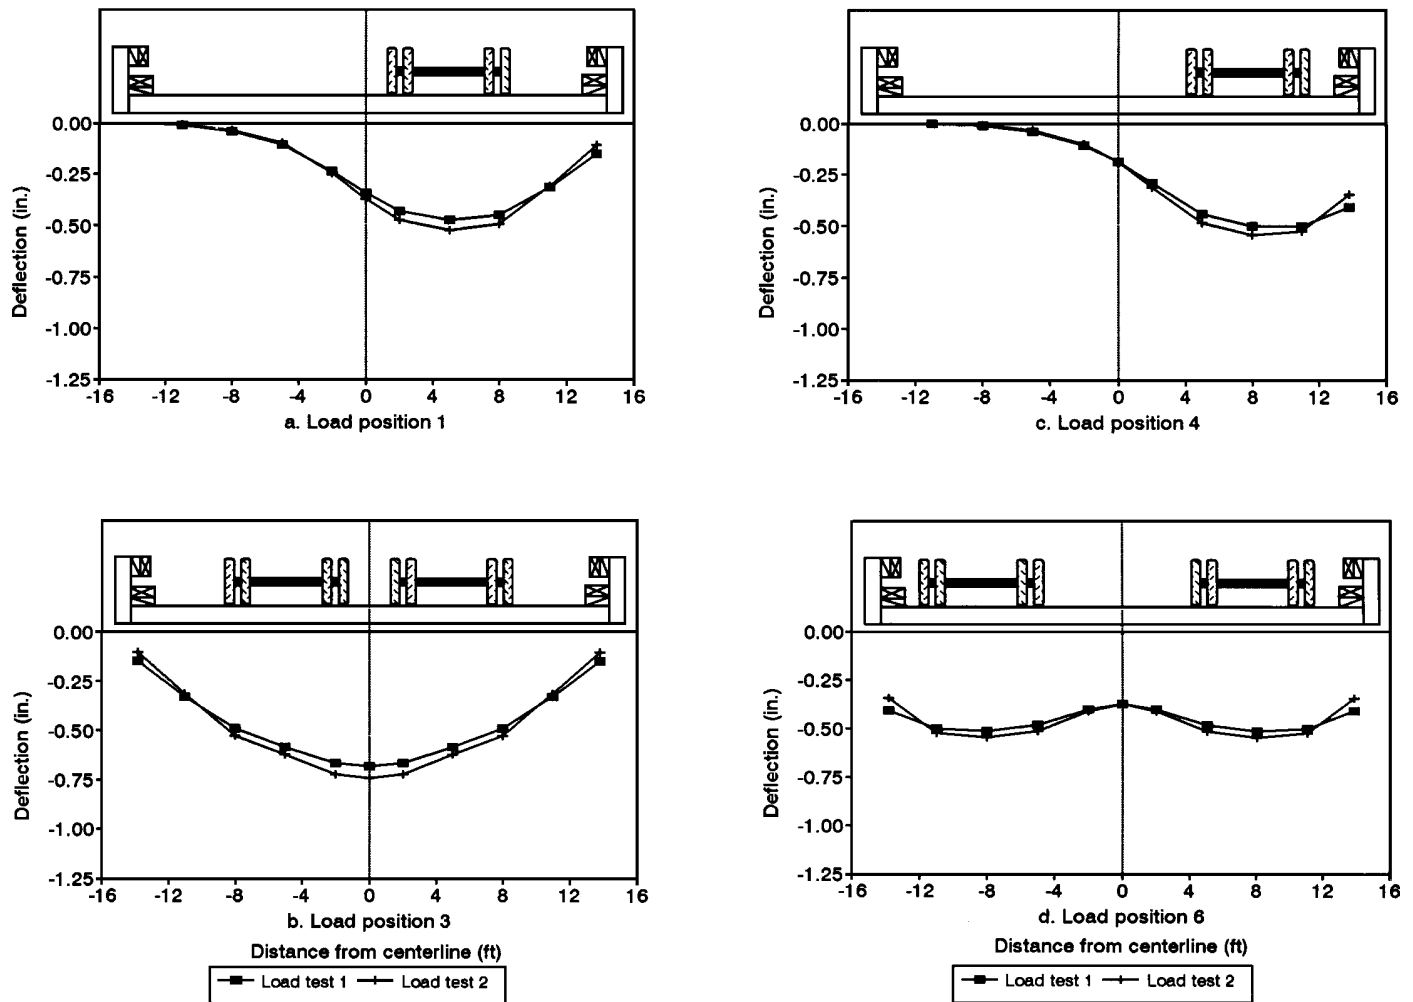
Figure 24—Maximum theoretical midspan deflection profile for AASHTO HS 25–44 truck loading (looking east). Load positions 1 and 4 are mirror images of load positions 2 and 5, respectively. Bridge cross-sections and vehicle positions are shown to aid interpretation and are not to scale.

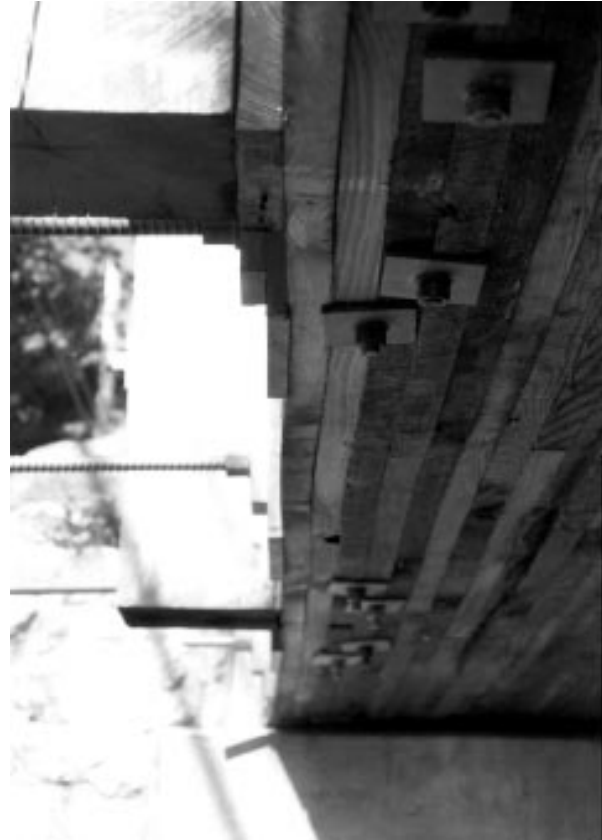
Figure 26—Distorted exterior lumber lamination noted during condition assessment at the time of load test 2.

- The wearing surface appears to be in good condition and shows no signs of distress.
- The exposed steel stressing bars and discrete anchorage plates showed no visible signs of corrosion or other distress. The plates were not distorted and crushing of the exterior lumber laminations was negligible, although the exterior laminations did appear distorted and wavy along the length of the bridge.
