Development of Two Test Level 2 Bridge Railings and Transitions for Use on Transverse Glue-Laminated Deck Bridges

Ronald K. Faller, Barry T. Rosson, Michael A. Ritter,
Eric A. Keller, and Sheila R. Duwadi

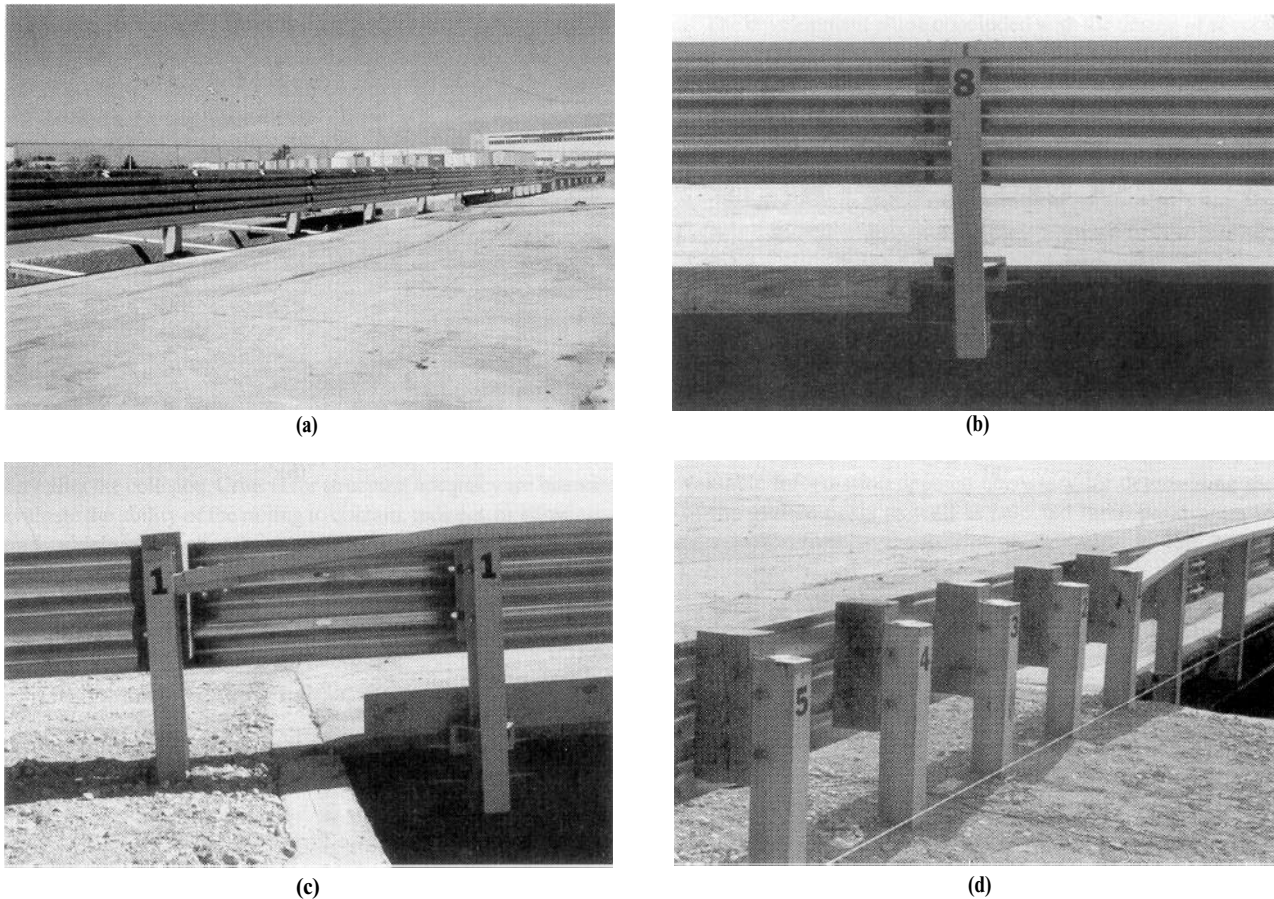
FIGURE 1 Steel thrie beam with channel bridge railing end thrie beam with channel transition, System 1

The first bridge railing, referred to as System 1, was a steel system constructed with a thrie beam rail, an upper structural channel rail, and wide-flange posts and blockouts. Photographs of the steel bridge railing system and the attached thrie beam approach guardrail transition are provided in Figure 1. The second bridge railing, referred to as System 2, was a wood system constructed by using a rectangular rail, posts, and blockouts, all of which were manufactured from glulam timber. Photographs of the wood bridge railing system and the attached W-beam approach guardrail transition are provided in Figure 2.

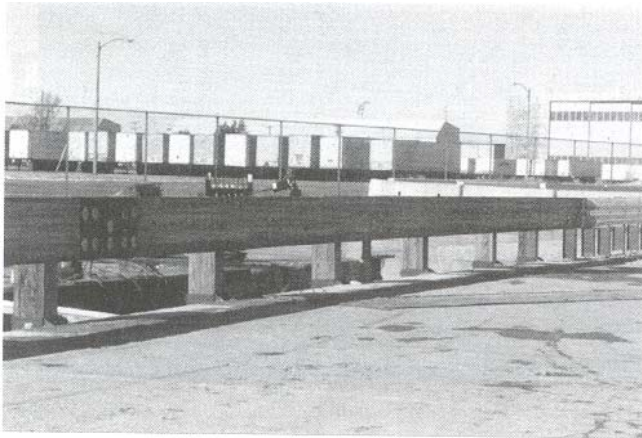
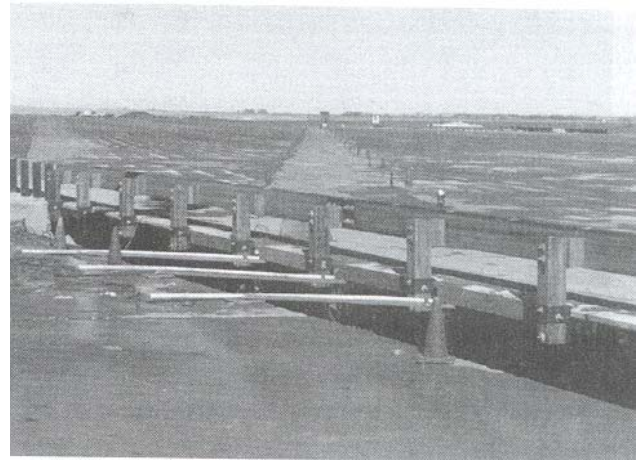
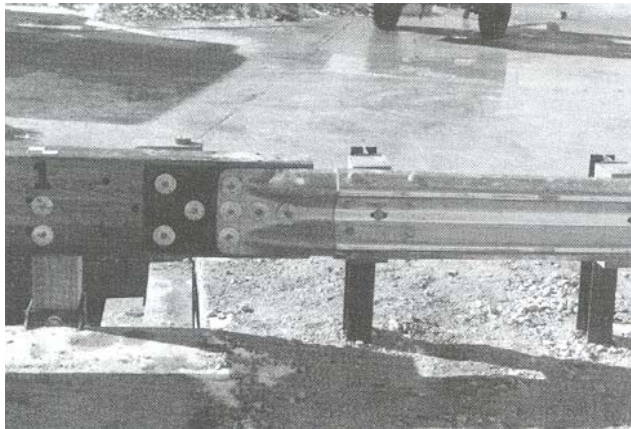
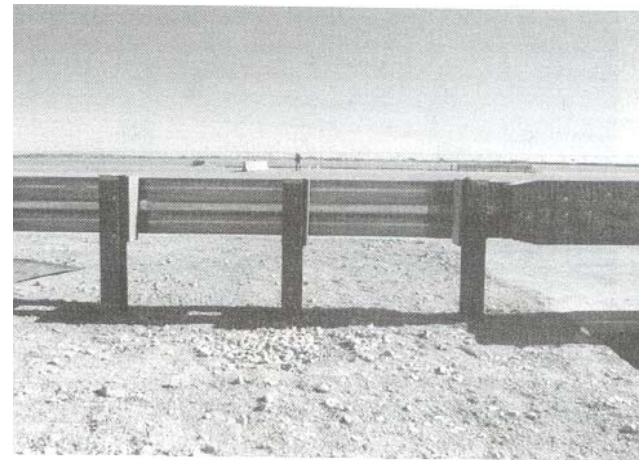
FIGURE 2 Glulam bridge railing end W-beam transition, System 2.

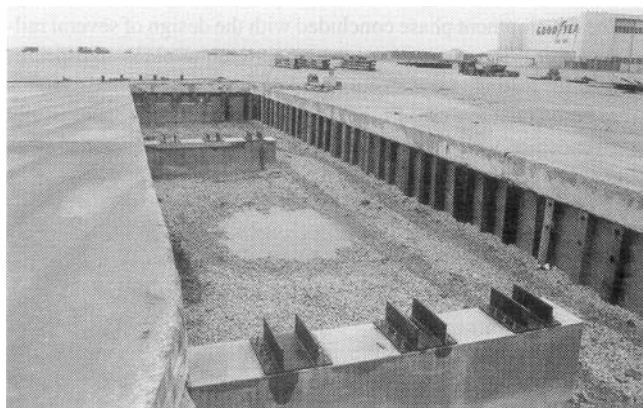
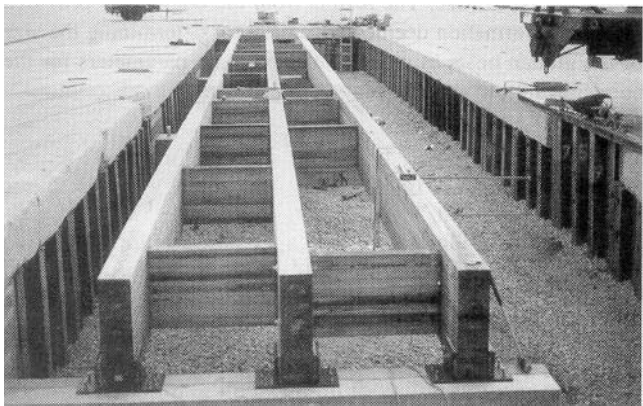
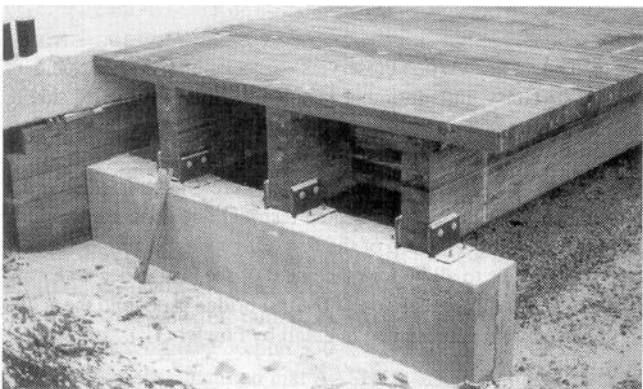
FIGURE 3 Simulated test bridge.

Testing of the bridge railing and approach guardrail transition systems was conducted at MwRSF's outdoor test site in Lincoln, Nebraska. To perform all the barrier testing, a full-size test bridge was constructed, as shown in Figure 3. The test bridge measured approximately 3.96 m wide and 36.58 m long and consisted of three simply supported spans measuring approximately 12.19 m each.

The transverse deck system was constructed of glulam timber panels 130 mm thick by 1.22 m wide. The glulam timber for the deck was Combination 47 southern yellow pine, as specified in the AASHTO *LRFD Bridge Design Specifications*. The timber was treated according to the American Wood Preservers' Association (AWPA) Standard C14 (23). Thirty glulam timber panels were placed side by side to achieve the 36.58-m length, and they were attached to the longitudinal glulam beams with standard aluminum deck brackets.

The test bridge was positioned on concrete supports that were placed in a 2.13-m-deep excavated test pit. The concrete supports were placed so that the top of the test bridge was 51 mm below the concrete surface to allow for placement of the bridge deck wearing surface. A detailed discussion of the test bridge is beyond the scope of this paper and is presented in detail by Fowler (17).

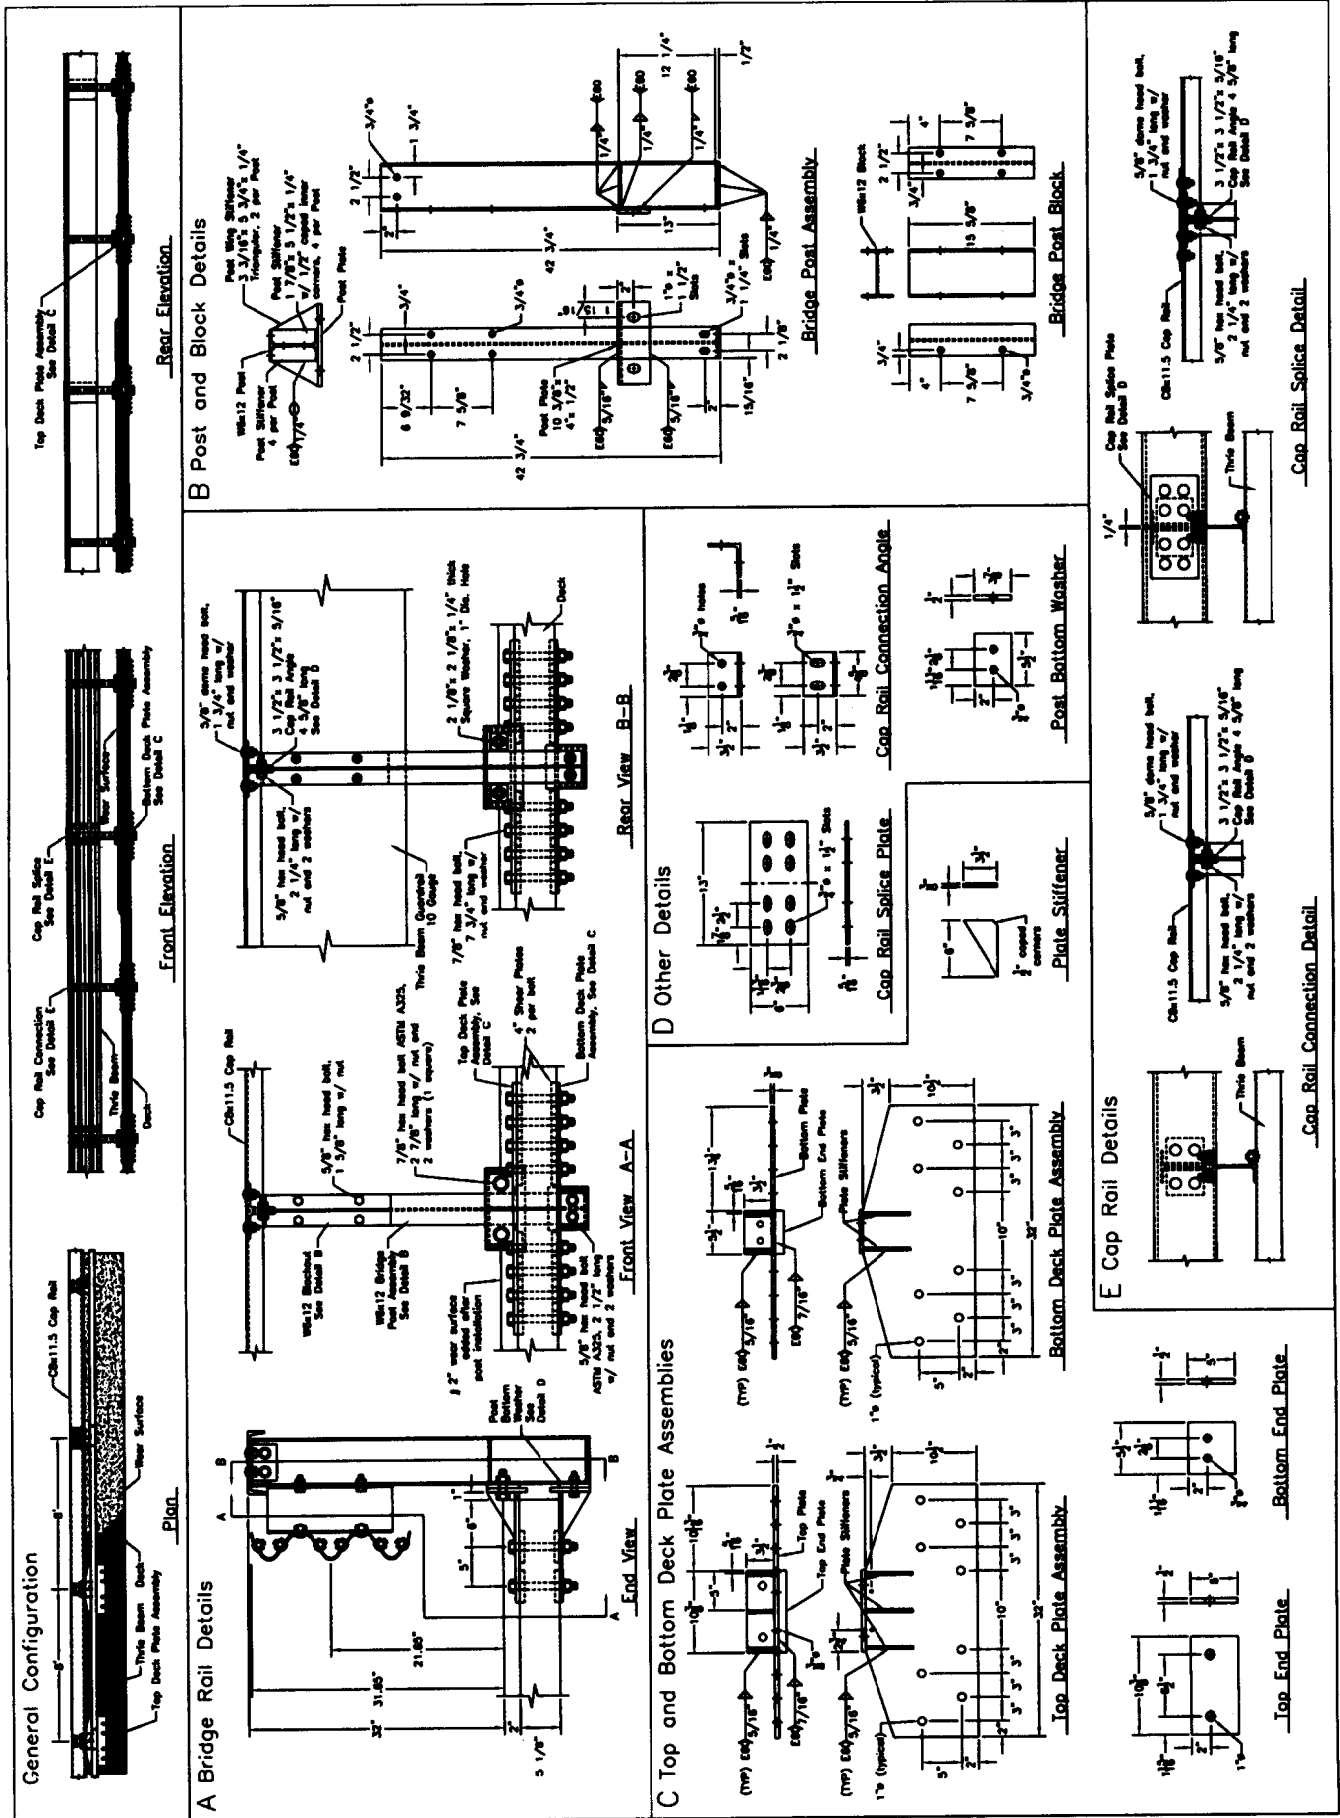
FIGURE 4 Steel bridge railing design details, System 1 (1 in. = 25.4 mm).

The first bridge railing system was designed as an all-steel system. This system was constructed with a thrie beam rail, an upper structural channel rail, wide-flange bridge posts and rail blockouts, and deck mounting plates. Specific details of this system are provided in Figure 4. For the steel system, a lo-gauge thrie beam rail was blocked away from wide-flange posts with wide-flange spacers. A structural channel rail was then attached to the top of the posts. The lower end of each post was bolted to two steel plates that were connected to the top and bottom surfaces of the bridge deck with vertical bolts.

several design modifications were deemed necessary. As a result, the upper structural tube rail on the TL-4 system was replaced with a channel rail section. This modification not only provided reduced weight but improved constructability. Other design modifications included a reduction in the size of the deck mounting plates and a decrease in the number of vertical bolts used to attach the mounting plates to the timber deck panels. A 2438-mm post spacing, also used with the TL-4 railings for transverse decks, was selected instead of the usual 1905-mm post spacing. The increased post spacing was selected to optimize the design and to significantly improve the constructability of the railing system, which was based on 1219-mm-

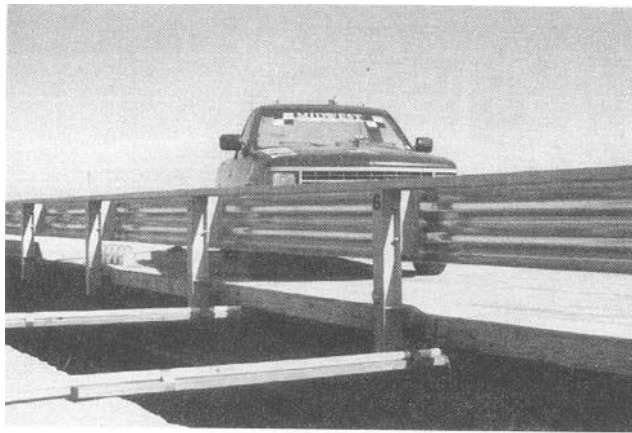
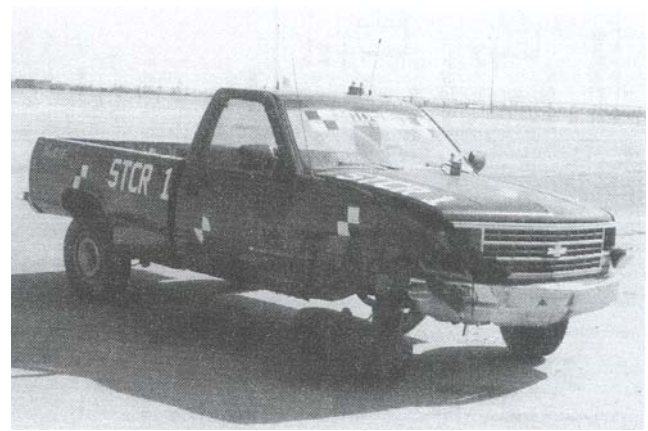
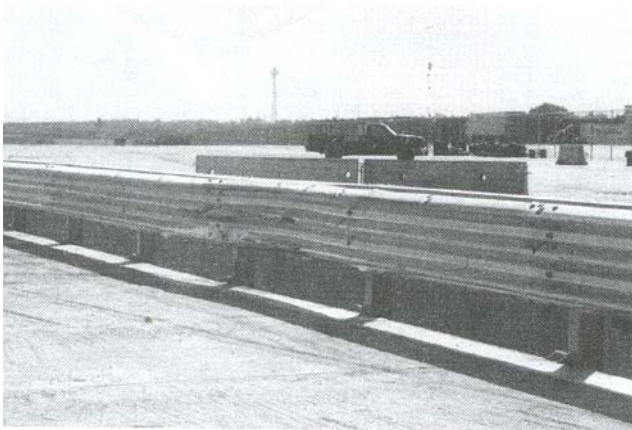
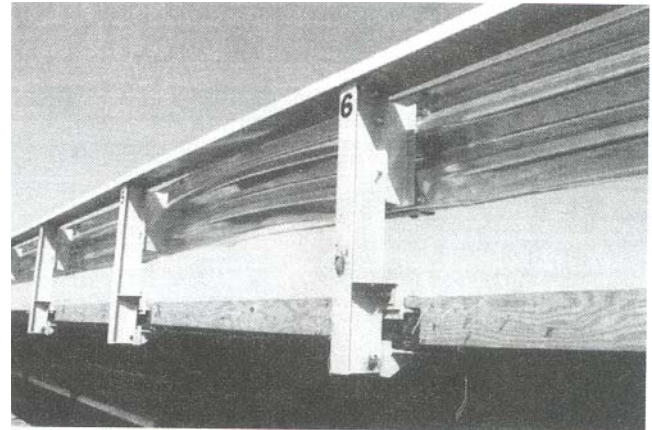
FIGURE 6 Test STCR-1: [a] impact location, [b] vehicle damage, and [c, d] bridge railing damage,

The first crash test, STCR-1, was successfully performed with a 1990 Chevrolet 2500 pickup truck with a test inertial mass of 1966 kg and at the impact conditions of 66.6 km/h and 25.6 degrees. During the impact event, the truck became parallel to the railing at 0.229 s and a speed of 46.1 km/h. At 0.519 s after impact, the vehicle exited the railing system at a speed of 45.2 km/h and an angle of 14.7 degrees. The maximum lateral permanent set and dynamic rail deflections were observed to be 102 and 157 mm, respectively. The location of the vehicle impact with the bridge railing, vehicle damage, and barrier damage are shown in Figure 6.

Following an analysis of the test results, it was determined that the steel bridge railing system met the TL-2 safety performance criteria provided in NCHRP Report 350. No significant damage to the test bridge was evident from the vehicle impact test. For the bridge railing system, damage consisted primarily of permanent deformation of the thrie beam rail, channel rail, wide-flange posts, and rail spacers. Although visual permanent set deformations of the steel components were found in the vicinity of the impact, all the steel members remained intact and serviceable after the test. Thus, replacement of bridge railing components would be based more on aesthetics than on structural integrity.

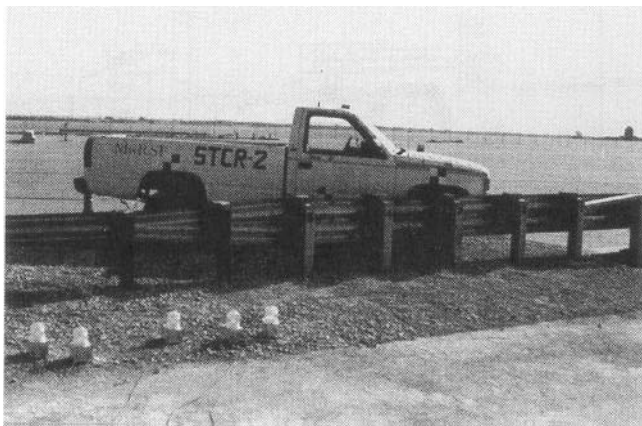
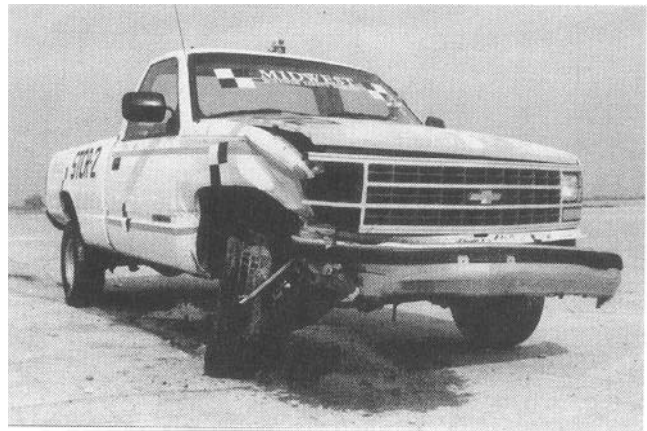
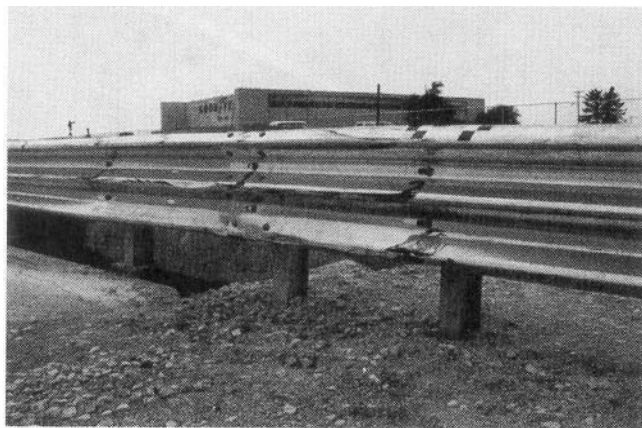
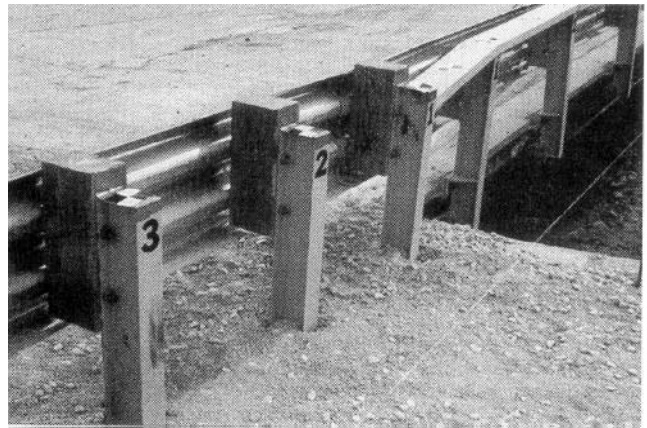
FIGURE 7 Test STCR-2: (a) impact location, (b) vehicle damage, end (c, d) bridge railing damage.

transition system at a speed of 45.5 km/h and an angle of 17.6 degrees. The maximum lateral permanent set and dynamic rail deflections were observed to be 117 and 202 mm, respectively. The location of the vehicle impact with the approach guardrail transition, vehicle damage, and barrier damage are shown in Figure 7.

Following an analysis of the test results, it was determined that the approach guardrail transition for use with the steel bridge railing system met the TL-2 safety performance criteria provided in NCHRP Report 350. No significant damage to the upstream end of the test bridge was evident from the vehicle impact test. For the approach guardrail transition system, damage consisted primarily of deformed thrie beam rail and bridge posts as well as displaced guardrail posts. Although visual permanent set deformations of the thrie beam rail were found in the vicinity of the impact, the rail remained intact and serviceable after the test. Thus, replacement of the guardrail would be based more on aesthetics than on structural integrity.

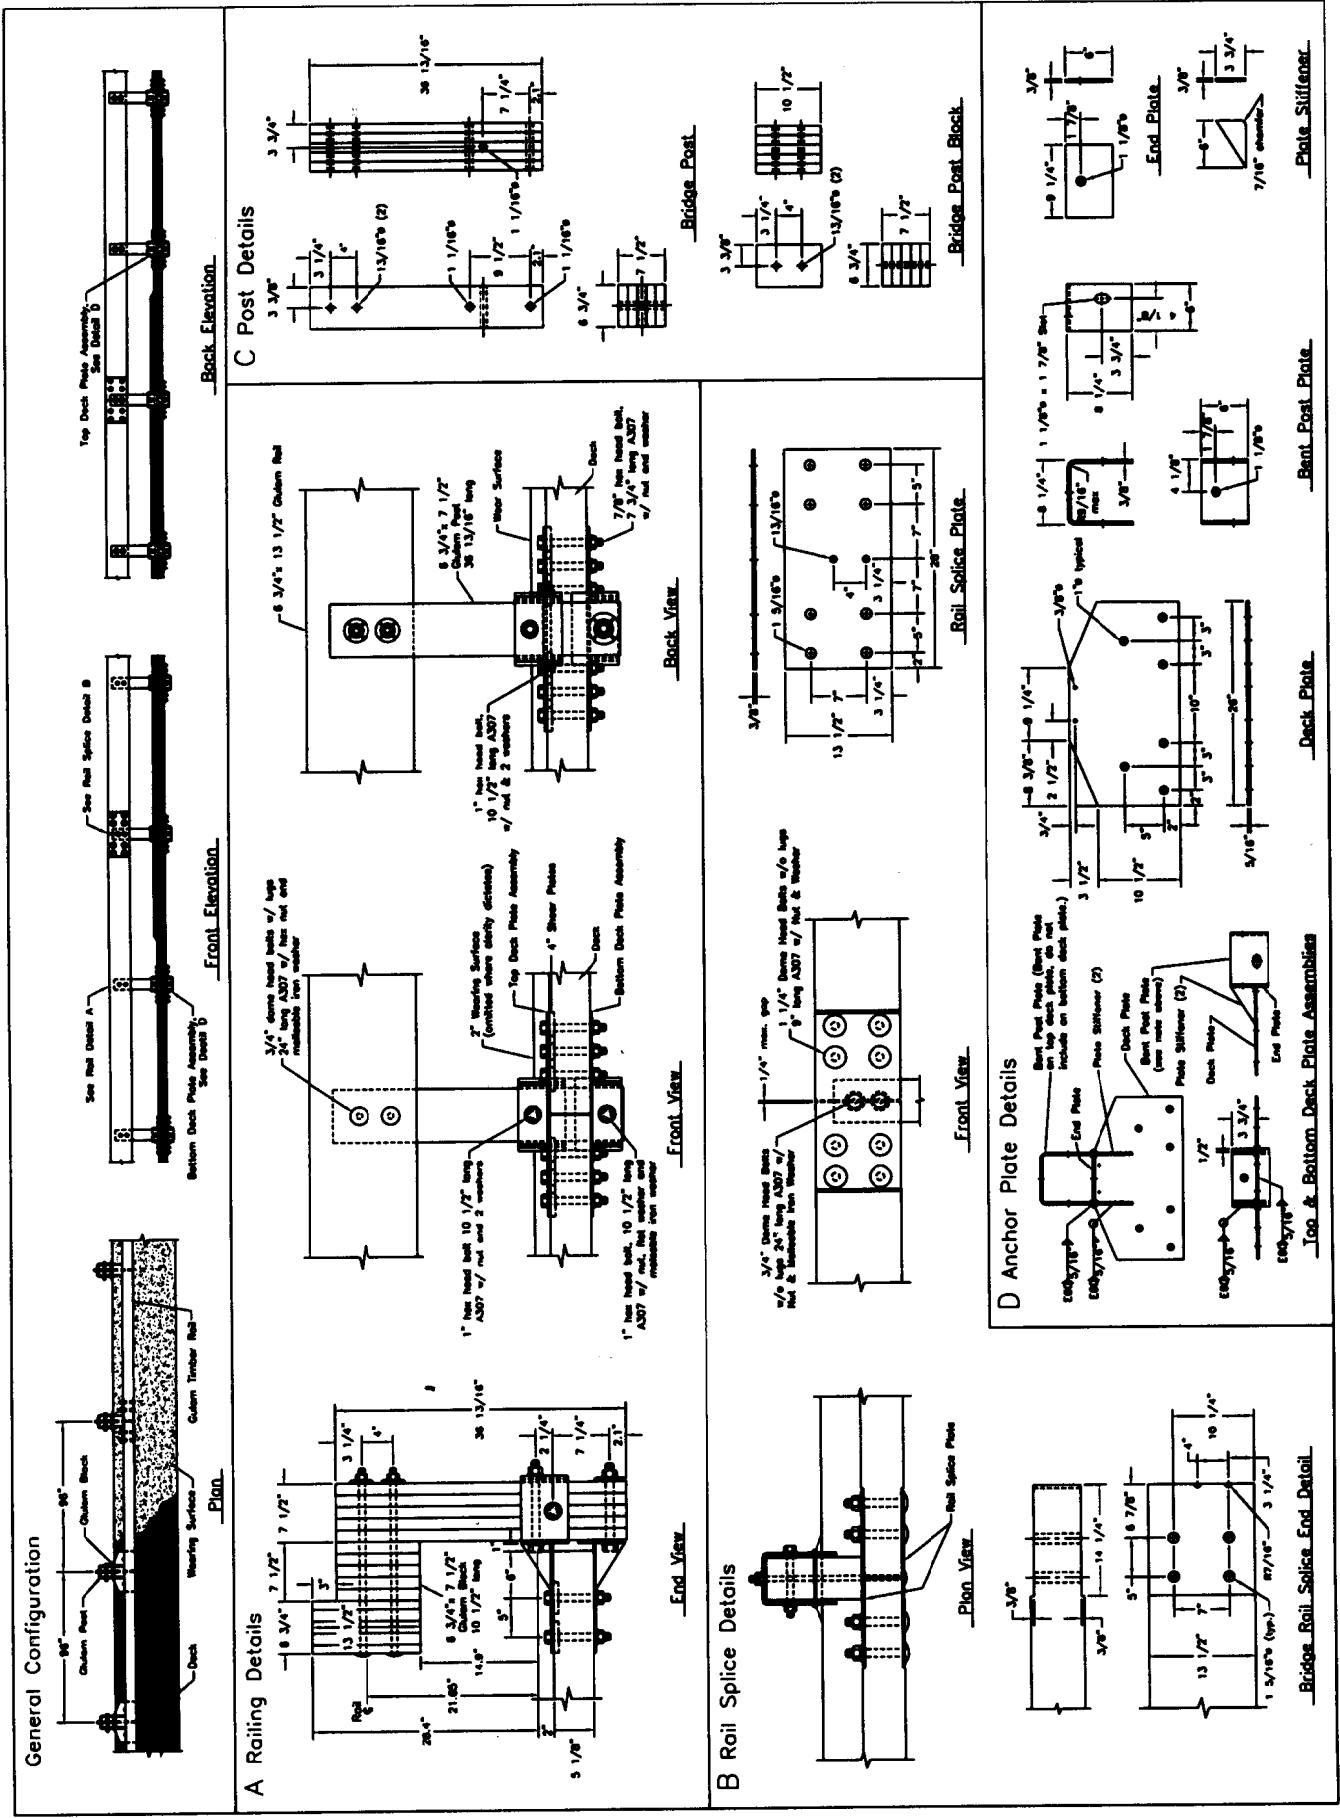
FIGURE 8 Wood bridge railing design details, System 2 (1 in. = 25.4 mm).

The second bridge railing system was designed to be an all-wood system, except for the structural steel connections. This system was constructed by using a rectangular rail, rectangular bridge posts, rail

blockouts, and deck mounting plates. Details of this system are provided in Figure 8. For the wood system, glulam timber for the rail and post members was Combination 48 southern yellow pine, as specified in AASHTO's *LRFD Bridge Design Specifications*, and it was treated with pentachlorophenol in heavy oil to AWP Standard C14 requirements (23). Glulam timber for the spacer blocks was fabricated with Combination 47 southern yellow pine, as specified by AASHTO, and was treated according to AWP Standard C14 (23).

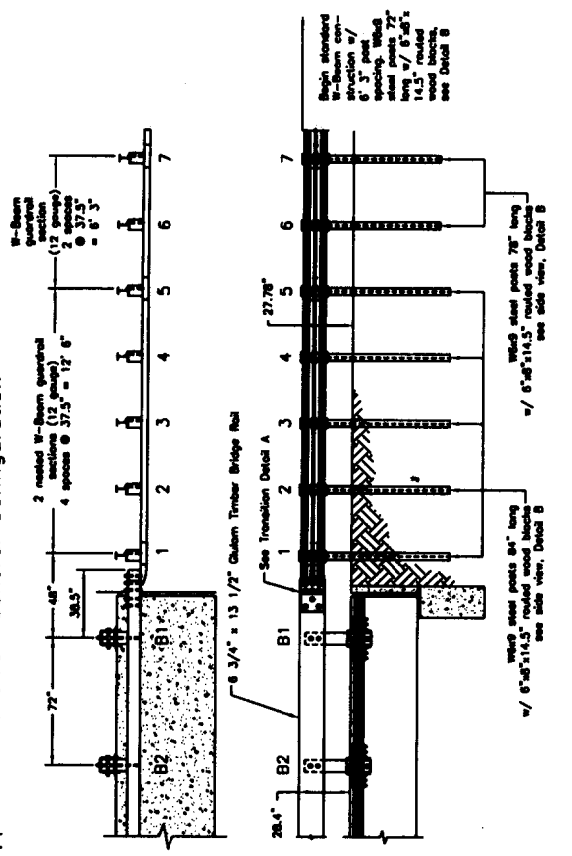
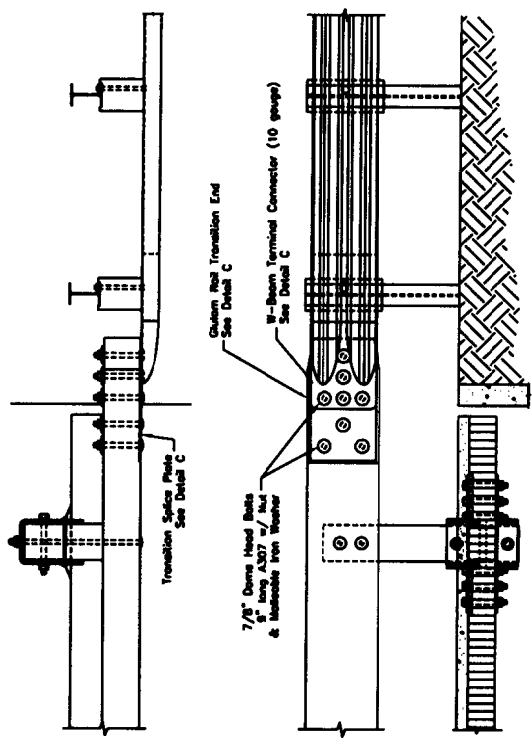
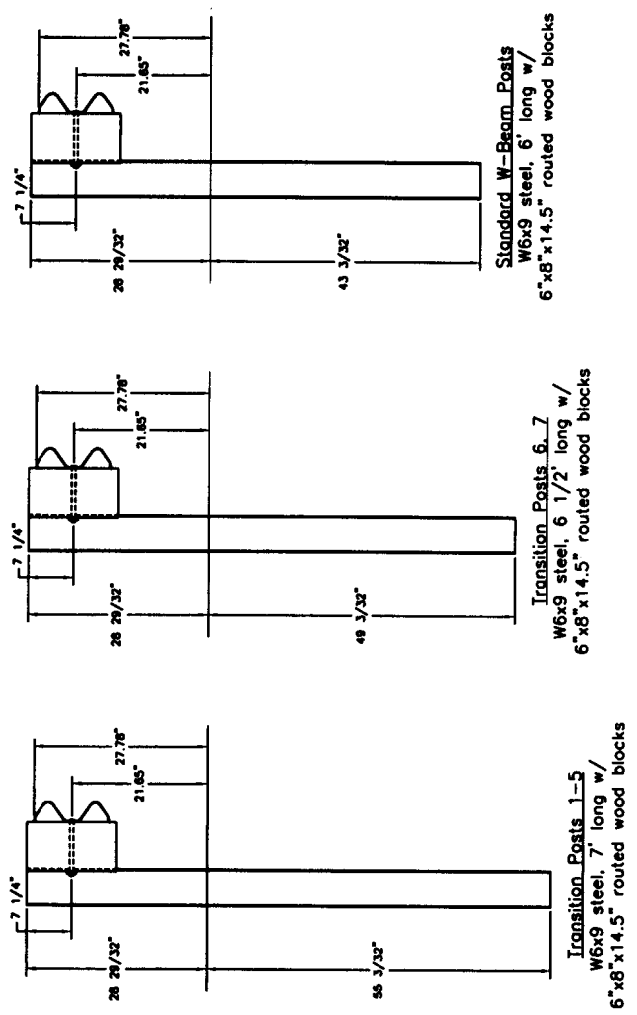
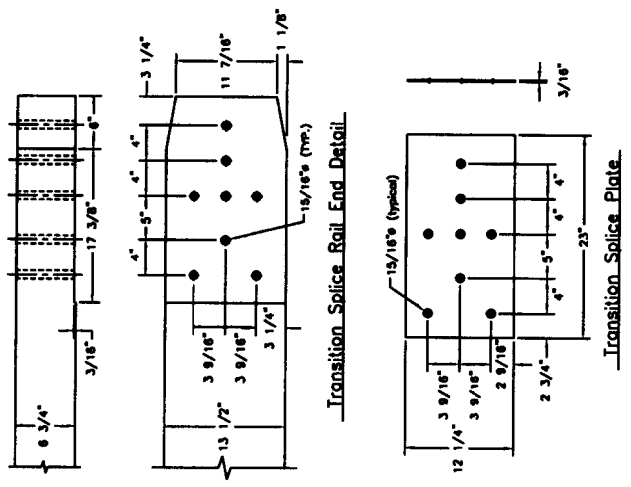
A Transition Splice Details

B Transition Posts Details

C Transition Splice Plate and Rail Details

FIGURE 9 Approach guardrail transition design details, System 2 (1 in. = 25.4 mm).

A TL-2 approach guardrail transition system was designed for attachment to each end of the bridge railing system. The system was constructed by using two nested steel W-beam rails, guardrail posts, and rail blockouts. Details of the approach guardrail transition used with System 2 are provided in Figure 9.

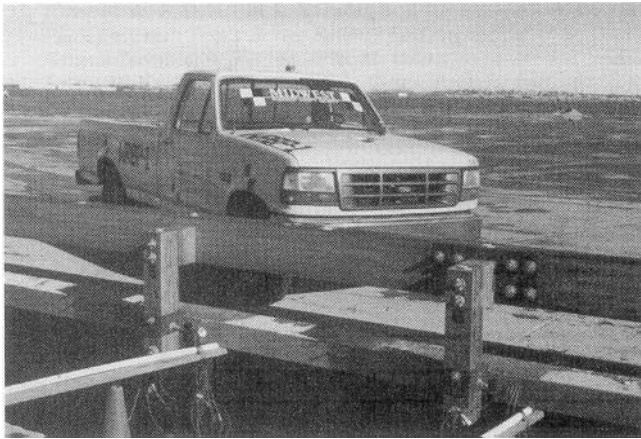
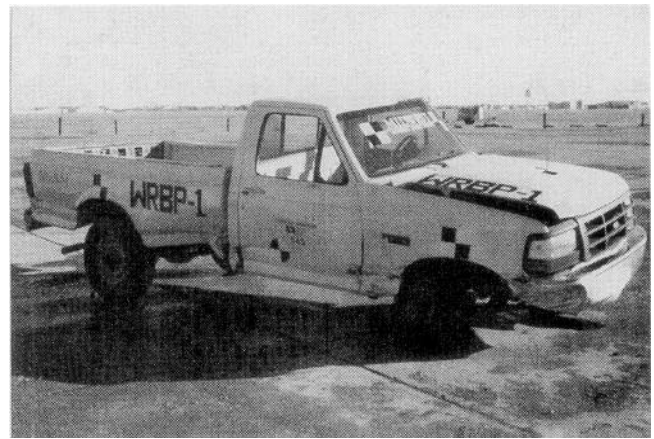
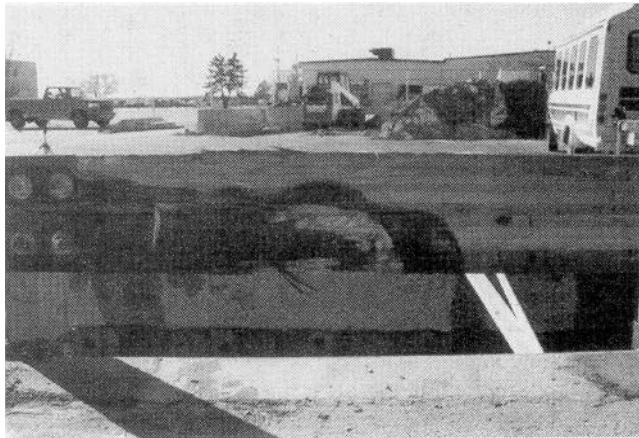
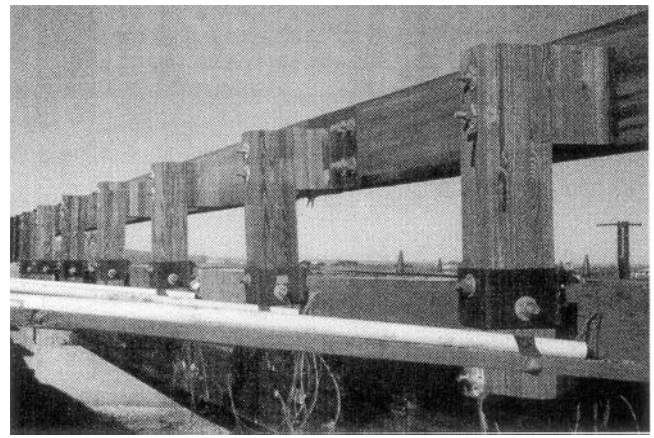
FIGURE 10 Test WRAP-1 : (a) impact location, (b) vehicle damage, and (c, d) bridge railing damage.

The first crash test, WRBP-1, was successfully performed with a 1994 Ford F-250 pickup truck with a test inertial mass of 2031 kg and at the impact conditions of 69 km/h and 26.2 degrees. During the impact event, the truck became parallel to the railing at 0.280 s and at a speed of 47.2 km/h. At 0.452 s after impact, the vehicle exited the railing system at a speed of 47.1 km/h and an angle of 5.9 degrees. The maximum lateral permanent set and dynamic rail deflections were observed to be 63 and 189 mm, respectively. The location of the vehicle impact with the bridge railing, vehicle damage, and barrier damage are shown in Figure 10.

Following an analysis of the test results, it was determined that the wood bridge railing system met the TL-2 safety performance criteria provided in NCHRP Report 350. No significant damage to the test bridge was evident from the vehicle impact test. For the bridge railing system, damage consisted primarily of rail gouging and scraping, as well as permanent set deformations of the steel deck mounting plates. The glulam timber railing remained intact and serviceable after the test. Railing replacement would not be considered necessary except to provide improved aesthetics.

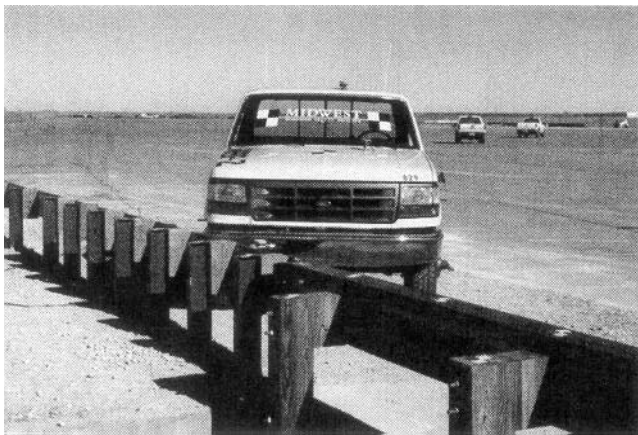
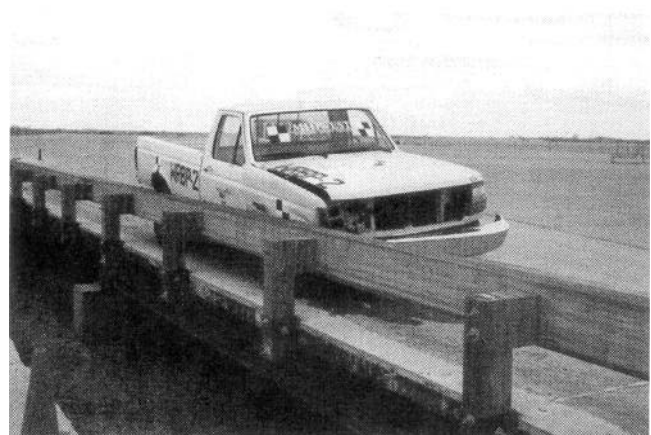
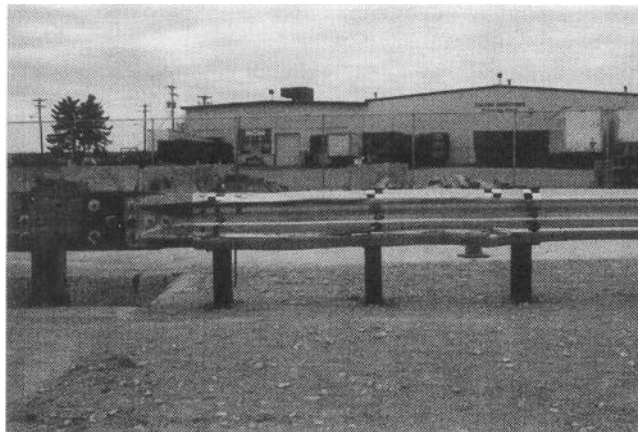
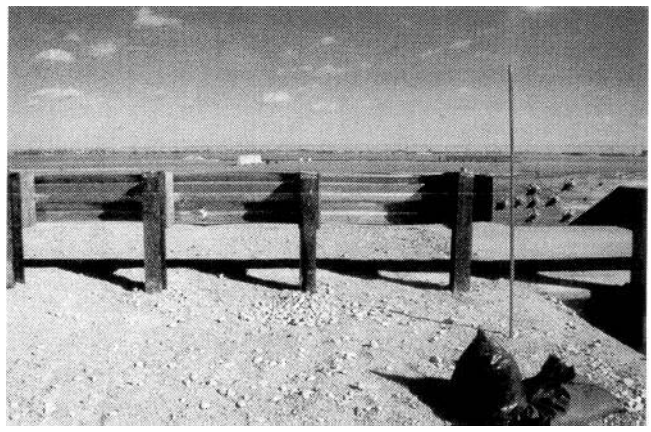
FIGURE 11 Test WRBP-2: (a) impact location, (b) vehicle damage, end (c, d) approach guardrail transition damage.

The first crash test, WRBP-2, was successfully performed with a 1993 Ford F-250 pickup truck with a test inertial mass of 2011 kg and at the impact conditions of 71.6 km/h and 26.3 degrees. During the impact event, the truck became parallel to the railing at 0.261 s and at a speed of 55.9 km/h. At 0.422 s after impact, the vehicle exited the transition system at a speed of 54.6 km/h and an angle of 3.5 degrees. The maximum lateral permanent set and dynamic rail deflections were observed to be 29 and 125 mm, respectively. The location of the vehicle impact with the approach guardrail transition, vehicle damage, and barrier damage are shown in Figure 11.

Following an analysis of the test results, it was determined that the approach guardrail transition for use with the wood bridge railing system met the TL-2 safety performance criteria provided in NCHRP Report 350. No significant damage to the upstream end of the test bridge was evident from the vehicle impact test. For the approach guardrail transition system, damage consisted primarily of deformed W-beam rail and displaced guardrail posts. Although visual permanent set deformations of the W-beam rail were found in the vicinity of the impact, the rail remained intact and serviceable after the test. Thus, replacement of guardrail would be based more on aesthetics than on structural integrity.
