Long Term Load Performance of FRP Reinforced Glulam Bridge Girders

Dan A. Tingley, P. Eng., Wood Science & Technology Institute (N.S.), Ltd.
Paul C. Gilham, M.S. P. E., Western Wood Structures, Inc.
Scott M. Kent, M. S., E.I.T., Wood Science & Technology Institute (N.S.), Ltd.

In: Ritter, M.A.; Duwadi, S.R.; Lee, P.D.H., ed(s). National conference on wood transportation structures; 1996 October 23-25; Madison, WI. Gen. Tech. Rep. FPL- GTR-94. Madison, WI: U.S. Department of Agriculture, Forest Service, Forest Products Laboratory.

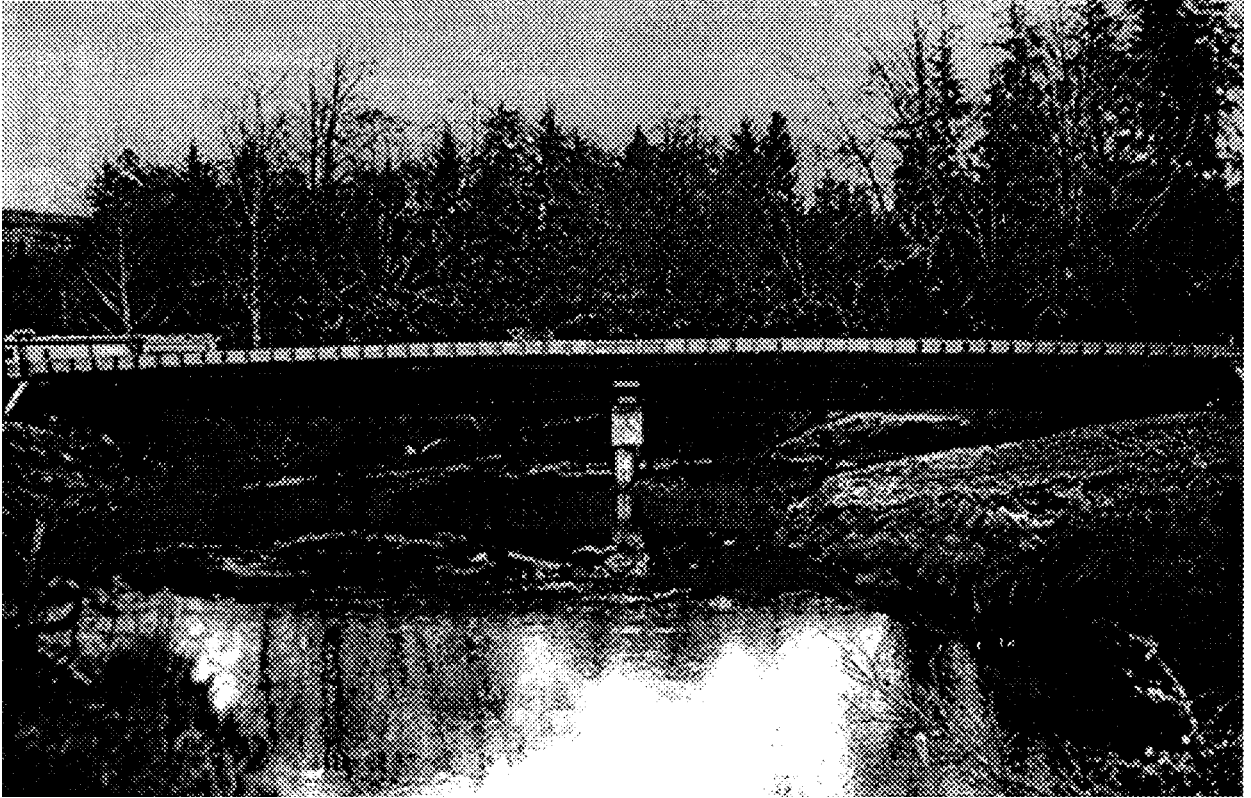
Figure 1-Side view of the Clallam Bay bridge.

A bridge composed of FiRP™ Reinforced glued laminated timber (glulam) girders and a transverse conventional glulam deck was constructed over the Clallam river near Sekiu, Washington. It consists of two simple spans, each 24.8 m, for a total span of 49.6 m with an HS-25 load rating. Six Douglas-fir (DF), L2 girders spaced at 1.60 m center-to-center are used for each span. A composite modulus of elasticity (E) of 14480 MPa was used to estimate deflections. The exterior girders are 222 mm wide by 1499 mm deep with four layers of 3.81 mm thick aramid reinforced plastic (ARP) FiRP™ Reinforcement. The interior girders are 171 mm wide by 1499 mm deep with seven layers of 1.78 mm thick carbon-m-amid reinforced plastic (CARP) FiRP™ Reinforcement. The bridge

deck is constructed of 52 conventional glulam deck panels oriented transversely to the girders. Also, glulams were used for deck stiffeners and curbs. All the lumber was pressure treated with pentachlorophenol. Figures 1 and 2 show side and end views of the Clallam Bay bridge, respectively.

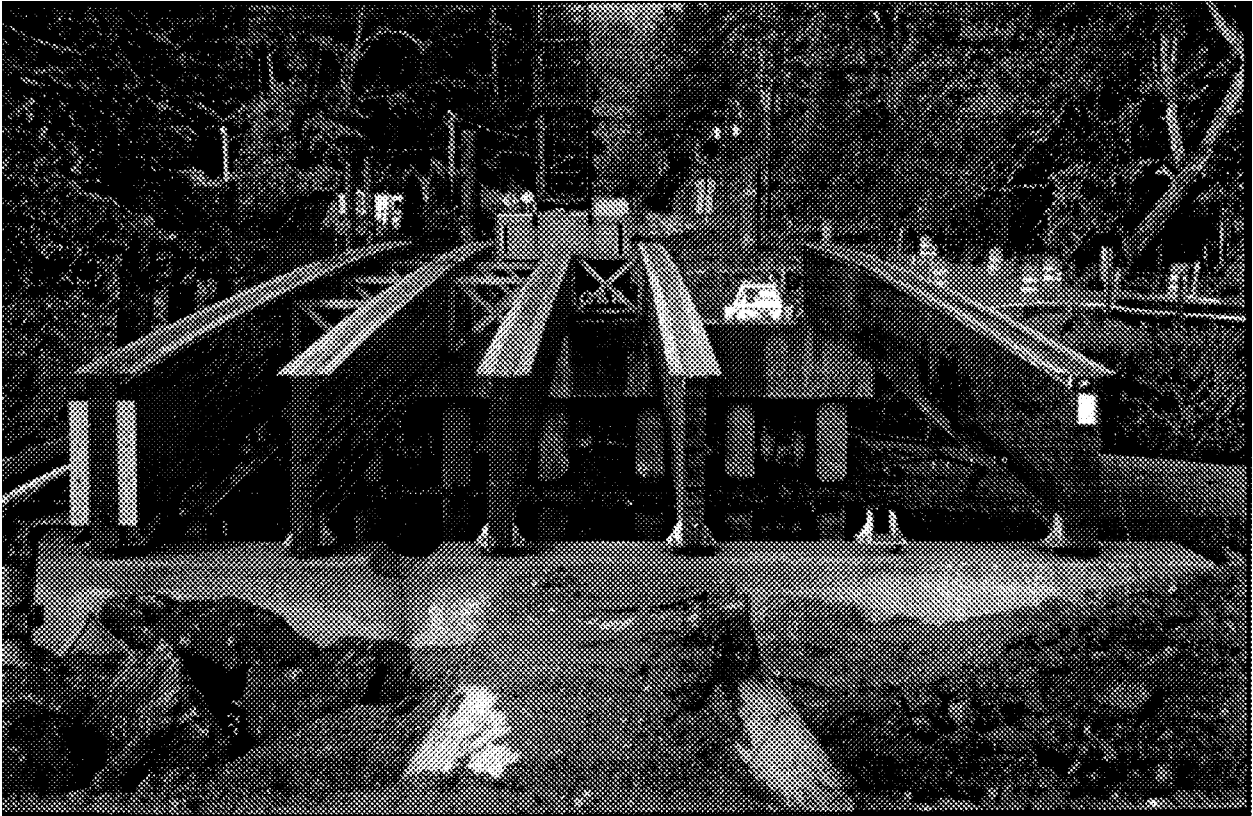
Figure 2-End view of the girders.

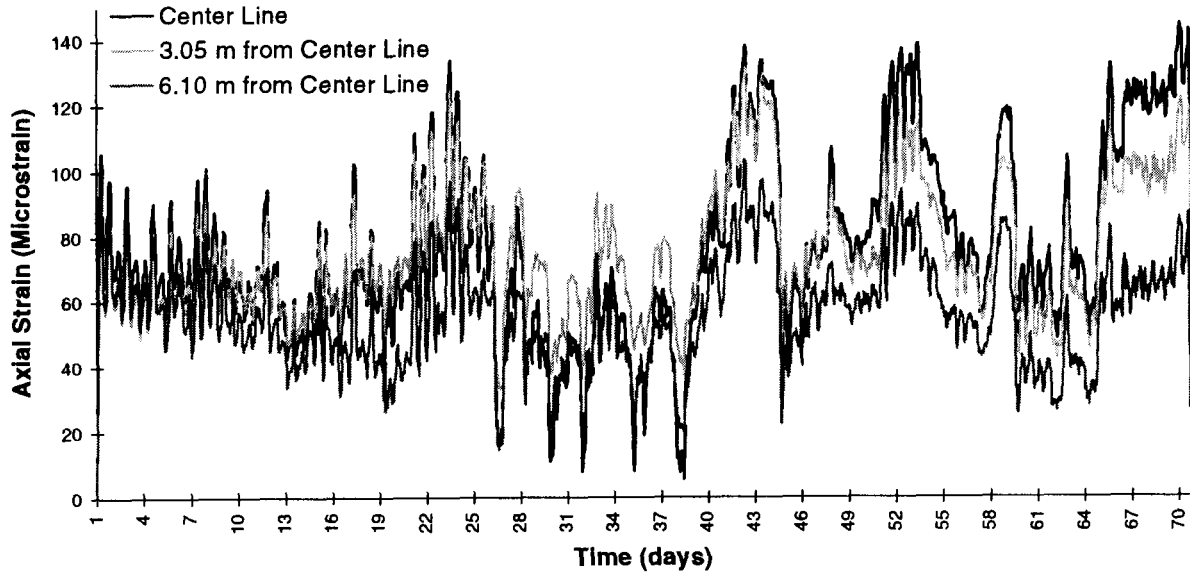
Figure 6-Response of strain gauges located at the centerline of each of the three gauged girders in the tension zone.

Figure 6 displays the axial strain on the wood of the northwest exterior girder at the centerline, 3.05 m from the centerline and 6.10 m from the centerline. As shown in Figure 6, the axial strain in the northwest exterior reinforced glulam beam in the extreme tension zone shows an initial increase due to application of the asphalt concrete wearing surface. However, after the initial strain increase, no significant creep can be seen. A significant amount of variation in the strain is apparent.

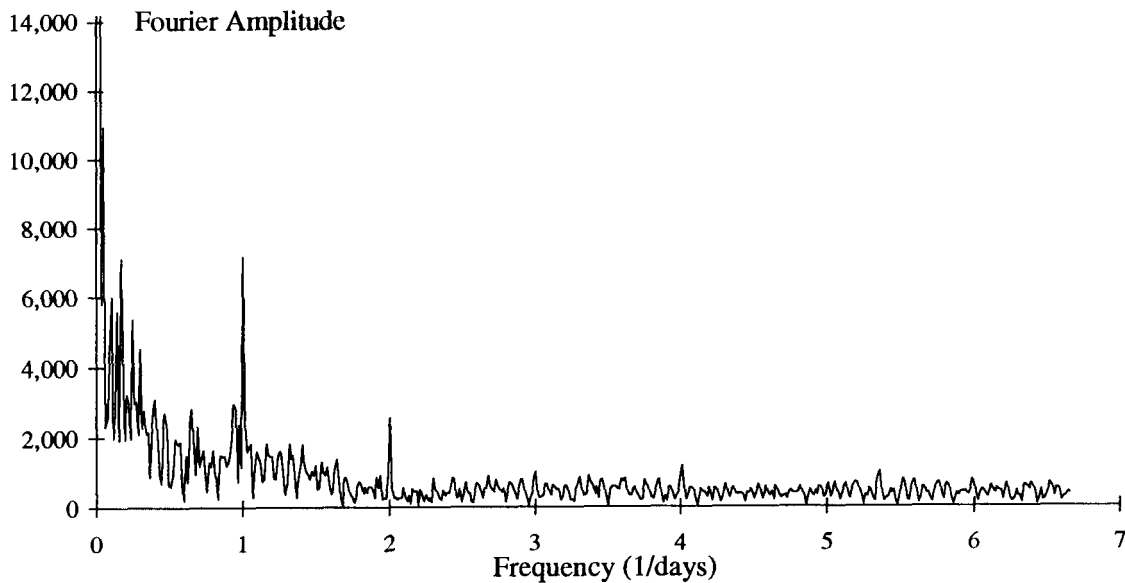
Figure 7-Fourier amplitude spectrum of a typical strain gauge response.

A Fourier analysis was conducted to transform the time-domain to the frequency-domain using a fast Fourier transform algorithm to check for the influence of cyclic events. Figure 7 displays the Fourier amplitude spectrum of a strain gauge mounted on the wood between the bottom lamination and the reinforcement on the northwest exterior girder. Perhaps the most important result from the Fourier analysis is the presence of a spike at the one-per-day frequency indicating that there is significant cyclic

behavior at one-day intervals (the corresponding harmonics can be seen at higher frequencies). All of the strain gauges experienced the cyclic behavior. The most reasonable explanation of this response is day-to-day temperature fluctuations.

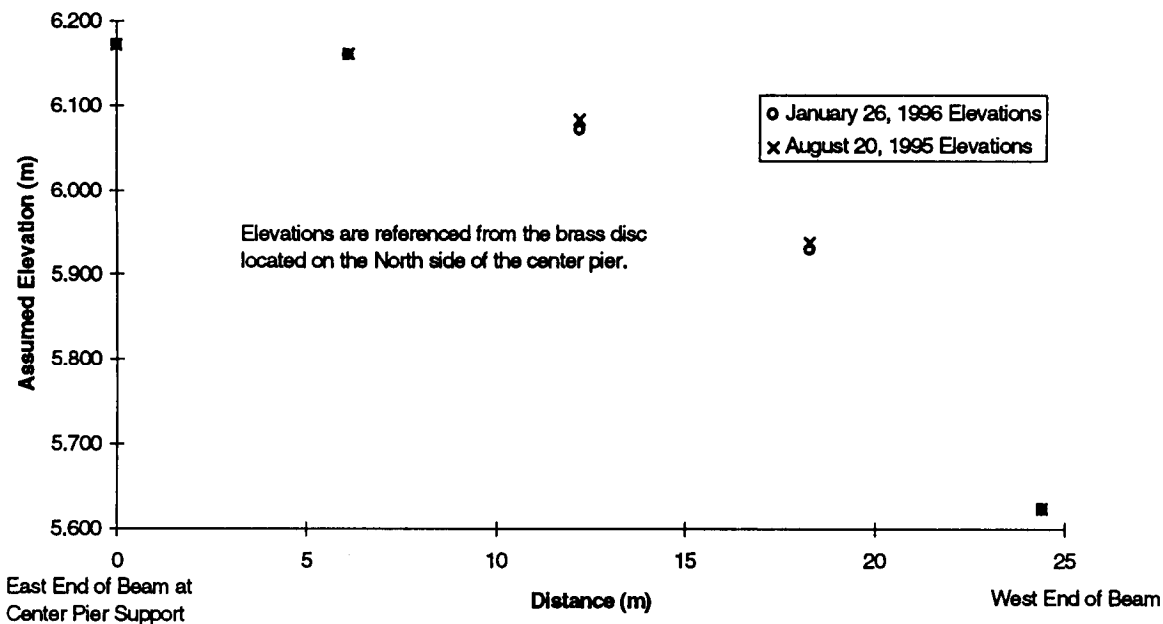
Figure 8-Survey results of the northwest exterior girder.

Using a precision automatic level, the elevation of the bottom of the northwest exterior girder was measured in reference to a brass benchmark located on the north side of the center pier (assumed elevation of 6.096 m). Figure 8 displays the results of the two surveys. A difference in the centerline deflection of 1.016 mm can be seen from Figure 8 as a result of the increased dead load from the asphalt wearing surface.
