Recent Trends in Preservative Treatments for Timber Bridges

James P. Wacker

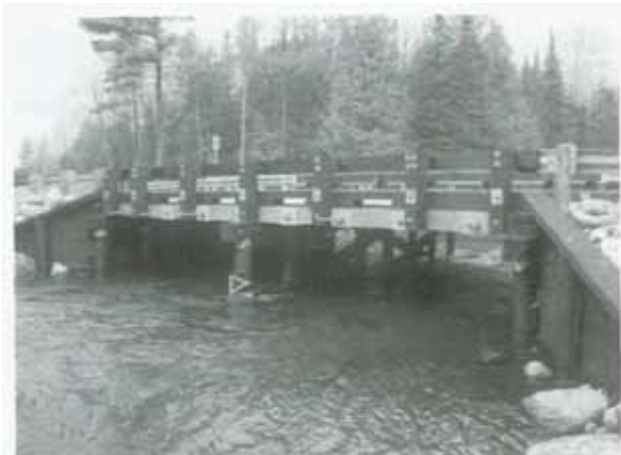
Figure 1.—Deck superstructure of the Graves Crossing Bridge is CCA treated.

New timber bridges have been built along primary and secondary roadways of several counties in Michigan. The locally available softwood species utilized for many of these timber bridges was red pine. CCA preservative was used for the first several structures (such as the Graves Crossing Bridge in Antrim County, **Fig. 1**), and creosote was used for structures built later (such as the Cameron Bridge in Crawford County, **Fig. 2**). However, some creosote-treated highway bridges experienced excessive amounts of bleeding, which raised environmental concerns. Preliminary field in-

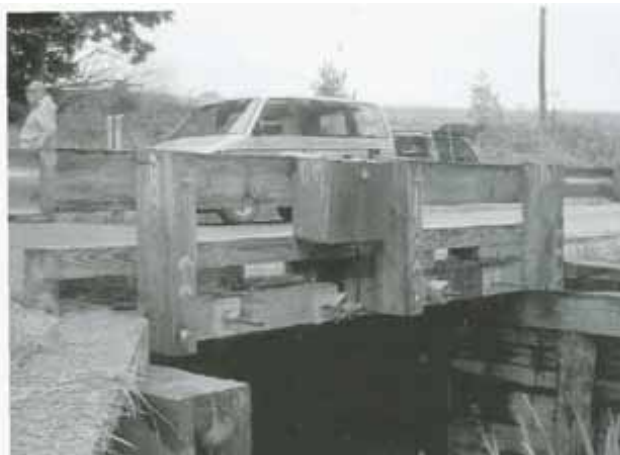
Figure 4.—McCurdy Road Bridge is ACQ treated.

ing the past 10 years. The softwood utilized for many of these timber bridges was southern pine. Alkaline copper quat (ACQ) was used for treating structural members in the McCurdy Road Bridge (fig. 4). ACQ with water-repellent additives was used for treating structural members in the Huntsman Road Bridge (Fig. 5) in efforts to alleviate concerns about dimensional stability for water-based preservative treatments used in bridges. The wood preservative ACQ (an arsenic-free alternative to CCA) was chosen primarily to address worker safety concerns associated with creosote and avoid environmental concerns associated with CCA. Some corrosive interaction was noted at the interface of ACQ-treated wood and galvanized steel components, and further field inspections are planned.

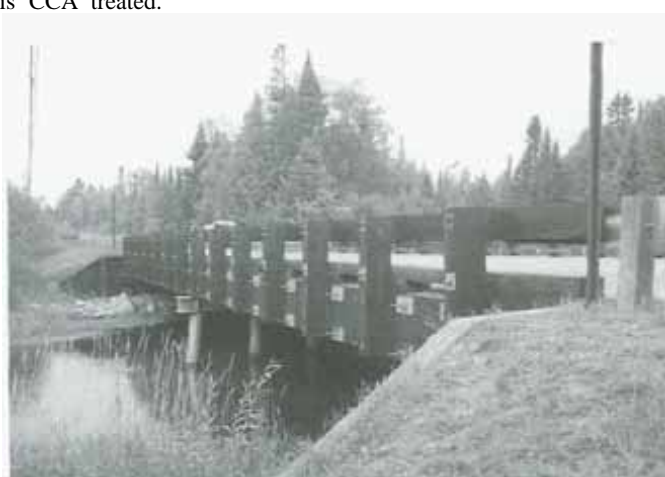
Figure 2.—Cameron Bridge is creosote treated.

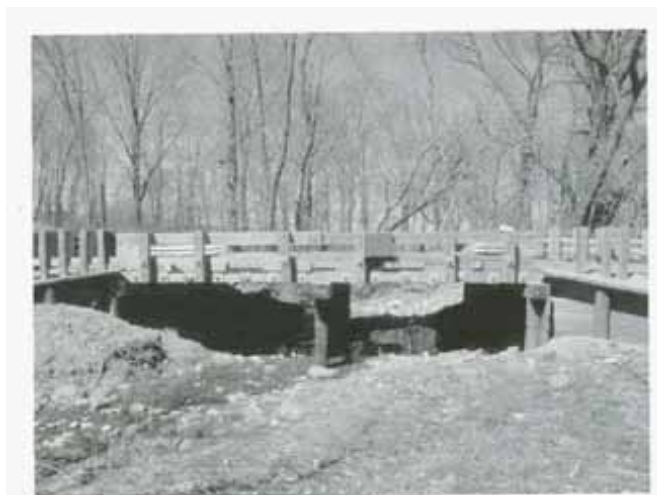
Figure 5.—Huntsman Road Bridge is ACQ treated with water-repellent additives.

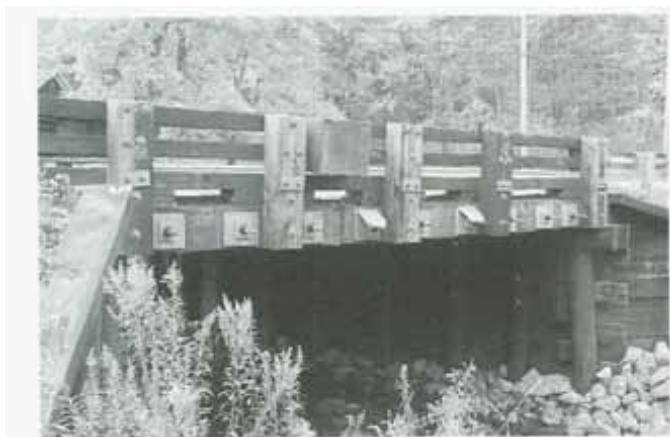
Figure 3.—Dutch Hill bad Bridge is creosote treated.

The Pennsylvania Department of Transportation (PennDOT) had approximately 20 timber highway bridges constructed on their secondary road system. The locally available hardwood species utilized for many of these timber bridges was northern red oak. Creosote was primarily used for these bridge structures (such as the Dutch Hill Road Bridge, **Fig. 3**). Some minor creosote bleeding has occurred at some bridge sites, but it has not led to significant environmental concerns to date.

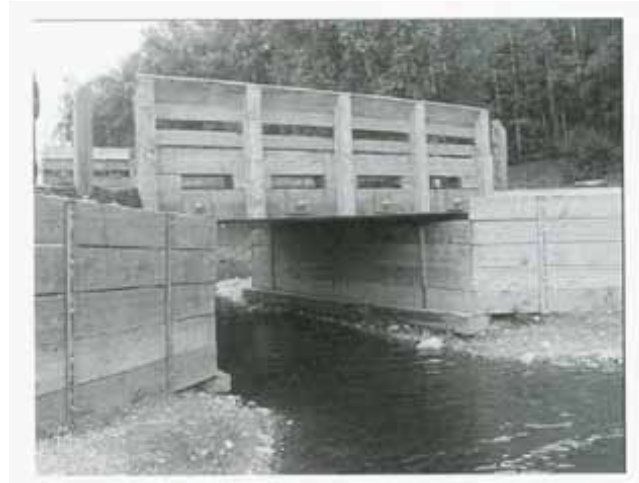
Figure 6.—Kepler-Bradley Bridge is copper fluoride treated.

Efforts are underway to develop a comprehensive Alaska Wood in Transportation Program. The program aims to identify specific Alaska wood species (yellow cedar, white spruce, Sitka spruce, and western hemlock) and preservative treatments (copper fluoride by double diffusion and natural decay resistance) as the basis for developing standardized timber bridge designs and enhancing forest-based communities.

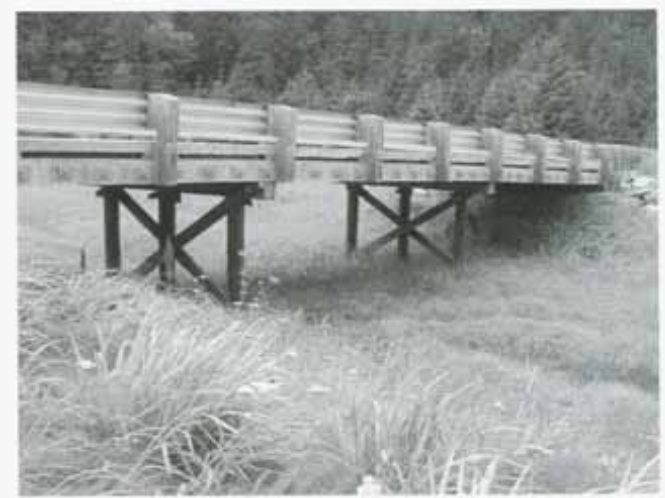
Figure 7.—Nelson Slough Bridge is naturally durable Alaska yellow cedar (untreated).
