Chapter 4

AFFECTED ENVIRONMENT

4.1 OVERVIEW OF THE AFFECTED ENVIRONMENT

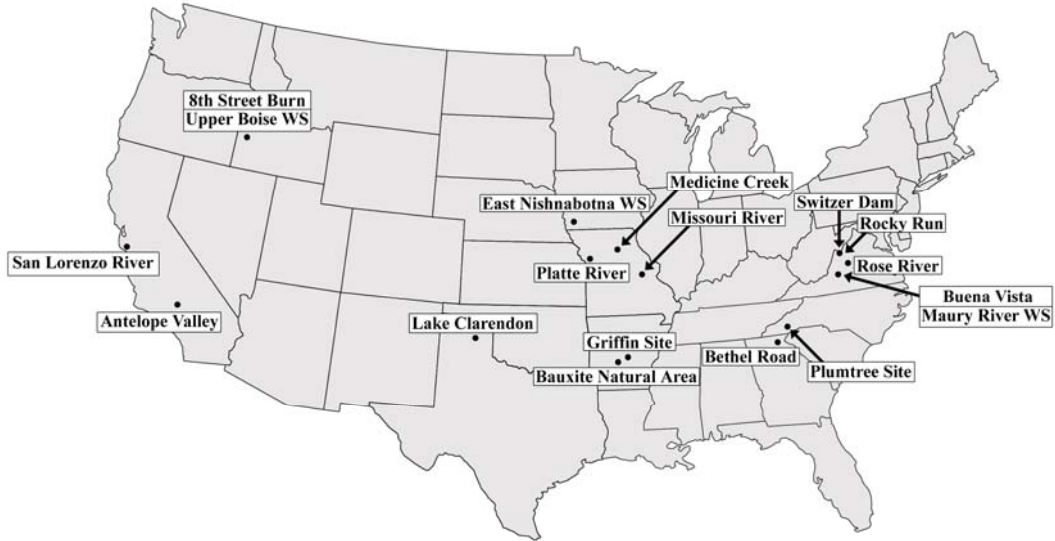
Fig. 4.1-1. Watershed Impairment Sites Used as Examples in the Analysis of EWP Program Impacts (WS = watersheds used in cumulative impacts analysis)

Twenty-three individual practice or floodplain easement sites were selected in 14 watersheds (Table 4.1-1) to represent typical impairments and EWP Program practices. Of the locations (Fig. 4.1-1), 6 were chosen to represent the range of affected human communities, and 3 were selected to illustrate cumulative effects throughout the watershed.

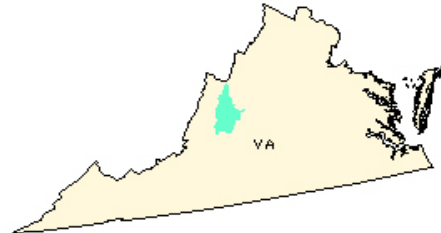
The City of Buena Vista is located in eastern Rockbridge County between the east bank of the Maury River and the west slope of the Blue Ridge adjacent to the George Washington and Jefferson National Forests. Through these forests drain four streams, eventually reaching the Maury River after passing through Buena Vista. These streams (from north to south) are Chalk Mine Run, Indian Gap Run, Noels Run, and Pedlar Gap Run.

Downpours resulting from Hurricane Fran in September 1996 caused considerable damage along the streams mentioned above. Debris clogged stream outlets, resulting in the flooding of several areas of the City. Severe erosion along streambanks also threatened many homes and businesses.

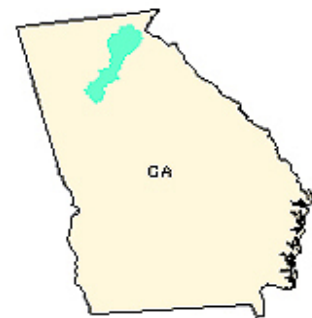
Hall County is located in northeastern Georgia and lies in the foothills of the Blue Ridge Mountains. The predominant geographic feature in this moderately hilly area is the Chattahoochee River.

Tornadoes destroyed homes and caused widespread damage in the forested watersheds when they struck in 1998.

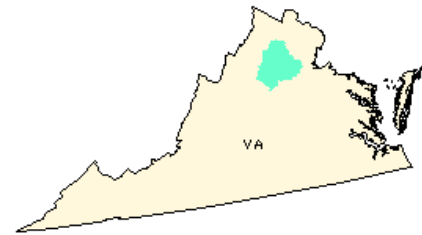
This area had 4 major flood events from June 1995 to December 1996. Floodwaters from these large storm events led to severe erosion, channel movement, and the heavy deposition of cobble and woody debris. The homeowner's access road was threatened, as well as some other features on the property. EWP stream restoration practices, including rock weirs, riprap, rootwads, and vegetative techniques were used to repair and protect the disturbed area.

The floodplain surrounding the EWP site is nearly void of vegetation from heavy grazing and the disruptive floodwaters. Several marginal wetlands are located downstream of the project area, which most likely would have been inundated with sediment if the EWP work had not been completed.

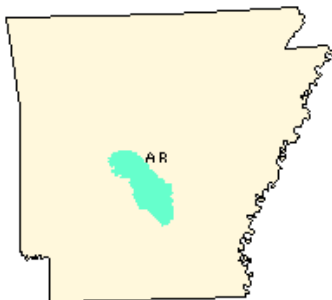
The Alcoa Corporation manages bauxite mining in central Arkansas in the vicinity of the towns of Benton, Bryant, and Bauxite, all southwest of Little Rock. In 1996, Alcoa entered into an agreement with The Nature Conservancy (TNC) to implement conservation and ecological management on 1,400 acres of land within the Bauxite Natural Areas on Alcoa lands. The region is home to several rare ecological communities and contains several federally listed species (TNC, 1998).

In March 1997, tornados ravaged central Arkansas and swept through the Alcoa/TNC managed area. The tornado was classified as an F4, with winds exceeding 200 miles per hour. An estimated 500 acres of woodlands were damaged and woody debris was

widespread. Much of the debris was gathered into brush piles. The piles resulted in a threat to the rare herbaceous species and an increased danger of wildfire due to the ready supply of fuel. Invasive species (kudzu and Japanese honeysuckle) also posed a threat to plant communities (TNC, 1998).

TNC acted in place of NRCS for this EWP project and drafted a plan to remove the debris and reduce the threats in the most environmentally sensitive manner possible. TNC staff and volunteers executed a series of prescribed burns and a large amount of hand clearing over an area of 265 acres. Follow-up monitoring has shown very positive results, as T&E species are thriving, exotic species have been suppressed, and re-growth is progressing (TNC, 1998).

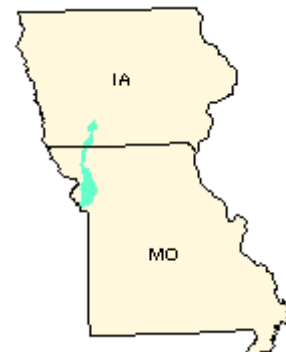
The Platte River floodplain easement site is located in western Missouri, north of Kansas City at the confluence of the Platte River (HUC 10240012) and the Little Platte River. The easement property is greater than 100 acres and the historical use of the property is agricultural, primarily tenant farming. Flooding is very frequent in this area, with 3 to 4 short duration floods per year in the spring (Berka, 1999). Traditionally, maintaining the levee at this site has been difficult (Howard, 1999).

During the rains leading to the 1995 flooding, a breach formed along the Platte River portion of the privately constructed levee on the northern edge of the property. Existing crops were lost and damage to the levee was substantial. NRCS determined that the levee repairs would only protect one landowner and were therefore not eligible for EWP repair funds. However, NRCS was able to offer a floodplain easement. The new floodplain resulting from this easement will be managed for the creation of wetlands (Berka, 1999).

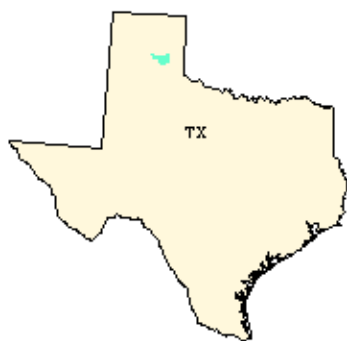
Clarendon is a town of approximately 2,000 located in the panhandle of northern Texas and is the county seat of Donley County. Just to the northeast of the city lies Clarendon Lake, a playa lake. Also located there is the municipal sewage plant, separated from the lake by a berm. Sewage is treated in holding ponds and then released into the lake.

The playa lake was rapidly filled after heavy rains struck the area in April 1997. Rainfall exceeded the 100-year rainfall event limits and the lake swelled to almost 10 times its normal area (Sears, 1999).

The EWP project used a diversion/berm to close off the plant and halt the flow of untreated sewage into the lake. This berm repair/diversion then allowed for the dewatering of the lagoon system and a return to normal operations.

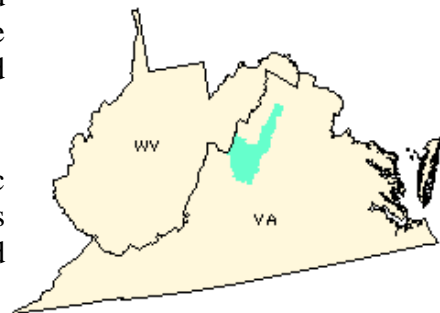
Flooding resulting from Hurricane Fran in September 1996 caused the destruction of two spillways on three dams located in the North River Watershed. The first earthen dam (Switzer Dam) is located at the confluence of Skidmore Fork and the Dry River Tributary. The second is located on the Dry River. The third dam is located on Dry Run, a tributary to the Dry River. The Dry River is a tributary to the North River, and the North River is a tributary to the South Fork Shenandoah River. All three dams suffered a high degree of erosion in their emergency spillways causing large amounts of sediment, cobble, and woody debris to be expelled into the Dry River. The damaged spillways caused an immediate threat to life and property should they fail and the dam suddenly breach.

The repair of the spillways involved excavating 2,100 cubic yards of storm deposited material; placing 6,000 cubic yards of fill in severely eroded areas; and grading, seeding, and fertilizing approximately 6 acres at the sites.
