Memorandum

To: Mike Gross, PE, U.S. Army Corps of Engineers, Portland District
From: Jeff Wallace, R.G. and Brian McNamara, R.G.
Date: May 12, 2008
Subject: Post-Removal Sample Collection, Bradford Island Disposal Site
Bonneville Dam Forebay - Cascade Locks, Oregon

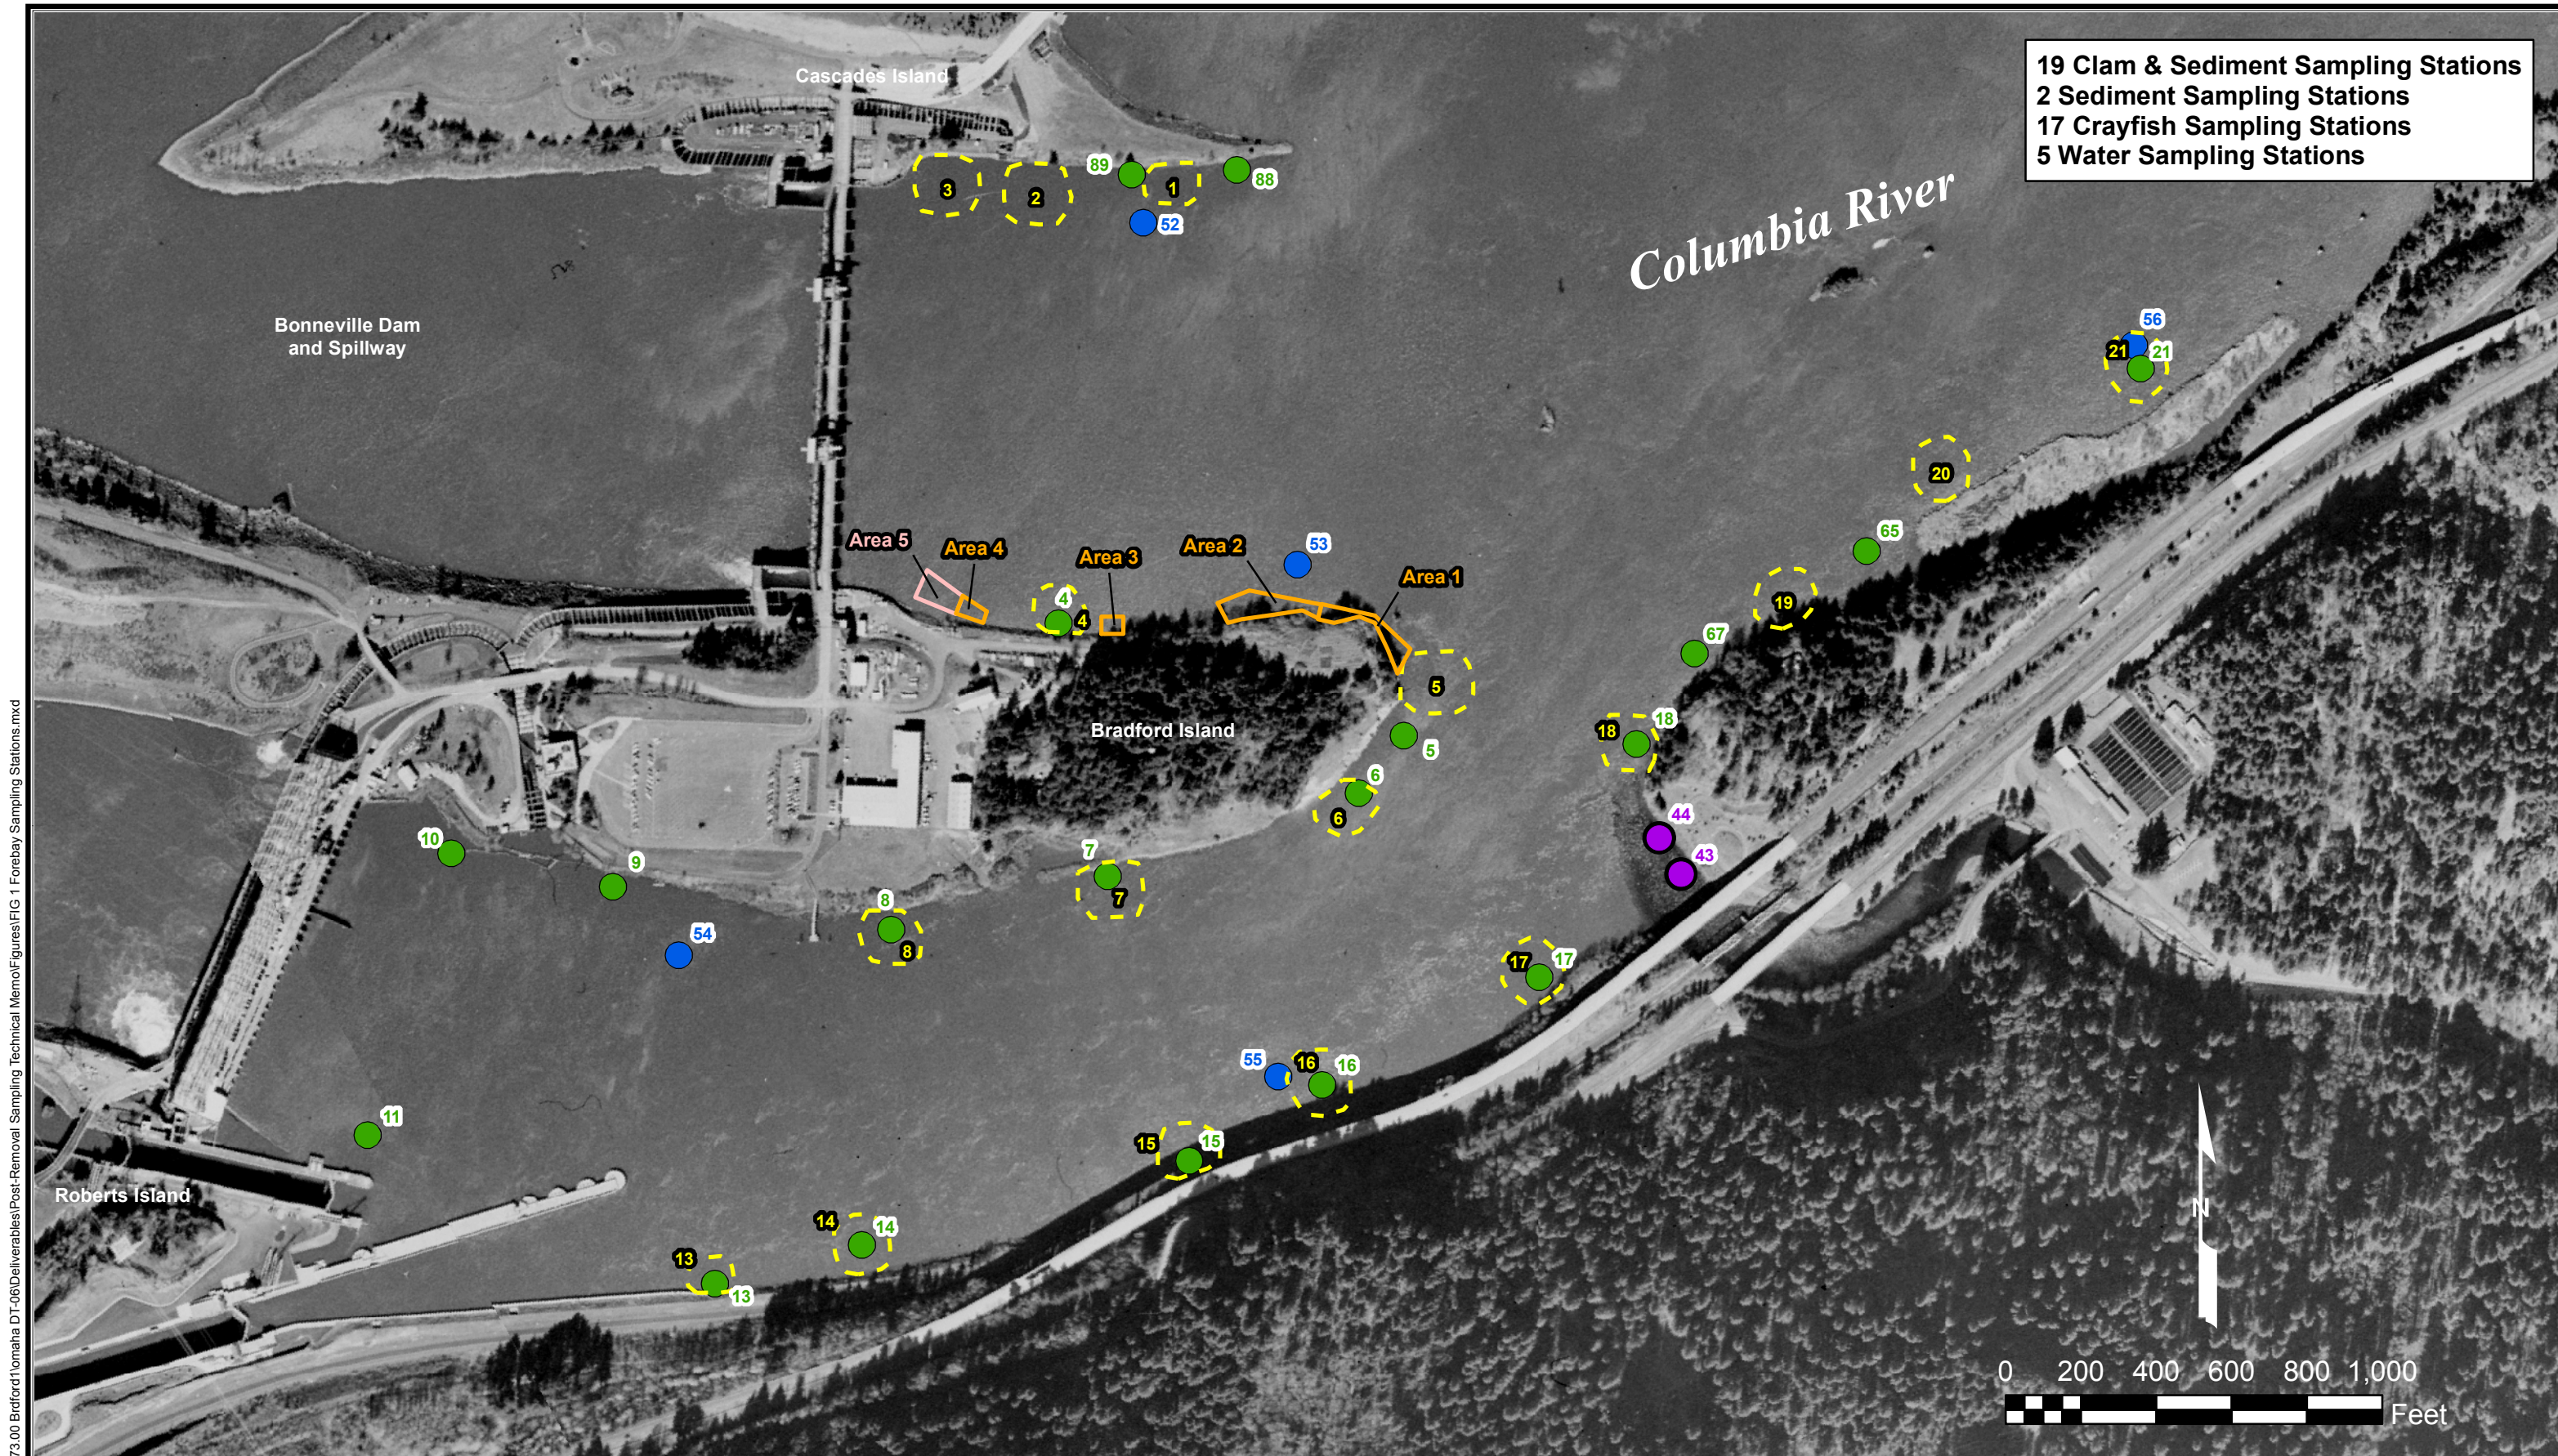
DRAWING NUMBER: FIGURE 1	
GIS FILE NUMBER: Fig 1	
SHEET:	REV.

19 Clam & Sediment Sampling Stations
 2 Sediment Sampling Stations
 17 Crayfish Sampling Stations
 5 Water Sampling Stations

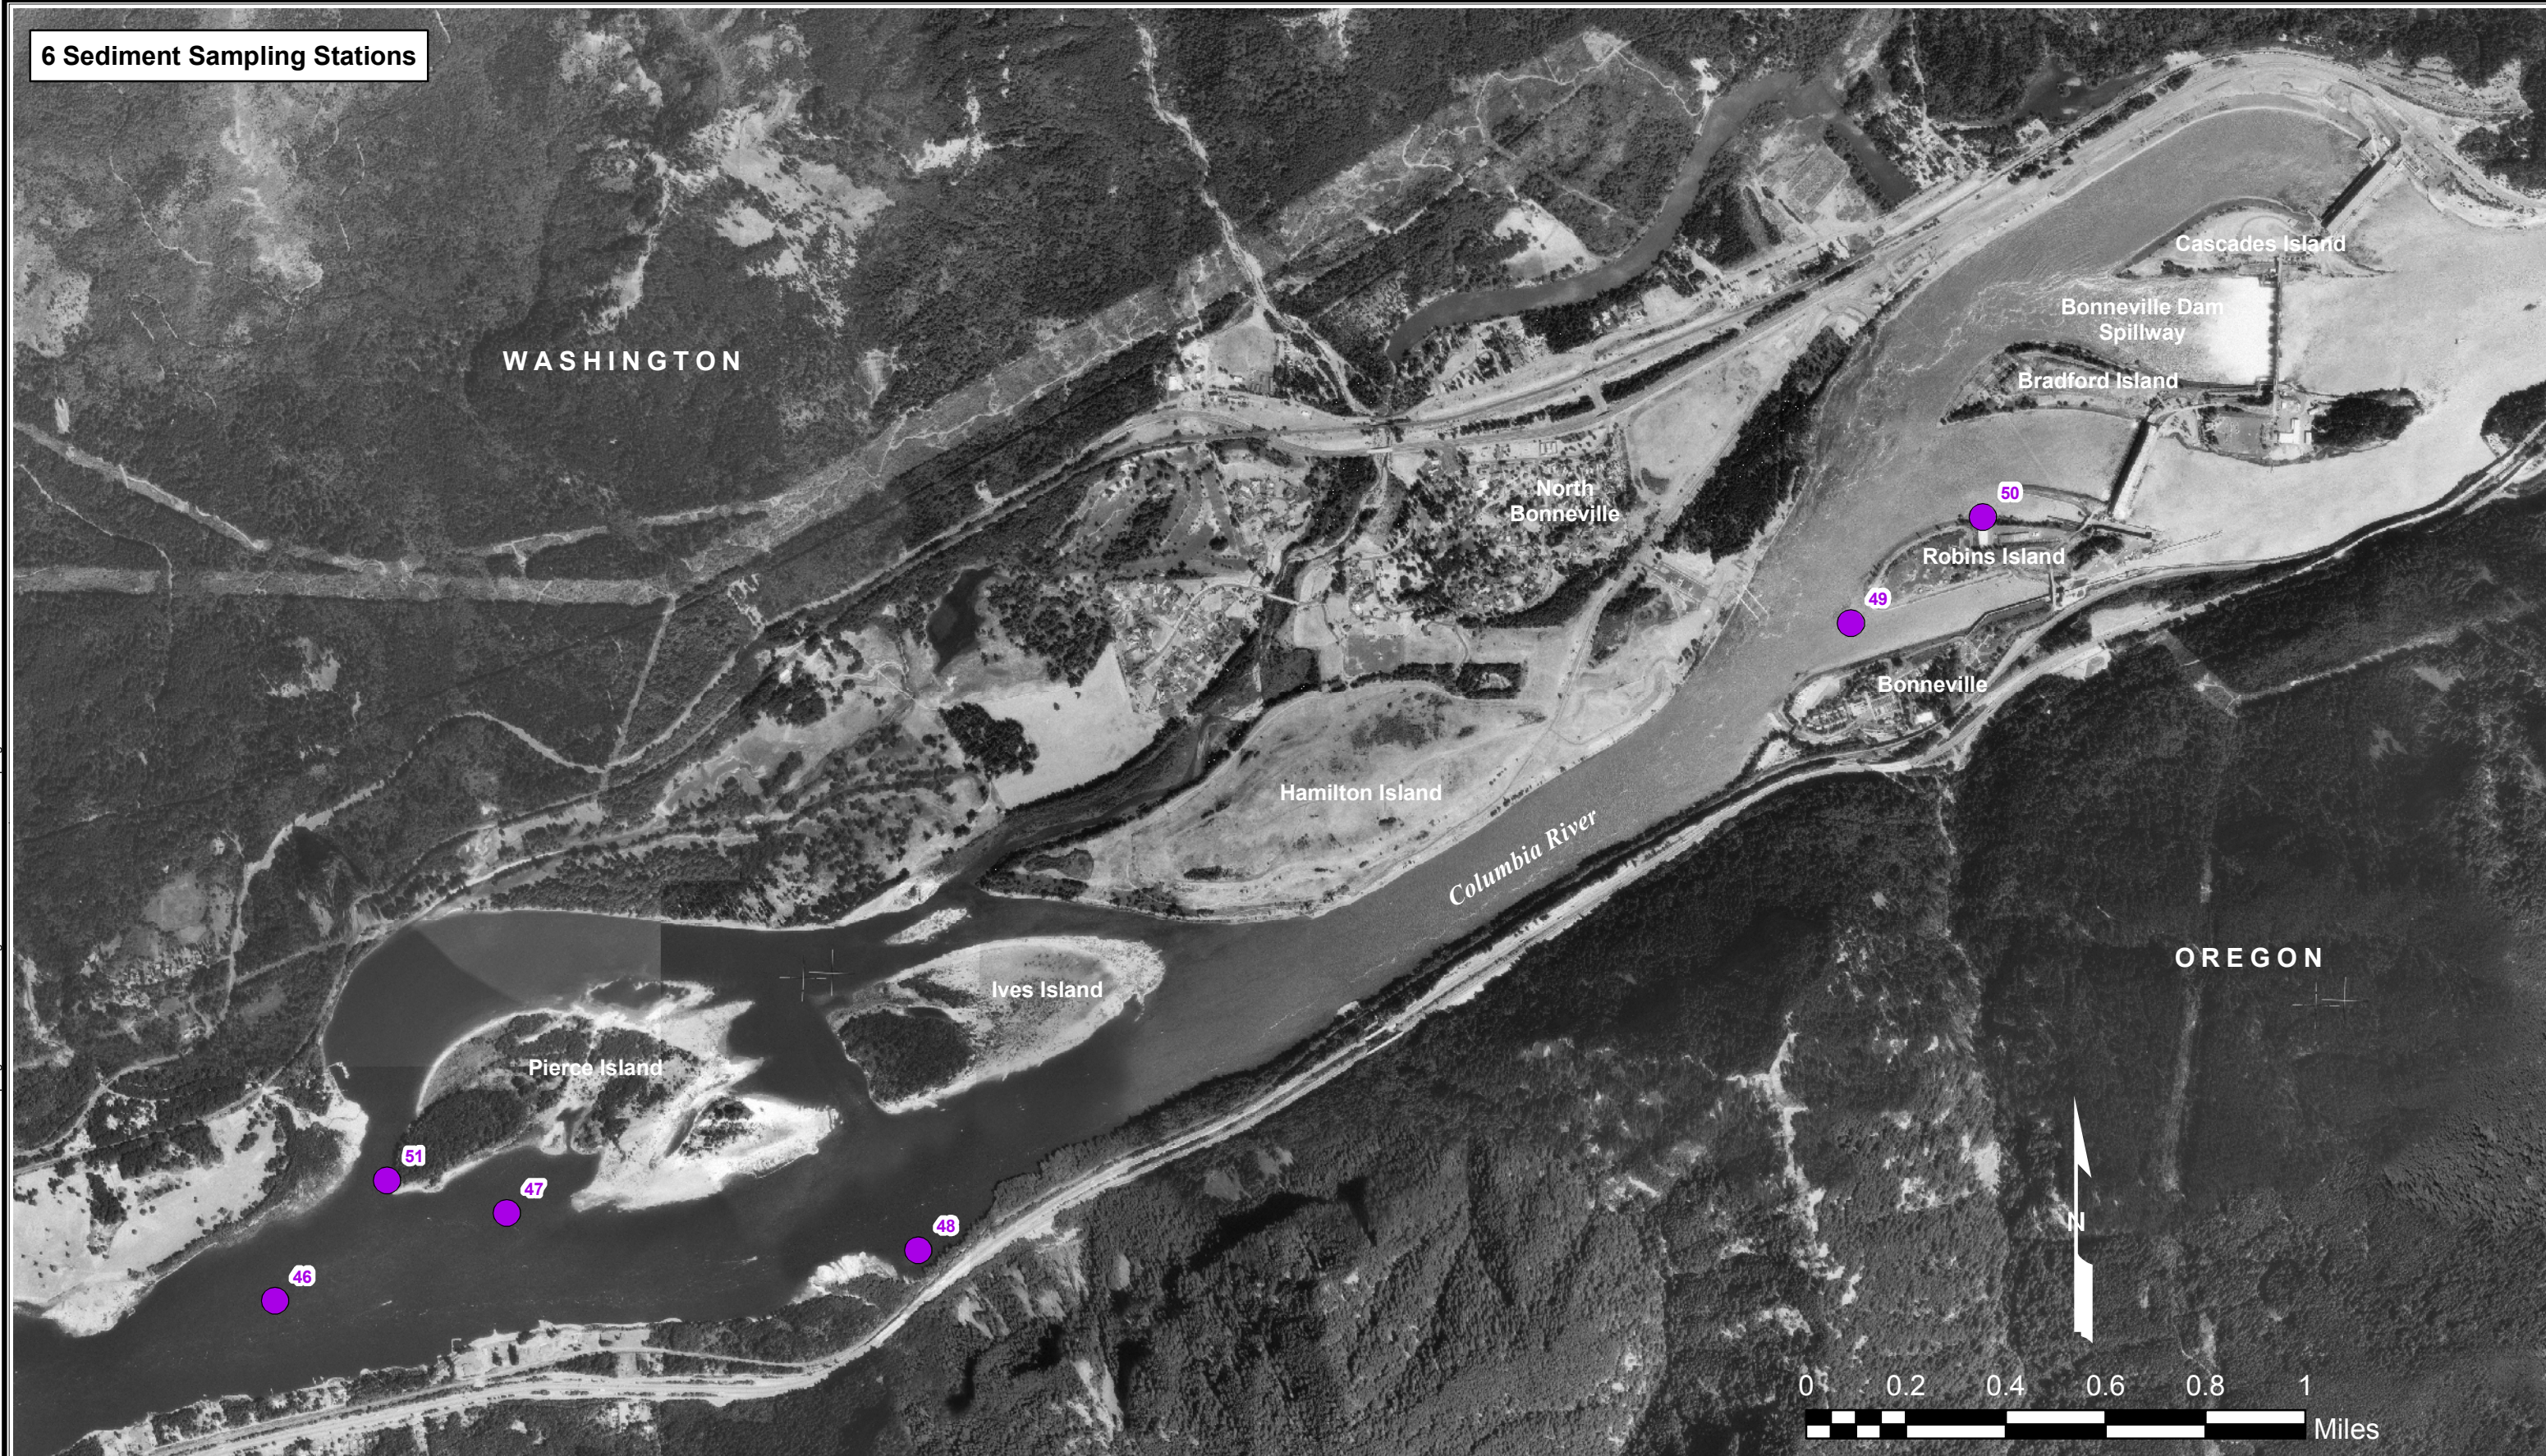
DRAWING NUMBER: FIGURE 2	
GIS FILE NUMBER: Fig 2	
SHEET:	REV.

6 Sediment Sampling Stations

Only samples submitted for chemical analysis are presented

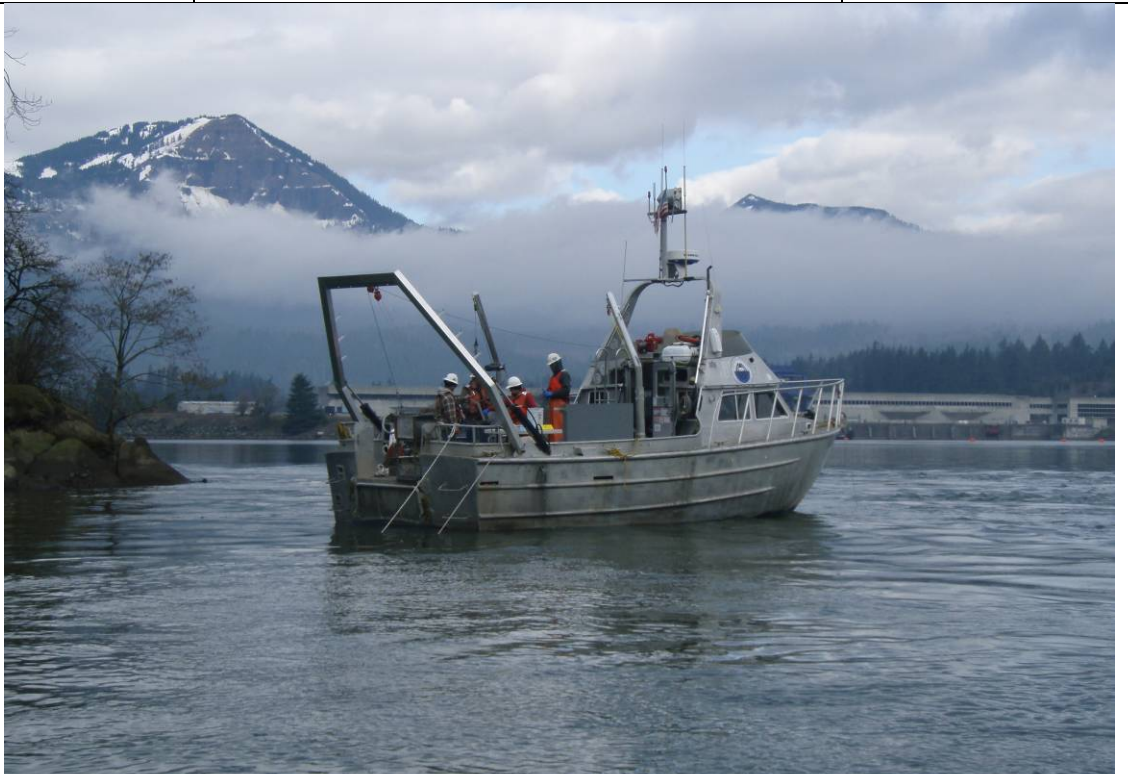
Photograph of the sampling boat (*Wolf Eel*) used for sediment and clam sample collection. The A-frame on the stern was used to deploy the box core sampler. The two davits on port and starboard were used to deploy the Van Veen sampler.

The box core sampler weighs approximately 70 pounds and has dimensions of 12 inches (in) by 12 in by 18 in deep. Prior to deployment, the box core rested in a stand which was fastened to the aft deck of the sampling boat. The box core was deployed using an A-frame davit equipped with a winch, picking it up off its stand and then lowering over the stern of the boat and slowly winching it down into the water. Upon impact with the substrate, the box core snaps closed and is retrieved using a winch on the boat.

deployed more rapidly than the box core. The Van Veen is a smaller than the box core and weighs approximately 40 lbs. This sampler was deployed using a winch-equipped davit on either the port or starboard side of the boat. Upon impact with the substrate, the Van Veen snaps closed and is retrieved.

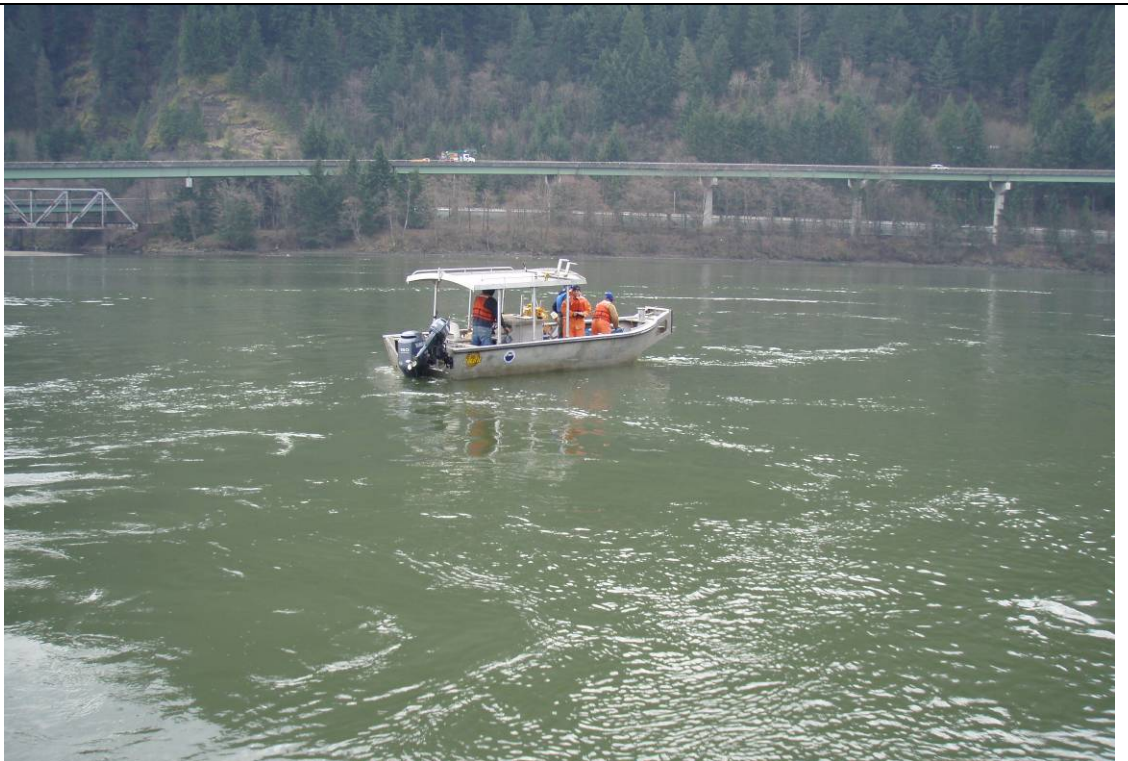
Photo No. 2	Date: 02/20/28
-----------------------	--------------------------

Photograph of the sampling boat (*Stanley*) used primarily for trapping and water sample collection. The *Stanley* was also used for sediment sampling at Stations 46 through 51, which are located downstream of Bonneville Dam. For sediment sampling, a davit was affixed to the *Stanley* to facilitate Van Veen deployment.

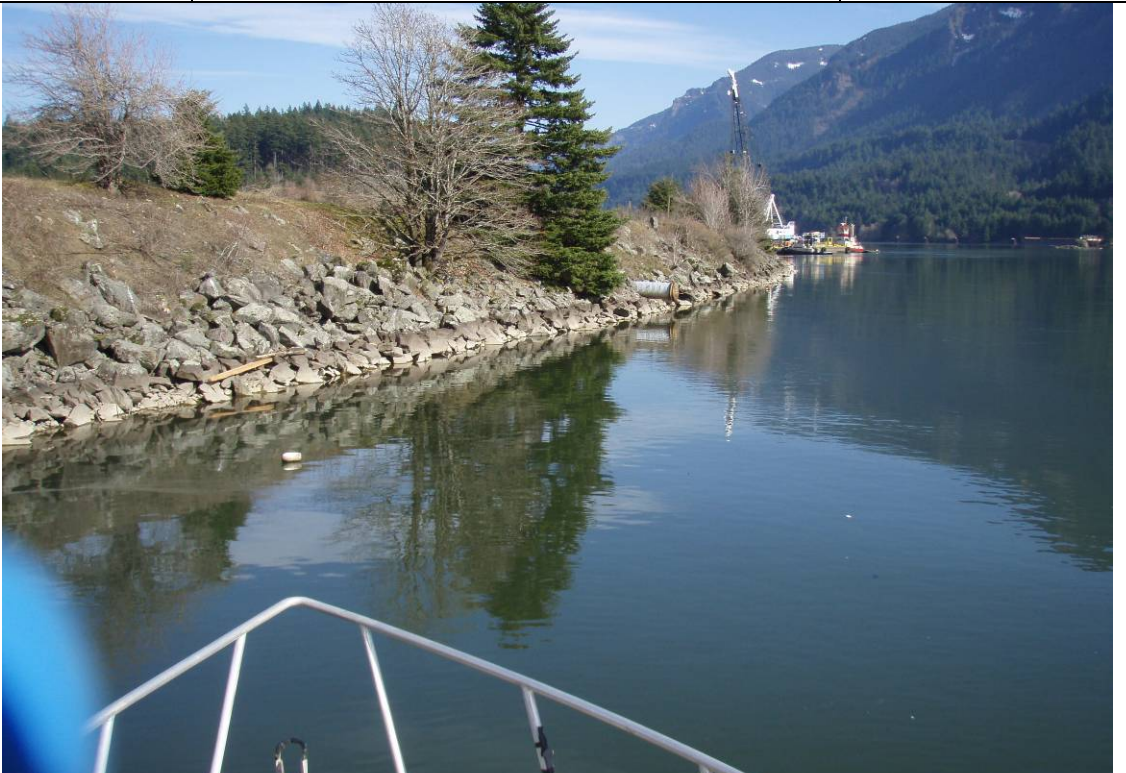
Client Name: United States Army Corps of Engineers		Site Location: Bonneville Lock and Dam – Oregon/Washington	URS Project No. 25696528
Photo No. 3	Date: 02/19/08

Direction Photo Taken: View to east of the locations for Stations 1, 88, 89, and 52.			
Description: South shore of Cascades Island. Note the rip rap along the riverbank. Divers were used to collect sediment and clams at Stations 88 and 89 due to the rocky substrate.

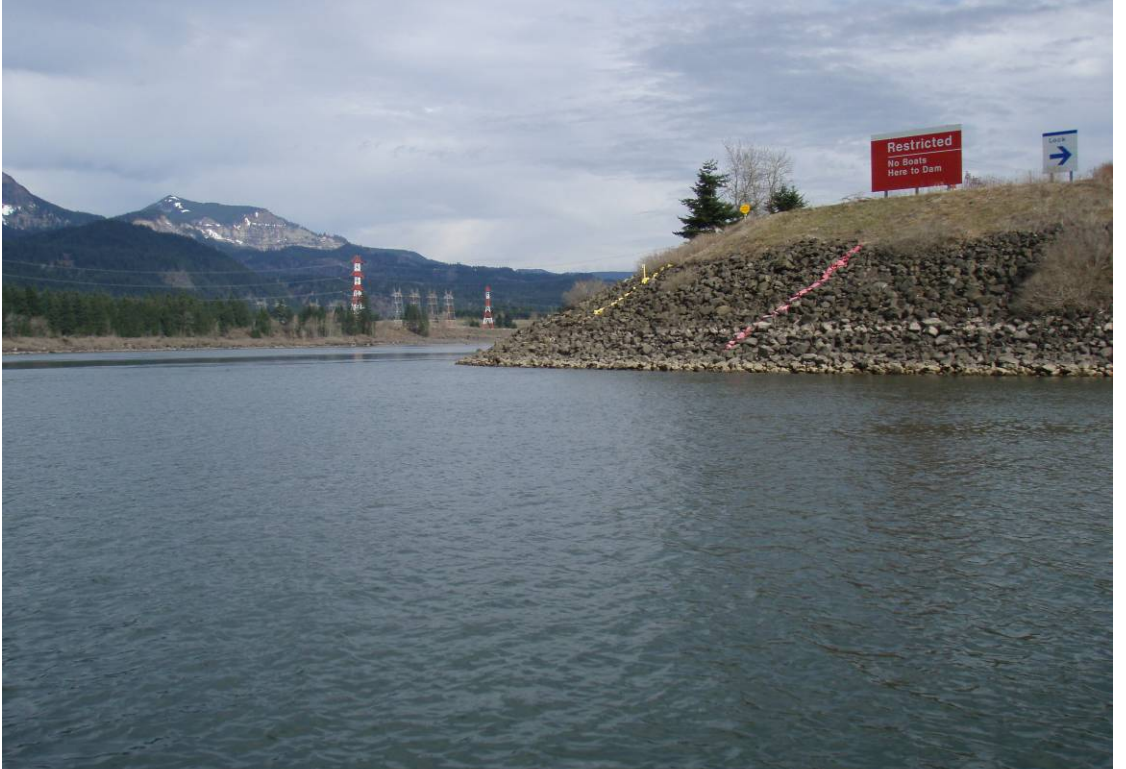
Client Name: United States Army Corps of Engineers		Site Location: Bonneville Lock and Dam – Oregon/Washington	URS Project No. 25696528
Photo No. 5	Date: 03/10/08

Direction Photo Taken: View to northeast of Station 49			
Description: Photograph of Station 49, located at the downstream end of Robins Island, below Bonneville Dam.

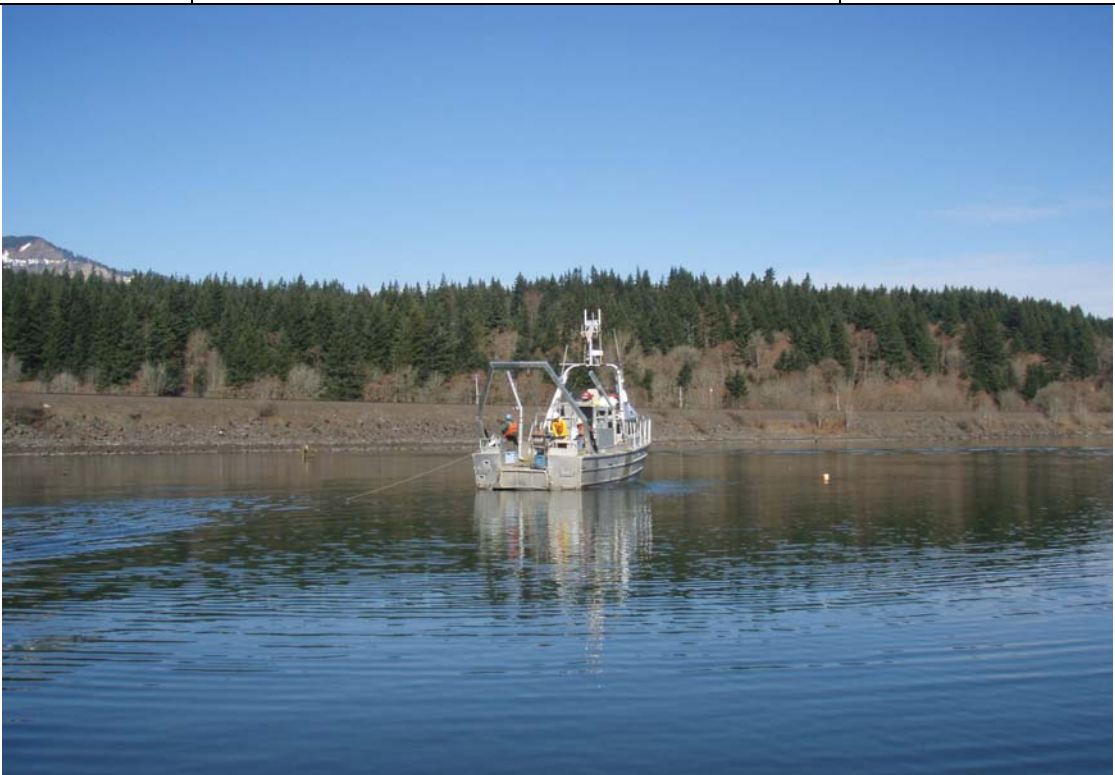
Client Name: United States Army Corps of Engineers		Site Location: Bonneville Lock and Dam – Oregon/Washington	URS Project No. 25696528
Photo No. 7	Date: 02/28/08

Direction Photo Taken: View to north			
Description: Photograph of reference area location along north bank of Columbia River.

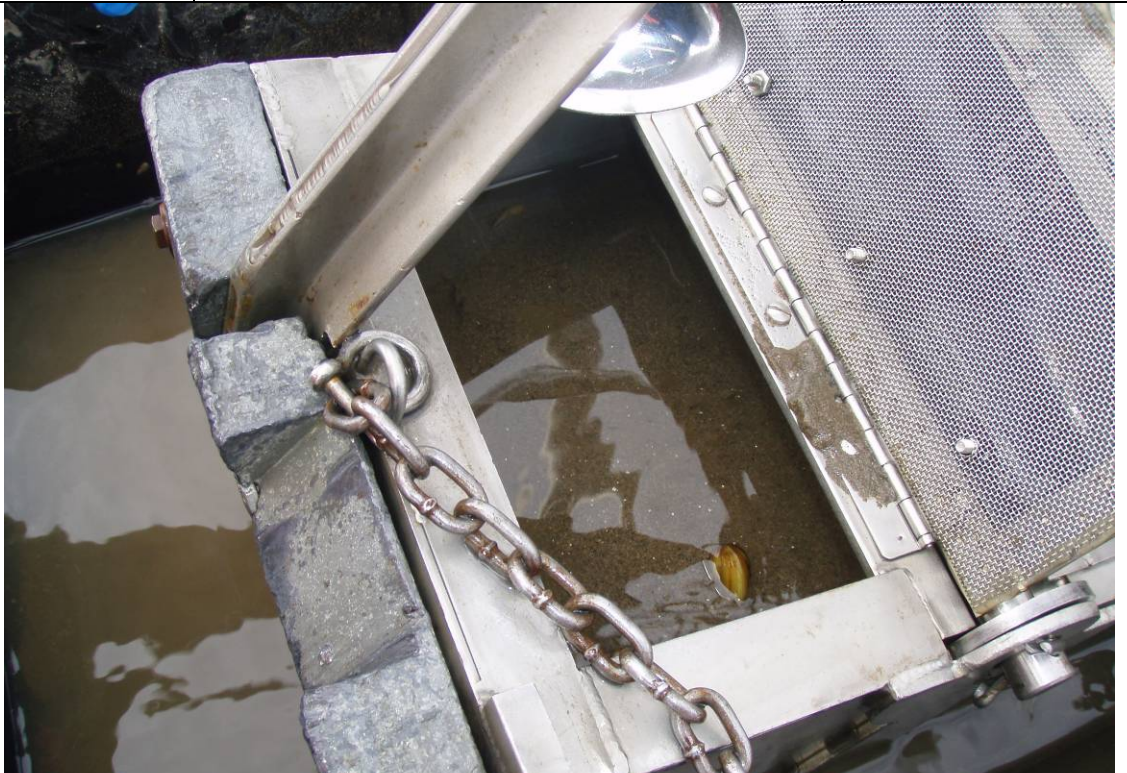
Photograph of acceptable Van Veen grab. Note the presence of standing water and relatively flat sediment surface within the Van Veen. An Asian clam is partially exposed in the lower right corner of the Van Veen.

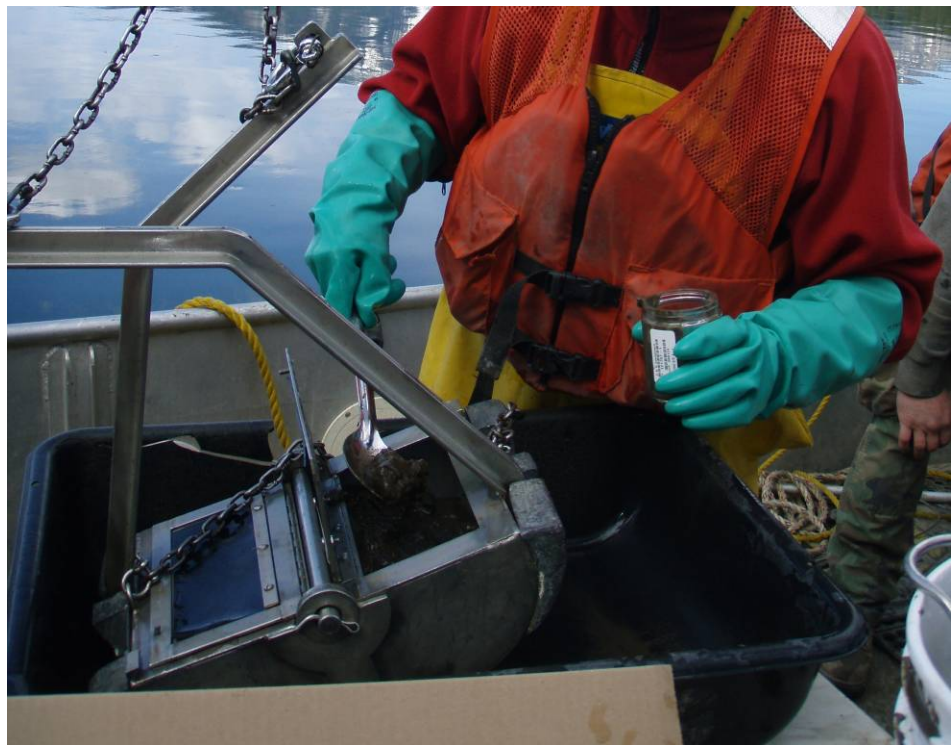
Close up photograph of sediment sampling process.

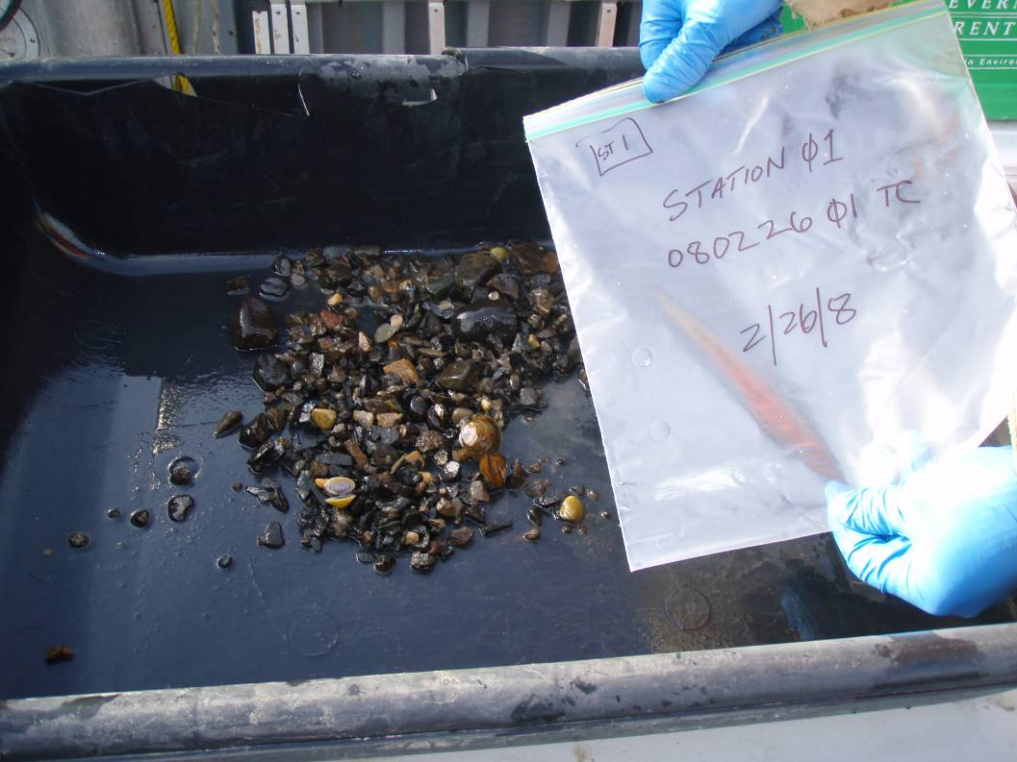
Client Name: United States Army Corps of Engineers		Site Location: Bonneville Lock and Dam – Oregon/Washington	URS Project No. 25696528
Photo No. 15	Date: 02/26/08

Direction Photo Taken: N/A			
Description: Close up photograph of clam sampling process. The grab sampler was emptied into the tub following sediment sample collection. Clams were then collected from the tub by hand and placed in plastic bags.

Initial attempts to collect Asian clams were conducted using the box core and Van Veen grab samplers described in Section 3.2.1. Asian clams were collected after sediment had been collected directly from the sampling device. The remaining sediment would be deposited in a wide, plastic bin and then sifted using gloved hands to search for Asian clams. Once the Asian clams were collected, the sediment was disposed of overboard and the bin was rinsed with river water.

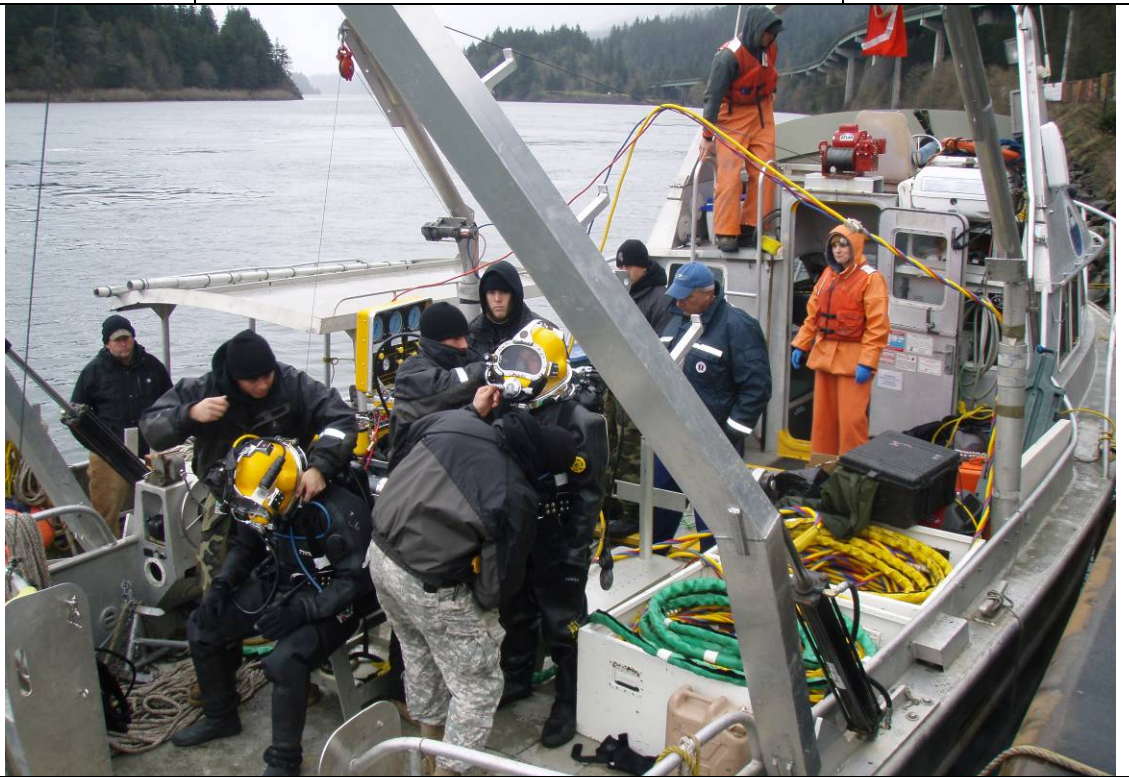
Description:
Photograph of Army Dive Team preparing on the sampling boat Wolf Eel.

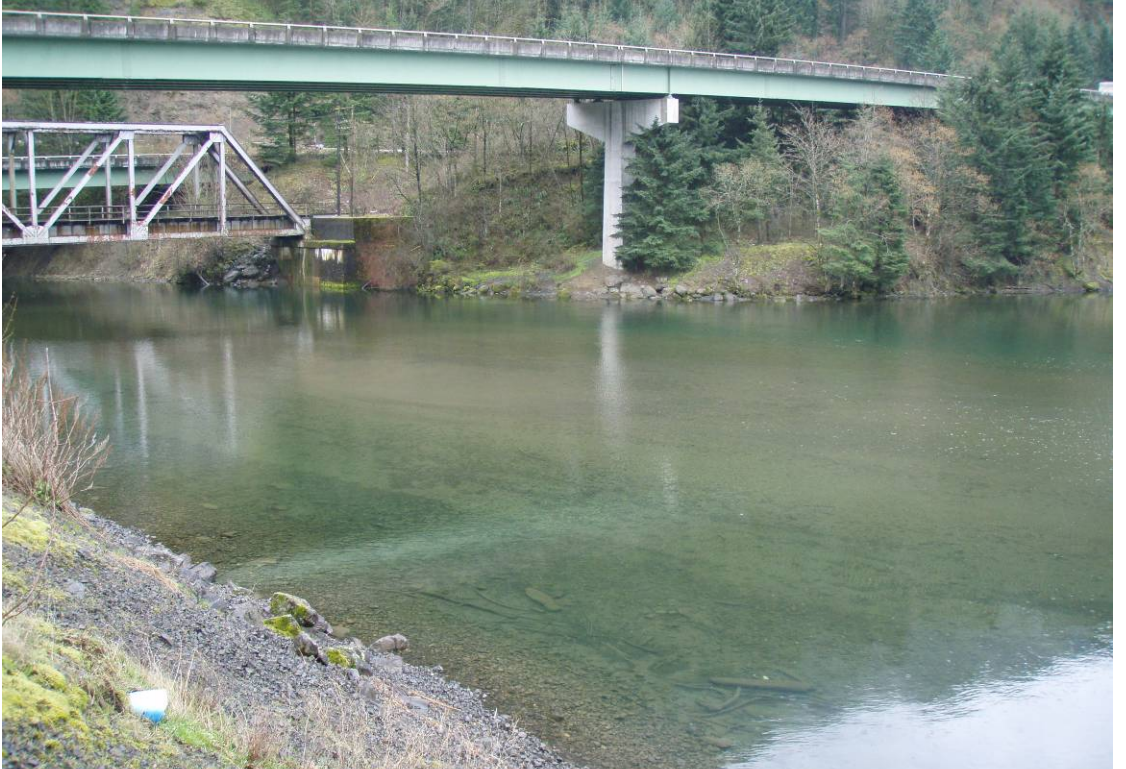
Client Name: United States Army Corps of Engineers		Site Location: Bonneville Lock and Dam – Oregon/Washington	URS Project No. 25696528
Photo No. 21	Date: 03/20/08

Direction Photo Taken: View to south of Station 44 location			
Description: Photograph of the confluence of Eagle Creek and the Columbia River. River sediment was collected from the sandbar in the center of the photograph (Station 44).

Two sediment sample stations (43 and 44) were accessed by wading into the Columbia River at the mouth of Eagle Creek. These locations are frequented by fishermen who wade to a gravel bar in the mouth of the creek. To collect the samples, field personnel waded out to a water depth of approximately 3 feet and collected sediment by scooping up a shovelful of sediment and then scraping the sediment into a laboratory-provided 8-ounce glass jar. Similar to the other sediment sample stations, 8 to 10 jars of sediment were collected at each sample station and later homogenized by CAS (Kelso). As specified in the QAPP, no Asian clams were collected at the Eagle Creek stations.

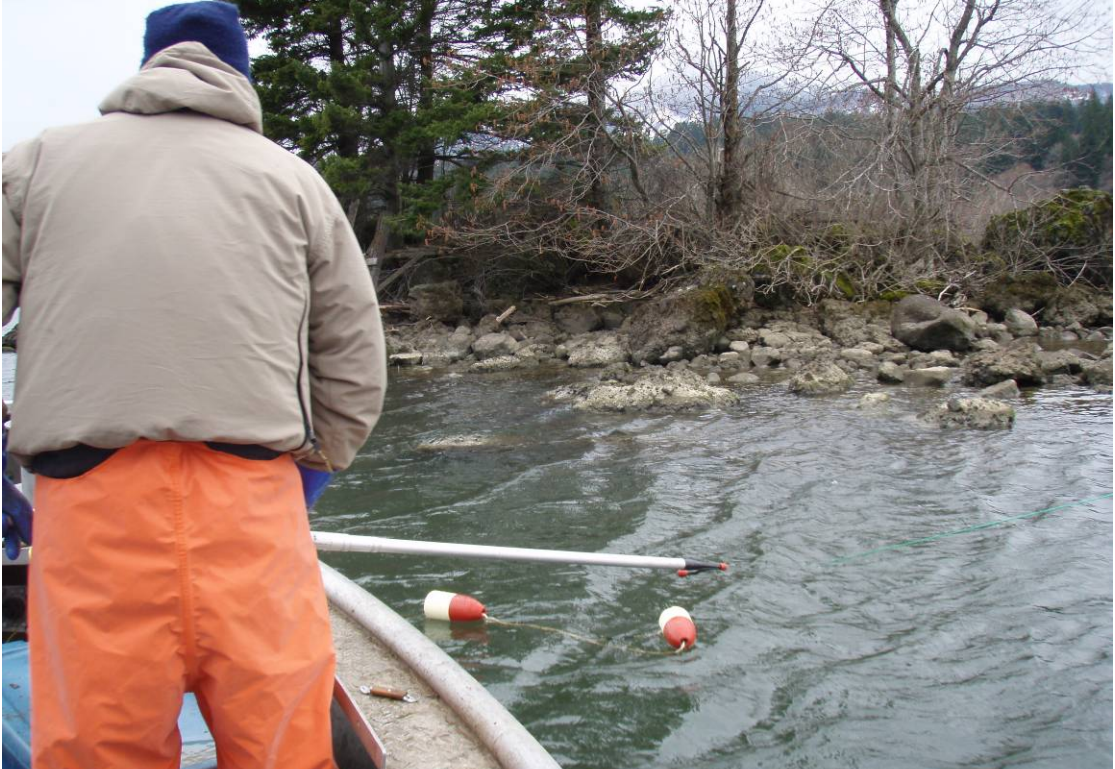
Client Name: United States Army Corps of Engineers		Site Location: Bonneville Lock and Dam – Oregon/Washington	URS Project No. 25696528
Photo No. 23	Date: 03/03/08

Direction Photo Taken: View to the north of Station 76.			
Description: Photograph of crayfish and sculpin trap retrieval process.

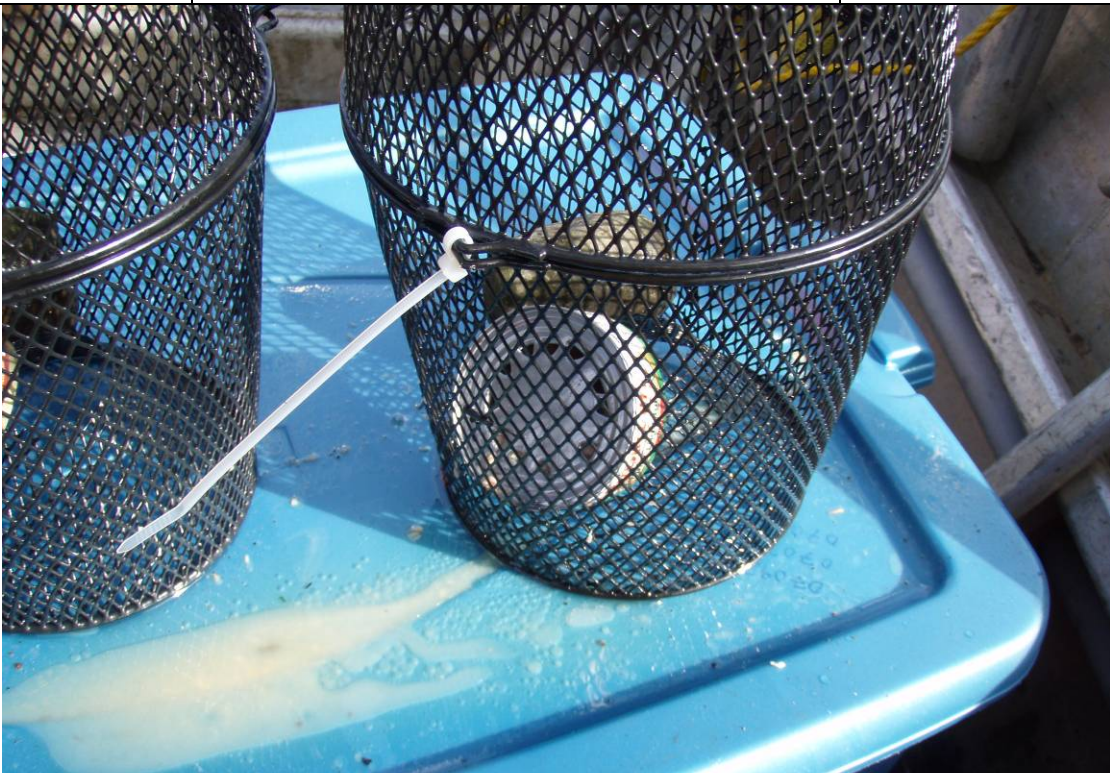
Client Name: United States Army Corps of Engineers		Site Location: Bonneville Lock and Dam – Oregon/Washington	URS Project No. 25696528
Photo No. 25	Date: 02/15/08

Direction Photo Taken: N/A			
Description: Close up photograph of baited crayfish and sculpin traps.

Two to four traps were deployed at each station for periods ranging from one to four days. Generally, one trap at each station had a 0.5-inch entrance diameter (minnow trap) and one had a 1-inch entrance diameter (crayfish trap). The smaller diameter targeted sculpin while the larger diameter targeted crayfish. In actuality, however, no pattern was observed between trap opening size and capture of crayfish and sculpin. The traps were baited with cans of dog

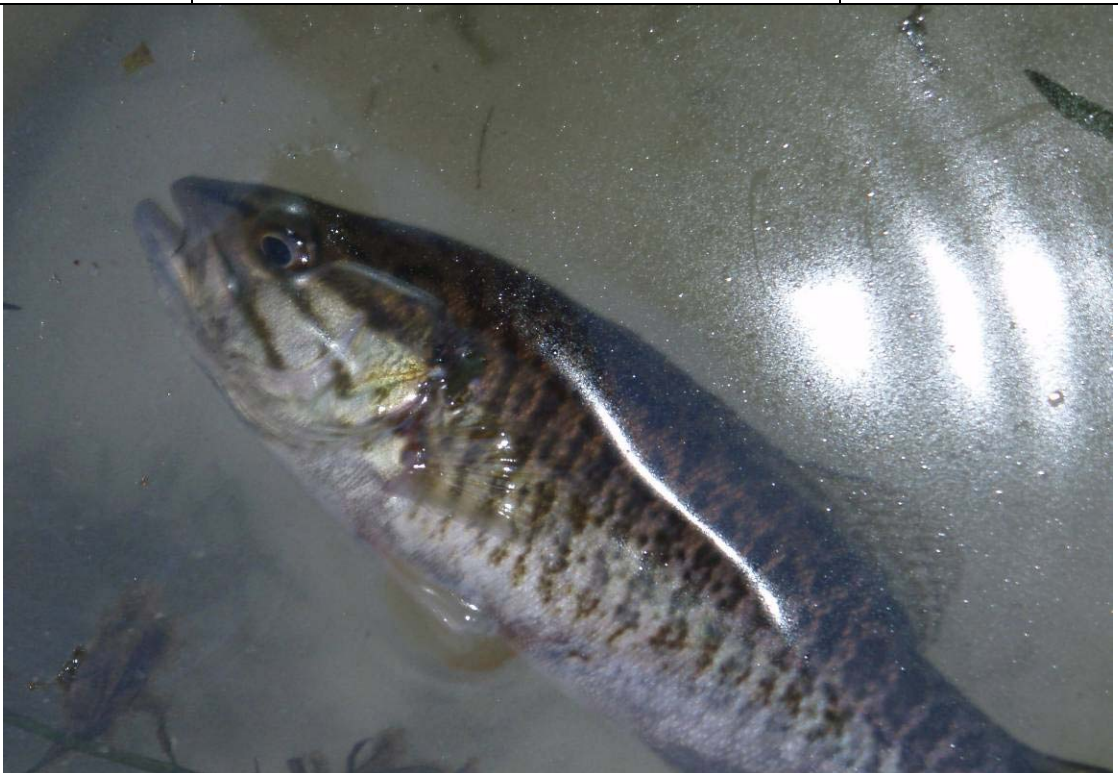
Client Name: United States Army Corps of Engineers		Site Location: Bonneville Lock and Dam – Oregon/Washington	URS Project No. 25696528
Photo No. 29	Date: 02/19/08

Direction Photo Taken: N/A			
Description: Photograph of by-catch (small-mouth bass) found in crayfish trap at Station 37. The fish was released to the Columbia River shortly after the photograph was taken.

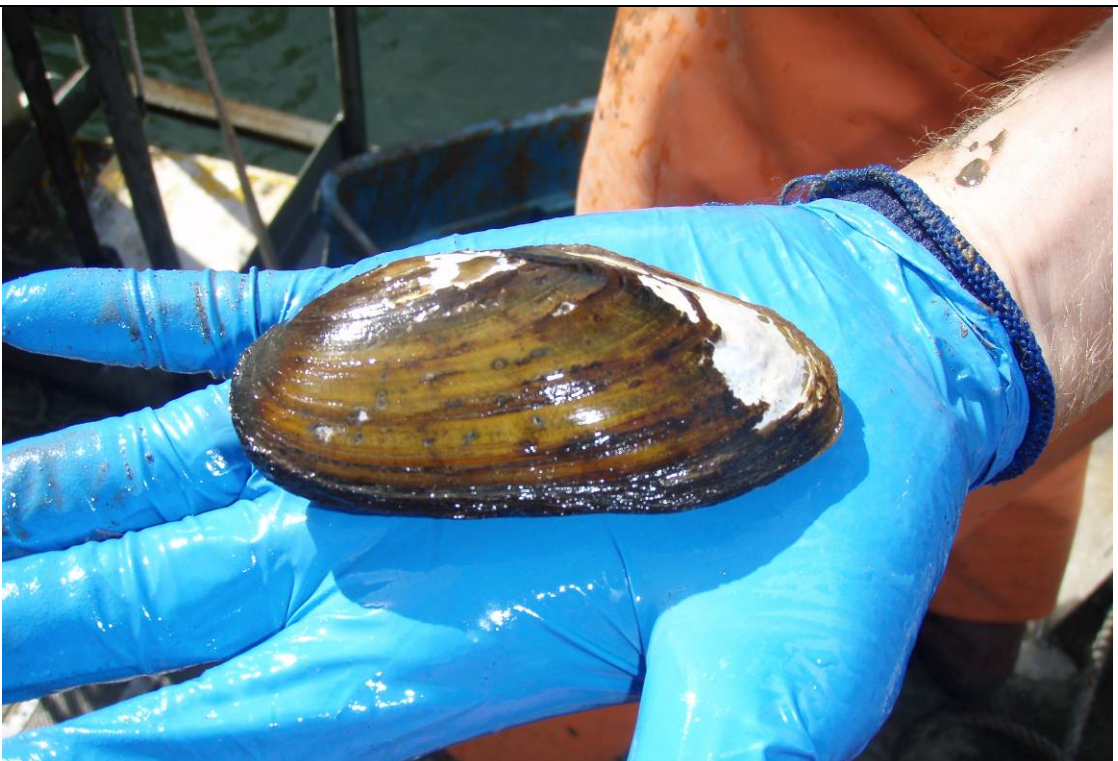
Photo No. 30	Date: 02/26/08

Direction Photo Taken: N/A		
Description: Photograph of by-catch (fresh-water muscle) collected by grab sampler. The mussel was released to the Columbia River shortly after the photograph was taken.

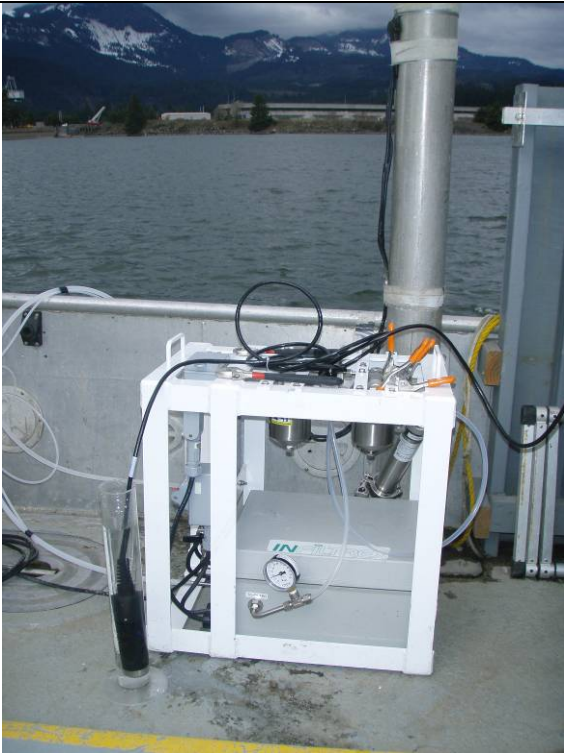
Client Name: United States Army Corps of Engineers		Site Location: Bonneville Lock and Dam – Oregon/Washington	URS Project No. 25696528
Photo No. 31	Date: 02/24/08

Direction Photo Taken: View to the northwest from Station 53			
Description: Photograph of high-volume water sampling pump (<i>Infiltrax 300 Organic Sampling System</i>).

High-volume water samples were collected using an Infiltrax 300 Organic Sampling System (Infiltrax) supplied by Axys Environmental Systems in Sidney, British Columbia, Canada. This method is used to concentrate trace levels of particulate-bound and dissolved-phase chemicals from a large volume of water for analysis by standard analytical methods. The Infiltrax pumps water through a wound-glass filter to remove particulate-bound chemicals, and then pumps the water through a column packed with macroreticular porous resin where dissolved-phase chemicals are absorbed. During this field effort, approximately 600 liters of water were pumped for each sample. A summary of field data collected during high-volume water sampling is located in Table 3.

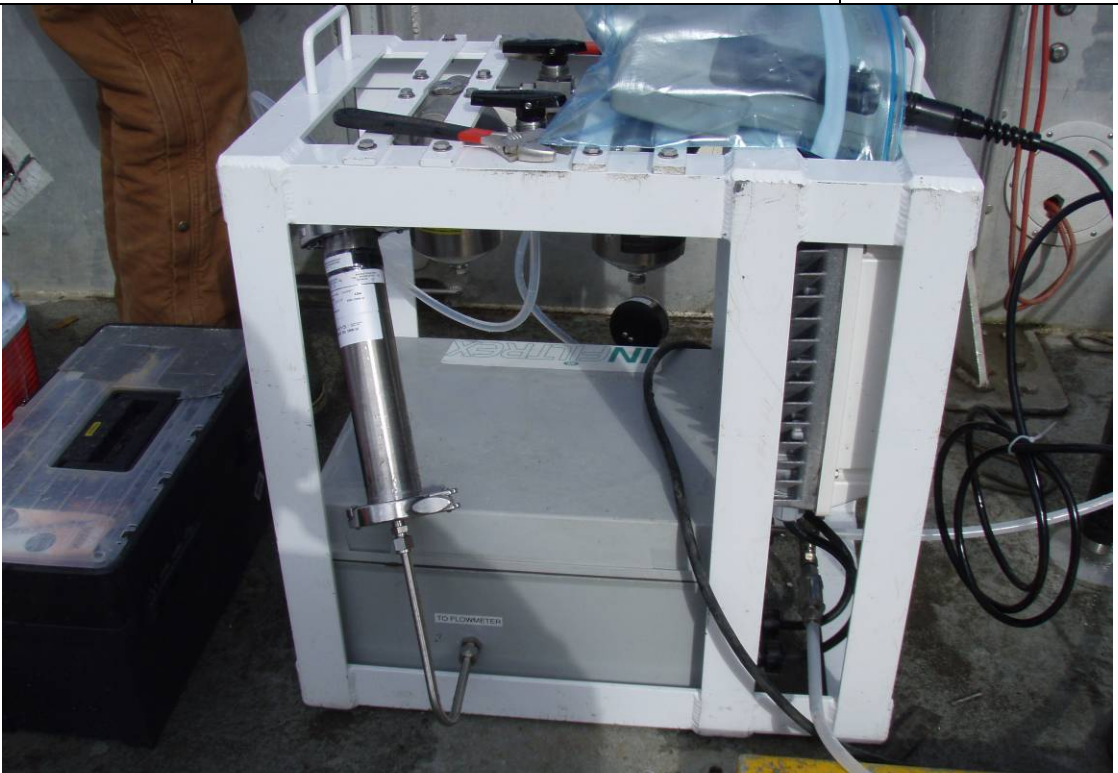
Client Name: United States Army Corps of Engineers		Site Location: Bonneville Lock and Dam – Oregon/Washington	URS Project No. 25696528
Photo No. 33	Date: 02/13/08

Direction Photo Taken: N/A			
Description: Close up of Infiltrix pump. The XAD column is the stainless steel cylinder to the left of center.
