Memorandum

To: Mike Gross, PE, U.S. Army Corps of Engineers, Portland District
From: Jeff Wallace, R.G. and Brian McNamara, R.G.
Date: May 12, 2008
Subject: Post-Removal Sample Collection, Bradford Island Disposal Site
Bonneville Dam Forebay - Cascade Locks, Oregon

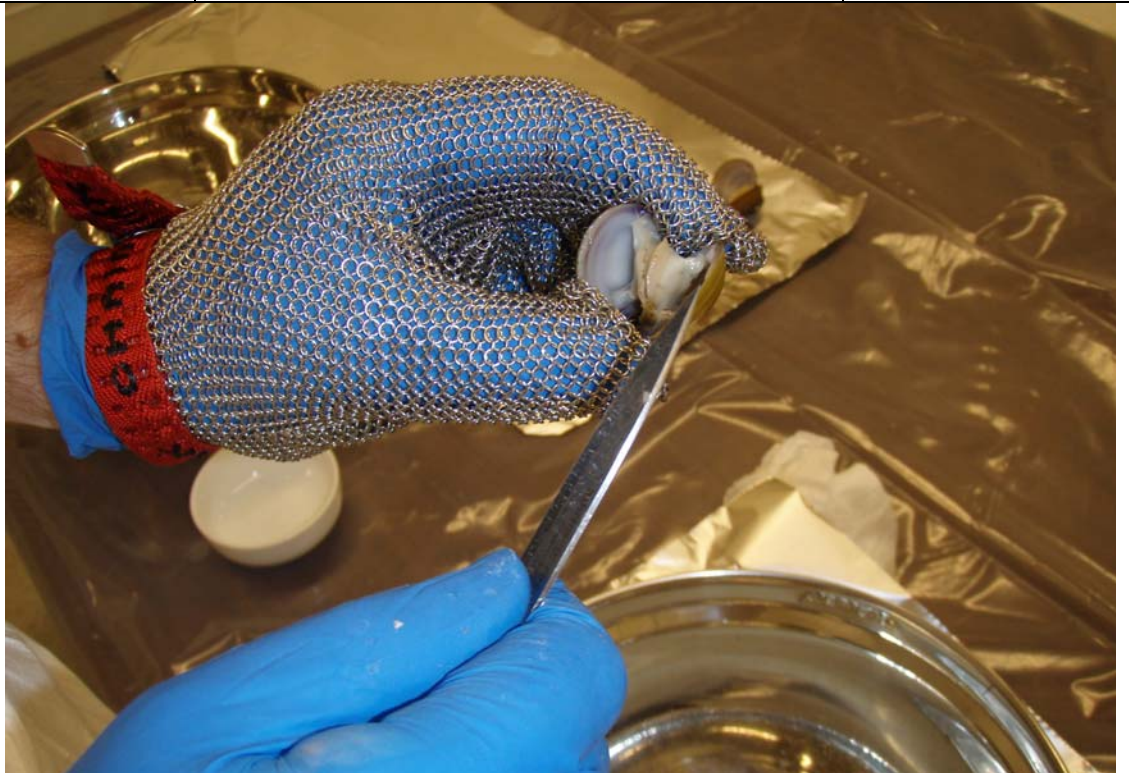
Photograph of clam shucking process at URS laboratory.

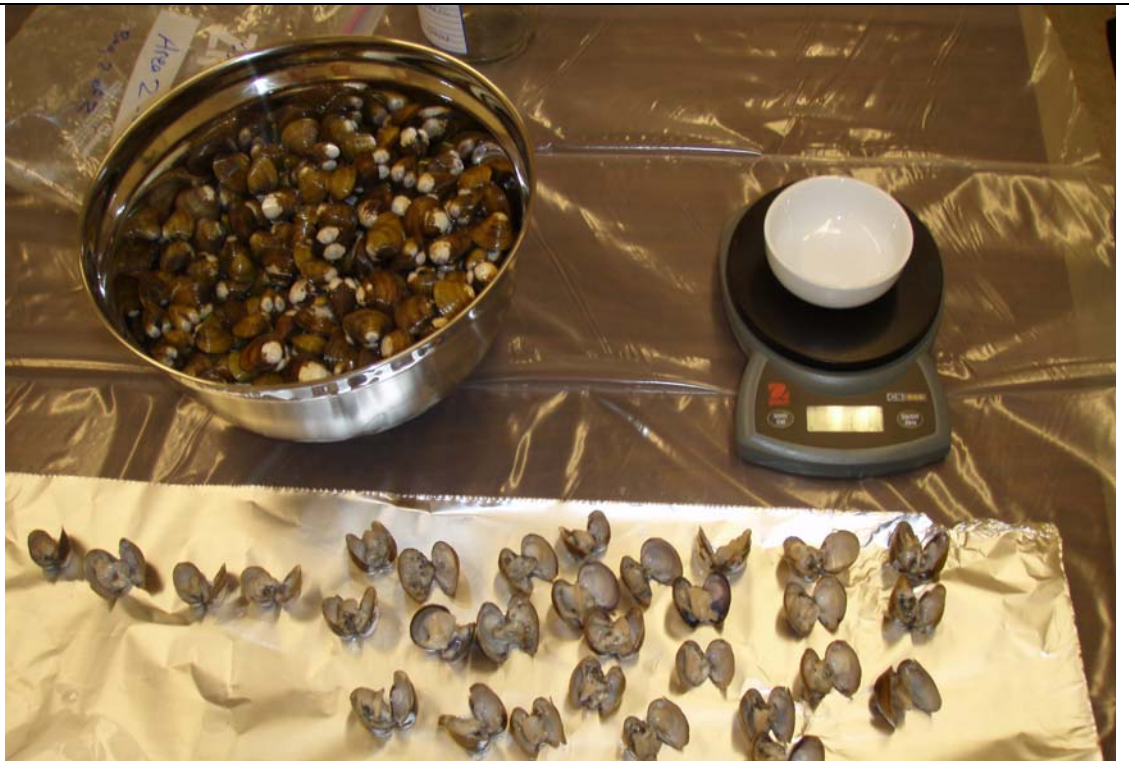
**Photo No.**
40**Date:**
09/28/07**Direction Photo Taken:**

Photograph of clam shucking process at URS laboratory.
