**An Evaluation of the Severity of  
the January 1998 Ice Storm in  
Northern New England  
Report for FEMA Region 1**

Kathleen F. Jones  
Nathan D. Mulherin

Prepared for:  
Federal Emergency Management Agency  
DR-1198-ME  
DR-1199-NH  
DR-1201-VT

April 1998

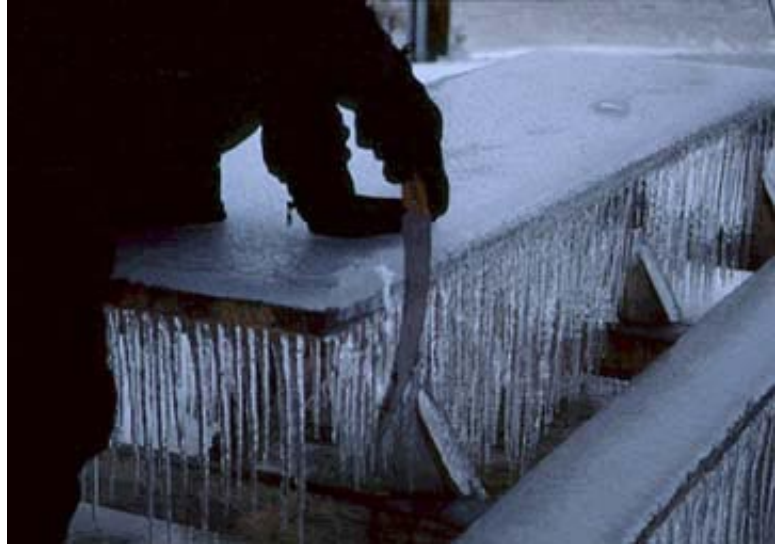
Figure 7. Ice on picnic table off Route 11, in northeastern New York, January 8, 1998 (photo Mulherin).

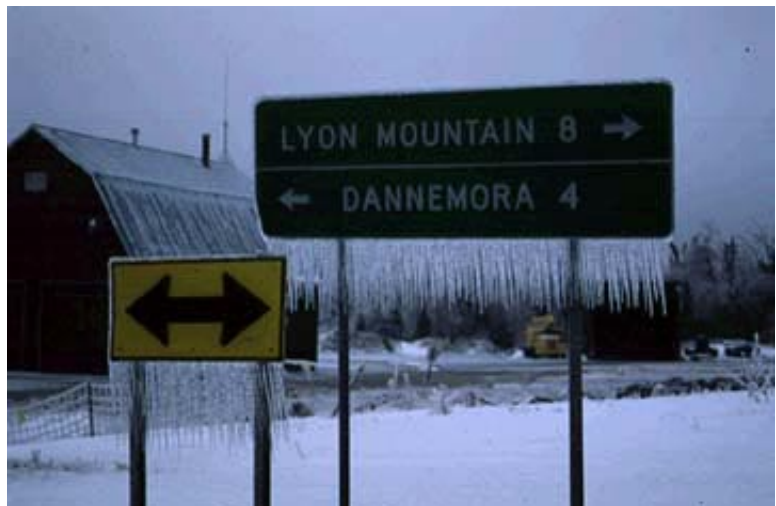
Figure 8. Ice on a sign near Dannemora, New York, January 8, 1998 (photo Mulherin).

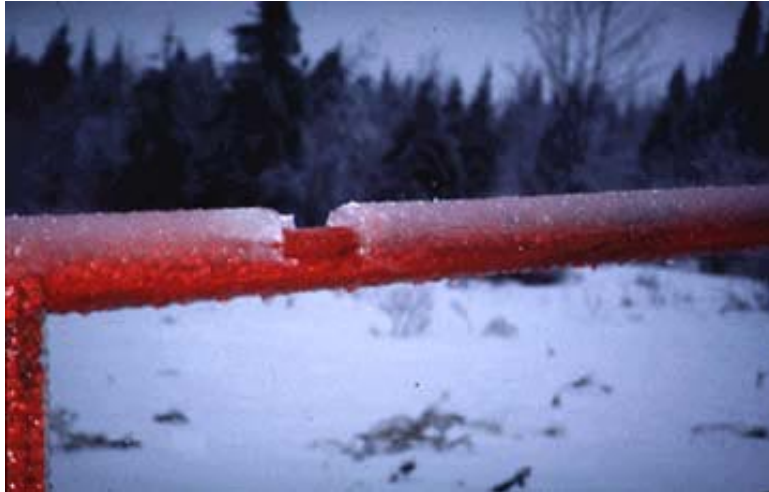
*a. Crescent on one side (photo Jones).*

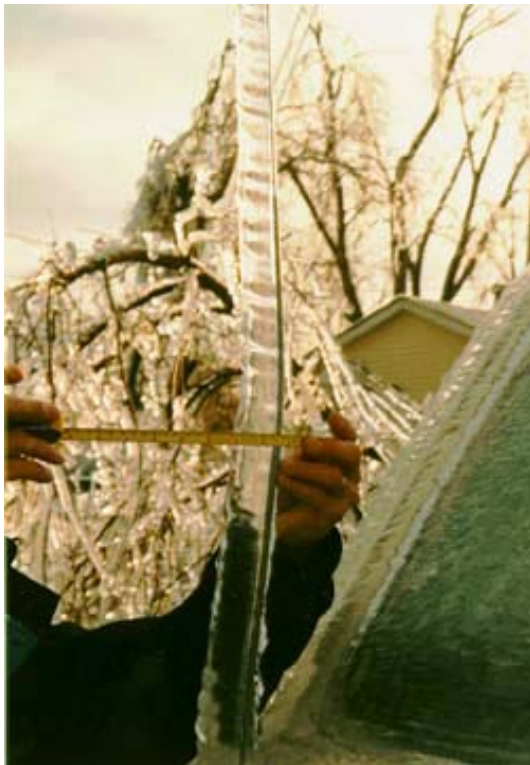
*b. Large accretion on windward side of car antenna (photo Jones).*

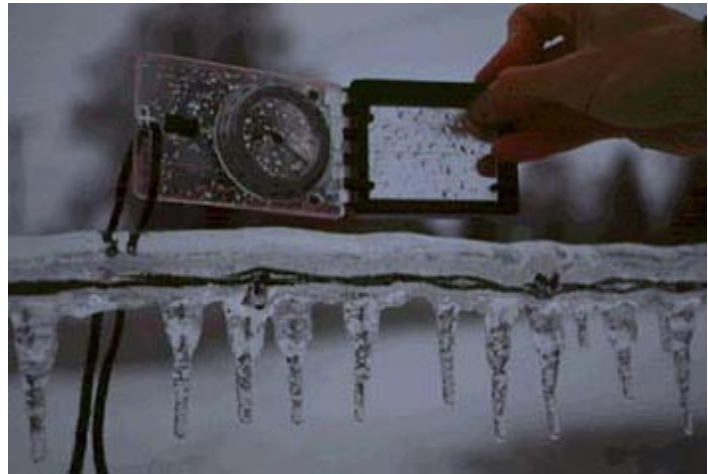
*c. Icicles on wire fence (photo Mulherin).*

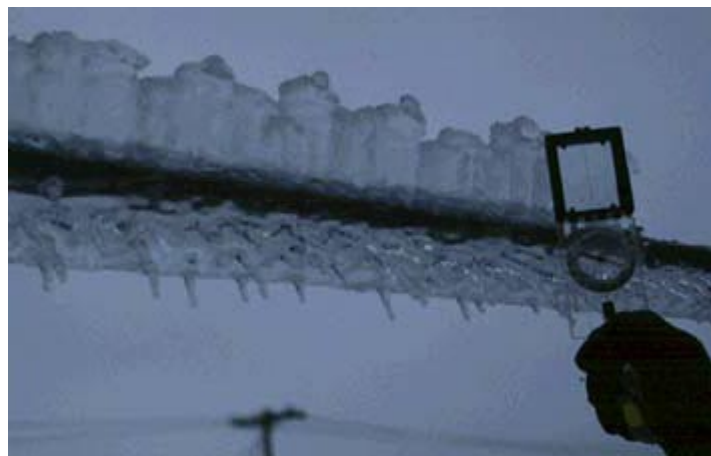
*d. Knobby accretion on Triplex (photo Mulherin).*

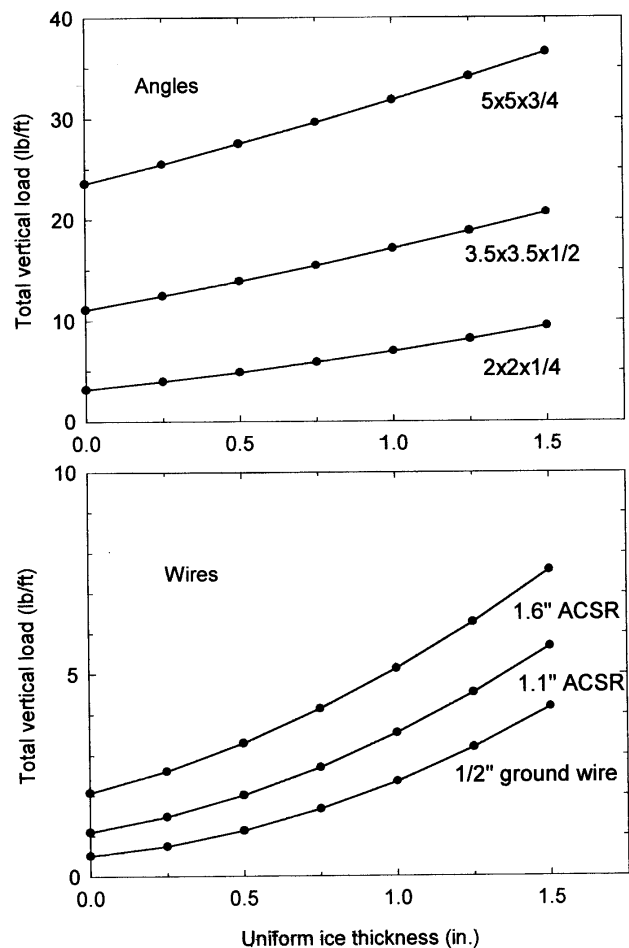
Figure 10. Ice loads in pounds per foot corresponding to uniform ice thicknesses from 0 to 1.5 in.

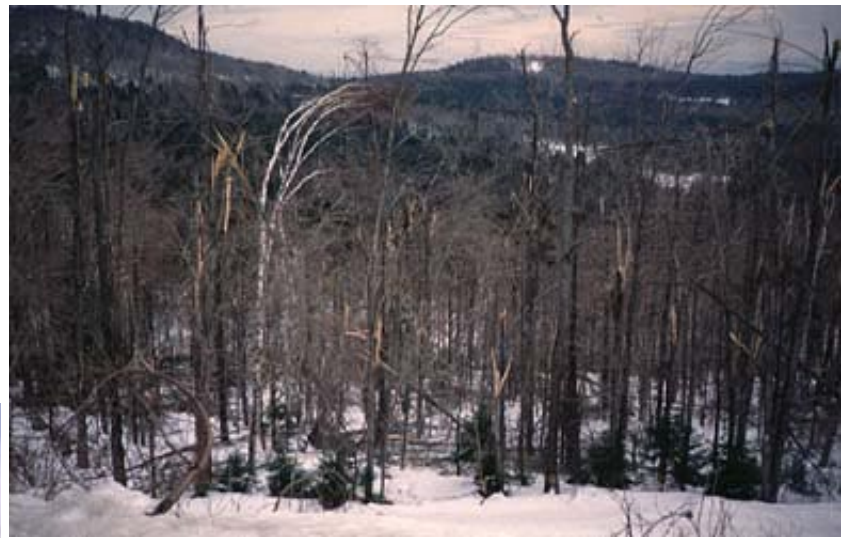
*a. Along the road between Randolph and Bethel at 1830 ft (photo Jones).*

*Figure 12. Tree damage in and near Vermont.*

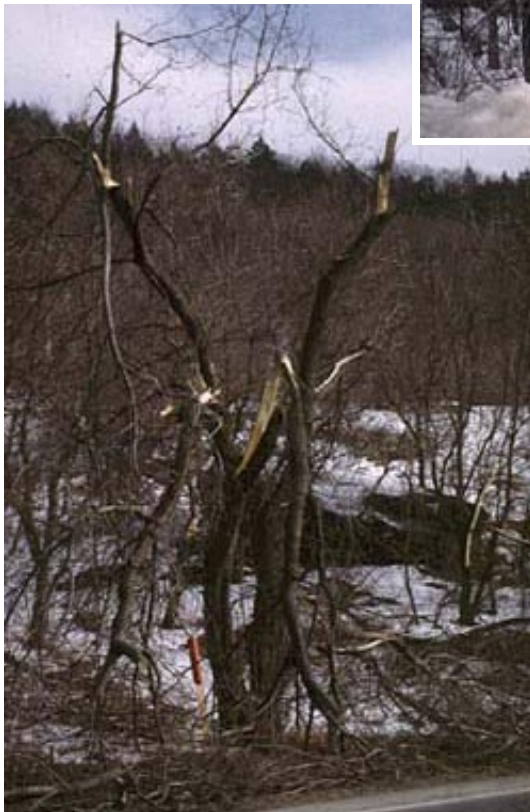
*b. Near Starksboro (photo Jones).*

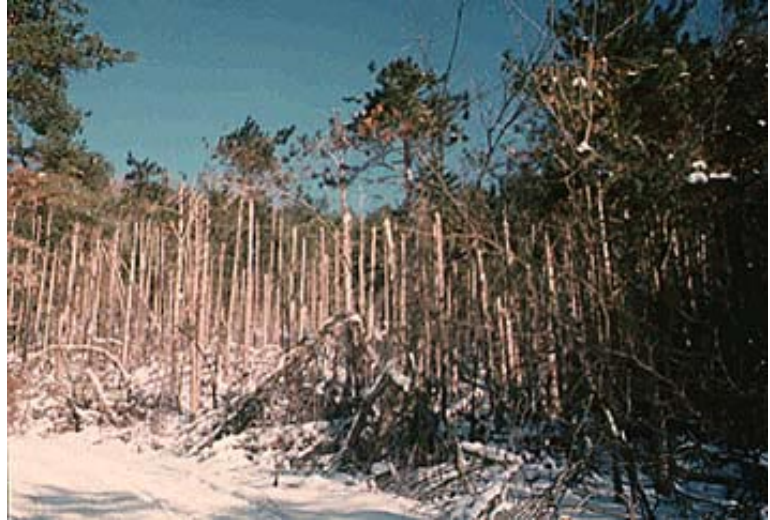
*c. Mount Philo at 400 ft (photo Gary Salmon, VDFPR).*

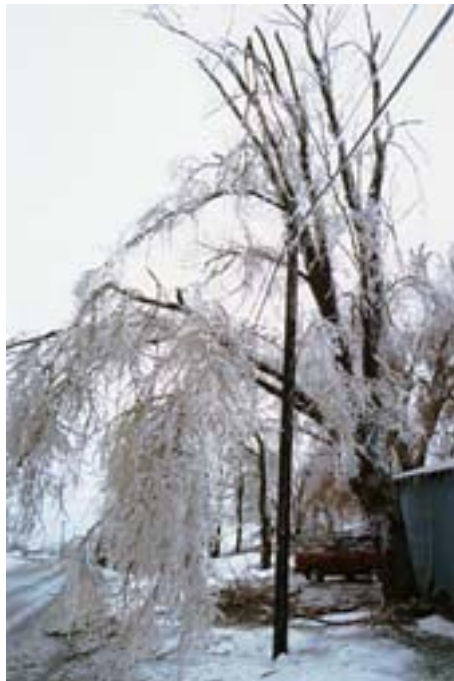
*d. Near Swanton at 100 ft (photo Jones).*

and extensive tree damage at and near lake level. Outside that area the boundary separating light and heavy damage trended toward higher elevations farther north in the state. Icing apparently did not extend above about the 3000-ft level. **Fig. 12a** shows the tree damage at 1830 ft between Randolph and Bethel. Farther east along this road, at elevations below about 1660 ft, trees were not damaged. Damaged trees near Starksboro (750 ft) in western Vermont are shown in **Fig. 12b**. On Mount Philo, south of Burlington in the Champlain Valley, even conifers were severely damaged. Mount Philo rises about 500 ft above the surrounding terrain, to an elevation of 800 ft, with a steep west-facing slope. Damage to red pines at the base of this slope is shown in **Fig. 12c**. Oaks and scotch pines growing on the northeast-facing terrace on the top of Mount Philo were also severely damaged. Tree damage farther north near Lake Champlain is shown in **Fig. 12d and e**. The photo in Fig. 12d was taken on January 8 at 8:50 a.m. near Swanton, Vermont at an eleva-

tion of 100 ft. That damage occurred with an ice load of 0.2 in. (Throughout this report we report ice loads in terms of the equivalent uniform ice thickness, as described in Sections 3 and 4.) The damaged trees in Fig. 12d were photographed at 11:15 a.m. on January 8 at the Beekmantown rest area on I-87 in New York, just north of Plattsburgh, two miles west of Lake Champlain at an elevation of 200 ft. The damage was caused by an ice load of 0.5 in.

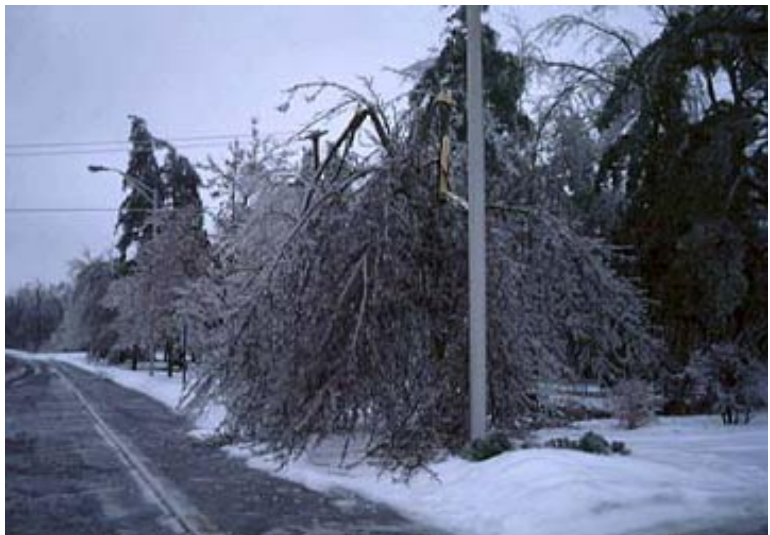
*e. Two miles west of Lake Champlain near Beekmantown, New York, at 200 ft (photo Mulherin).*

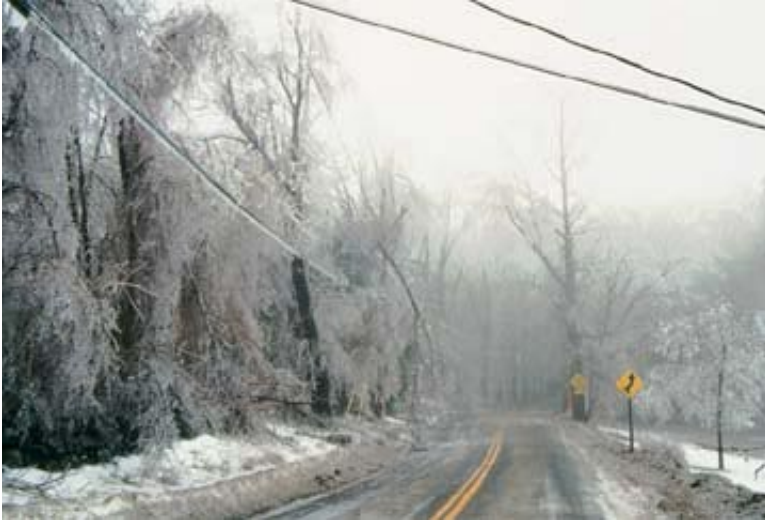
*a. Between Harrisville and Dublin at about 1500 ft (photo Nick Collins).*

*Figure 13. Tree damage in New Hampshire.*

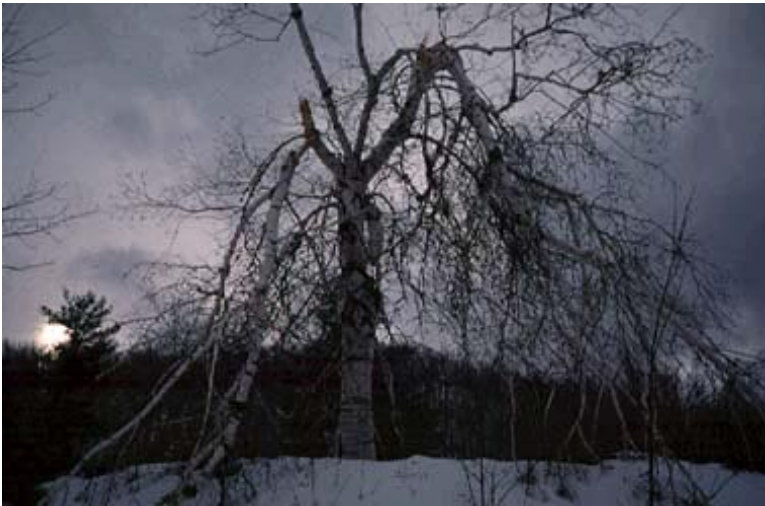
*b. Bradford at 1250 ft (photo Jones).*

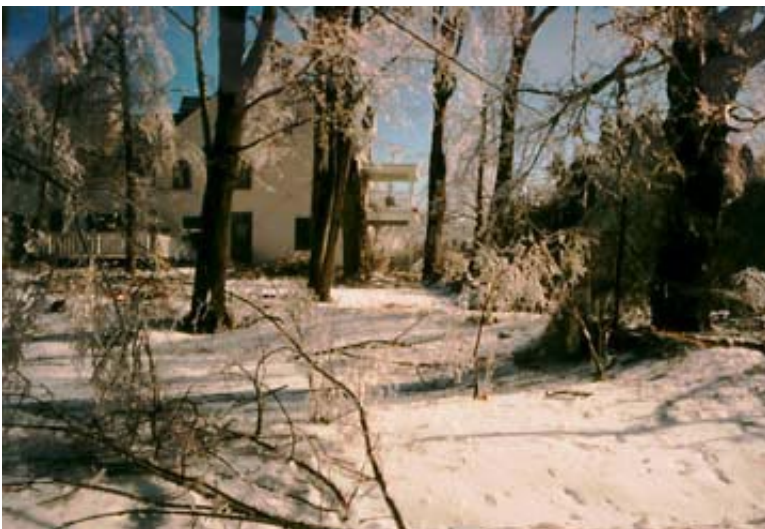
*c. New London at 1300 ft (photo Kathy Lowe-Bloch).*

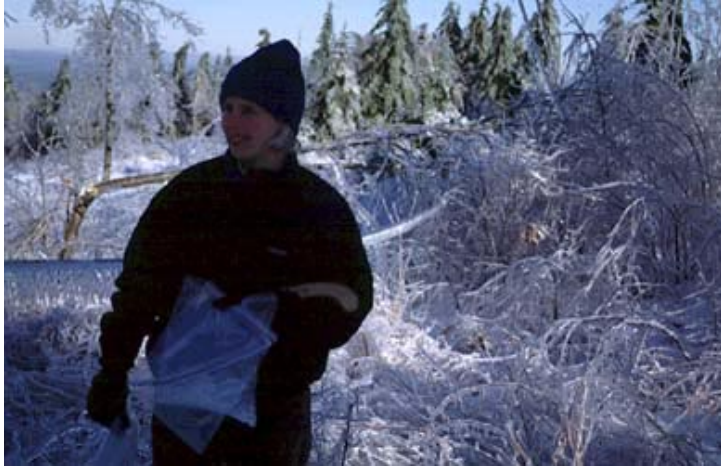
*d. Enfield at 1660 ft (photo Mulherin).*

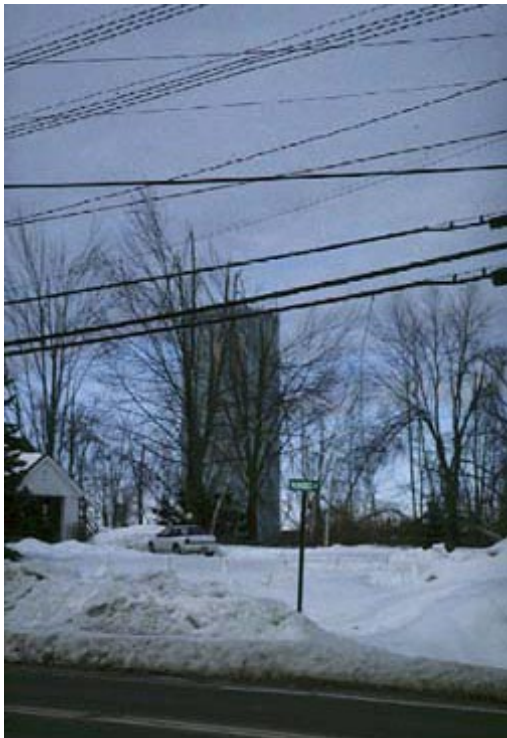
*e. Wolfeboro at 540 ft (photo Jones).*

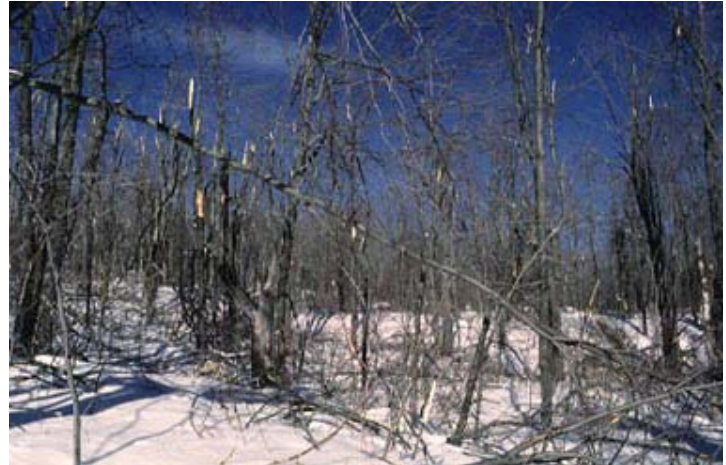
*f. Berlin at 1640 ft (photo Mulherin).*

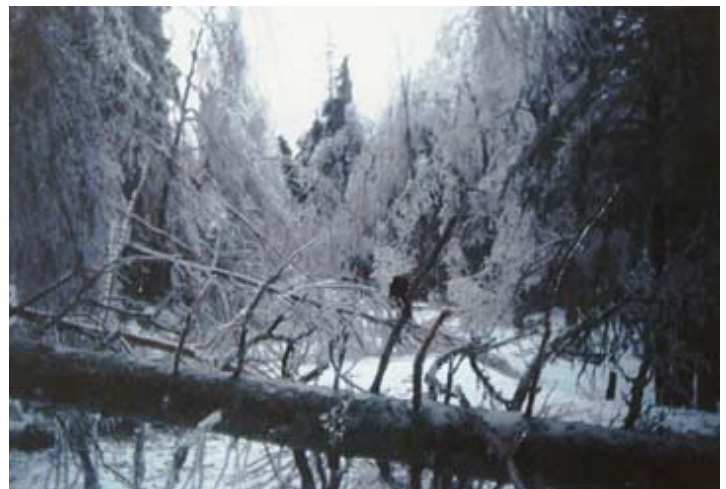
*g. Mount Washington (photo Eric Meyerson, UNH).*

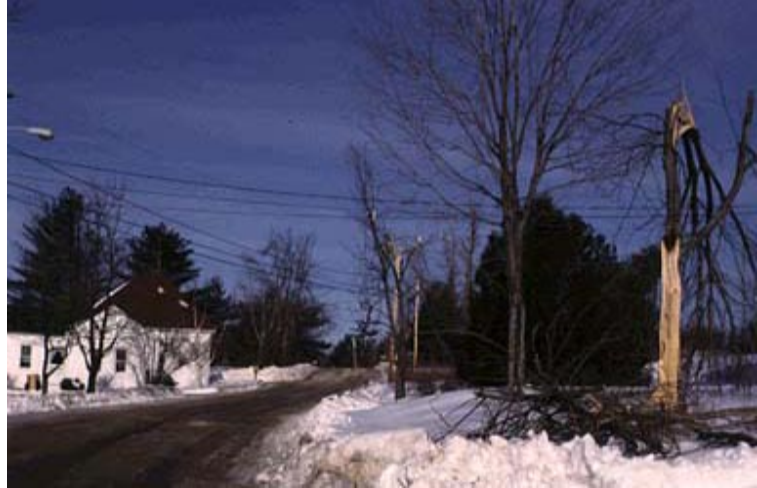
a. Minot at 330 ft (photo Mulherin).

Figure 14. Tree damage in Maine.

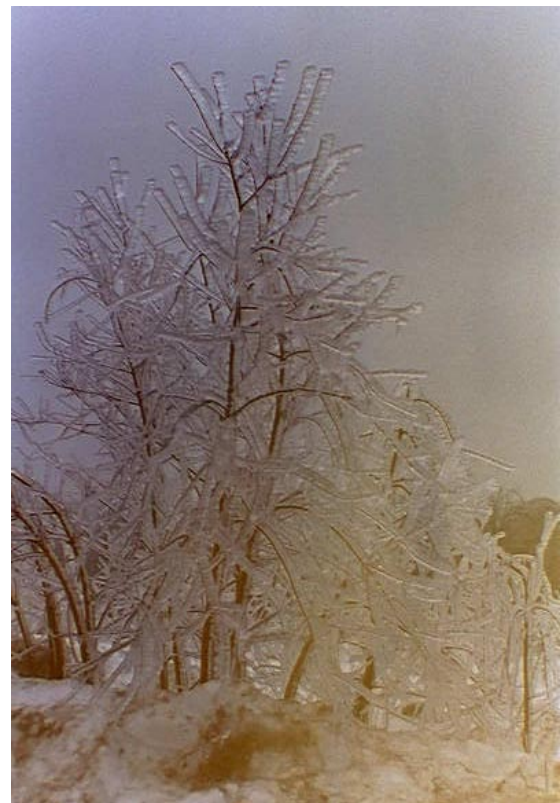
b. Gray at 400 ft (photo John Jensenius, NWS).

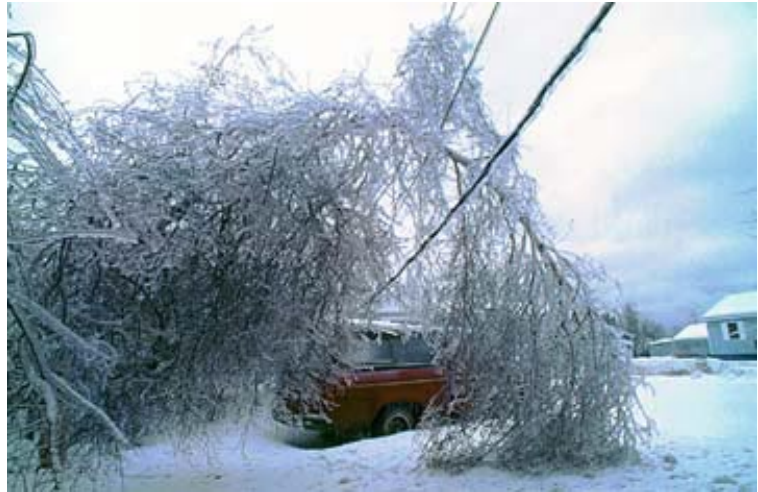
c. Near Augusta (photo Central Maine Power).

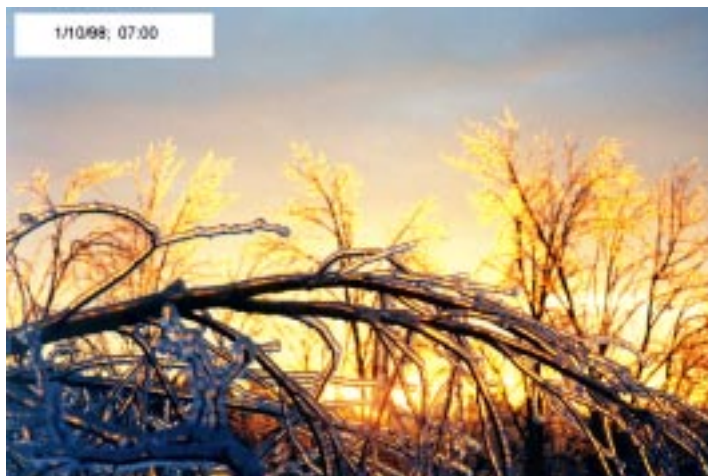
d. Between Mount Vernon and Vienna at 500 ft (photo Bill Duffy, Geomatics).

In Maine the forest damage assessment was undertaken by the Maine Forest Service. Its map ([Fig. 11c](#)) shows seven levels of damage severity. The levels are defined by the percent of affected trees: a) trace, 1 to 5% breakage, b) light, 6 to 20% breakage, c) moderate, 21 to 50% breakage, and d) high, over 50% breakage. Two regions with trace-to-light damage, primarily along the coast, total 1.6 million acres. Ice loads caused moderate damage and moderate-to-high damage just inland of this region, over 3.8 million acres. Even farther inland, light and light-to-moderate damage occurred over 2.8 million acres. There was high damage to 0.3 million acres in the northwestern corner of the state, while 4.7 million acres had only trace damage or less. Examples of tree damage in the storm are shown in [Fig. 14a through e](#). Ice accumulation damaged trees in Minot (330 ft) shown in [Fig. 14a](#). At an elevation of 400 ft in Gray, north of Portland, there was extensive tree damage ([Fig. 14b](#)) caused by ice loads approaching 1 in., while in Portland itself there was very little ice. The region around Augusta was hard hit by the storm ([Fig. 14c](#)). The ice load that bent the birch trees to the ground in [Fig. 14d](#), between Mount Ver-

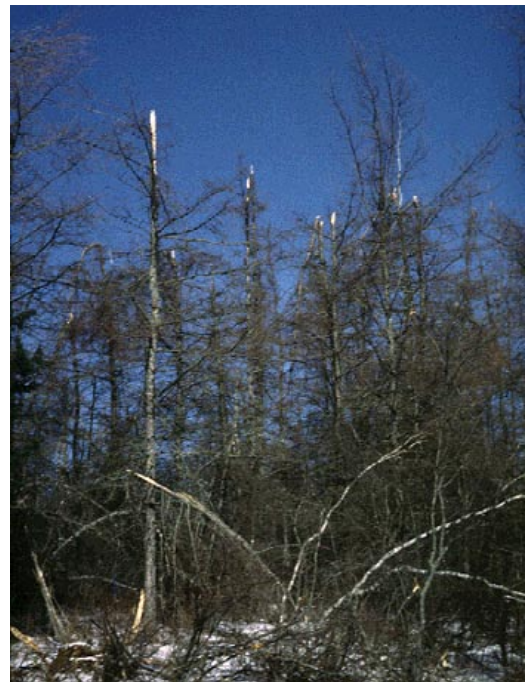
e. Near Deblois (photo Jones).

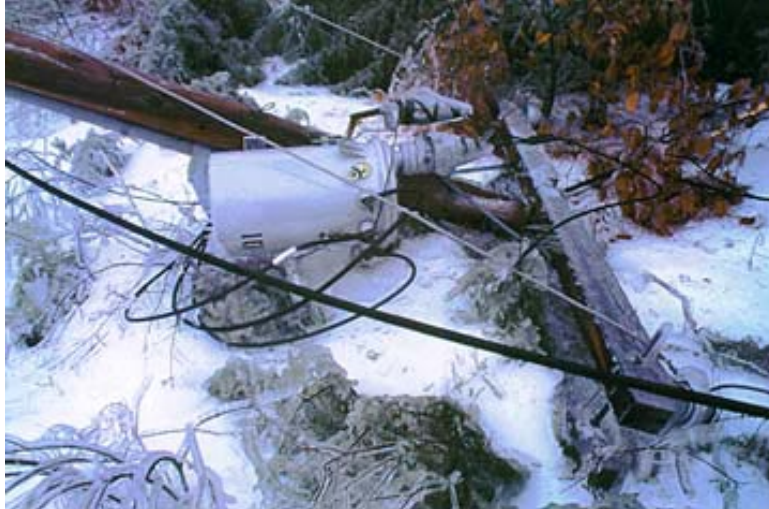
*a. Near Augusta, Maine (photo Central Maine Power).*

Damage to power distribution lines, which serve individual houses and businesses, occurred throughout the region hit by the ice storm. Distribution lines were damaged primarily by trees leaning on the wires and by broken branches and trees falling on wires, pulling the wires down or breaking crossarms or poles. (Fig. 15). Because a) homeowners and municipalities plant trees and resist tree trimming and removal for aesthetic reasons, and b) trees are ideal collectors of ice, distribution line outages often occur early in an ice storm. These outages tend to be long-lasting because a) damaged trees must first be removed to gain access to the downed line and b) all portions of a circuit must be repaired before any customers on that circuit can be brought back on line. In the rural areas in Maine, New Hampshire, and Vermont, where miles of distribution line may serve only a few customers, outages were prolonged. The number of customers without power and the duration of outages because of problems in the power distribution system are likely to be closely tied to the closeness of the association between people and trees in the region and the extent of the storm, rather than with the magnitude of the ice load. An evaluation of the outage pattern in the distribution systems in all three states might identify districts in which additional

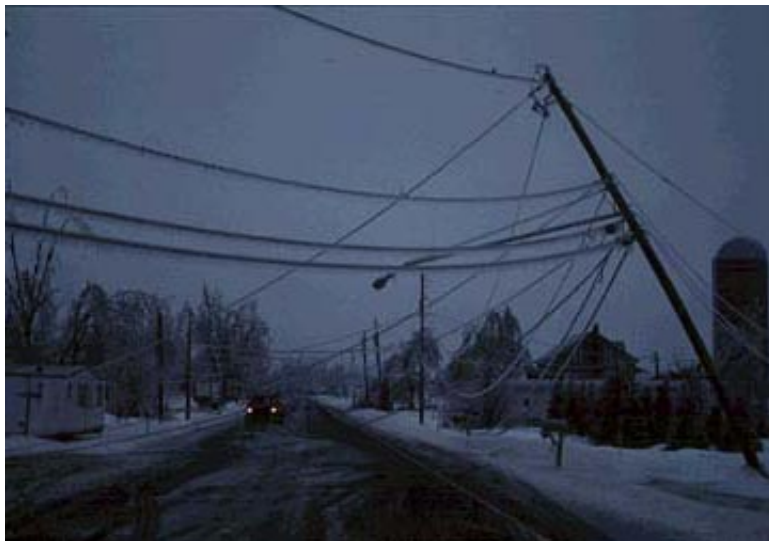
*b. Champlain, New York (photo Mulherin).*

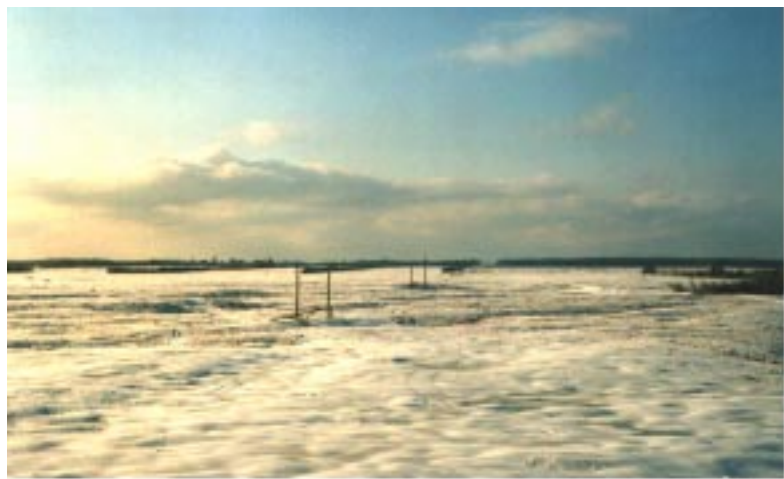
*Figure 17. Six miles of Bangor Hydro's 115-kV H-frame transmission line in the blueberry barrens east of Deblois failed under the ice load (photo Larry Billings, Bangor Hydro).*

In Maine, Bangor Hydro's 115-kV line east of Deblois failed (Ken Miller, Larry Billings, Jeff Fenn, George Baker, Bangor Hydro, personal communication). That radial line, built in 1955, is the only line serving the Calais region in eastern Maine. The cascade failure of six miles of H-frame structures (Fig. 17) was initiated by a single conductor breaking from the heavy (~1 in.) ice load. The cascade was stopped at one end by a corner tower, and at the other by a long span that absorbed the load. Power was restored to the region, while a new line was under construction, by routing electricity along existing 33-kV lines, and using local generation (diesel and wood). There were a number of problems in CMP's power transmission system, primarily in its 34-kV system, with only a few problems in the 115-kV system (Tom Bragg, CMP, personal communication). The 34-kV lines are particularly vulnerable to tree damage, because the wires are on relatively short poles (35 to 40 feet tall), and the lines are in narrow right-of-ways or near the edge of wider right-of-ways for 115-kV lines. As redundancy is incorporated in the system, many of the problems caused no outages. Other outages, generally limited to four hours, occurred during switching or sectionalizing of a line. There were, however, a

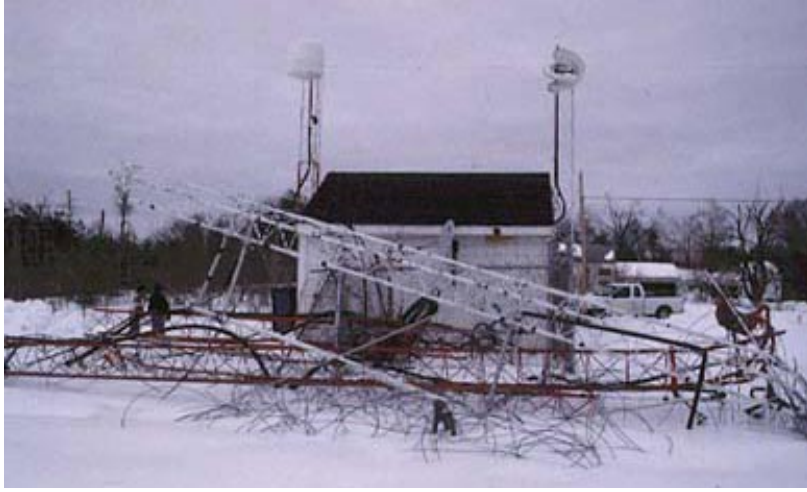
*a. WLNH tower in Laconia, New Hampshire (photo Mulherin).*

*Figure 18. Communication tower damage.*

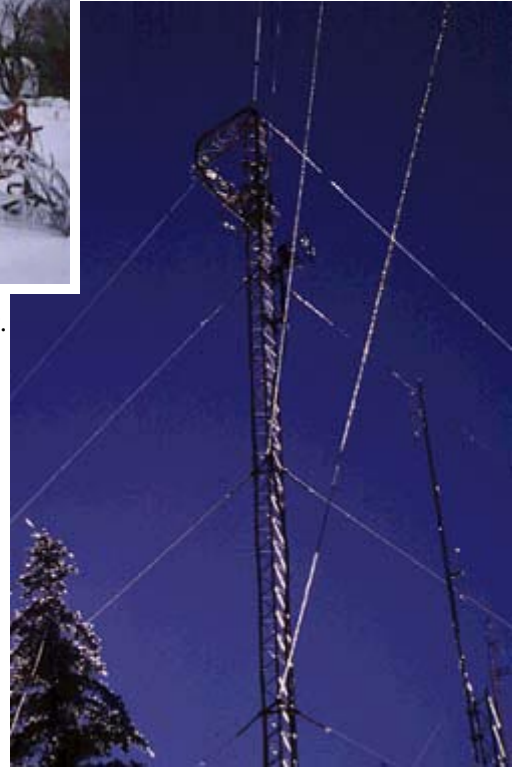
*b. WEZQ tower in East Eddington, Maine (photo Mulherin).*

WCDQ-FM	Sanford, ME N43-25-06 W70-48-06	240	680	Ice on guys estimated 5 in. thick
WEZQ-FM	E. Eddington, ME N44-45-30 W68-34-00	140	1000	Guys failed, top half of tower fell
WKZS-FM WHTH-FM backup New Gloucester Fire Dept	New Gloucester, ME N43-57-10 W70-17-40	500	500	Top half of tower fell; ice on guys estimated 4 to 5 in. thick
WLNH-FM	Laconia, NH N43-35-50 W71-29-50	245	850	
WCIZ-FM	Watertown, NY N43-57-20 W75-50-25		1000	
WTNY-AM	Watertown, NY N43-56-40 W75-56-50		445	
WUZZ-AM	Watertown, NY			
Four 2-way towers	Watertown, NY N43-58 W75-55			
<b>UNCONFIRMED TOWER FAILURES</b>				
Cellular tower	Watertown, NY

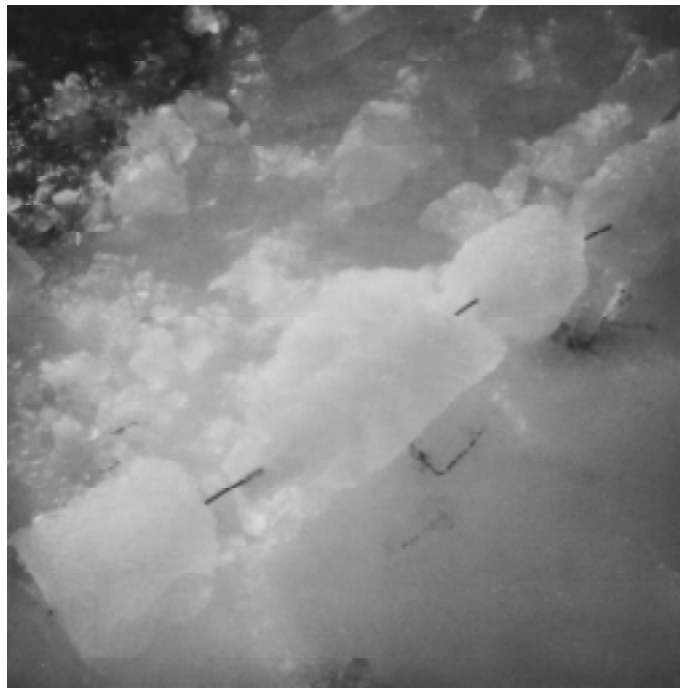
a. ~5 in. on a 0.25-in. guy on the summit of Cadillac Mountain (photo Robert Parker, U.S. Coast Guard).

The range of modeled ice loads shown in Fig. 16 and Table 4 are consistent with ice loads we measured and with most estimated ice loads that we have been able to document. However, as mentioned in Section 6.1.3, we have a number of reports of much larger ice accretions on communication towers on mountaintops in New Hampshire and Maine at elevations between 700 and 1600 ft. The photo in Fig. 22a shows ice accreted on 0.25-in.-diameter guys of a tower on Cadillac Mountain (1500 ft) in Acadia National Park on the coast of Maine. Using the diameter of the guy for scale, assuming a round cross section for the accreted ice, and assuming that this is glaze ice, rather than lower-density rime ice, we estimated an equivalent uniform ice thickness of

between 4 and 5 in. This estimate is conservative. If the ice is not glaze ice, or if the accretion cross section is oval, then the equivalent uniform thickness is actually less. It is likely that ice that accreted on structures and trees on some mountaintops was from both freezing rain falling from clouds that were in the warm air layer, and in-cloud icing, from windblown supercooled droplets in low clouds in the cold air layer. The relative contributions to the ice load from the low-level clouds and from the rain can only be estimated because cloud liquid water contents are not measured except at a few sites (at Mount Washington Observatory in supercooled clouds, for example) and by research aircraft. From a database of measurements from research aircraft we have determined the average liquid water content of supercooled stratus-type clouds to be about  $0.15 \text{ g/m}^3$

(Jones and Ryerson, unpublished). With an average freezing-rain rate of 1 mm/hr in this storm, and an assumed wind speed of 8 m/s at the summit of Cadillac Mountain (about 50% higher than was measured at weather stations, to take topographic effects into account), we estimated a flux of water from the supercooled cloud droplets that is about twice the flux of water from the freezing rain. The mass of ice that accretes on an object from cloud droplets depends not only on the flux of water, but also on the diameter of the droplets and the size of the object. Those factors, along with the wind speed, determine the collision efficiency of the droplets with the structure (Finstad et al. 1988). The accreted ice mass also depends on the density at which the ice accretes, because that determines the size of the accretion, which feeds back into the collision efficiency. The ice density is determined by the cloud liquid water content and air temperature as well as the previously mentioned factors (Jones 1990). The additional flux of water from clouds in the cold-air layer in this storm is likely to have been the major contributor to the accreted ice load on mountaintops that were high enough to be in the low-level clouds throughout the storm and low enough to be below the warm air layer. The contribution to the ice load on trees and structures on the sides of mountains at these elevations would be less pronounced because of the decreased topographic effect on wind speed.

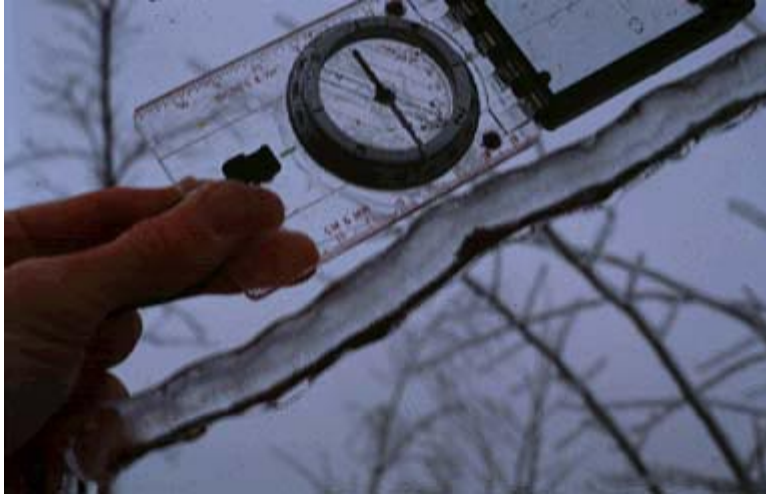
*b. 0.2 in. at 100 ft in Swanton, Vermont, at 8:50 a.m. on January 8 (photo Mulherin).*

Additional photos of accreted ice and our measured or estimated ice load, in terms of the equivalent uniform ice thickness, are shown in [Fig. 22 b through l](#). [Fig. 22b](#) shows a 0.2-in. ice load in Swanton, Vermont, (100 ft) at 8:50 a.m. on January 8. We measured a 0.7-in. ice load ([Fig. 22c](#)) near Rouses Point (110 ft) on the Vermont/New York border a half-hour later. The 0.7-in. ice load in [Fig. 22d](#) was measured after the storm in Enfield, New Hampshire (1660 ft). The photo in [Fig. 22e](#) was taken during the storm in New London (1300 ft). We have estimated an ice load of about 0.6 in. from this photo and the branch diameters, assuming an almost round cross section for the accreted ice. Other ice load estimates from similar photos taken in New London during the storm range up to about 0.8 in. The ice in the photo in [Fig. 22f](#) remained on the trees in a road cut near Ossipee (900 ft) three weeks after the storm. The measured load at that time was 0.5 in., providing a lower bound for the load during the storm. We estimated the amount of ice at a site between Vienna and Mount Vernon, Maine (500 ft), on January 8 from the photos in [Fig. 22g](#), calculating a load of 0.2 in. The photo in [Fig. 22h](#) of preserved ice on twigs at the same location indicates a load between 0.3 and 0.4 in. Photos taken in Gray near the National Weather Service office (400 ft) are shown in [Fig. 22i and j](#). Estimates from the measured maximum ice thickness and the observed cross-sectional shape (John Jensenius, NWS, personal communica-

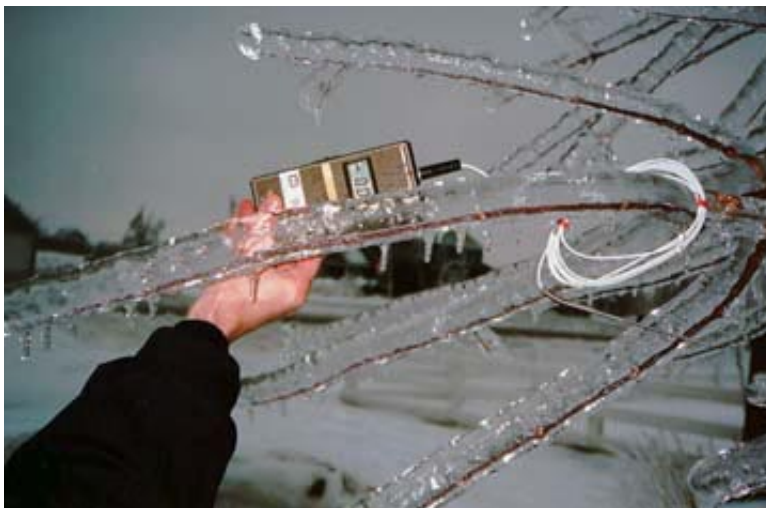
*c. 0.7 in. at 110 ft near Rouses Point at 9:20 a.m. on January 8 (photo Jones).*

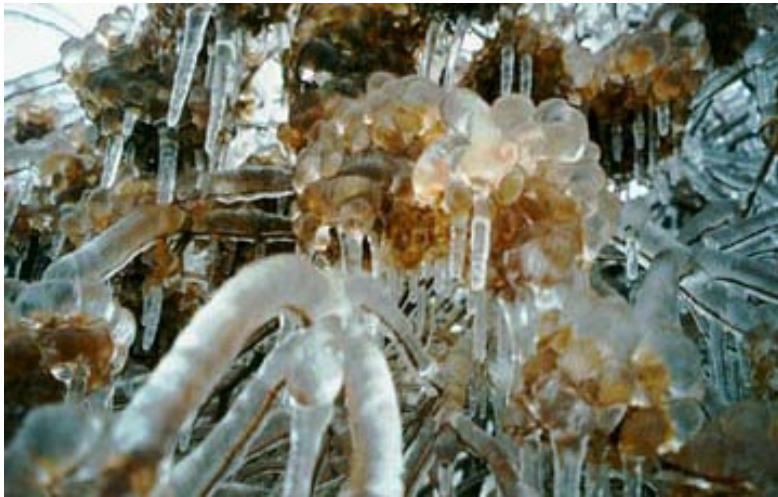
*e. ~0.6 in. at 1300 ft in New London during the storm (photo Kathy Lowe-Bloch).*

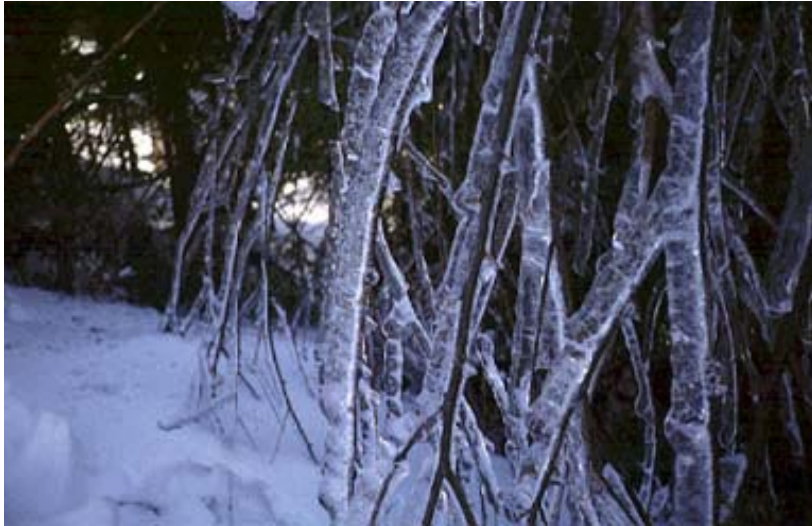
*f. 0.5 in. remaining at 900 ft in Ossipee three weeks after the storm (photo Jones).*

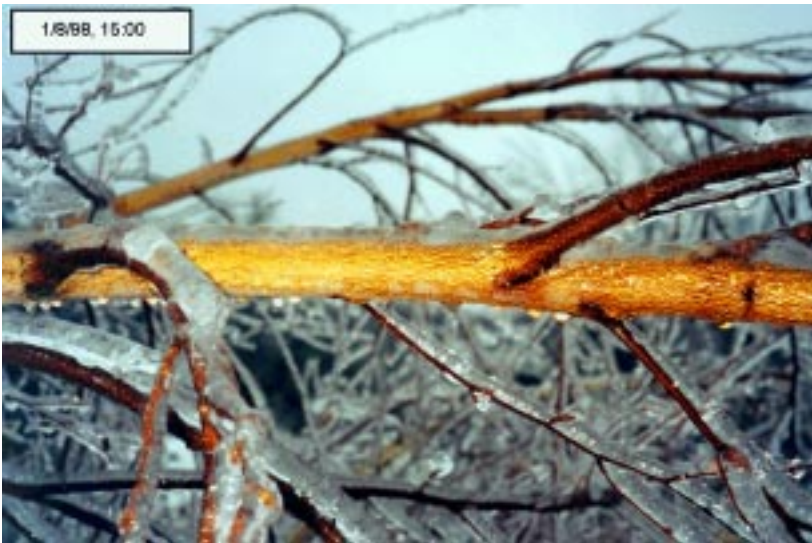
*g. ~0.2 in. at 500 ft between Vienna and Mount Vernon, Maine, on January 8 (photo Bill Duffy, Geomantics).*

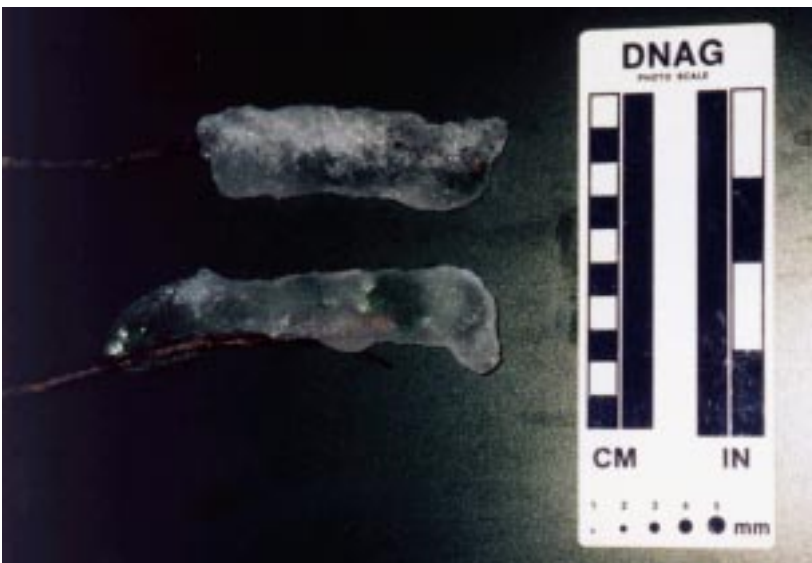
*h. ~0.3 or 0.4 in. at the same location, preserved by being buried in the snow after the storm (photo Bill Duffy).*

*Figure 22 (cont'd). Ice accretions with measured or estimated uniform ice thickness.*

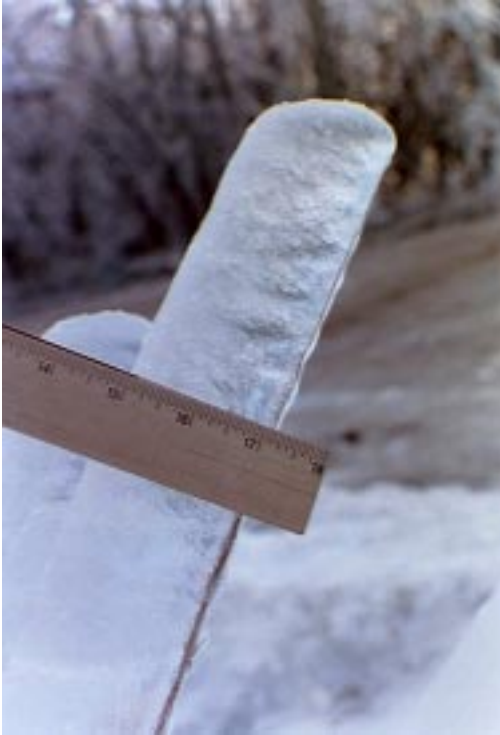
*i. ~0.7 in. at 400 ft in Gray, Maine (photo John Jensenius, NWS).*

tion) results in ice loads of 0.7 and 1 in., respectively. Royce Benedict and John Farr at the Berlin Fish Hatchery (1640 ft) in New Hampshire estimated the diameter of the round ice accretion on the fishing lines over the ponds in [Fig. 22k](#) to be 3/4 in. Including the icicles in the load and ignoring the small diameter of the fishing line, results in an ice load estimate of about 0.4 in. The photo in [Fig. 22l](#) of the ice that accreted on the conductor of the Bangor Hydro transmission line

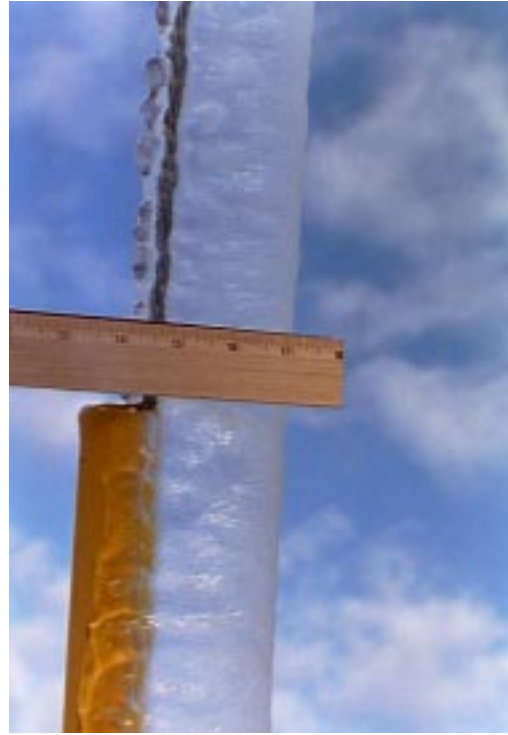
*j. ~1 in. at the same location (photo John Jensenius, NWS).*

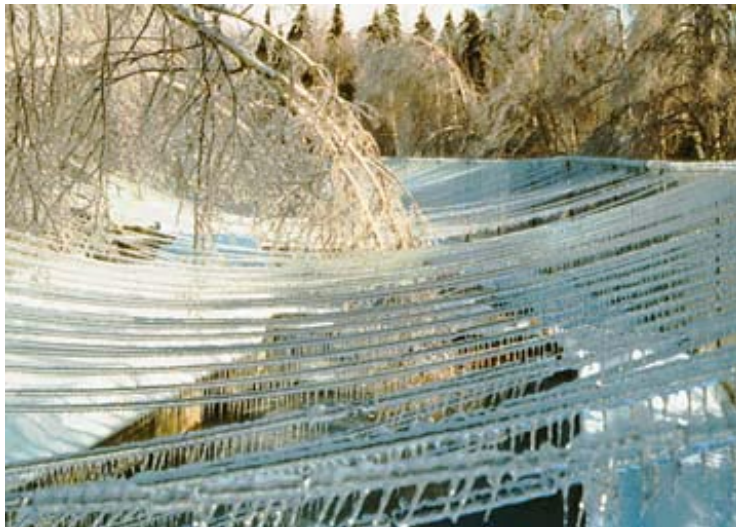
*k. ~0.4 in. at 1640 ft near Berlin (photo Wayne Paschal, Berlin Fish Hatchery).*

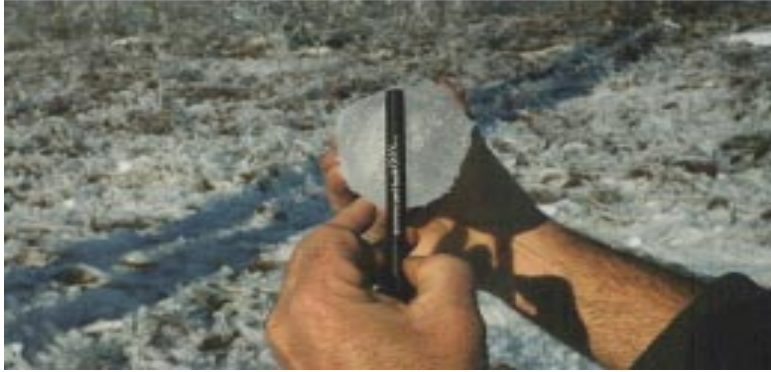
*l. ~0.9 in. accreted on a conductor at about 200 ft east of Deblois, Maine (photo Larry Billings, Bangor Hydro).*

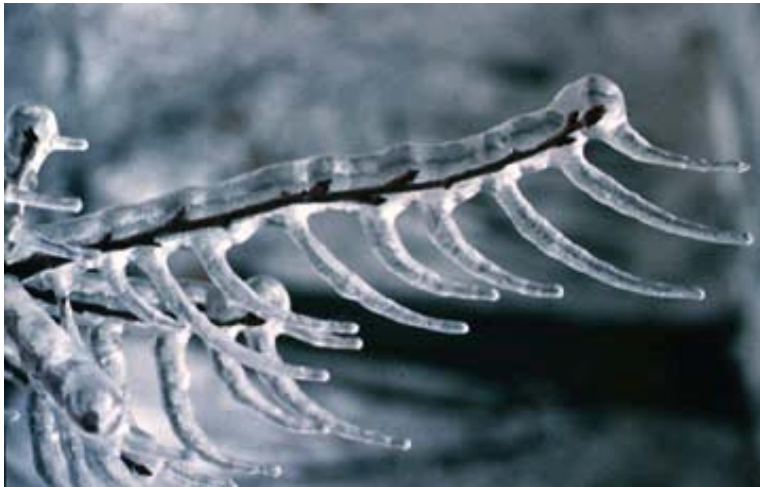
*m. ~0.7 in. on a twig in Burlington, Vermont (photo Gary Salmon, VD-FPR).*
