Final Preliminary Assessment/Site Inspection Report

Additional and Uncharacterized Sites Operable Unit Crab Orchard National Wildlife Refuge NPL Site Marion, Illinois (Williamson County)

June 2003

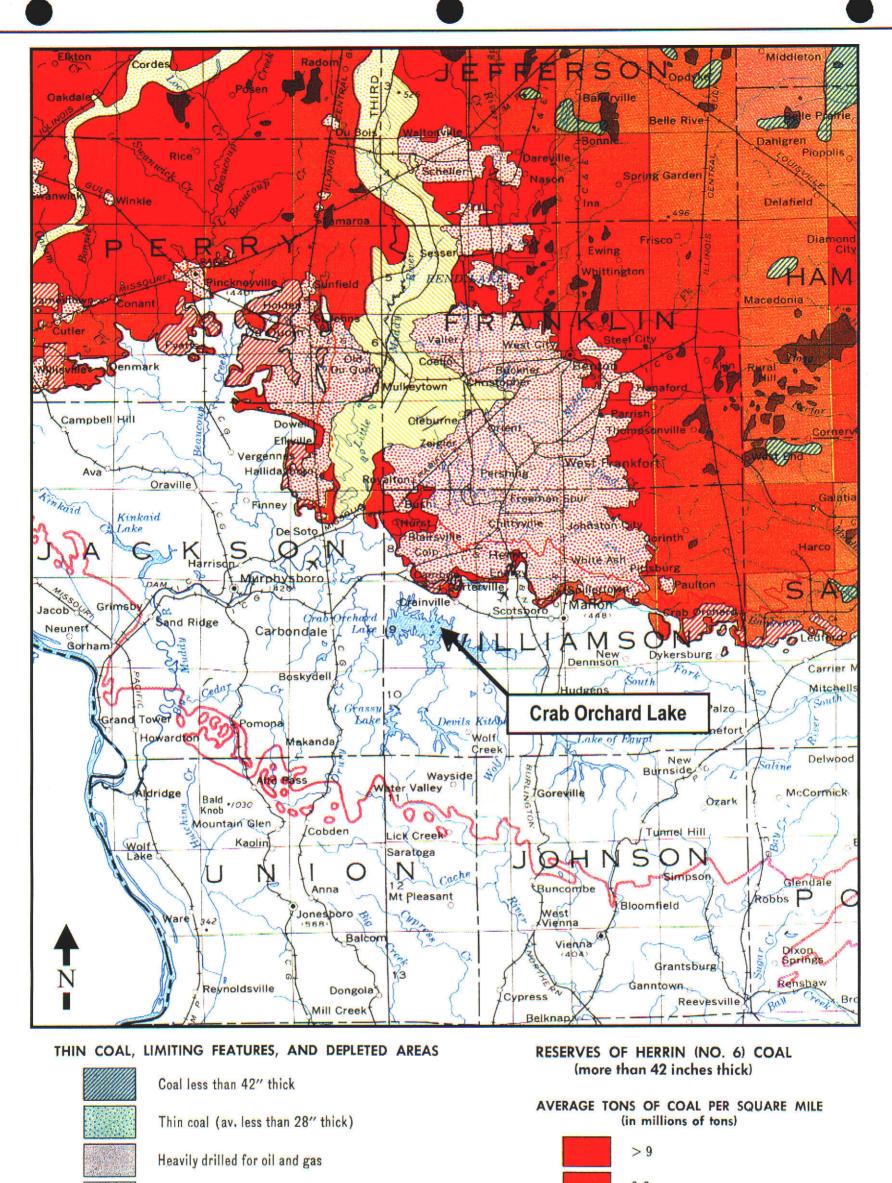
8-9			
	7-8			entra desti all'ancia del
	6-7			
	5-6			
	4-5			
	1" = A	pproxima	ately 13.5 Miles	
PA/SI REPORT – AUS OU PROJECT NO. CRAB ORCHARD NWR, MARION, ILLINOIS 2320000026.00				
	URS			
DRN. BY: MCH DSGN BY: MCH CHCK. BY: CMW	Herrin No. 6 Coal Se	am	FIG. NO. 2-2

Source: Smith, William H. and Bengal, Lawrence E., Coal Reserves of Illinois, Herrin (No. 6) Coal, Cooperative Report 4, Plate 1, State of Illinois, Department of Registration and Education, Illinois State Geological Survey, January 1975.

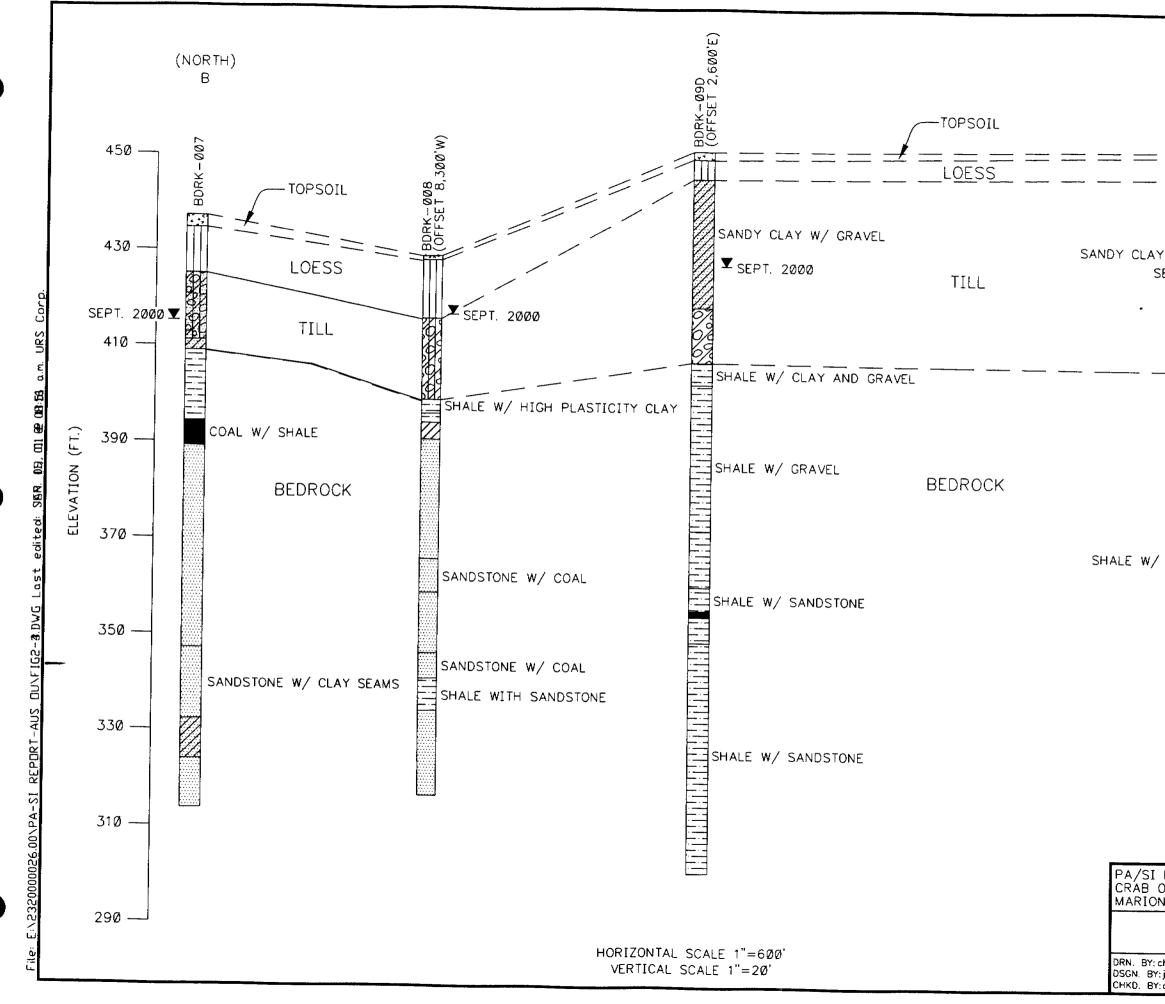
I REPORT-AUS OU ORCHARD NWR ON, ILLINOIS Trichs 1/5/01 Geologic Cross-Section B-B' for Bedrock Wells near Former Major Load Lines PROJECT NO. 2320000026.00 FIG. NO. 2-6	(SOUTH) B' AY W/ GRAVEL SEPT. 2000	LEGEND ■ GROUNDWATER ELEVATION ■ FILL ■ SILT SILTY CLAY ■ SILTY CLAY ■ COV PLASTIC CLAY W/GRAVEL ■ HIGH PLASTIC CLAY ■ SANDY CLAY ■ SANDY CLAY ■ SANDSTONE ■ SHALE ■ COAL ■ SILTY CLAY W/ GRAVEL ■ SILTY CLAY W/ GRAVEL ■ SILTY CLAY W/ GRAVEL ■ SILTY CLAY W/ GRAVEL
r:chs 1/5/01 Geologic Cross-Section B-B' FIG. NO.	ORCHARD NWR	2320000026.00
	3Y:jmr 1/5/01	Geologic Cross-Section B-B' FIG. NO.

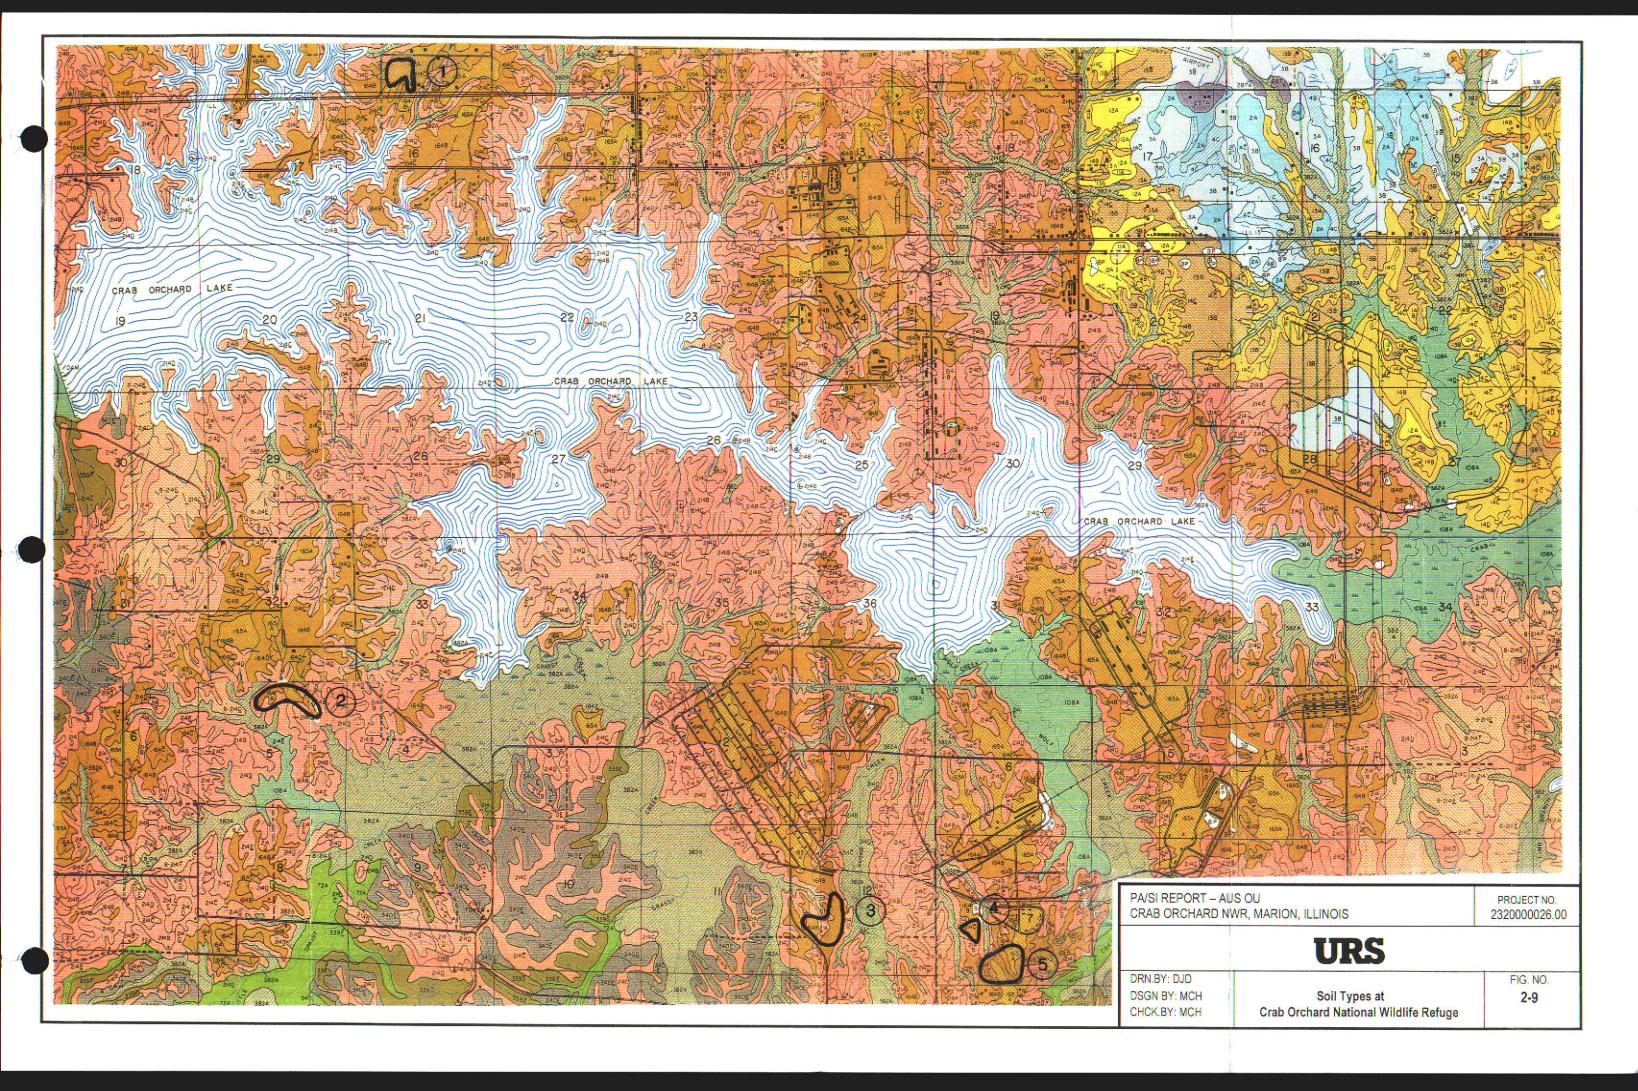
KEY TO FIGURE 2-9

Criterion No. 2: Figure 2-9 shows soil types on the Refuge. Soil types differ by geologic origin and soil chemistry. As shown in the figure, the predominant soil types for the AUS OU sites are

165A (Wier silt loam with 0 to 1.5% slopes) and 164B (Stoy silt loam with 1.5 to 4% slopes). Both these soil types are developed on 5.5 to 12.5 ft of loess¹⁴. (Virtually all the soil types shown in Figure 2-9 that are within the AUS OU are developed on loess, except for 108 and 382, which are developed on sediment deposits).

Criterion No. 3: for the northern part of the Refuge, grass covered areas are shown in white in Figure 2-9, and forested areas are shown in green. Most candidate areas that meet Criterion No. 2 are grass-covered.

Five areas were found that meet the criteria listed above. These are shown on Figure 2-9. A total of 30 soil samples were taken from the depth interval 0- to 6-inches, at locations distributed through these areas. These samples were analyzed for metals and TOC. Specific sample locations were based on field conditions, visual observation, and accessibility. Samples were not obtained from any area with visible signs of debris or potential contamination sources. Further, the approach was modified to include previous soil background data.
