Health Hazard Evaluation Report

ROTHAN & ROTHAN, DDS CINCINNATI, OHIO

HETA 87-147-1873 FEBRUARY 1988 ROTHAN & ROTHAN, DDS CINCINNATI, OHIO NIOSH INVESTIGATOR: John N. Zey, M.S., C.I.H.

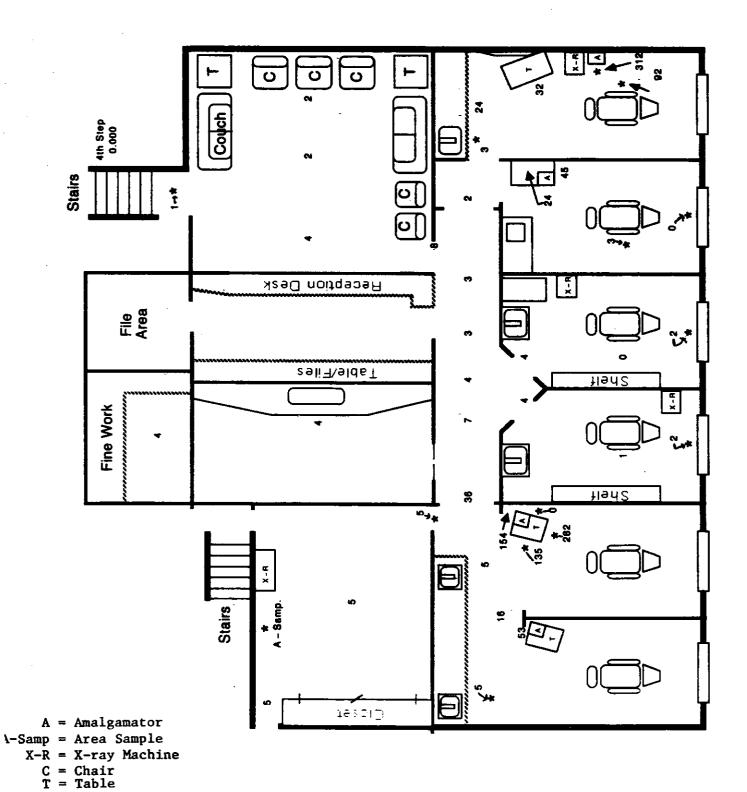
Figures 1-2 present the results of mercury concentrations measurements taken near surfaces. Highest values were found in the immediate vicinity of mercury use areas (amalgamators). Most readings were relatively low (0-10 ug/m³) except at the mercury use areas where readings ranged up to 312 ug/m³. The NIOSH investigators noted mercury concentrations near the rug surface increased after the powered vacuum cleaner was used (Figure 2). Values often increased by 2-4 times.

Figure 1
Surface Mercury Vapor Readings (ug/m³)
Rothan & Rothan, DDS
HETA 87-147
April 21, 1987

- 1. The old carpet which is contaminated with mercury should be replaced.
- 2. If new carpeting is installed, vacuum cleaners designed for mercury clean up such that mercury vapor is not discharged into the workroom air should be obtained and used.
- 3. Spilled mercury droplets should be cleaned up using a vacuum system with a water trap.
- 4. Pre-enclosed amalgam capsules should be considered for future use, as this would eliminate one mercury-handling step.
- 5. The amalgamators not equipped with vibration chamber covers should be so equipped.
- 6. The old separation material should be disposed of and the drawer it was stored in and all the contents of the drawer, cleaned with a wet cloth.
- 7. If a nitrous oxide system is installed, it should be equipped with a scavenging system.

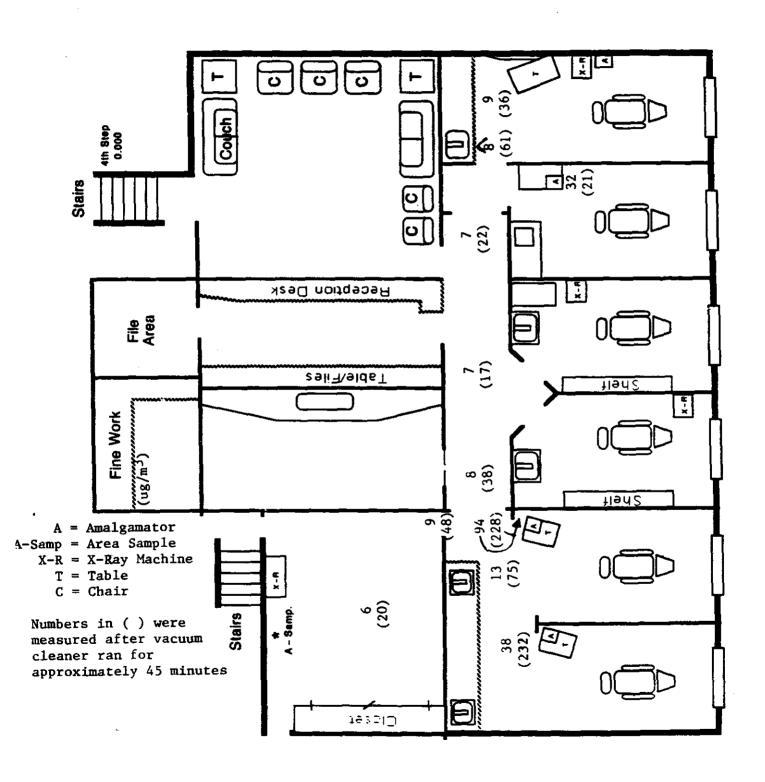
The highest readings were obtained on or inside the powered vacuum cleaner. Readings of 1300 and 1700 ug/m^3 were measured inside the vacuum cleaner beater bar and hose respectively.

Figure 2
Surface Mercury Vapor Readings (ug/m³)
Before and After Powered Vacuum Cleaner was operated for 45 minutes
Rothan & Rothan, DDS
HETA 87-147
April 21, 1987
