# **Balance-of-Plant Impacts at Big Brown and Poplar River Power Stations**

**John Pavlish**

**Energy & Environmental Research Center**

DOE NETL Mercury Control Technology Conference

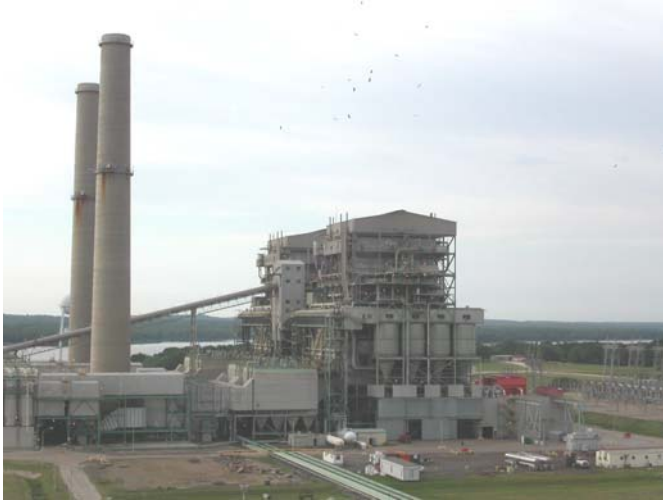
- TXU's Big Brown Station, tested one-quarter of Unit 2

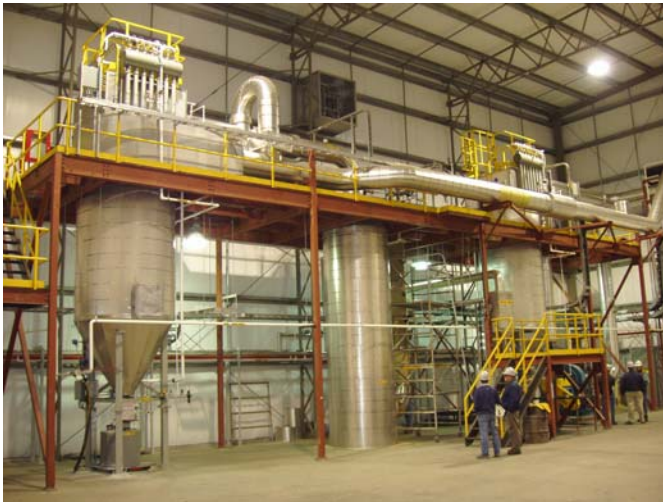
- SaskPower's slipstream ECRF at Poplar River Station

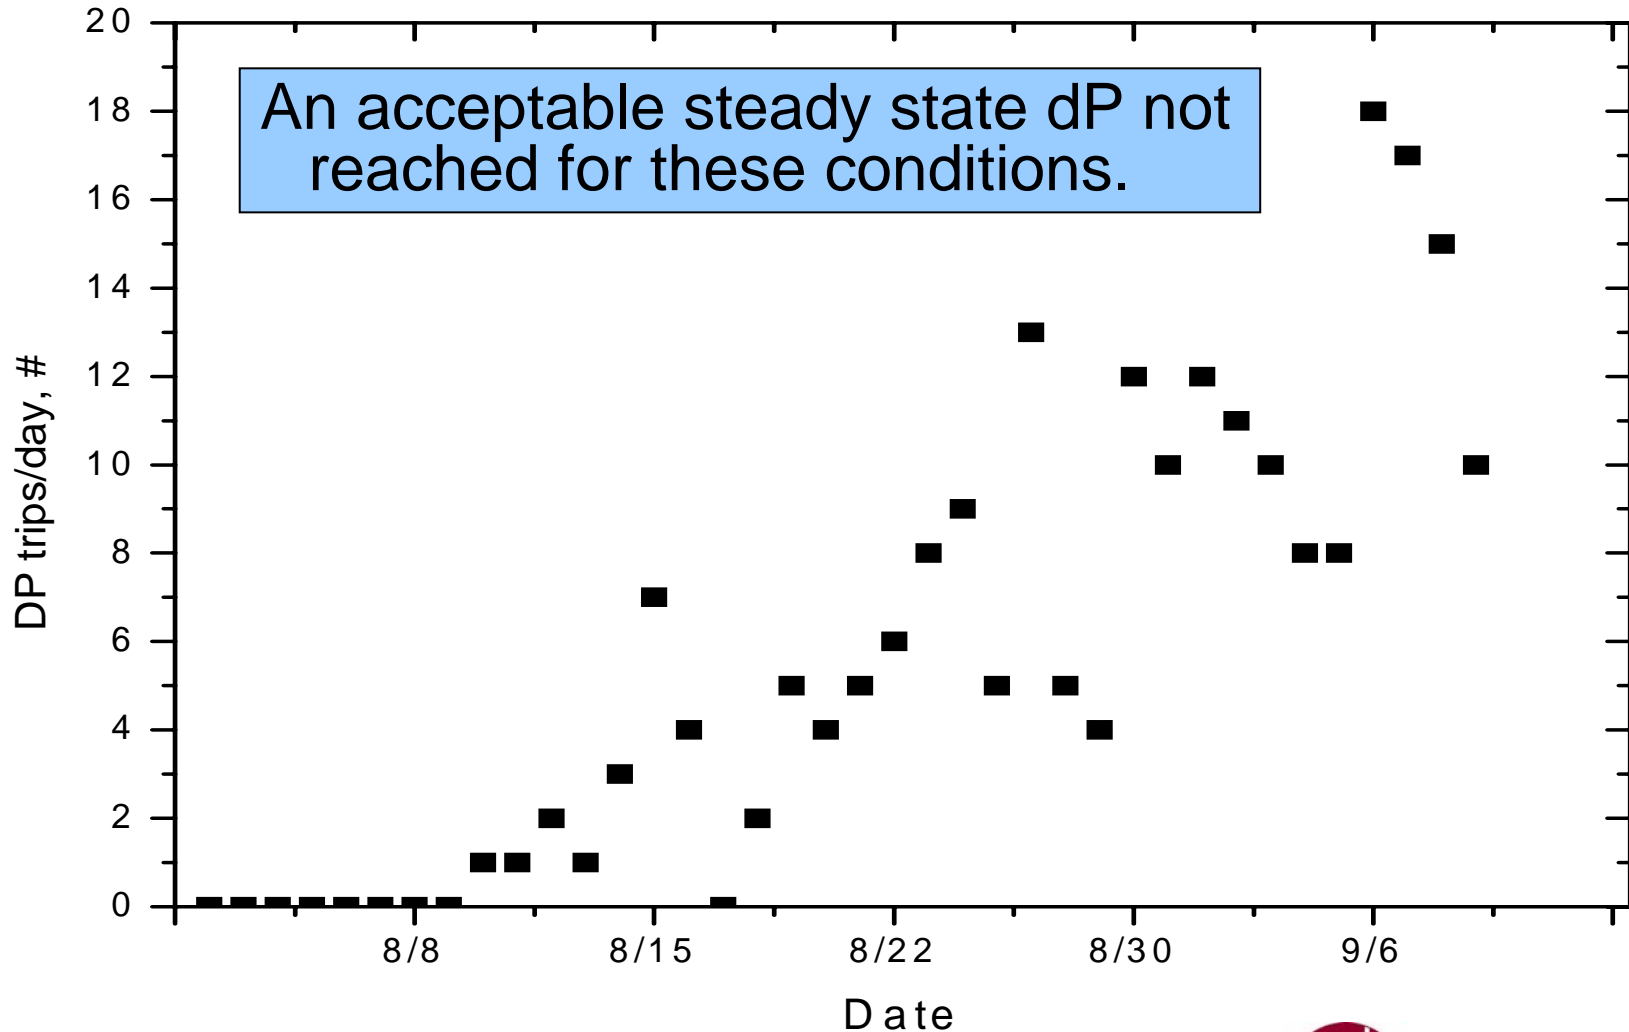
# ECRF LT1 Cleaning "Trips" at dP of 10" WG

<sup>1</sup> Cleaning also initiated when dP reaches 10" WG.

Designation	LT1	LT2	LT3
Air-to-Cloth, ft/min	6	6 & 8	6
FF Outlet Temp., °F	300	300	300
Ash Loading, lb/Macf	34	4.7	34
AC Feed, lb/Macf	2.5	2.5	2.8
Cleaning, p/b/hr <sup>1</sup>	3.4	3.4	3.4
Bag Type	Std.	Std.	Hi-Perm.
Duration, weeks	5	10	10

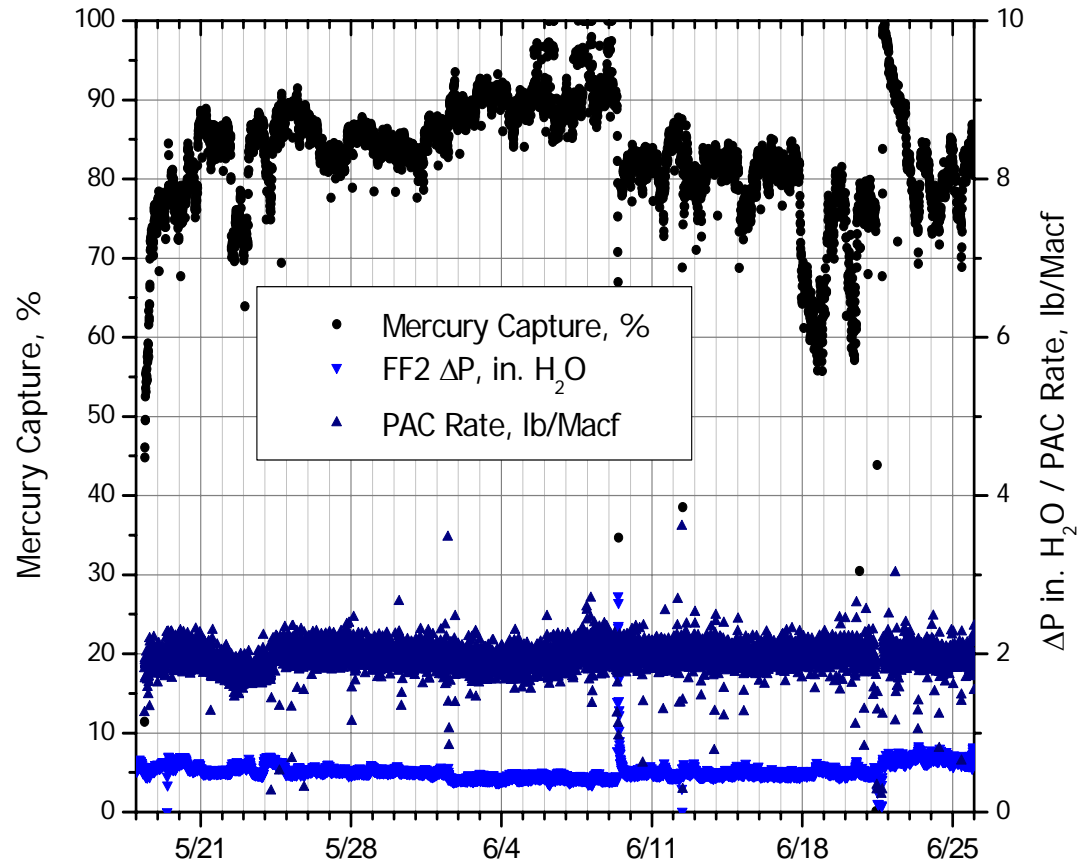
# LT 3—Hg Capture, ACI Rate, and dP

- With a switch to high-perm bags and the same ash loading conditions of LT1, steady-state dP was less than 1”.
