# Mercury Control by EPRI MerCAP<sup>™</sup> Process

NETL Mercury Control Technology Conference December 13, 2006

Tom Machalek, URS Corporation

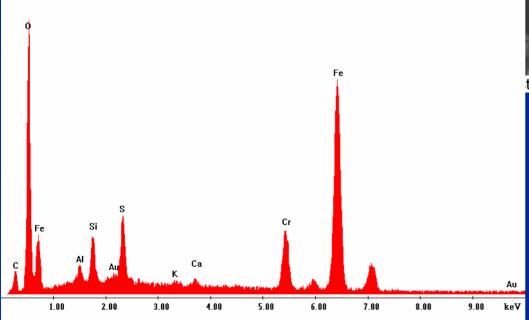
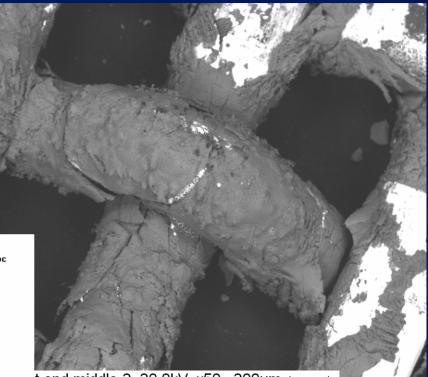
Label A: section 2 west end middle-2

# SEM Analysis with EDS

t end middle-2 20.0kV x50 200µm ⊢

- Initial Results indicate high level of mercury removal is possible
- Acidic conditions in flue gas corrode gold and stainless steel substrates
- Material build-up on gold surface inhibits mercury adsorption
  - Compounds include rust, gypsum fines, other sulfur oxides
  - Effect of flue gas flow rate not evident when plates are fouled
  - Wash system demonstrated improvement in mercury removal in short section of gold
- Ontario Hydro confirmed results seen with SCEMs

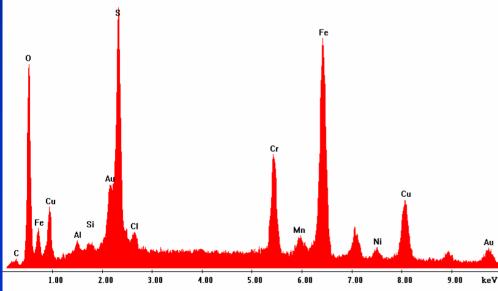
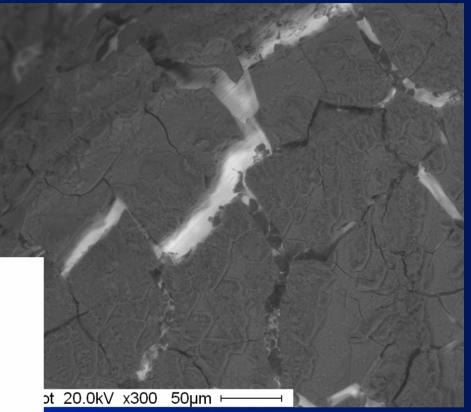
Label A: section 3 spot

# SEM Analysis with EDS

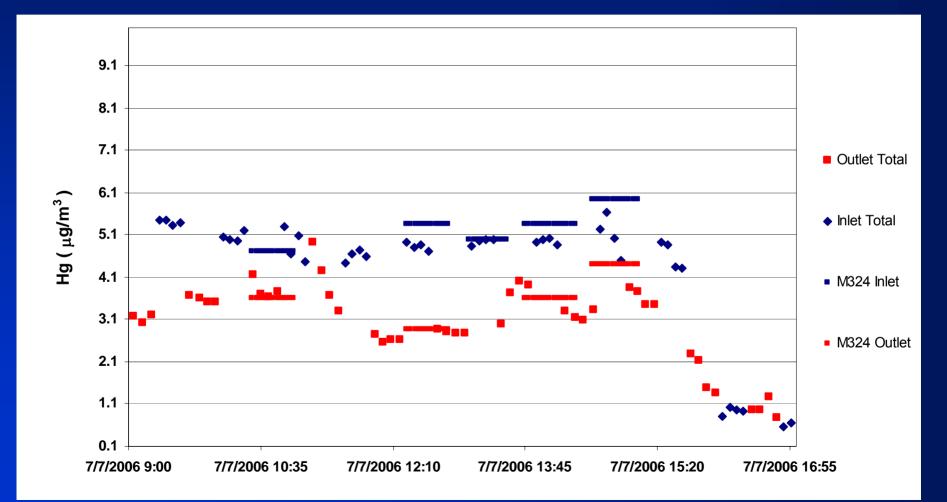
- 22nd Month of service time
- Method 324 Measurements conducted to verify Hg CEM results
- Removal remains variable depending on gas temperature and lime/slurry feed-rate
- 40 50% removal observed after nearly 2 years of continuous treatment service
