**Post-Restoration Review on Round Meadow
Chemult Ranger District, Winema National Forest
May 24, 2004**

Evaluation of Round Meadow Restoration

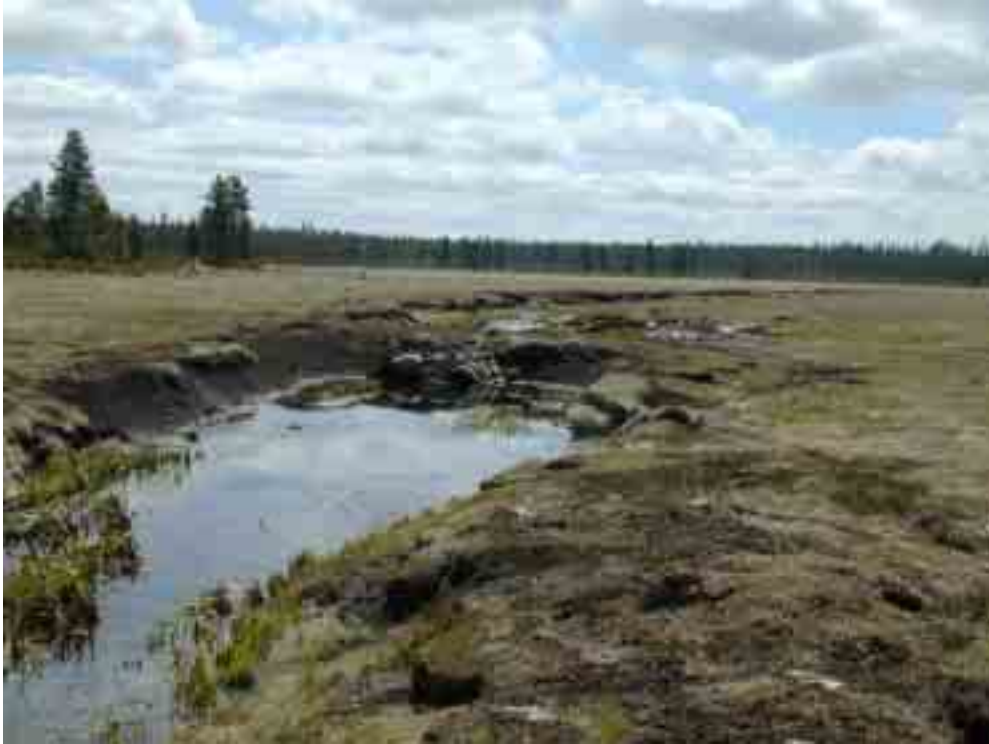
Photo 1: BEFORE photo taken at the lower end of the meadow of the main ditch where a crossing was developed for vehicle crossing.

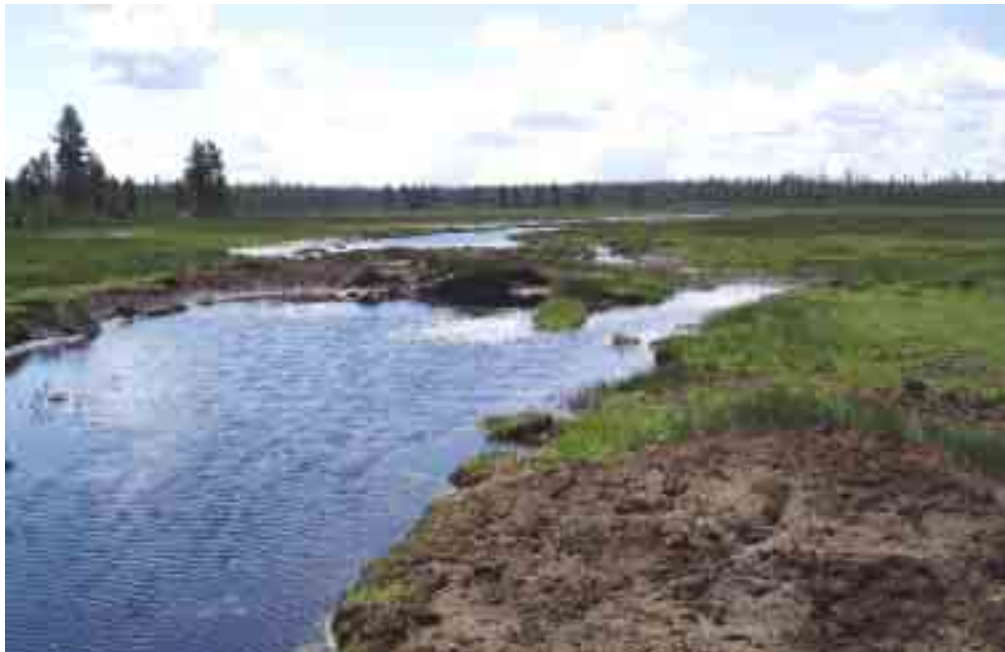
Photo 2: AFTER photo showing how a plug upstream of the crossing (30ft) is backing up the water and causing it to disperse to the left. At the lower end where the gradient increases there is some minor maintenance needed.

All the maintenance that we are recommending occurs around the lower end of the meadow where the gradient increases.

1. At the lowest couple of dams the dams could use some additional sod work to reinforce the dam and to create further dispersion of water out onto the flood plain. The photos below show how there are a few small locations that could have the potential to headcut up through the dam prior to vegetation establishment. They are minor sites that could be done with a hand crew. This photo also shows how the flow is getting spread out to both side of the channel.

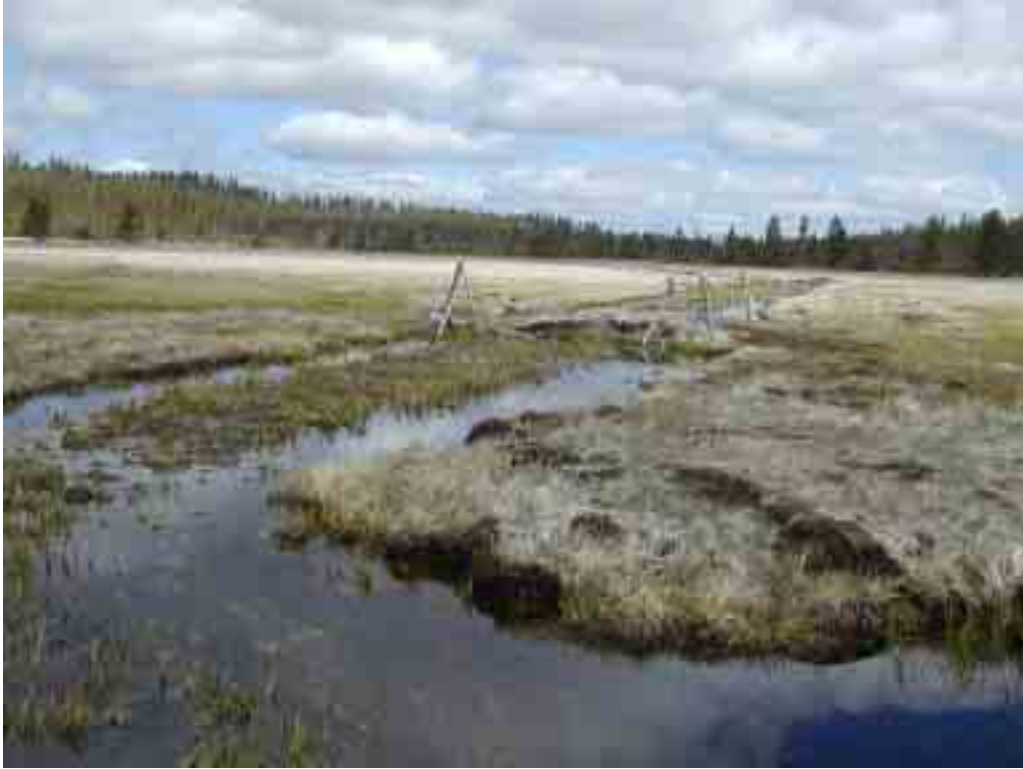
Photo 3: BEFORE photo showing how the water rarely flooded on the meadow.

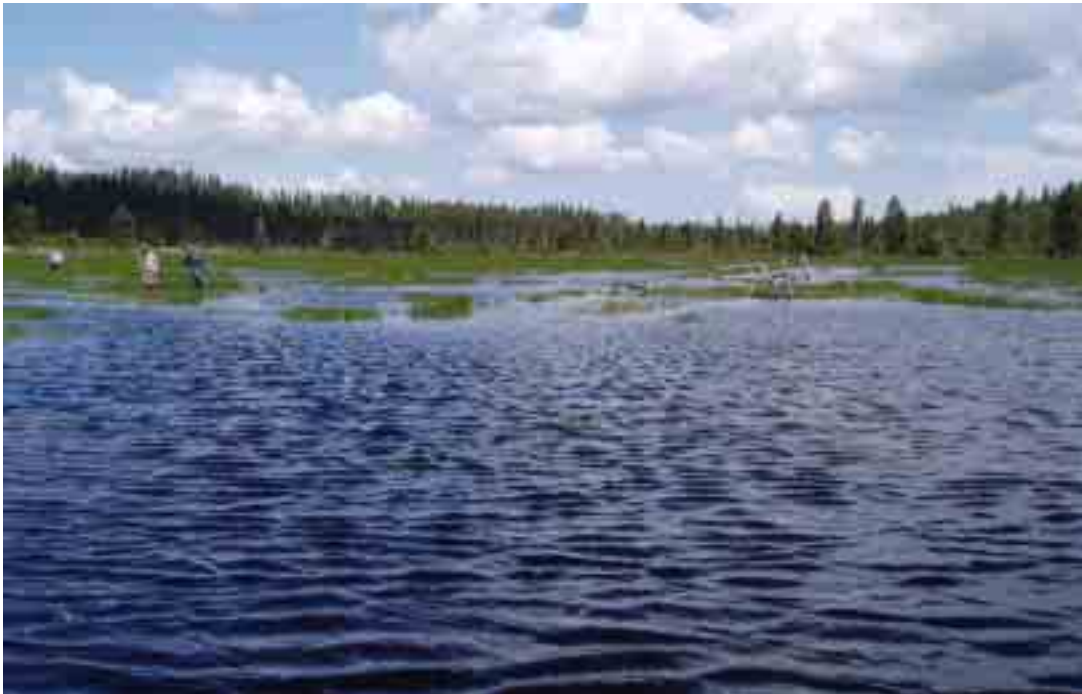
Photo 4: AFTER photo showing the success of the mimicked beaver dam plugs for dispersing and inundating the meadow. This will also hinder encroachment of the adjacent lodgepole pine.

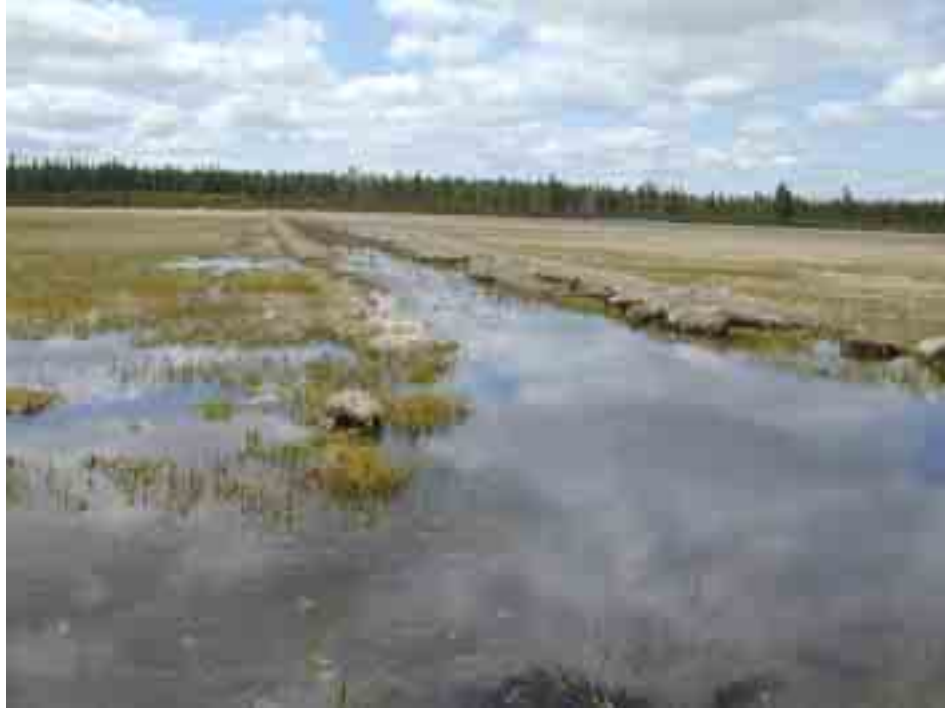
Photo 5: BEFORE photo looking at the upper end of the meadow with the old ditch spoils on both sides of the ditch.

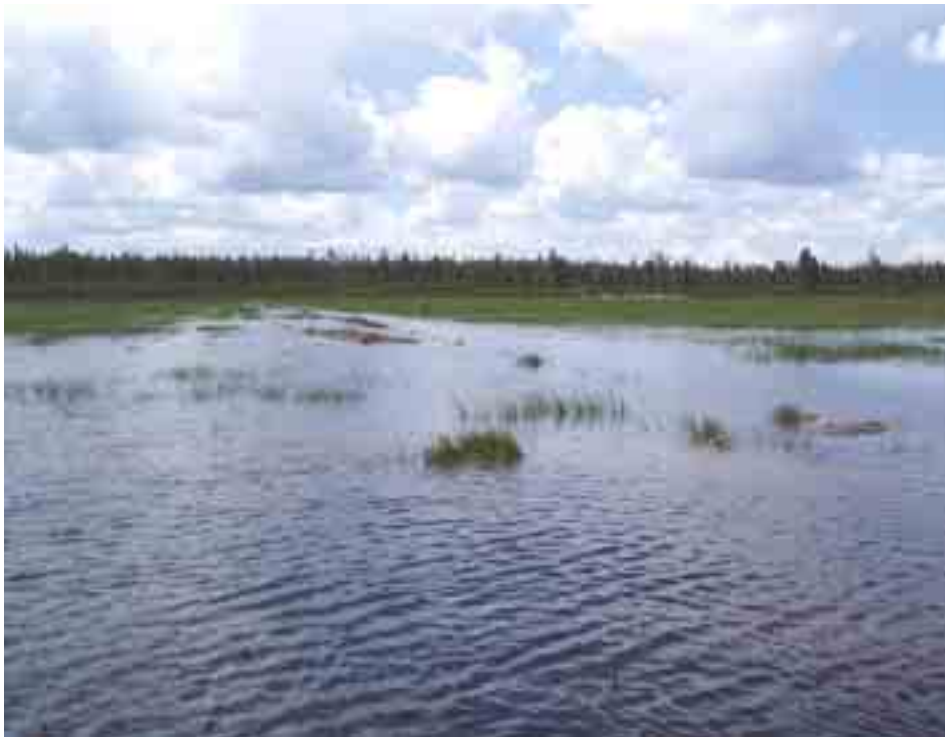
Photo 6: AFTER photo showing better than expected water inundation. The old ditch spoils were used along with thinned lodgepole to create the dams to disperse the water and restore hydrologic function. Outstanding!

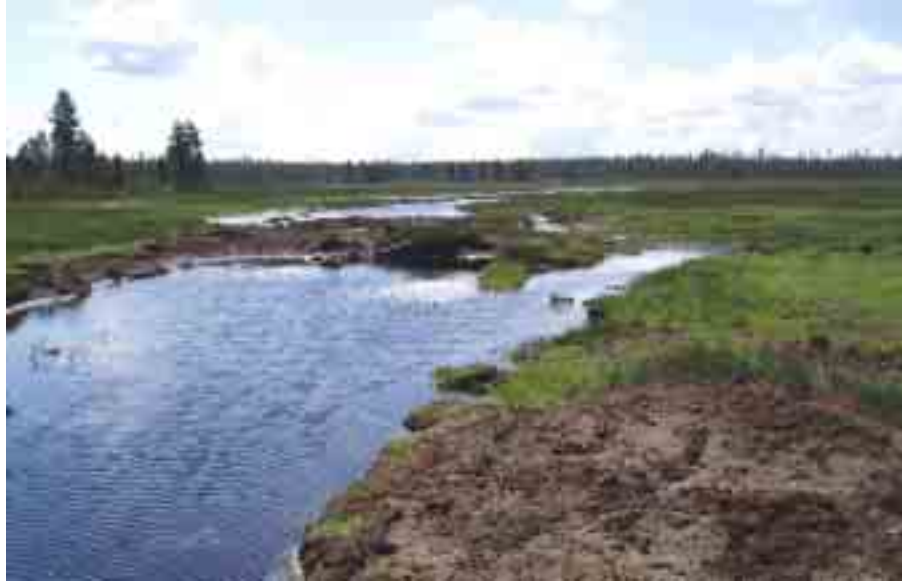
2. The next area needing maintenance is at the old culvert crossing as shown by the photo below. First off the old road and wheel ruts leading into this crossing from the right should be modified to allow water to disperse onto the meadow rather than concentrating the flows back into the ditch. Need to disperse as much of the water as possible to elevate unnecessary erosion energy. The second and final maintenance work would be to reinforce the two dams. Again this would place sod at low point to raise the elevation of the dam where it meets the meadow to prevent concentrated flow, erosion, and headcutting upstream. Work also needs to occur to completely plug the culverts. This work could be done with an excavator or hand crew.
