# Long-Term Performance of Epoxy-Coated Reinforcing Steel in Heavy Salt-Contaminated Concrete

PUBLICATION NO. FHWA-HRT-04-090

JUNE 2004

U.S. Department of Transportation  
**Federal Highway Administration**

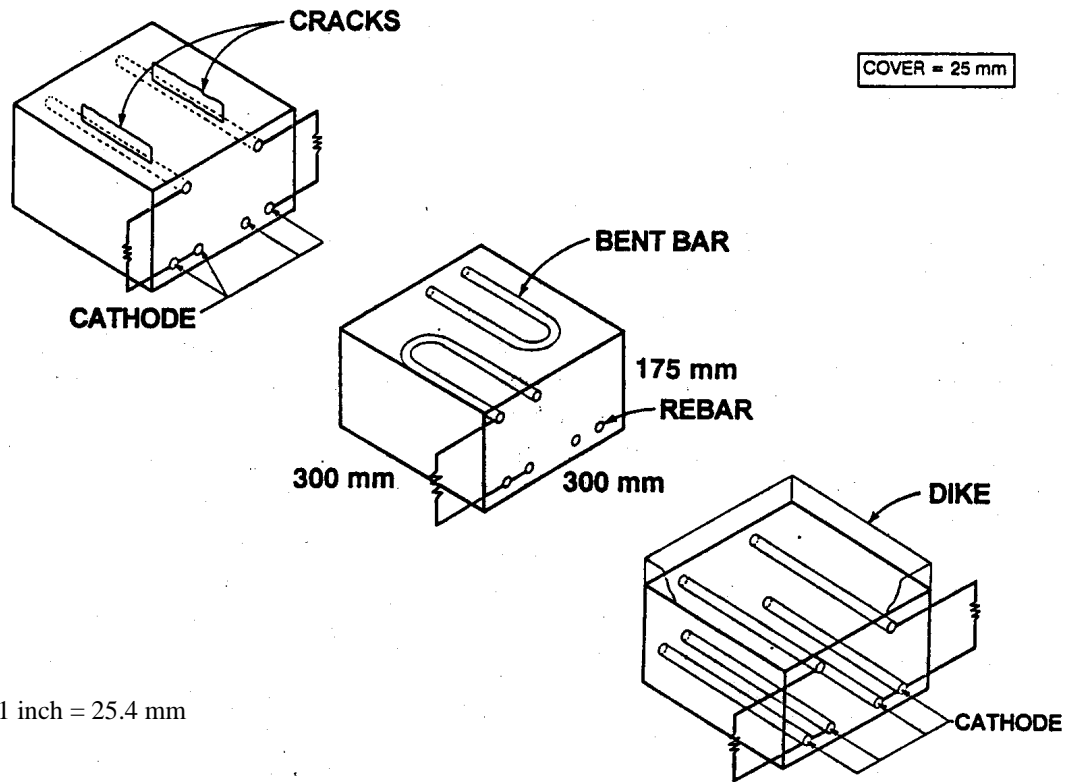
Figure 1. Configuration of test slab

Configuration of the concrete slabs used in this FHWA study measured 30.5 x 30.5 x 17.8 centimeters (cm) (12 x 12 x 7 inches) and contained two layers of 29.2-cm (11.5-inch) long and 1.6-cm (5/8-inch) diameter reinforcement, as shown in figure 1. The top mat acted as a macroanode and contained either two straight or two bent reinforcing bars, while the bottom mat was a macrocathode that contained four straight reinforcing bars. The top mat bar was connected to two bottom mat bars through a 10 Ω resistor. A clear cover of 25.4 millimeters (mm) (1.0 inch) was used in all specimens. This cover conforms to either the American Association of State Highway and Transportation Officials- (AASHTO) specified bottom-of-slab cover, or possible minimum in-place clear cover, allowing for construction tolerances when 3.8- to 5.0-cm (1.5- to 2.0-inch) cover requirements are specified. While most previous published corrosion studies used only crack-free concrete slabs, some of the test slabs used in this project contained the cracks directly over a top mat rebar to simulate cracks observed on actual bridge decks. Table 1 presents the concrete mix design data for the test slab concrete.

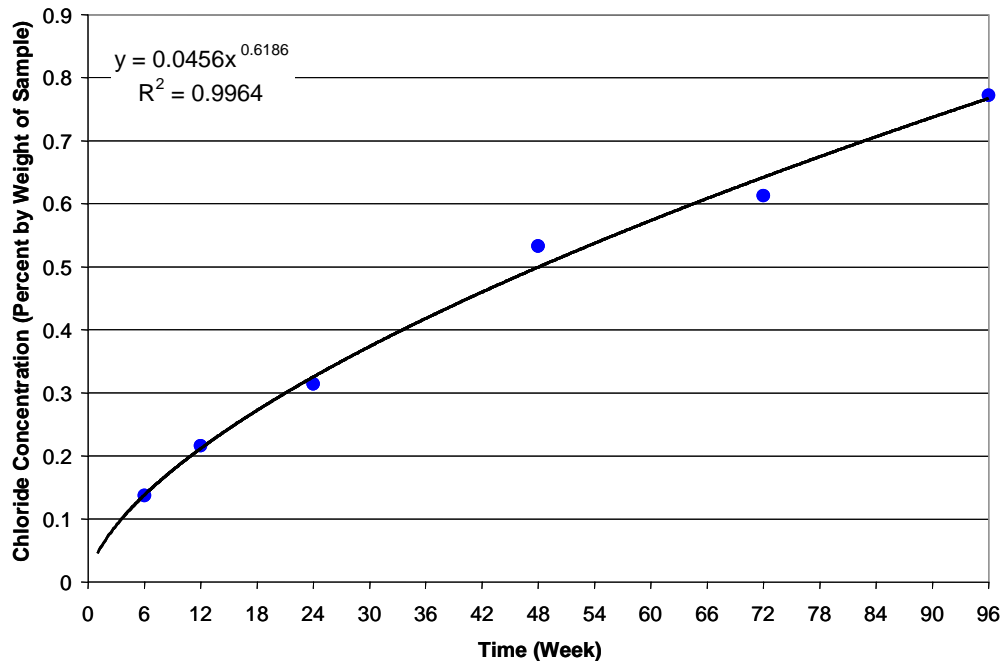
Figure 2. Estimated chloride accumulation at 25.4 mm (1.0 inch) depth with time in the concrete test slab

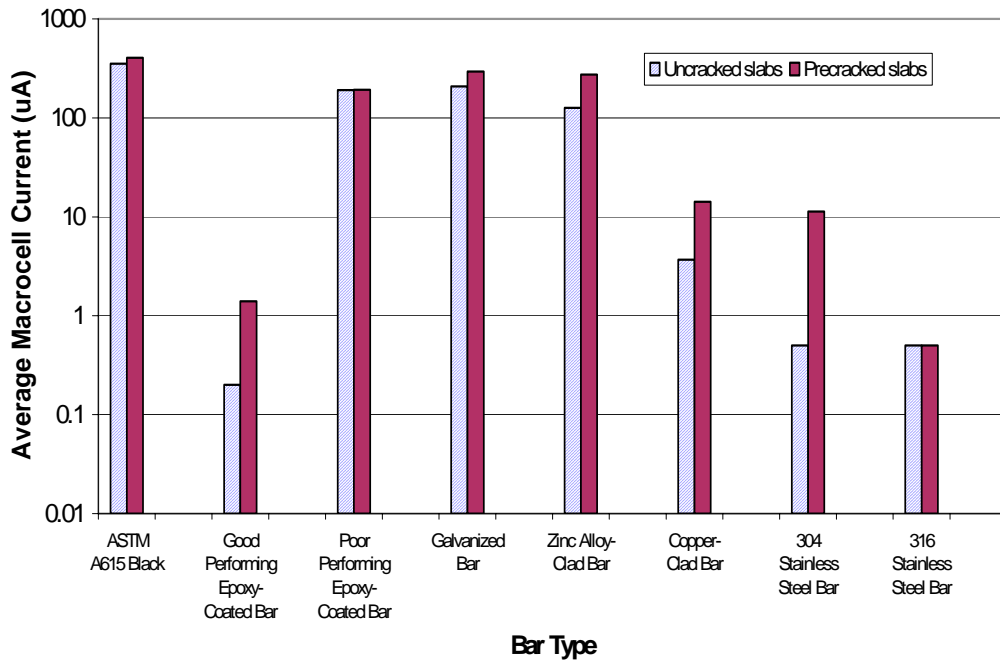
Figure 3. Average macrocell current data of eight reinforcing bar materials for 96-week SE tests

Table 3 summarizes the performance data of seven different rebar materials tested under the 96-week FHWA test program. Figures 3 and 4 show average macrocell current and mat-to-mat AC resistance data of each type reinforcing bar in table 3. Furthermore, table 4 classifies average macrocell current and mat-to-mat AC resistance of the ECR slabs for each coating type. The 96-week FHWA study concluded that the best ECR performance was obtained when the bars were tested in a straight condition, with 0.004 percent damage in uncracked concrete using an ECR cathode in the bottom mat. Researchers also found that there was a clear relationship between the mat-to-mat resistance values of the ECRs and their corrosion performance. Better corrosion protection was provided by those coating systems that had high electrical resistance, that is, the corrosion was strongly dependent on the amount of damage in the coating.<sup>[4]</sup>

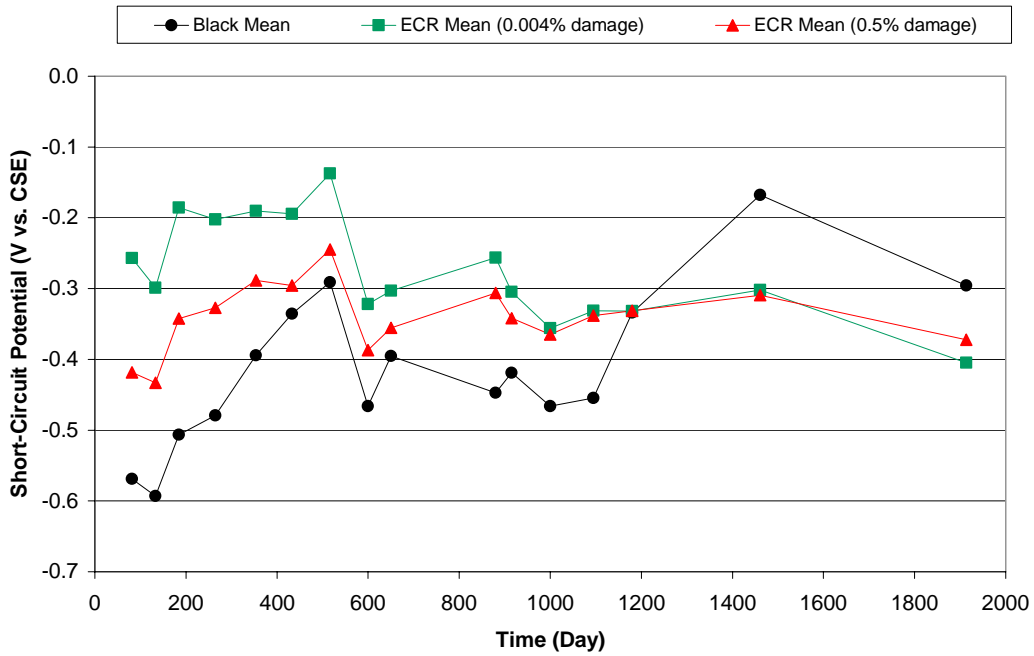
Figure 5. Short-circuit potential change with time (straight top (black and ECR)-black bottom-uncracked concrete) during outdoor exposure

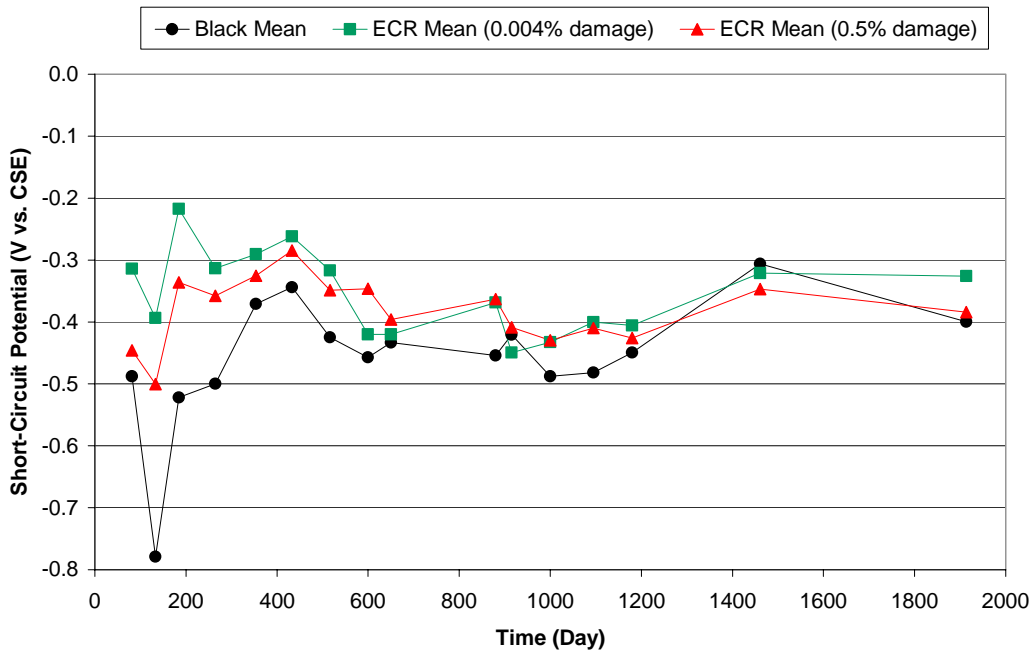
Figure 7. Short-circuit potential change with time (straight top (black and ECR)-black bottom-cracked concrete) during outdoor exposure

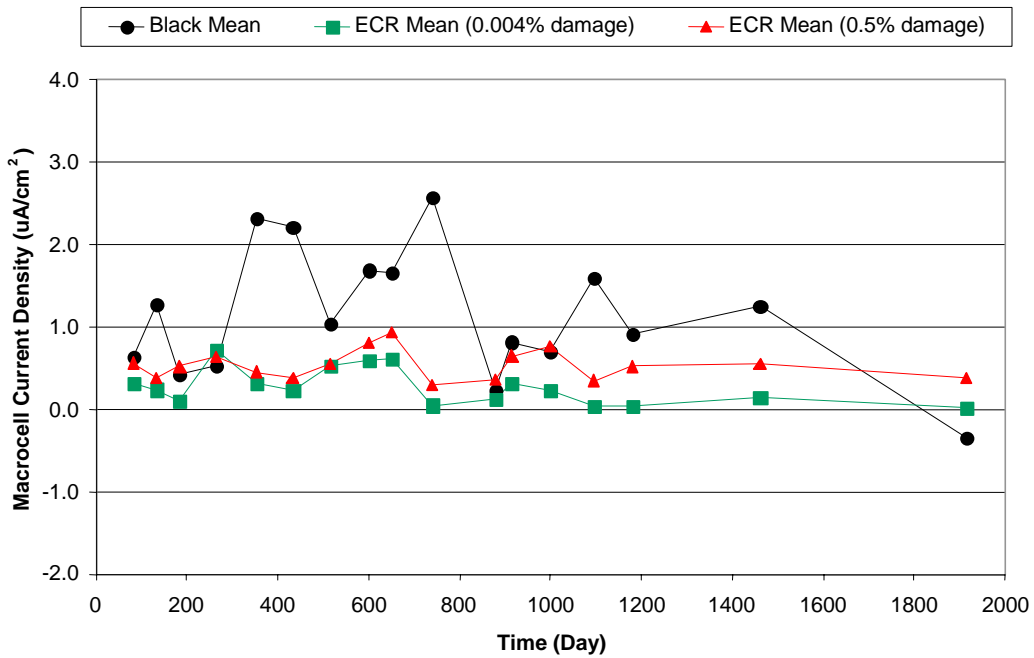
Figure 8. Macrocell current density change with time (straight top (black and ECR)-black bottom-cracked concrete) during outdoor exposure

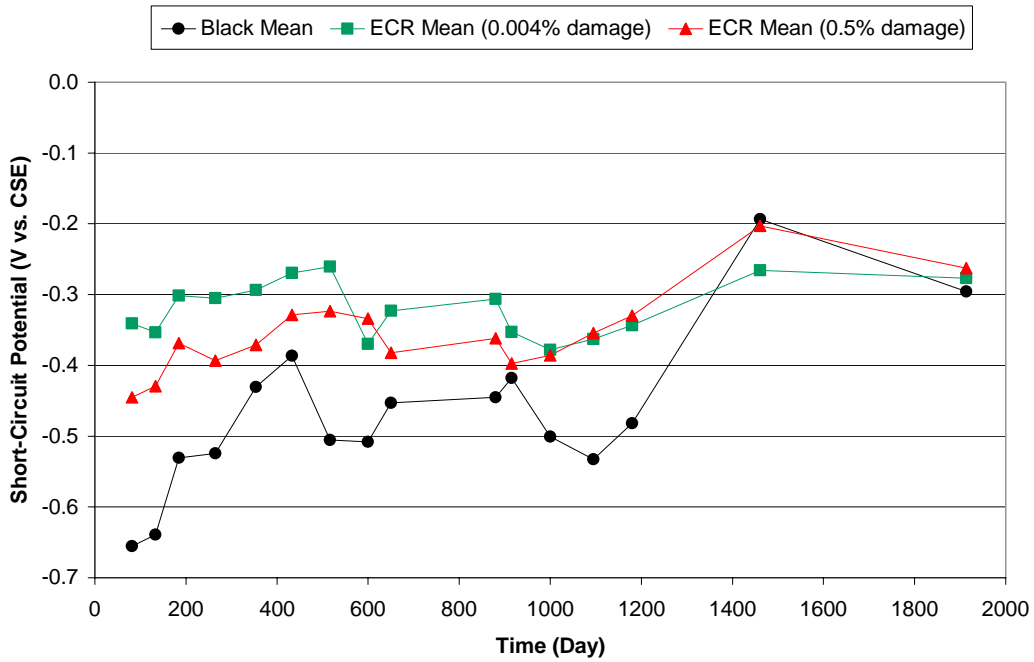
Figure 9. Short-circuit potential change with time (bent top (black and ECR)-black bottom-uncracked concrete) during outdoor exposure

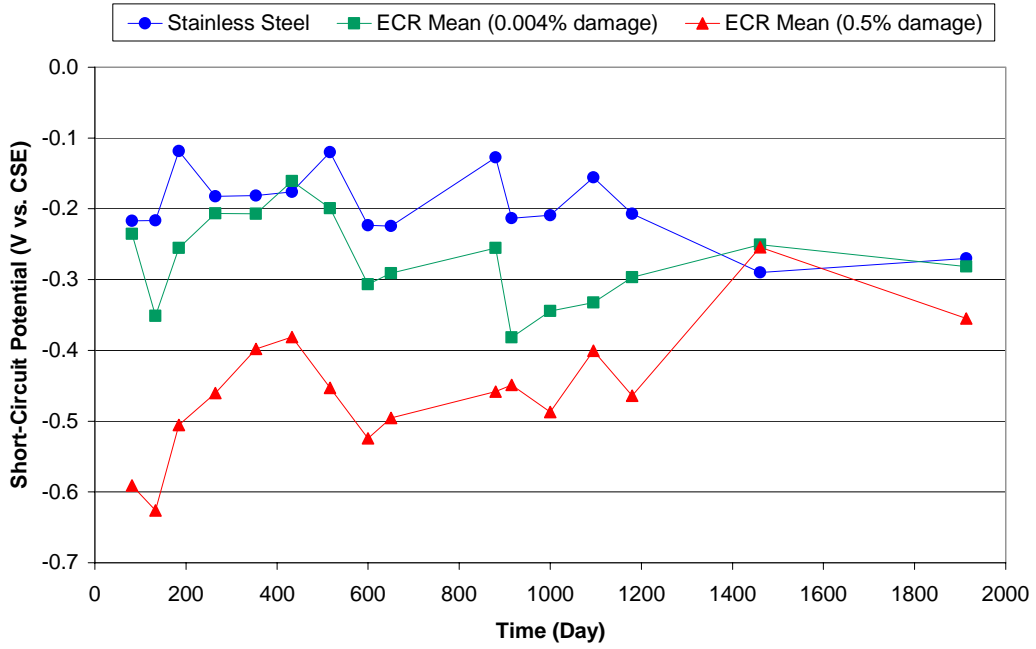
Figure 11. Short-circuit potential change with time (stainless steel and ECR in both mats-uncracked concrete)

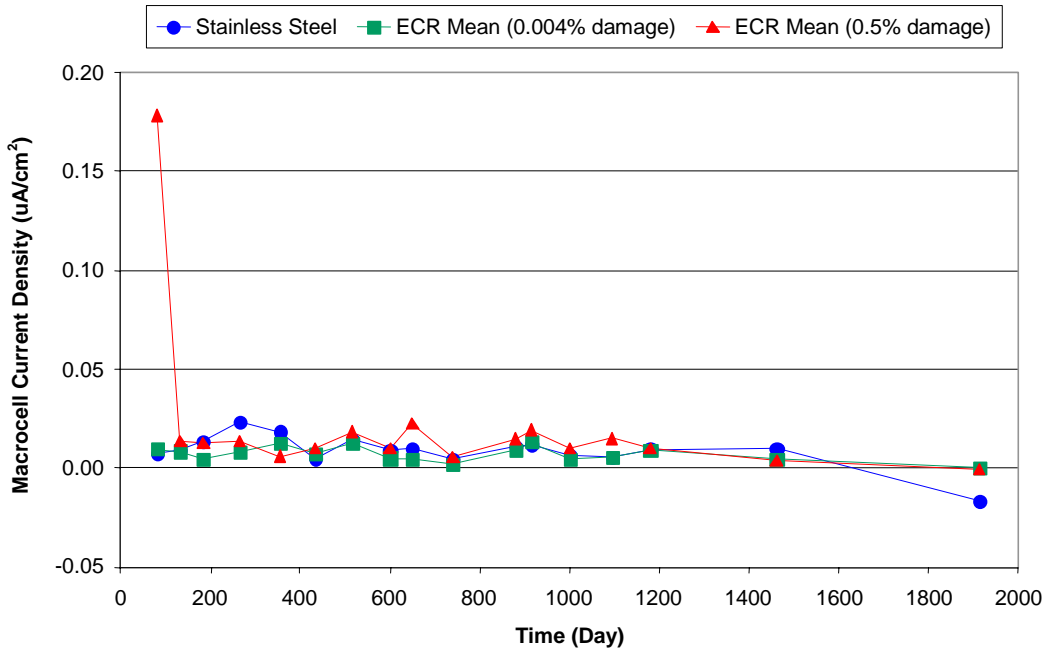
Figure 12. Macrocell current density change with time (stainless steel and ECR in both mats-uncracked concrete)

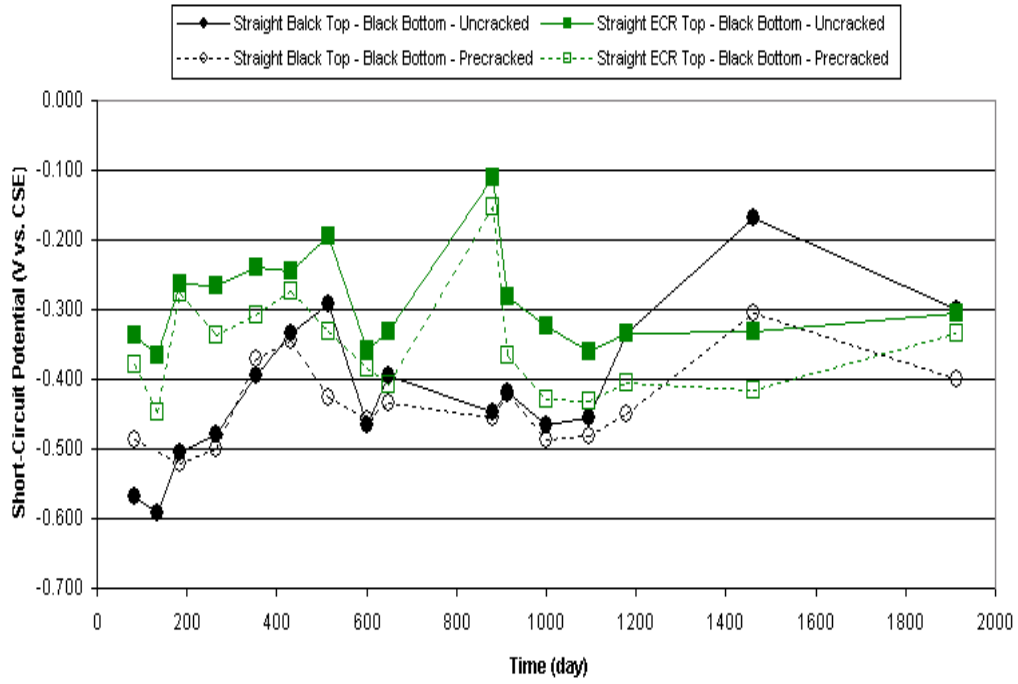
Figure 13. Mean short-circuit potential change with time (uncracked vs. precracked concrete)

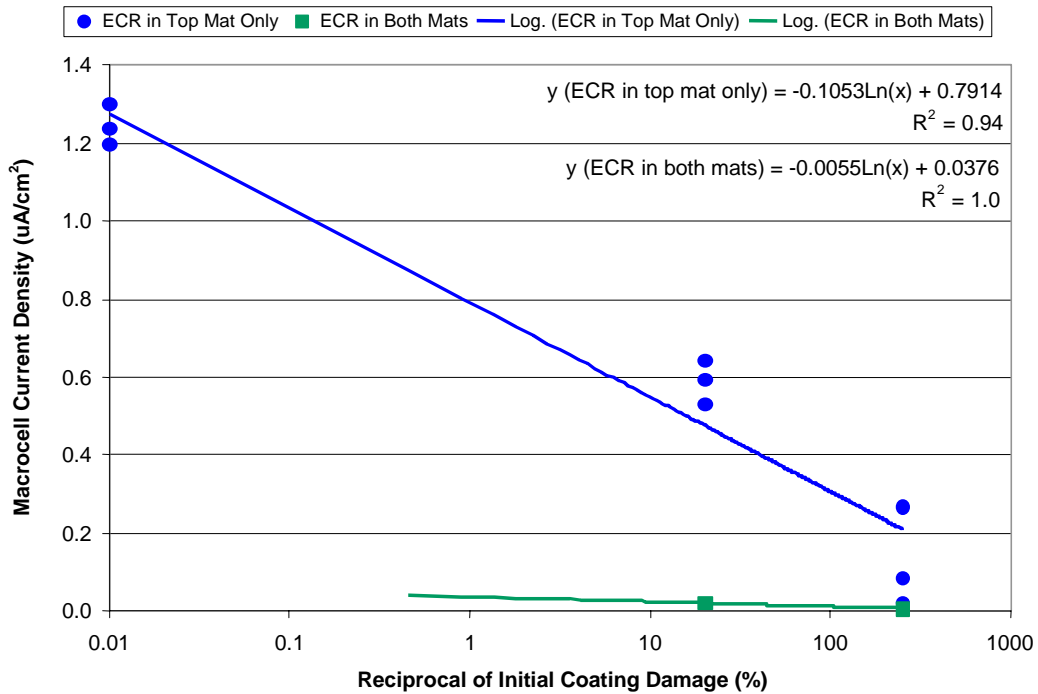
Figure 20. Relationship between macrocell current density versus initial artificial coating defects

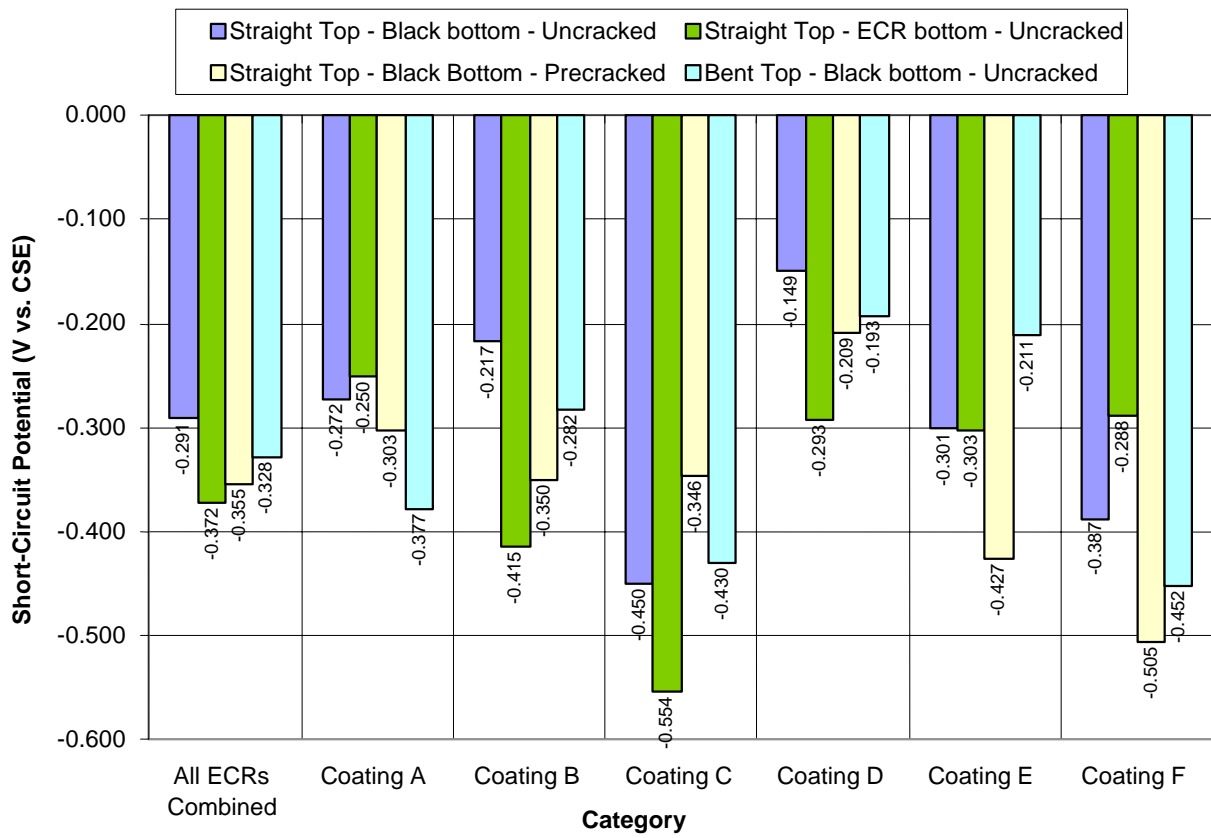
Figure 21. Short-circuit potential data classified by coating type

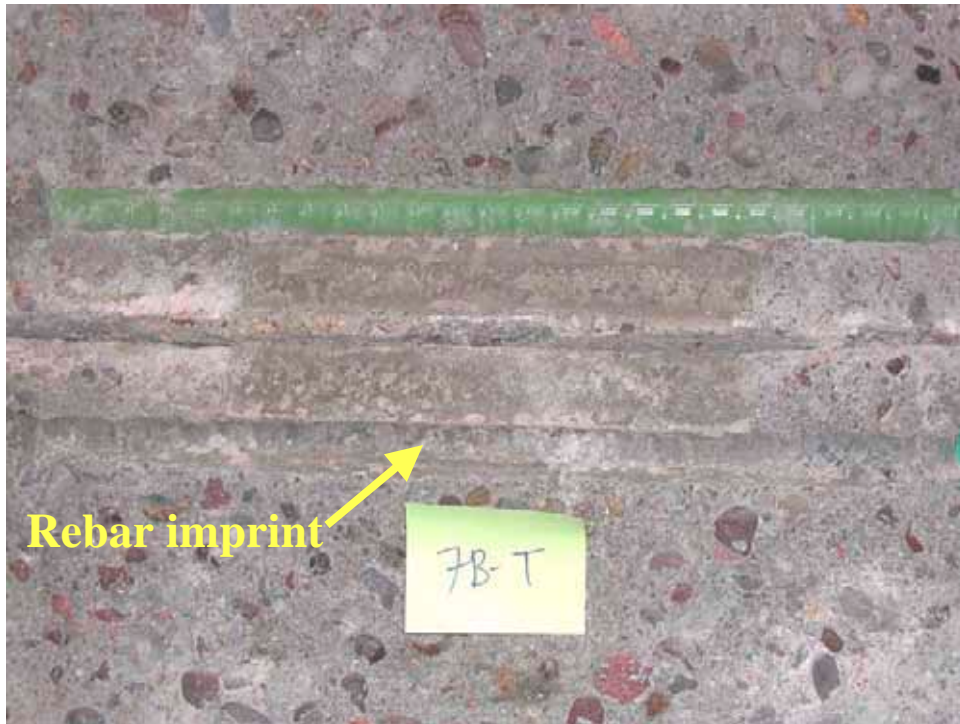
Figure 29. Typical condition of ECR with good corrosion resistance (slab #7—top right bar)

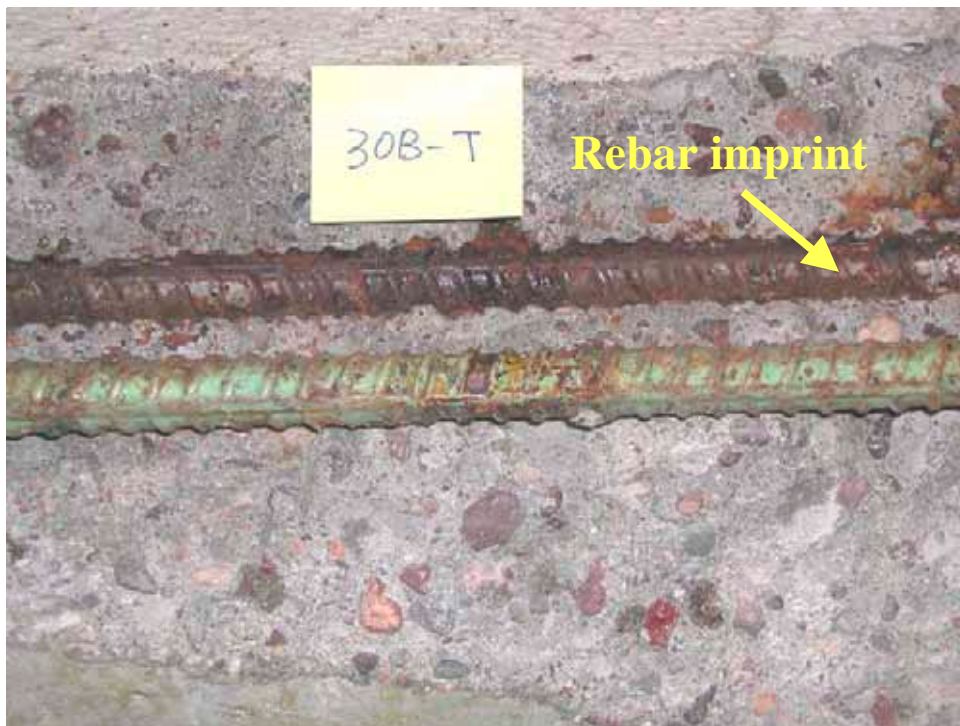
Figure 30. Typical condition of ECR with poor performance (slab #30—top right bar)

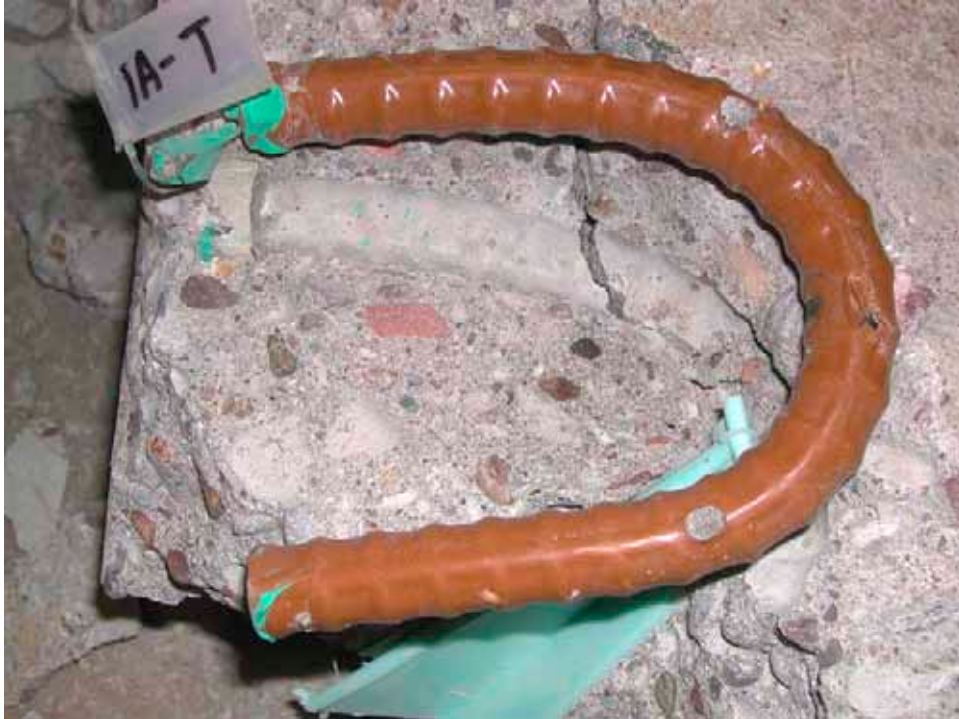
Figure 31. Typical condition of a bent ECR with good performance (slab #1—top left bar)

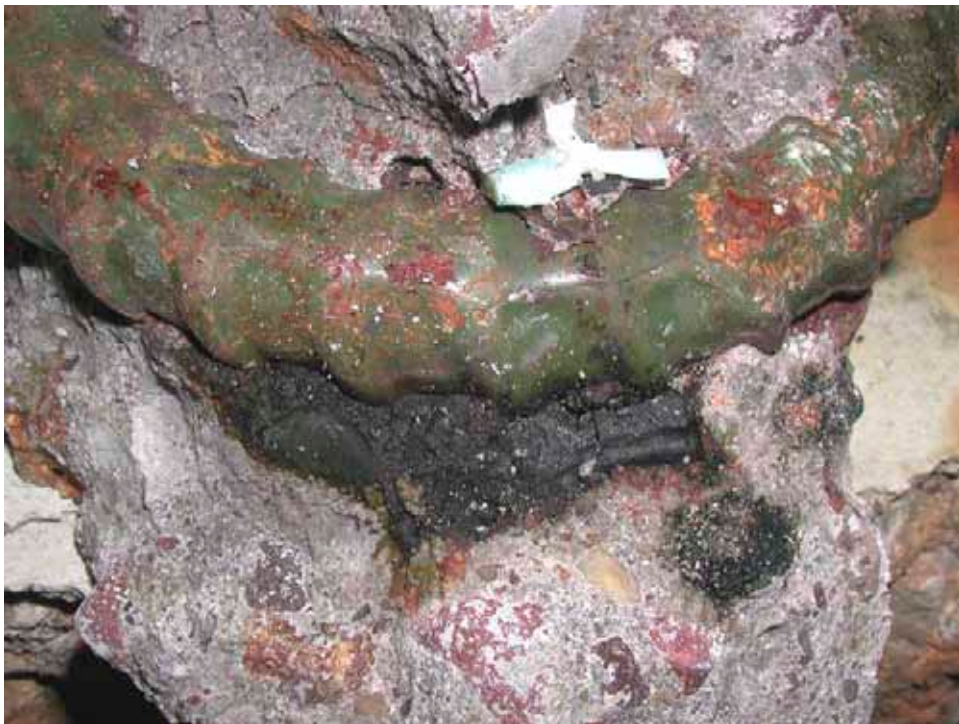
Figure 32. Typical condition of a bent ECR with poor performance

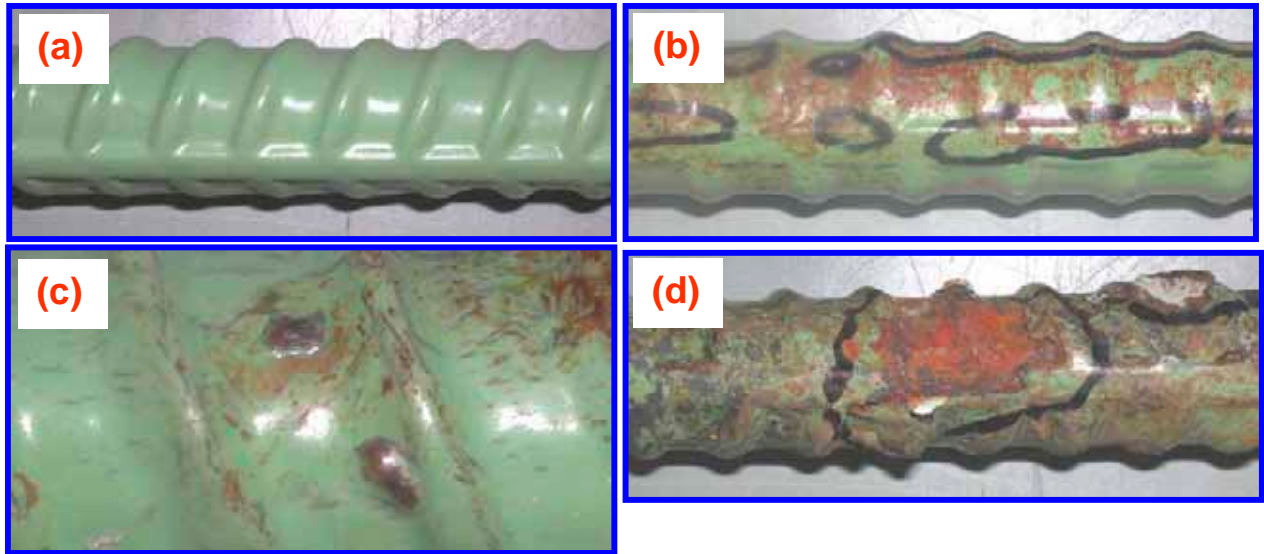
Figure 33. Closeup views of ECRs exhibiting various conditions: (a) an intact ECR; (b) an ECR containing hairline coating cracks; (c) an ECR containing coating blisters and hairline coating cracks; and (d) a delaminated ECR revealing severely corroded substrate

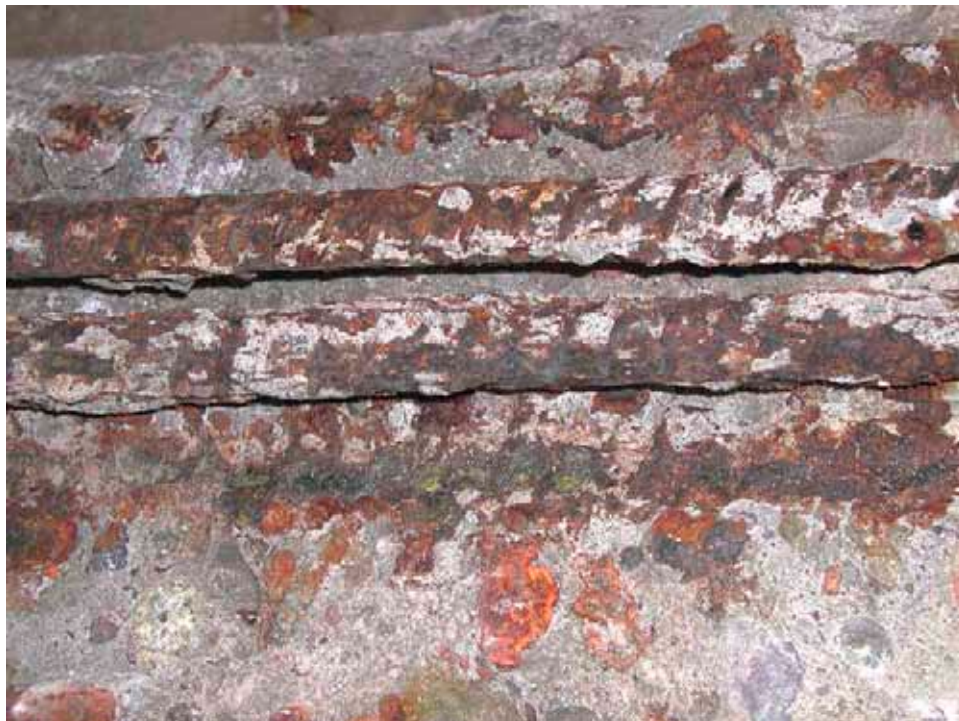
Figure 34. Typical condition of black bars in the top mat

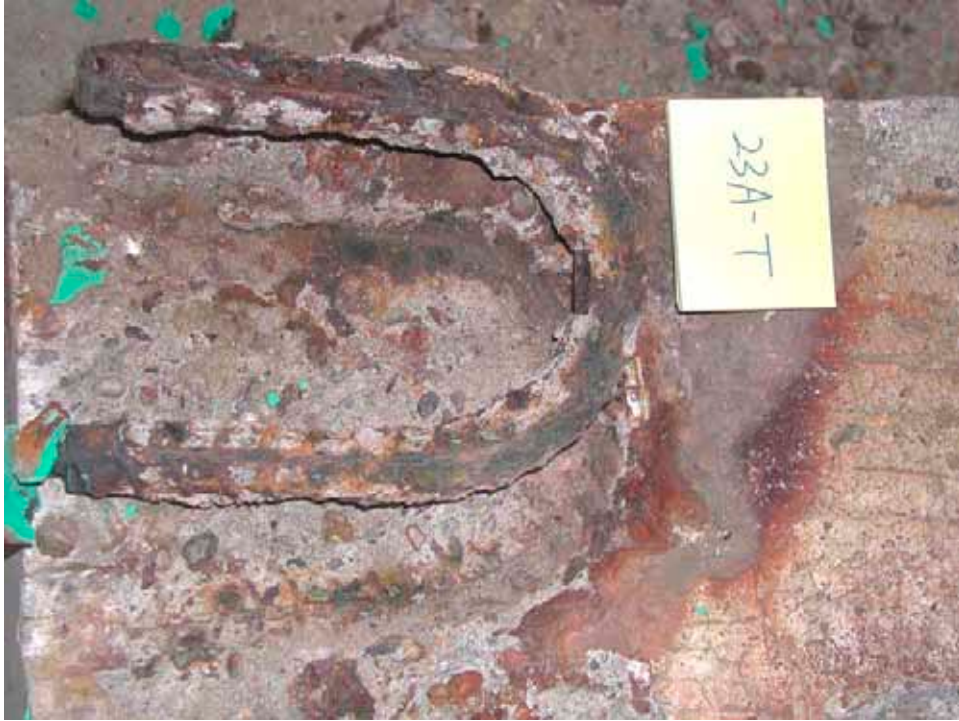
Figure 35. Typical condition of black bent bars in the top mat (slab #23—top right bar)

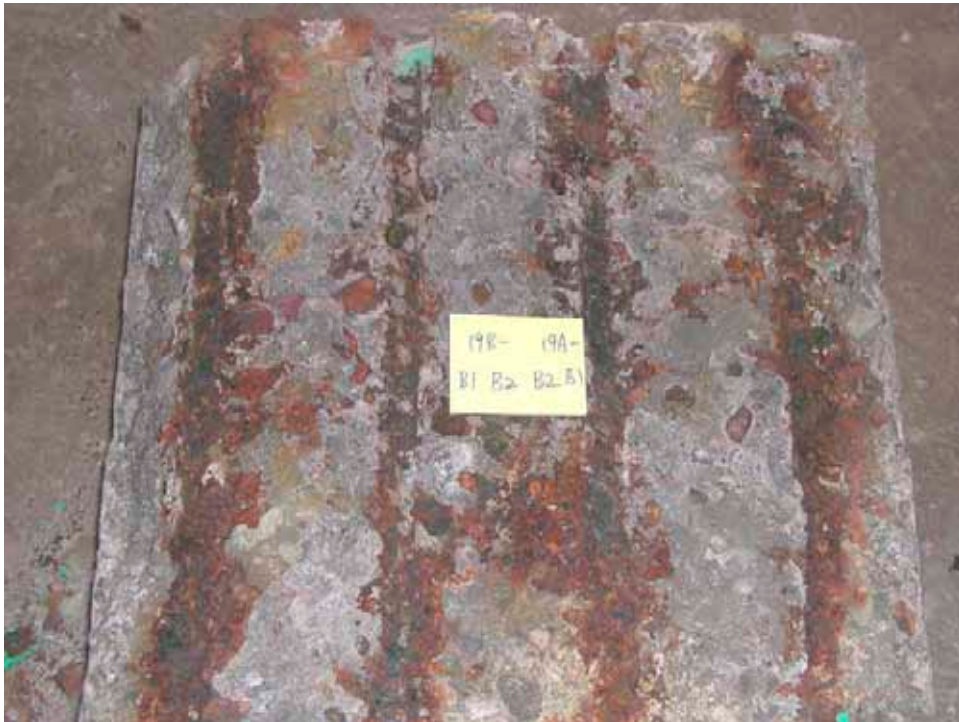
Figure 36. Corroded bottom mat (slab #19)

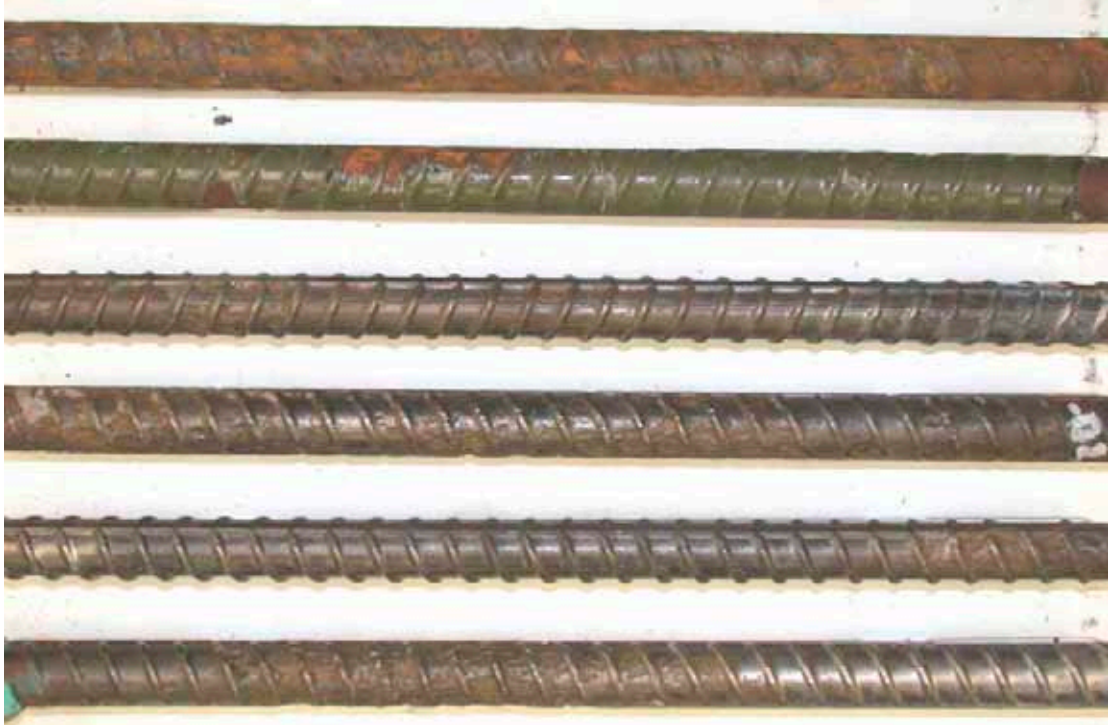
Figure 37. Photograph of autopsied bars extracted from slab #18 (ECR top-black bar bottom)

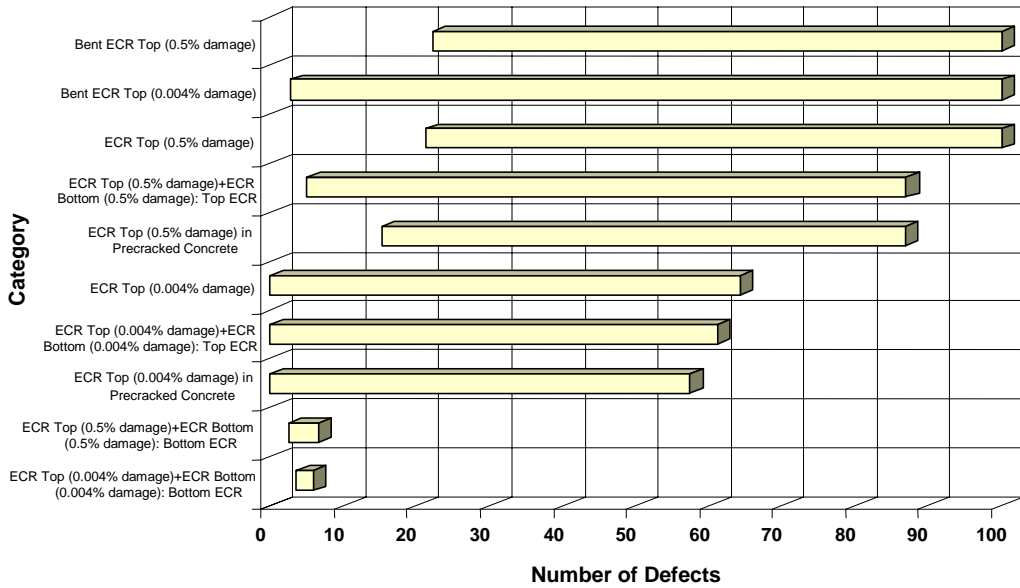
Figure 39. Ninety-five percent confidence intervals for number of final defects

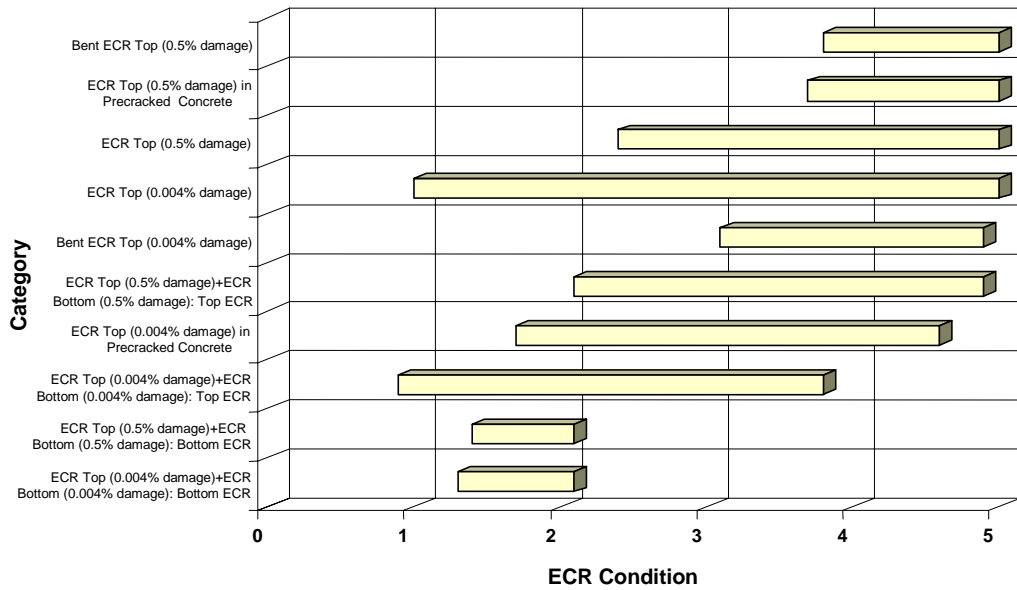
Figure 40. Ninety-five percent confidence intervals for ECR rating data

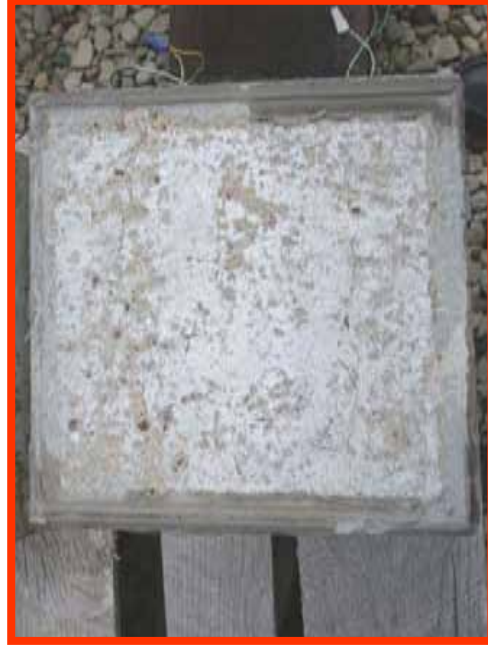
Specimen ID	12A	12B
Top mat	Coating C	Coating C
Bar shape (straight/bent)	Straight	Straight
Coating defect (%)	0.5	0.004
Bottom mat	Coating C	
Coating defect (%)	0.5	0.004
Precracked	No	No

Figure 78. Slab #12 front, rear, and top views with specifications
