5. SUMMARY OF OBSERVATIONS AND FINDINGS

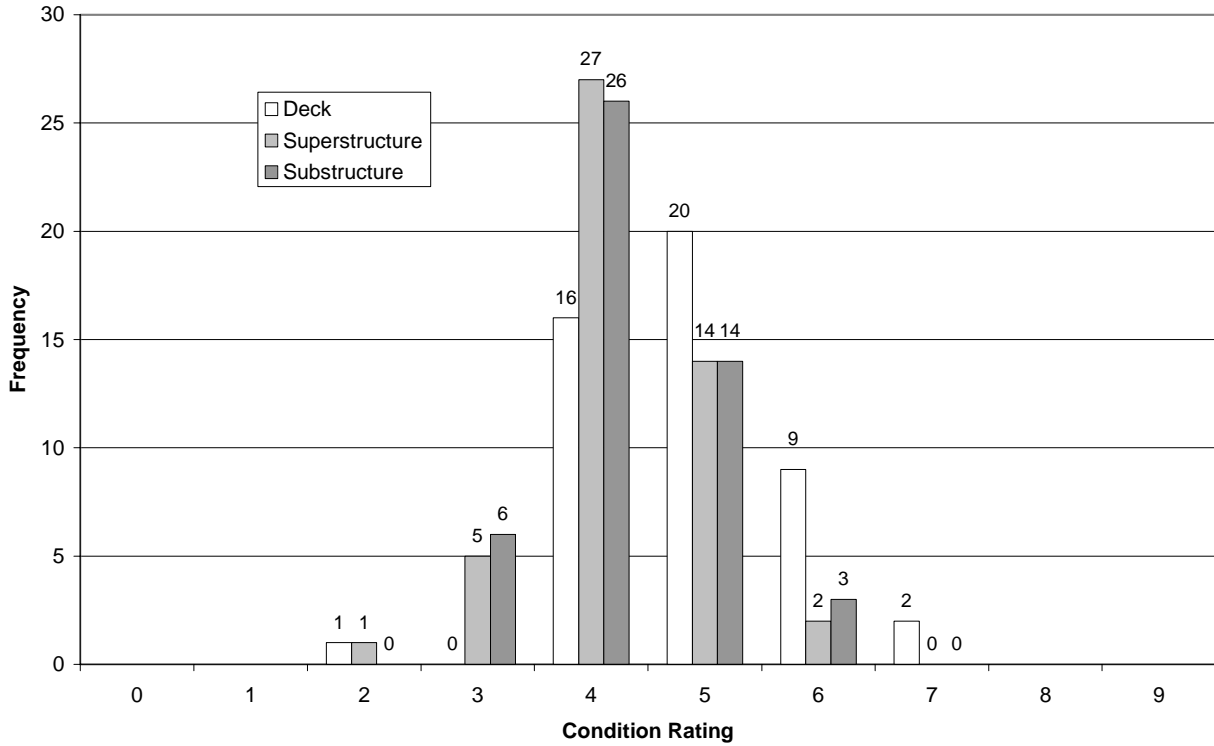
Figure 56. Task B – Condition Rating frequency distribution.

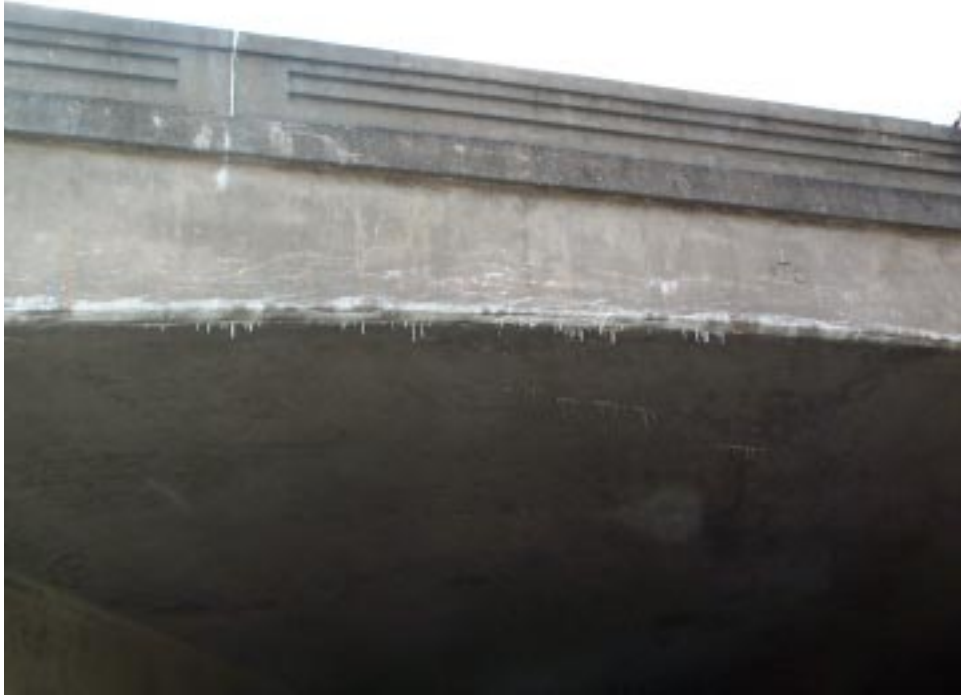
Figure 87. Inspector Photograph 1 – Longitudinal cracking in southern face of superstructure.

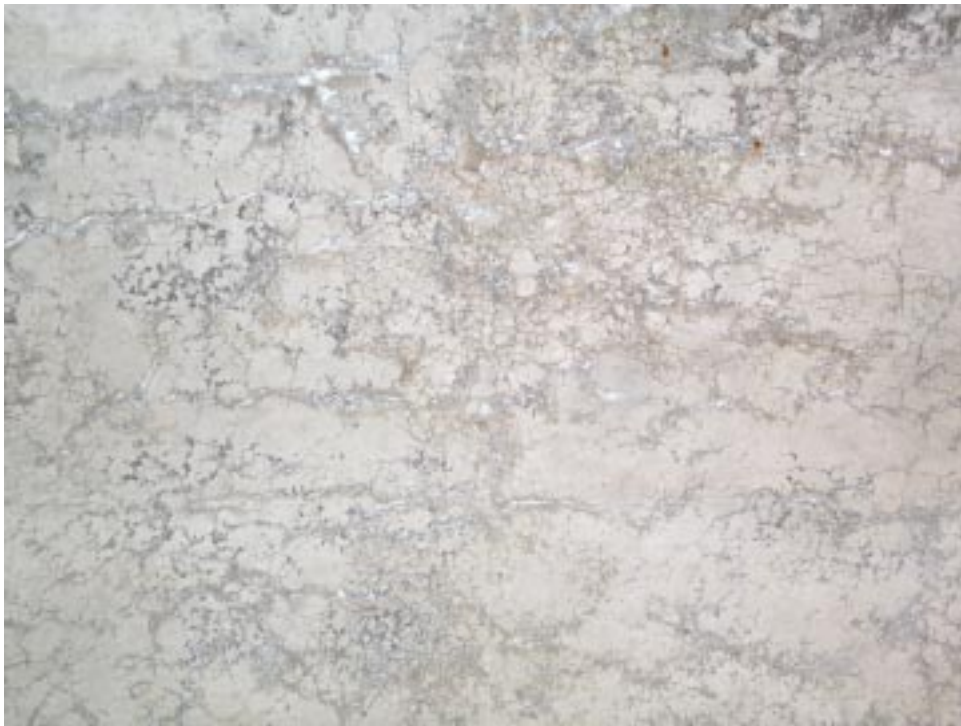
Figure 88. Inspector Photograph 2 – Typical underside deck cracking.

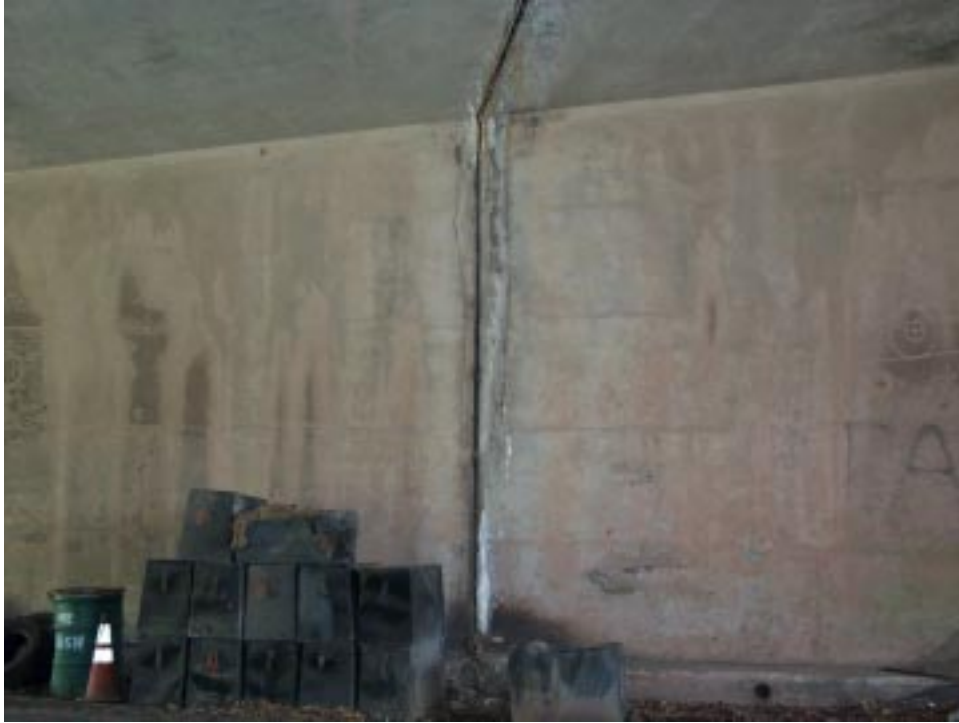
Figure 89. Inspector Photograph 3 – West backwall longitudinal joint deterioration.

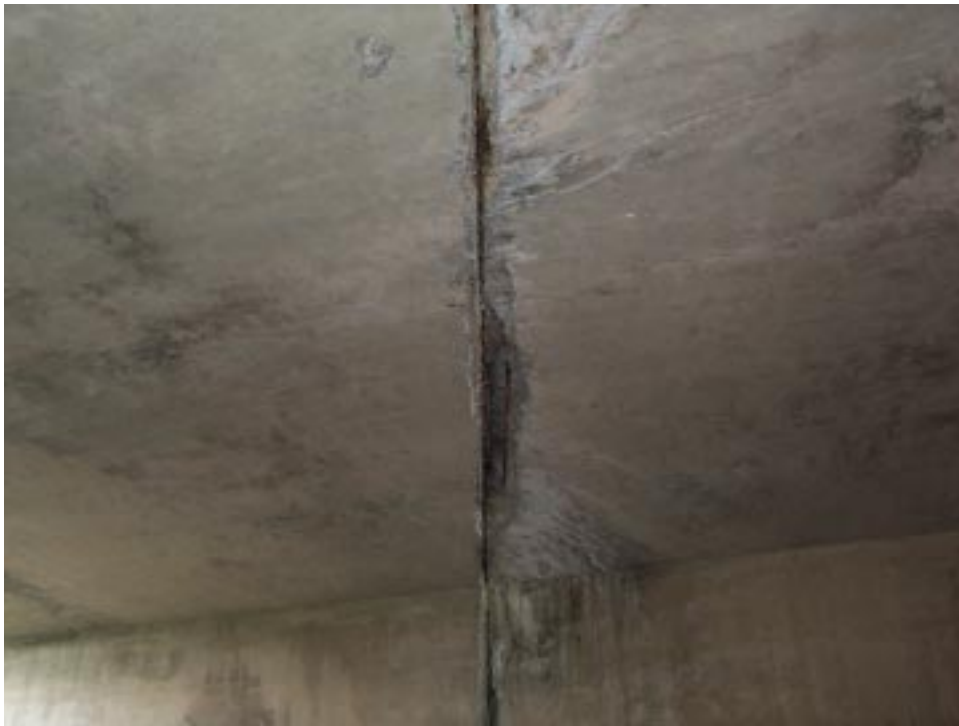
Figure 90. Inspector Photograph 4 – Underside deck longitudinal joint deterioration.

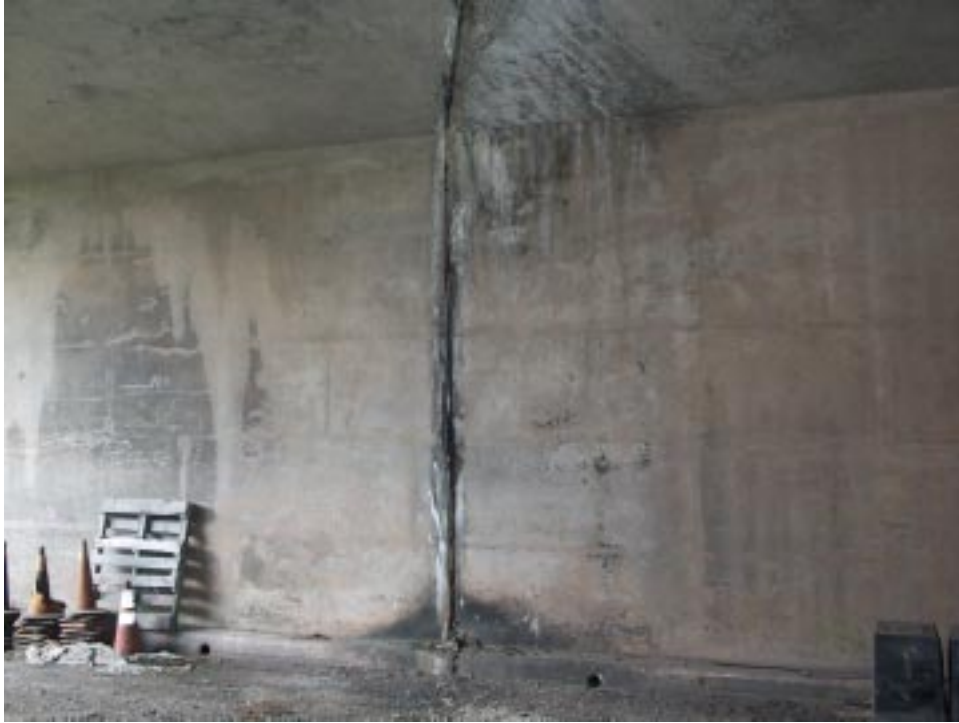
Figure 91. Inspector Photograph 5 – East backwall longitudinal joint deterioration.

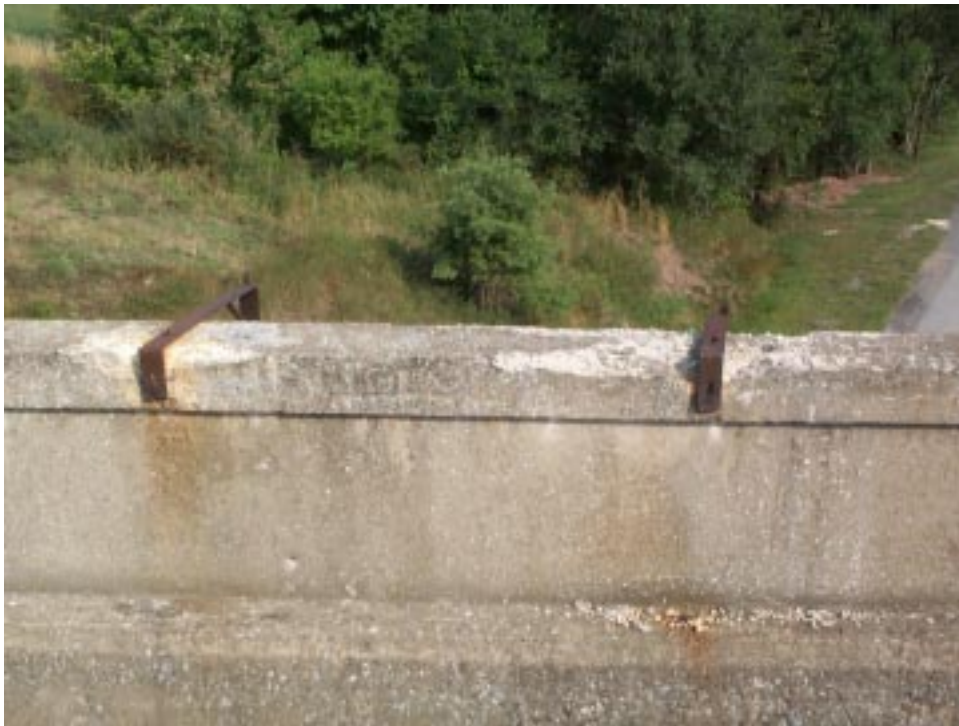
Figure 92. Inspector Photograph 6 – Failed overhead sign connection.

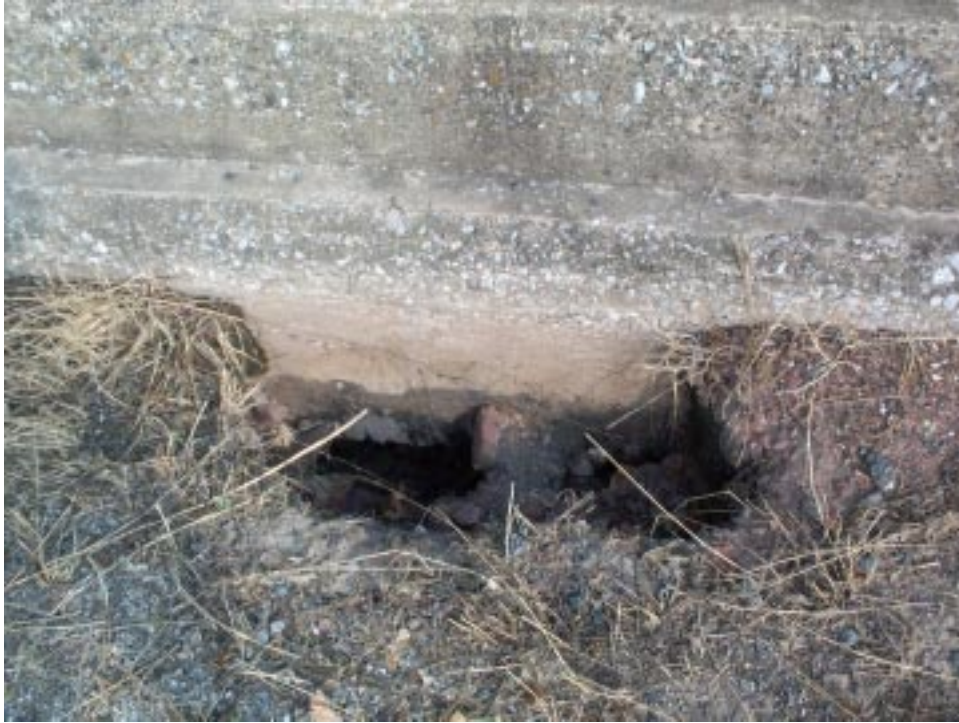
Figure 93. Inspector Photograph 7 – Hole in east approach.

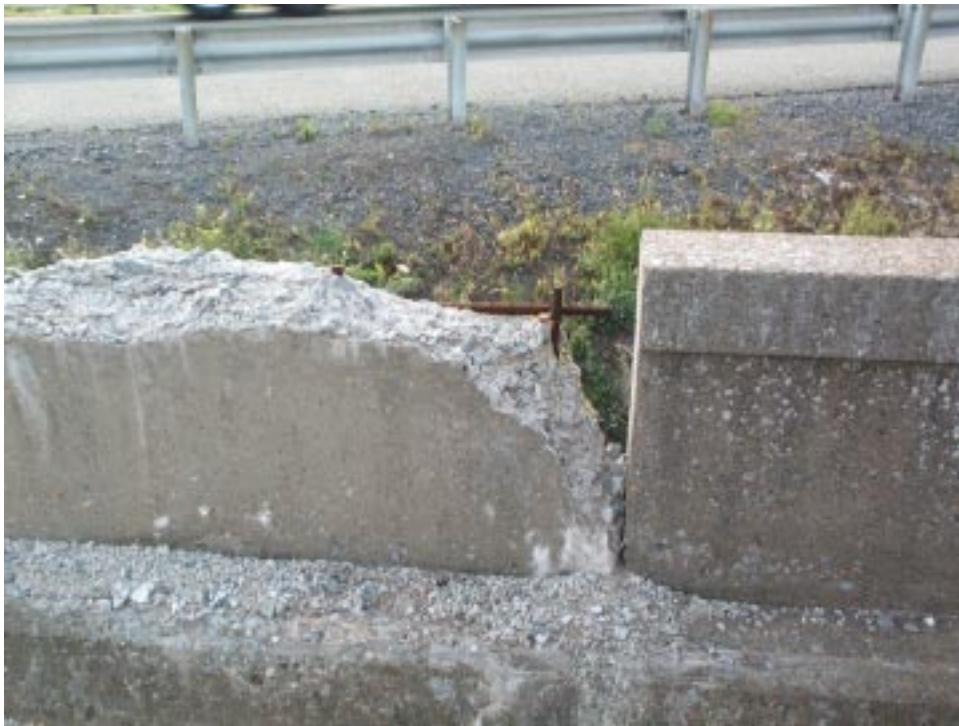
Figure 94. Inspector Photograph 8 – Typical parapet concrete deterioration and exposed reinforcement.

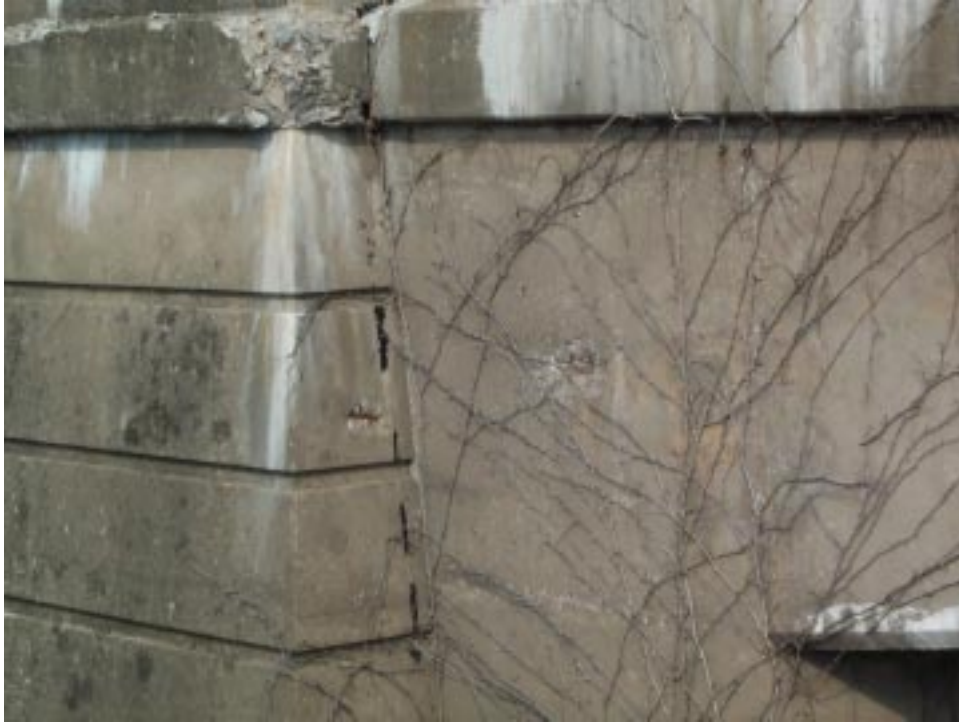
Figure 95. Inspector Photograph 9 – Localized spalling in northeast wingwall.

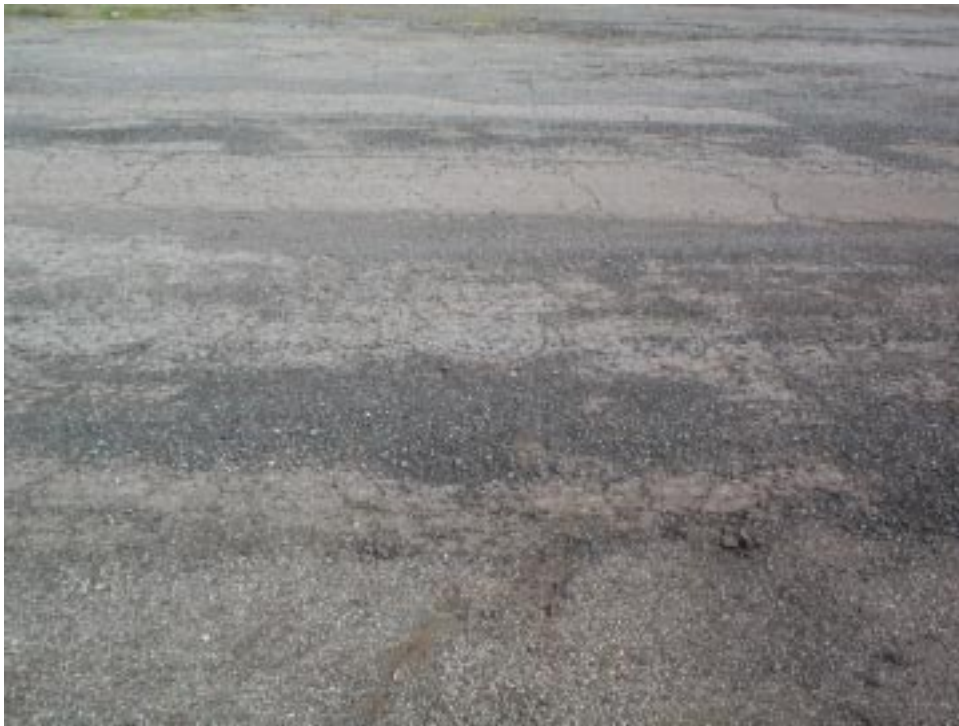
Figure 96. Inspector Photograph 10 – Typical wearing surface deterioration.

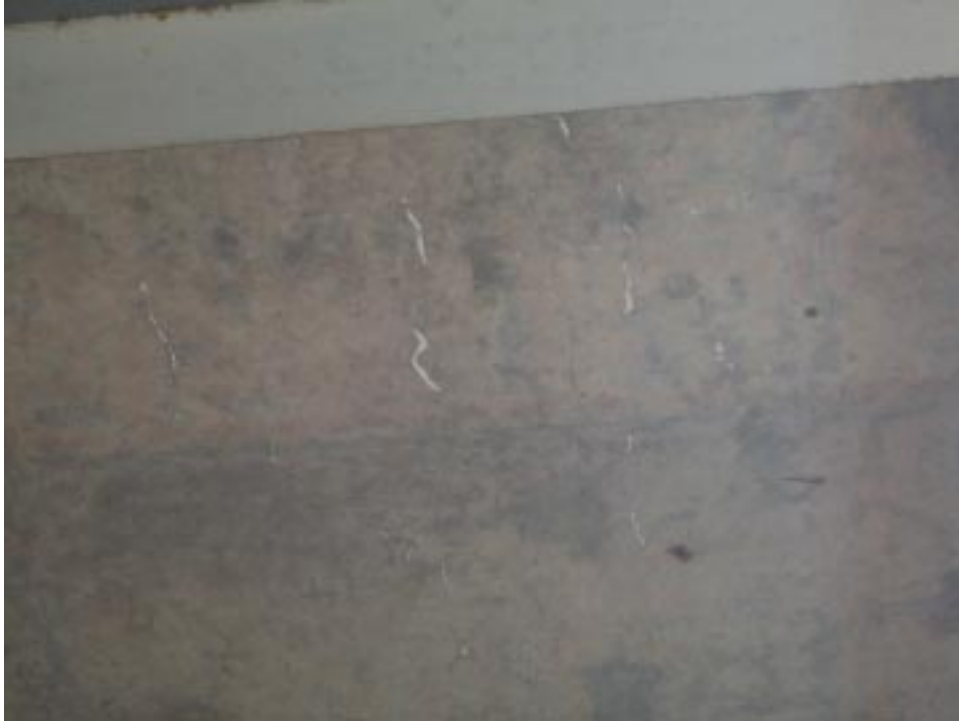
Figure 105. Deterioration described by Note A1 – Underside deck cracking and/or efflorescence.

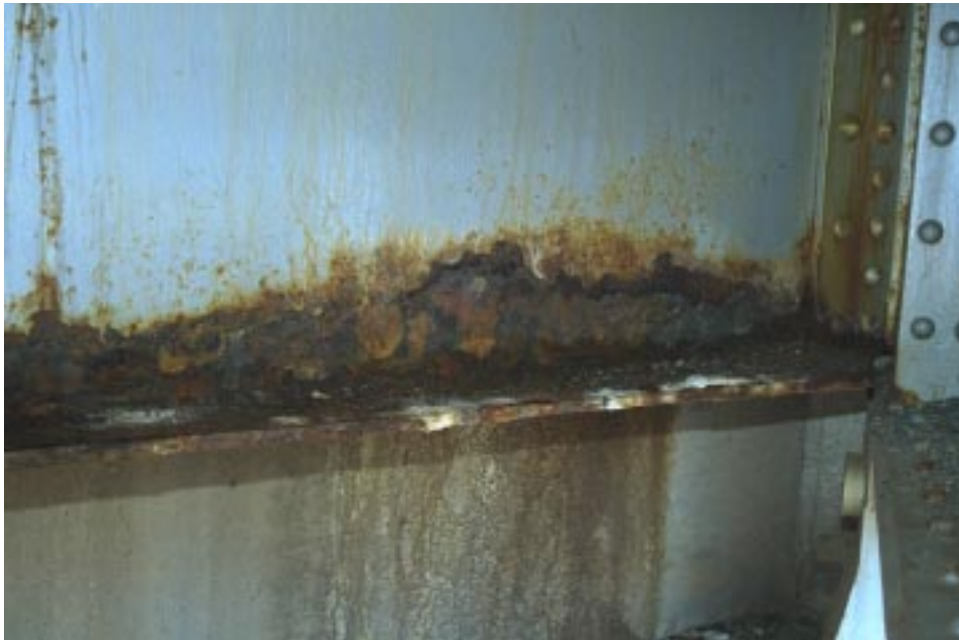
Figure 106. Deterioration described by Note A2 – Heavy corrosion of end floor beam.

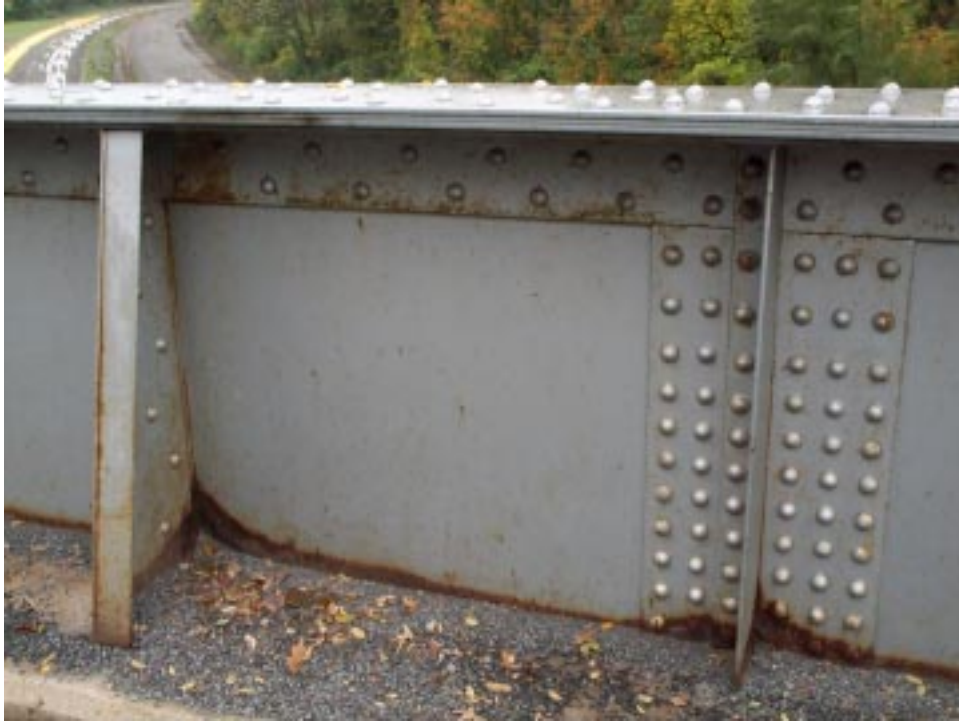
Figure 107. Deterioration described by Note A3 – Minor to moderate corrosion of stringer web at deck interface.

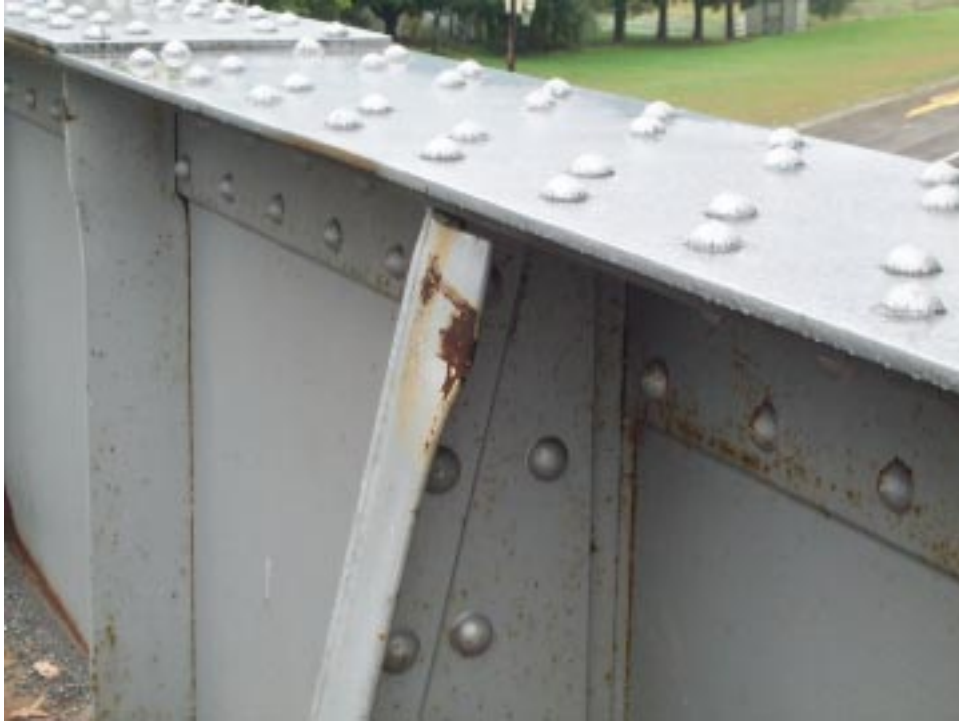
Figure 109. Deterioration described by Note A5 – Impact damage to superstructure stiffeners.

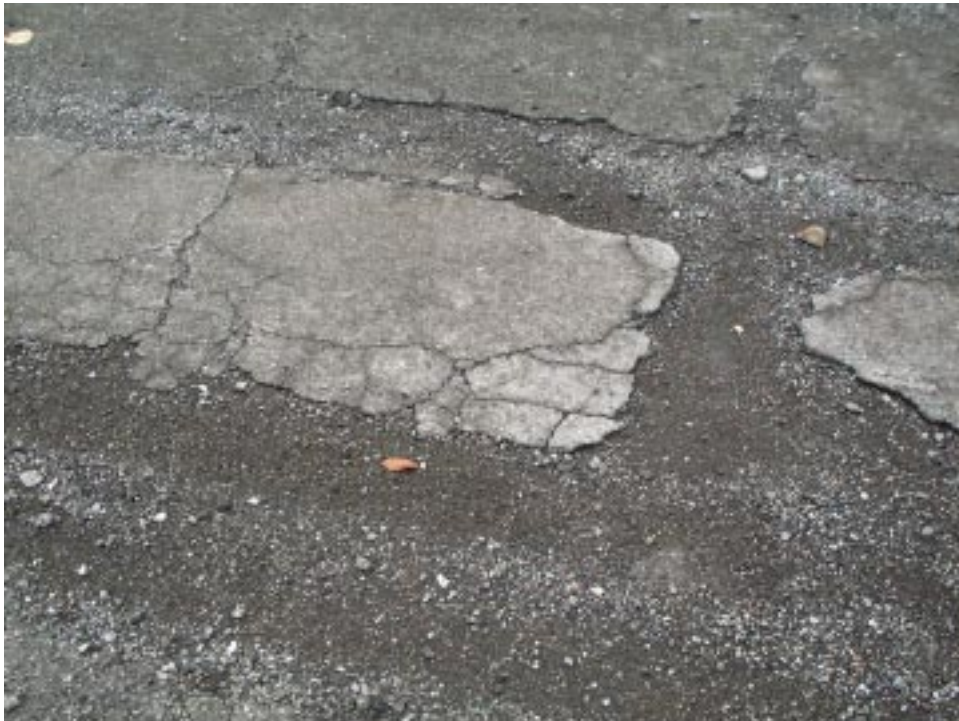
Figure 110. Deterioration described by Note B1 – Severe deterioration of wearing surface.

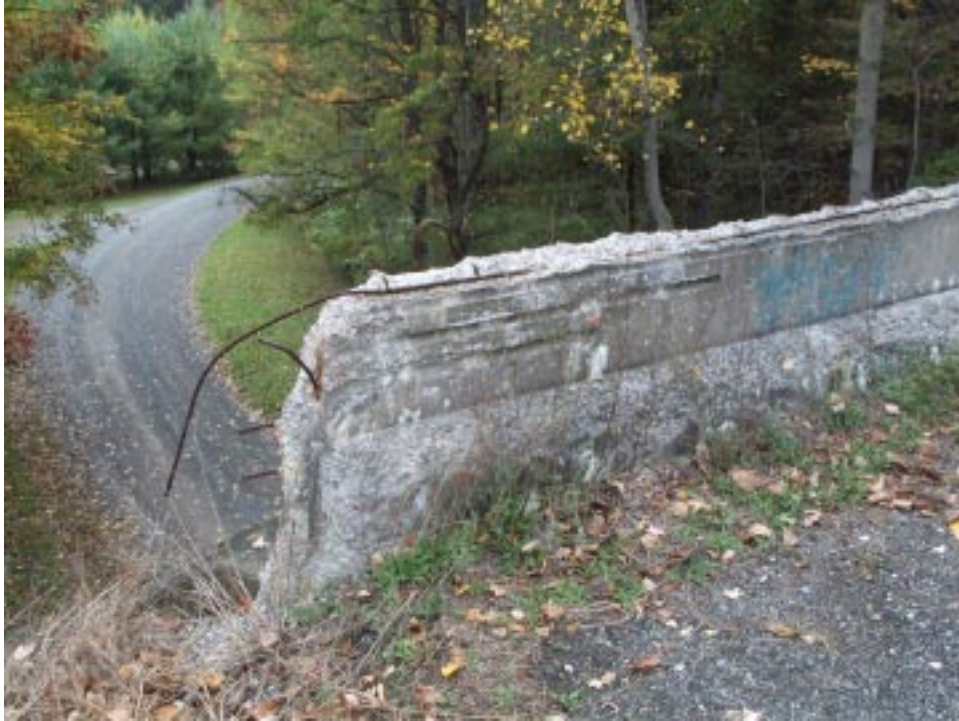
Figure 111. Deterioration described by Note B2 – Severe parapet deterioration.

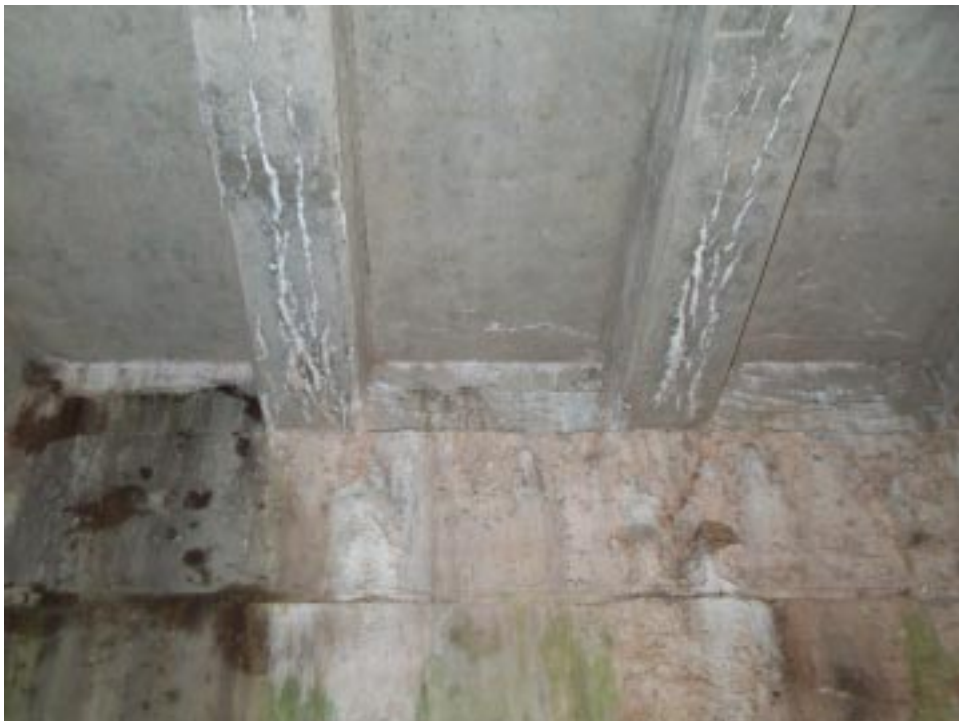
Figure 112. Deterioration described by Note B3 – T-beam deterioration.

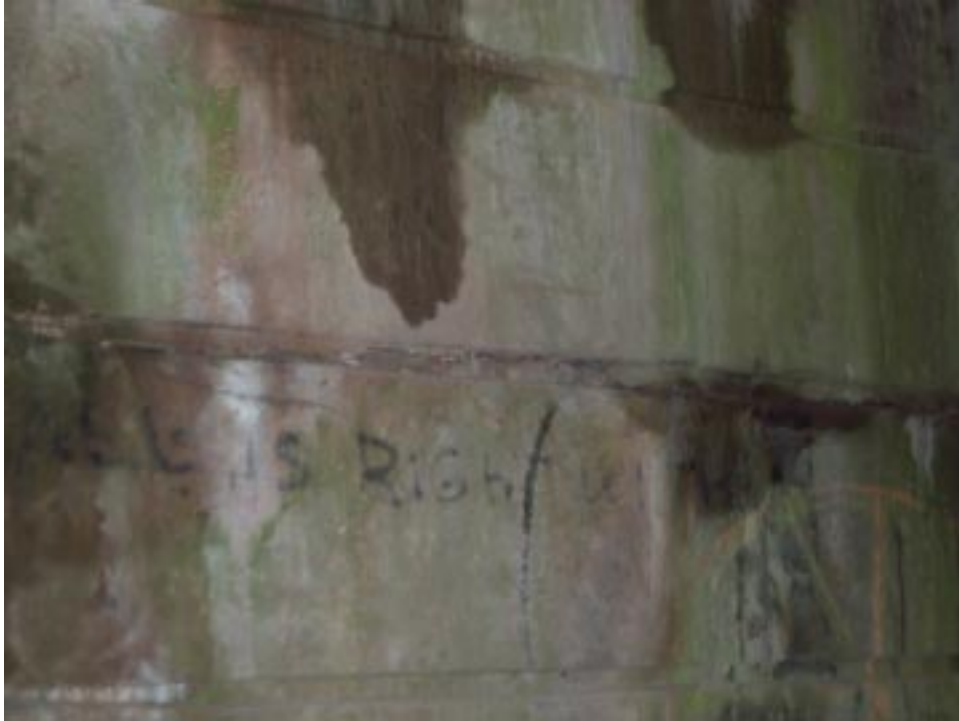
Figure 113. Deterioration described by Note B4 – Full-length horizontal crack.

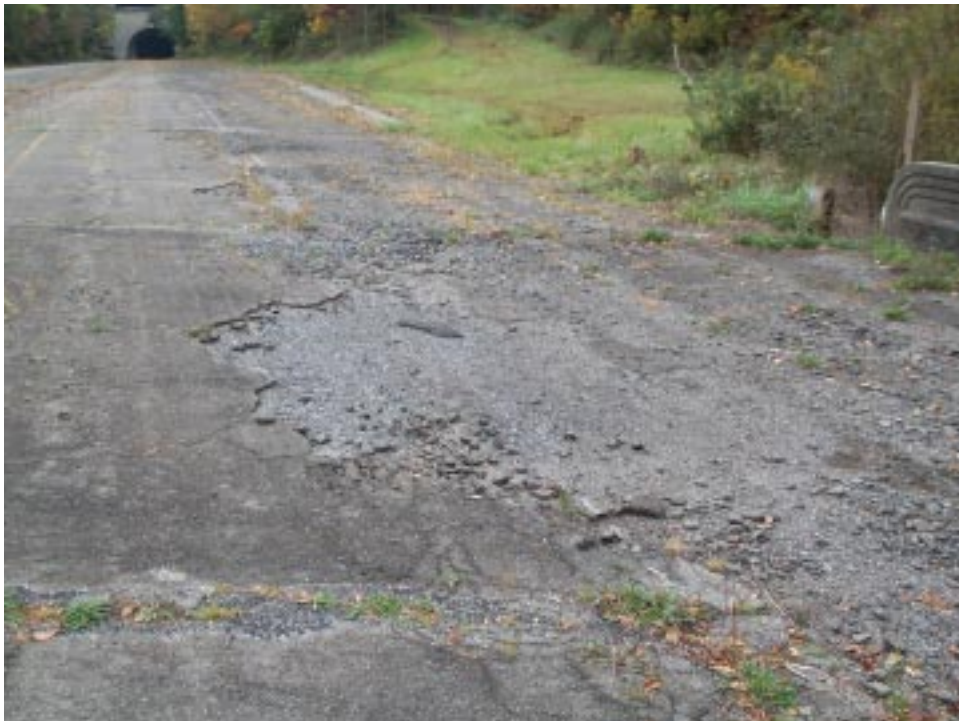
Figure 114. Deterioration described by Note C1 – Severe deterioration of wearing surface.

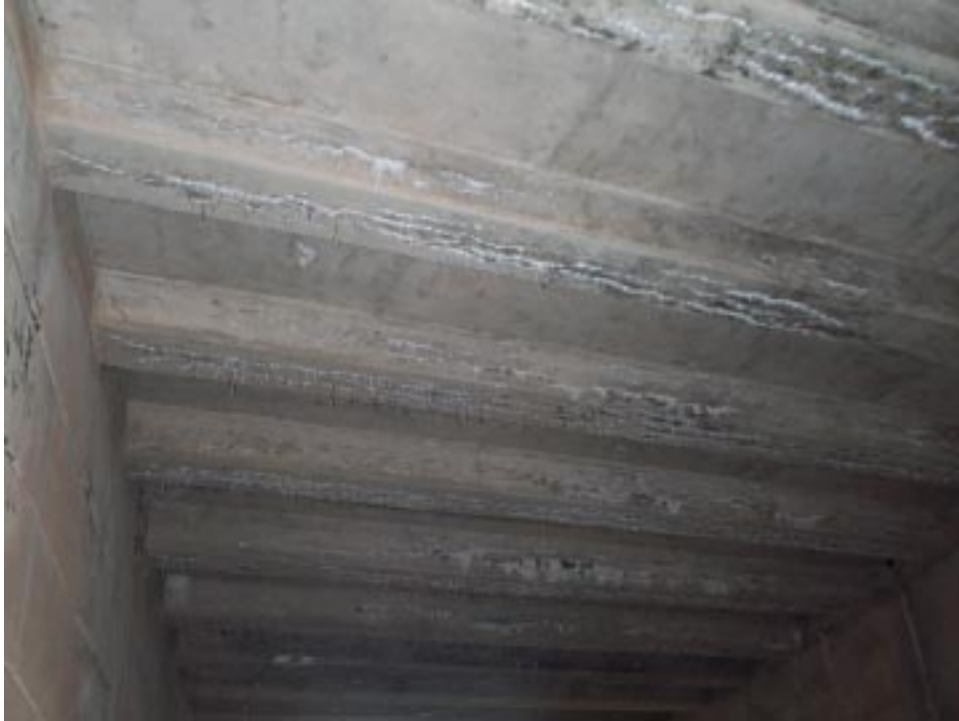
Figure 115. Deterioration described by Note C2 – T-beam deterioration.

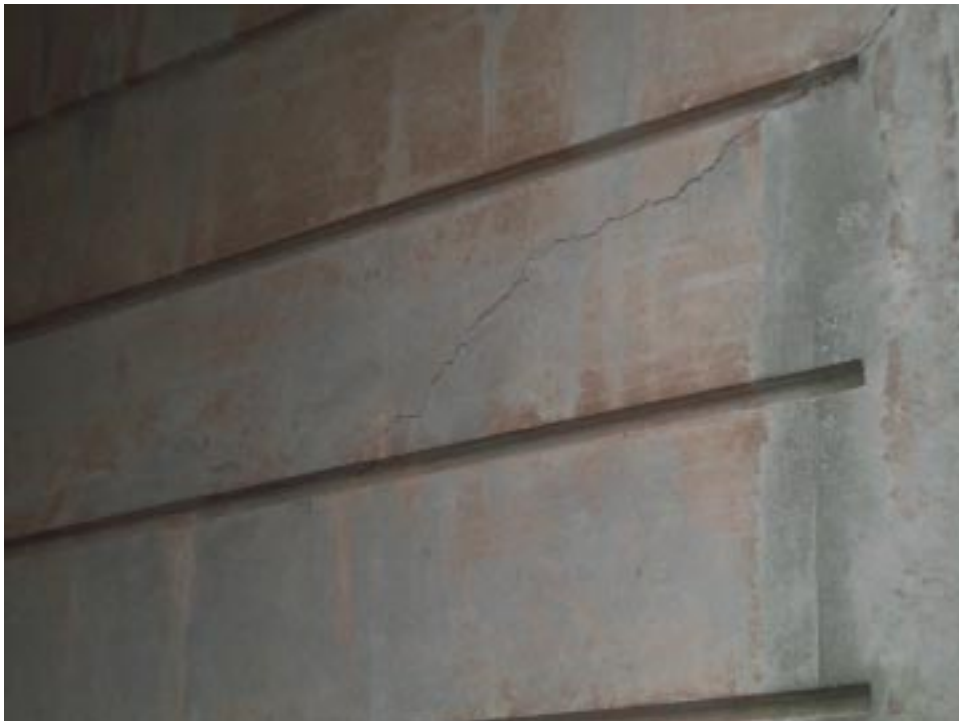
Figure 116. Deterioration described by Note C3 – Three-quarter length transverse crack in east abutment.

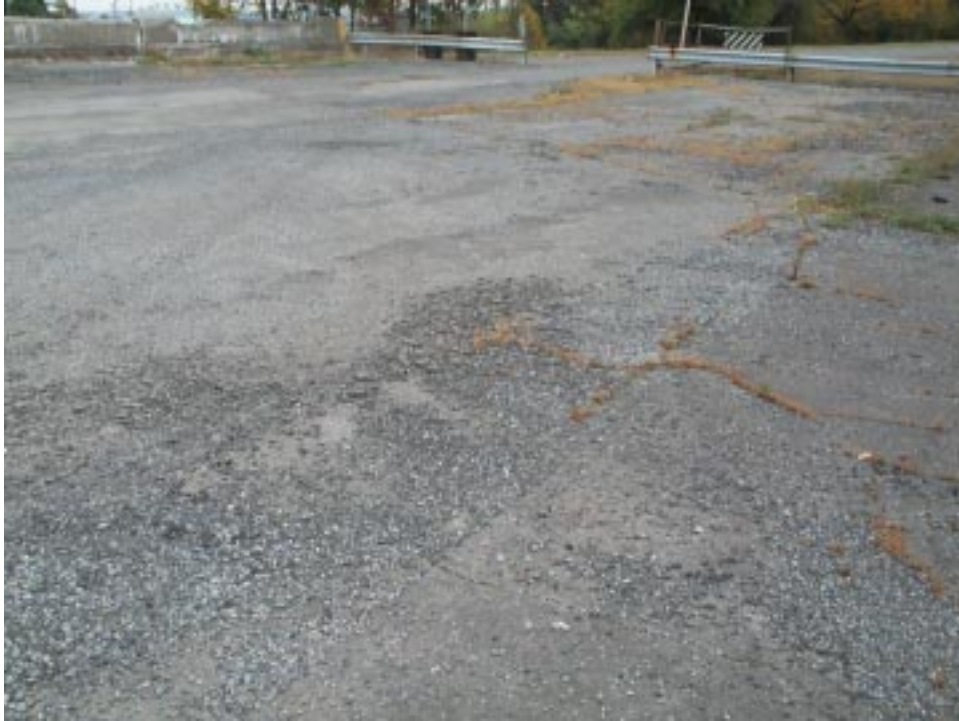
Figure 117. Deterioration described by Note D1 – Severe deterioration of wearing surface.

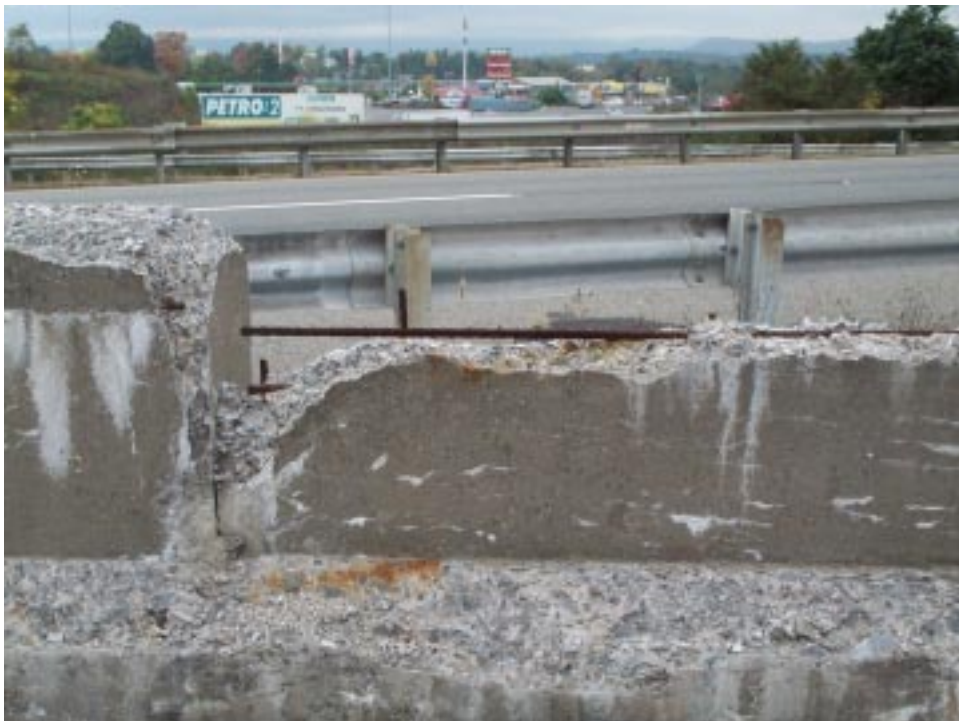
Figure 118. Deterioration described by Note D2 – Severe parapet deterioration.

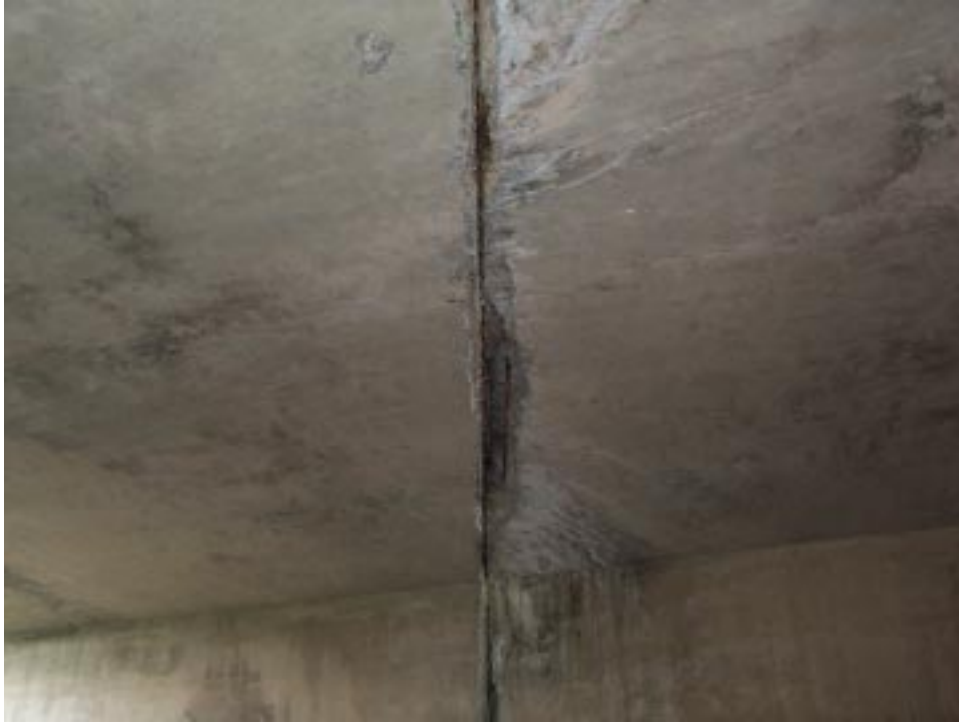
Figure 119. Deterioration described by Note D3 – Longitudinal joint deterioration.

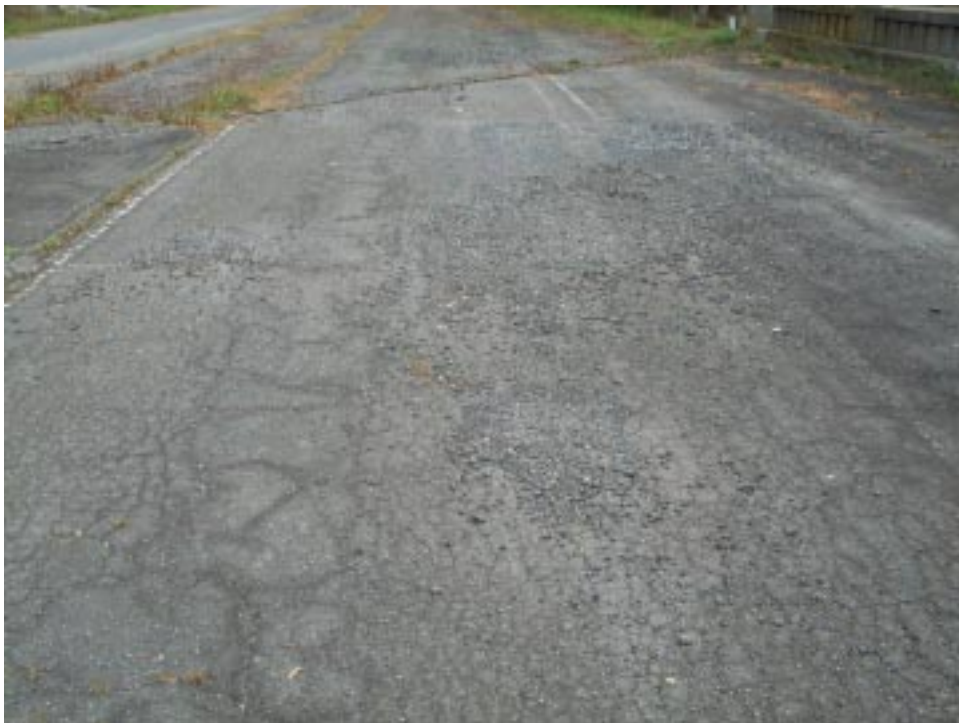
Figure 120. Deterioration described by Note E1 – Severe deterioration of wearing surface.

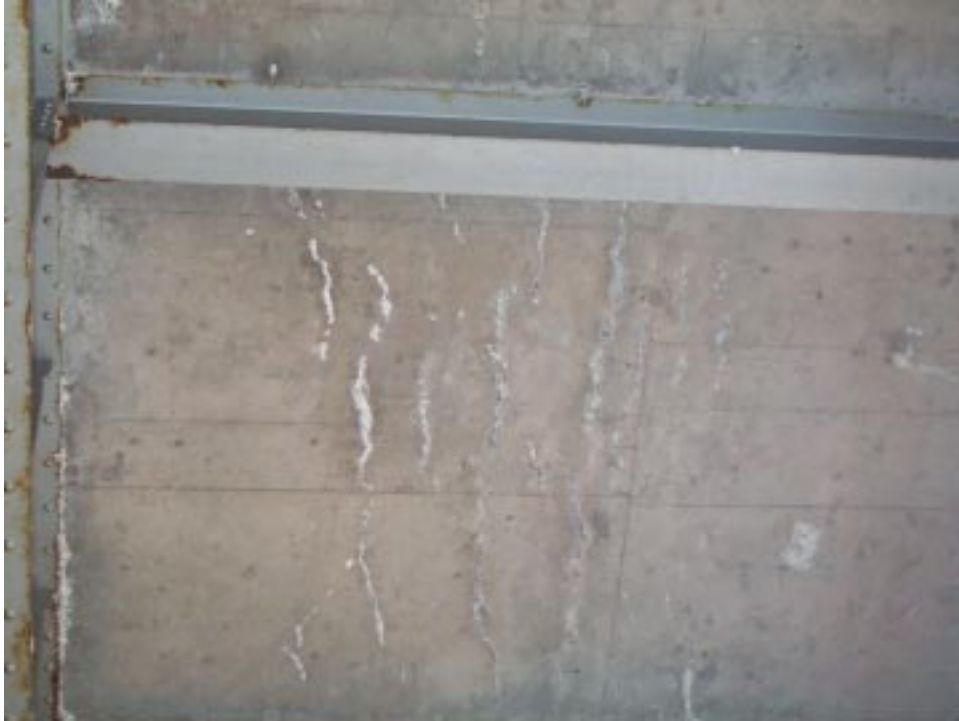
Figure 121. Deterioration described by Note E2 – Underside deck cracking and/or efflorescence.

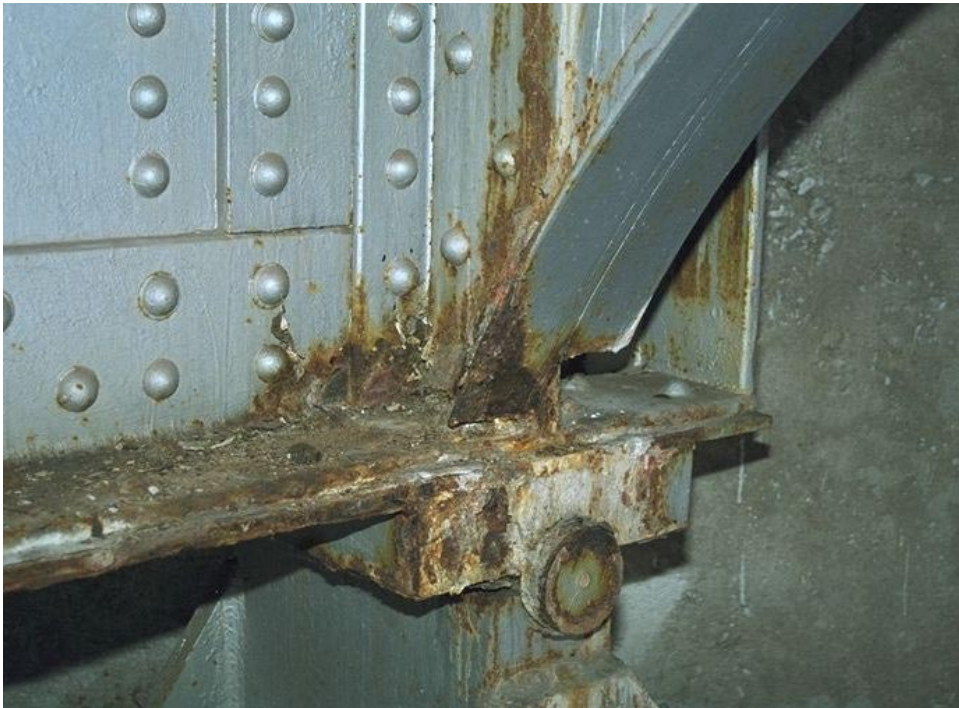
Figure 122. Deterioration described by Note E3 – Minor to moderate superstructure corrosion.

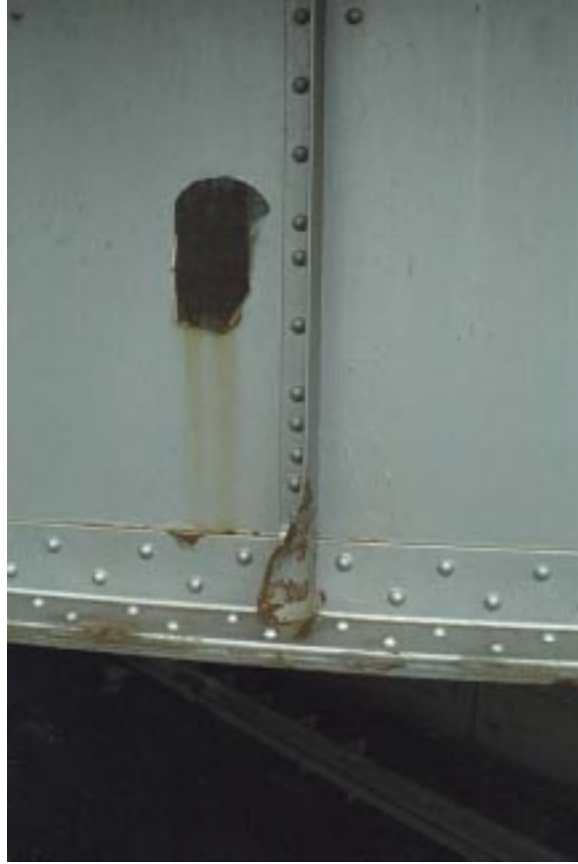
Figure 123. Deterioration described by Note E4 – Impact damage to south fascia girder.

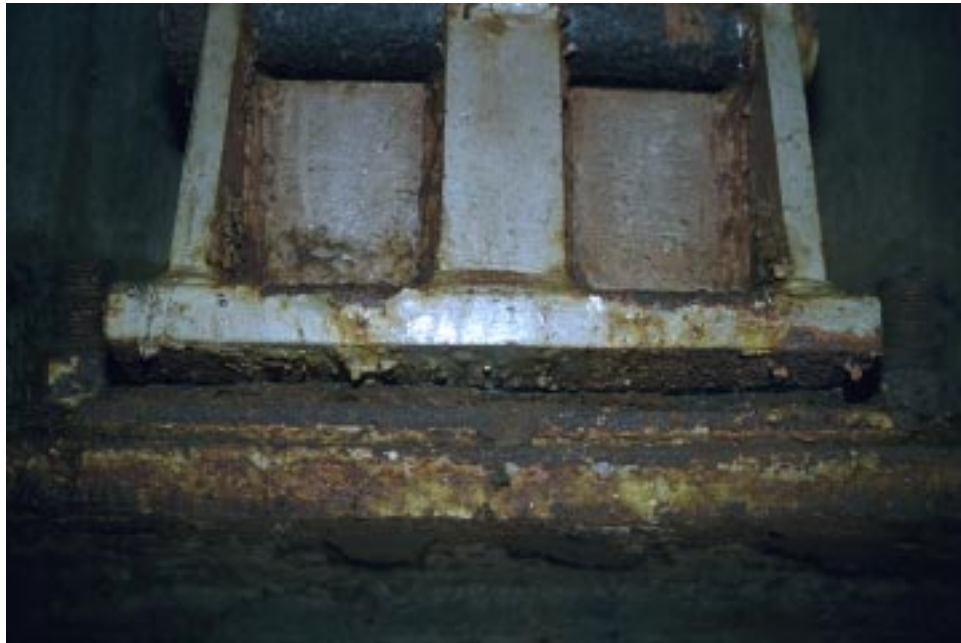
Figure 124. Deterioration described by Note G1 – Moderate to severe corrosion of abutment bearings.
