Protecting our Marine Resources at Virgin Islands National Park and Virgin Islands Coral Reef National Monument

Rafe Boulon, Chief Resource Management Virgin Islands National Park/ Coral Reef National Monument

CRTF, October 2006

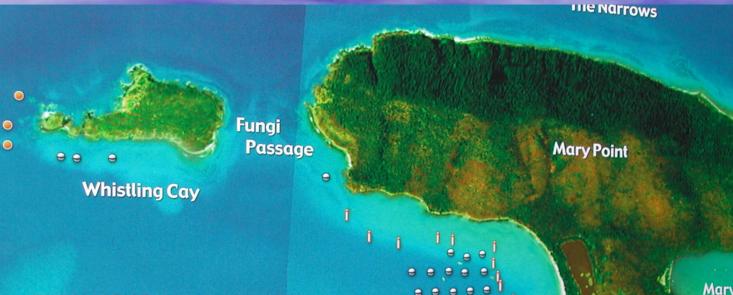
CINNAMON BAY to MARY CREEK

Maho Bay	28
Little Maho Commercial	4
Francis Bay	29
Whistling Cay	3
Whistling Cay SCUBA	3
Fungi Passage	1

Moorings limited to 60' boats

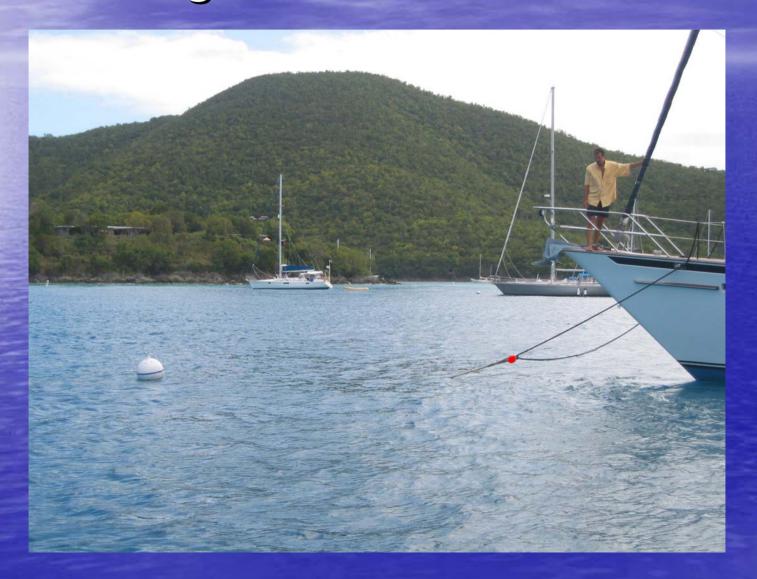
Hard substrate attachment

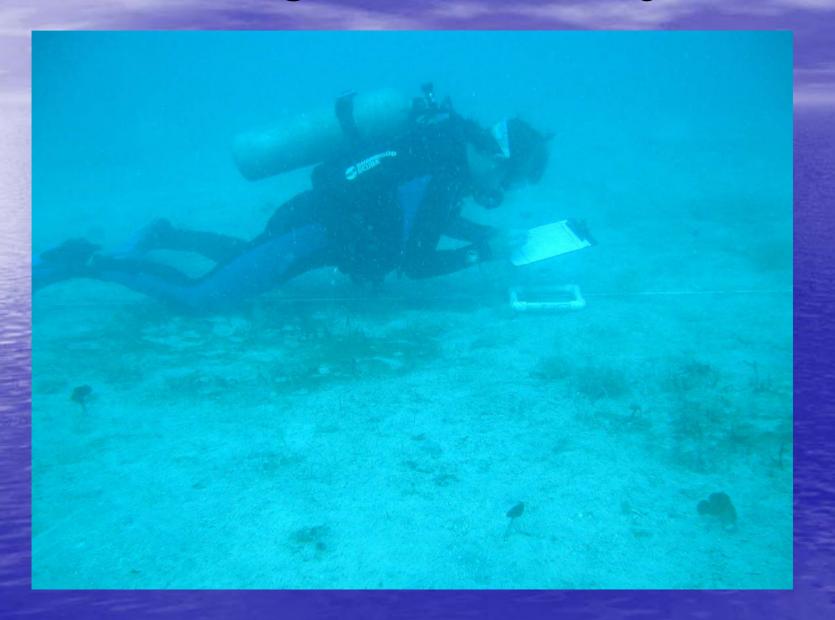
Maho Bay Mooring #129 (2000-04). Avg. # short shoots/20 cm2 quadrat (N = 40)

Seagrass Recovery

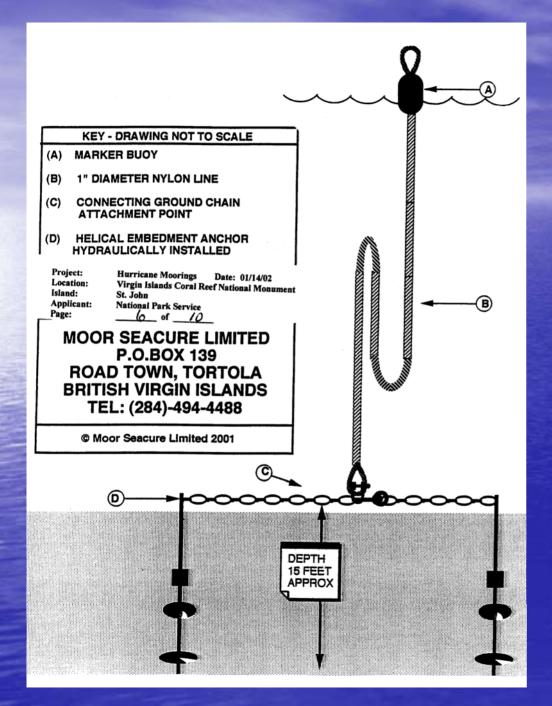
Hurricane Mooring Schematic

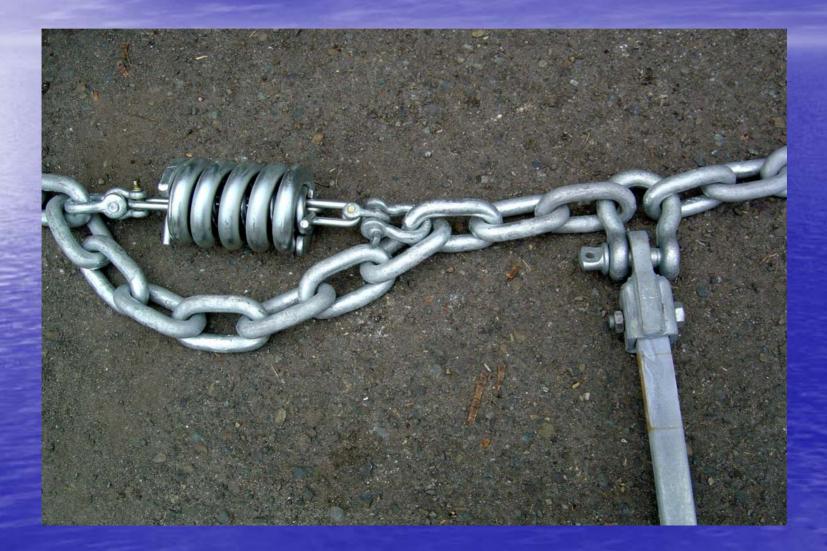
Storm Mooring Details

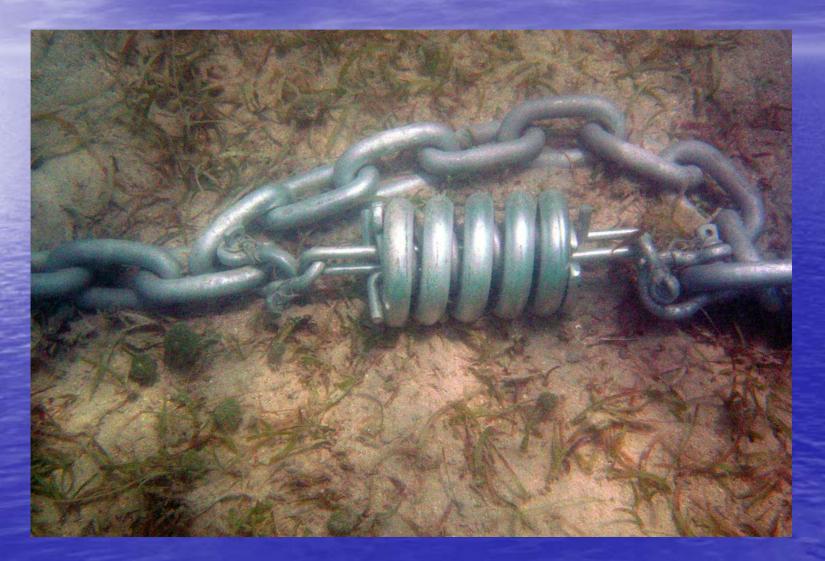
Storm Mooring Installed

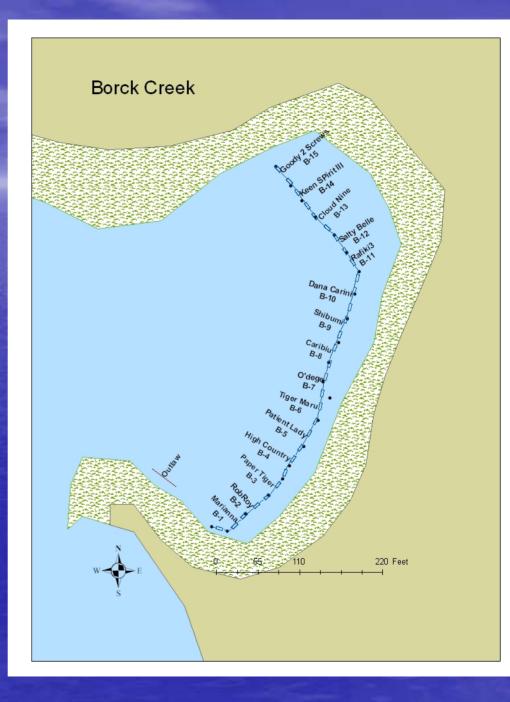
Hurricane Mooring System (2005)

Mangrove Protection:
