U.S. CHEMICAL SAFETY AND HAZARD INVESTIGATION BOARD

INVESTIGATION REPORT

METHANOL TANK EXPLOSION AND FIRE

BETHUNE POINT WASTEWATER TREATMENT PLANT

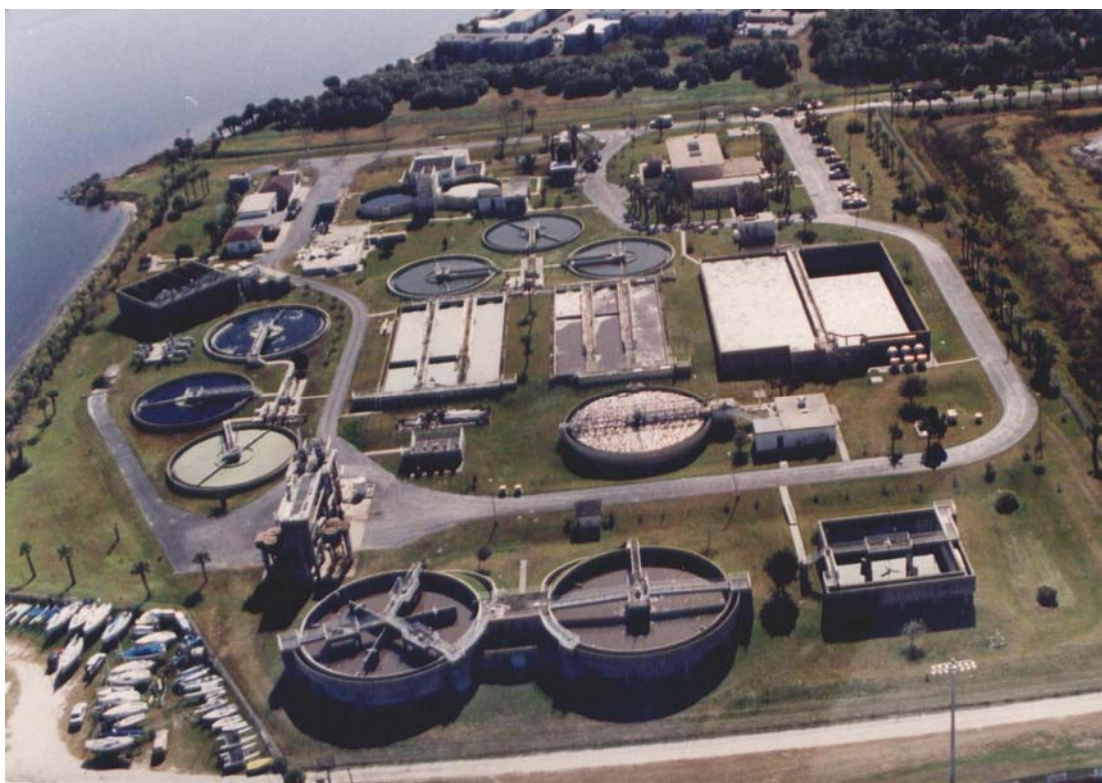
Figure 1. Bethune Point WWTP.
(Picture courtesy of the City of Daytona Beach)

Eleven city employees operate the Bethune Point WWTP, treating about 13 million gallons per day before discharging to the Halifax River (Figure 1).

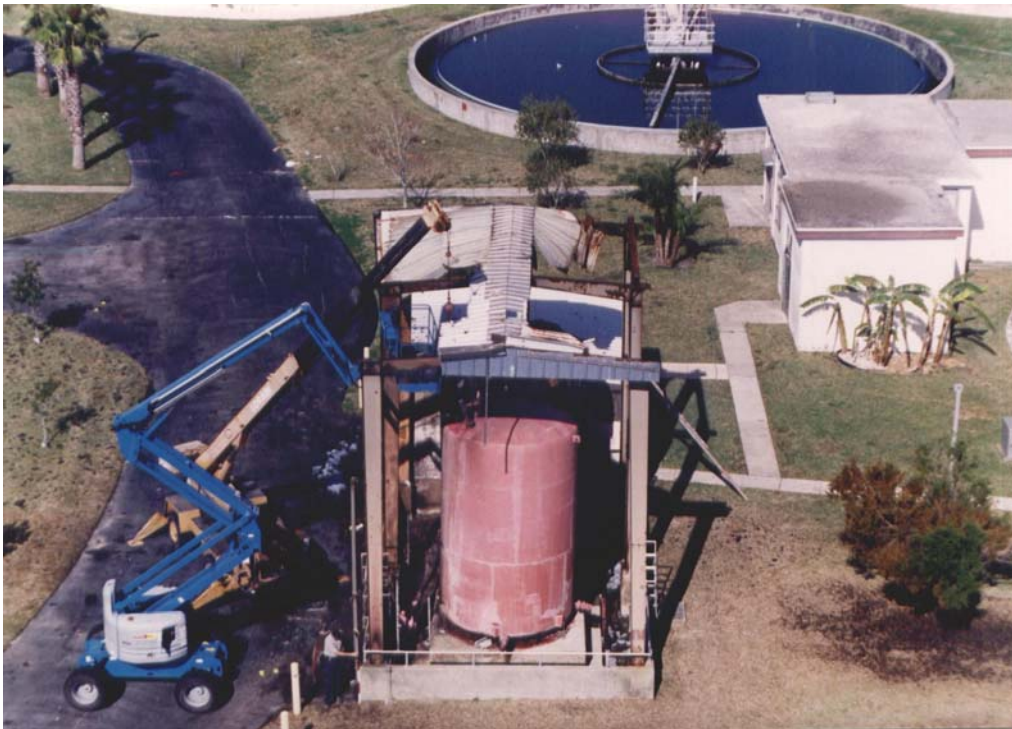
Figure 2. Bethune Point WWTP accident site.

- rounded the tank's flat bottom, permanently deforming the tank and raising the side wall about one foot;
- ripped the nuts from six bolts used to anchor the tank to a concrete foundation;
- blew the flame arrester off the tank vent pipe;
- blew a level sensor off a 4-inch flange on the tank top;
- separated two 1-inch pipes, valves, and an attached level switch from flanges on the side of the tank;
- separated a 4-inch tank outlet pipe from the tank outlet valve; and
- separated a 4-inch tank fill pipe near the top the tank.

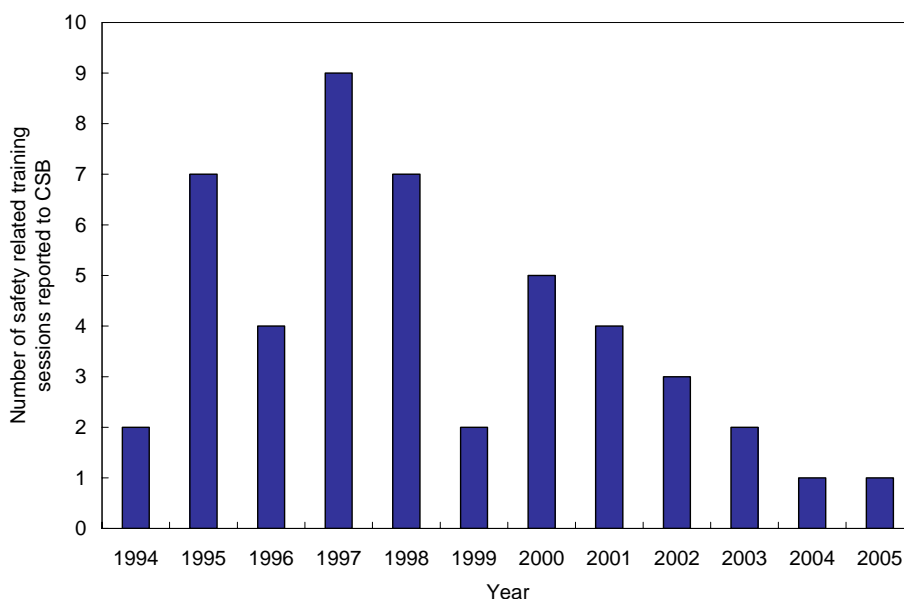
Up to calendar year 2000, the City offered an average of five safety-related training sessions at Bethune Point WWTP each year; however, since 2000 the number of such sessions⁷ declined steadily (Figure 3). This decline may have been influenced by the repeal of the Florida public employee safety law (2000) and the elimination of City of Daytona Beach full-time Safety Position (2004).

Figure 3. Bethune Point WWTP safety related training sessions.

In summary, the CSB found that the scope, content, and frequency of the HAZCOM training provided to Bethune Point WWTP employees did not adequately prepare them to deal with the hazards associated with flammable materials such as methanol.

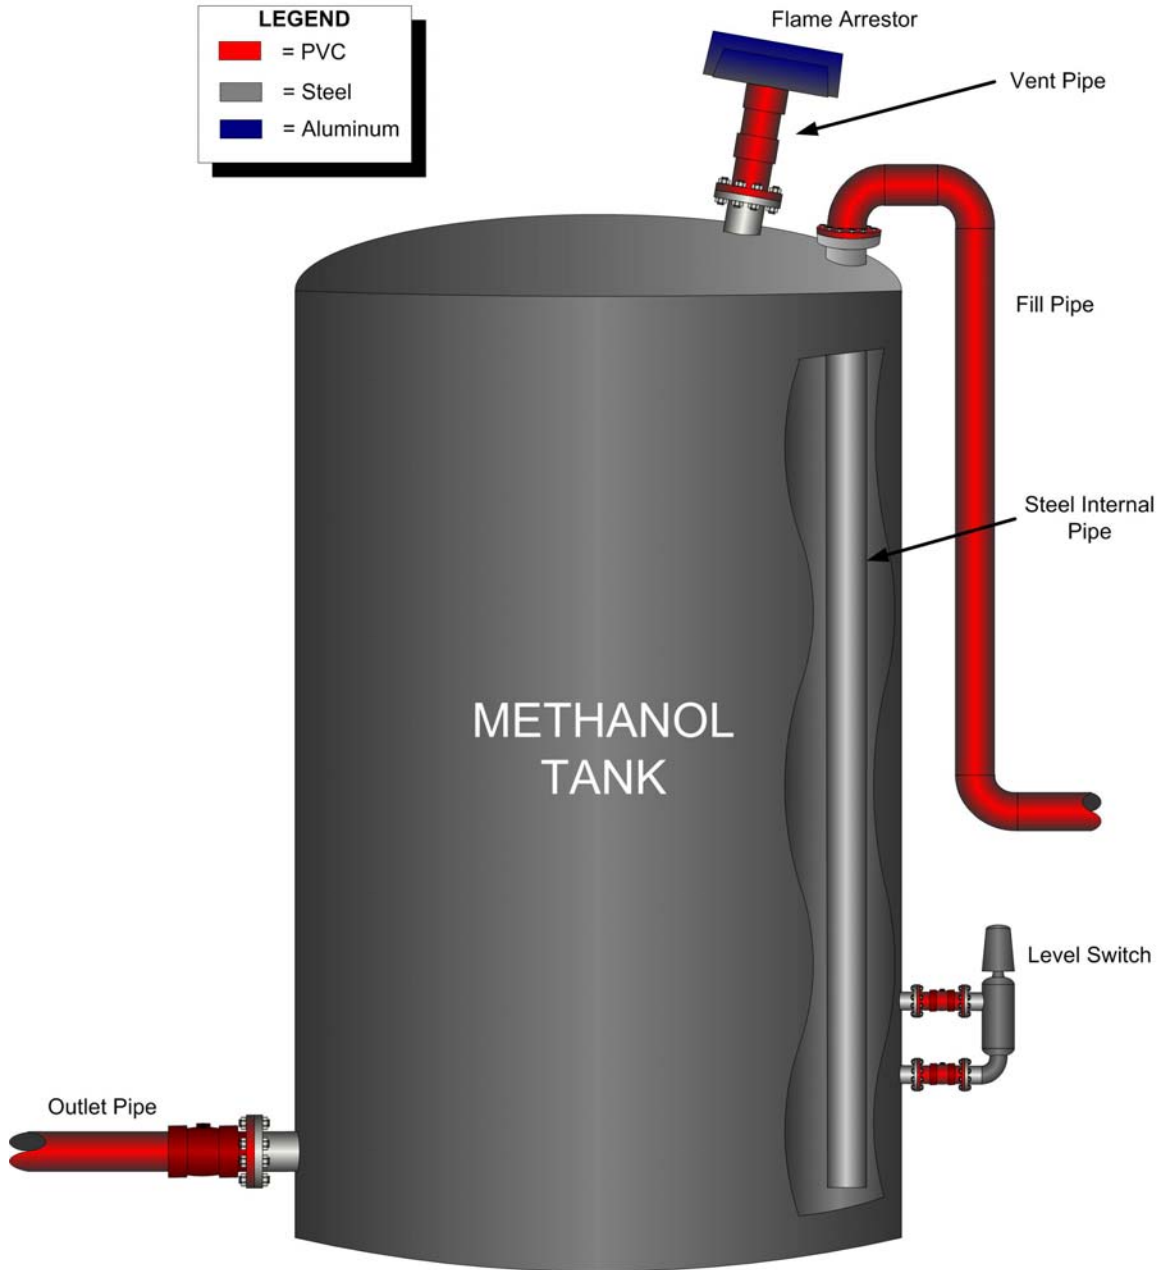
- a 4-inch nominal pipe size (NPS) fill pipe that connected a flange on the top of the tank to a fill connection near ground level;
- a 4-inch NPS outlet pipe, connected to a valve on a flange near the bottom of the tank that supplied the methanol pumps;
- two 1-inch NPS pipes and PVC valves that connected a level switch to two flanges near the bottom of the tank; and
- a 4-inch NPS vent pipe connected to a flange on the top of the tank to the flame arrester. The flame arrester end of this pipe was threaded.

Figure 4. Aboveground PVC methanol pipes

OSHA standard 1910.106 does allow materials that soften on fire exposure such as plastics, but only when “necessary.” CDM stated¹³ that it specified PVC for its compatibility with methanol and its ability to withstand the system pressure. The CSB noted that published corrosion data indicate that steel is compatible with methanol, that steel piping is widely used in flammable liquid systems, and that the methanol tank specified by CDM was made of steel. From this, the CSB concluded that no necessity to use PVC pipe existed.

Communicate the findings and recommendations of this report to all companies that contracted with CDM for methanol and other flammable liquid systems that were constructed with aboveground plastic pipe. Recommend replacing plastic pipe with an appropriate material in accordance with NFPA 30 and OSHA 1910.106.

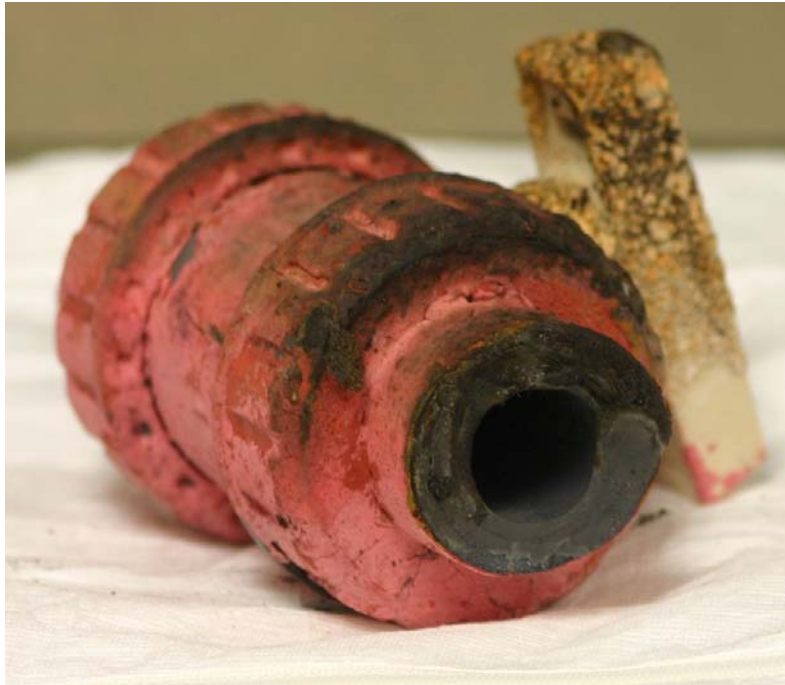
steel flanges on the tank and steel flanges on the level switch. A recovered valve shows the fractured PVC pipe between the valve and flange (Figure 5).

Figure 5. Failed 1-inch PVC pipe showing fracture surface

Had the methanol piping and valves been constructed of steel, the system would most likely have remained intact. The mechanic in the crane would likely not have been killed, and the other two workers may have been less severely injured.

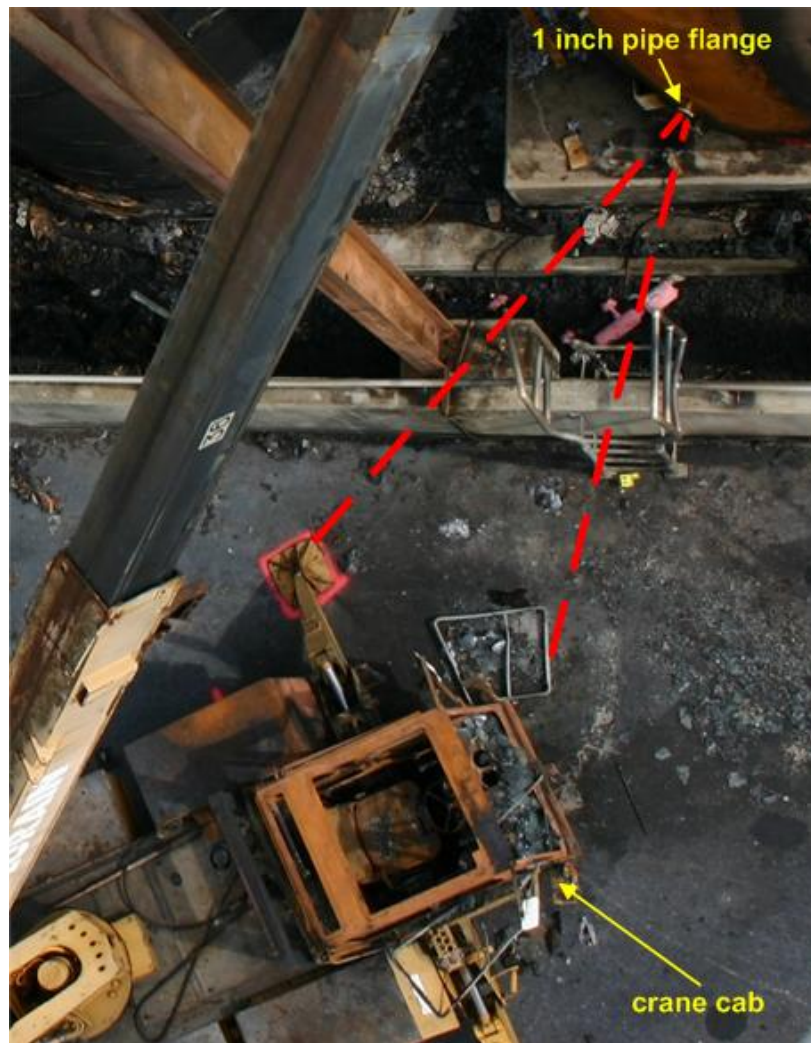
The two fractured PVC pipes supporting the level switch pointed directly toward the crane cab where the mechanic was sitting. Methanol discharging under pressure most likely sprayed the cab, ignited and seriously burned the mechanic inside. Figure 6 shows the burned-out cab aligned with the 1-inch pipe flanges on the tank.

Figure 6. Methanol spray from 1-inch pipe flanges onto the crane cab.

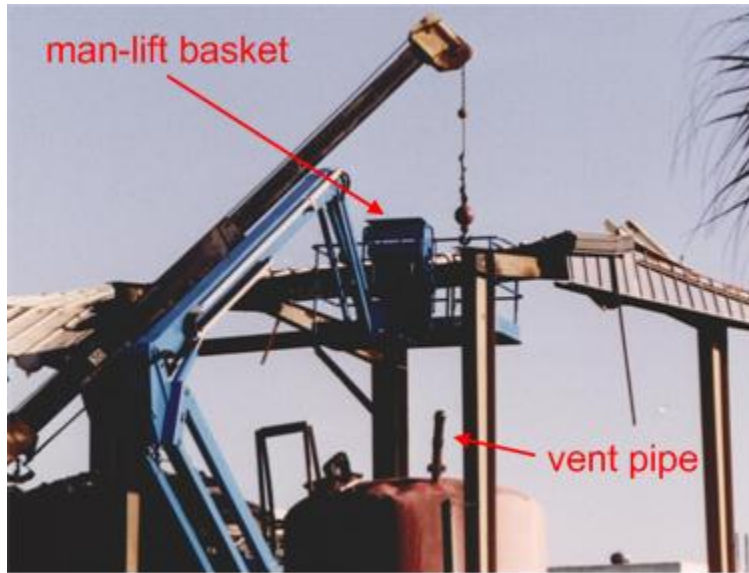
The PVC vent pipe was below the man-lift basket. After the flame arrester blew off the vent pipe, burning methanol vapors under pressure would have likely discharged into the basket where two workers were standing. Figure 7 shows the location of the basket relative to the vent pipe.

Figure 7. Location of man-lift basket and 4-inch vent pipe

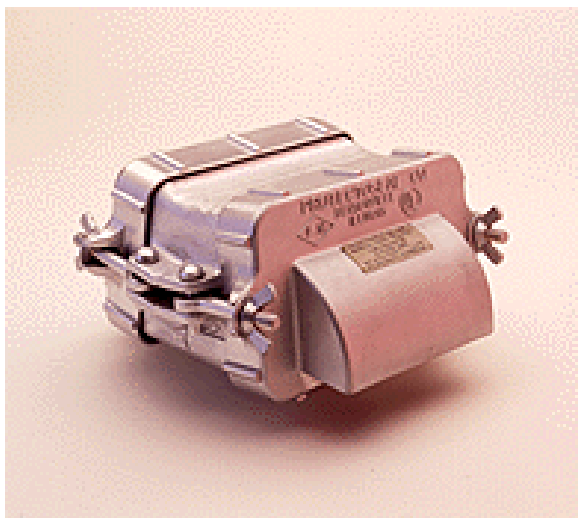
The flame arrester on the methanol storage tank vent pipe was a Protectoseal Model No. 864 (Figure 8). Because the vent through the flame arrester was always open, the tank discharged methanol vapors when filled or warmed and took in air when drained or cooled.

Figure 8. Protectoseal Model No. 864 flame arrester

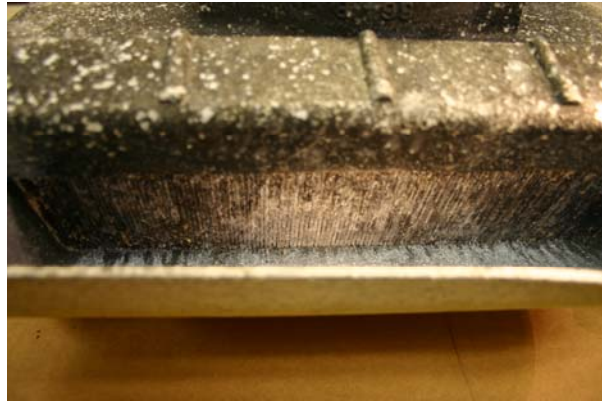
The flame arrester plates and housing were aluminum. Published corrosion data¹⁸ indicates that methanol corrodes aluminum. The flame arrester was severely corroded on the interior surface, the plates were clogged with aluminum oxide scale, and plates were broken with portions missing (Figure 9 and Figure 10). Corrosion on the broken plate edges indicates that the broken plate damage most likely occurred prior to the incident.

Figure 9. Flame arrester plate corrosion (outside)

Flame arresters require regular inspection and maintenance (cleaning) to maintain functionality. Dirt and small particles collecting in the narrow gaps between the flame arrester plates, insects nesting in the housing, and corrosion can degrade performance. Regular inspection can identify excessive corrosion. In 1993, when the methanol system became operational, both Protectoseal¹⁹ and a major methanol producer²⁰ recommended regular flame arrester maintenance and inspection. However, no requirement for flame arrester maintenance and inspection was included with the operation and maintenance instructions CDM provided the City. Interviews indicate that Bethune Point WWTP personnel were unaware of the need to inspect and maintain the flame arrester.

The CSB concluded that the flame arrester did not prevent the fire outside the tank from igniting the tank contents. Routine inspections would have detected the corrosion in the flame arrester that occurred over 12 years. The use of an aluminum flame arrester in methanol service, coupled with the lack of inspection and maintenance, allowed the flame arrester to corrode to the point that it no longer functioned.

Communicate the findings and recommendations of this report to all companies that contracted with CDM for flammable liquid systems that included a flame arrester. Emphasize the importance of periodic maintenance of the flame arrester to ensure its effective performance.

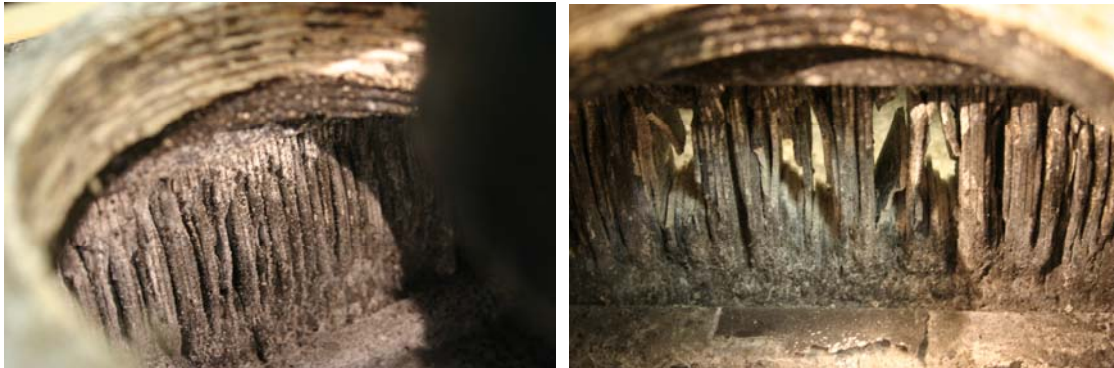
Figure 10. Flame arrester plate corrosion (inside)

11. The flame arrester was so degraded (gaps between the plates inside the flame arrester were plugged with dirt and aluminum oxide and portions of the plates were corroded away) that it did not prevent a flame from entering the tank which greatly increased the consequences of the incident.
12. No Florida state laws or regulations exist to require municipalities to implement safe work practices.
13. No Florida state laws or regulations exist to require municipalities to communicate chemical hazards to municipal employees.
14. Florida municipalities are not covered by OSHA workplace safety standards.
15. No state or federal oversight of public employee safety exists in the State of Florida.
