R5-TP-026b

Home Destruction Examination

Grass Valley Fire

Lake Arrowhead, CA

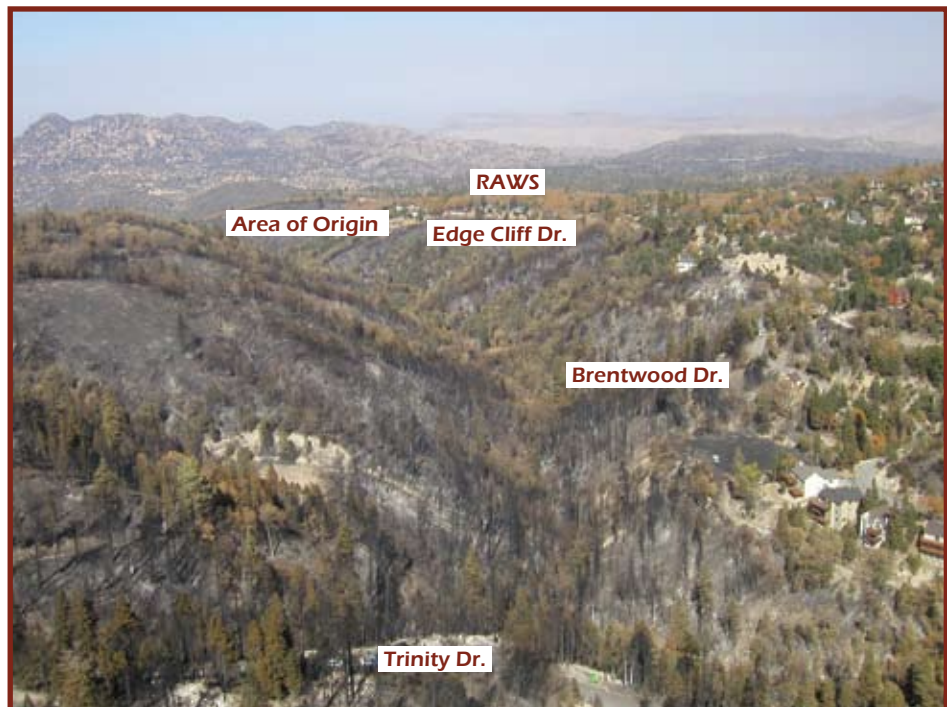
Figure 1. Aerial view of the Grass Valley drainage looking north toward the area of origin and Rock Creek RAWS.

The east flank of the Grass Valley Fire progressed upslope and into homes located on Edge Cliff and Brentwood (See Figure 1). Fire intensity was moderate to high (shrub and single/group tree torching) (Figure 6).

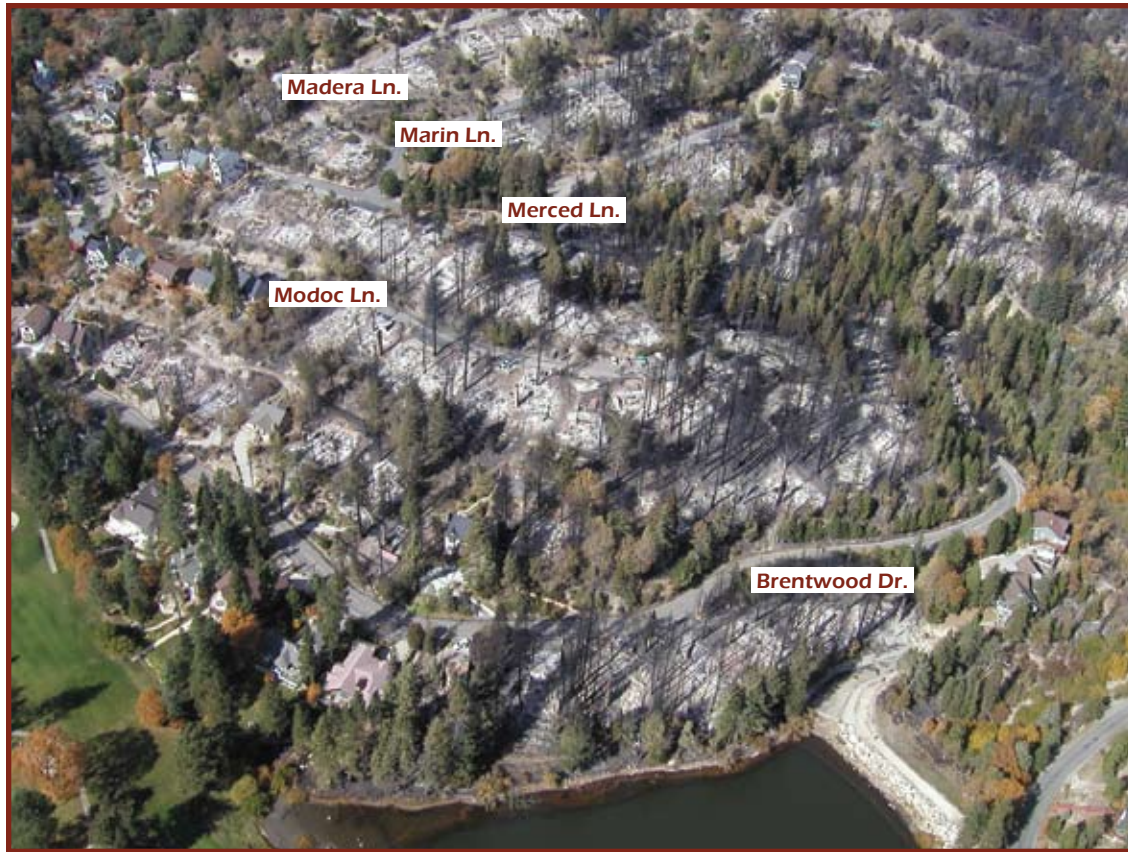
Figure 4. Aerial view of home destruction looking northwest. Grass Valley Lake is in the foreground and Lake Arrowhead Country Club is to the left.

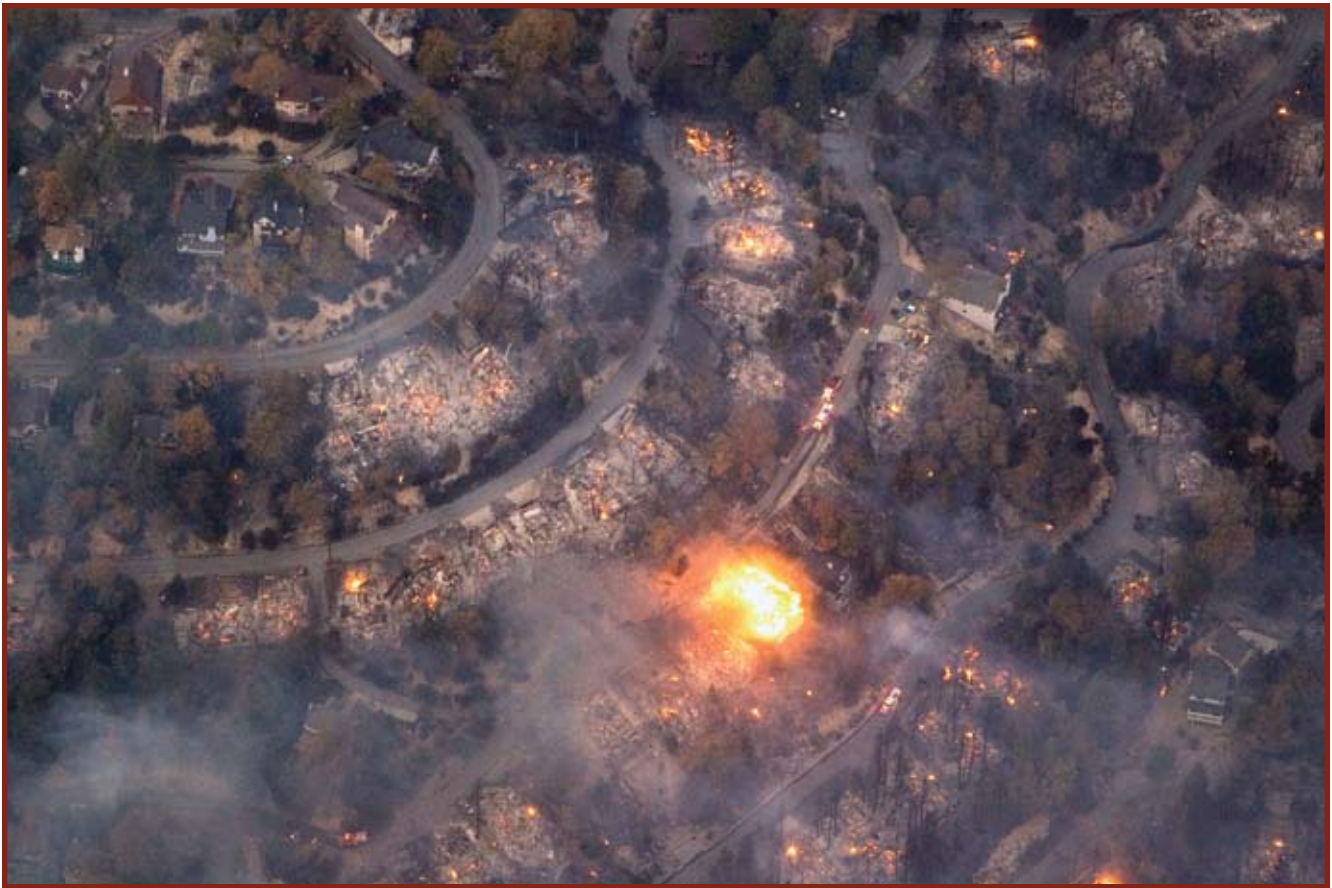
Figure 5. A home on Madera Ln. fully involved approximately seven hours after the wildfire impacted the area.
 (Photo taken at 1715 by Don Kelsen, Los Angeles Times)

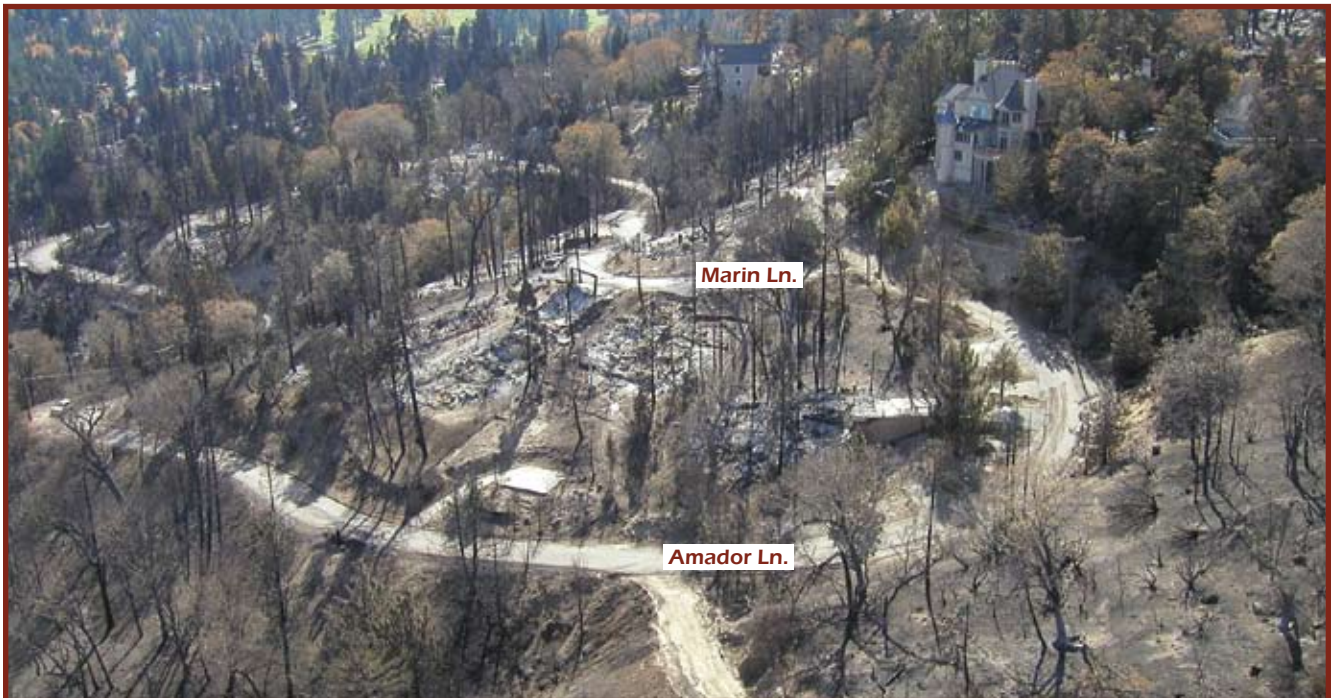
Figure 10. An aerial view of home destruction looking south toward Lake Arrowhead Country Club.

Pushed by northerly winds gusting to 30 mph (per Rock Camp RAWS), the head of the Grass Valley Fire progressed southwest through the Grass Valley drainage and upslope into homes located on Windward (Figures 7-9), Amador (Figure 10), Marin (Figure 10), and Trinity (Figure 11).

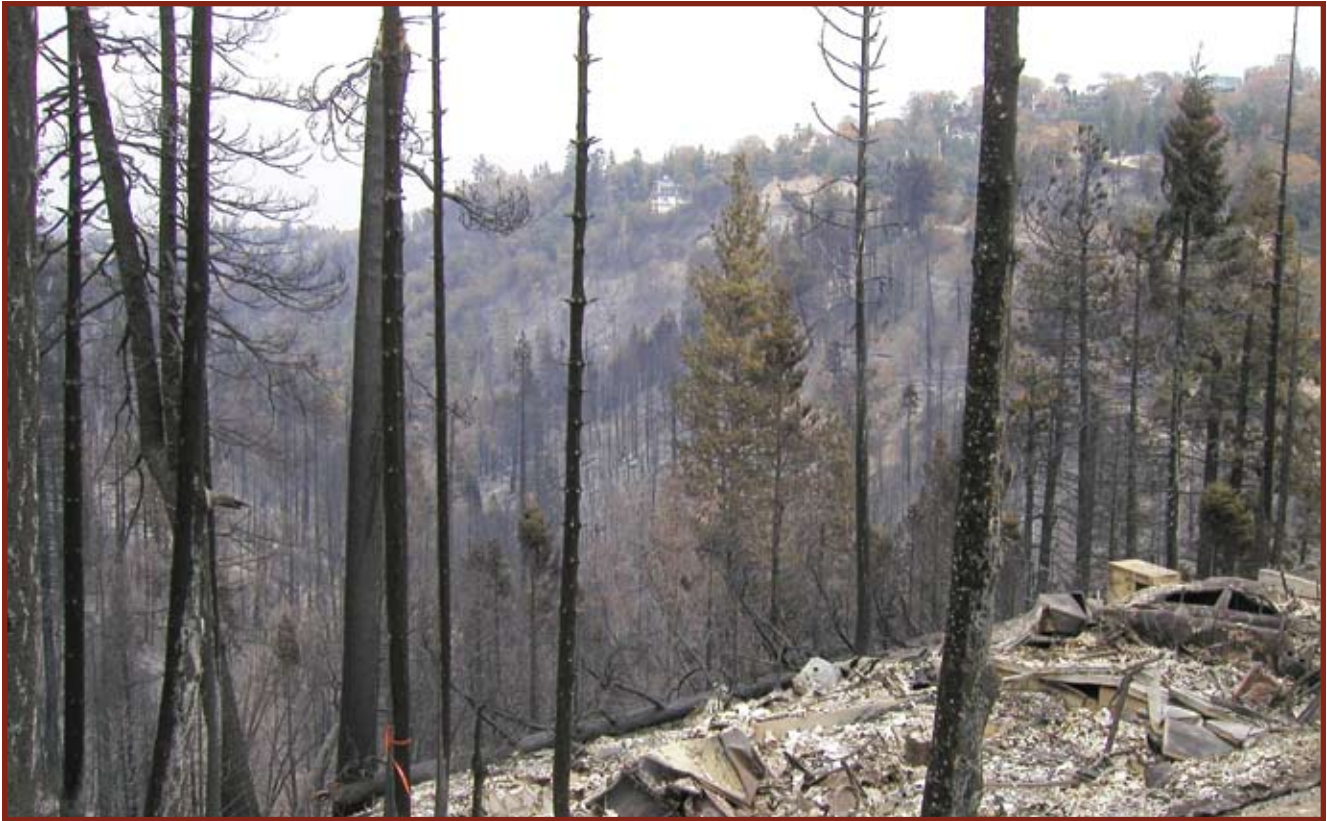
Figure 11. A destroyed home on Trinity Dr. looking northeast across Grass Valley drainage; Brentwood Dr. is in the upper right. This photo shows the patchiness of aerial fuels exposed to high wildfire intensities.

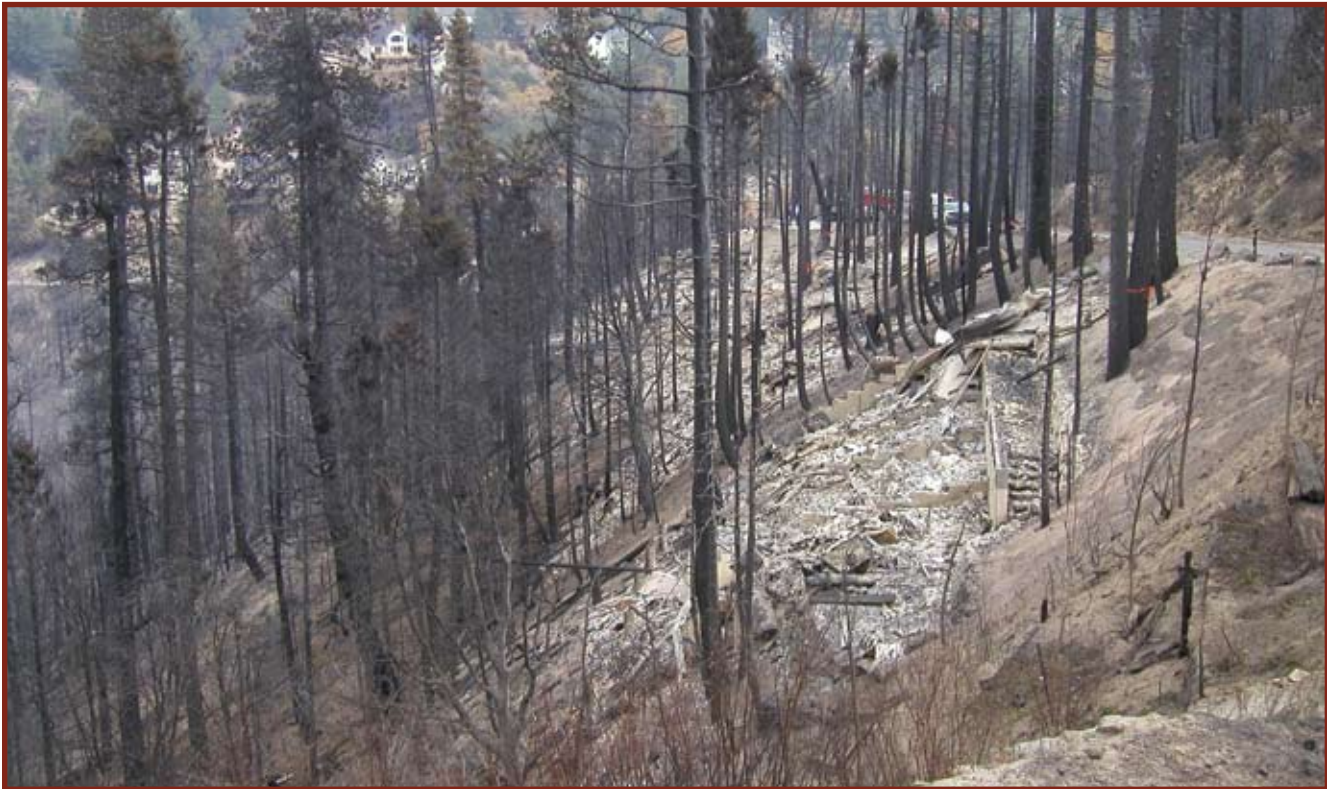
Figure 12. View to the east, principally of five destroyed homes on Trinity Dr. (971-949). The high degree of consumption of tree and shrub foliage downslope from these homes likely indicates high intensity flame exposure.

Fire intensity was locally high due to burning shrub canopies and low to mid-height conifer branches, single/group tree torching, and localized crown fire runs. Homes on Windward were impacted first and predominantly exposed to firebrands; homes on Trinity were exposed to the highest flame intensities (Figure 12).

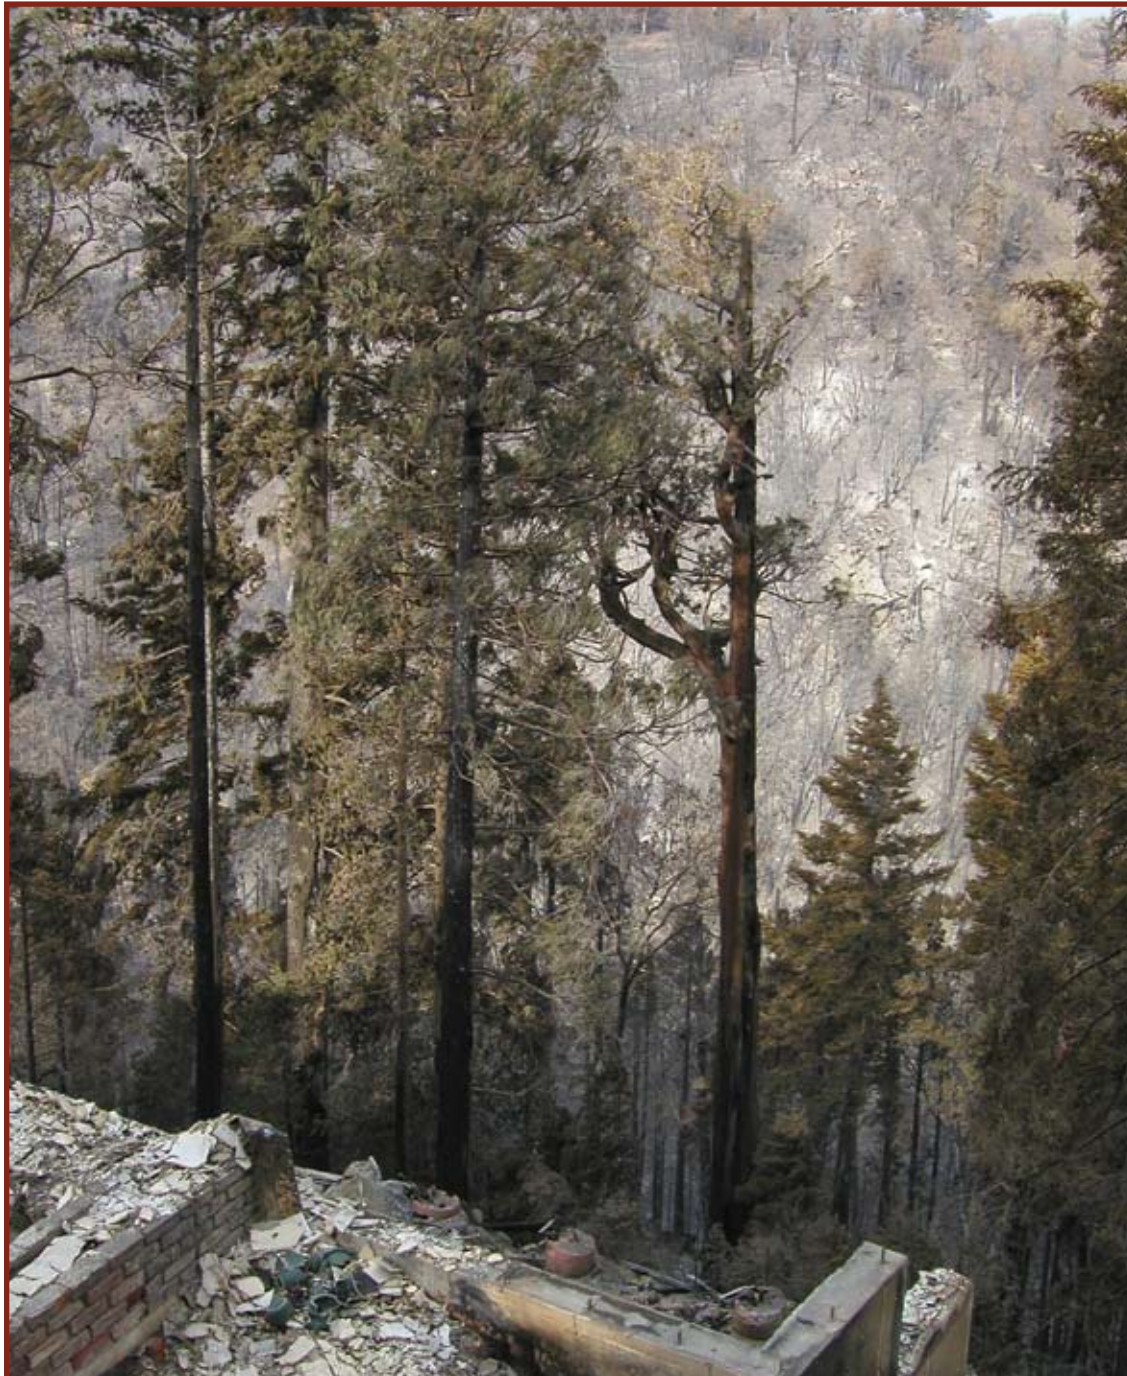
Figure 13. Destroyed home at 1114 Brentwood Dr. looking across Grass Valley drainage west. Note the unconsumed canopy indicating this home was destroyed by surface fire and/or directly ignited from firebrands.

The east flank of the Grass Valley Fire progressed upslope into four homes on Brentwood (Figure 13) and southeast into homes on lower Trinity (Figure 14). Fire intensity was low (surface fire) to moderate (shrub and single tree torching).

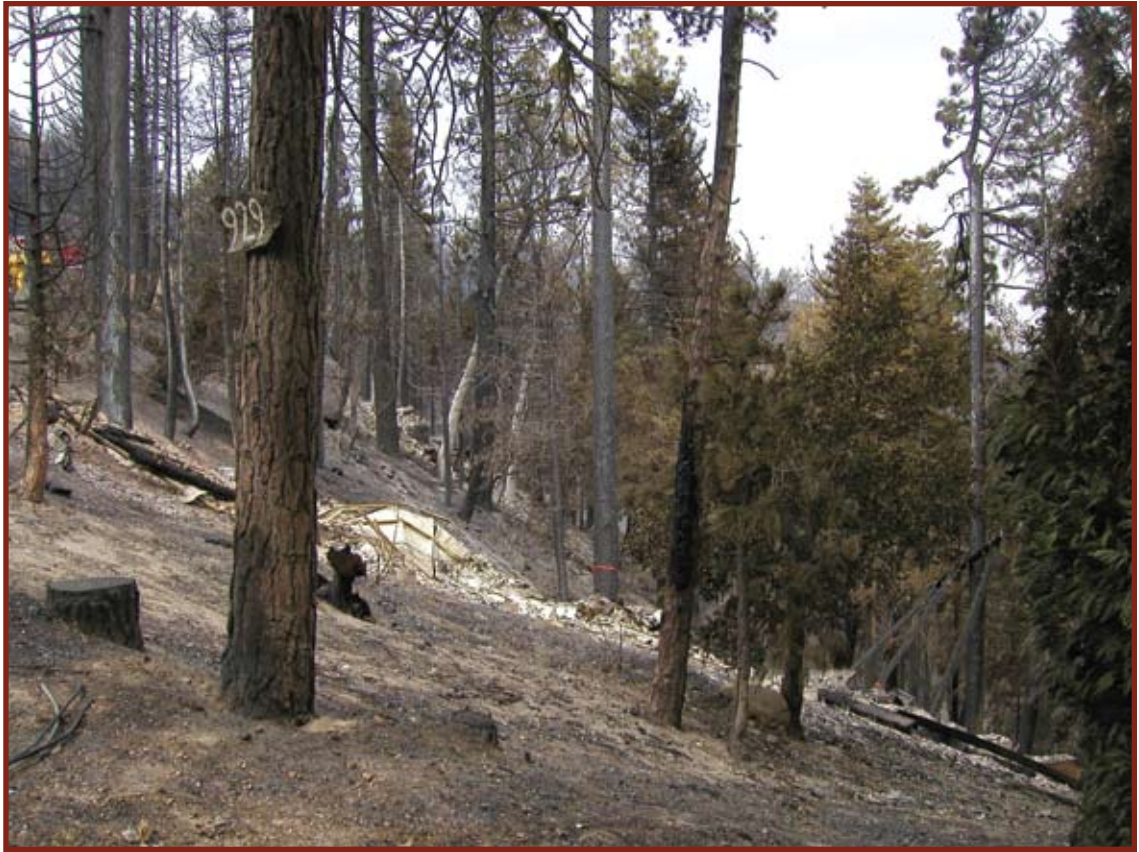
Figure 14. Destroyed home at 933 and 941 Trinity Dr. The low hanging, unconsumed canopy suggests that these homes were ignited from a surface fire and/or directly from firebrands.

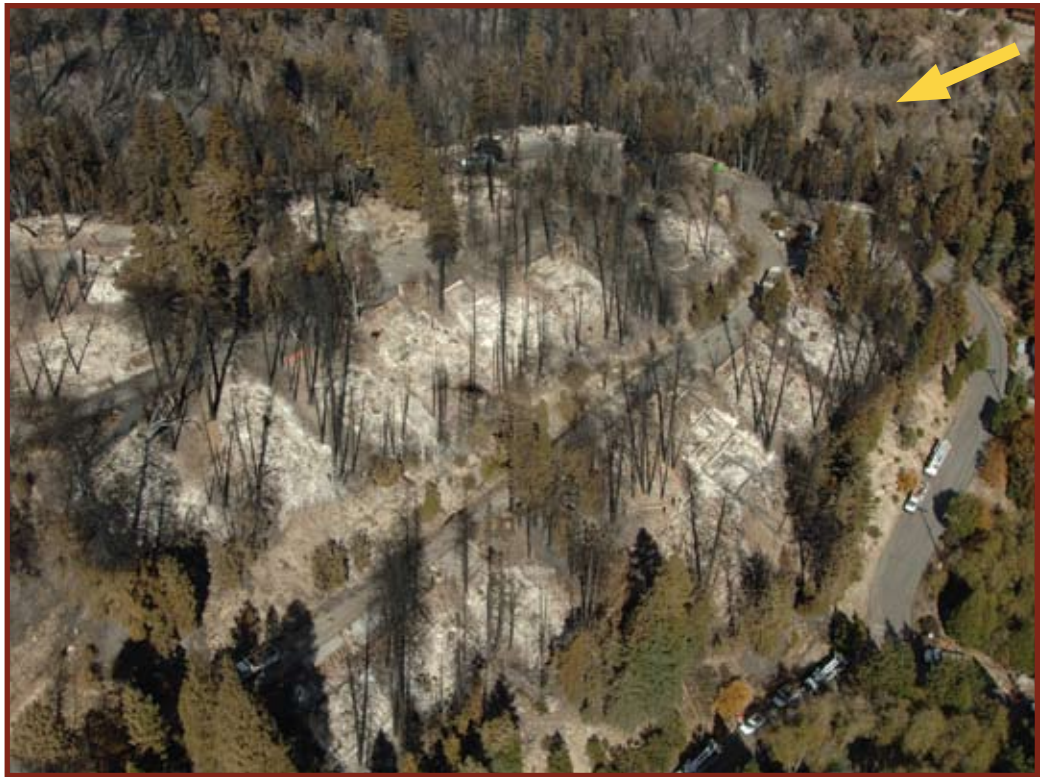
Figure 17. An aerial view of home destruction on Modoc Ln. (middle) and Inyo Ct. (top). Trinity Dr. is the road to the right (northeast) that wraps around the hill. Unconsumed tree canopies surround the home destruction. Burned canopies are over and between the destroyed homes. This indicates that the trees burned due to the burning homes, and the head fire that impacted Trinity Dr. from the north (arrow) did not continue into the subdivision. In this area, home destruction is primarily house-to-house. (Photo by Tom Iraci)

The steep terrain likely increased fire spread and firebrand production and lofting as well as the downhill cascade of collapsed burning debris (Figure 16). All of these factors result in a 'domino effect' of home destruction (Figures 17 and 18). Although there were significant tactical successes that stopped fire from spreading further along a street, the suppression forces were strategically overwhelmed, due to multiple homes burning simultaneously with little chance of preventing the disaster.

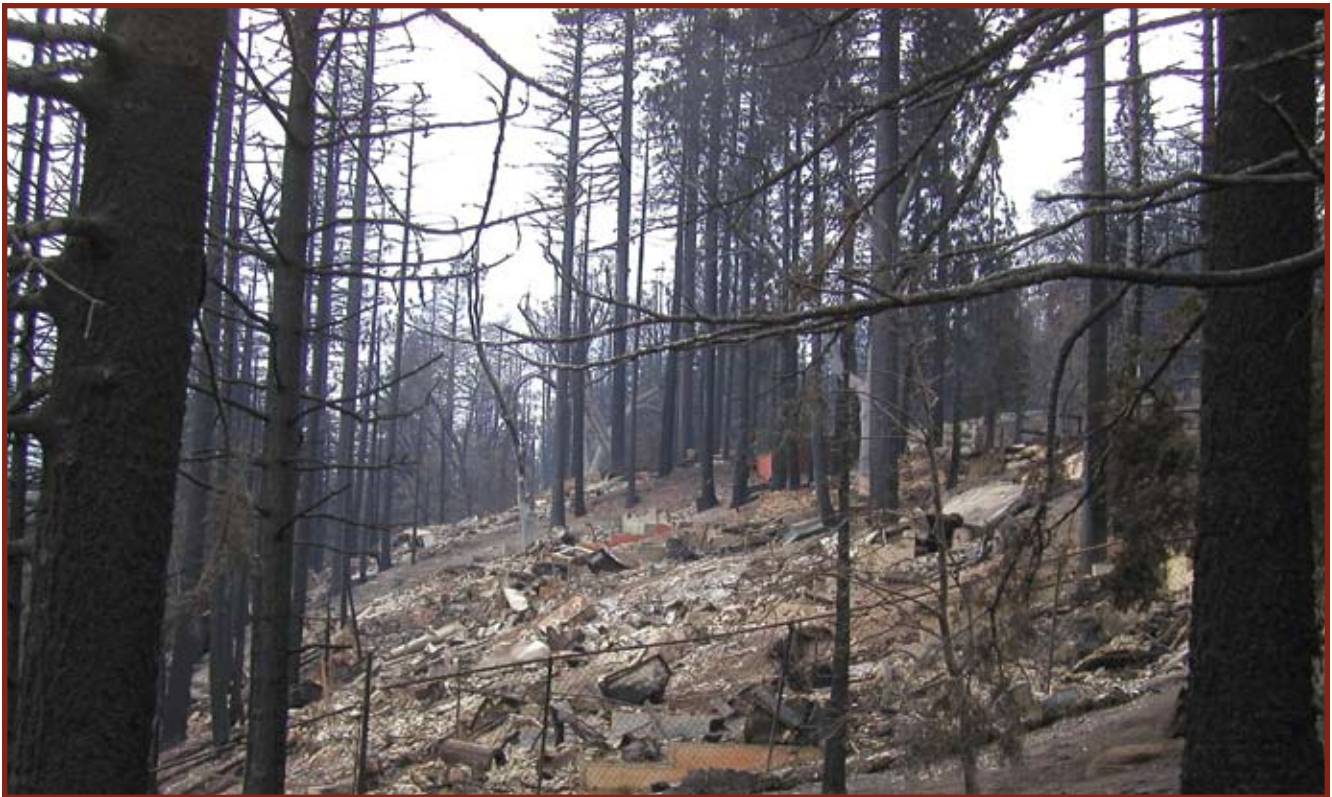
Figure 18. View of seven destroyed homes looking southwest on Inyo Ct. The burning homes primarily caused the tree canopy consumption.

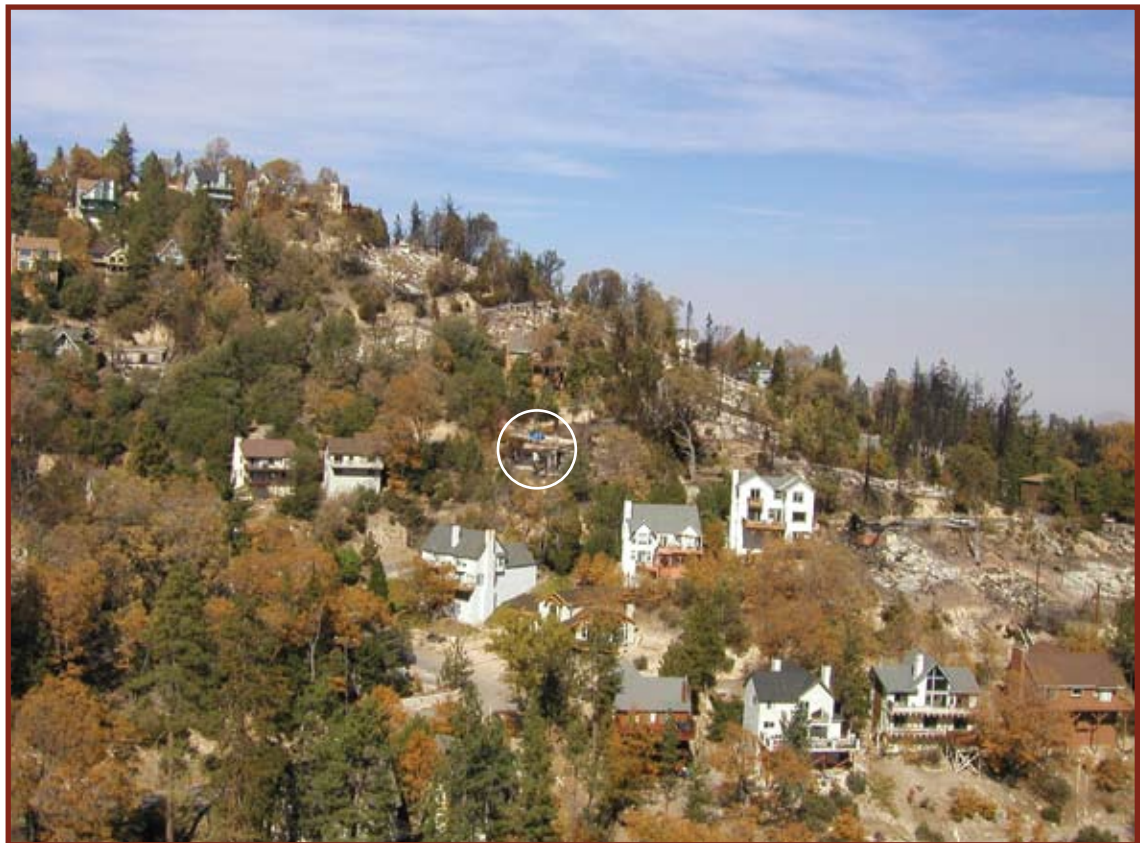
Figure 19. Photo of homes on Merced Ln. (1st row of homes) toward Kings Ct. (top of the hill). The destroyed home in the center of the photo (845 Del Norte Ln. [circled]) ignited from a surface fire and/or firebrand(s). Fire suppression stopped the house-to-house spread in this area due in part to the ‘lee’ effect the hill had on the northeast winds, the north-northeasterly wind shift at 1100, and the vacant parcels that reduced the house-to-house fire exposure.

Fires followed the hillside around to the southwest (Figure 19). Homes near the top of the hill (on Sonoma, Del Norte, and Madera) (Figures 20-22) and mid-slope (Marin) (Figure 23) were exposed first. Firebrands, possibly from 837 or 845 Del Norte, likely spotted across Madera and ignited a

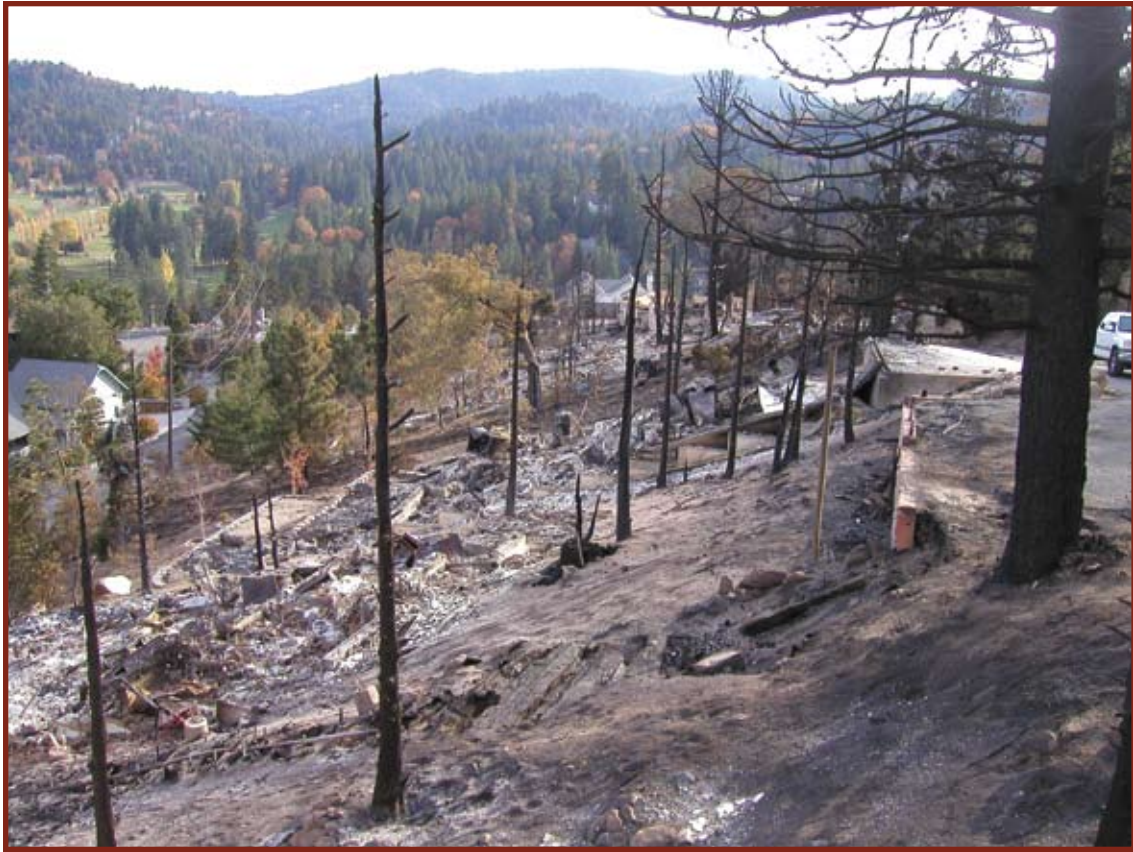
Figure 22. View of five destroyed homes on Madera Ln. looking south to Lake Arrowhead Country Club. The un-consumed tree canopies, in the middle-left of the photo, are in a vacant lot that surface burned.

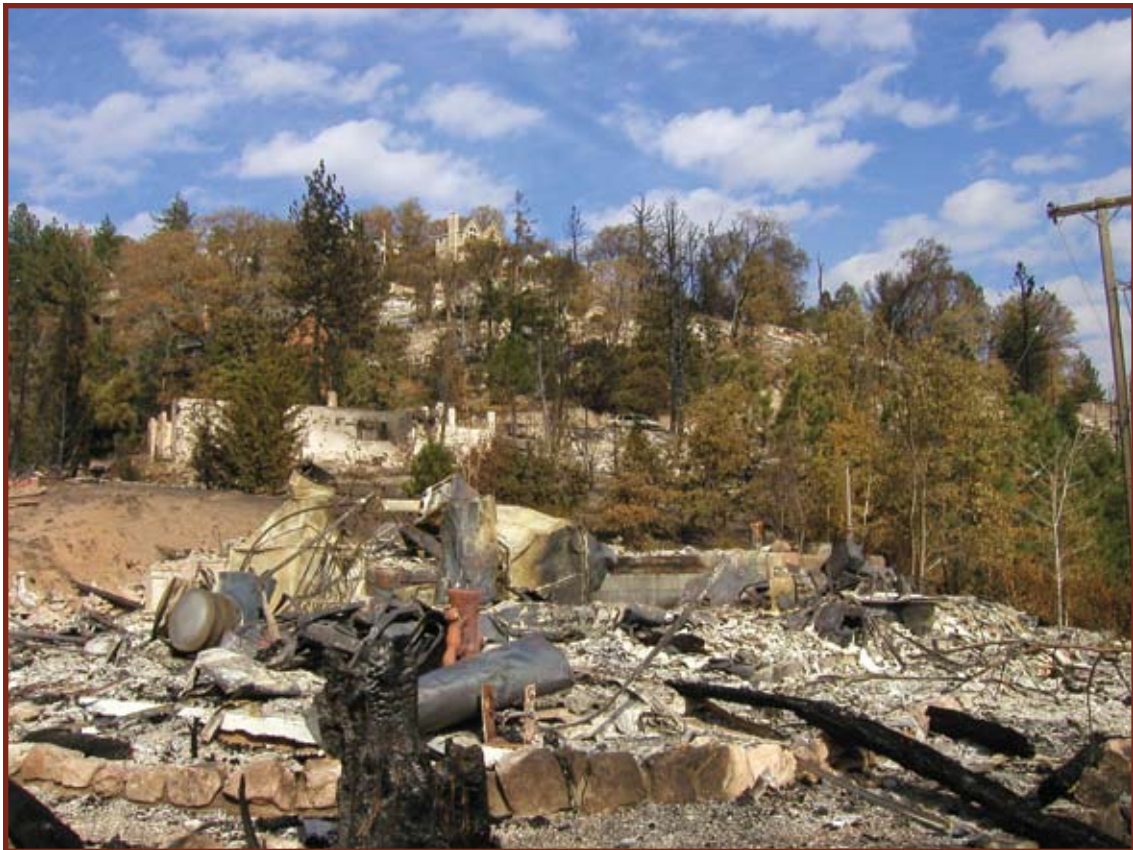
Figure 23. A view to the northwest upslope from 810 Marin Ln. through four levels of home destruction. The unconsumed vegetation between rows of destroyed homes indicates that a high intensity vegetation fire did not spread through the residential area.

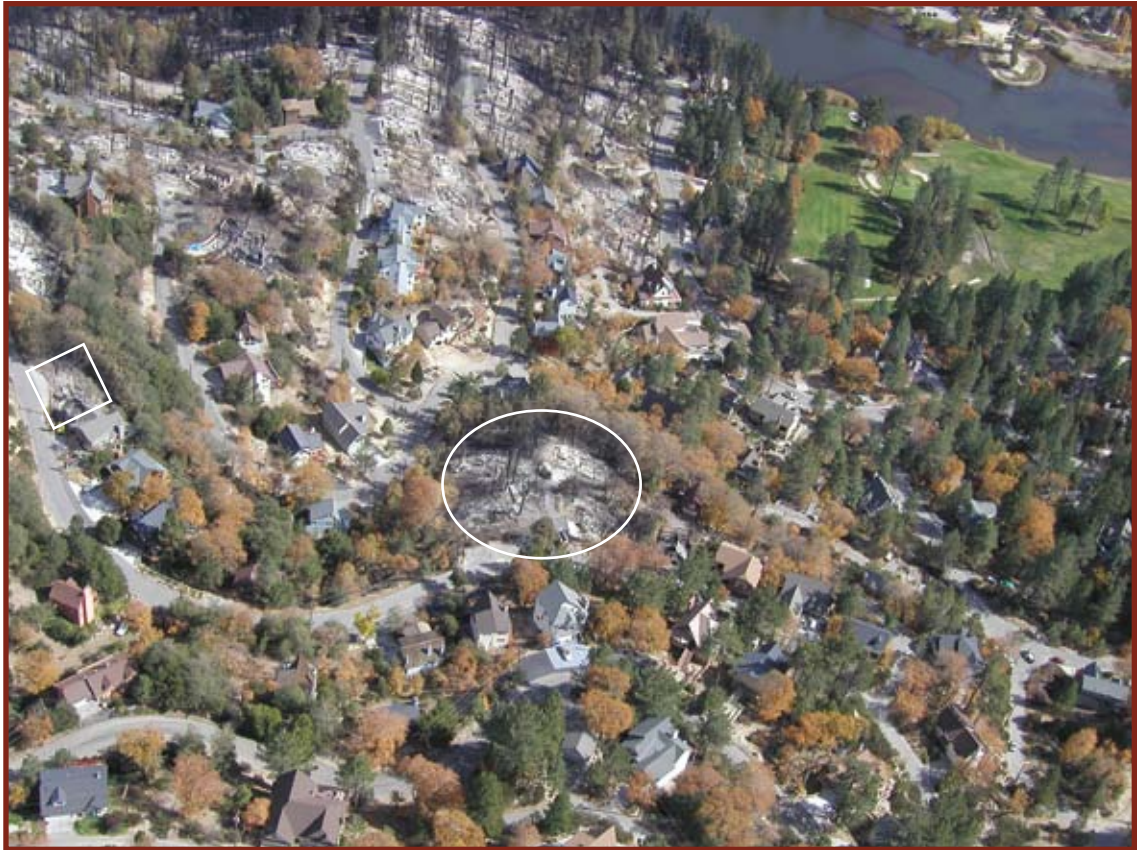
Figure 24. Aerial view looking down on five homes (circled) on Del Norte Ln. and Merced Ln. that were initially started by firebrands, possibly from burning homes or vegetation at 837 or 845 Del Norte (framed).

home(s) on Madera/Del Norte resulting in the eventual loss of five homes (Figure 24). At approximately 1100, the wind shifted north-northwesterly, spreading fire and burning debris downhill (southeast) to Merced, Modoc, and Brentwood (Figures 25-27).

Madera (see Figure 24), start a surface fire and/or directly ignited 26530 Placer resulting in destruction (Figures 29 and 30). The burning house caused minor exterior damage to the neighboring house at 26540.

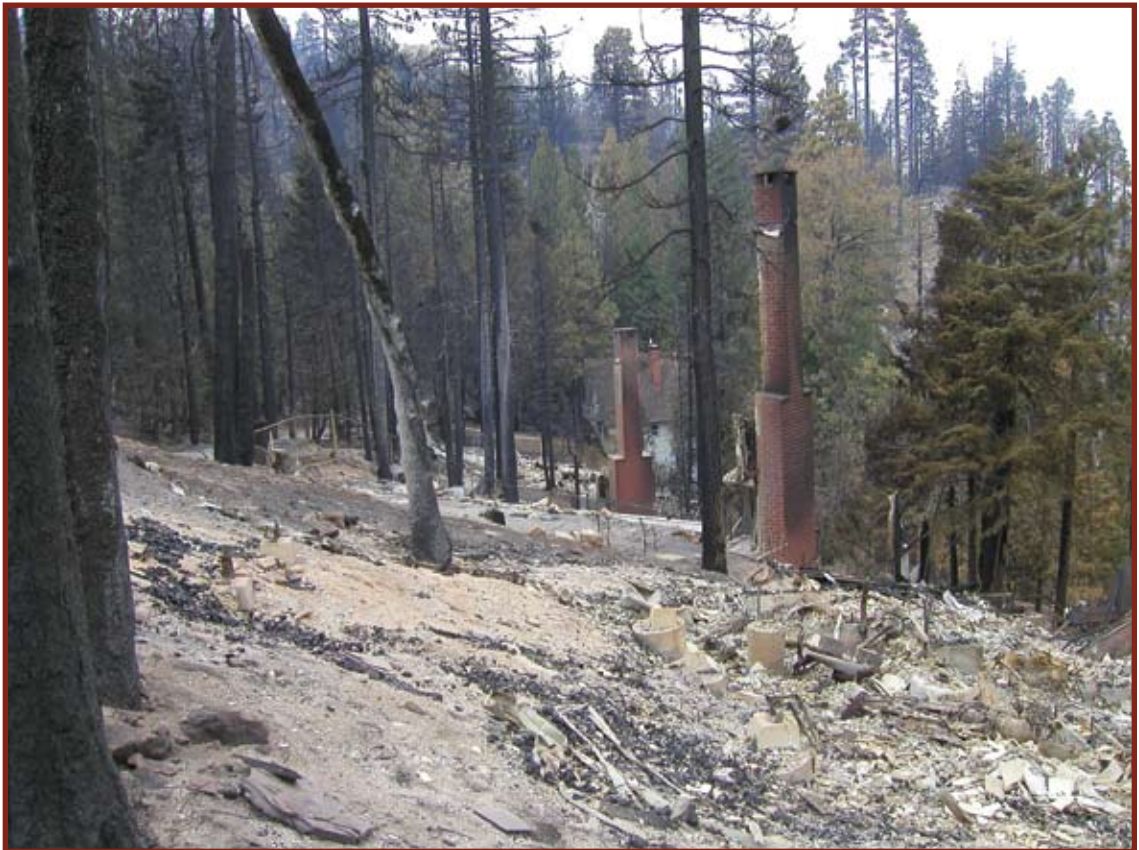
Figure 25. Four destroyed homes on Brentwood Dr. looking northwest. The home in the background is 850 Brentwood.

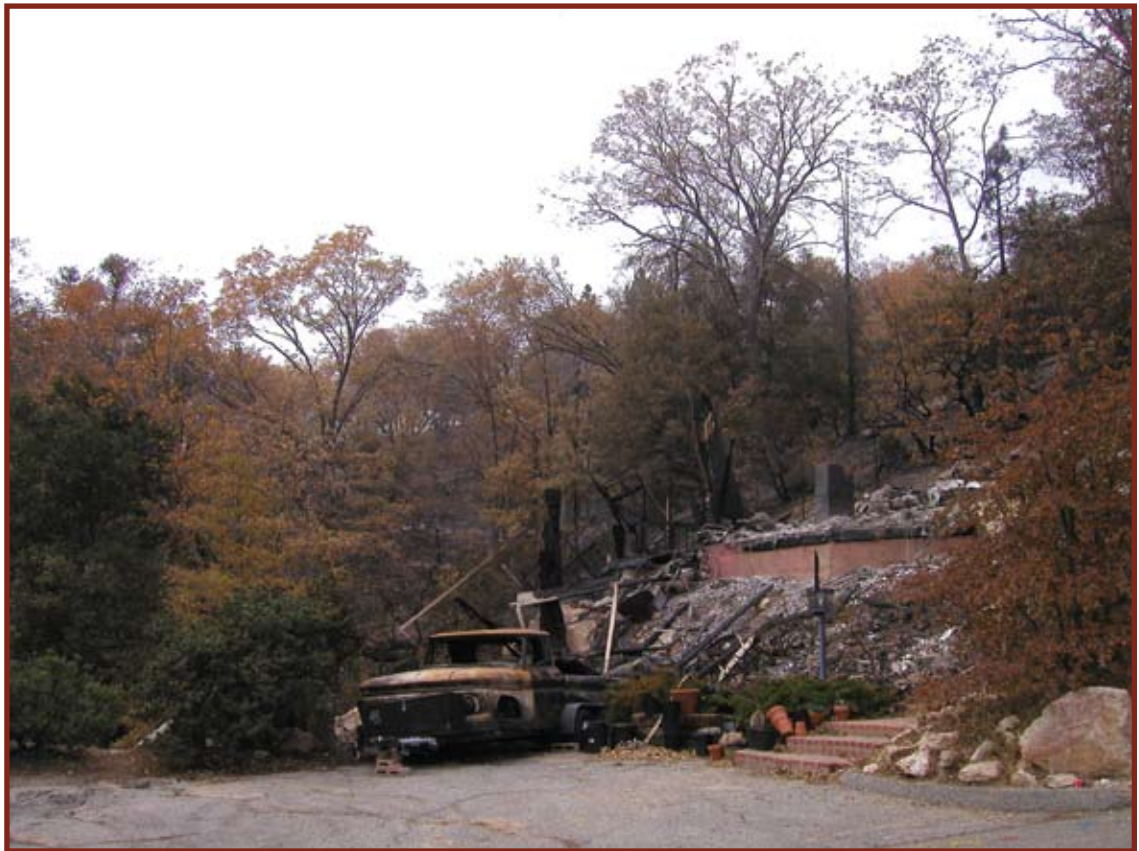
Figure 28. View of 710 Sonoma Dr. National Forest System lands are directly behind the destroyed home (west). The unconsumed vegetation surrounding the destroyed home indicates the likely cause was surface fire and/or firebrand(s). The neighboring house directly uphill survived (out of view to the right at 26516 Amador Ln.).

A spot fire west of 700 Sonoma and east of Tunnel 2 Rd. grew to about 35 acres. A surface fire and/or firebrand(s) directly ignited 710 Sonoma (Figure 28). Firebrands, possibly from the five burned homes on Del Norte/

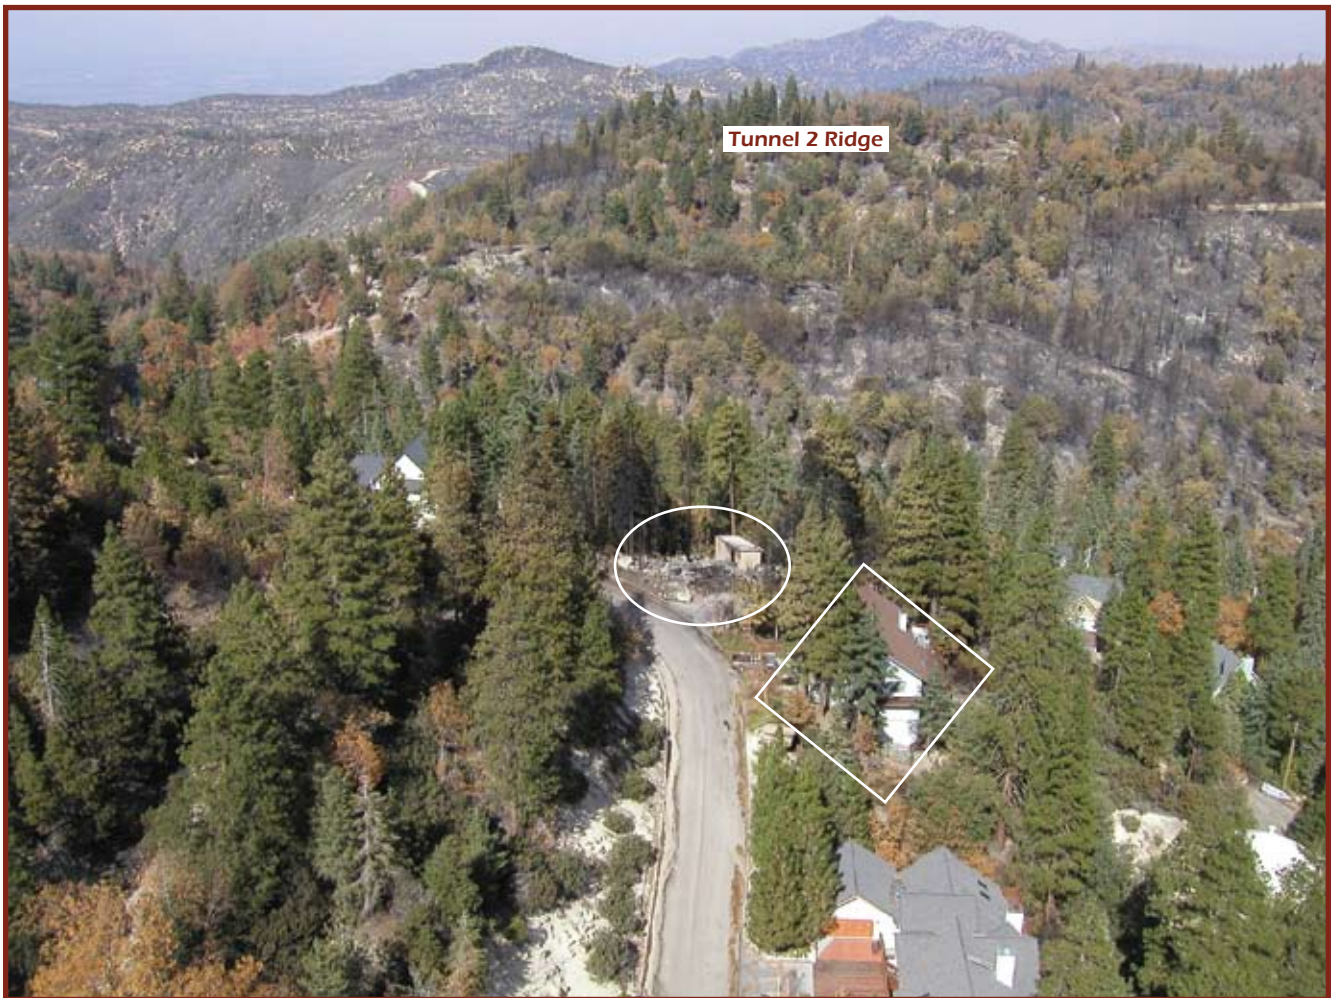
Figure 31. Aerial view looking northwest up Walnut Hills Dr. to destroyed home at 26142 (circled) and damaged home at 26150 (framed). Tunnel 2 Ridge is directly across drainage and shows evidence of group tree torching.

Firebrands, possibly from an area of torching across the drainage from Walnut Hills Dr. (Tunnel 2 Ridge) (Figure 31), started several spot fires upslope of Fairway Dr. Surface fire and/or firebrand(s) destroyed 26088 (Figure 33); 26142 (Figure 31); 26150 Walnut Hills (Figure 31) it was severely damaged on the sides exposed to 26142 (Figure 32). Surface fire and/or firebrand(s) destroyed 26088 (Figure 33); 26305 received minor exterior damage.
