**RESULTS OF THE
FIRST UNITED STATES
MANNED ORBITAL SPACE FLIGHT
FEBRUARY 20, 1962**

**Manned Spacecraft Center
NATIONAL AERONAUTICS AND SPACE ADMINISTRATION**

This document presents the results of the first United States manned orbital space flight conducted on February 20, 1962. The prelaunch activities, spacecraft description, flight operations, flight data, and postflight analyses presented form a continuation of the information previously published for the two United States manned suborbital space flights conducted on May 5, 1961, and July 21, 1961, respectively, by the National Aeronautics and Space Administration.

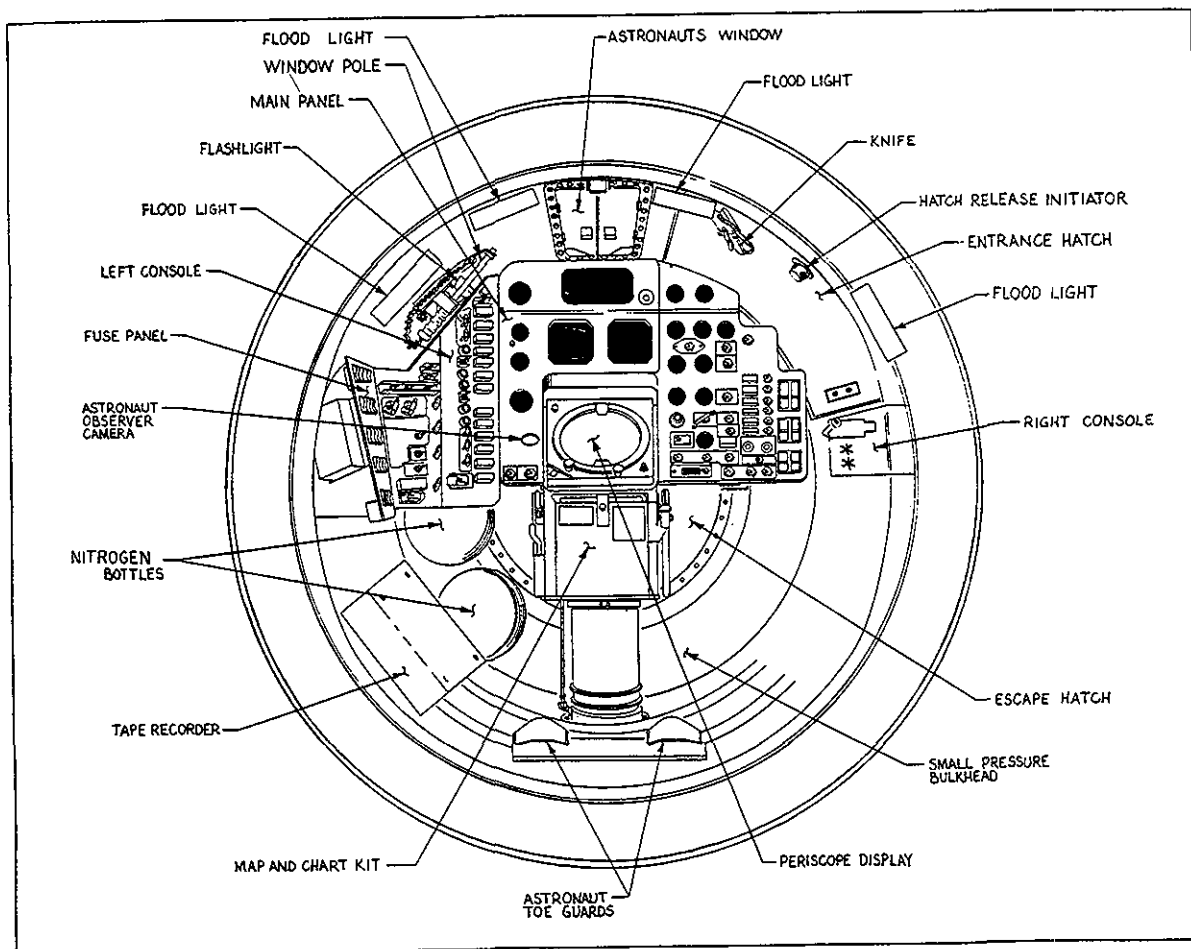
FIGURE 2-3.—Spacecraft cabin arrangement.

A window is provided, in the conical section over the astronaut's head, for the astronaut to use for observations and for obtaining visual attitude references. The astronaut entrance and egress hatch is located in the conical section as indicated by the outline to the astronaut's right. The astronaut can also egress through

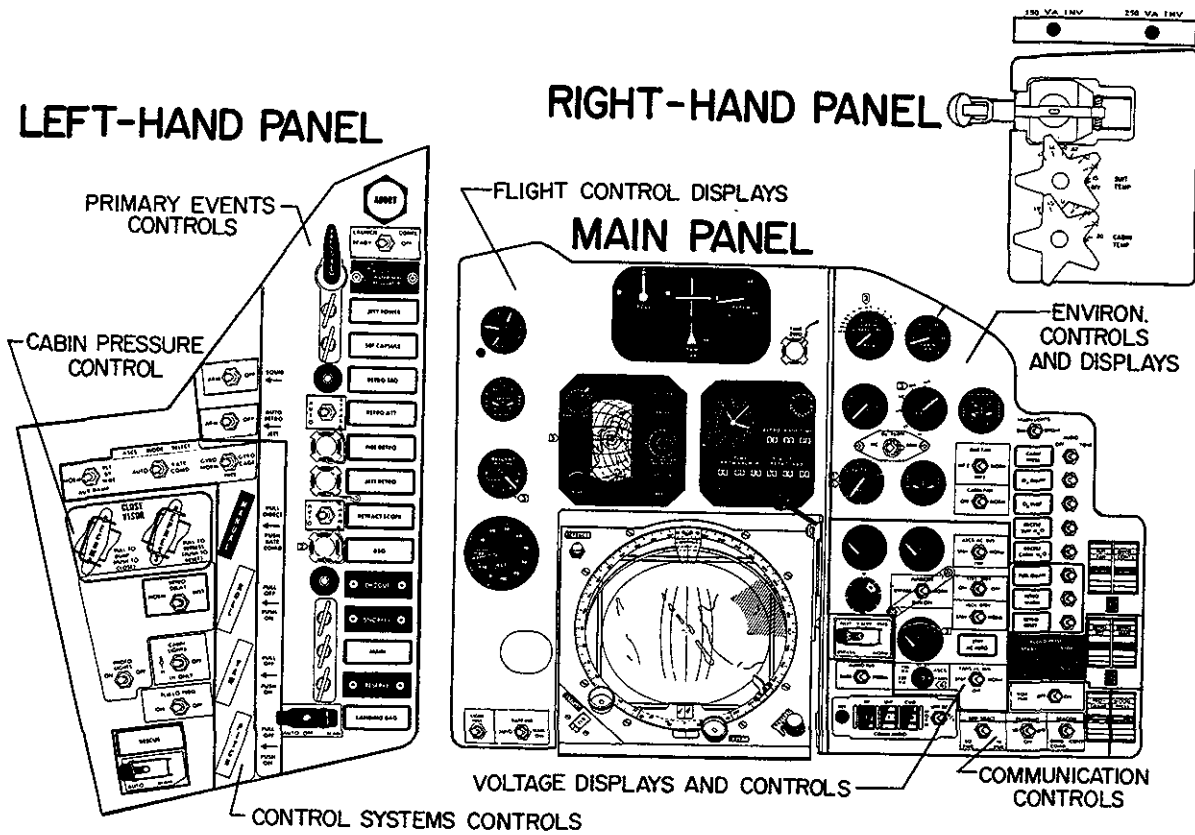
FIGURE 2-4.—Instrument panels.

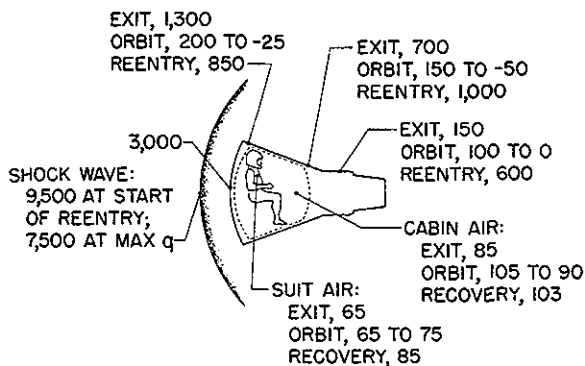
FIGURE 2-7.—Representative temperatures in degrees Fahrenheit.

During the exit flight, when the small end of the spacecraft points in the direction of flight, the afterbody shingles are also subjected to aerodynamic heating, attaining maximum temperatures as high as about 1,300° F. With the local temperatures dependent upon local flow conditions and the thermal mass of the spacecraft surface.

The temperature variation of the outer shingles around the astronaut's pressure compart-

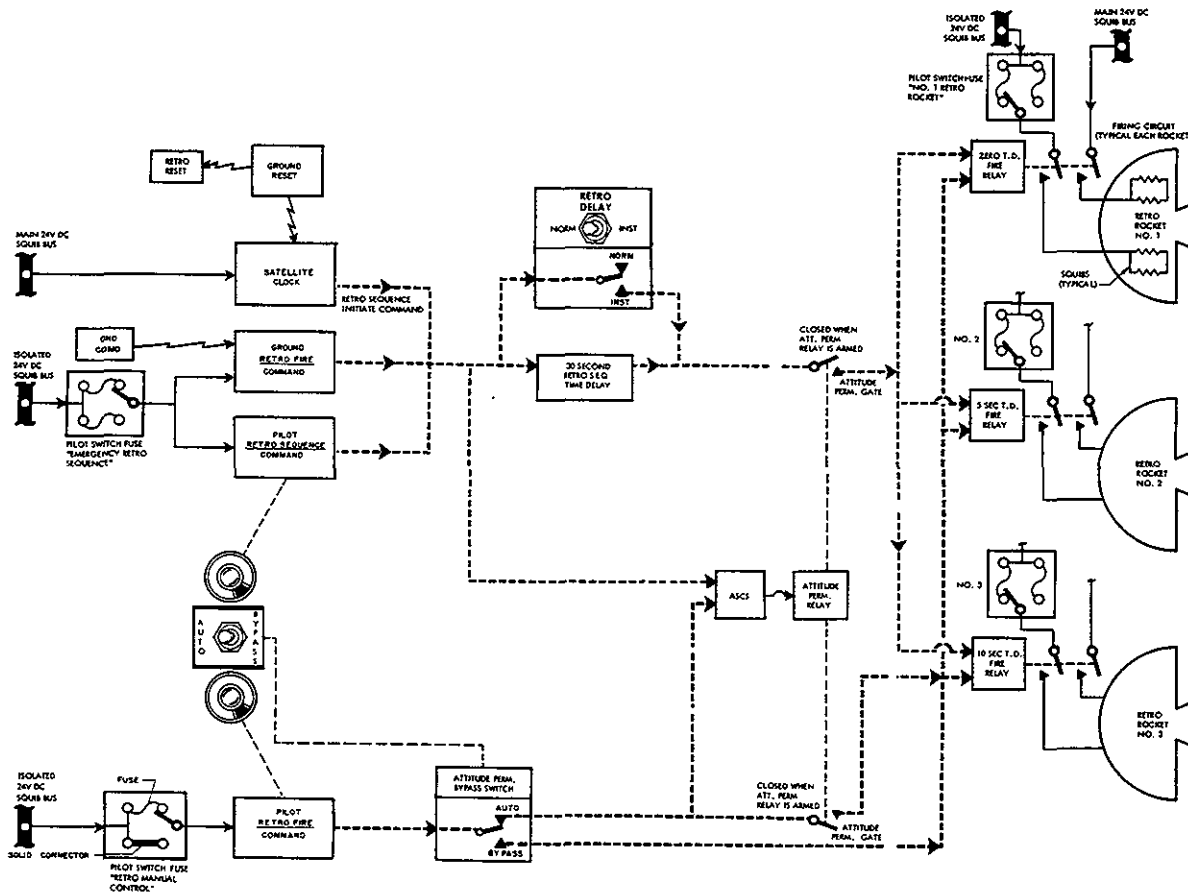
FIGURE 2-10.—Retrorocket fire schematic diagram.

All rocket motors have dual ignition systems from separate electrical power sources. In addition, each ignition system has dual squibs

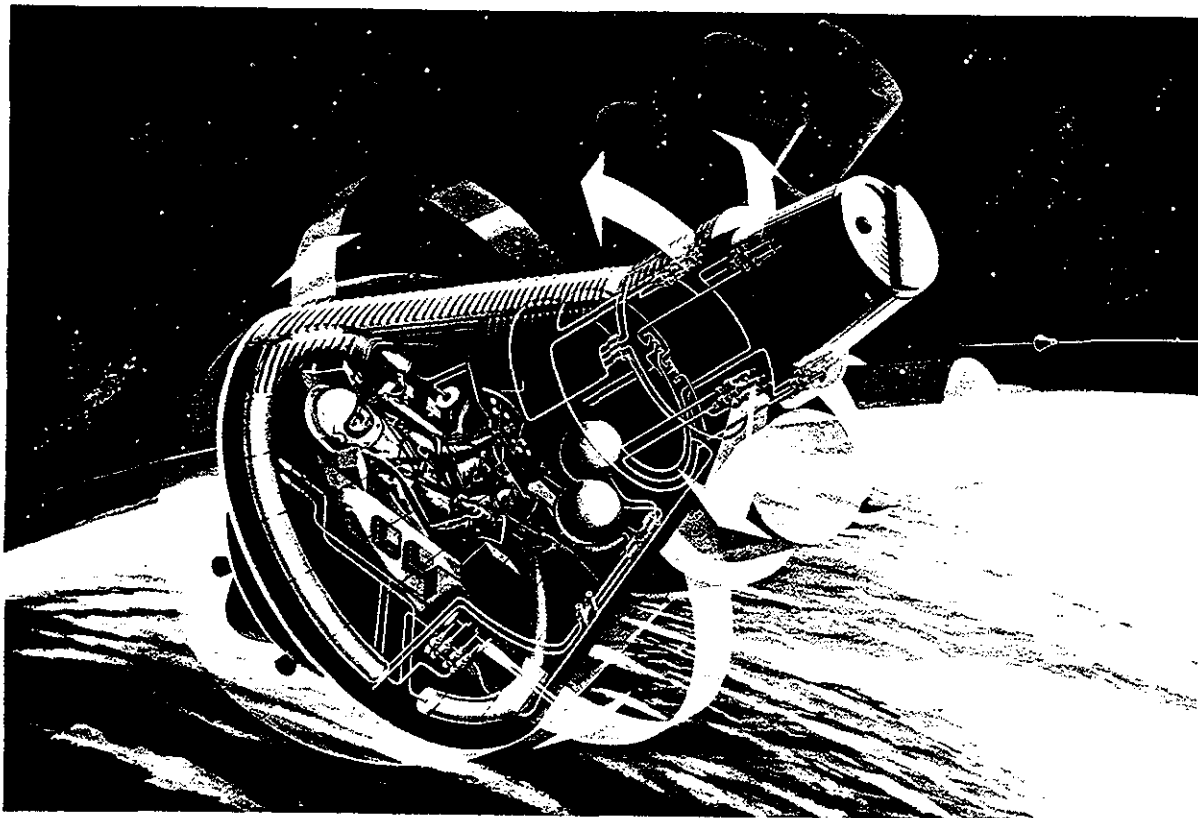
FIGURE 2-11.—Arrangement of reaction control system.

The thruster impulse is directed by the four basic control modes through 18 individual system, as shown in figure 2-11. Figures thrusters—12 on system A and 6 on the manual 2-12(a) and 2-12(b) show the A and B systems RCS schematic diagrams. Figures 2-12(a) and 2-12(b) do not show completely the methods of electrically controlling the thrusters; in figure 2-12(a) there is a switch missing between the hand controller and the ASCS control box which permits selection of either FBW or ASCS. Similarly, in figure 2-12(b) the connection of the hand controller through a switch and the ASCS control box to the thruster solenoids for RSCS control is missing. Metered quantities of hydrogen peroxide are decomposed in silver-plated catalyst beds in each of the thruster chambers to provide the desired impulse. Twelve of the thrusters, used on the Mercury spacecraft are sized to provide adequate control during the retromaneuver.

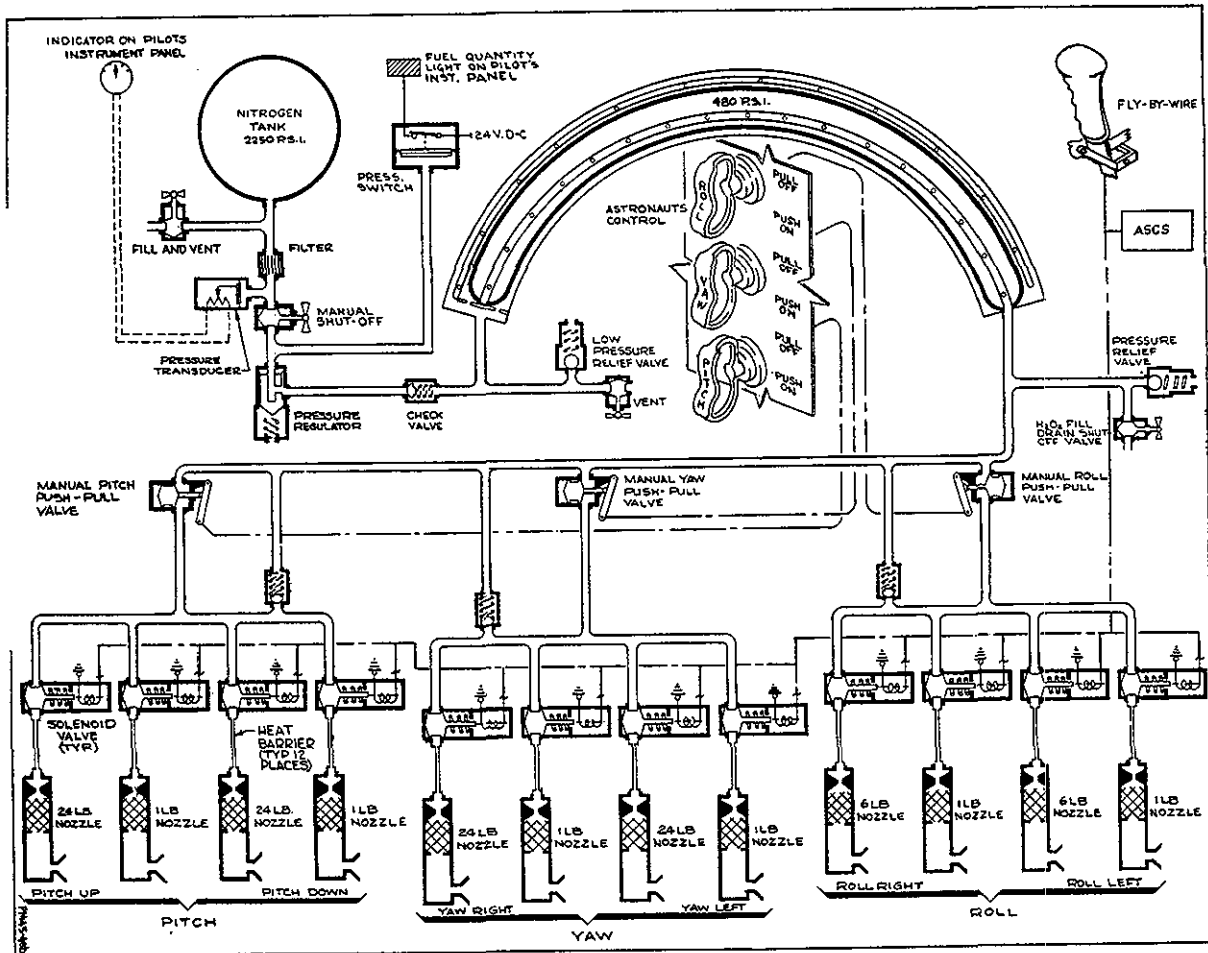
(a) System A.

FIGURE 2-12.—Reaction control system schematic diagrams.

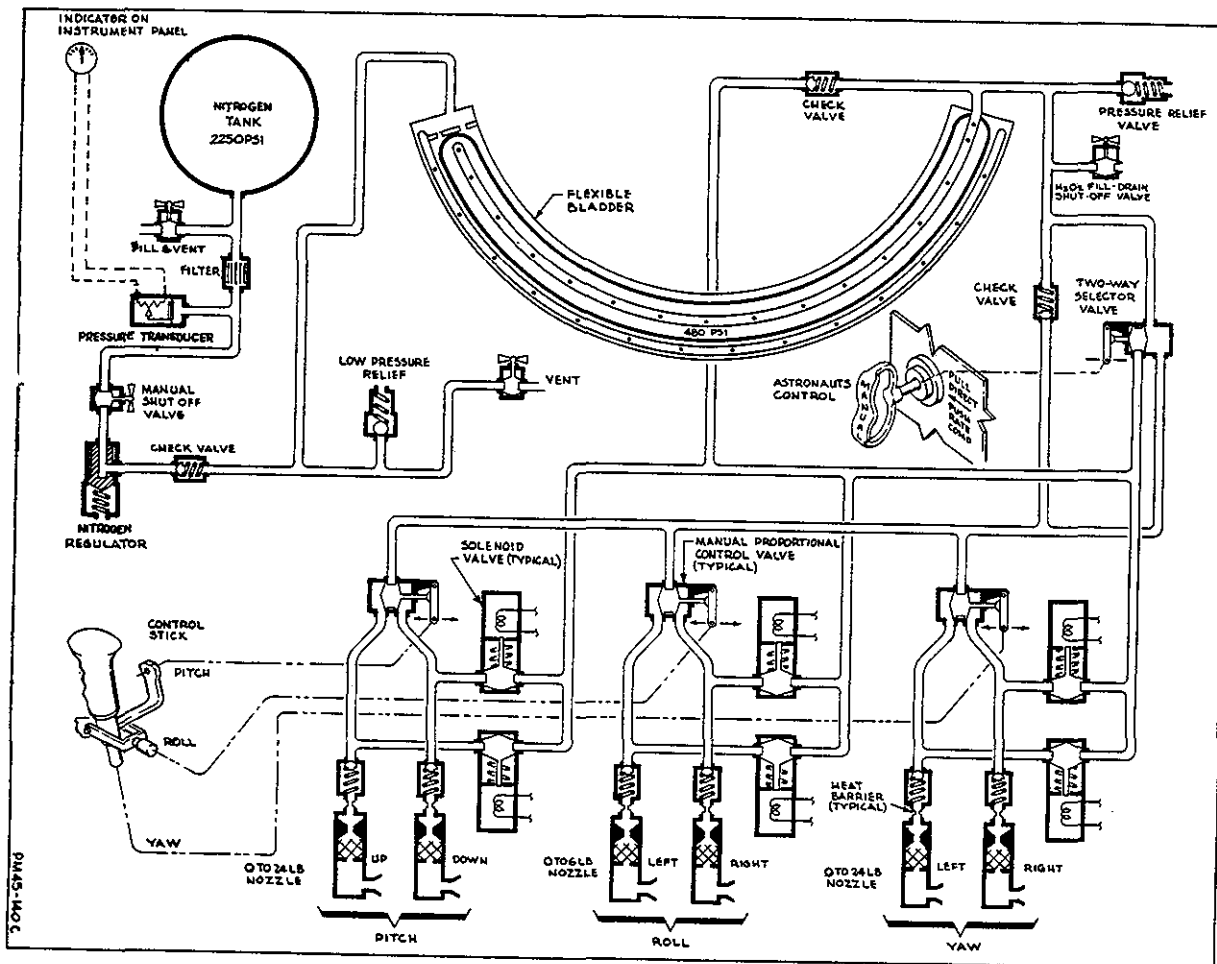
(b) System B.
 FIGURE 2-12.—Concluded.

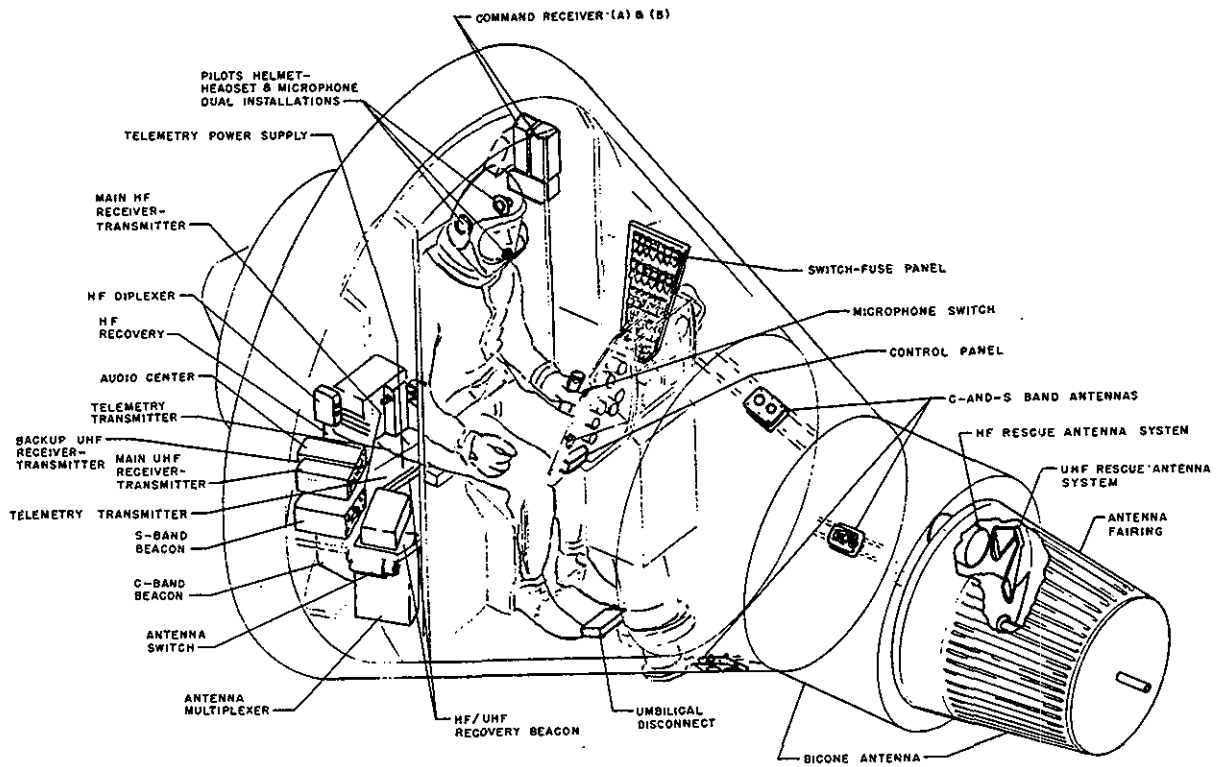
FIGURE 2-13.—Locations of major components of communications system.

The spacecraft communications and instrumentation systems consisted of voice, radar, command, recovery, and telemetry links. Each system had main and backup (or parallel) equipment for redundancy, with selection of the desired system generally at discretion of the astronaut through switches mounted on the instrument panel. Table 2-II is a list of the systems, and figure 2-13 shows the physical lo-

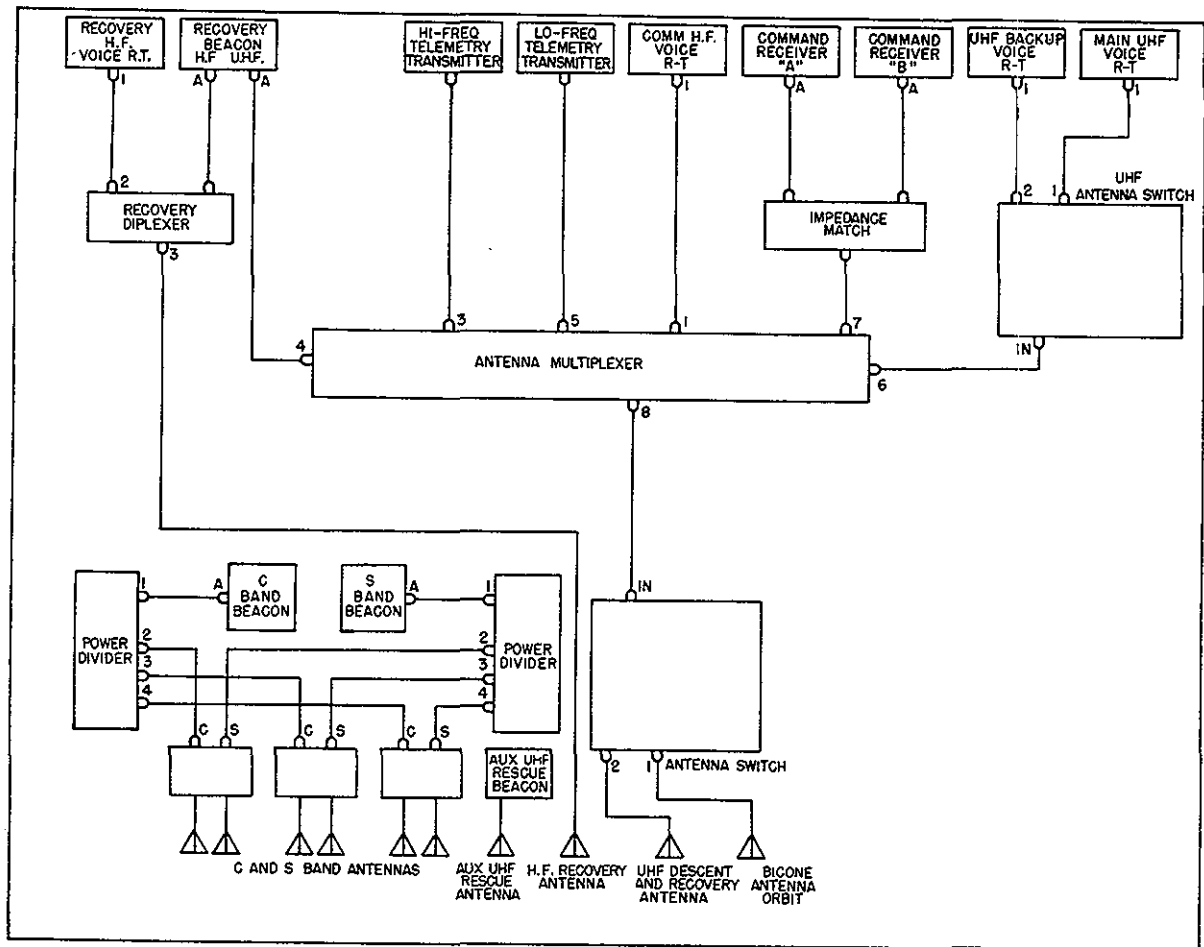
FIGURE 2-15.—Communications and antenna systems schematic diagram.

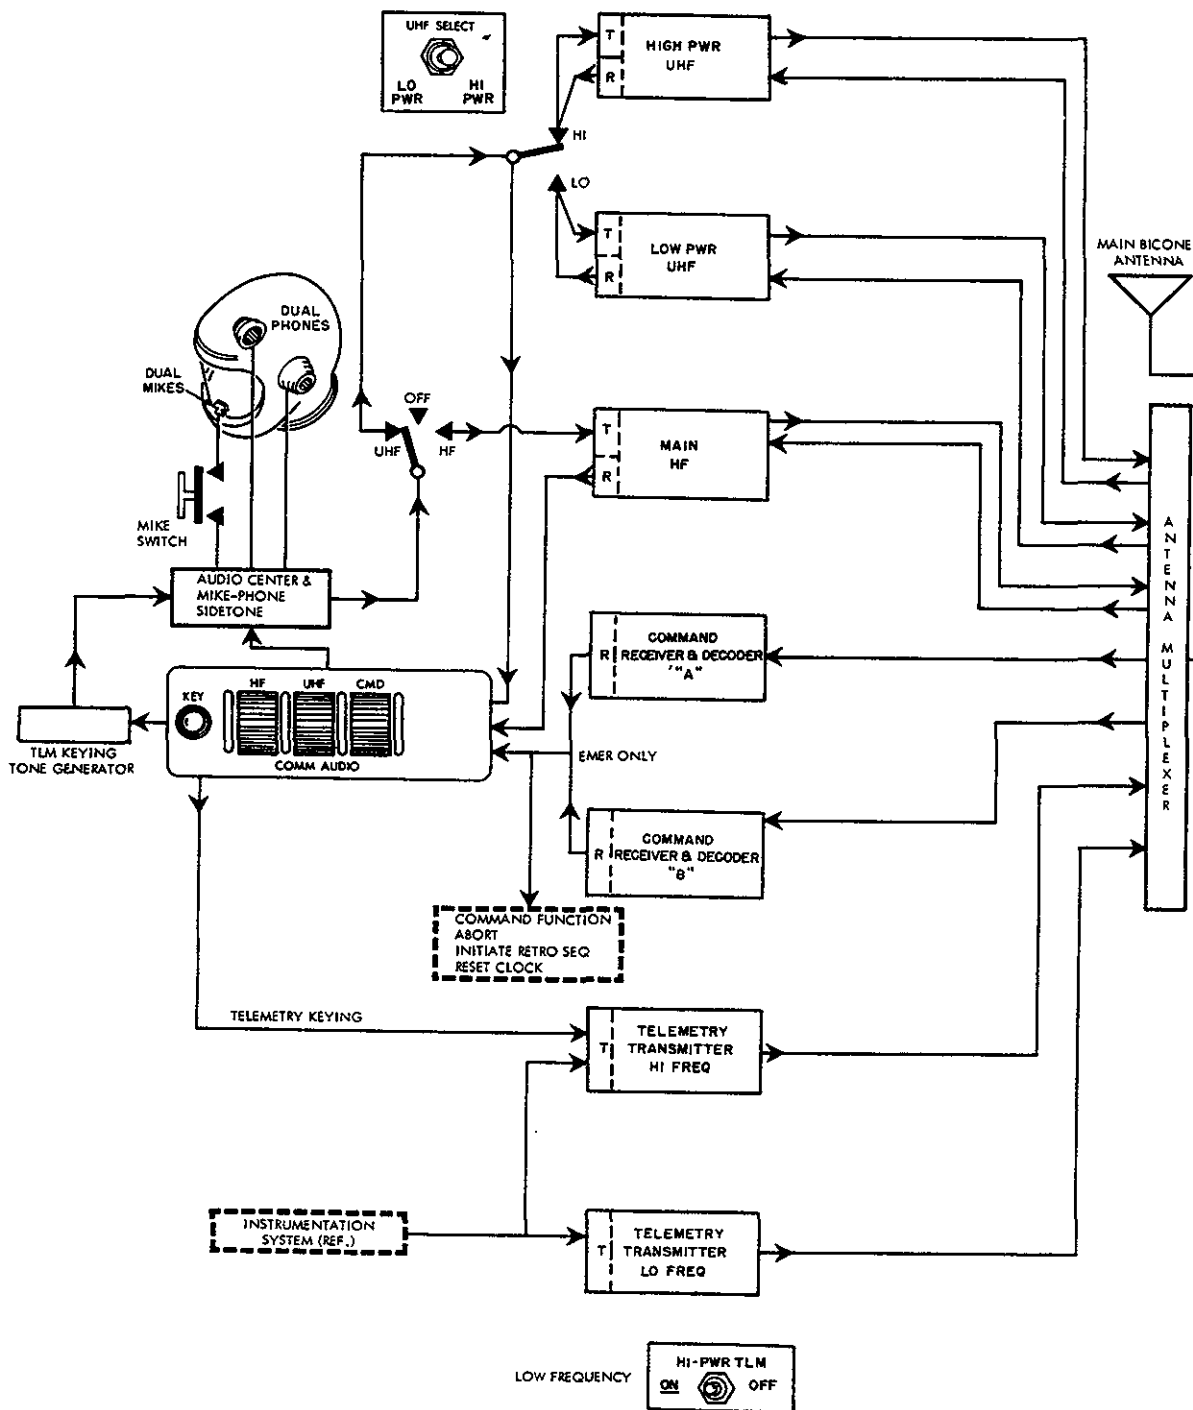
FIGURE 2-16.—Voice systems schematic diagram.

perience and ground tests, it was known that the HF system had somewhat poorer voice fidelity but longer range than the UHF system. The UHF system, because of its slightly better voice quality, was considered to be the primary system. From previous experience, it was known that the range of the UHF system was approximately equal to the line-of-sight range and was entirely adequate for a normal mission. The main voice traffic was therefore conducted on the UHF system, with a small amount of traffic conducted on the HF system to verify system operation. It might be noted that the UHF system consisted of a main and a backup transmitter-receiver. Thus, three separate voice systems were available for choice of the astronaut—HF, UHF main, and UHF backup—as shown in figure 2-16. Also, a redundant ground-to-air voice link is available through the command receiver channel. An additional air-to-ground communication link is available to the astronaut by keying the low-frequency telemeter carrier. It should be noted that all of these links use the main bicone antenna through the use of a multiplexer.

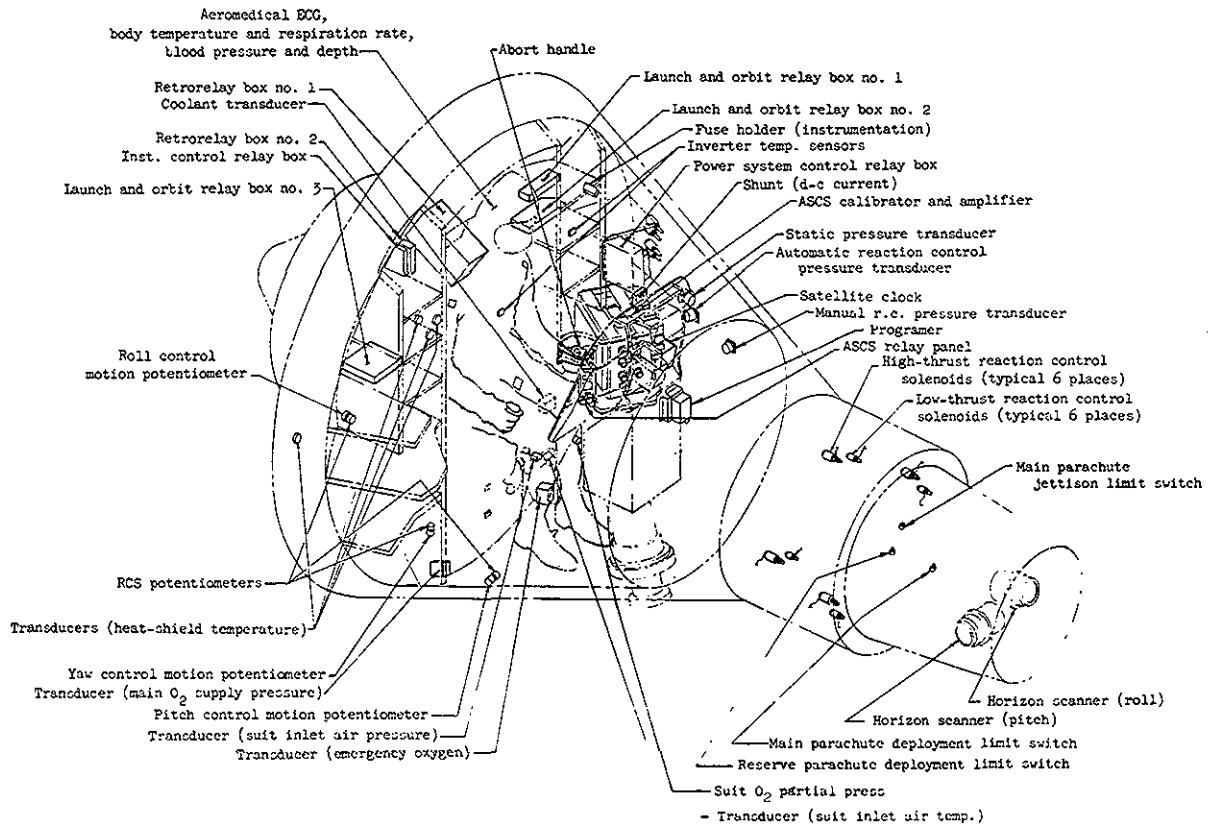
FIGURE 2-17.—Location of some spacecraft instrumentation sensors.

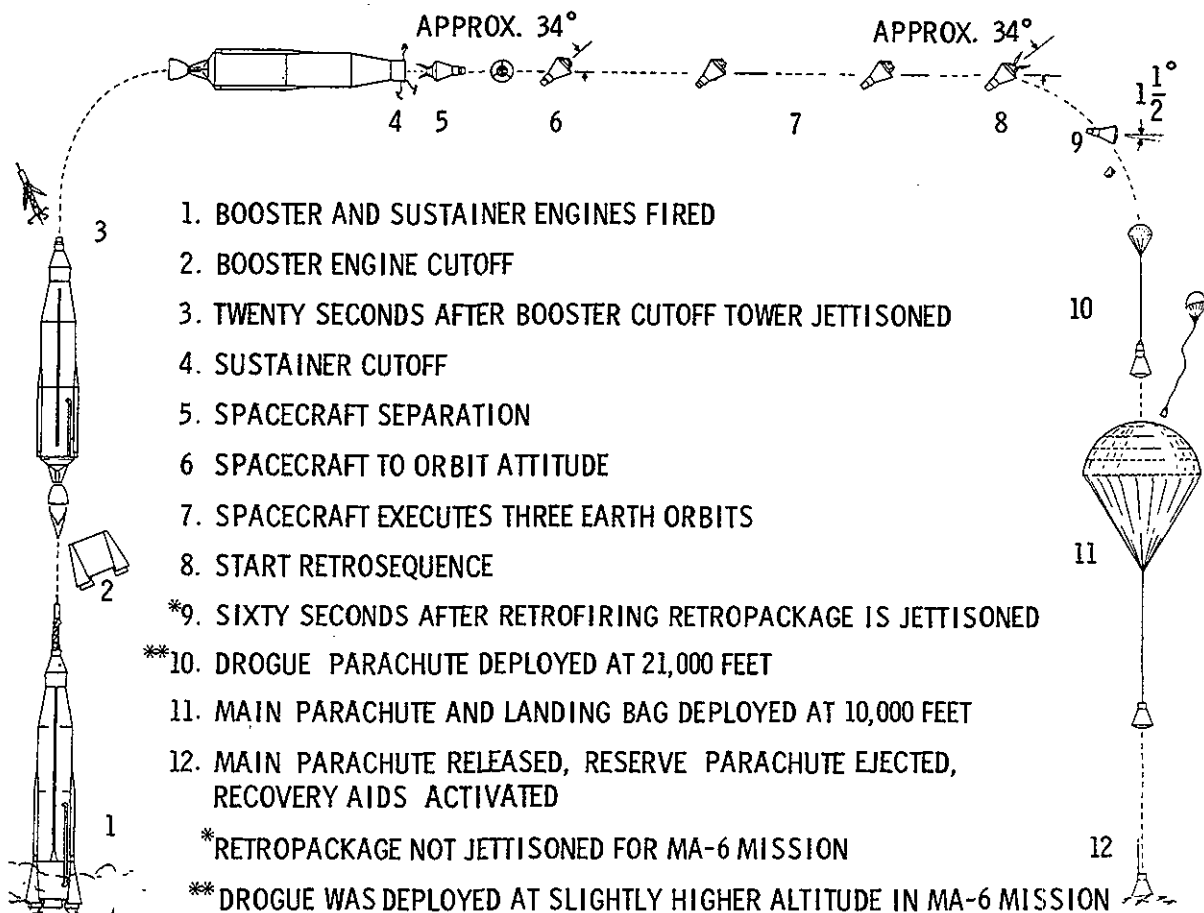
FIGURE 2-22.—Sequence of major events for the MA-6 mission.

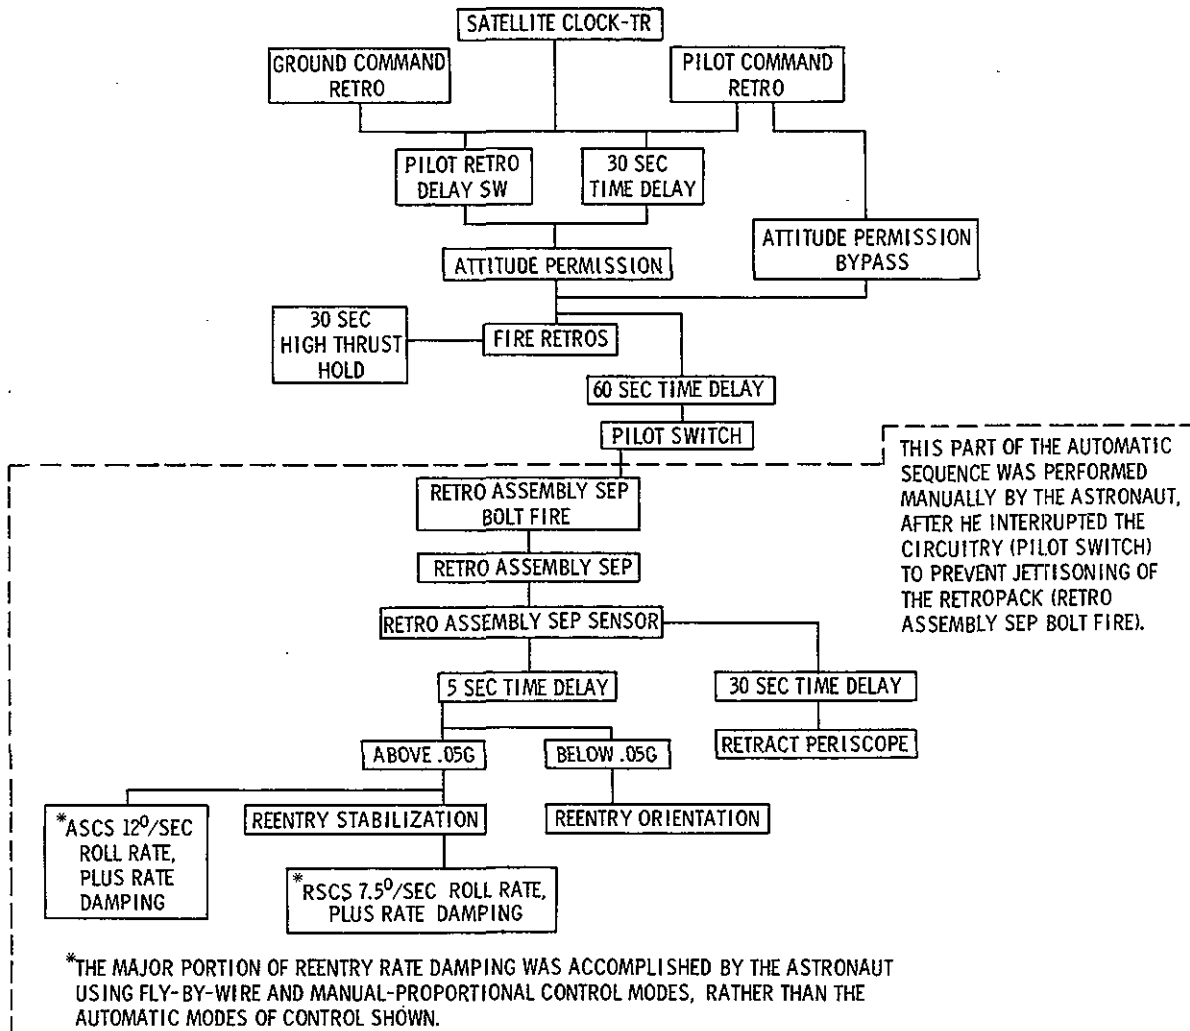
(b) Retrograde and reentry.

FIGURE 2-23.—Continued.

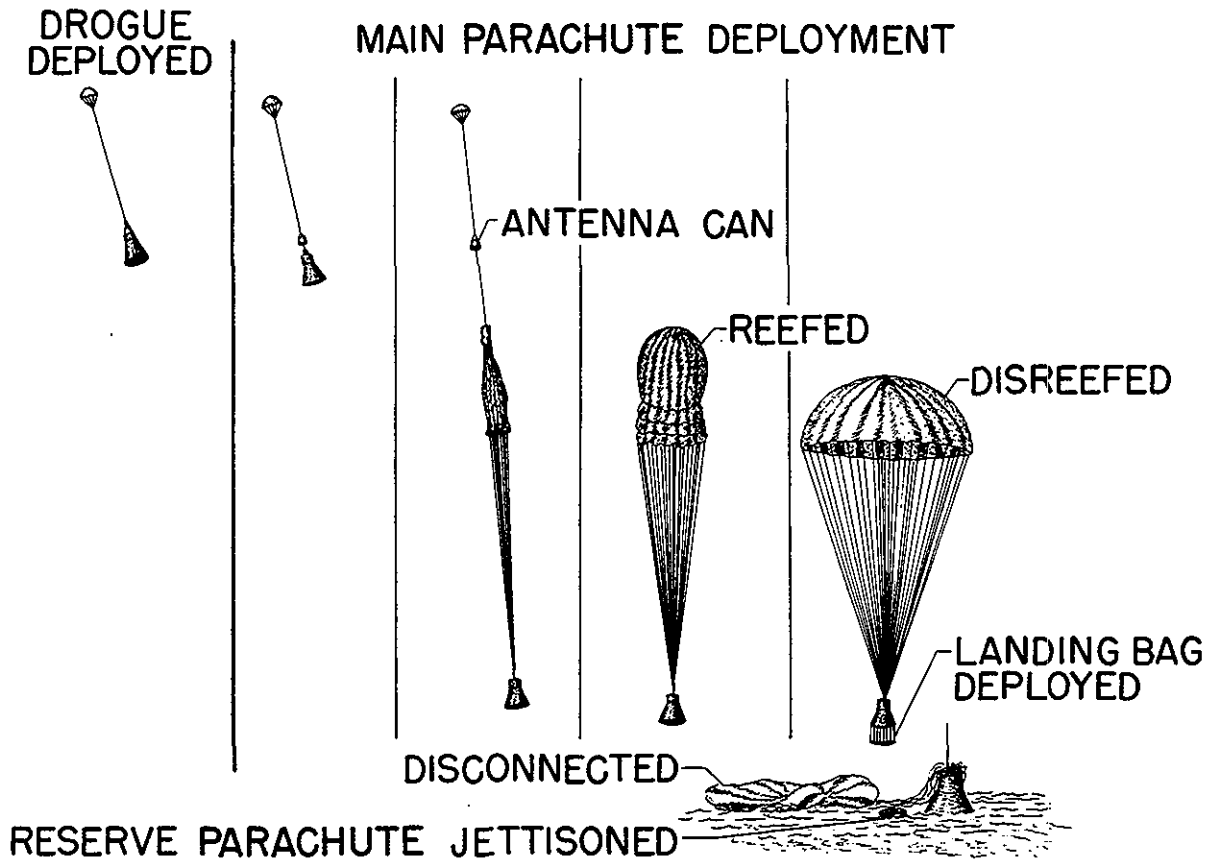
FIGURE 2-24.—Sketch depicting use of spacecraft landing systems.

The landing system is normally actuated at an altitude of about 21,000 feet by either one of two barostats which sense atmospheric pres-

sure. At this time, the drogue parachute is deployed to decelerate and stabilize the spacecraft. At about 10,000 feet, the antenna section and drogue parachute are jettisoned by the signals from another dual barostat and the main parachute is deployed in a reefed condition opened to 12-percent of the maximum diameter for 4 seconds to minimize the opening shock. The main parachute deploys fully after 4 seconds of reefing. A reserve parachute may be deployed by the astronaut in the event the main parachute is unsatisfactory. After main parachute deployment, the landing bag is extended to provide attenuation of the landing load. Immediately after landing, the main parachute is automatically disconnected and the reserve parachute is ejected.

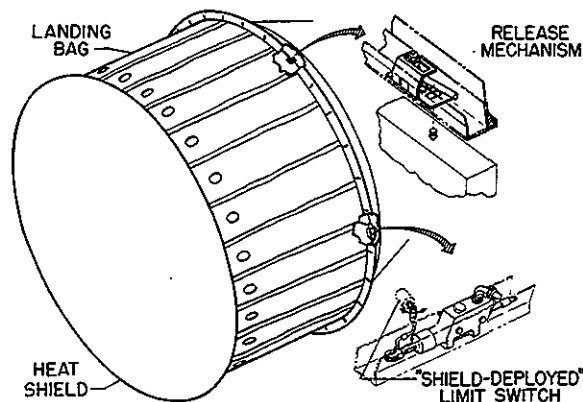
FIGURE 2-25.—Details of heat-shield deployment mechanism and sensing switches.

The "heat-shield-deployed" signal, that is sent to the telemetry system, is furnished by either one of two limit switches which sense the movement of the heat-shield retention devices as shown in figure 2-25. During the orbital flight portion of the MA-6 mission, one of these switches sent a "shield-deployed" signal to the ground monitoring stations. Post-

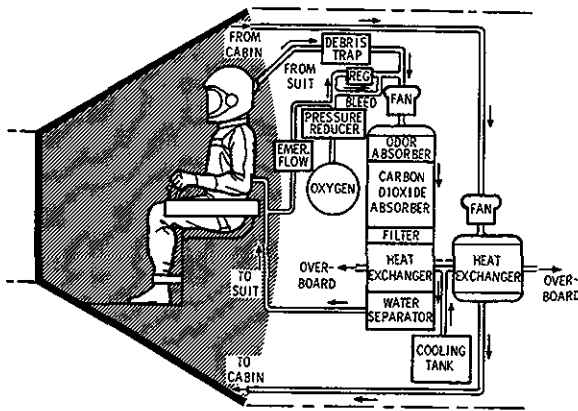
FIGURE 3-2.—Schematic diagram of the Mercury environmental control system.

The pressures in the cabin and pressure suit are maintained at 5.1 psia in normal flight with a 100-percent oxygen atmosphere. The system is designed to control automatically the environmental conditions within the suit and cabin throughout the flight. Manual controls are provided to enable system operation in the event of automatic control malfunction. In describing the environmental control system, it can be considered as two subsystems; the pressure-suit control system and the cabin system. Both of these systems operate simultaneously from common coolant water and electrical supplies. The coolant water is stored in a tank with a pressurized bladder system to facilitate weightless flow of water into the heat exchanger. Electrical power is supplied from an onboard battery supply. Oxygen is supplied at an initial

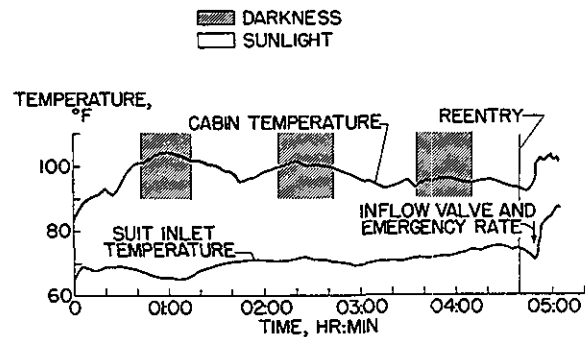
FIGURE 3-3.—Variation of suit and cabin temperatures with time.

The cabin air temperature (fig. 3-3) fluctuated between 90° F and 104° F as the spacecraft passed from darkness into sunlight. The astronaut reported that at least five attempts to reduce cabin air temperature by increasing water flow to the cabin heat exchanger resulted in the illumination of the excess-water light. This light indicated that the cabin heat ex-

changer was operating near its maximum capacity for the existing conditions. Even so, the mean cabin air temperature was steadily reduced during the mission after the first hour in orbit.

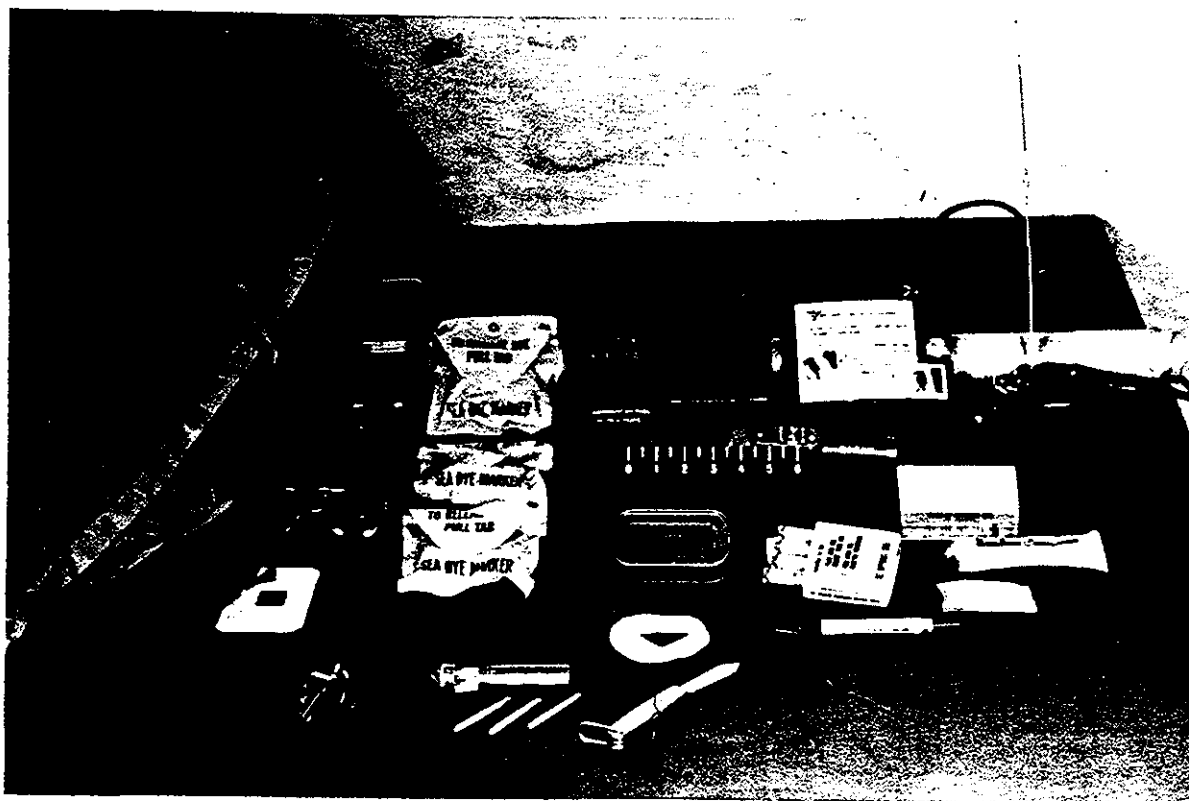
FIGURE 3-9.—Survival kit components.

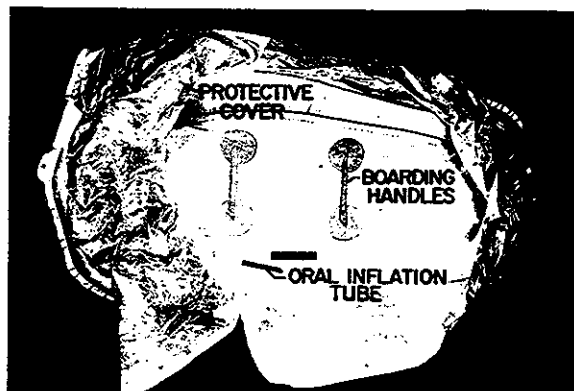
FIGURE 3-11.—Liferaft top view.

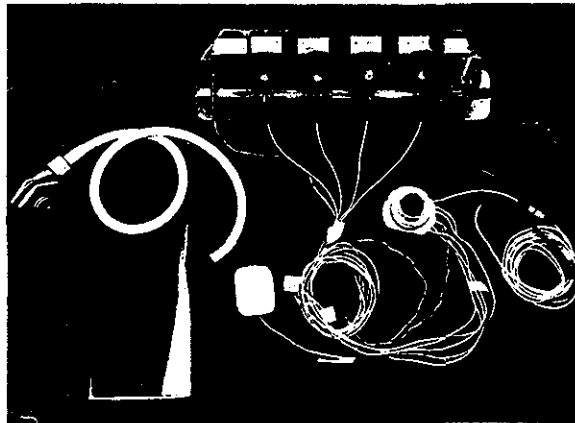
FIGURE 3-15.—Flight sensor harness.

The ECG sensors consist of rings composed of silicone rubber. The rings are constructed

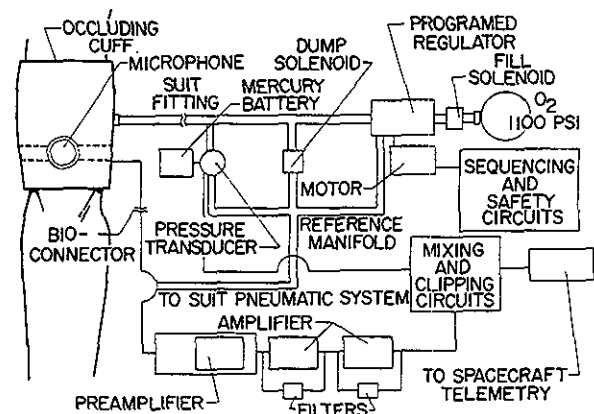
FIGURE 3-16.—Block diagram of automatic BPMS.

The original concept of the BPMS (fig. 3-16) was an automatic system, which would be initiated from a tracking station through the command receiver, by an automatic sequencing device onboard or by the pilot. The automatic system incorporated special safety circuits to dump the cuff pressure if the cuff stayed above

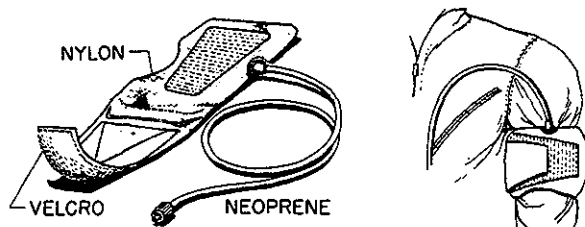
FIGURE 3-17.—BPMS cuff.

During the testing of the preliminary system on astronauts and other flight personnel it became evident that the standard 5-inch clinical cuff was unsatisfactory because of its stiffness, bulk, and the fact that arm movement was restricted. A new cuff (fig. 3-17) was devised by

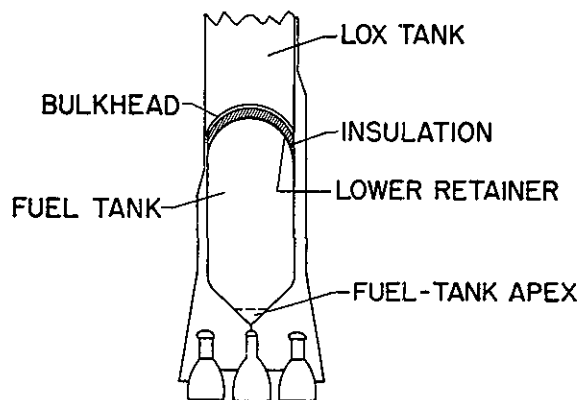
FIGURE 4-14.—Bulkhead between fuel and liquid oxygen tanks.

After electrical mating, the launch vehicle and spacecraft participate jointly in all tests. These tests are discussed in paper 5 on spacecraft preparation. The first attempt to launch MA-6 was on January 27, 1962. The launch vehicle was loaded with fuel on January 24. However, the mission was canceled because of excessive cloud cover in the launch area and was rescheduled for February 1; so the fuel tank was drained. On January 30, the fuel tank was again loaded; however, normal inspection procedures disclosed that the insulation-retaining bulkhead in the fuel tanks was leaking. Figure 4-14 shows a sketch of this bulkhead.

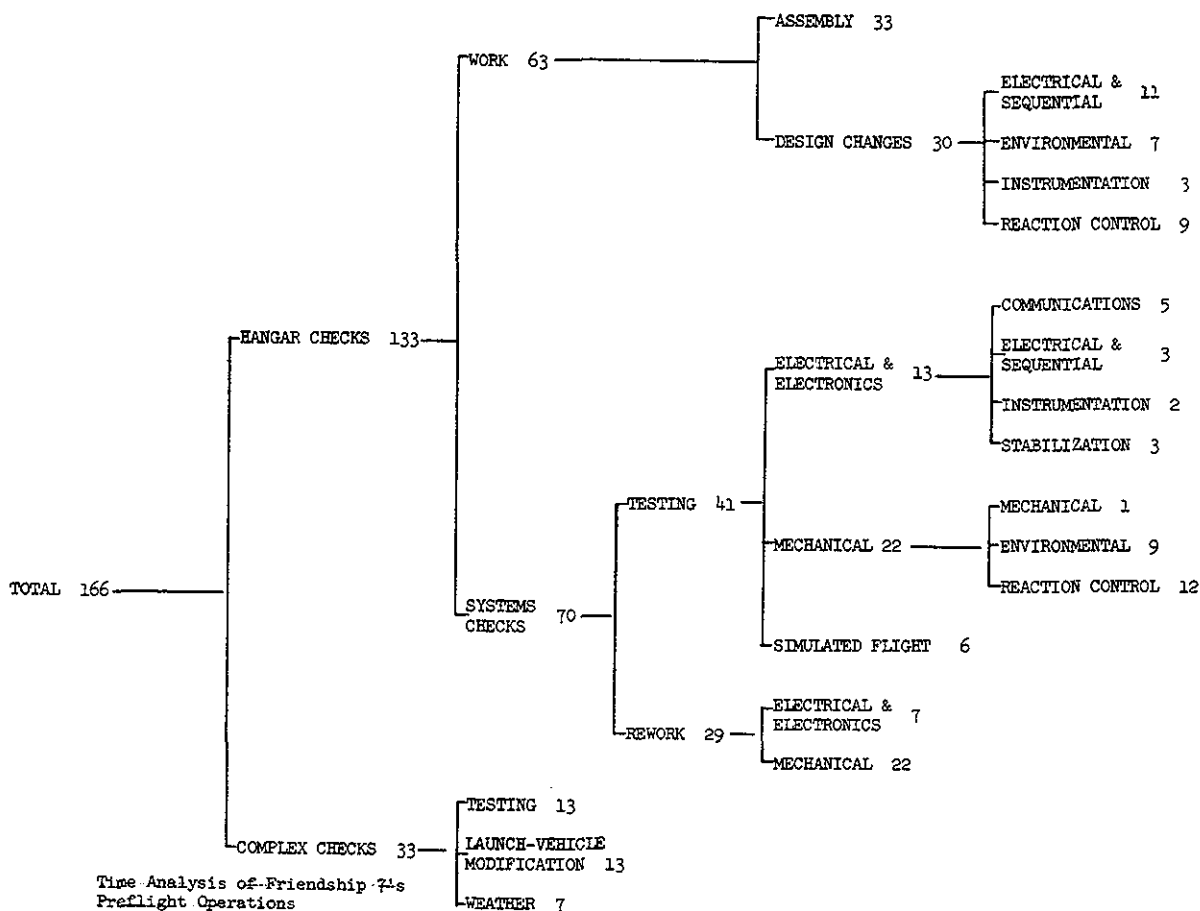
FIGURE 5-1.—Time analysis of preflight operations on Friendship 7.

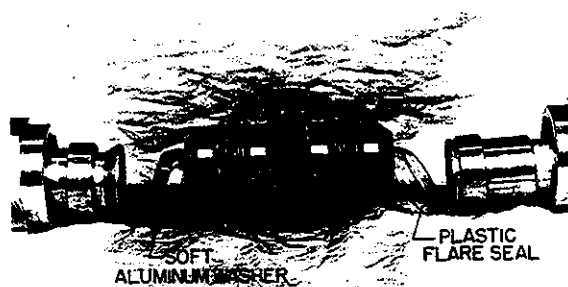
FIGURE 5-2.—Reaction Control System flare seals.

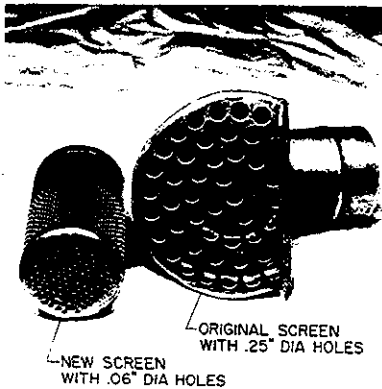
FIGURE 5-5.—Cooling fan duct inlet screens for Friendship 7 and Spacecraft 9.

(2) The cooling fan duct inlet screens were changed to screens having 0.06-inch diameter holes. (See figure 5-5.) This change was required when the postflight inspection of spacecraft 9 revealed that the cabin fan was jammed by small bits of metal, fabric, and rubber, shown in figure 5-6, which were ingested into the fan under zero-g conditions through the 0.25-inch diameter holes in the inverter cooling duct screens.

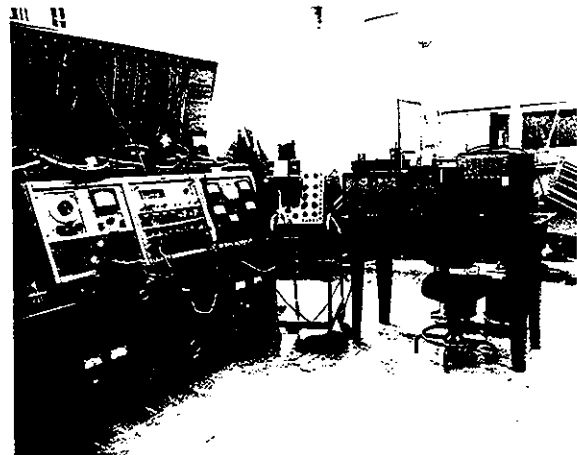
FIGURE 5-8.—Bench setup for testing spacecraft instrumentation.

The instrumentation system was thoroughly tested and calibrated on the bench as shown in figure 5-8 at Cape Canaveral prior to its installation in the spacecraft. The system was tested again after it had been installed in the spacecraft. The primary purpose of the latter test is fourfold: (1) to determine the error, if any, between the hardline signal normally used to transmit data to the blockhouse or other test equipment in the hangar and the signal radiated through the transmitter; (2) to determine possible system interference with the system operating in the spacecraft; (3) to make a sin-

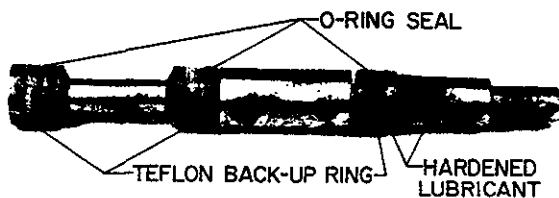
FIGURE 5-9.—High-pressure shutoff oxygen valve stem shown with hardened lubricant.

(1) Excessive leakage of the high-pressure oxygen shutoff valve was noted. The stem was removed from the valve body and the lubricant was found to have hardened on the O rings and sealing surfaces (fig. 5-9). The O rings and backup seals were replaced, and the component was lubricated and replaced in the valve body. The valve continued to show a leakage caused by the seals not seating properly. The

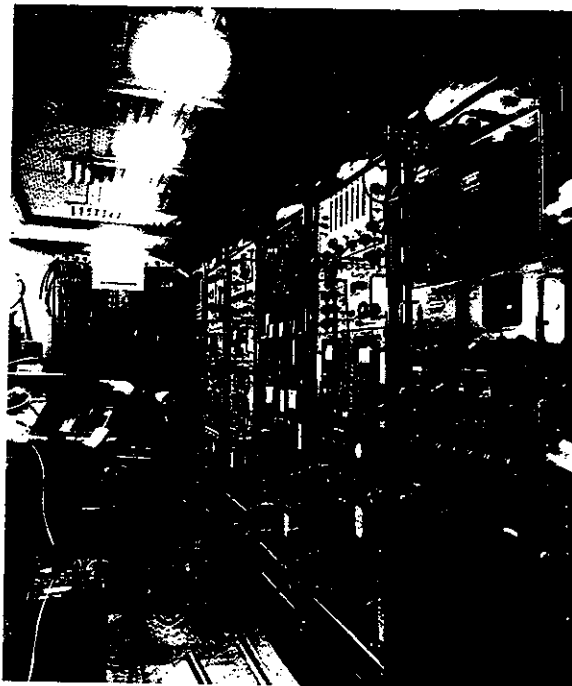
FIGURE 5-10.—Communications system test equipment in checkout trailer.

The primary purpose of the communication system tests was to determine the electrical characteristics of the individual components that comprise the onboard communications system. Although the test equipment was physically located approximately 100 feet away in the checkout trailer (fig. 5-10), the test was
