**RESULTS OF THE
FIRST UNITED STATES
MANNED ORBITAL SPACE FLIGHT
FEBRUARY 20, 1962**

**Manned Spacecraft Center
NATIONAL AERONAUTICS AND SPACE ADMINISTRATION**

This document presents the results of the first United States manned orbital space flight conducted on February 20, 1962. The prelaunch activities, spacecraft description, flight operations, flight data, and postflight analyses presented form a continuation of the information previously published for the two United States manned suborbital space flights conducted on May 5, 1961, and July 21, 1961, respectively, by the National Aeronautics and Space Administration.

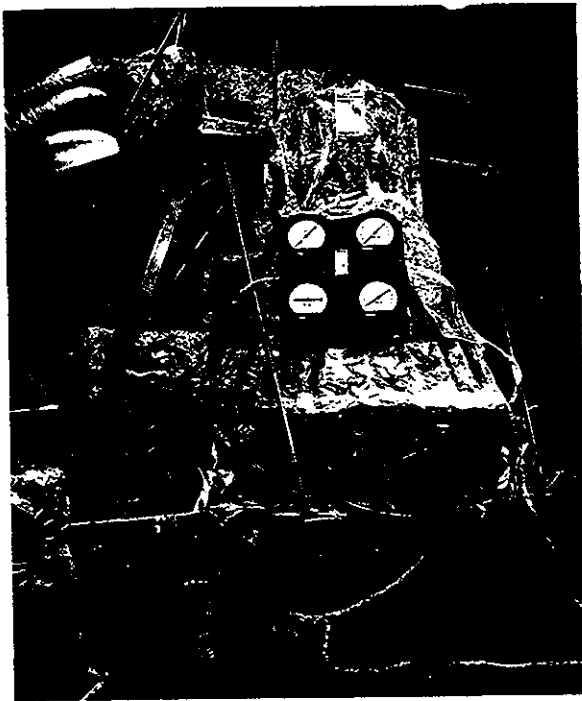
FIGURE 5-11.—Spacecraft in reaction control system facility for functional test of system.

The reaction control system (RCS) checkout procedure determined the condition and operation of the RCS system. Tests were conducted in a special test cell (fig. 5-11). Several gas checks were employed to determine the overall

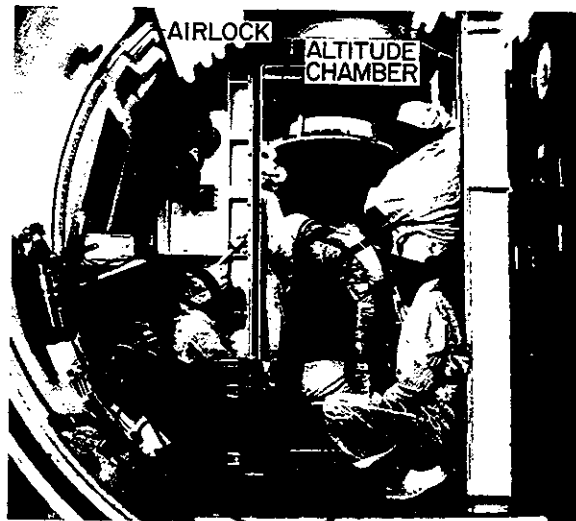
FIGURE 5-15.—Overall evaluation of the environmental control system in altitude chamber.

The altitude-chamber tests (fig. 5-15) were used to determine the operating characteristics of the overall environmental control system (ECS). The astronaut was suited and connected into the ECS for the first time during the altitude-chamber tests. The chamber was pumped down to a simulated altitude of ap-

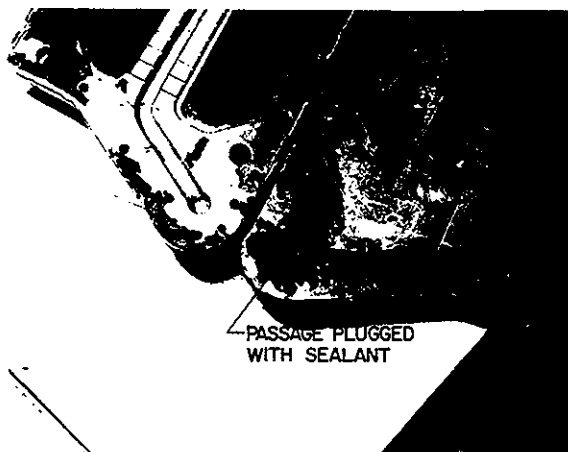
FIGURE 5-16.—Plugged inlet part of cooling plate for 150 v-amp inverter.

verter remained cool. A subsequent investigation indicated that the flow passages in the water-type heat exchanger (cooling plate) were plugged. It was found that sealant used in the construction of the cooling plates had penetrated into the flow passages as shown in figure 5-16. The passages were cleaned and the original orifices were reinstalled. Flow tests on the final installation showed that the system was clean.

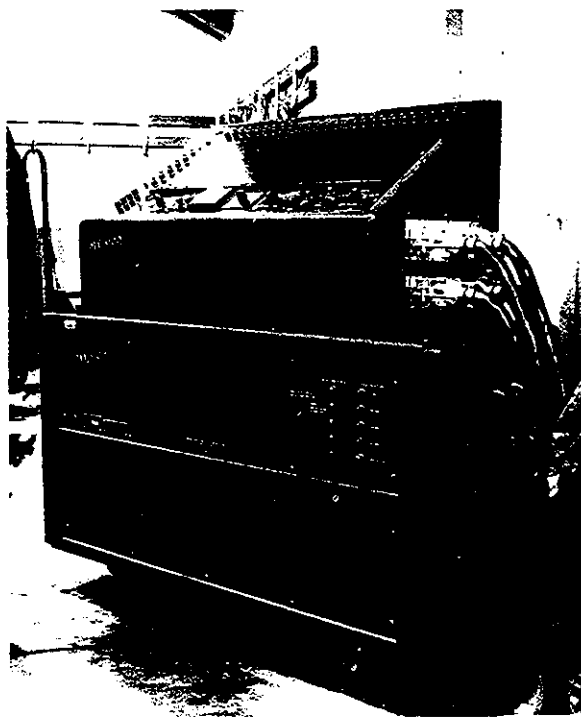
FIGURE 5-20.—Automatic wiring checker used to check cabling involved in preflight operation.

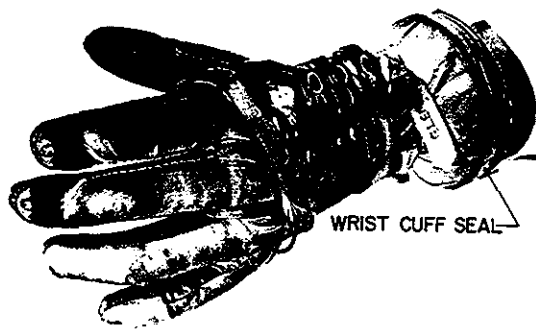
FIGURE 5-27.—Pressure-suit gloves showing cuff slip joint.

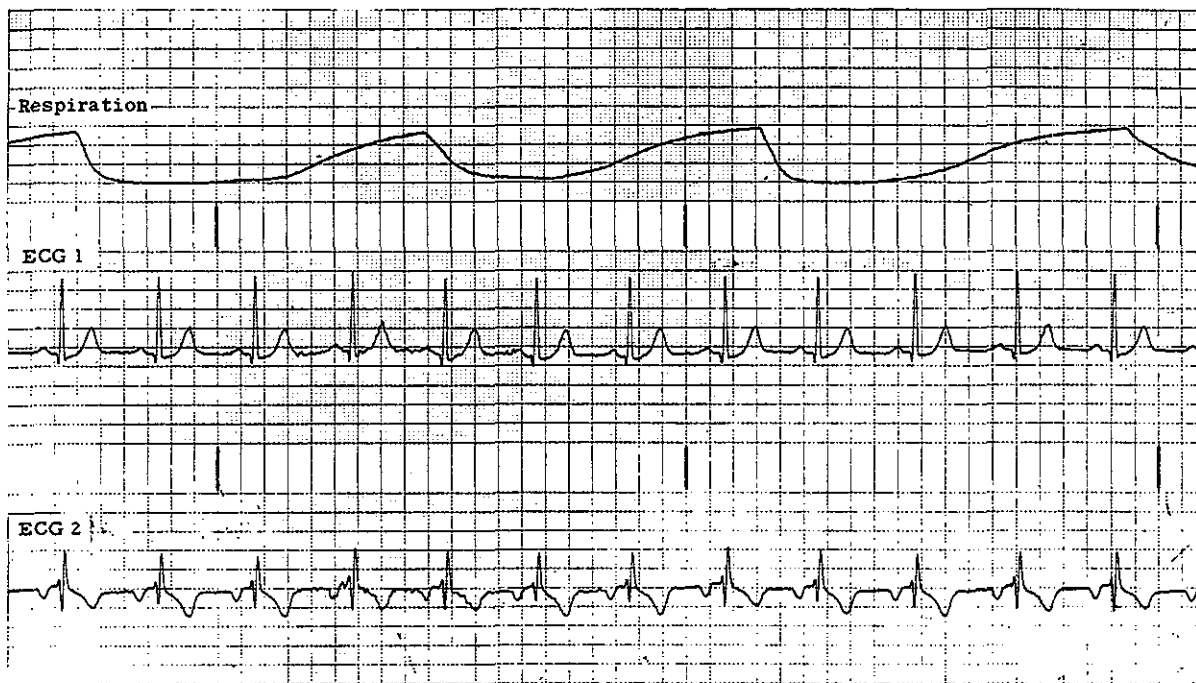
FIGURE 9-2.—Sample of blockhouse physiological record at insertion, 6:06 a.m. e.s.t. Lead 2 is inverted. (Recorder speed 25 mm/sec).

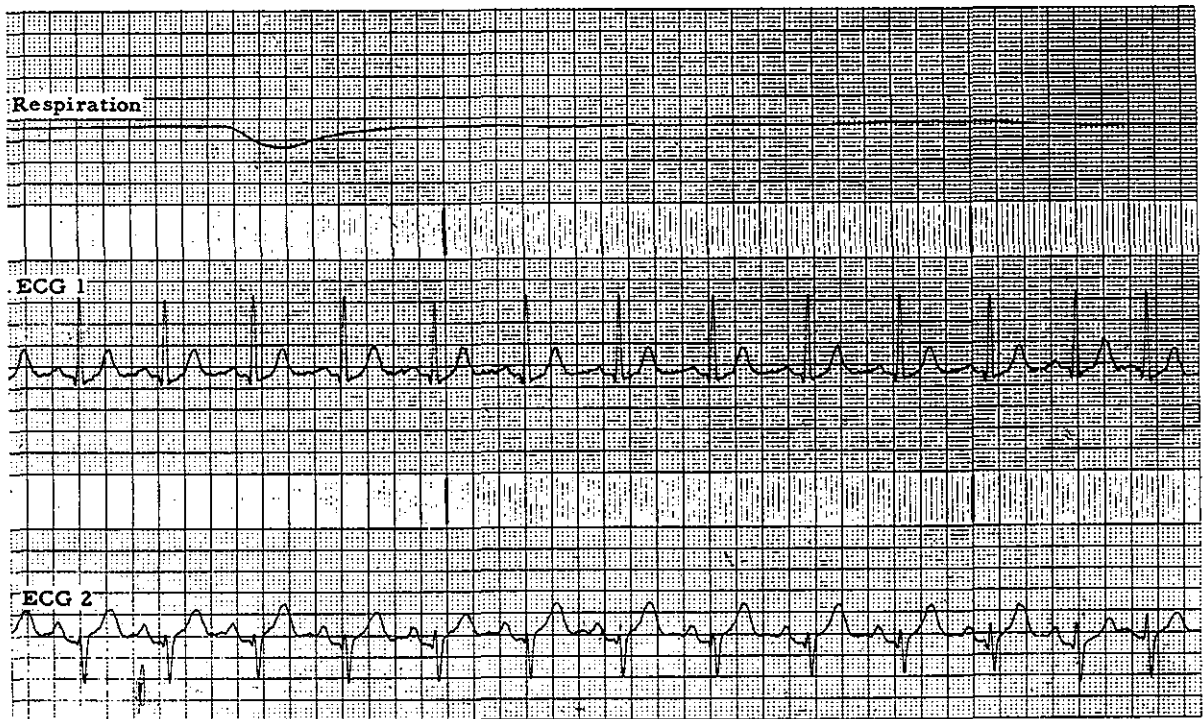
FIGURE 9-6.—Sample of physiological record received at Bermuda Range Station during powered phase of flight, approximately 4 minutes after lift-off. (Recorder speed 25 mm/sec).

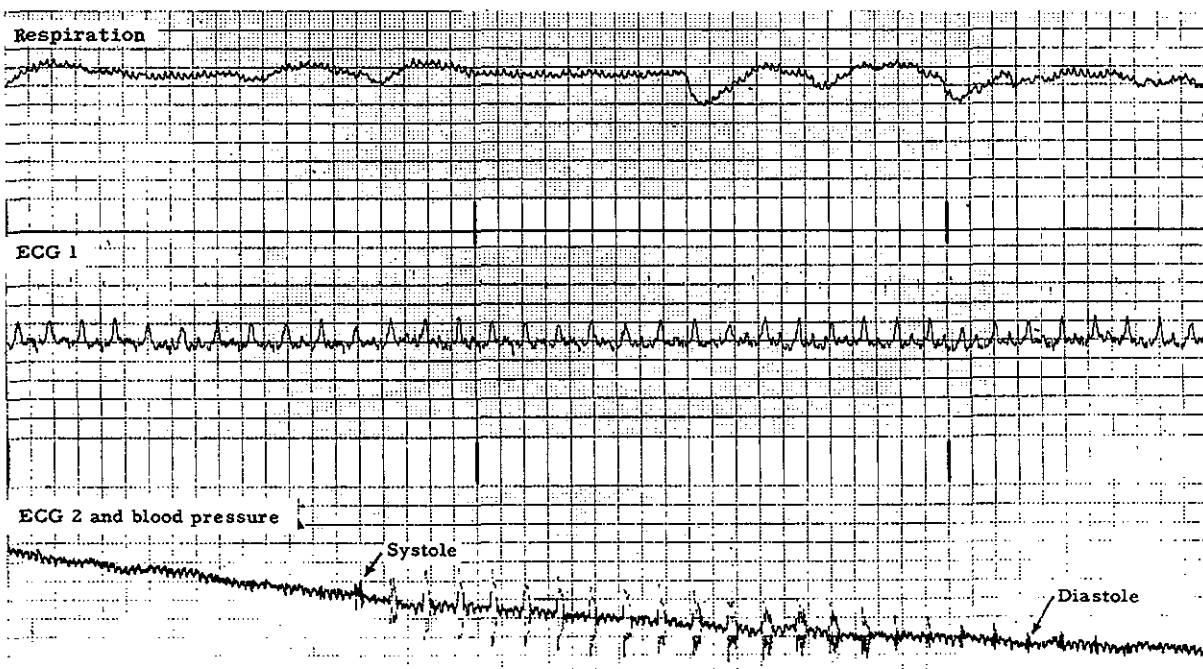
FIGURE 9-7.—Sample of playback record from the onboard tape showing physiological data after 2 hours and 53 minutes of weightlessness, with inflight blood pressure trace, value of 135/64. (Recorder speed 10 mm/sec).

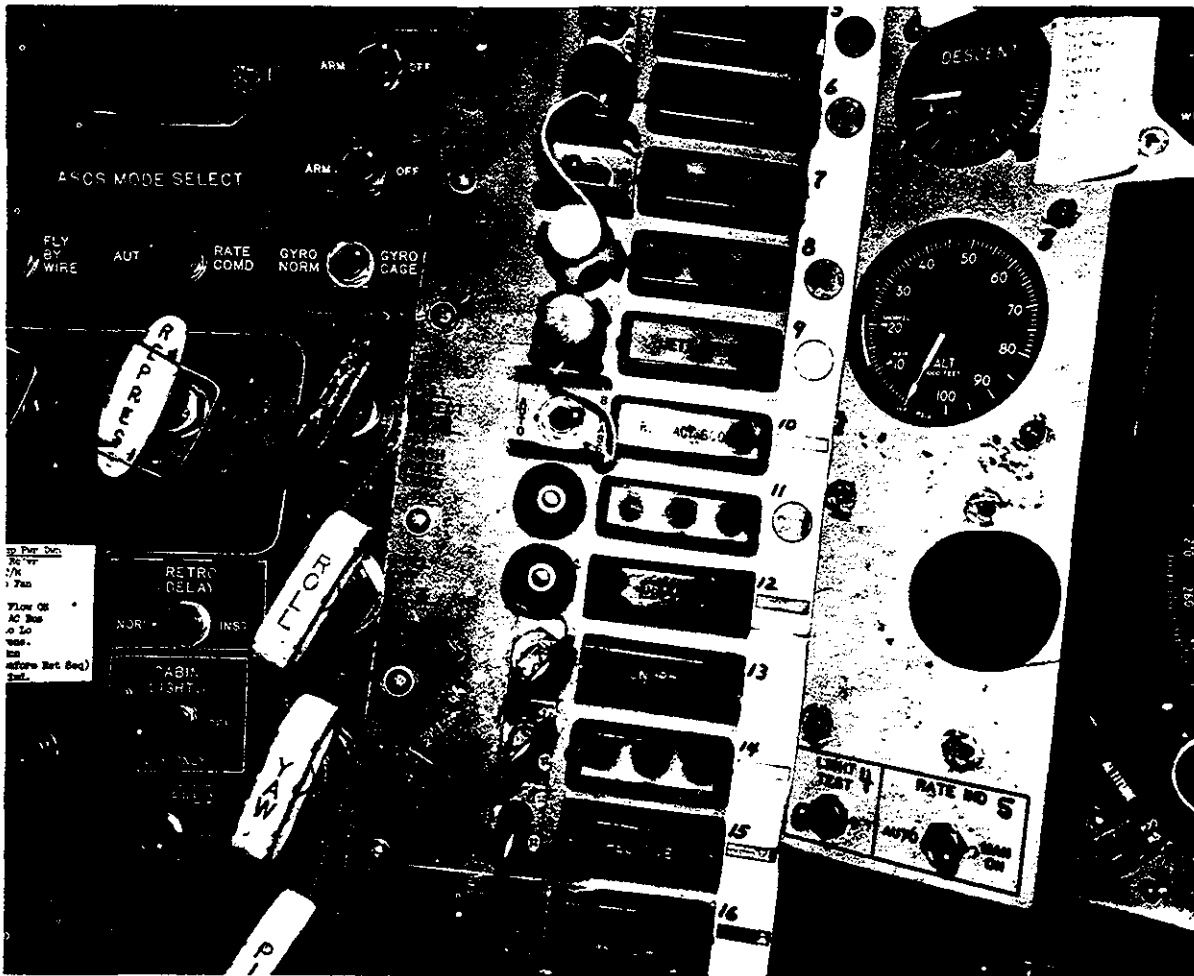
FIGURE 11-1.—MA-6 instrument panel, left section.

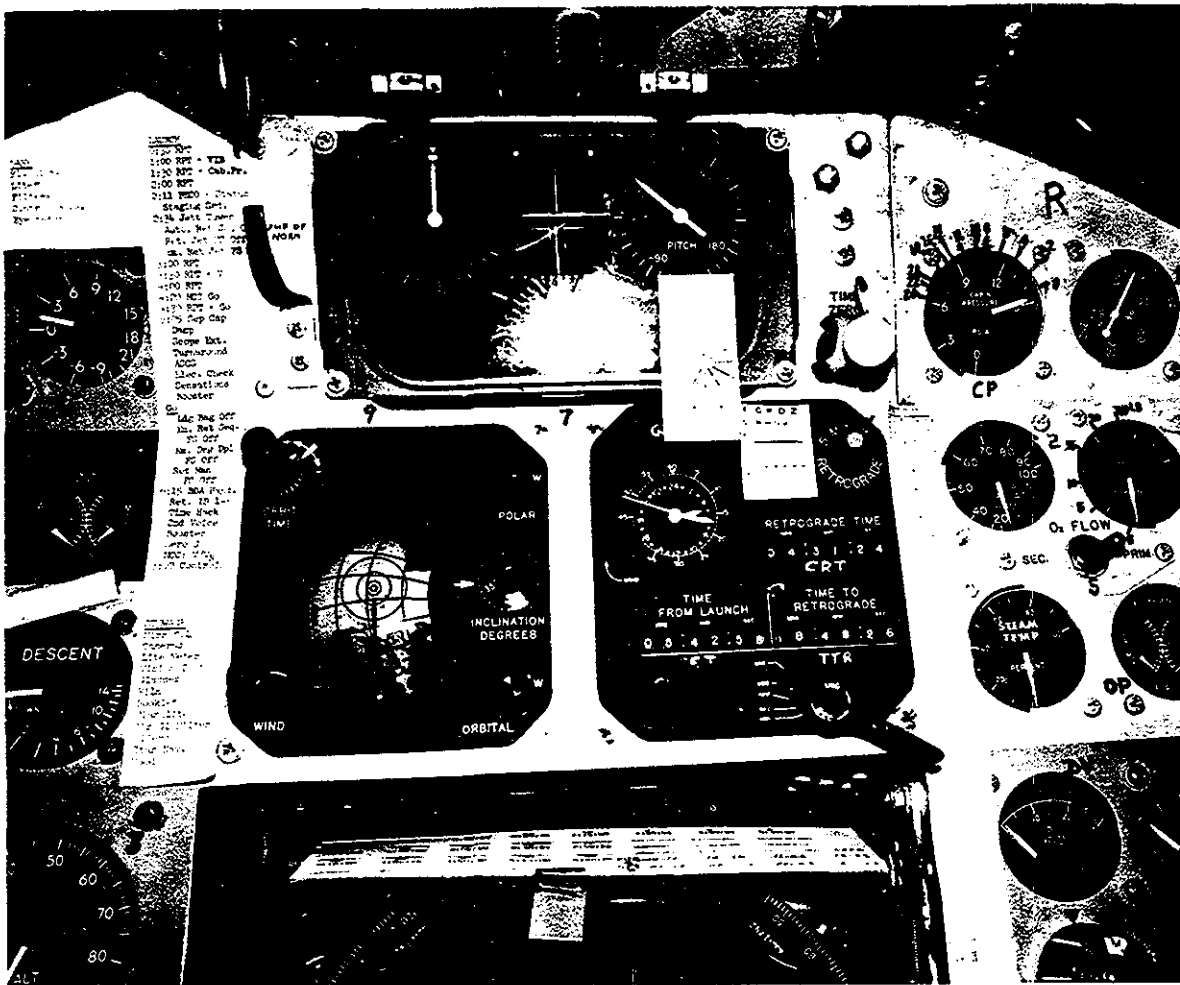
FIGURE 11-2.—MA-6 instrument panel, center section.

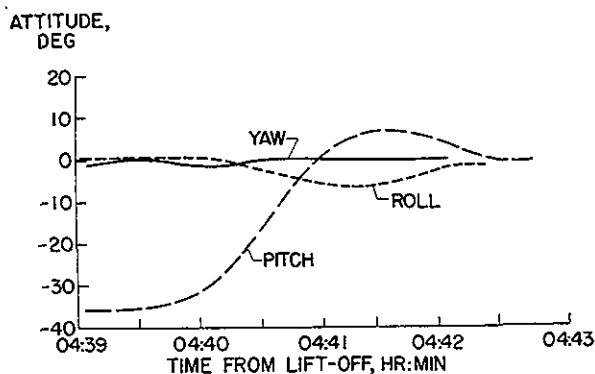
FIGURE 11-5.—MA-6 reentry pitch maneuver.
