Summary of Significant Aspects of the Manufacture and Acceptance Test of Cryogenic Oxygen Storage Tank Serial No. 10024XTA0008

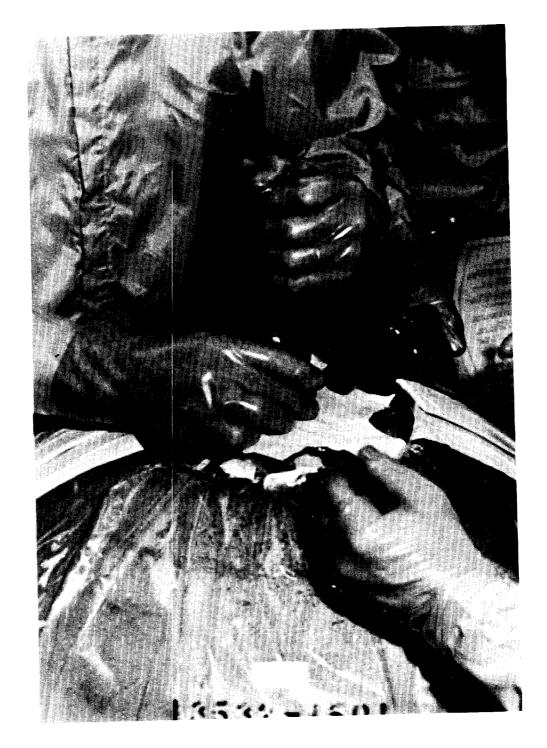
Figure C4-34.- Final lowering of heater probe.

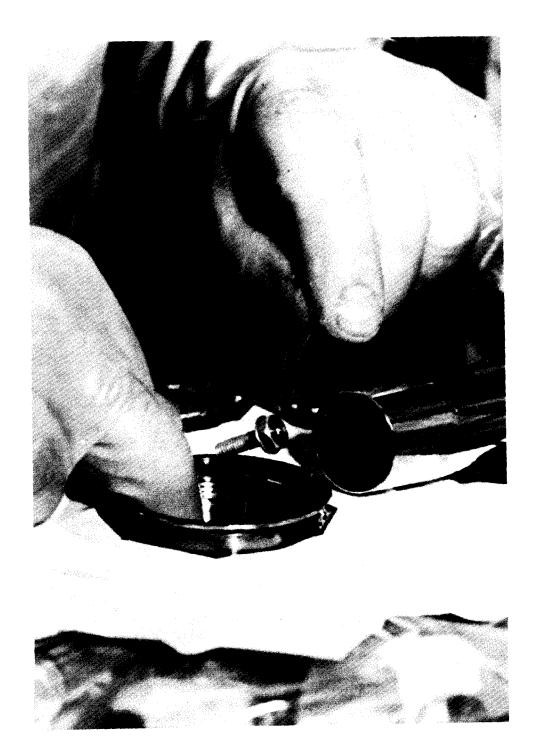
Figure C4-35.- Wire loop used to install heater probe retaining bolt.

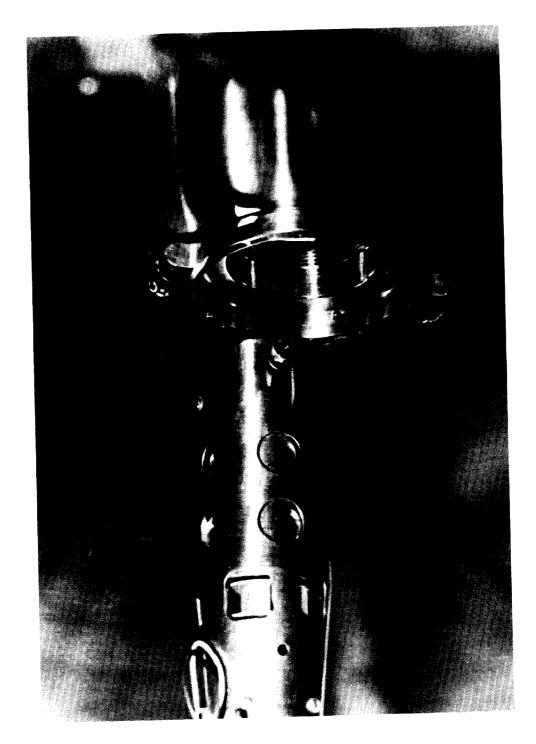
Figure C4-36.- View inside tank showing heater probe upper retaining bolt.

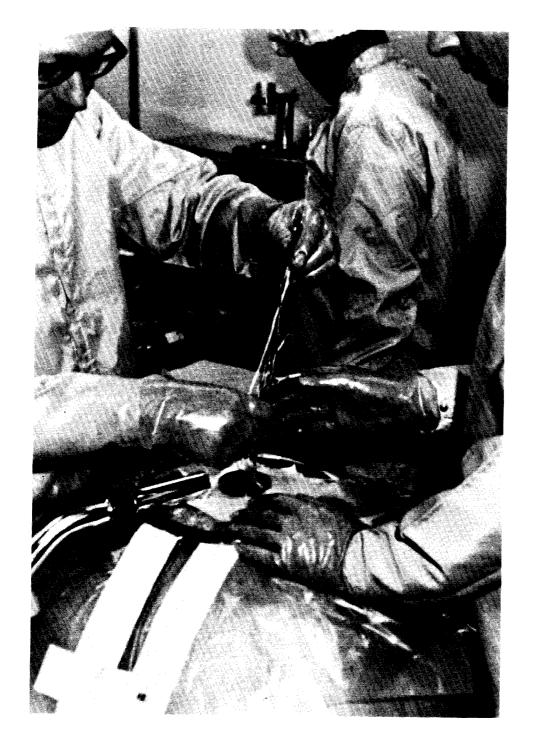
Figure C4-37.- Pulling wires from tank.

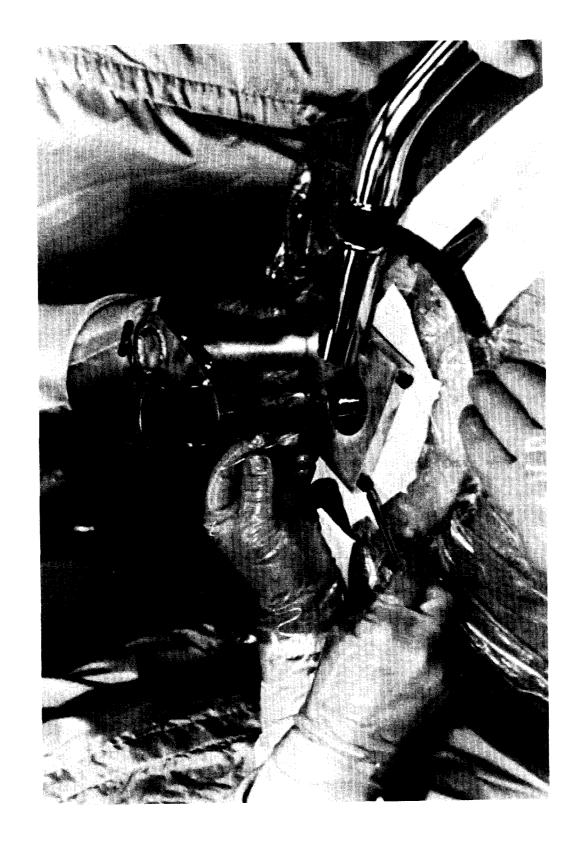
Figure c^{4} -38. Lowering wires into tank with fixture to hold quantity probe installed.

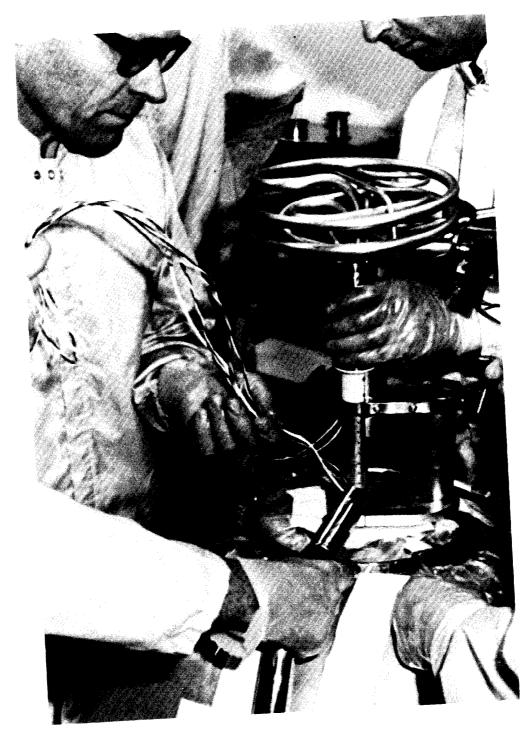
Figure C4-39.- Quantity probe being installed in fixture and heater probe wires being pulled from the tank.

At this point the wires are once again withdrawn from the tank. Again any possible tangles are removed. Then the pull wires previously installed in the probe are soldered to the motor and heater lead bundles. The solder joints are thoroughly cleaned and taped to made a smooth transition from each single pull wire to each bundle of six leads. These wire bundles are pulled into the conduit one bundle at a time with one man feeding the wires at the feedthrough hole in the quantity probe and the other man pulling approximately 25 to 35 pounds on the pull wire (figs. C4-40 through C4-42). The bundles are pulled through until the slack is taken out of the wire bundle with the probe in this elevated position (about 9 inches of slack when probe is lowered into into tank) (fig. C4-43). Then holding the probe assembly, the fixture is removed from the tank neck and the probe is lowered into the tank (fig. C4-44). The probe assembly is then rotated counterclockwise approximately one turn. The unit is then very carefully rotated clockwise to start the quadruple thread and pilot the lower end of the probe into the ring provided at the bottom of the tank. If the probe assembly in the tight position does not result in alignment of the supply tube, then the probe assembly is re-indexed in 90-degree increments to achieve alignment. These procedures are carried out to a specific Manufacturing Operations Procedure and in the presence of quality control inspectors. (Figures C4-45 and C4-46 show the typical routing of wires from the heater and fan probe assembly into the quantity probe.)

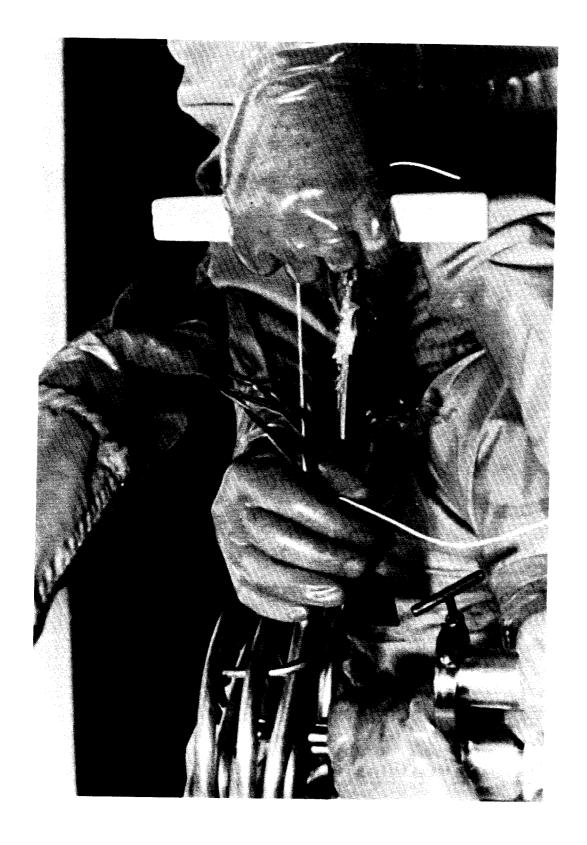
Figure C4-40.- Pulling first bundle of heater and fan motor leads into upper coil assembly.

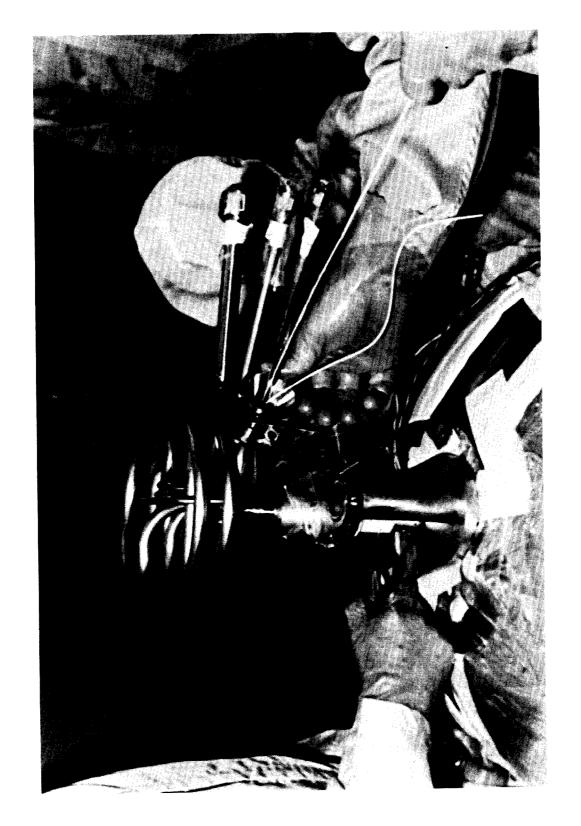
Figure C4-41.- Full wire used to route heater and fan motor leads into upper coil assembly.

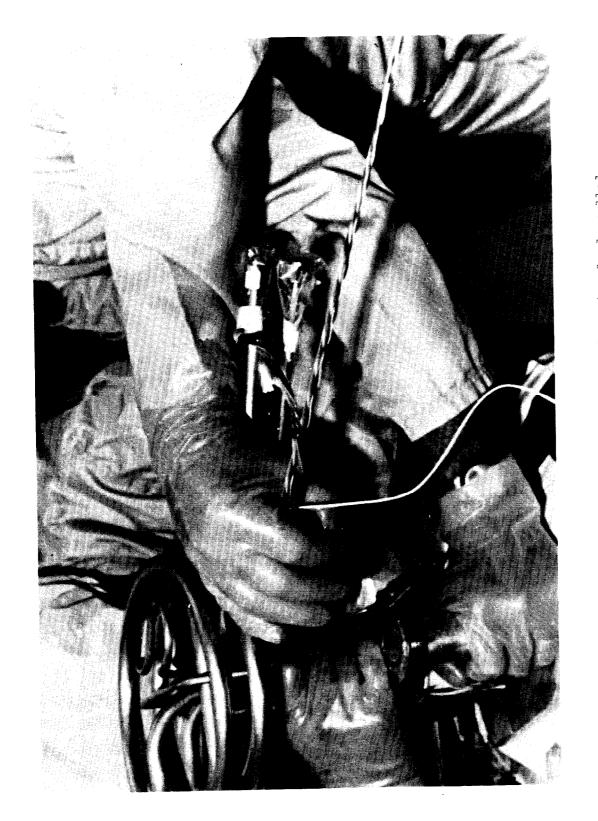
Figure C4-42.- First bundle of heater and fan motor leads pulled through upper coil assembly.

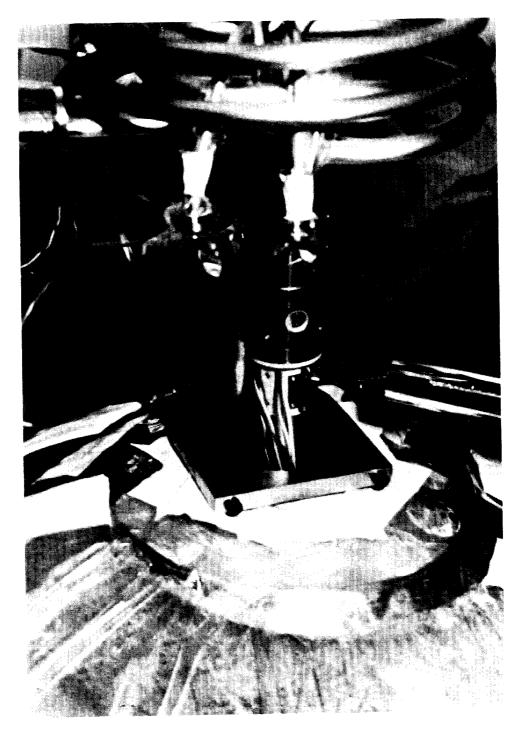
Figure C4-43.- Heater and fan motor lead routing into quantity probe.

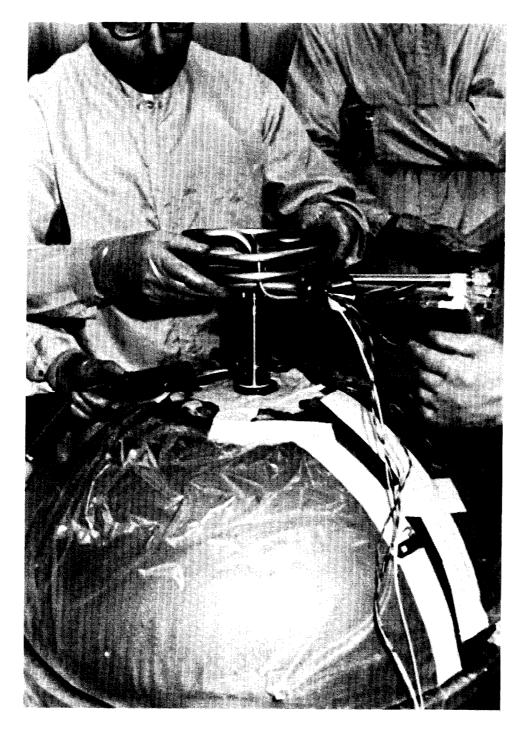
Figure C4-44.- Lowering quantity probe assembly into tank.

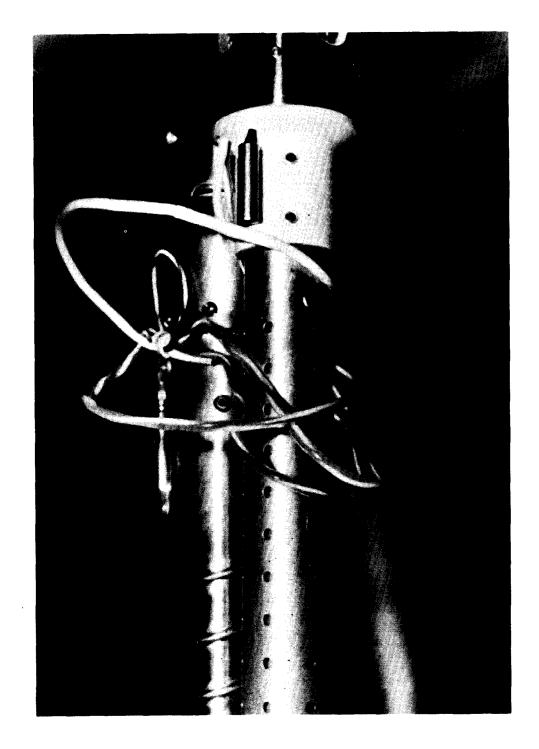
Figure C-4.45 - View inside of tank of typical wire routing from heater probe to quantity probe.

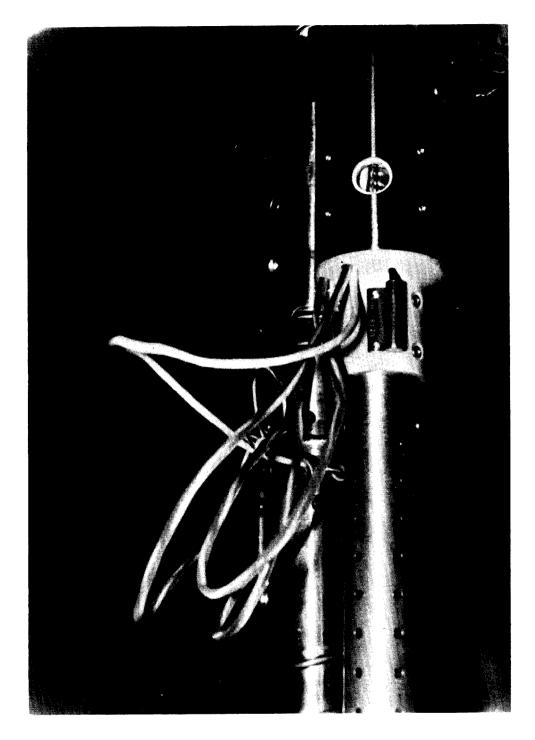
Figure C-4.46 - View inside of tank of typical wire routing of heater probe wires into quantity probe.

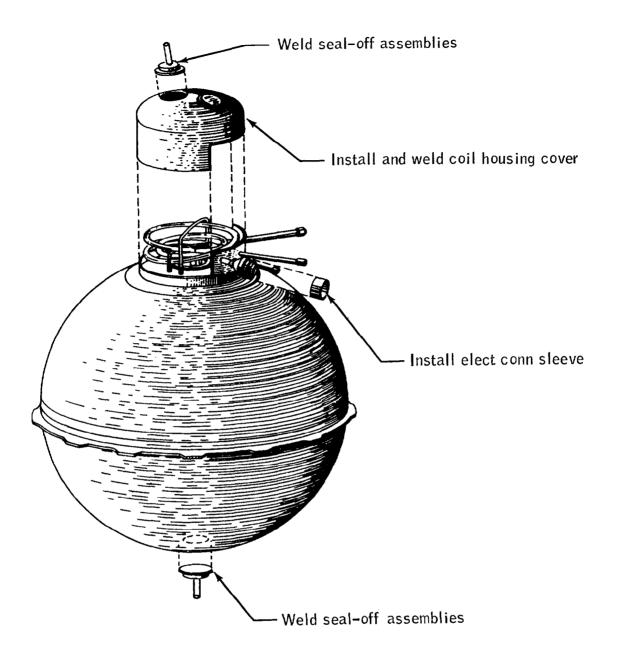
The coil housing (dome) cover is now welded in place. The housing contains the vacuum pumpdown tube, the blowout disc, and the vac-ion pump bracket (fig. C4-47). In addition, a pumpdown tube is welded to the lower hemisphere to speed the pumping process. After the welds are X-rayed, a preliminary pumpdown is made.

Figure C4-47.- Final vacuum closure operations.
