## PART F3.6

### ZERO-g TEFLON FLAME PROPAGATION TESTS

## PART F3.7

### FULL-SCALE SIMULATED OXYGEN TANK FIRE

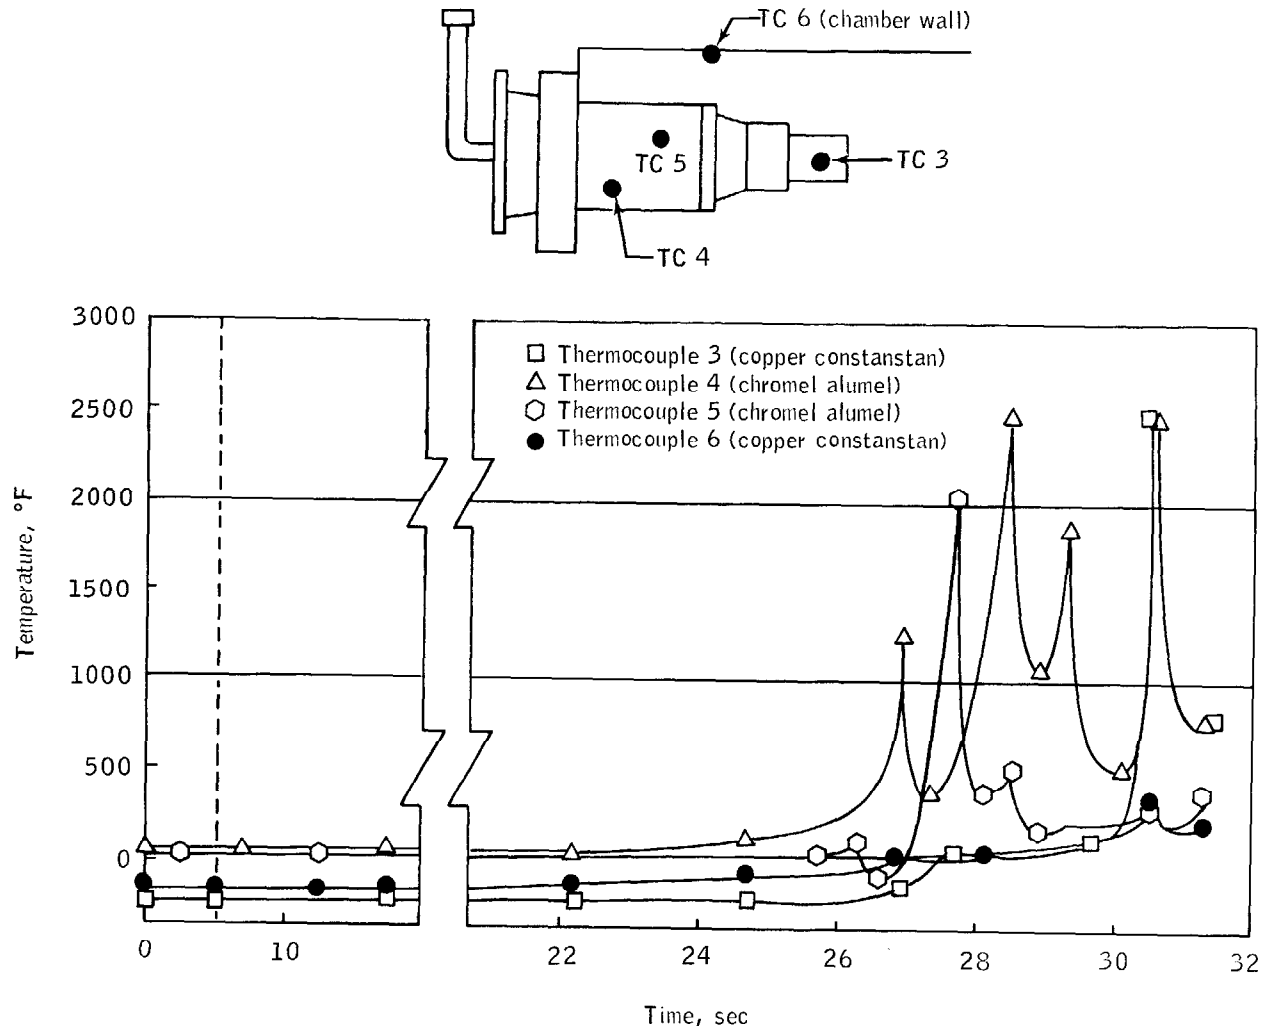
Figure F3.5-4.- Temperature history of quantity probe and chamber wall.

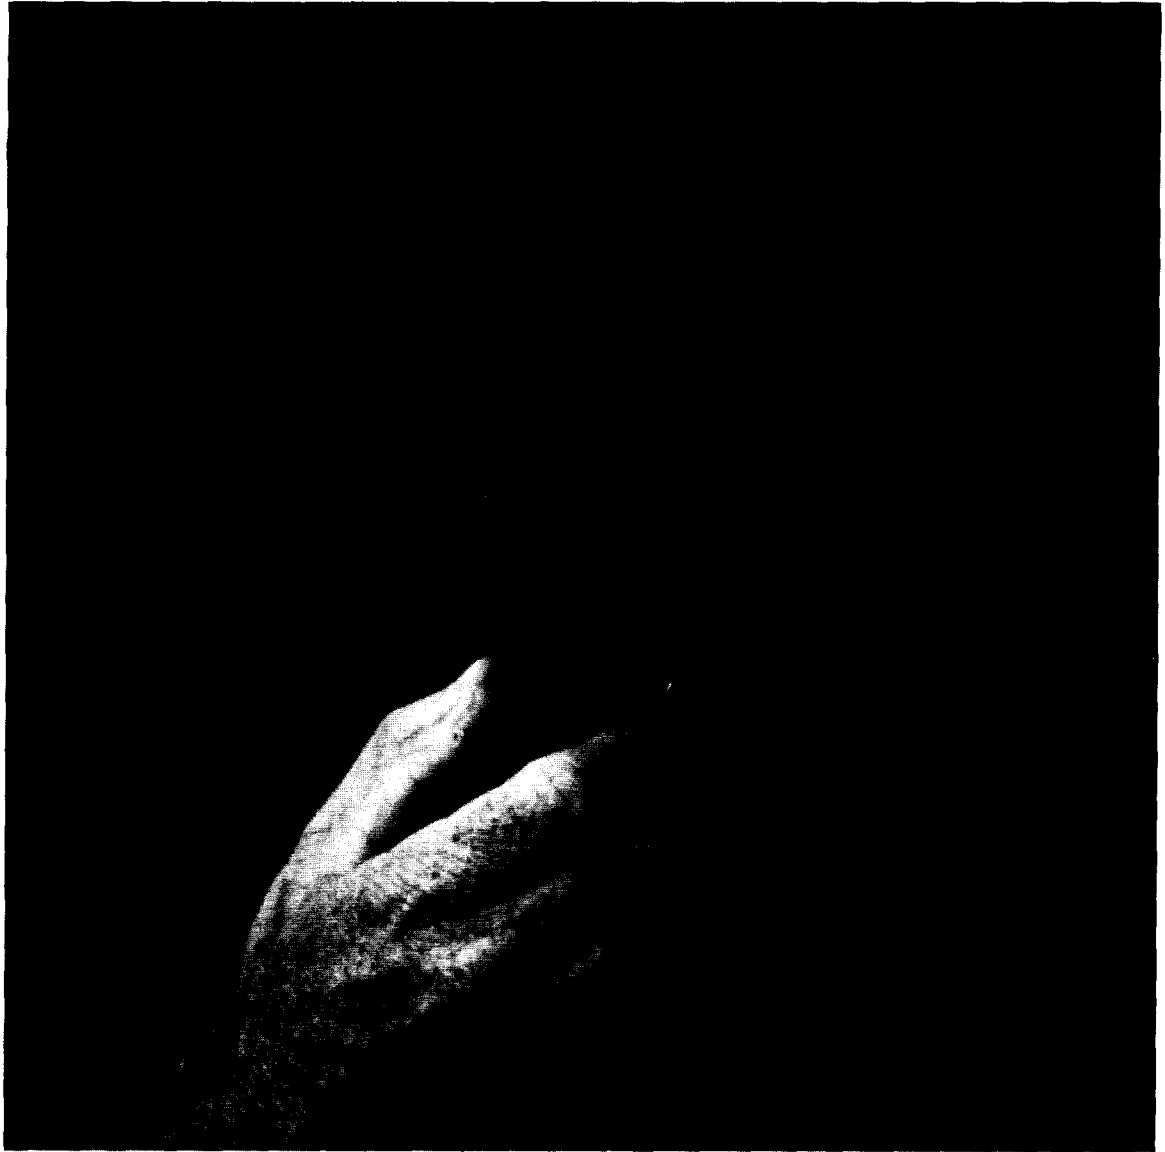
Figure F3.5-14.- Portion of probe which remained in the test chamber.

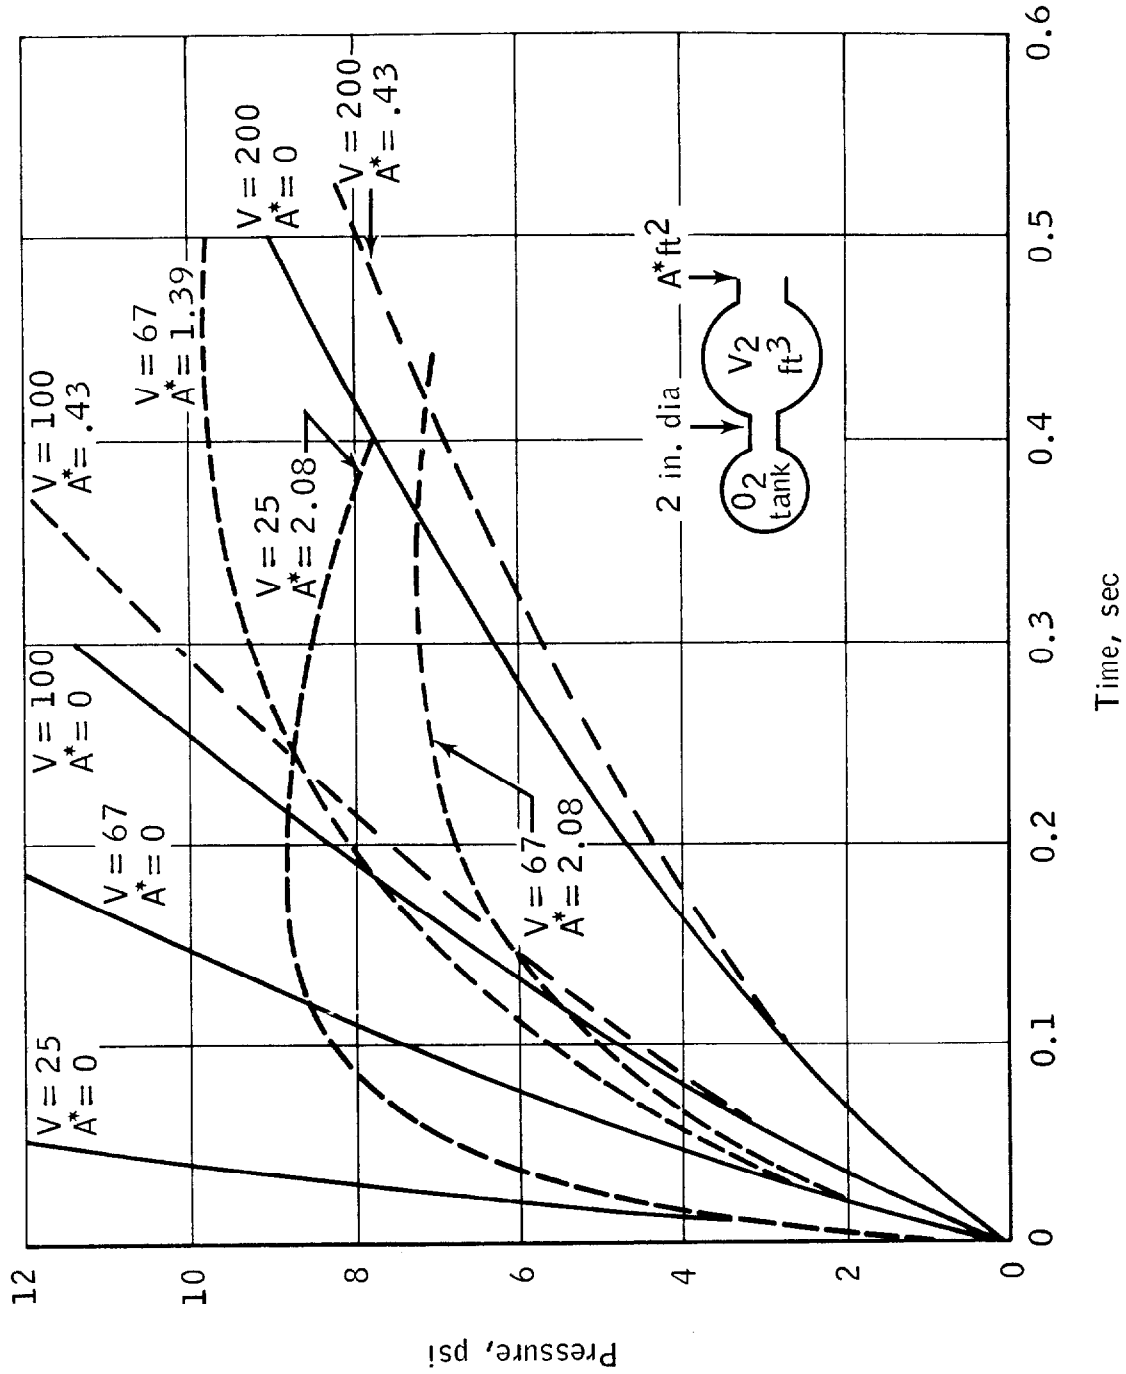
Figure F3.8-4.- Pressure rise against time (expanded scale).

Figures F3.8-3 and F3.8-4 are plots of pressure time histories for various combinations of secondary volumes and orifices. The time scale in this case is only applicable to the 2-inch diameter exit orifice in the oxygen tank. The combinations of  $V$  and  $A^*$  shown in figure F3.8-3 were chosen to roughly simulate the components of the SM as follows:
