PART F3.10

PANEL SEPARATION TESTS

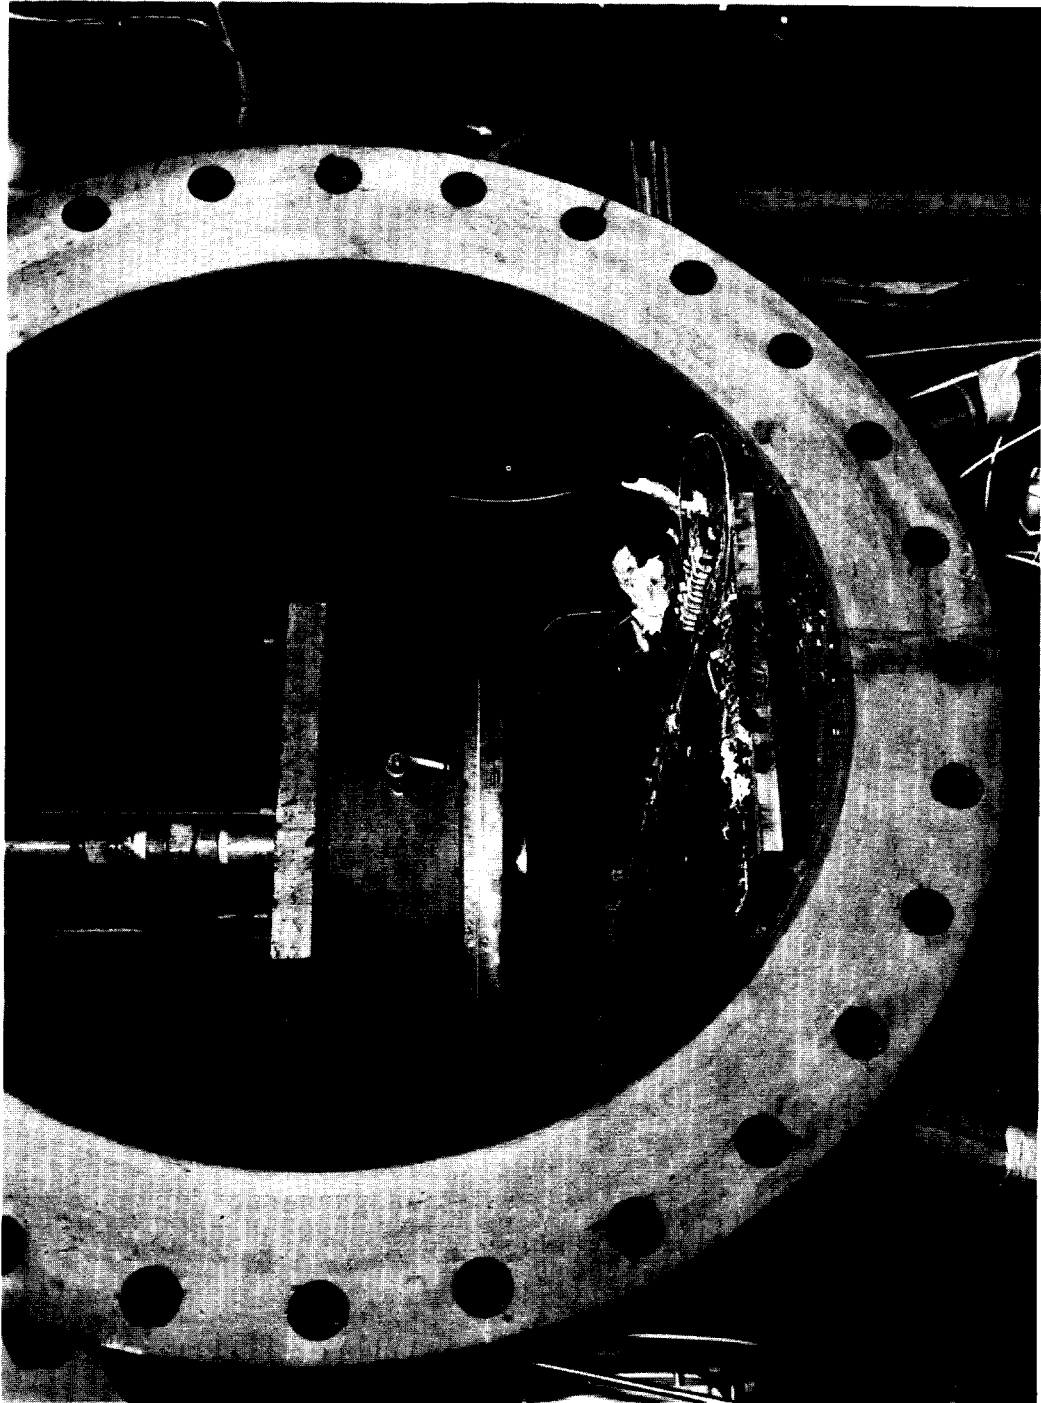
Figure F3.9-5.- View of chamber conditions after test.

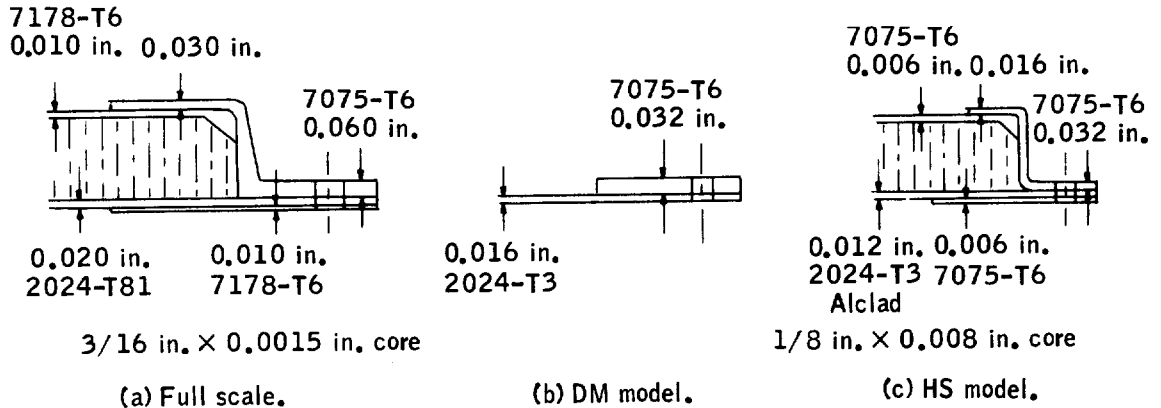
Figure F3.10-1.- Panel designs.

The full-scale panel is a honeycomb sandwich structure with a z-bar edge closeout attached to the SM by 1/4-inch bolts around the edges and to each of the bay shelves. The first one-half scale panel models, designated DM and shown in figure F3.10-1(b), scaled membrane properties of the full-scale sandwich panel inner and outer face sheets with a single isotropic panel having the correct nominal ultimate tensile strength. The z-bar was simulated by a flat bar that represented the shear area of the outer z-bar flange. Fastener sizes, bolt patterns, and bonding material were duplicated from full scale.

One-half size honeycomb sandwich panels, designated HS and shown in figure F3.10-1(c), scaled both bending stiffness and membrane stiffness. Although core density of the sandwich models is slightly high, the dimensions, materials, bonding, and z-bar closeout are scaled. Some alloy substitutions were made but nominal strength requirements were met.

Models.- Figure F3.10-1 shows the full-scale and model panel cross sections.

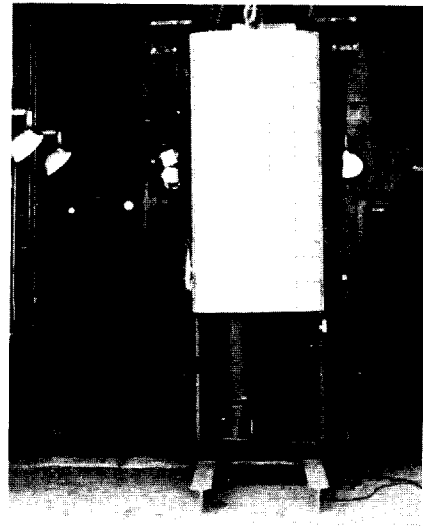
(a) General view.

(b) Fixture with panel installed.

(c) Internal view.

Figure F3.10-3.- One-half size boilerplate mockup of the SM bay 4 and central tunnel.

Pressurization system.- The pressurization system can also be seen in the photographs of figure F3.10-3. A 3000-psi accumulator is discharged on command through an orifice by mechanically rupturing a diaphragm. The gas expands into the oxygen shelf space of bay 4 through a perforated diffuser. In order to obtain uniform pressure over the entire panel for some tests, the diffuser was lowered so that it discharged into both the oxygen and hydrogen shelf spaces. For these particular tests, extra vent area was provided between all shelves to insure uniform pressure throughout bay 4. For most tests, a shield was placed between the diffuser and panel to minimize direct impingement.

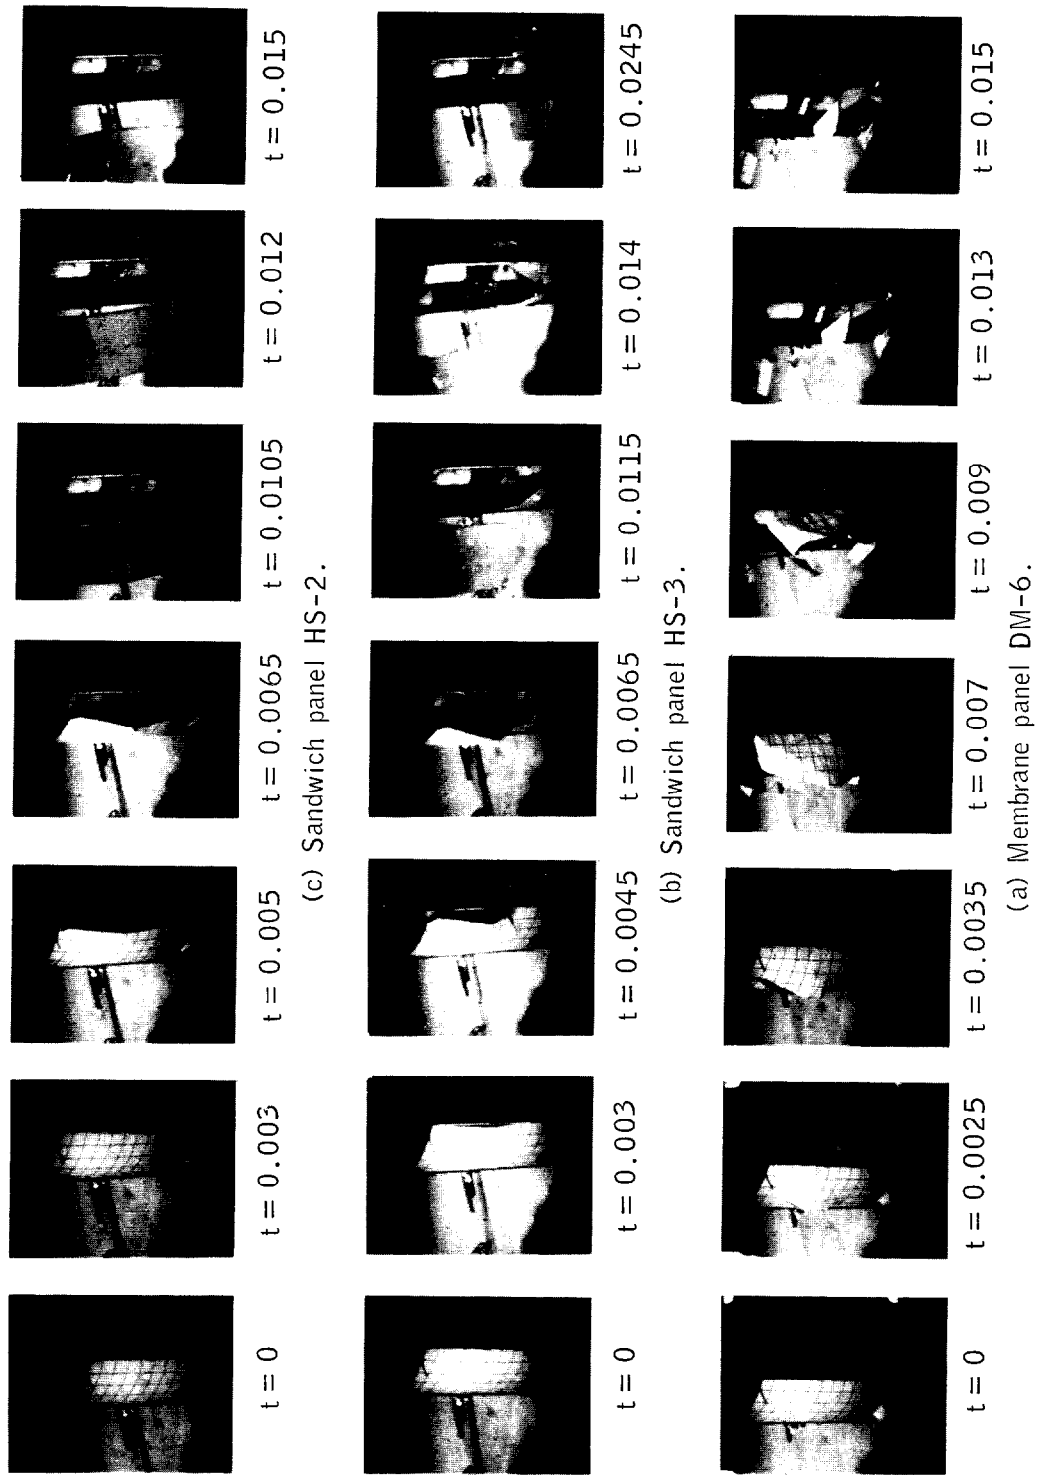
Figure F3.10-5.- Sequential failure of two sandwich and one membrane panel (t = time from first observed failure).

Failure mechanism.- The failure mechanism for complete separation of a membrane panel is demonstrated by the photographic sequence in figure F3.10-5(a). Failure is probably initiated by a localized high pressure near the edge of the oxygen shelf space. A crack formed where a shelf bolt head pulled through and rapidly propagated through the panel. Expansion of the pressurizing gas through the openings accelerated

panel fragments to very high velocities. Inertia loads from the high acceleration completed the separation. Membrane panels were observed to separate in three pieces--one large and two small fragments.

The failure of a sandwich panel under uniform loading in vacuum is shown in the picture sequence of figure F3.10-5(c). Failure started at the edge of the oxygen shelf space by pull-through of the edge bolts through the upper sandwich face sheet. Very rapid tearout along three edges followed, primarily by tension in the face sheets and tearing of the core material from the z-bar at the edge. The panel then rotated like a door and separated from the test fixture in one piece.

Nonuniform loading of a sandwich panel led to the failure shown in figure F3.10-5(b). Initial failure was at the panel edge near the fuel cell shelf. Tearout along one edge and the top rapidly followed, similar to the previous failure. However, the edge tear stopped before reaching the bottom and became a diagonal rip that left the lower third of the panel attached to the fixture. The upper two-thirds of the panel then rotated door-like and separated. Finally, a vertical tear propagated through the center of the remaining fragment, the bottom tore out, and rapid rotation separated the remnants in two pieces.
