4.6 LUNAR MODULE SYSTEMS DEVELOPMENT AND PERFORMANCE

4.6.2 Structures

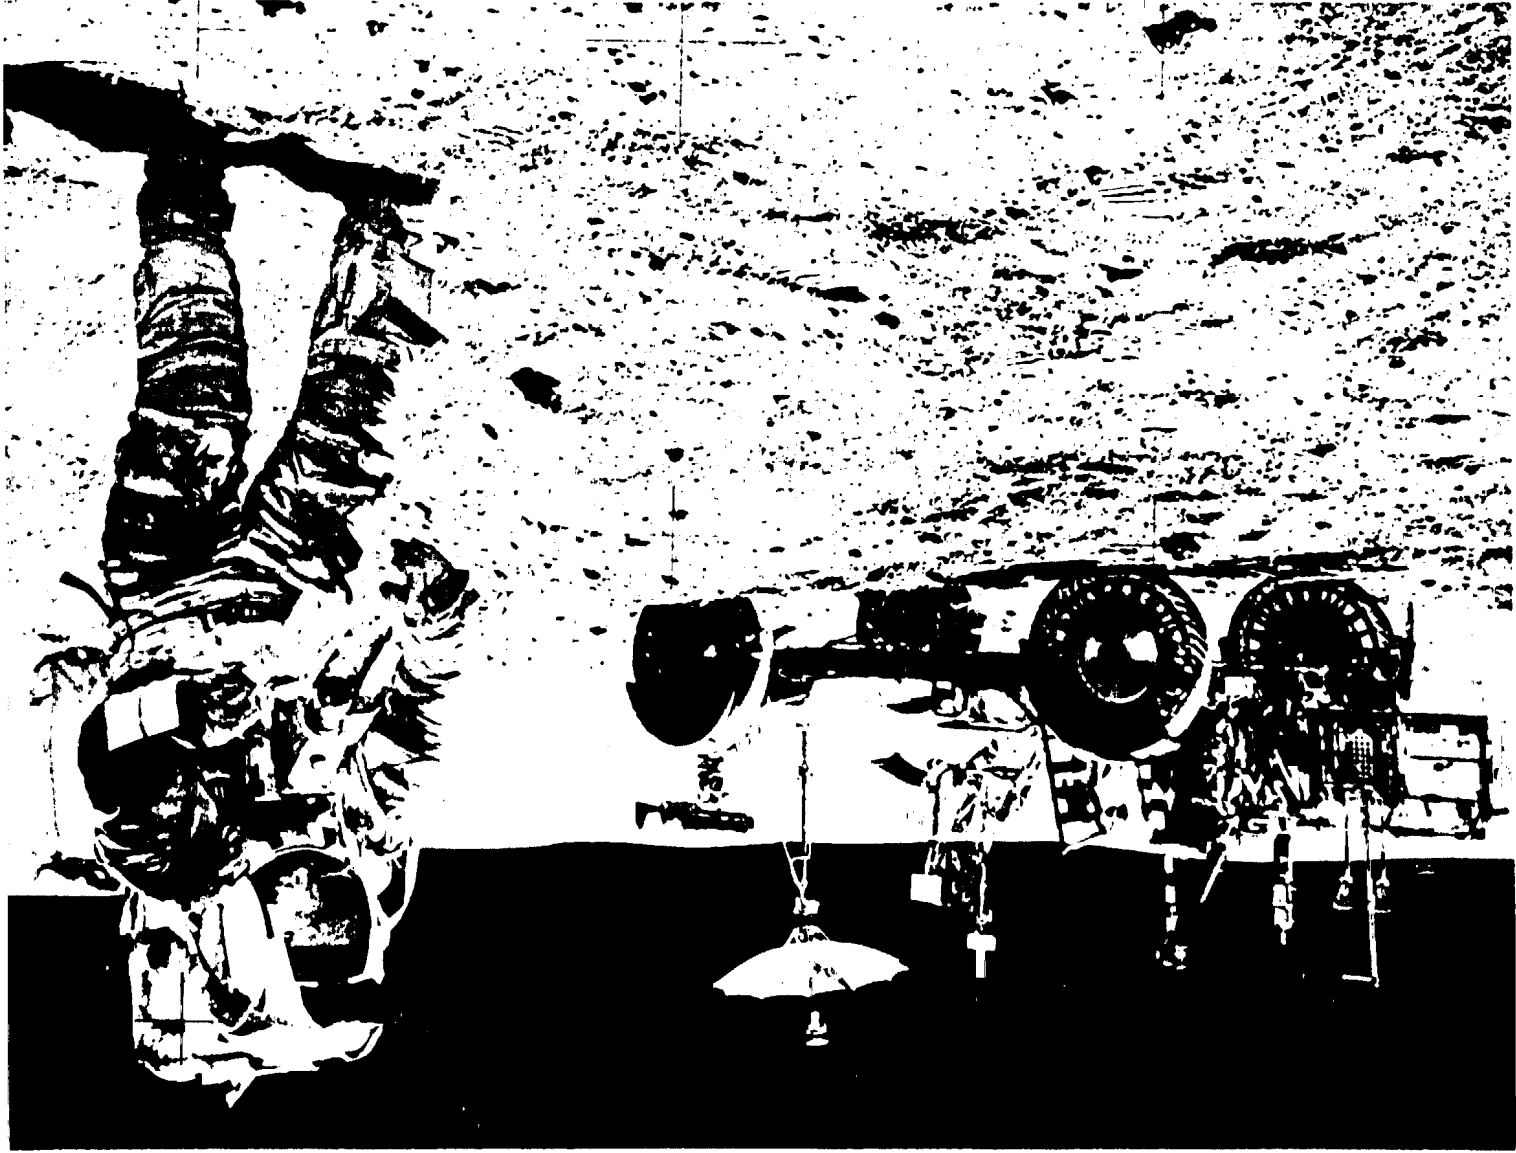
The lunar roving vehicle (fig. 4-23), used for the three extended-stay lunar missions, was a four-wheeled manually-controlled, electrically-powered vehicle that carried the crew and their science equipment over the lunar surface. The increased mobility and ease of travel made possible by this vehicle permitted the crew to travel much greater distances than on previous lunar landing missions. The vehicle was designed to carry the two crewmen and a science payload at a maximum velocity of approximately 16 kilometers per hour on a smooth, level surface, and at reduced velocities on slopes up to 25 degrees. It could be operated by either crewman from a control and display console located on the vehicle centerline. The deployed vehicle was approximately 10 feet long, 7 feet wide and 45 inches high. The chassis was hinged such that the forward and aft sections folded back over the center portion, and each wheel suspension system rotated so that the folded vehicle would fit in quadrant I of the lunar module descent stage for transport to the moon. The gross operational weight ranged from approximately 1530 pounds to 1600 pounds, of which 450 pounds was the weight of the vehicle itself and the remainder was the weight of the crewmen, tools, communications equipment, and the science payload.

The wheels had open-mesh tires with chevron tread covering 50 percent of the surface contact area. A separate traction drive consisting of a harmonic-drive reduction unit, drive motor, and brake assembly was provided for each wheel. A decoupling mechanism permitted each wheel to be decoupled from the traction drive, allowing any wheel to "free-wheel." An odometer on each traction drive transmitted pulses to a navigation signal processing unit. The harmonic drive reduced the motor speed and allowed continuous application of torque to the wheels at all speeds

Figure 4-23.- View of Apollo 16 lunar roving vehicle and crewman.

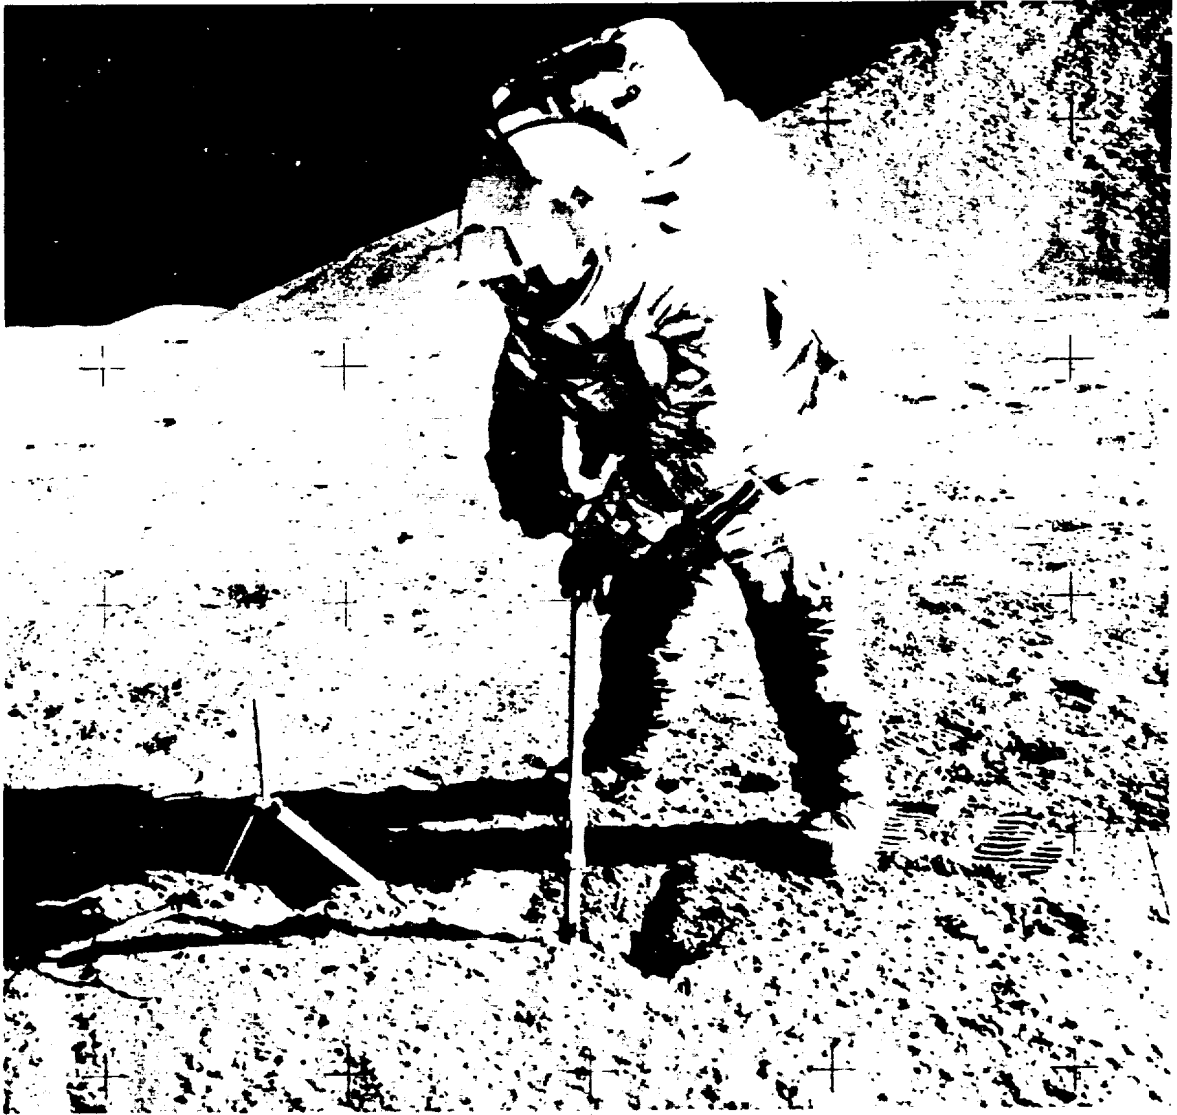
Figure 4-26.- Lunar surface extravehicular mobility unit supporting astronaut activity.

The extravehicular mobility unit (fig. 4-26) was comprised of two main subsystems: (1) the pressure garment assembly and its accessories and (2) the portable life support system. Emergency oxygen and water-cooling systems were provided in case of portable life support system failure. The subsystems and some of the accessories of the extravehicular mobility unit are shown in figure 4-27.

4.10.1.2 Portable life support system.- The portable life support system (fig. 4-29) was a self-contained unit that controlled the environment within the space suit during extravehicular activities on the lunar surface. The unit was worn as a backpack (fig. 4-26) and was connected to the suit by umbilicals. System development was based on previous spacecraft (Mercury and Gemini) environmental control system technology, but the Apollo unit was the first truly portable, self-contained life support system to be used in the space program.
