The Effects of Seatback Reclined Positions of Occupants in Motor Vehicles Collisions

Seattle CIREN Team (Bulger, Dissanaiké, Kaufman, Mack)

University of Washington

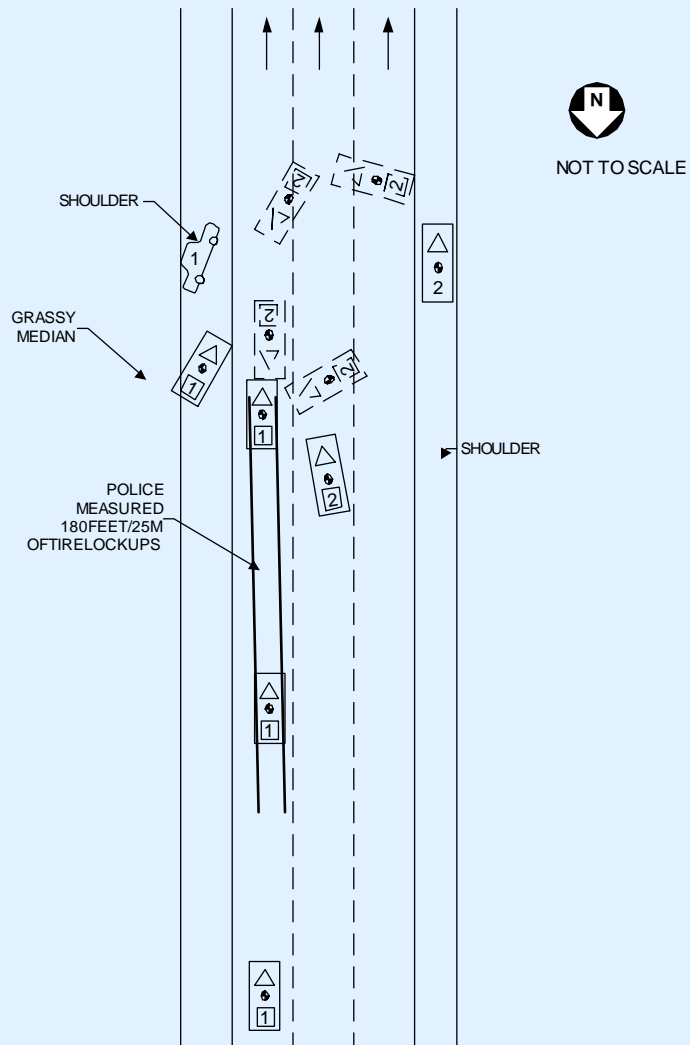
CIREN Case Review 1 – Scene

Head-on

Full frontal crash

Speed Limit

70mph/112kmph

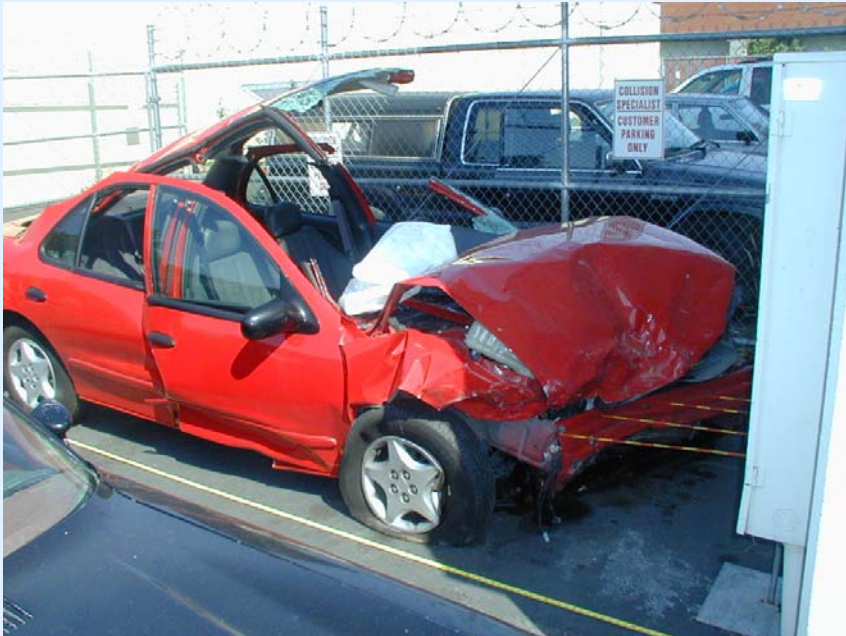
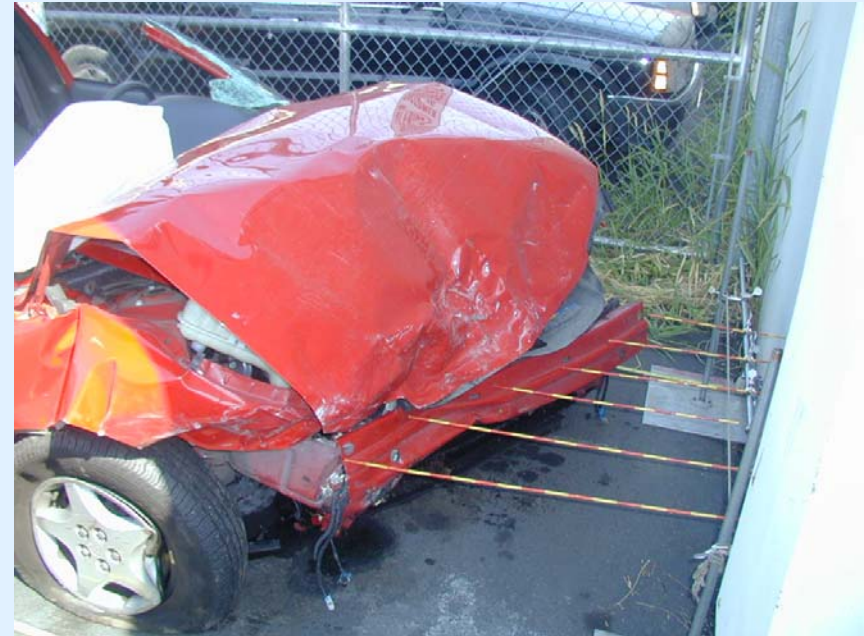
Seatback Recline CIREN Case Review 1 – Vehicle

2003 Compact 4 door sedan

PDOF – 12 o'clock

Delta V = 44kmph/ 27 mph (smash missing run)

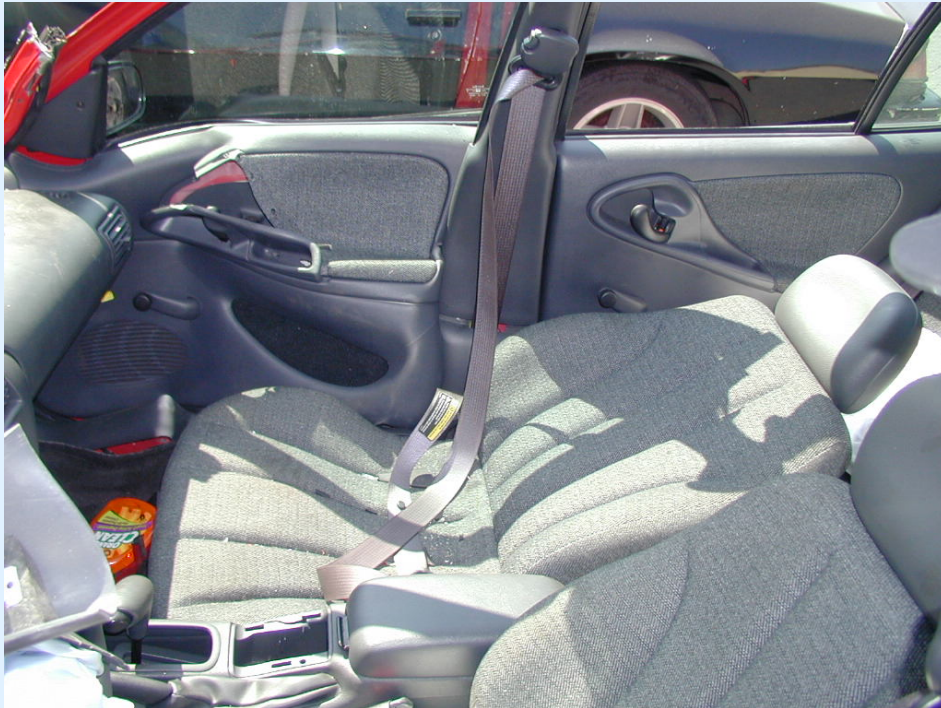
Case Review 1 – Case Occupant

20's yr. – Female

Lap/shoulder & Air bag

Fully reclined seatback
position and sleeping

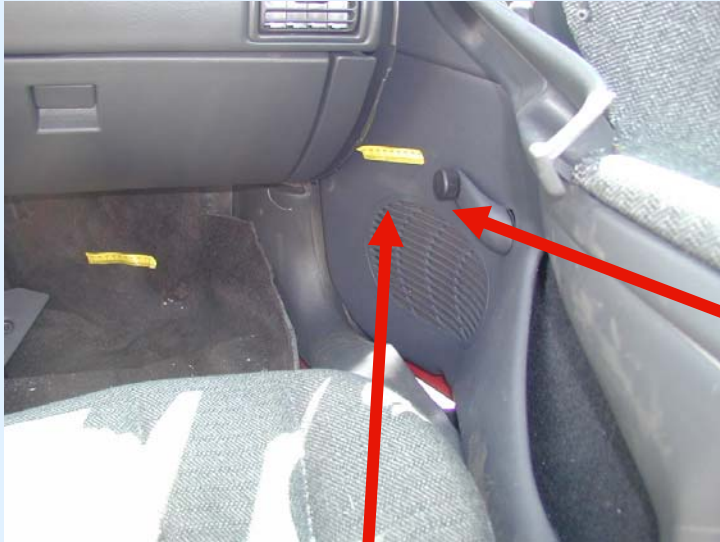
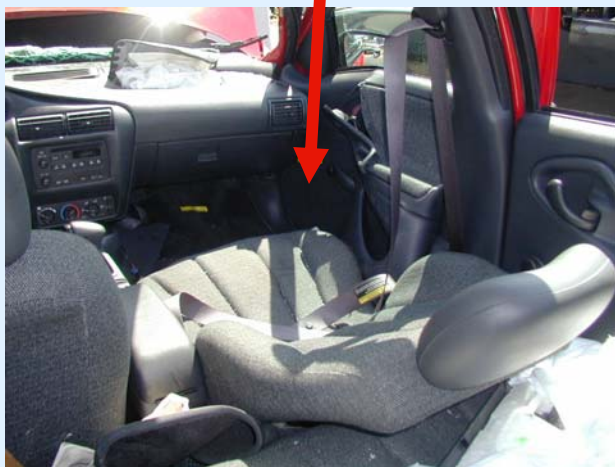
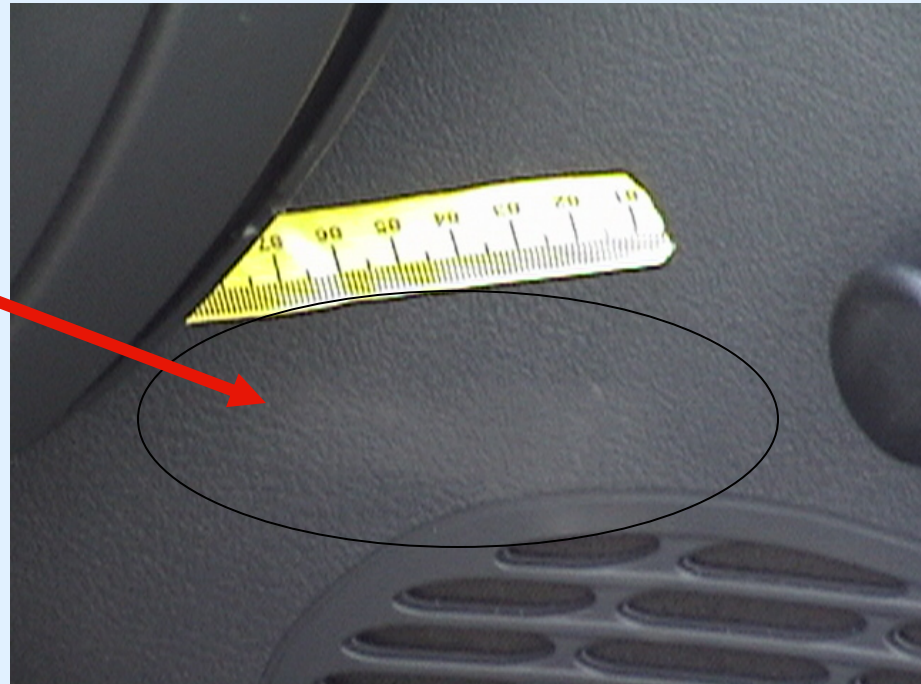
CIREN Case Review 1 – Contacts

R knee/Leg contact
scuff to door panel

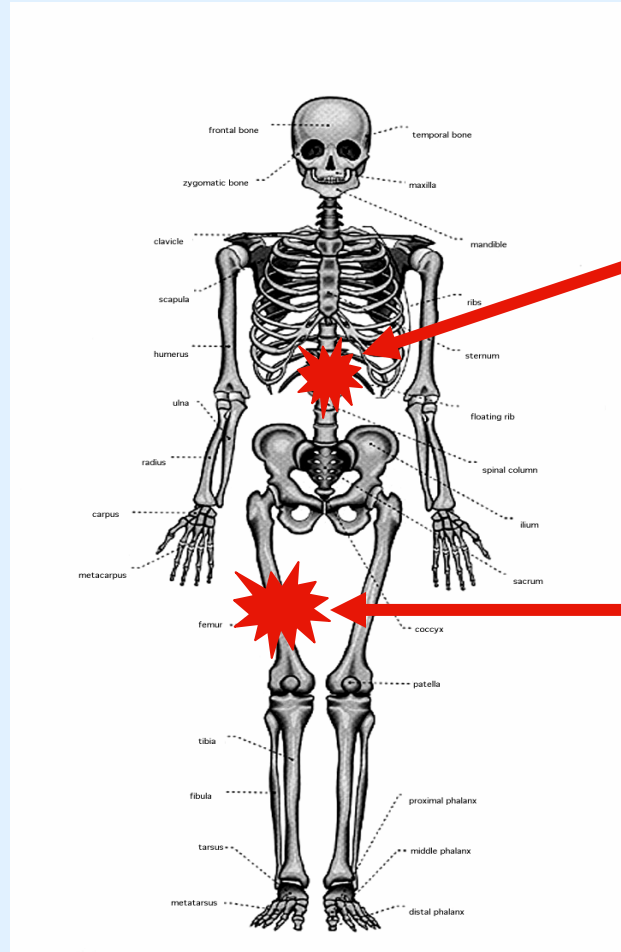
CIREN Case Review 1 – Injuries

AIS 3
T-Spine

AIS 3
Lower Extremity

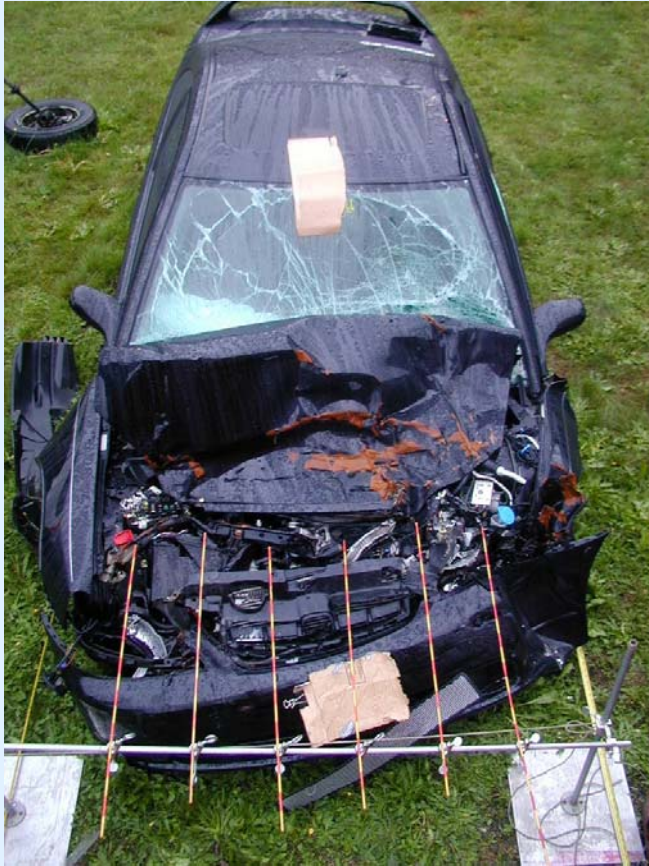
CIREN Case Review 2 – Case Vehicle

2003 Compact Sedan 2-door

PDOF - 12 o'clock

Reconstruction

Delta V = 24mph/38kmph

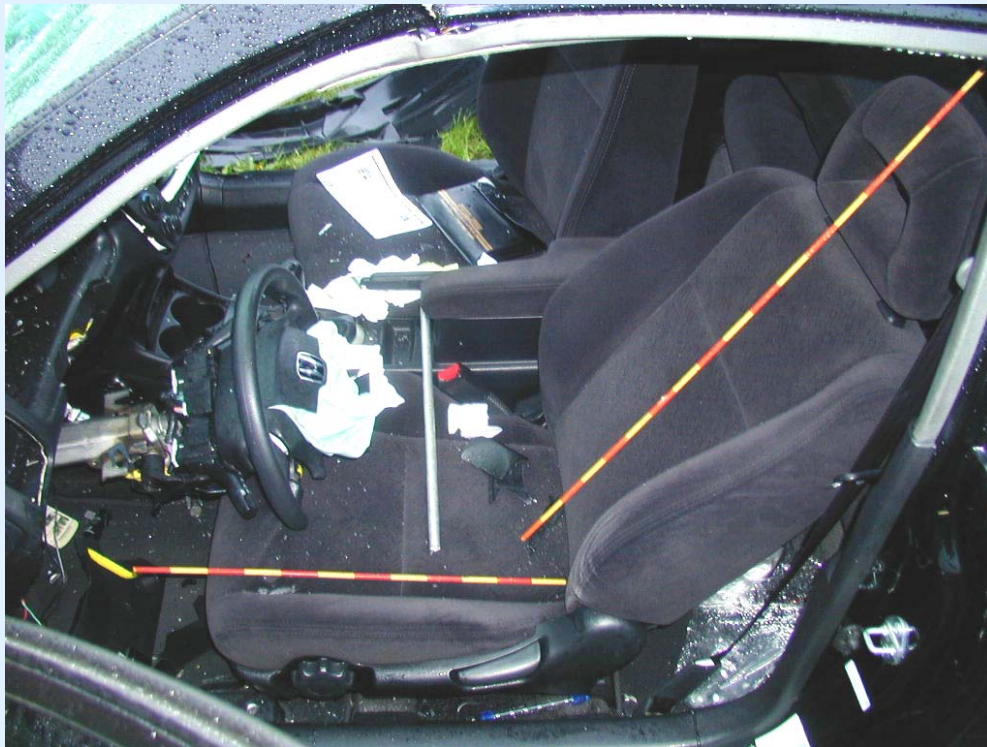
Case Review 2 – Case Occupant

Driver

Teenager – Male

Frontal steering
column air bag
deployment

No manual seat belt
use

Seatback full recline

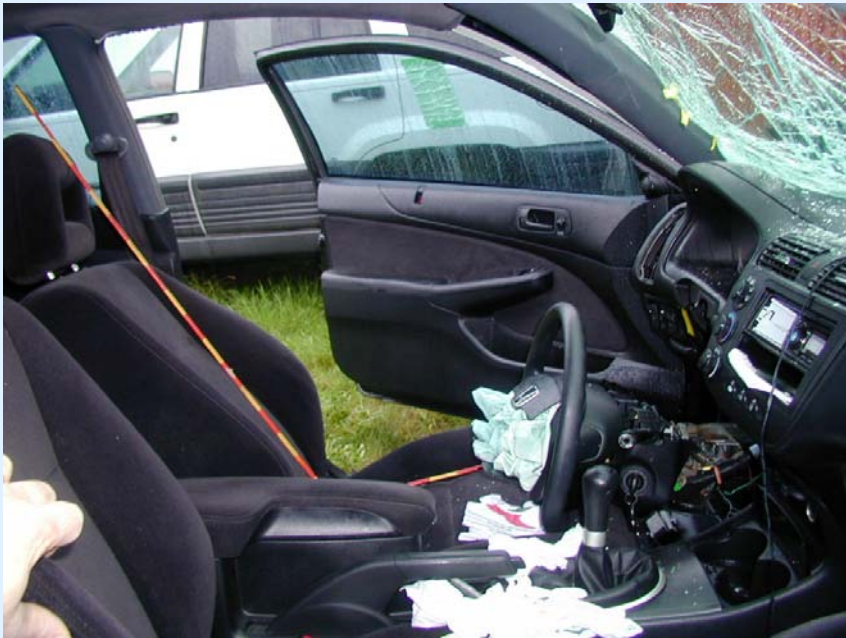
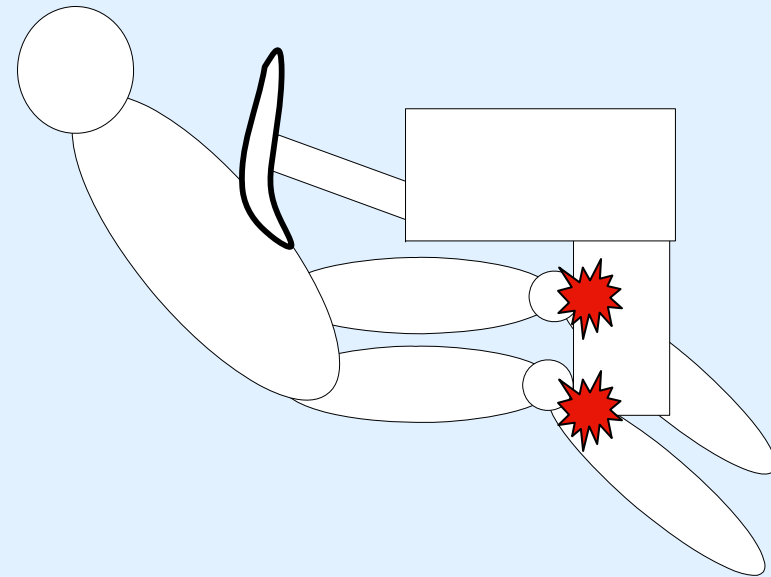
Case Review 2 – Occupant Kinematics

Bilateral knee bolster contacts

Deformed Steering Rim

Complete collapse steering
column

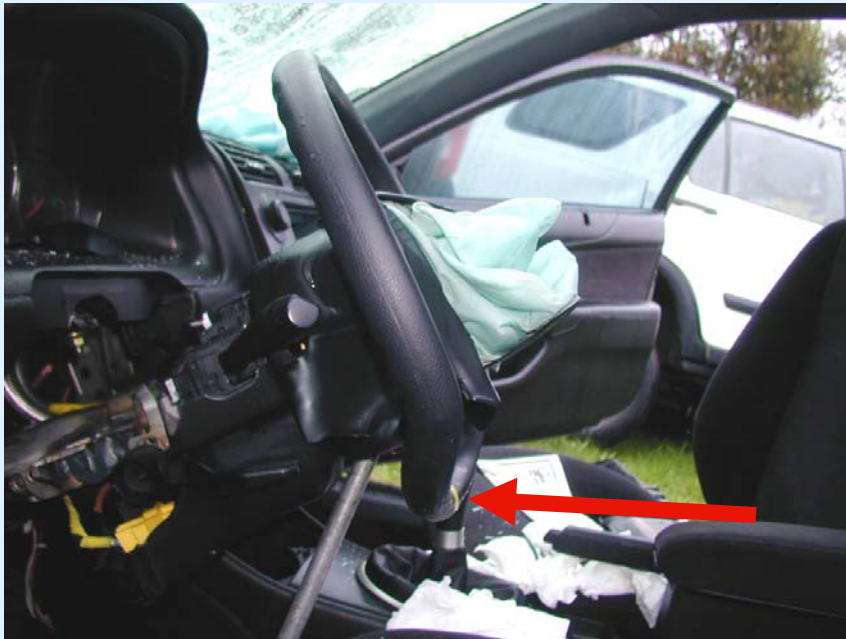
Seatback Recline Case Review 2 – Contacts

Steering Rim Deformation

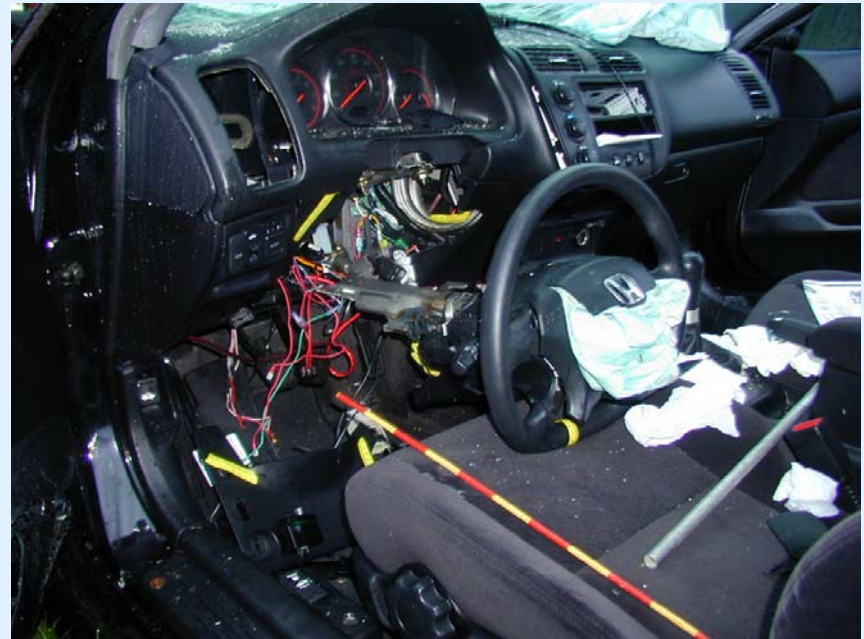
Complete Steering Column
Collapse

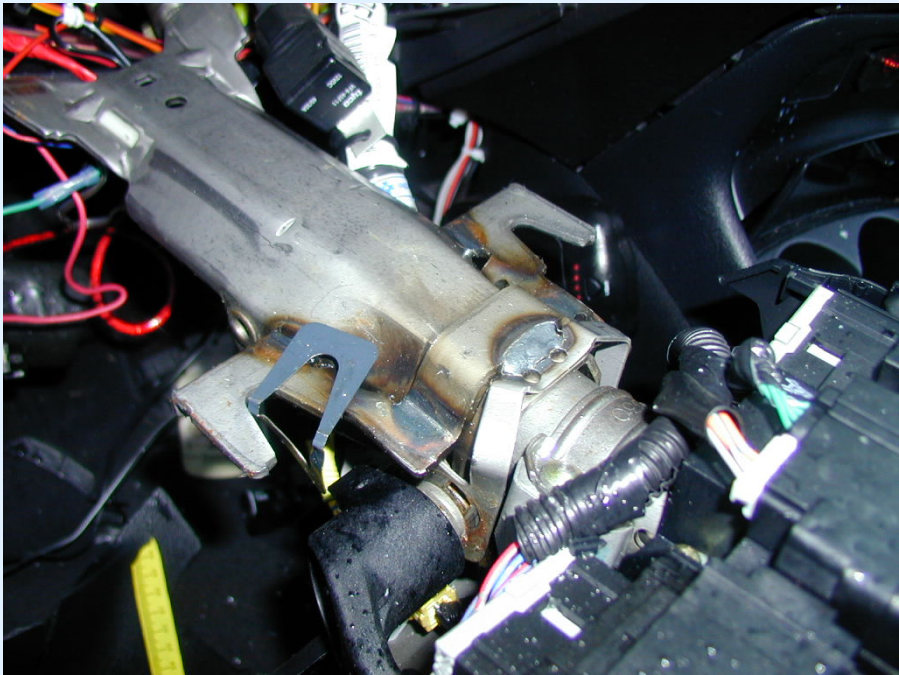
Seatback Recline Case Review 2 – Contacts

Shear Capsules

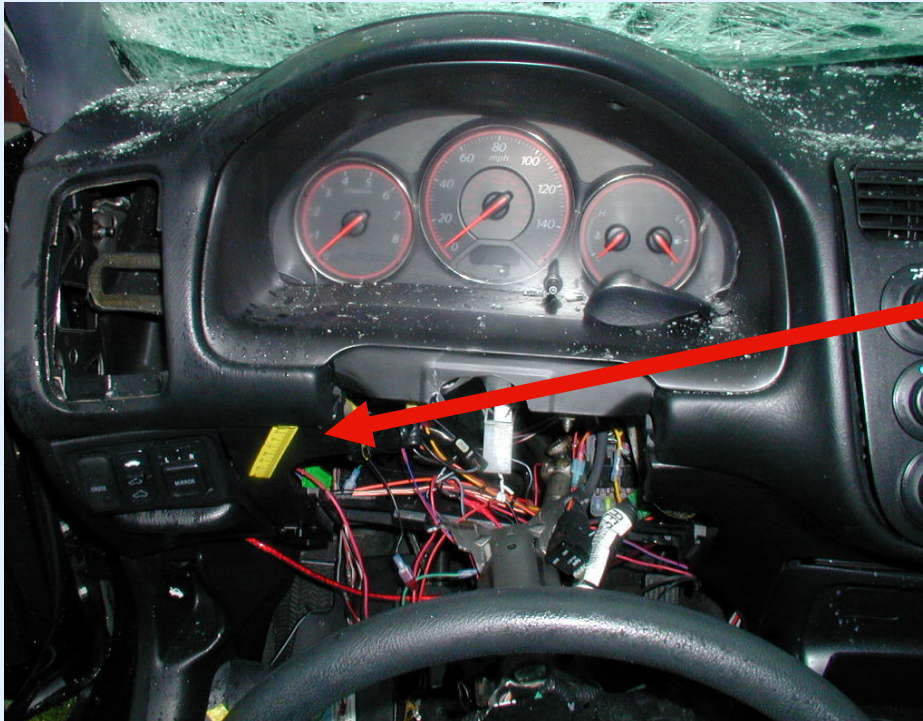
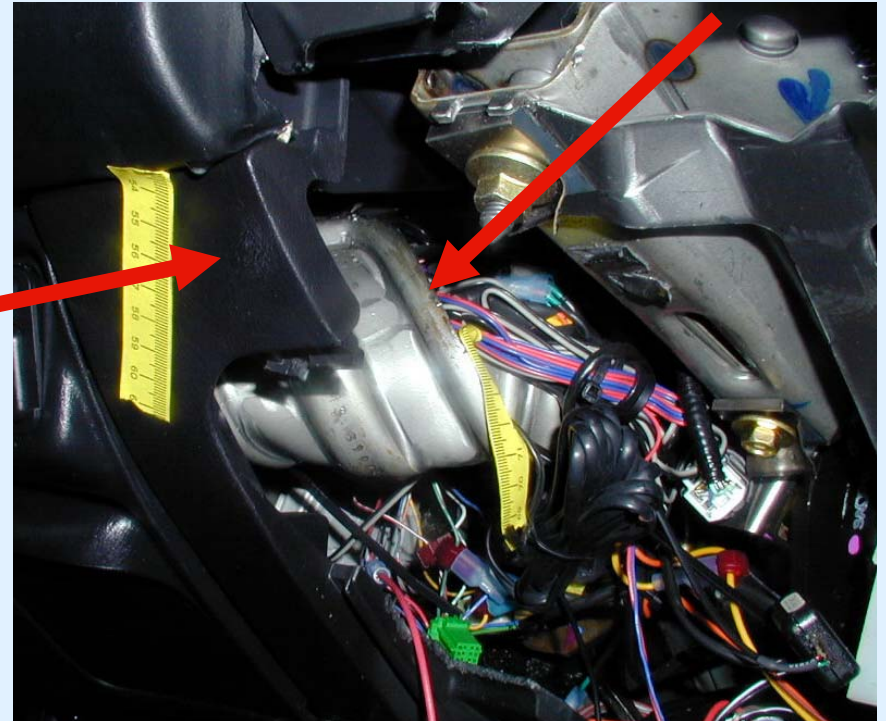
Seatback Recline Case Review 2 – Contacts

Left knee contact

Scuffed cover, Deformed Bolster

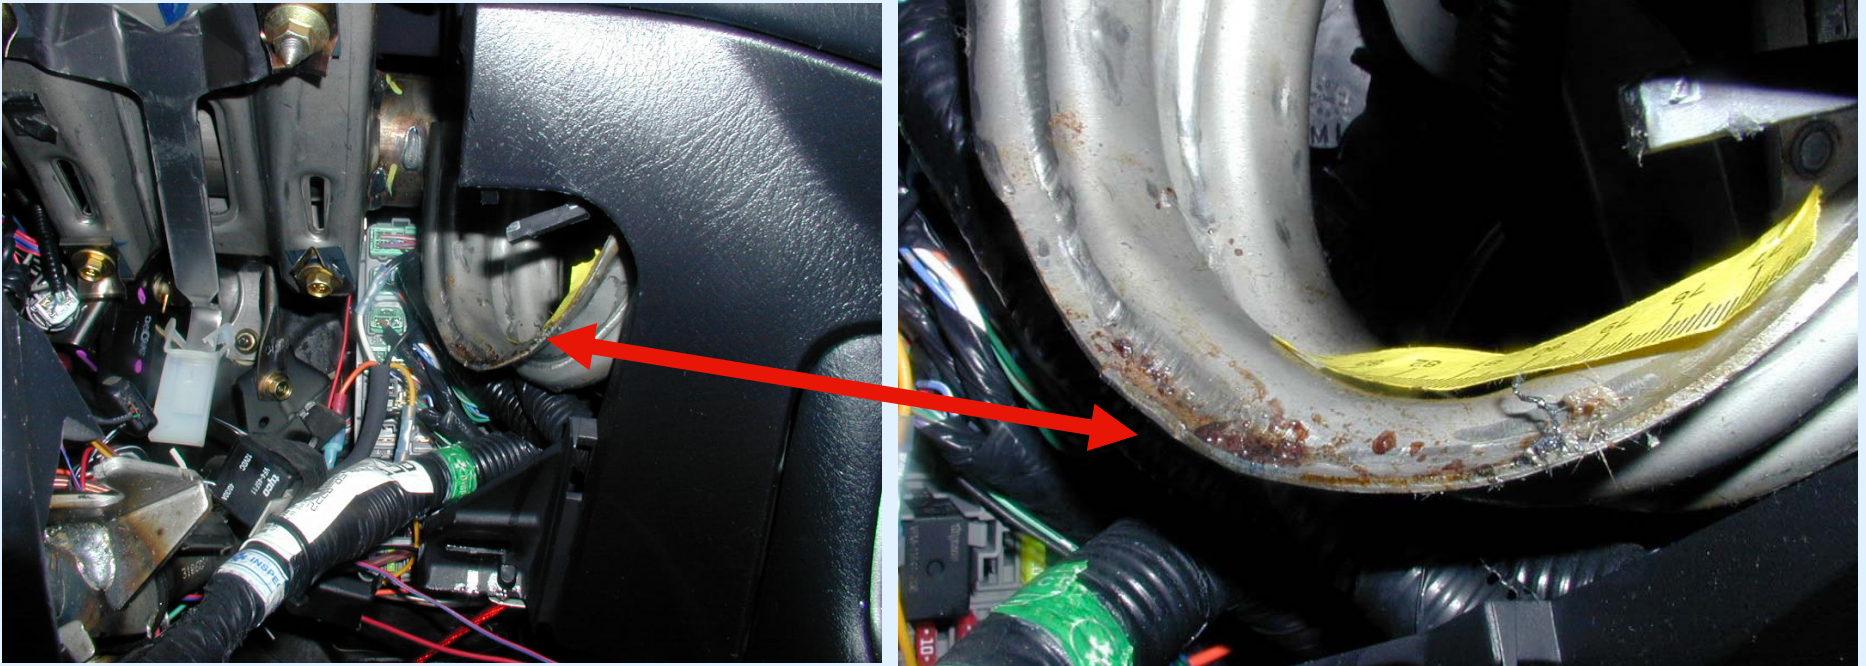
Seatback Recline Case Review 2 – Contacts

Right knee contact to bolster

Evidence: skin, fabric, hair

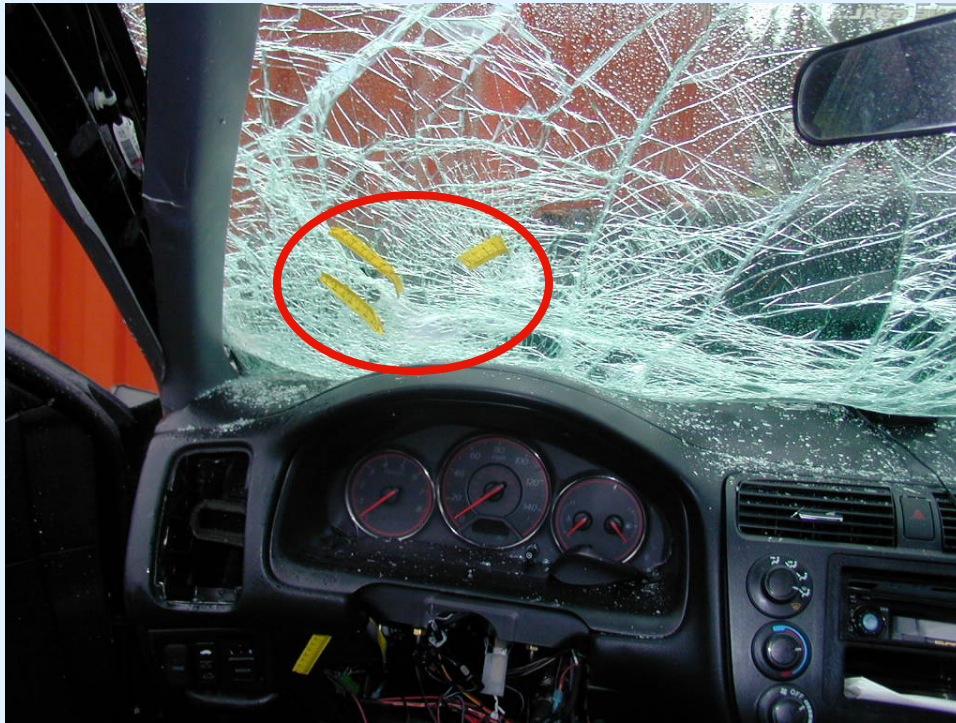
Seatback Recline Case Review 2 – Contacts

Left hand contact with intrusion of
windshield reinforced by exterior hood

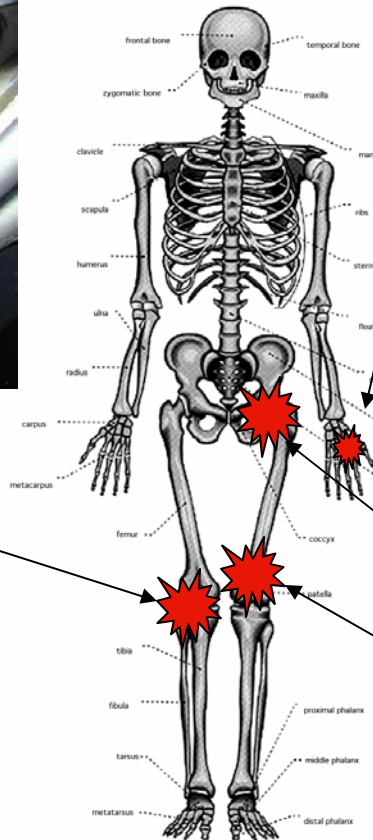
AIS 2 – Hand

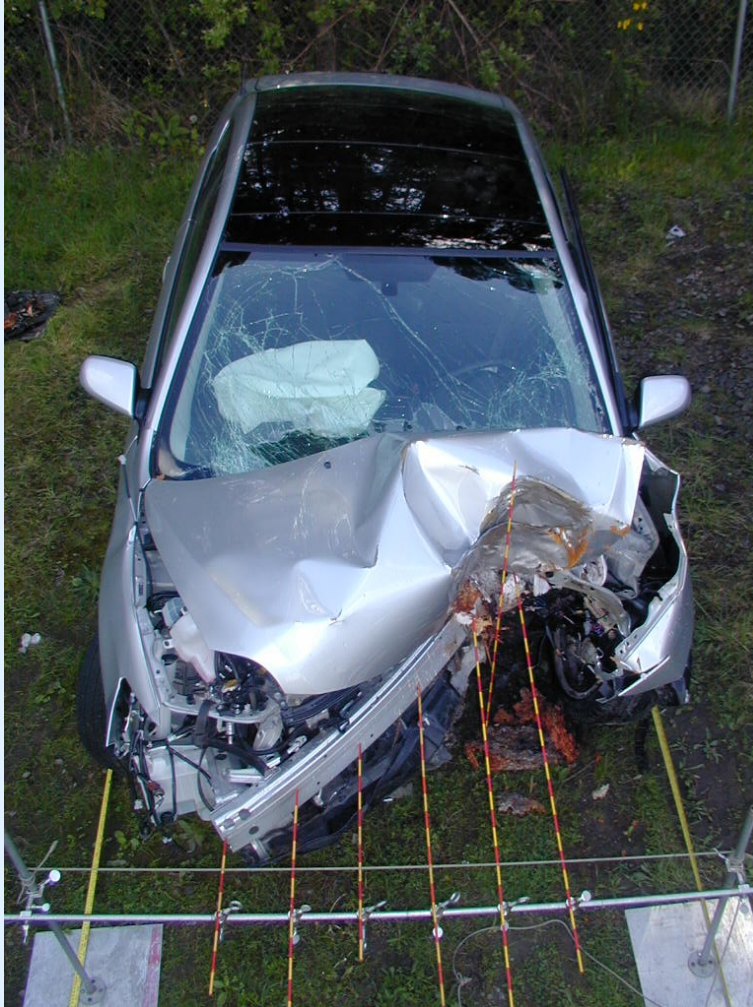
Seatback Recline Case Review 2 – Case Vehicle

2006 Compact - 2HB

12 o'clock PDOF

Delta V = 30 mph / 48 kmph

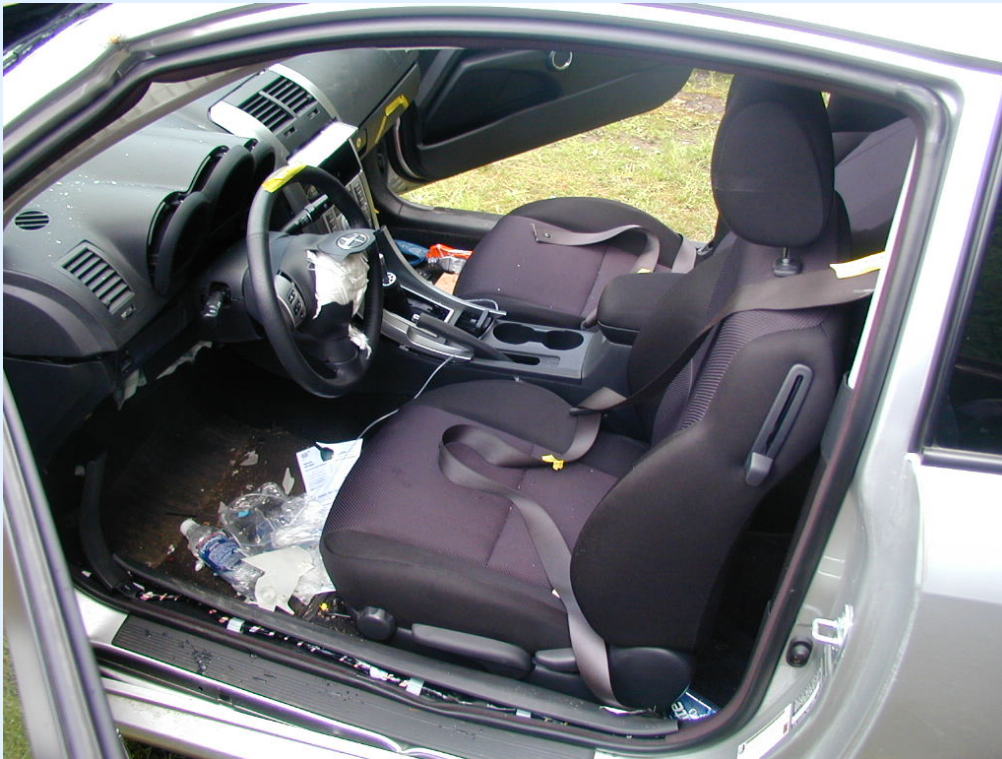
CIREN Case Review 3 – Driver

Elderly – Male

Seatback Upright Position

Manual Lap/Shoulder belt
w/ Pretensioner

Air bag Deployments

- Steering Column

- Knee Bolster

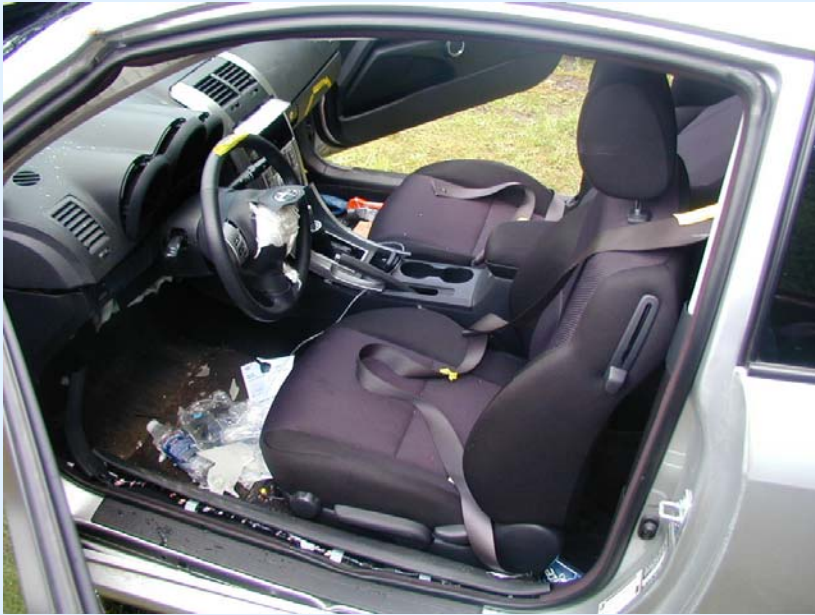
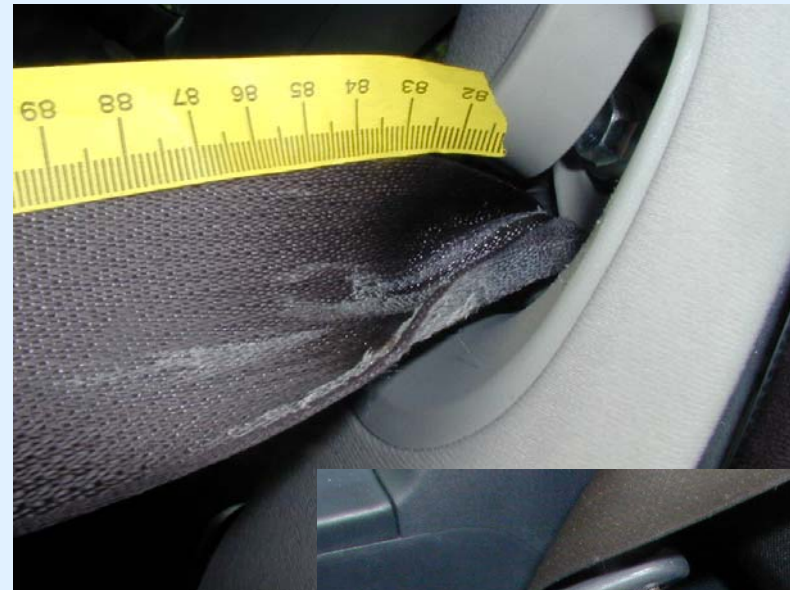
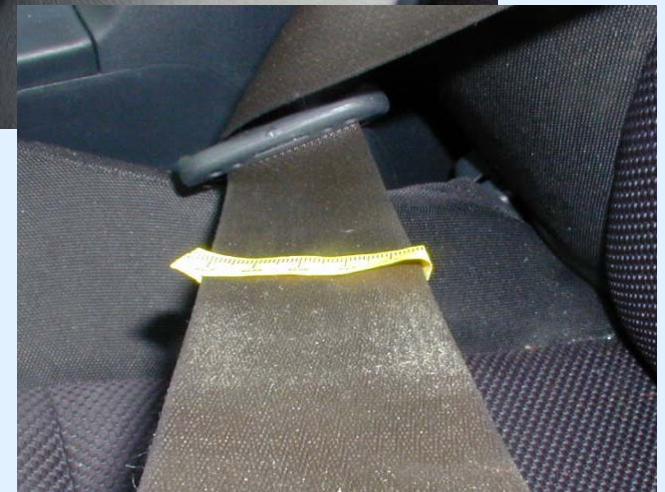
Seatback Recline CIREN Case Review 3 – Driver

Safety belt usage evidence at latch plate
and pillar point

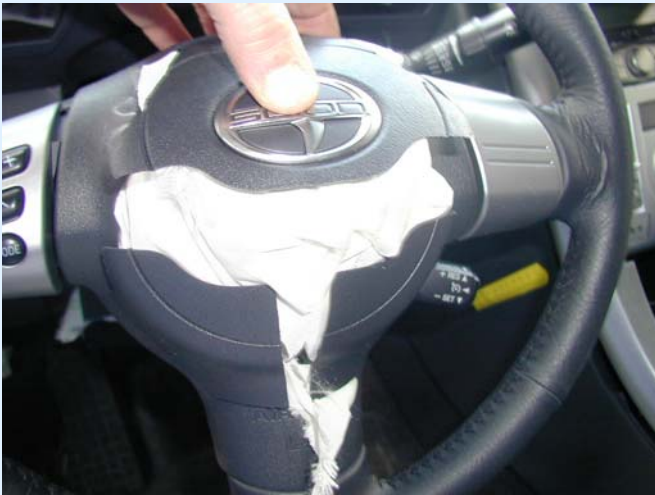
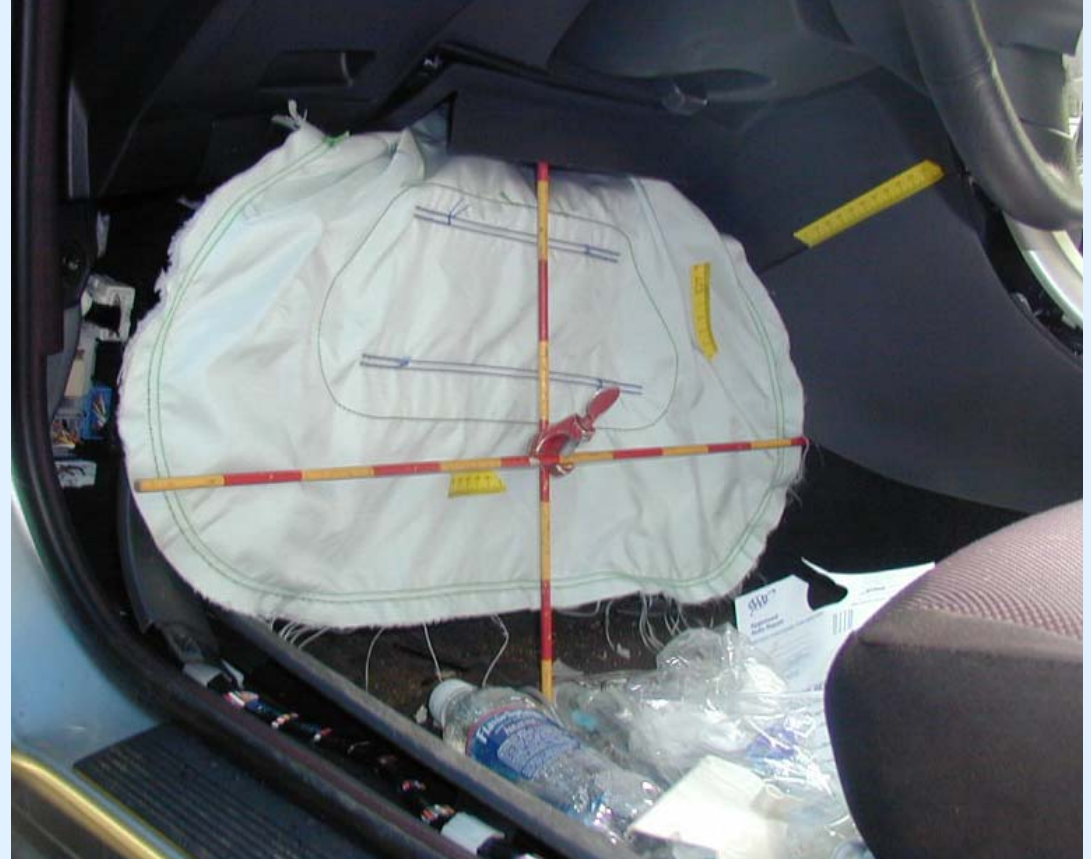
Seatback Recline CIREN Case Review 3 – Driver

Air bag
Deployments

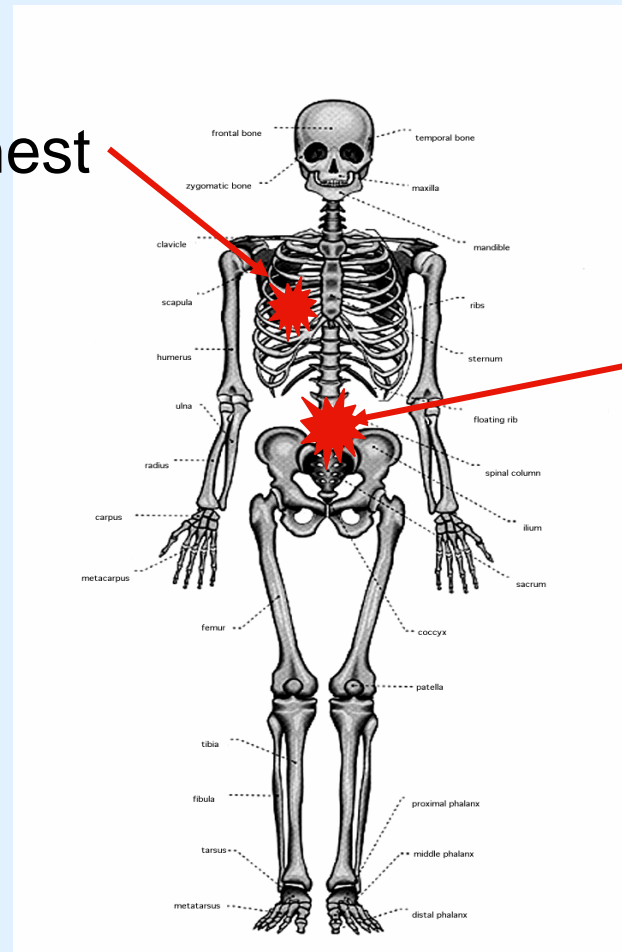
Case Review 3 – Driver Injuries

AIS 2 – Chest

AIS 3
L-spine

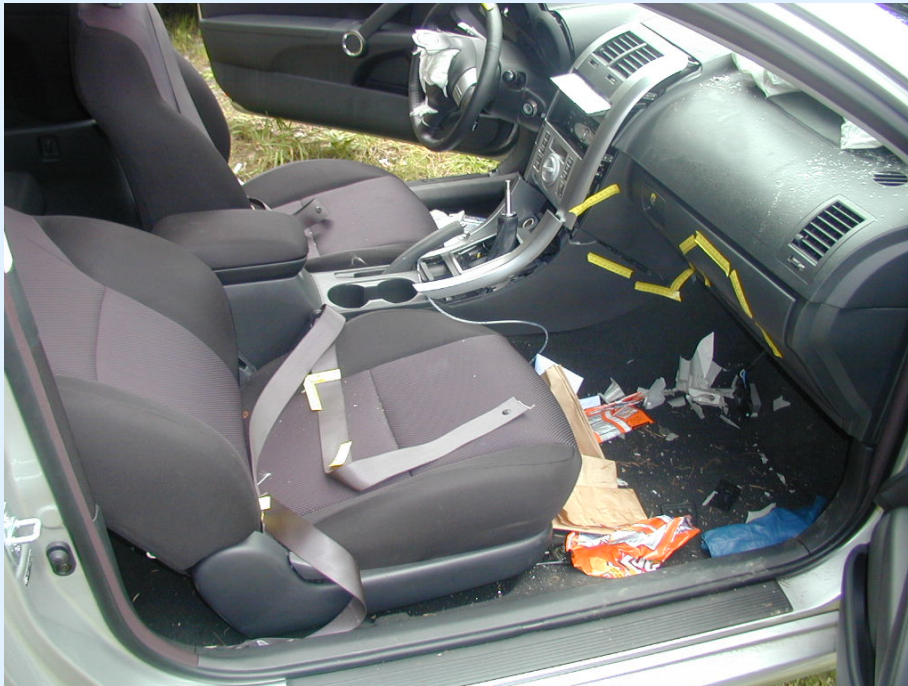
Case Review 3 – Case Occupant

Elderly – Female

Fully reclined
seatback

Manual lap/shoulder
w/pretensioner

Instrument panel air
bag deployment

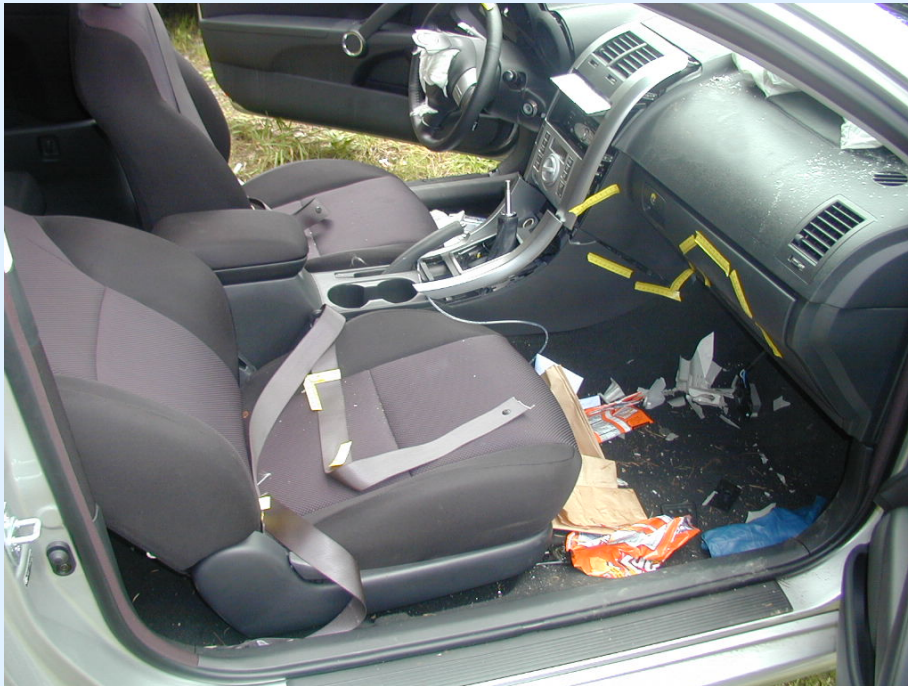
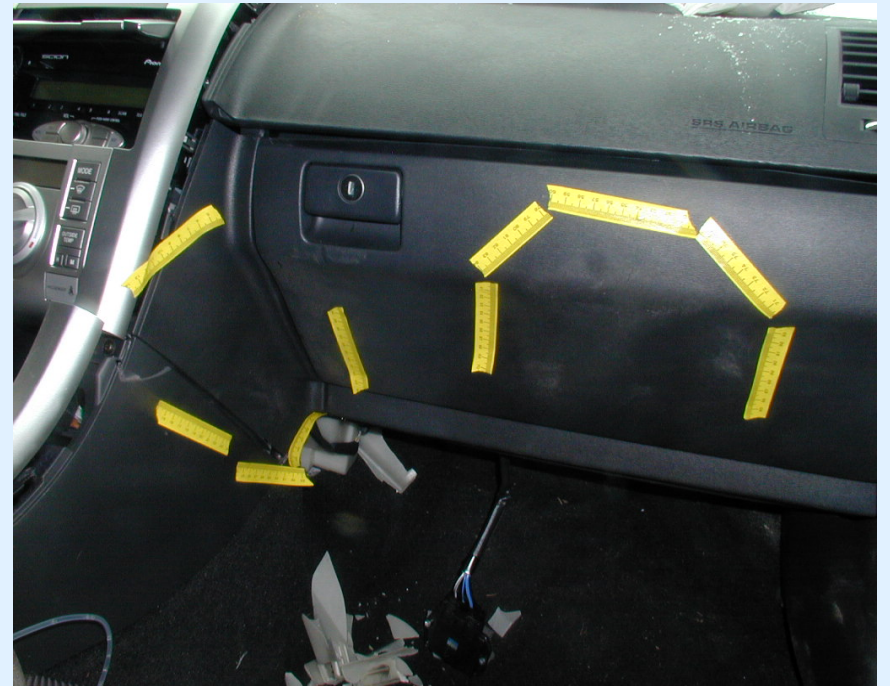
Seatback Recline Case Review 3 – Contacts

Left and Right Knee contacts

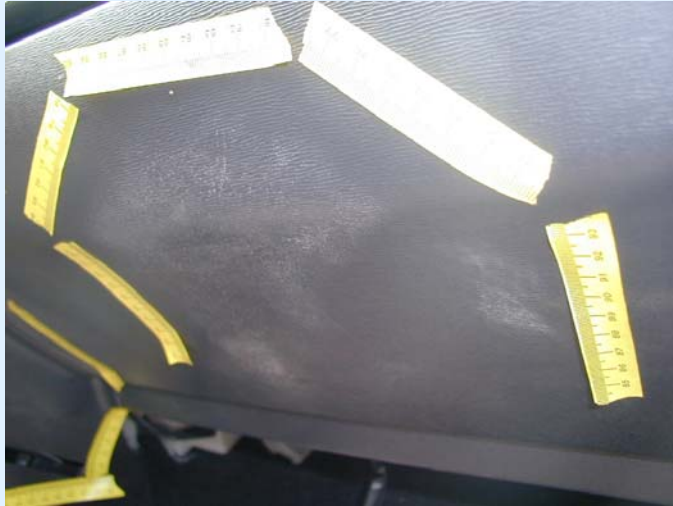
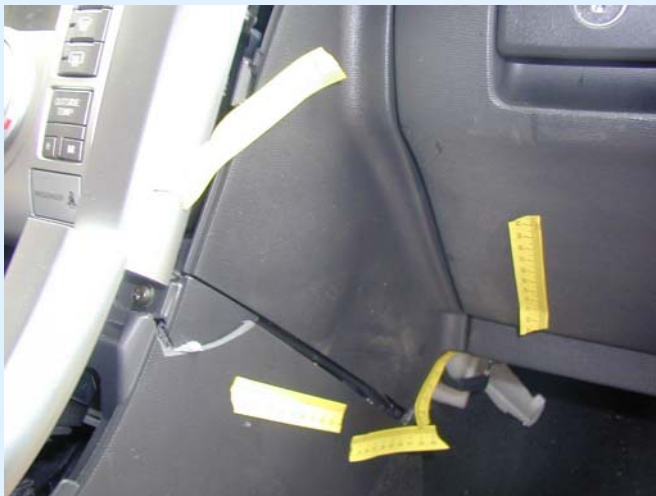
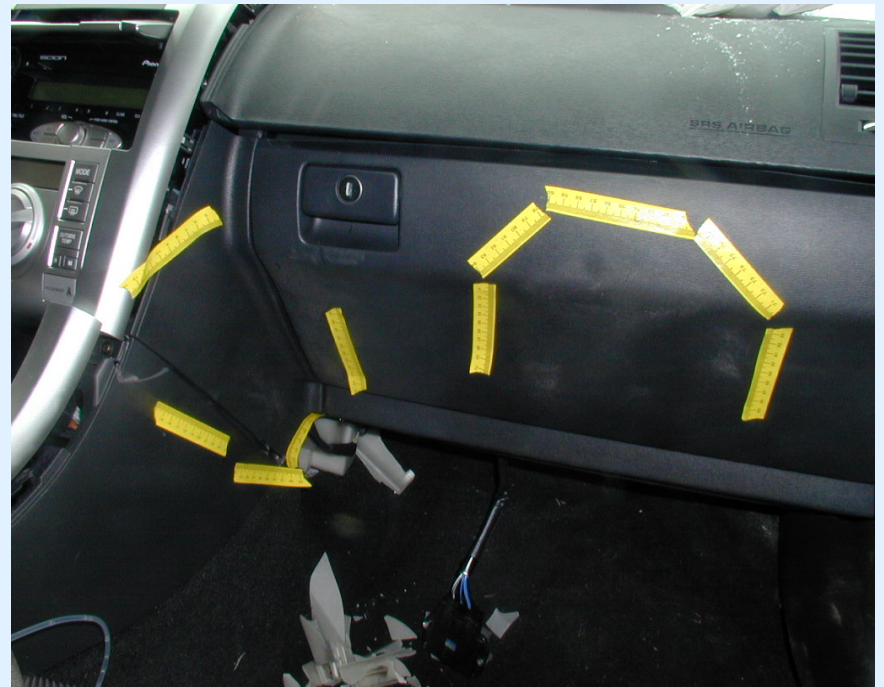
Seatback Recline Case Review 3 – Contacts

Left and Right Knee contacts

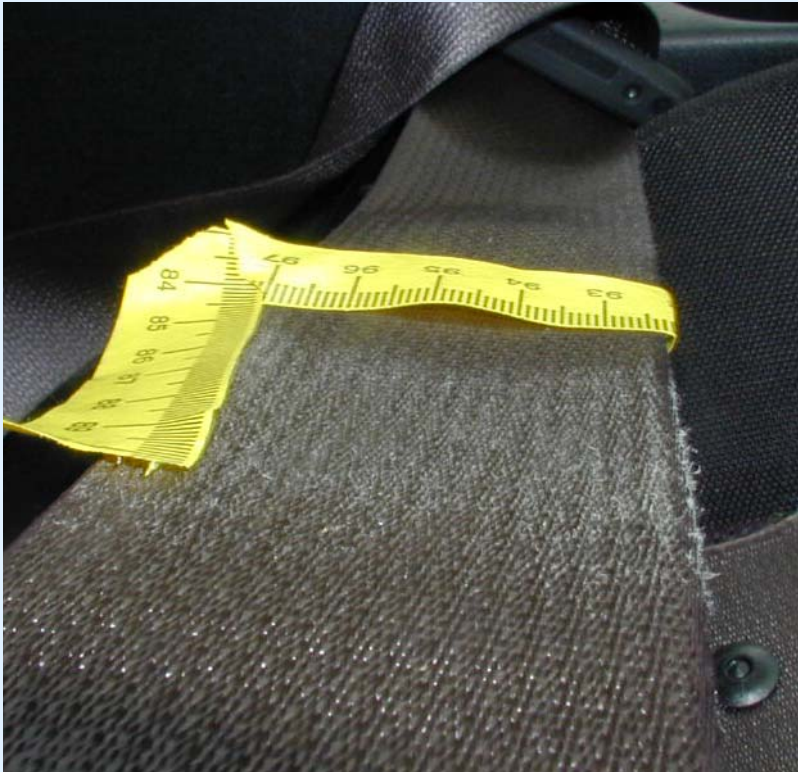
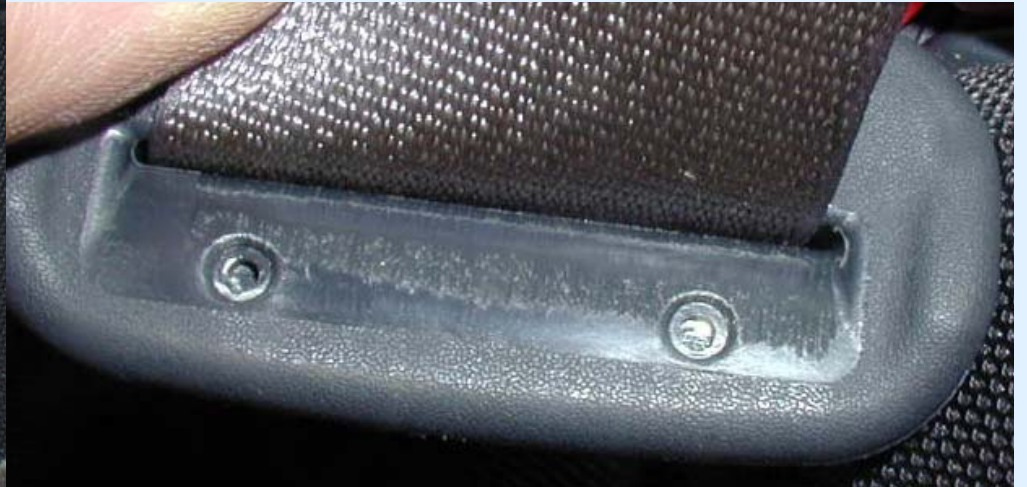
Seatback Recline Case Review 3 – Safety Belt

Safety belt latch plate
and webbing

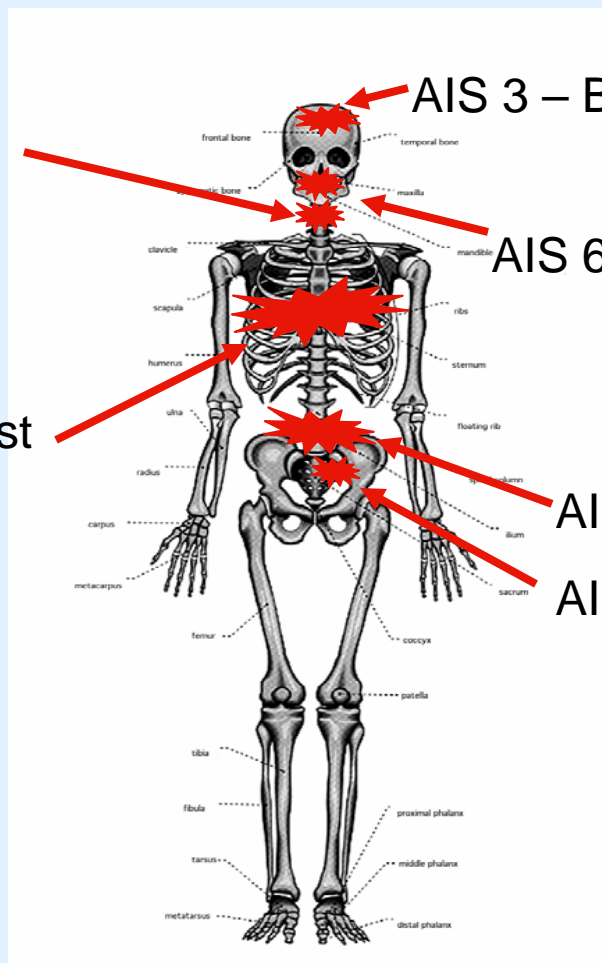
Seatback Recline Case Review 3 – Injuries

AIS 6 C-spine

AIS 4 – Chest

AIS 3 – Brain

AIS 6 - Brain

AIS 3 – Abdomen

AIS 3 – Pelvis

- Patterns of lower extremity injuries
- Associated thoracic trauma in restrained
 - Spine injury from flexion over shoulder belt “clothesline” type
 - Rib fracture patterns
- Positioning of lap belt resulted in upper abdominal injuries
