Appendix F
(F1 through F21)
Direct Shear Test Photos

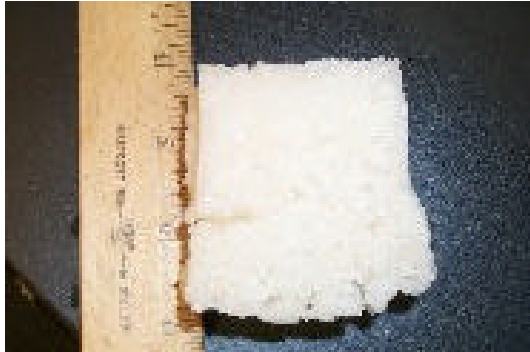
Appendix F1 – Direct Shear Test Photos of Specimen 1 (7.5 lb/in² Normal Stress), 54F-128
(After Test)

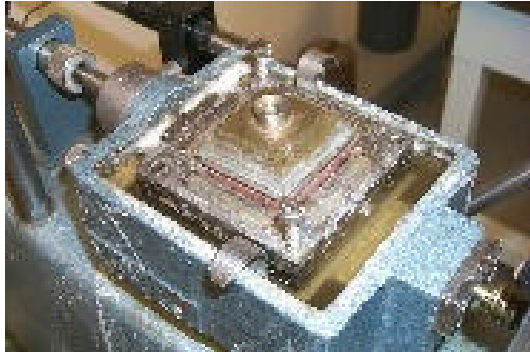
Appendix F2 – Direct Shear Test Photos of Specimen 2 (15 lb/in² Normal Stress), 54F-128
(After Test)

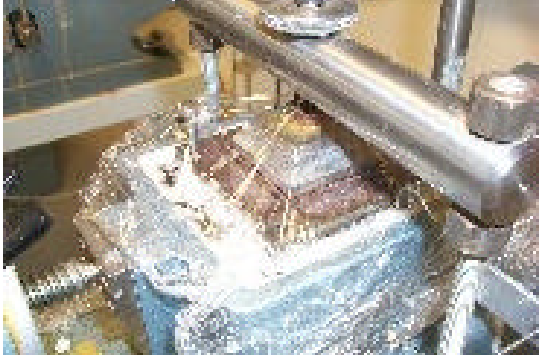
Appendix F3 – Direct Shear Test Photos of Specimen 3 (30 lb/in² Normal Stress), 54F-128
(After Test)

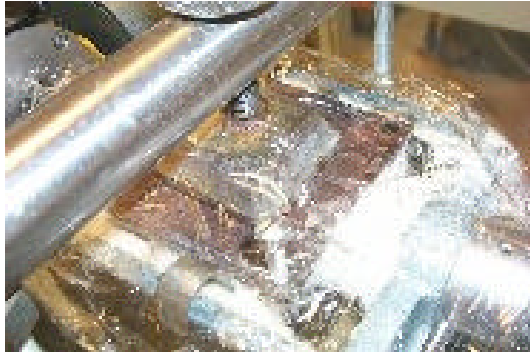
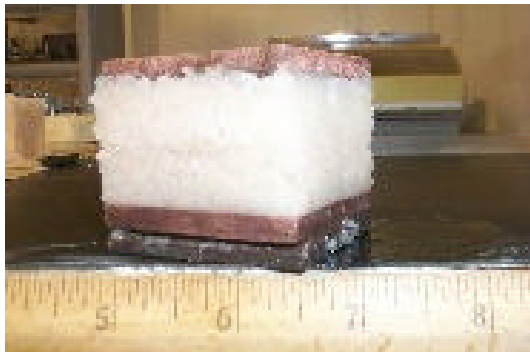
Appendix F7 – Direct Shear Test Photos of Specimen 3 (30 lb/in² Normal Stress), 54F-132 (After Test)

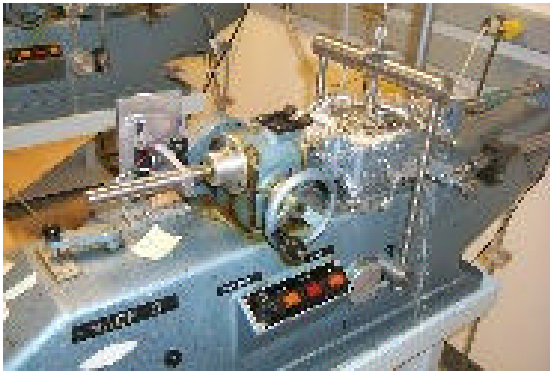
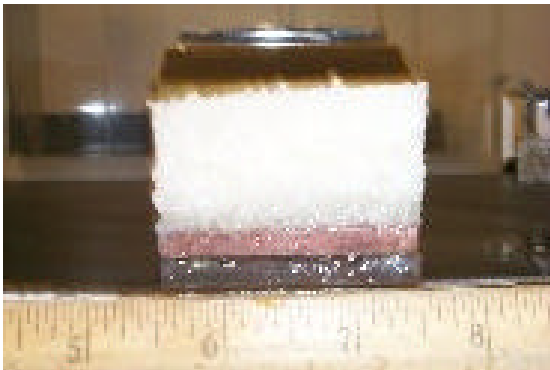
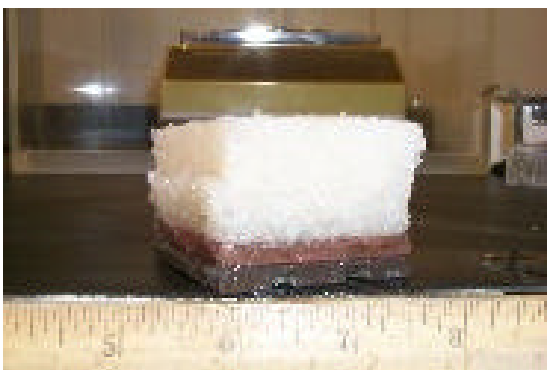
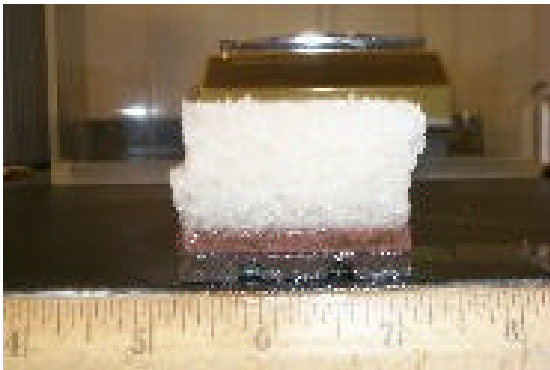
Appendix F11 – Direct Shear Test Photos of Specimen 3 (30 lb/in² Normal Stress), 54F-135 (After Test)

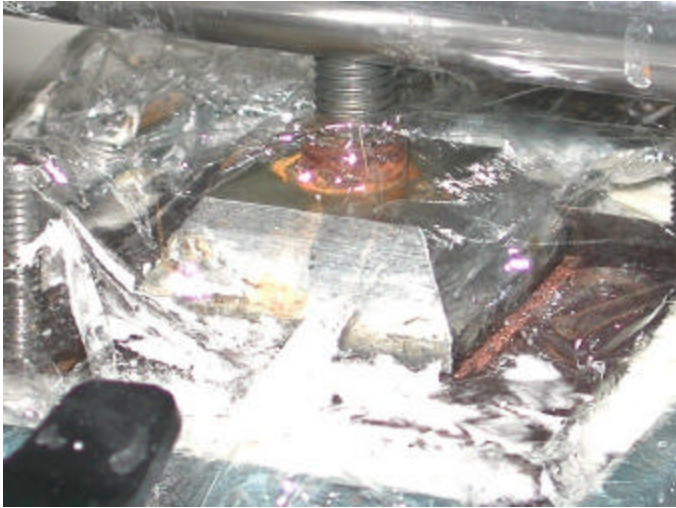
Appendix F13 – Direct Shear Test Photos of Specimen 1 (7.5 lb/in² Normal Stress), 54F-136
(After Test)

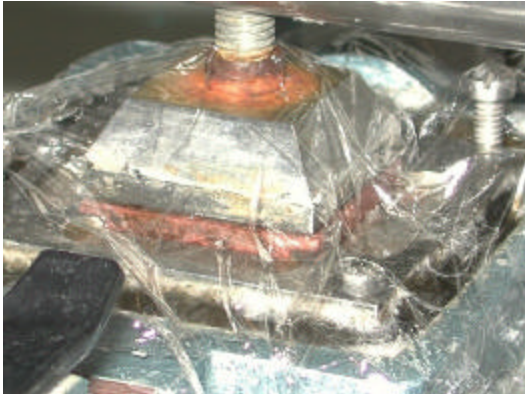
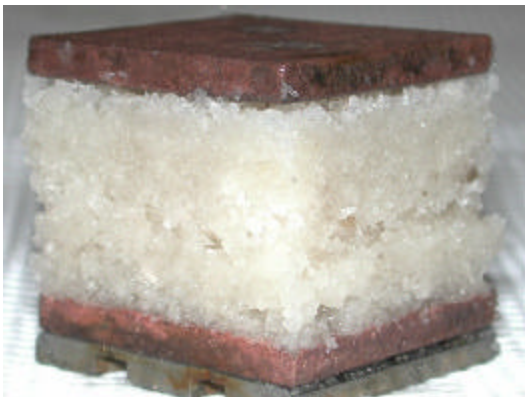
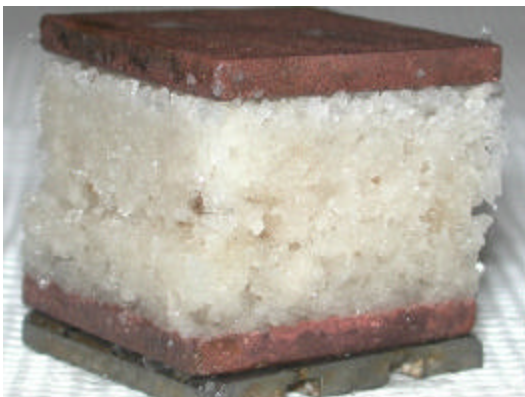
Appendix F14 – Direct Shear Test Photos of Specimen 2 (15 lb/in² Normal Stress), 54F-136 (After Test)

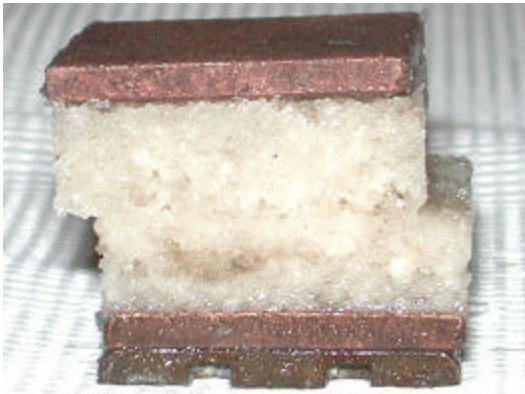
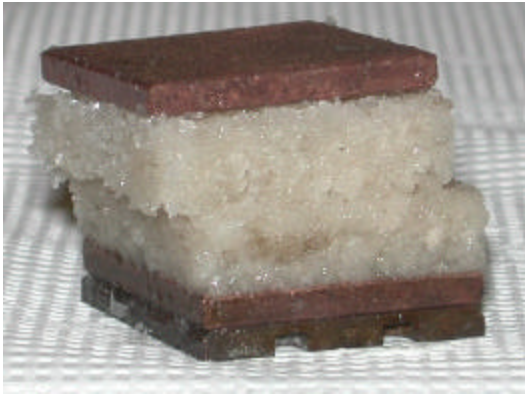
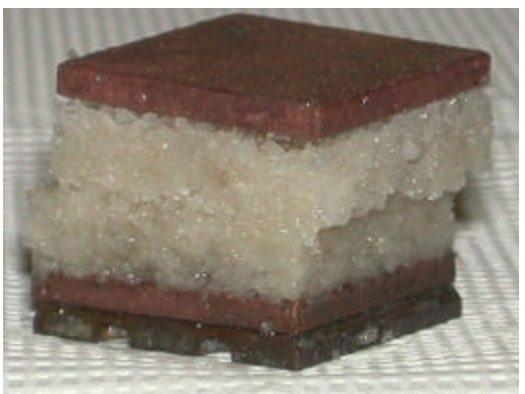
Appendix F15 – Direct Shear Test Photos of Specimen 3 (30 lb/in² Normal Stress), 54F-136 (After Test)

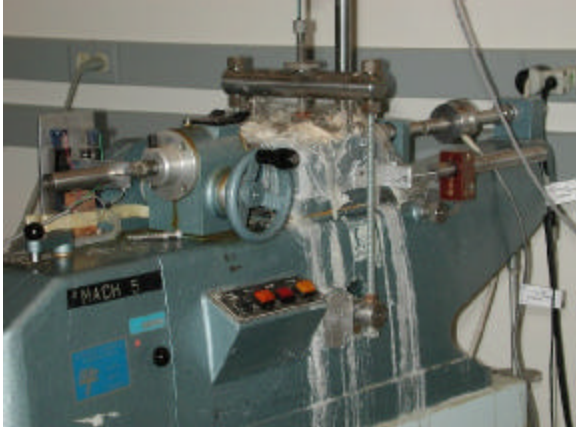
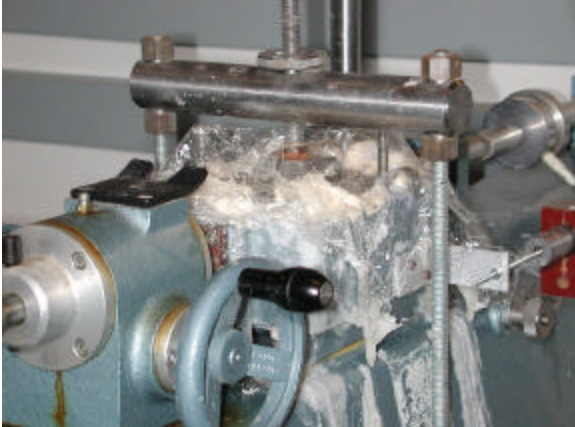
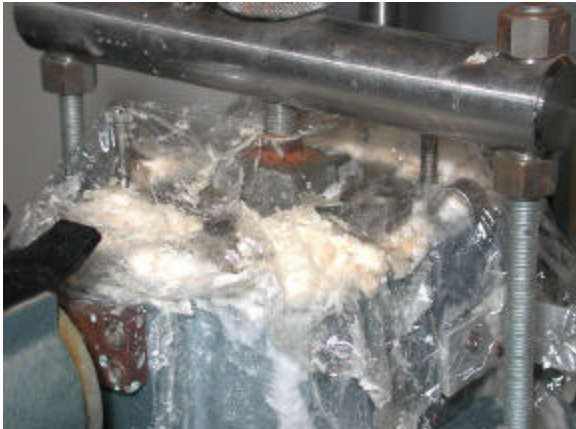
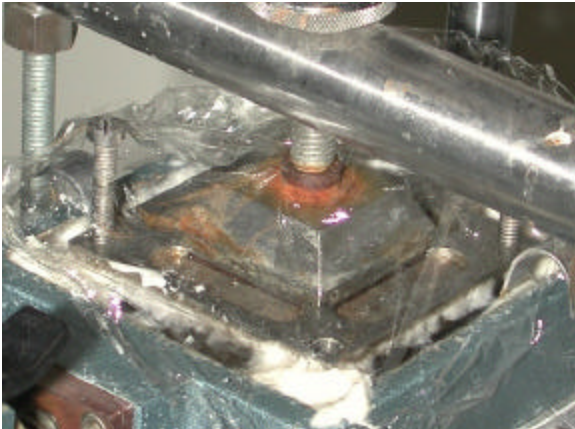
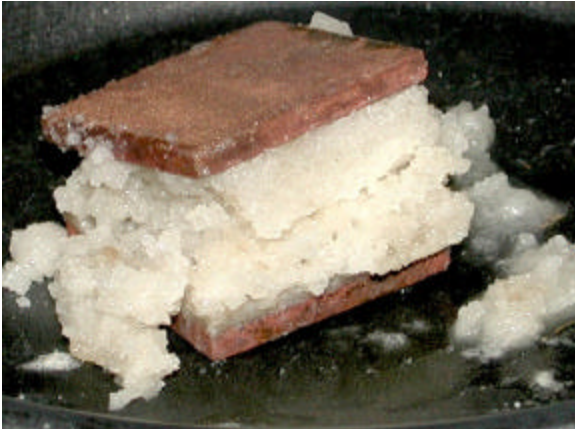
Appendix F16 – Direct Shear Test Photos of Specimen 3 (30 lb/in² Normal Stress) at 0.00003 in/min Strain Rate, 54F-136 (After Test)

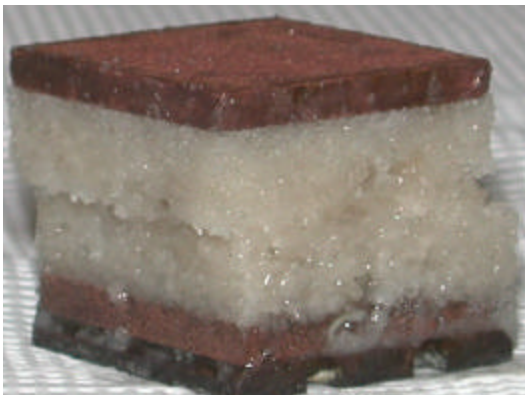
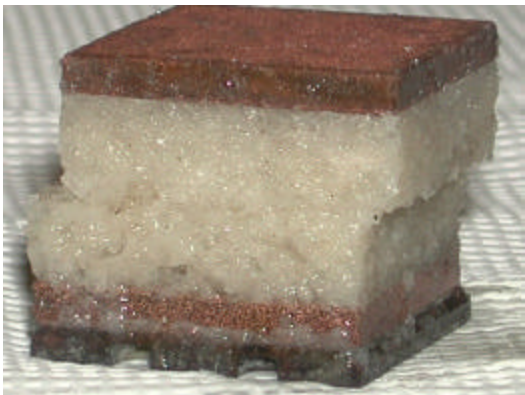
Appendix F17 – Direct Shear Test Photos of Specimen 4 (60 lb/in² Normal Stress), 54F-136 (After Test)

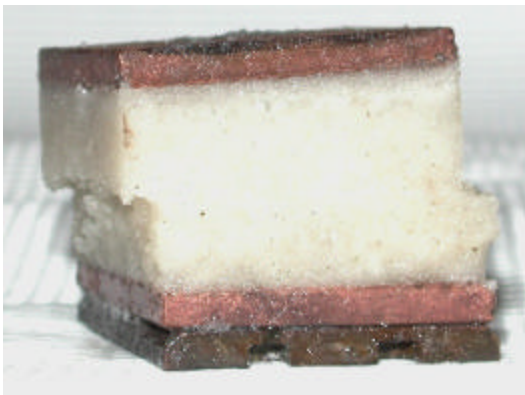
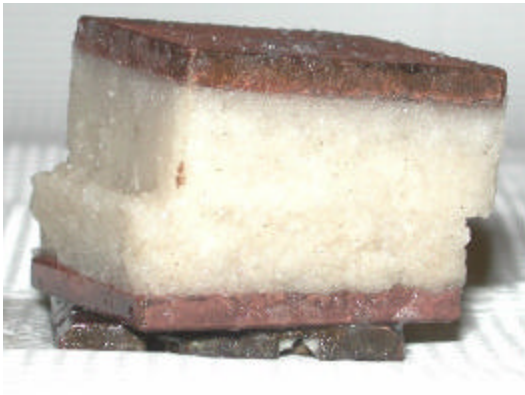
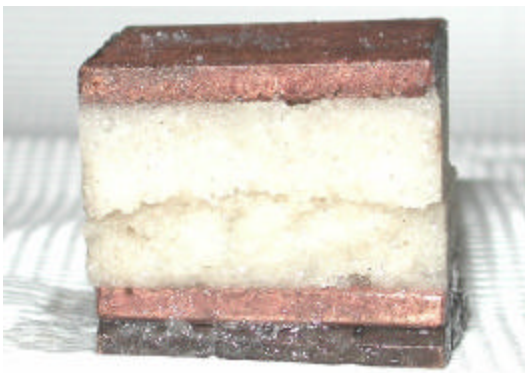
Appendix F18 – Direct Shear Test Photos of Specimen 1 (7.5 lb/in² Normal Stress), 54F-138 (After Test)

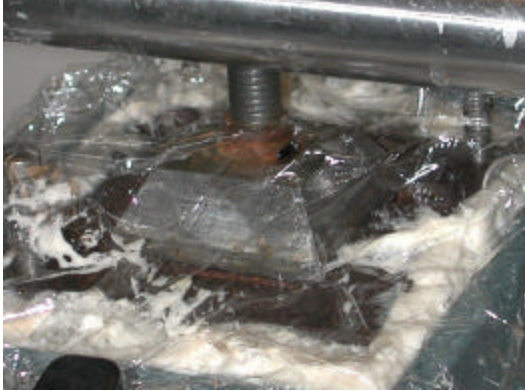
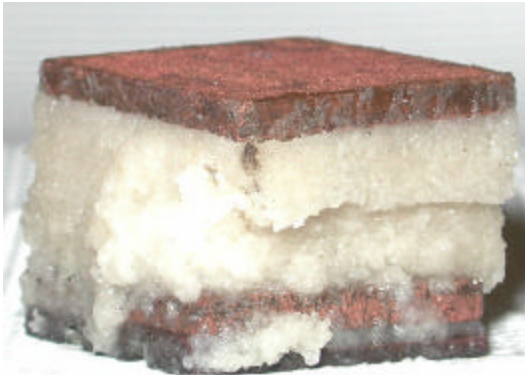
Appendix F19 – Direct Shear Test Photos of Specimen 2 (15 lb/in² Normal Stress), 54F-138 (After Test)

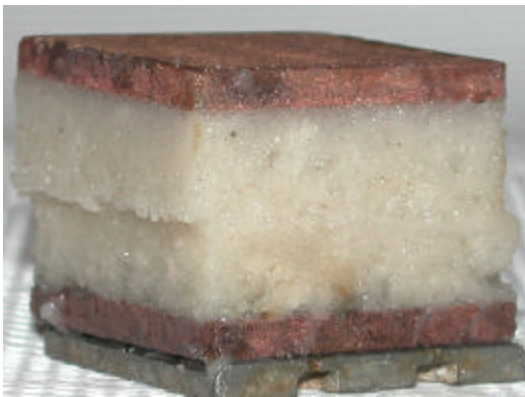
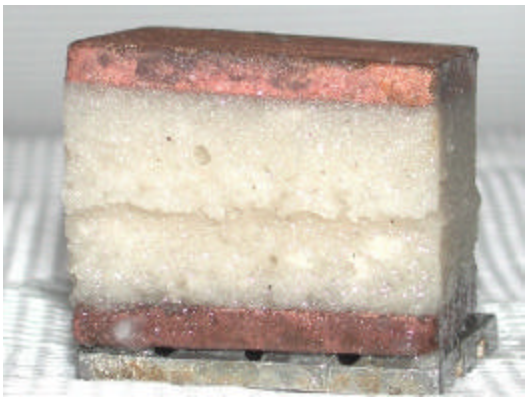
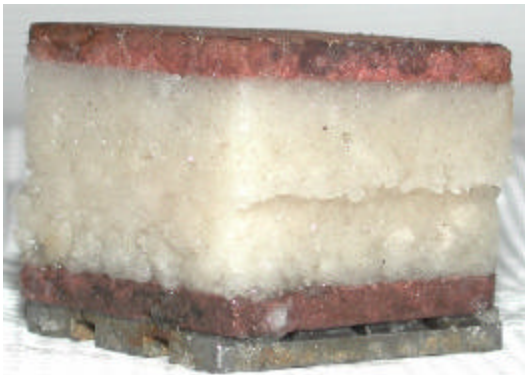
Appendix F20 – Direct Shear Test Photos of Specimen 3 (30 lb/in² Normal Stress), 54F-138 (After Test)

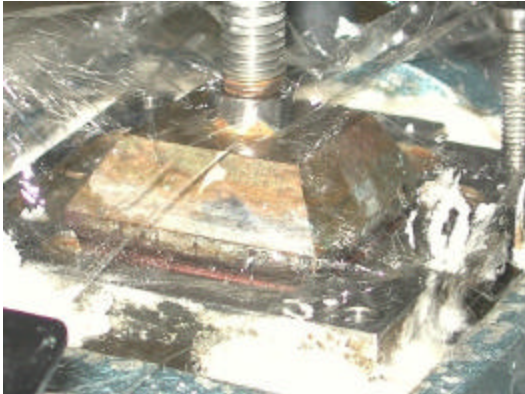
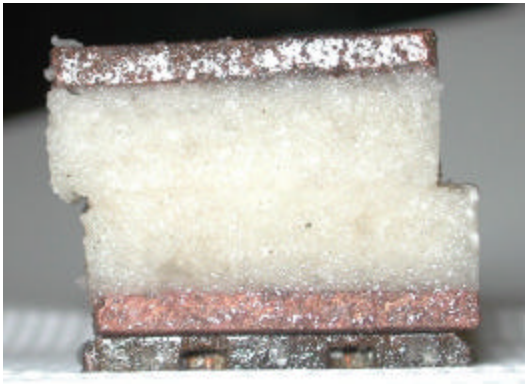
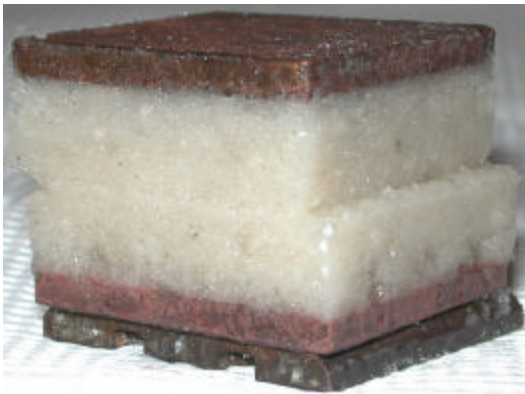
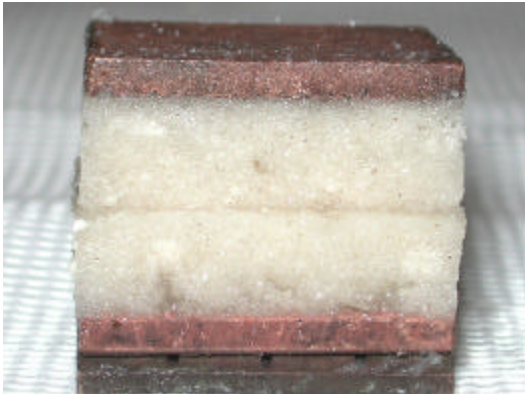
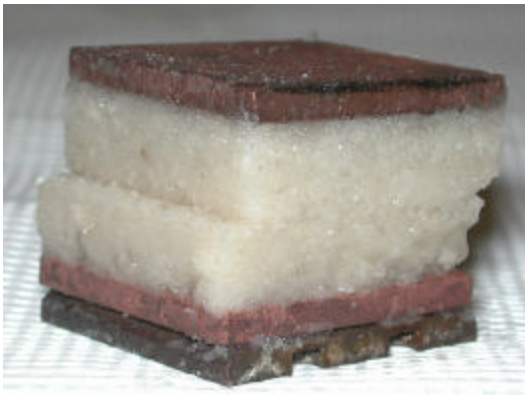
Appendix F21 – Direct Shear Test Photos of Specimen 4 (60 lb/in² Normal Stress), 54F-138 (After Test)
