**Yuma Desalting Plant**

## **Demonstration Run Report**

**U.S. Department of the Interior  
Bureau of Reclamation  
Lower Colorado Region**

**December 2008**

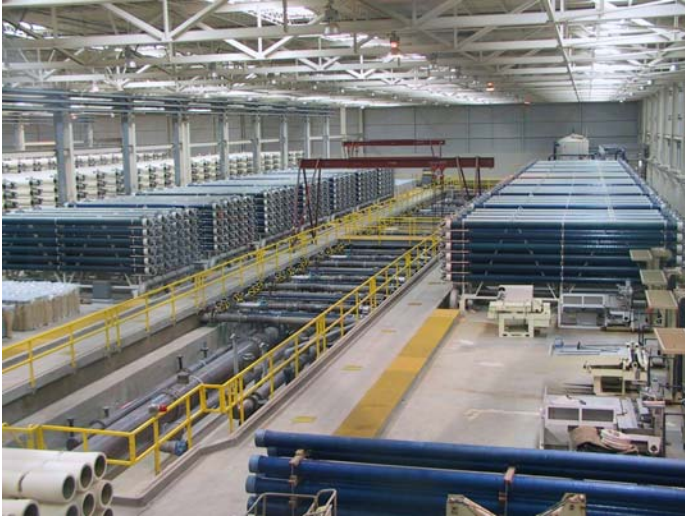
Hydranautics Desalting Vessels

In order to operate at least at ten percent capacity, six Hydranautics control blocks would need to be used—four for first stage and two for second stage. Control blocks 11 through 6 were selected for use, although any of the other Hydranautics blocks could have been used since new control block valves and actuators had been installed for the entire Hydranautics section of the Plant.

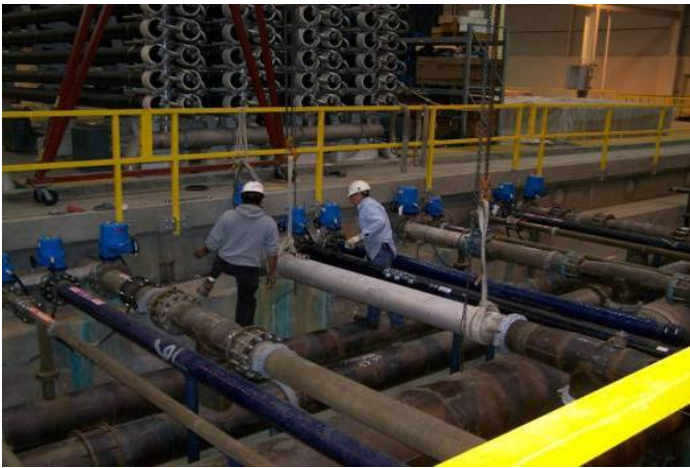
Bright Blue Devices are Control Valves and Actuators

As part of the process of resolving design deficiencies, aluminum-bronze control block valves and actuators were replaced in the Hydraulics portion of the Plant. The replacements are fabricated of stainless steel and the replacement was completed prior to beginning the demonstration run.

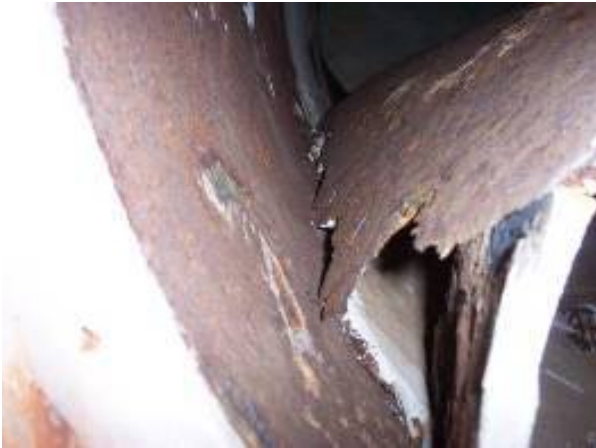
This equipment was, for the most part, found to be in a condition that would be expected for a plant that had been maintained but not operated in 14 years. Two pipes, however, were found to be damaged to an extent that unanticipated time-consuming repairs were required. A 72-inch diameter underground pipe that conveys water between the grit sedimentation basins and the solids contact reactor deteriorated at one location to a condition which required a patch. Deterioration was believed to be the result of prolonged exposure to ground water. An 8-inch wide seal was placed around the entire circumference of the pipe at the location of greatest damage. This patch successfully eliminated leakage and there were no performance issues with this pipe during the demonstration.

Spalling of Concrete Pipe Lining

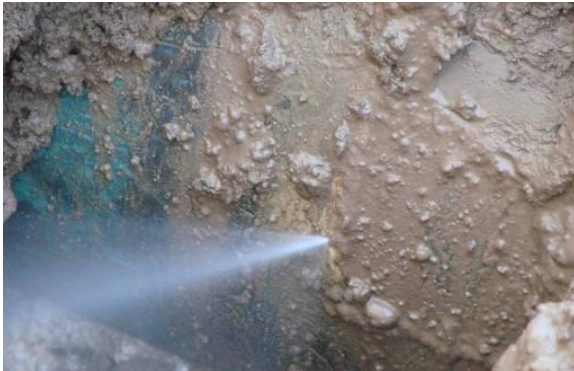
During the demonstration start-up and operation, the Plant experienced pipe leaks at nine locations, three of which caused process outages as explained earlier. Eight of

Leak in Aluminum-Bronze Pipe during Demonstration Operation

the nine leaks occurred at welds in the piping. The ninth leak was in a pipe wall. Six of the nine leaks were successfully repaired, but repeated attempts to repair the other three proved unsuccessful, confirming welding expert's assertions that aluminum-bronze is one of the most challenging alloys on which to perform field welds. As pointed out previously, leak volume was very small compared to process flow and there were no adverse impacts on the desalting operation.

Independent of the demonstration project, a comprehensive assessment of the Plant piping was performed under contract during 2007 (CH2MHill, 2008). This assessment included x-ray examination of a statistically significant sample of pipe welds, most of which were found to be substandard. Based on results of the assessment, experience during the demonstration run, and current industry knowledge, Reclamation believes that all aluminum-bronze pipe will need to be replaced.

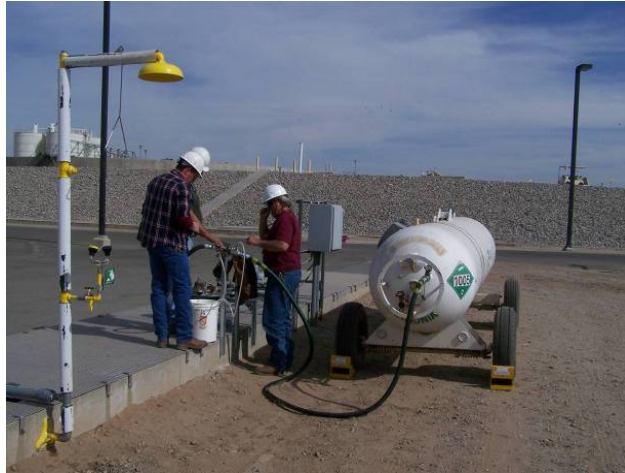
Because of the level of Plant operation during the demonstration, special systems for polymer, anti-scalant, and ammonia injection were required. These systems were procured only for the duration of the demonstration preparation and operation and are shown as a preparation cost. Because they were only temporary features, they were either skid-mounted or mounted on trailers for ease of installation and removal.

Temporary Ammonia Injection System
