Baker Station
Historic Context
Tuolumne County, California
Stanislaus National Forest

Historic Context
for
Baker Station

by
Pamela A. Conners, Historian
Stanislaus National Forest
September 2003

Baker Station Historic District

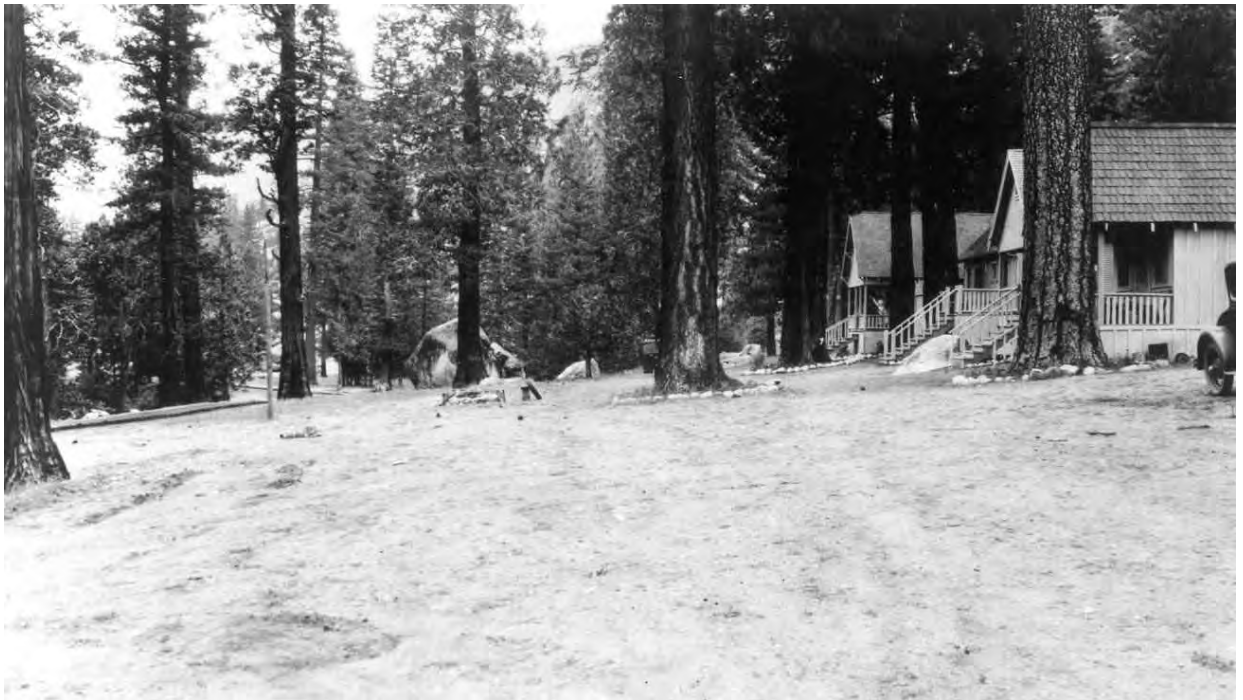
*Baker Highway Maintenance Station, 1931.
California State Archives Collection*

Baker Station, approximately toward the northwest, down the old Sonora-Mono Road; shows oblique view of dining hall flanked by residences, with Social Hall closest to photographer. Department of Public Works; Division of Highways, California Highway Commission Records, Inventory F3778: 1364B, Box 10 of 40 (Location VB462); California State Archives.

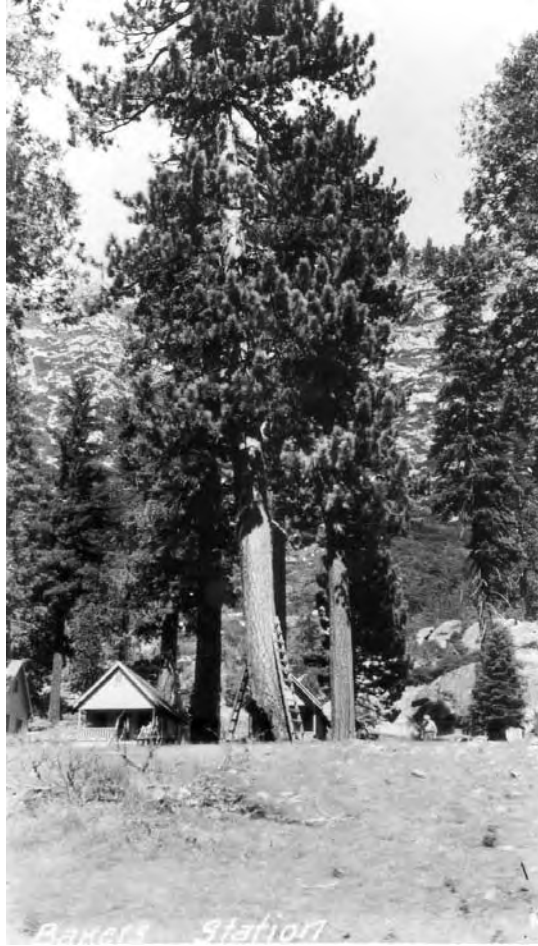
This undated photograph was probably taken in about 1930, when construction of the new highway maintenance station at Baker Station was well underway, but before construction of the new bunkhouse. Note that the view of the Social Hall is nearly entirely obstructed by the large pine tree and that the tree (with the ladders against it) is deeply fire-scarred at the base.

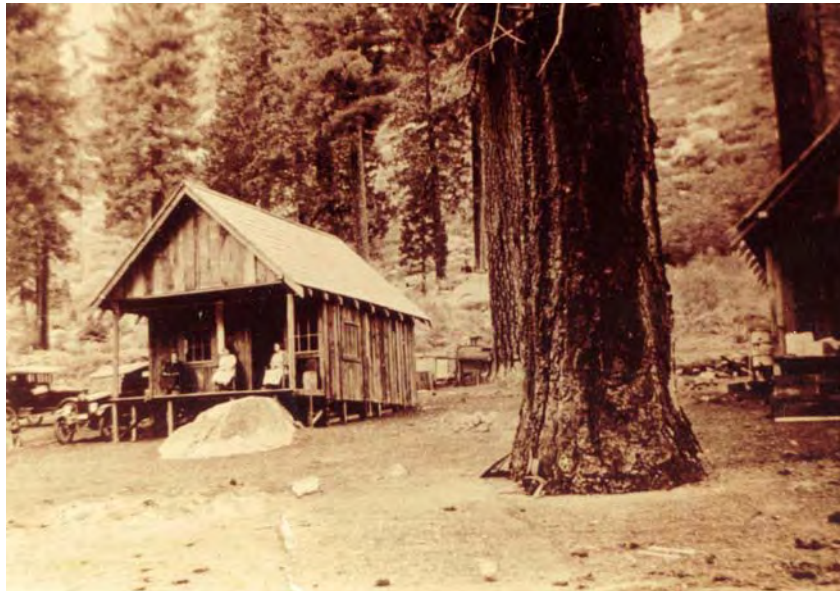
This photograph, reportedly taken in about 1920, shows the vertical board and batten siding, the ample, open front porch, the steeply-pitched front gabled roof, and the multi-light wooden windows that characterize the buildings constructed in the residential area for the Baker Highway Maintenance Station, completed in about 1931 or '32. Typically, the cottages for state highway maintenance stations were roofed with composition asphalt shingles; the roofs at Baker were wood shingles.

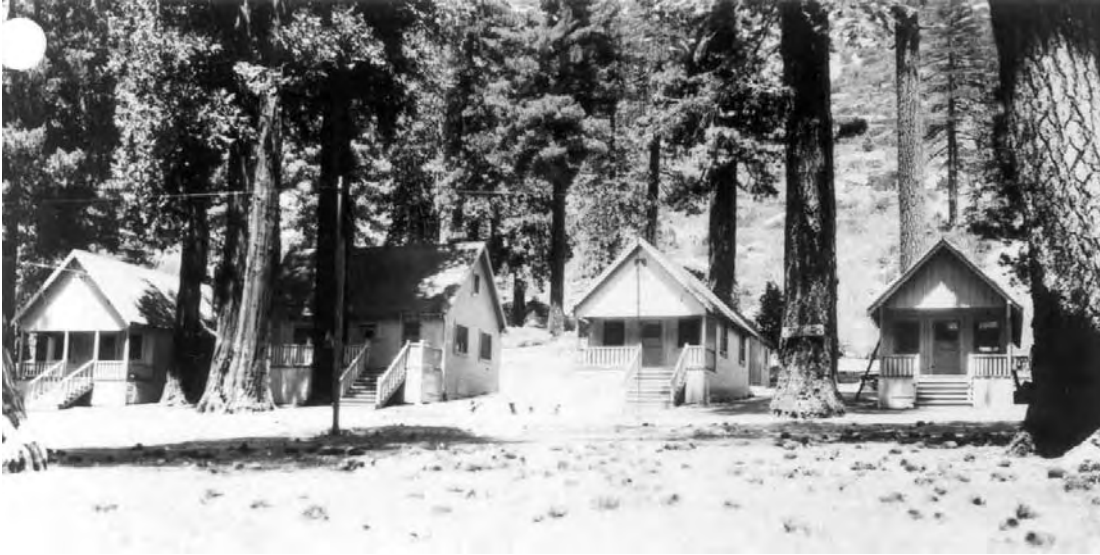
*This photograph of Baker Station, probably taken in about 1930 shows, from left to right, the foreman's cottage (cabin 3, building 1113); the dining hall (cookhouse, building 1112); the worker cabin (cabin 1, building 1222); and the social hall (clubhouse, building 2814). The women's bathhouse can be seen behind cabin 1. Note the sign on the tree between cabin 1 and the social hall, as well as the large, fire-scarred tree on the right side of the frame.
Courtesy of Caltrans History Library*

The buildings in the residential area at Baker Station are not colonial in design. Rather than the cross-gabled and side-gabled buildings described as the standard plans, most of those at Baker are single, front-gabled; the superintendent's cottage and the dining hall are single, side-gabled buildings. Rather than having the typical enclosed rear porches and roofed front entry porches supported by square columns, at Baker the main buildings in the residential area—the superintendent's cottage, the foreman's cottage, the dining hall, the worker's cottage, the social hall, and the bunkhouse—all have prominent, full, front porches, facing the highway. The close proximity of the buildings at Baker Station also departs from the prescribed plan. The manual instructed that buildings be at least 25 feet apart for fire protection... at Baker, the buildings from the foreman's cottage to the bunkhouse range from only about eight to 20 feet apart (CA 1938: 316). Finally, a distinctive feature of the typical maintenance station is a perimeter fence topped with three strands of barbed wire, primarily used to define the station limits and to provide security for equipment and tools: Baker Station is not fenced. Moreover, each element of Baker Station's residential area has a prominent front porch and is oriented with its front façade and entrance facing the highway.

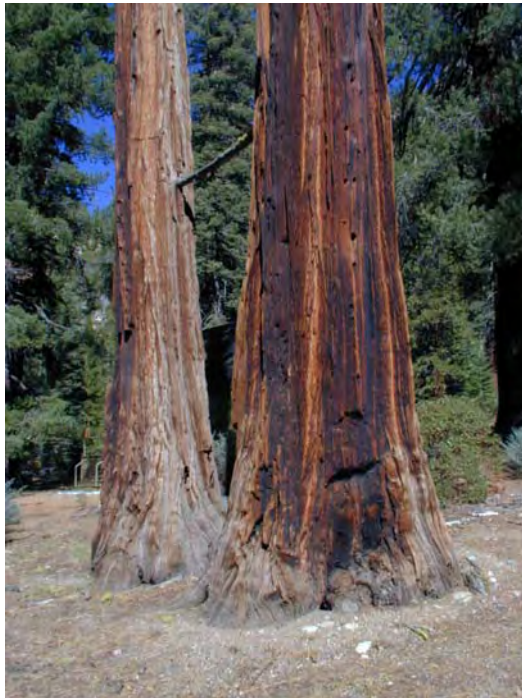
Molly’s swing, as it appeared in 2002. Braced between two, large incense cedars, the wooden bar and hand-wrought, iron hardware reportedly dates to the Baker Toll Station era, in the 1880s; Molly was reputedly Greenbury C. Baker’s daughter. Molly’s swing is in front of the foreman’s cottage and dining hall, between the alignment of the old Sonora-Mono Road and the current alignment of Highway 108.

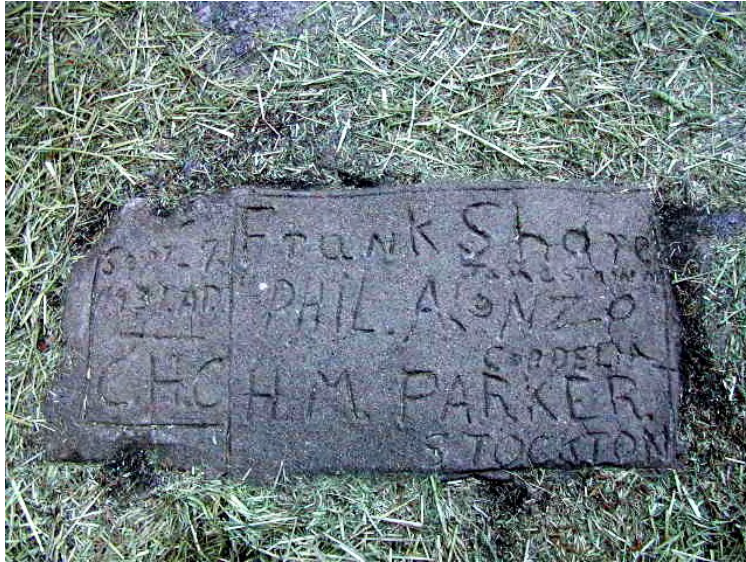
California Highway Commission marker, embedded on the ground near the truck shed, Baker Station. Although 1931 is shown on this marker, 1932 is scribed in the cement foundation of the generator house.

A cement slab, probably commemorating completion of the Baker Highway Maintenance Station, is located near the truck shed. Dated "Sept. 7, 1931 A.D.," it is identified as a

“C.H.C” project; the following names are also hand-scribed into the cement: Frank Shore, Jamestown; Phil Alonzo, Cordelia; and H. M. Parker, Stockton.

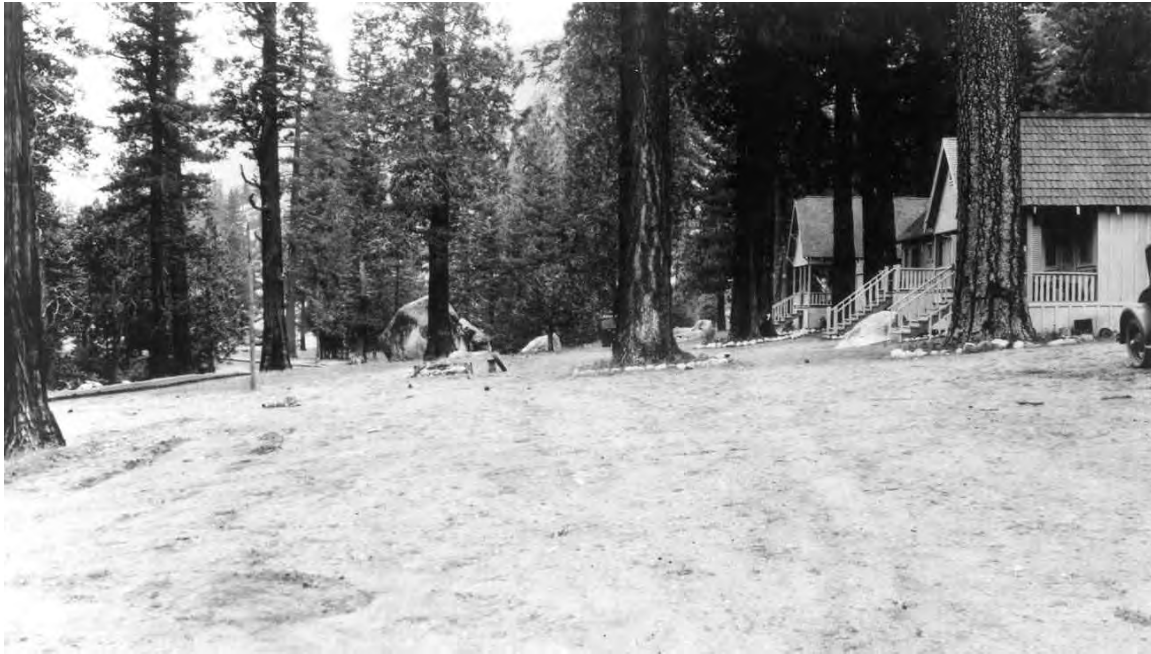
This photograph of Baker Station is labeled "1931"; it is unknown if this represents the date the photograph was taken or the date that the maintenance station was essentially completed. The landscaping, although minimal, would suggest a slightly later date.
