JOURNAL

OF ACCIDENT INVESTIGATION

A biannual publication to promote transportation safety through science

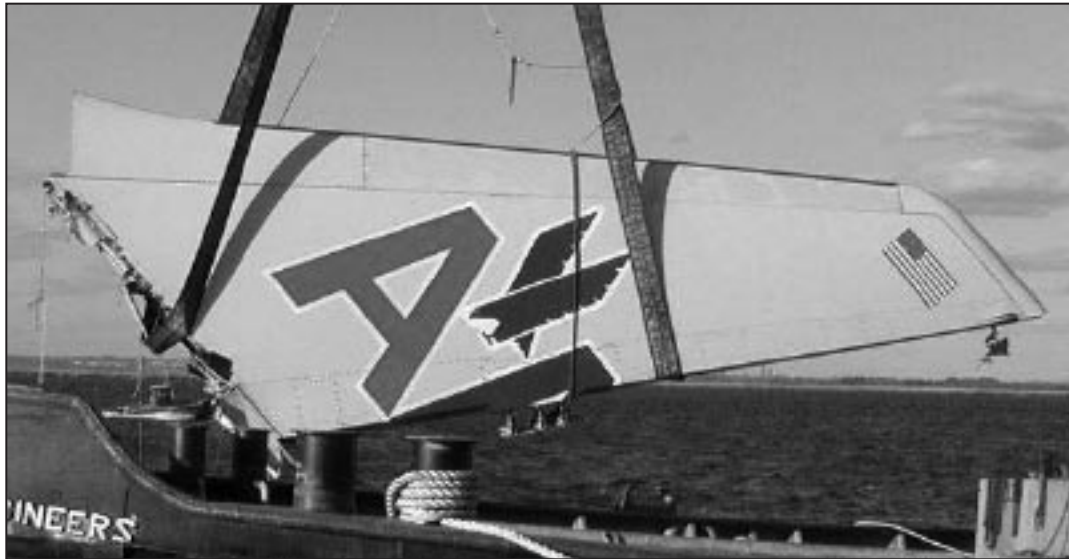
Figure 4. Vertical stabilizer as recovered from Jamaica Bay.

During the visual examination, investigators found that the vertical stabilizer was largely intact with no significant areas of skin buckling. An overall view of the vertical stabilizer as it was being recovered from the water of Jamaica Bay is shown in figure 4. At the lower end, each of the six attachment locations had separated from the fuselage either by fractures that intersected the lug attachment hole or by fractures through the structure above the hole. A schematic of the lower end of the vertical stabilizer is shown in figure 5, which shows a general fracture location for each lug, pointing to overall views of each lug fracture. Portions of rib 1, the rib 1 rib-to-skin attach angle, and the lower end of the forward spar also were fractured. In addition, the trailing edge panels were damaged in several locations.⁸

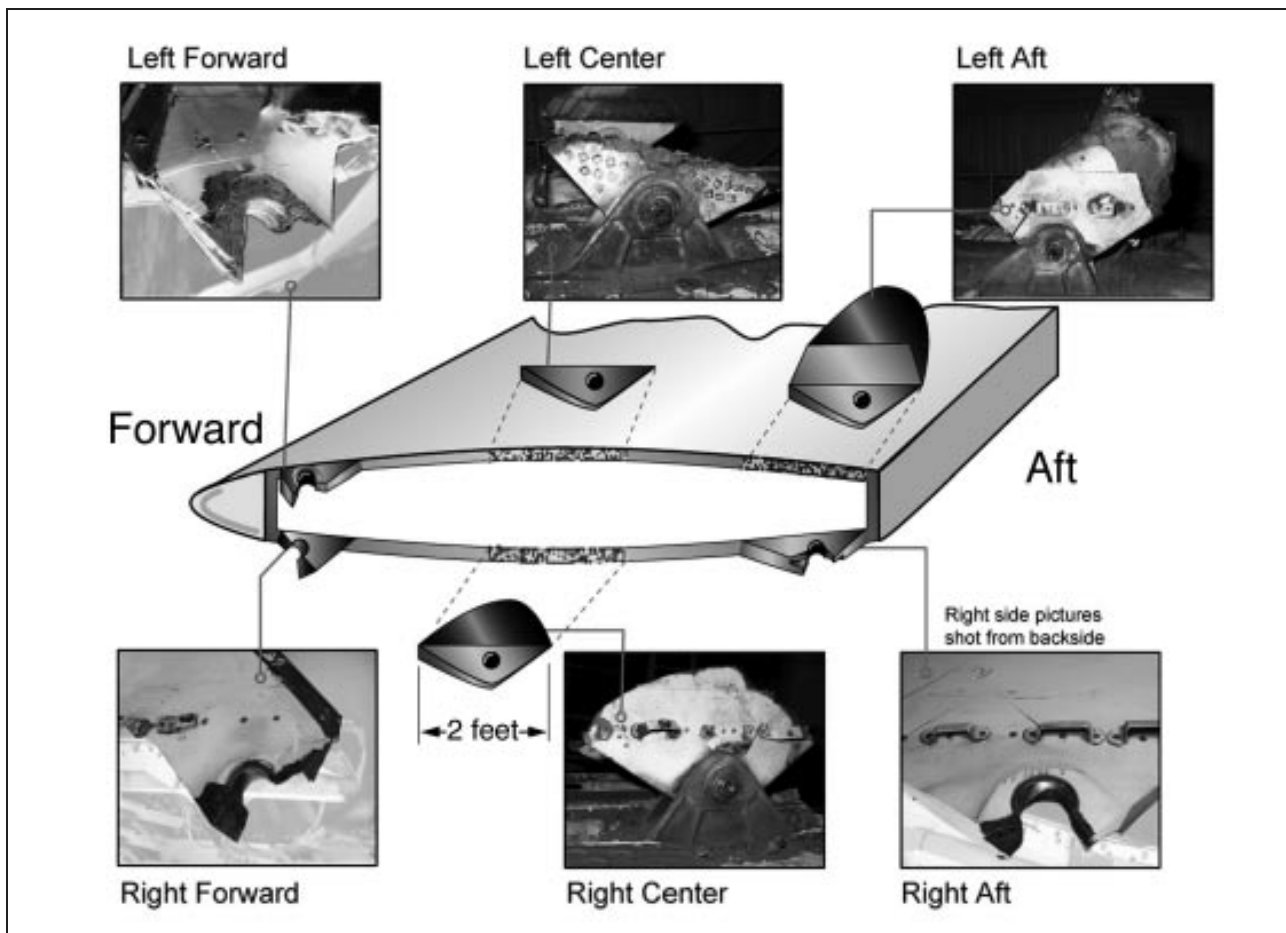
Figure 5. Overall views of main lug fractures with relative locations on vertical stabilizer.

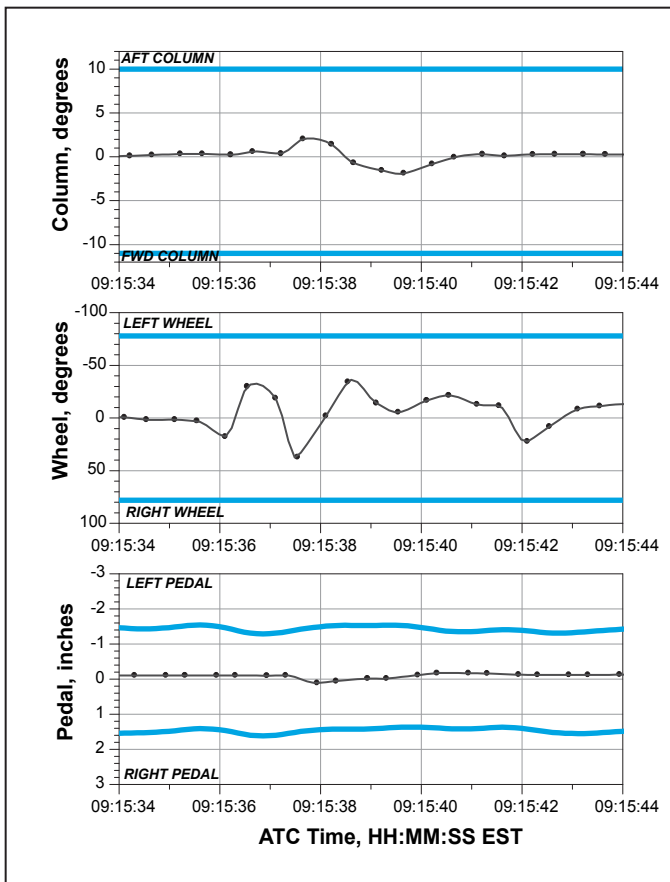
Figure 1. Control input during first wake encounter.

Figure 1, illustrating the first officer's control inputs during the first wake turbulence encounter, shows that the column and wheel limits remained constant, but the pedal limit varied in accordance with the rudder control system's design. The figure also shows that the first officer responded to the first wake turbulence encounter with column and a series of large wheel inputs, but did not use the rudder pedals.

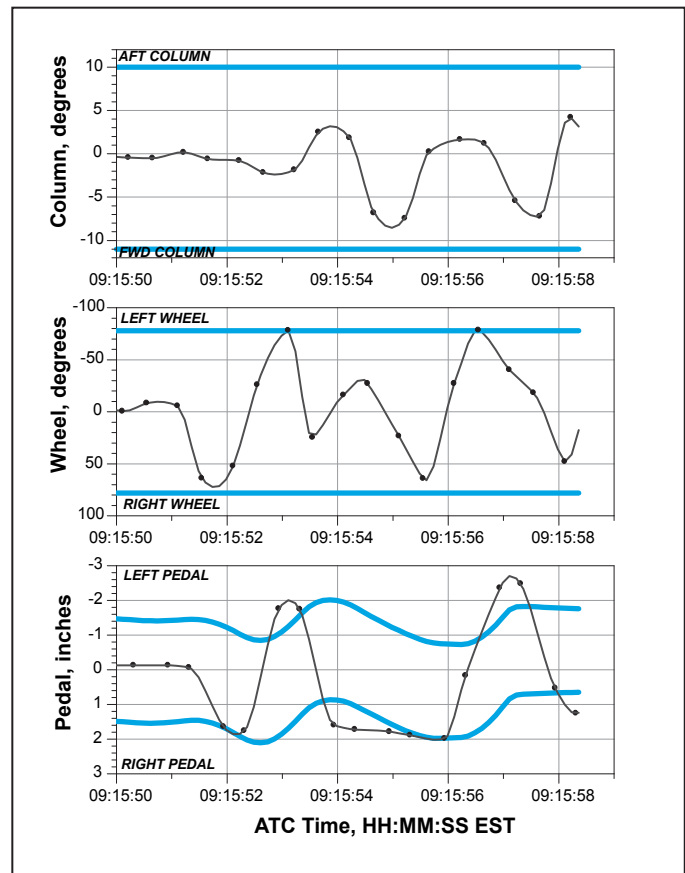
Figure 2. Control input during second wake encounter.

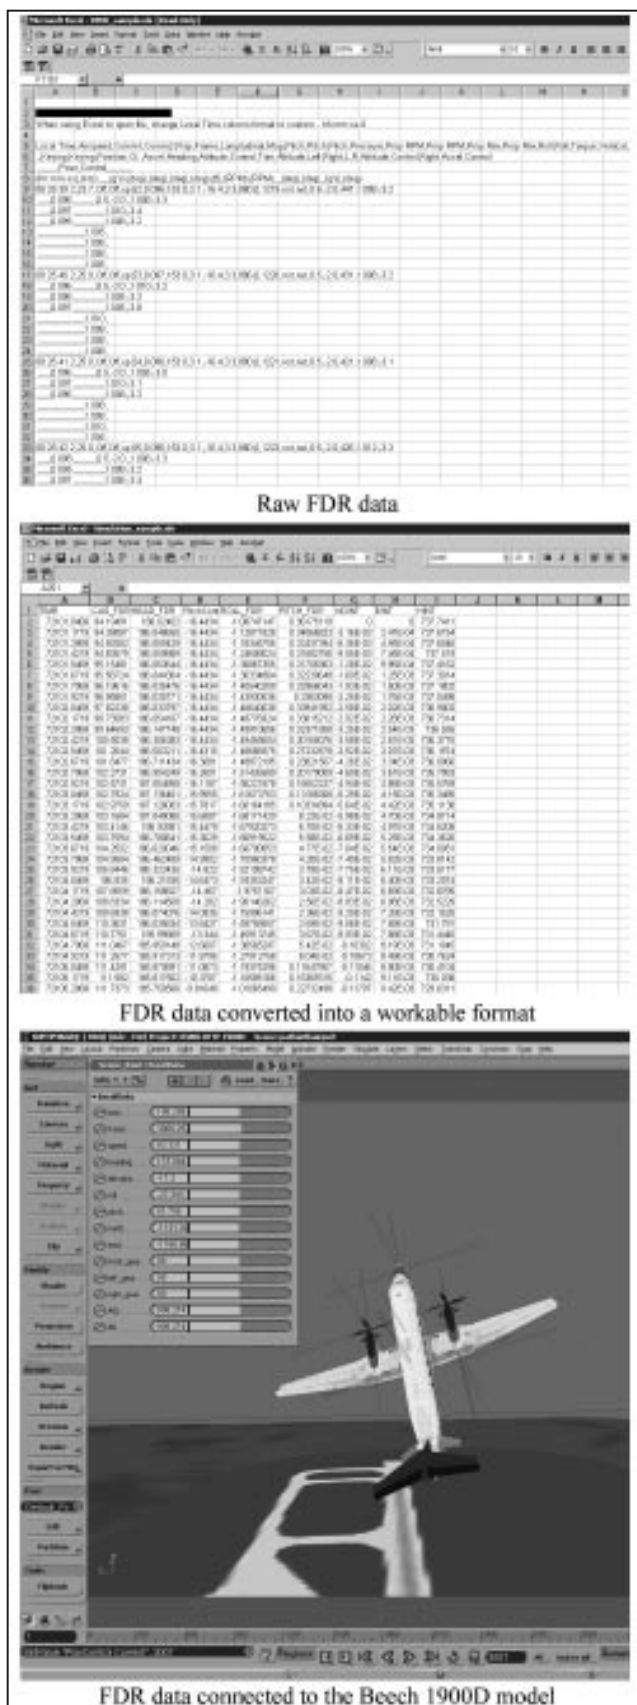
Figure 5. FDR data converted and inserted into the animation. (still images from the animation).

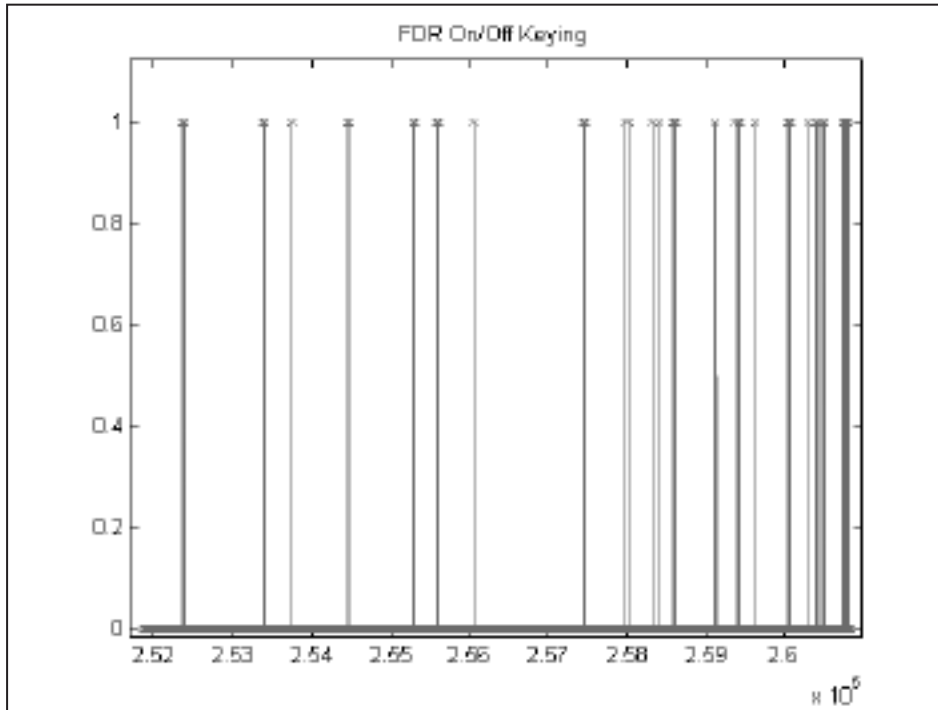
Figure 4. FDR *on-key/off-key* data, $FDR(n)$, where “ n ” represents the subframe reference number (SRN) corresponding to the number of seconds since the FDR first began recording. A “1” indicates that the microphone was found keyed-on at the sample time.

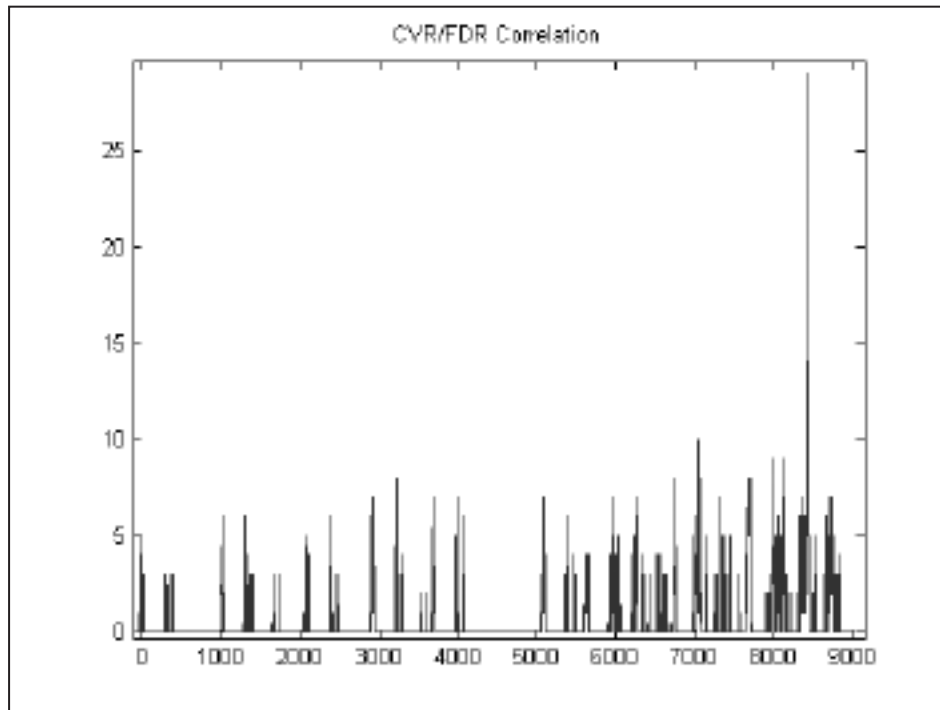
Figure 6. Results of the cross-correlation between FDR(n) and CVR(n) showing a well-defined peak at $n = 1763$ lags.

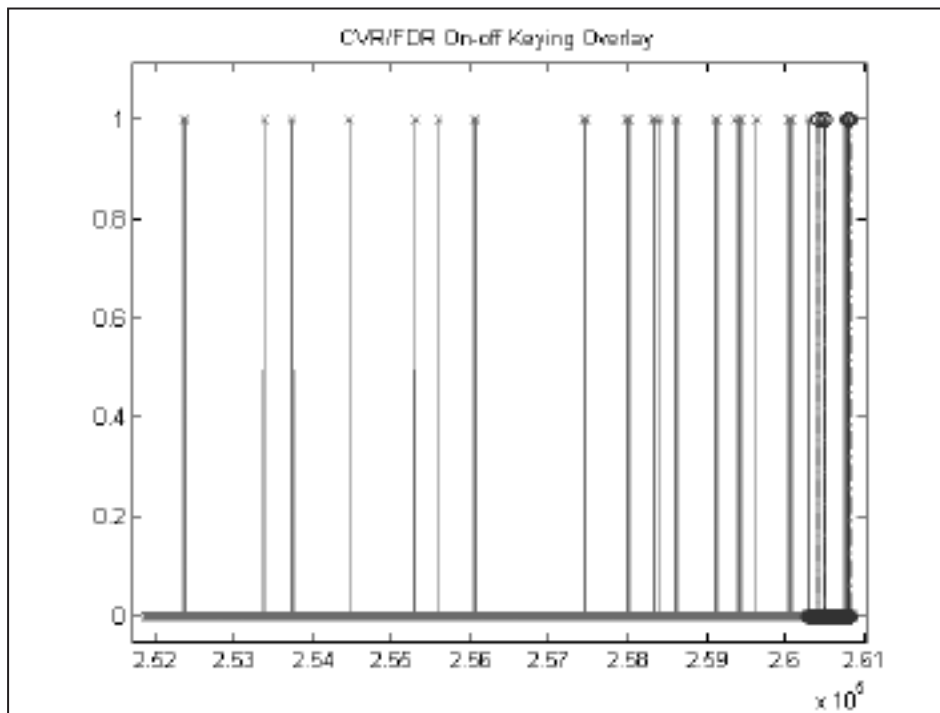
Figure 7. Overlay of FDR(n) [designated by x's] with CVR(n) [designated by o's] showing the alignment of identical events once the offset found via the cross-correlation was applied.

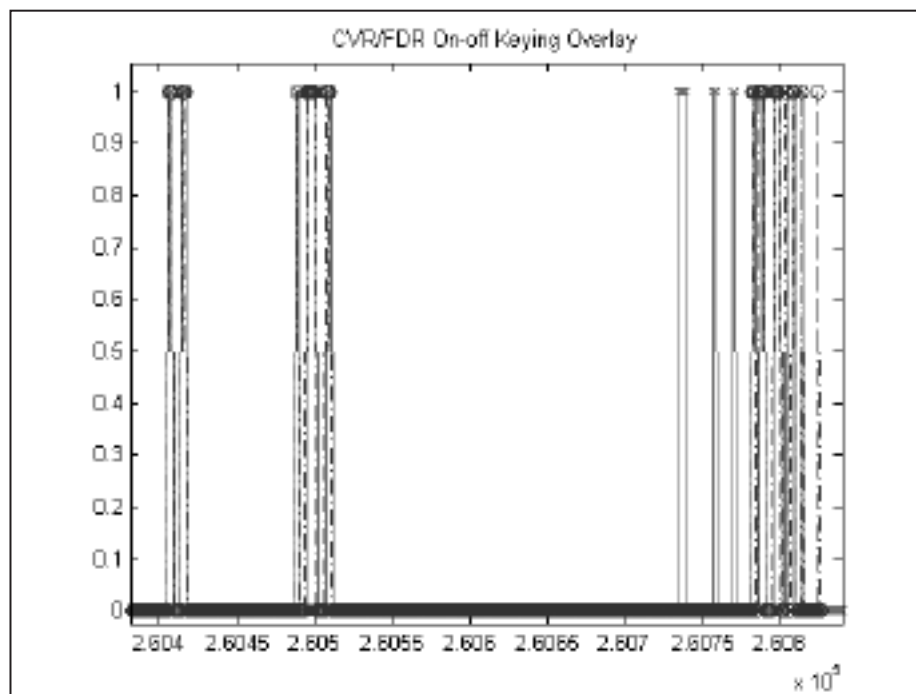
Figure 8. Overlay of FDR(n) [designated by x's] with CVR(n) [designated by o's] with the x-axis expanded to show the goodness of fit between the two data sets.

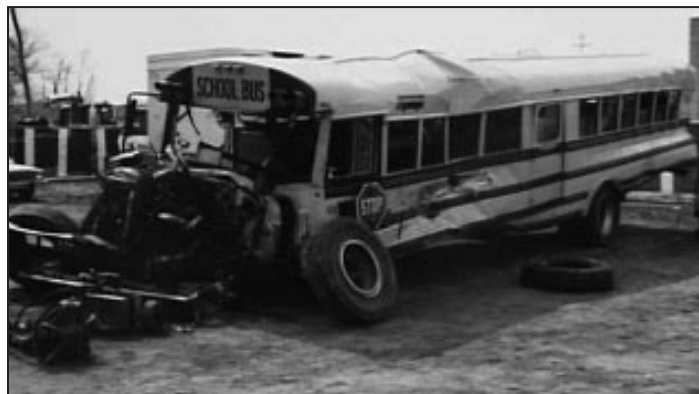
Figure 1. Damage to the bus in the Monticello, Minnesota, crash.

school bus. At impact, the front of the school bus hit the right front side of the truck tractor at the tractor's right front wheel with about 43 inches of overlap. A second impact occurred when the right truck tandems and the right front corner of the semitrailer struck the left side of the bus body, about 9 feet behind the forward edge of the bus body. A third impact occurred when the rear of the school bus rotated clockwise into the right side of the semitrailer. See figure 1.

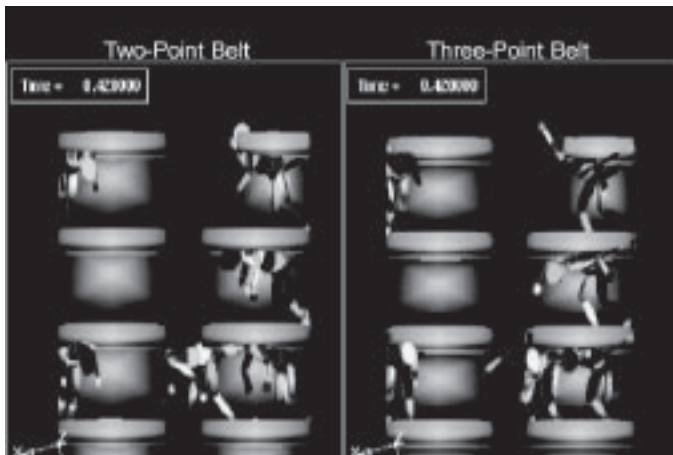
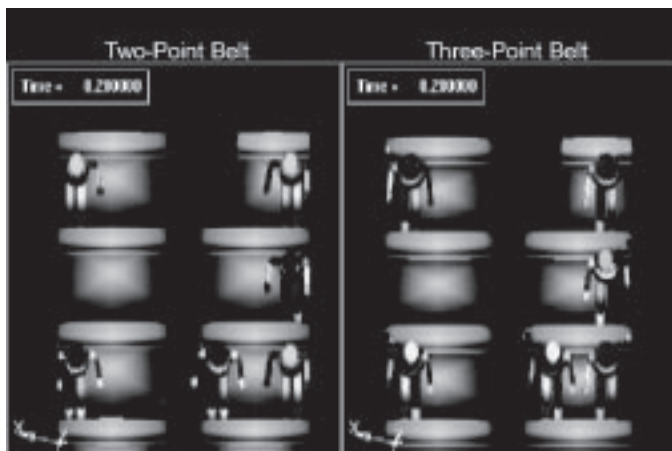
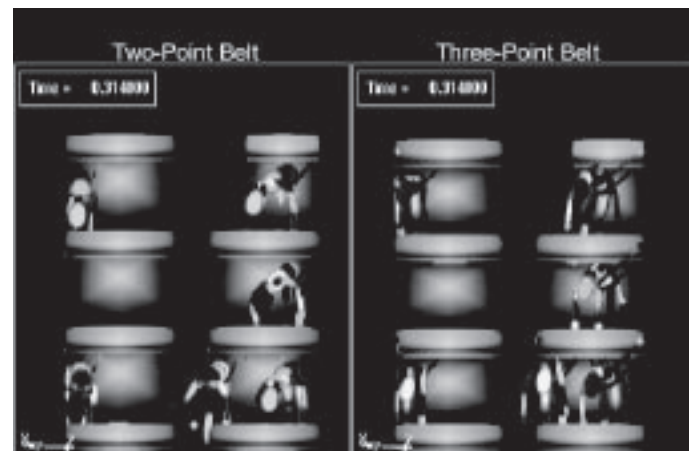
Figure 3. Time lines for occupant motion in the lap (left side) and lap/shoulder-belted (right side) conditions (simulated).

Figure 3 illustrates the occupant kinematics simulated for lap-belted and lap/shoulder-belted occupants. (The figure does not show the actual or compartmentalized condition.)

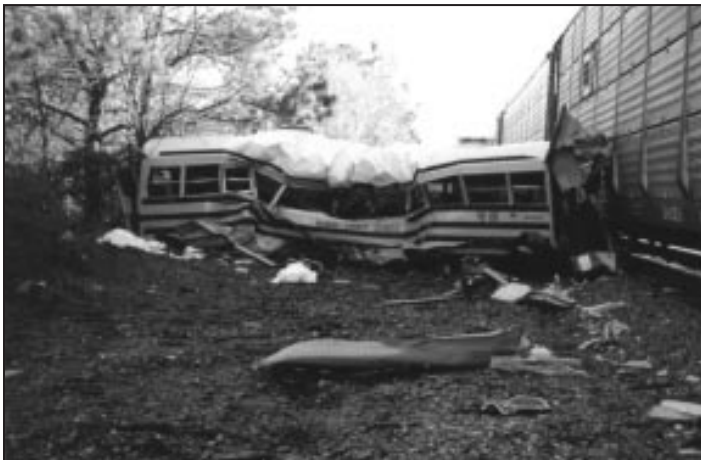
Figure 4. The bus body came to rest against the side of the train (Conasauga, Tennessee).

On March 28, 2000, a southbound CSX Transportation, Inc., 33-car freight train, en route to Atlanta, Georgia, collided with the passenger side of a westbound Murray County, Georgia, school bus at a railroad/highway grade crossing near Conasauga, Tennessee. The school bus was on its morning route to pick up children and had entered Liberty Church Road from U.S. Route 411. On board were seven children and the driver. As the school bus traversed the passive grade crossing, it was struck by the train. Figure 4 shows the final resting position of the bus body.

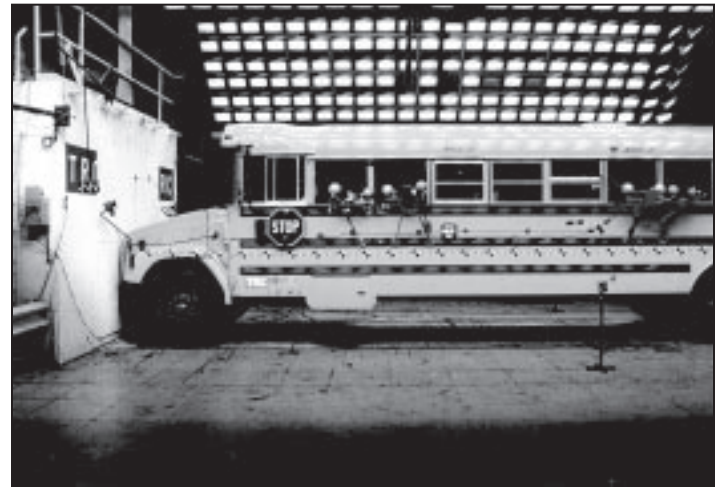
Figure 8. The school bus in the frontal impact scenario before the impact.

Figures 8 and 9 show the frontally impacted bus before and after the impact. As is typical of large school buses, the body of the bus was mounted to the frame rails of the chassis by a series of clips or clamps. This non-rigid mounting feature allowed the bus body to slide forward approximately 36 inches during impact (see figure 10). This dissipation of impact energy over a longer time reduced the acceleration levels experienced by the vehicle's occupants.

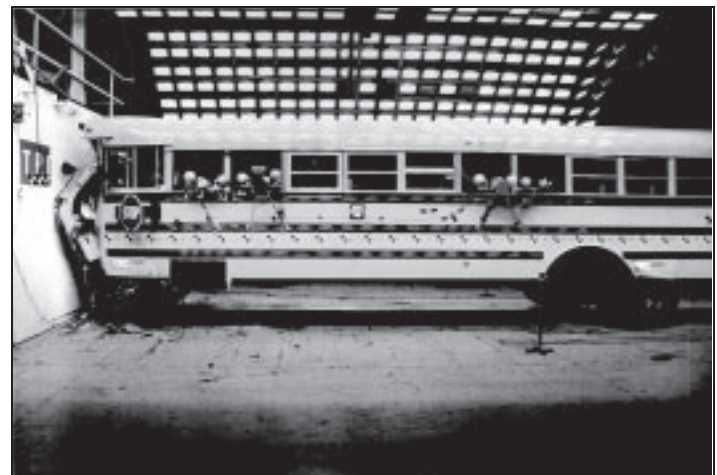
Figure 9. The school bus in the frontal impact scenario after the impact.

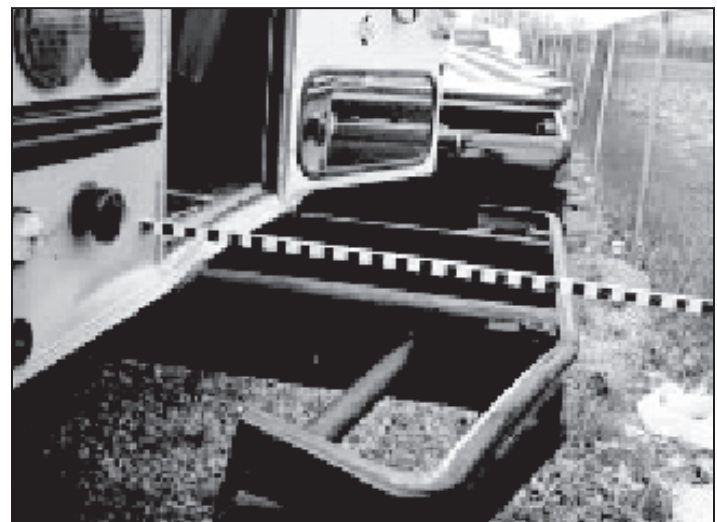
Figure 10. Displacement of the bus body on the chassis during frontal impact.

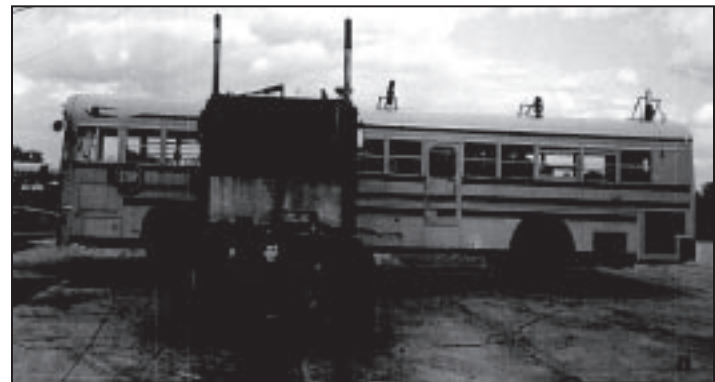
Figure 12. The heavy truck relative to the side of the school bus before impact.

12 and 13.) During impact, the truck penetrated the bus side approximately halfway into the compartment and remained engaged while rotating 180 degrees before coming to a stop. The front axles were severed from both vehicles (figure 13).

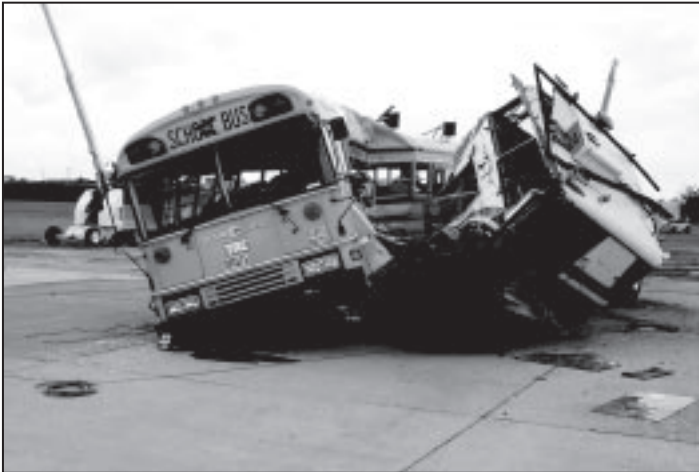
Figure 13. The heavy truck relative to the side of the school bus after impact.

Accelerometers placed along the length of the school bus recorded a peak lateral acceleration of 72 g at the center of impact. Acceleration levels dropped significantly with distance from the point of impact, largely because the deformation that occurred at the point of impact absorbed and dissipated much of the energy that would otherwise have been transmitted to the occupants of the bus. Unlike the frontal crash, no single pulse fully represented the range of vehicle responses observed in the side-impact crash. However, the overall pulse shape and pulse duration were similar for most of the measured locations along the length of the bus.

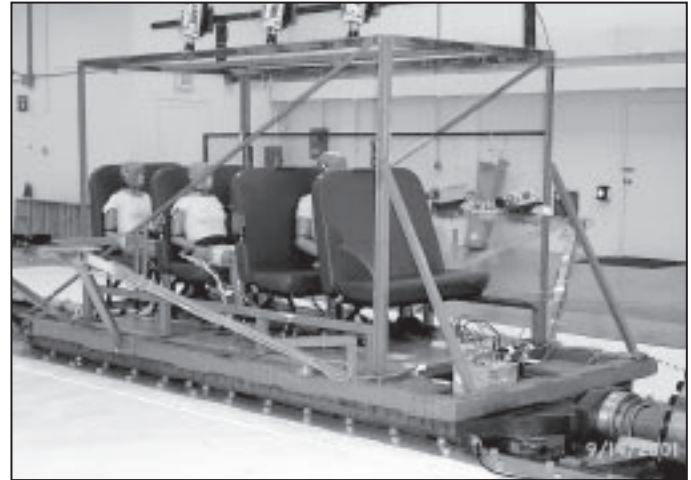
Figure 16. A photograph of the modified sled buck used in the second test series.
