NTSB National Transportation Safety Board

Office of Highway Safety

Construction Activity & Traffic Conditions on I-35W Bridge

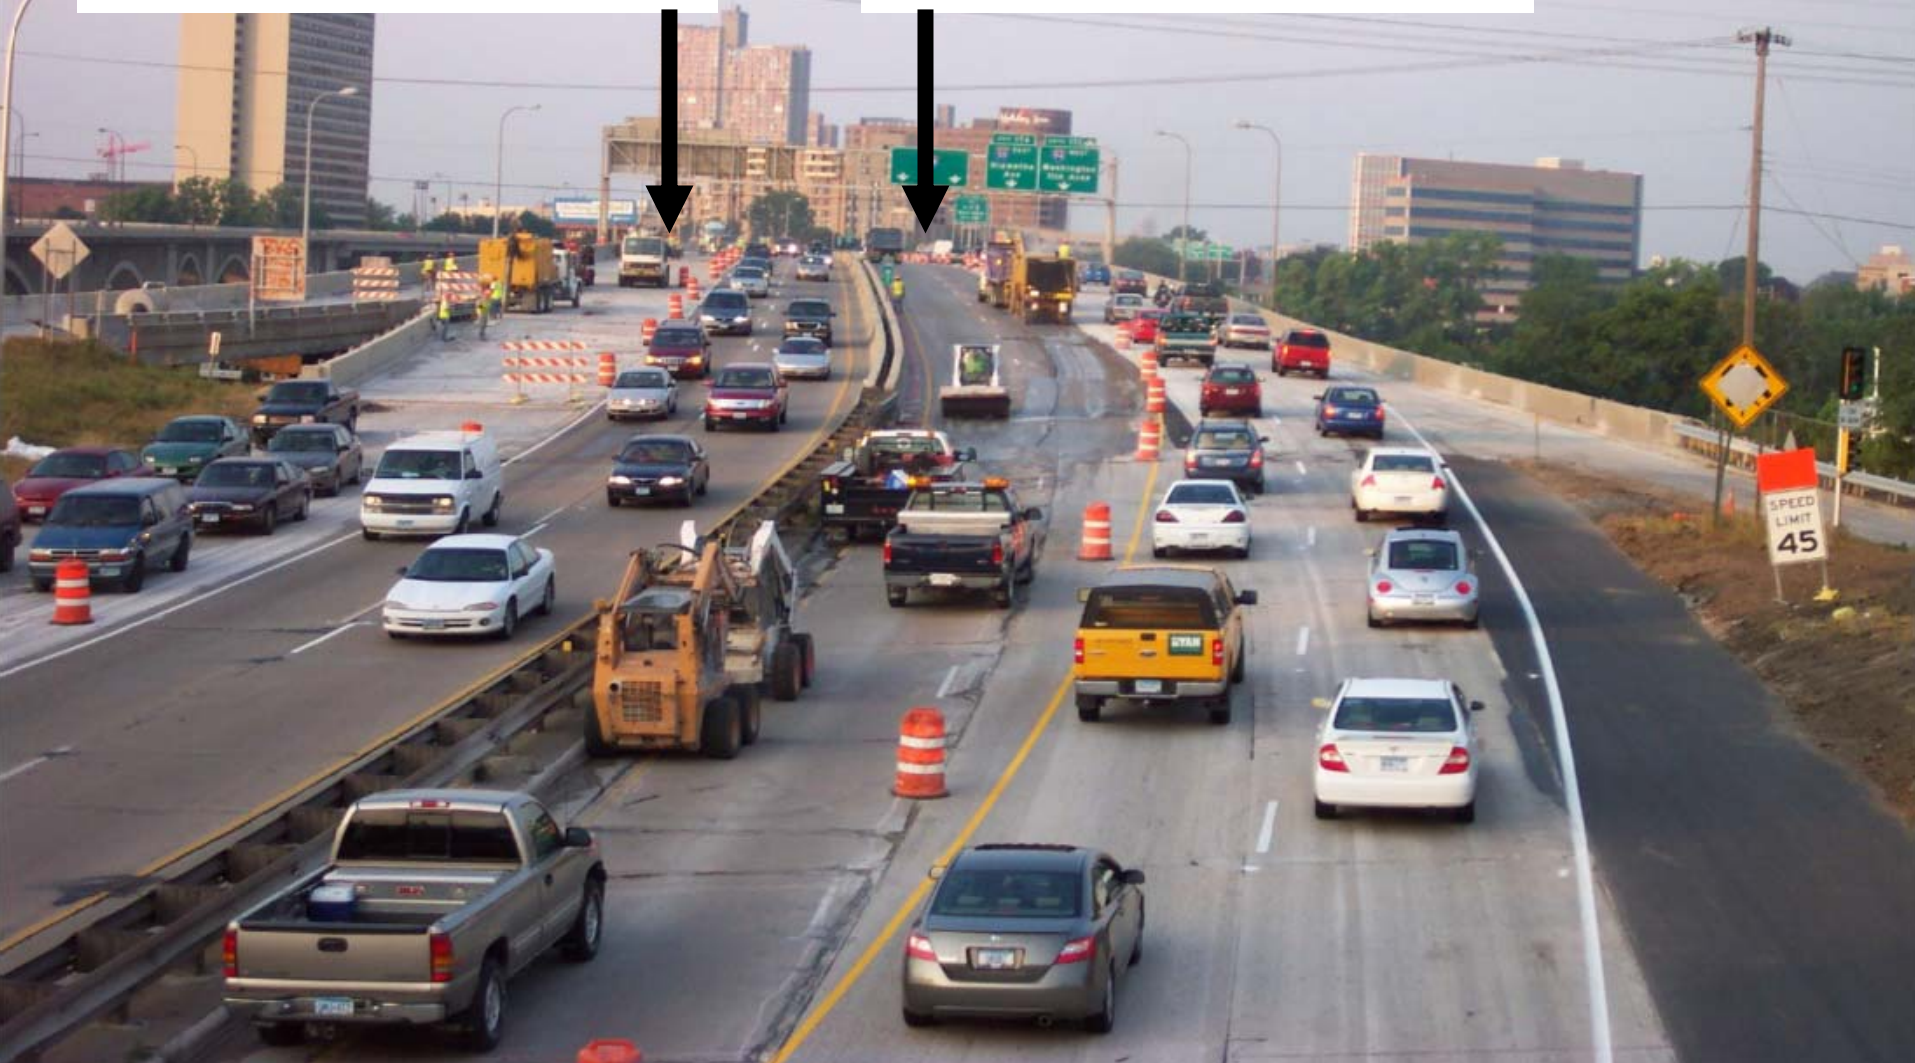
Roadway Construction Work

2 closed outside
northbound traffic lanes

2 closed inside
southbound traffic lanes

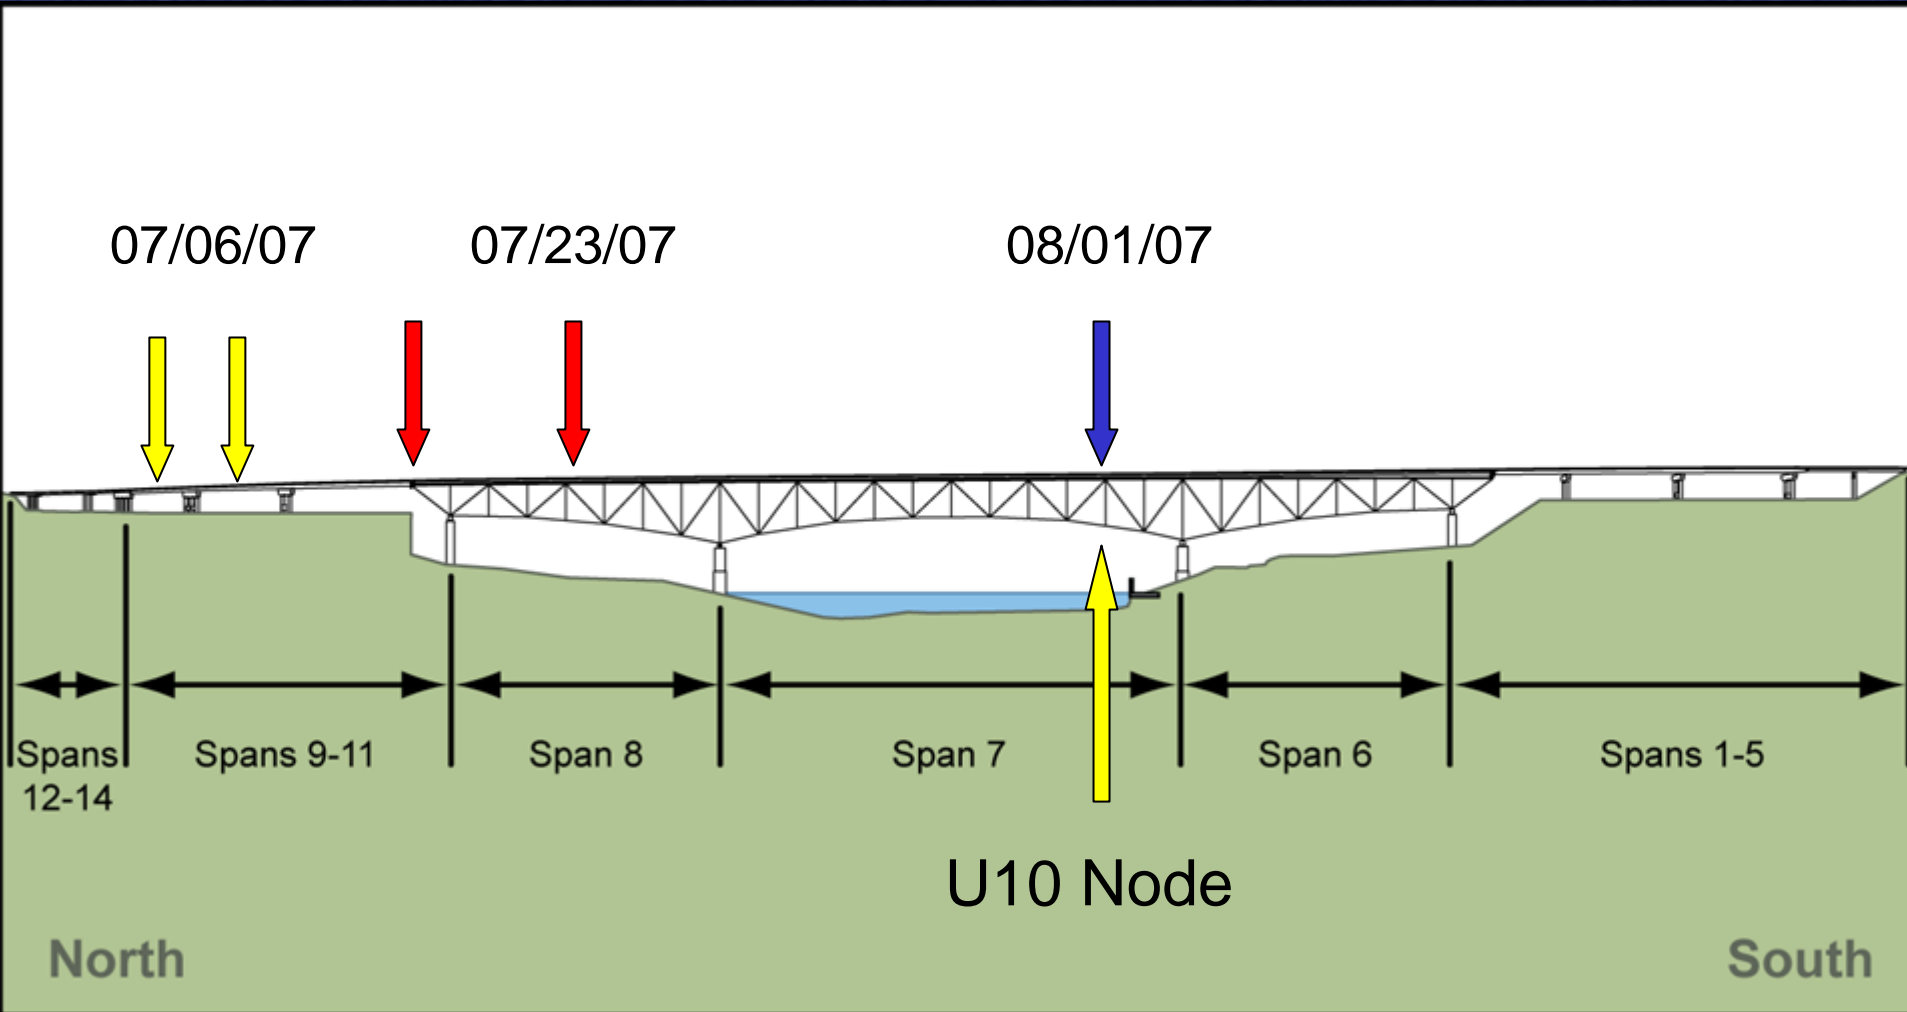
Staging of Construction Material

- Mn/Dot project requirements
 - Low slump concrete: dense concrete mix, low water/cement ratio, sets up quickly, higher strength
 - Mix concrete close to pour site
 - Lane closure restrictions
 - Materials mixed near worksite (sand, gravel, cement, and water)
- Materials and machinery staged on two inside southbound lanes

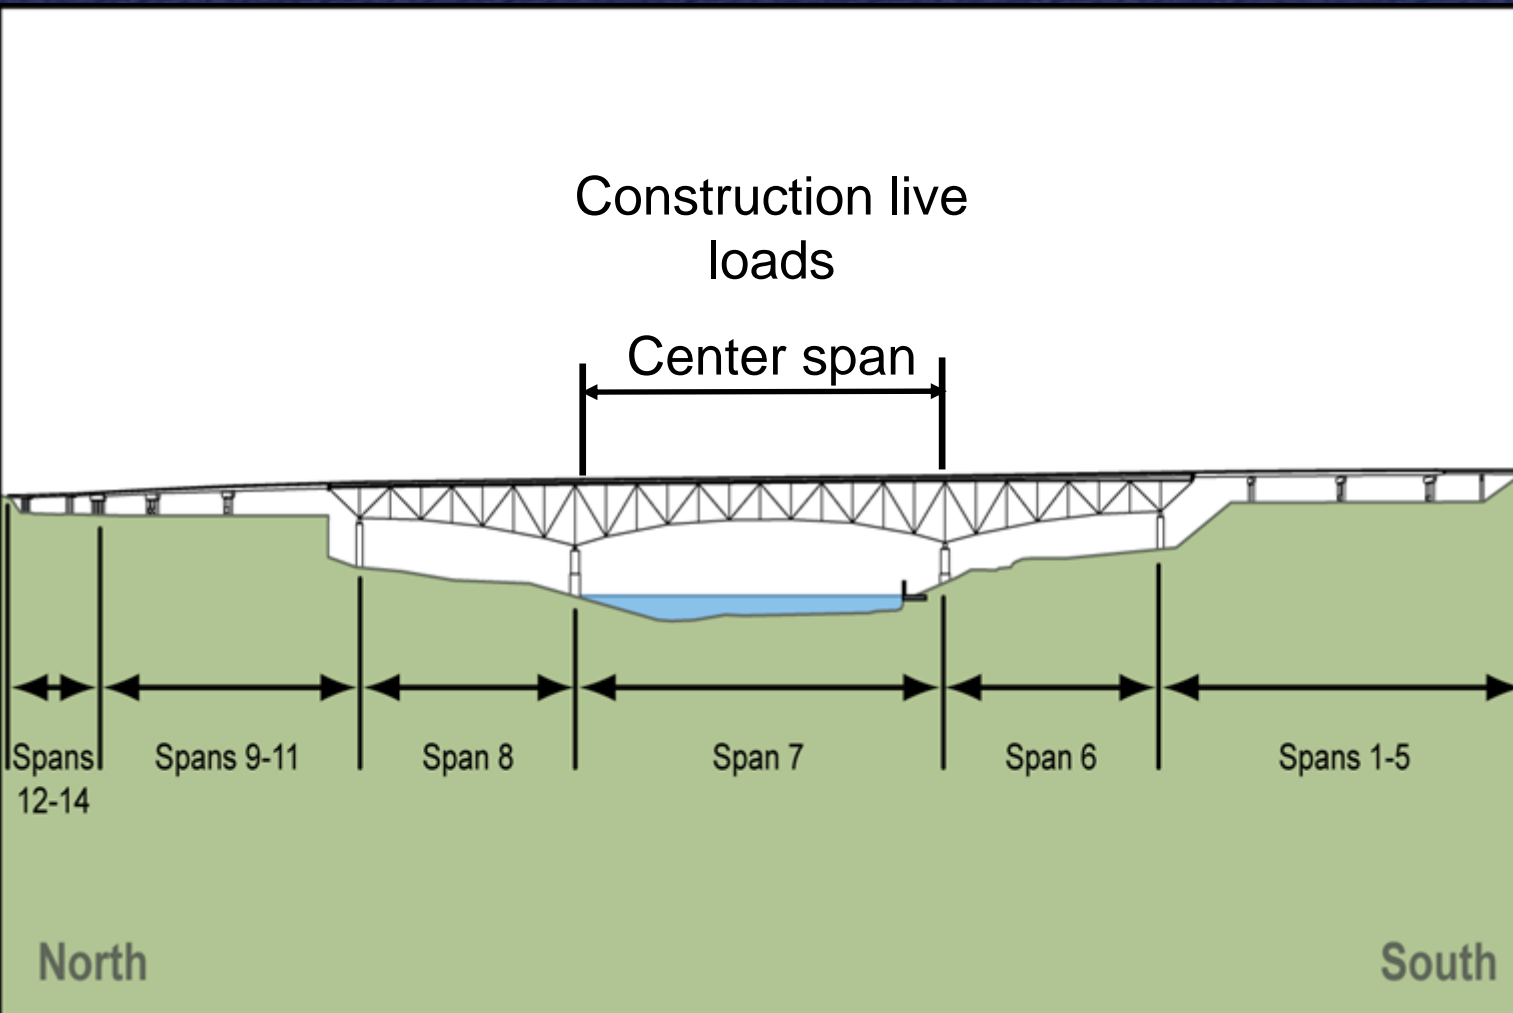
Construction Live Loads – Center Span

Construction live loads
578,700 lbs

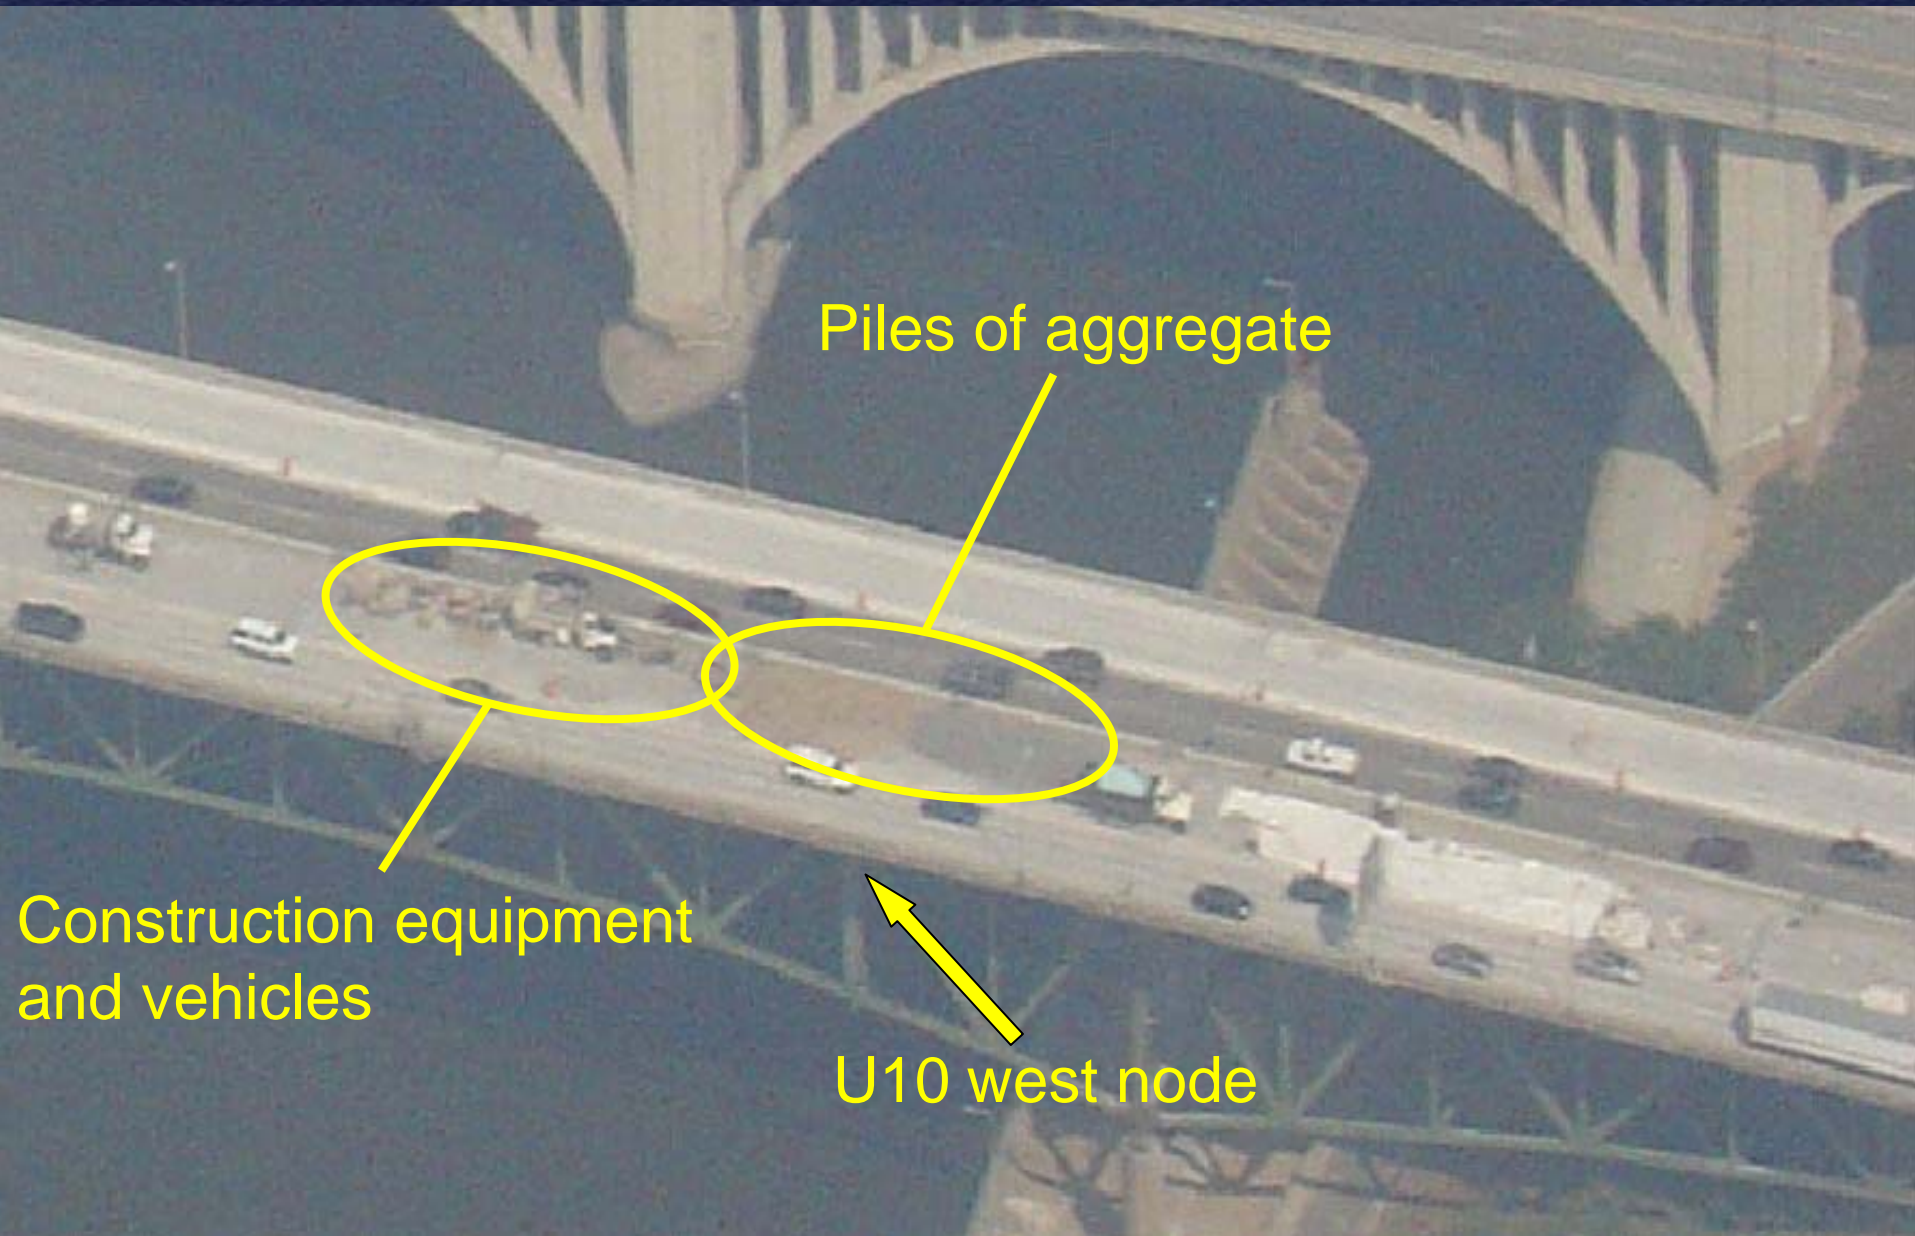
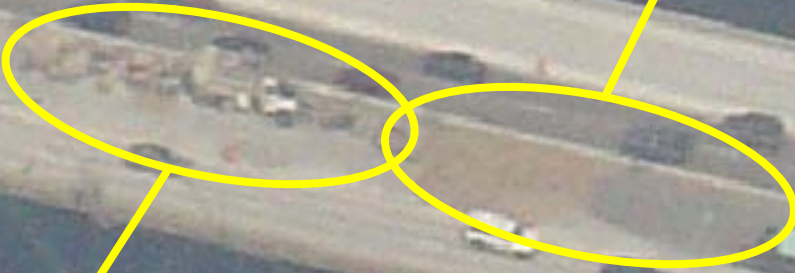
Construction Work – Day of Accident

Piles of aggregate

Construction equipment and vehicles

U10 west node

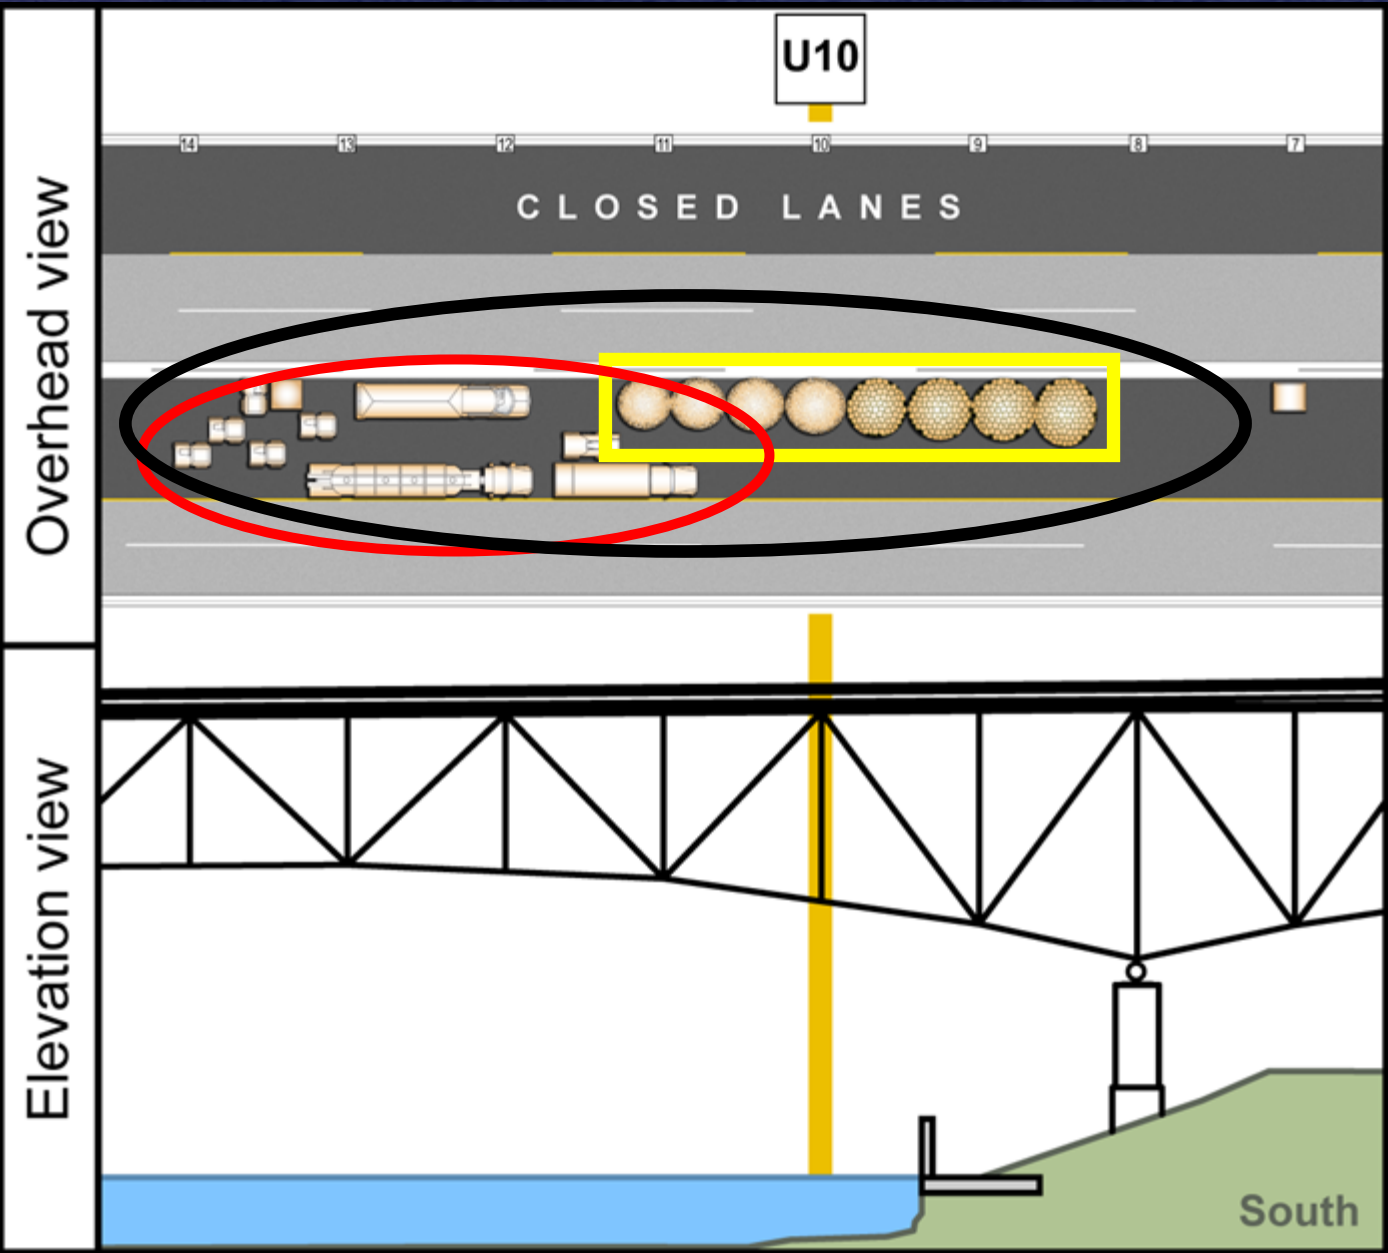
Construction Materials & Vehicles

Construction materials
383,000 lbs

Construction equipment
195,500 lbs

Center span combined
Construction load
578,500 lbs
