**NATIONAL TRANSPORTATION SAFETY BOARD  
OFFICE OF AVIATION SAFETY  
WASHINGTON, D.C. 20594**

**SYSTEMS GROUP CHAIRMAN'S  
FACTUAL REPORT OF INVESTIGATION**

DCA02MA001

Operator: American Airlines  
Aircraft: A300-600R  
Location: Belle Harbor, New York  
Date: November 12, 2001  
Time: 09:16 EDT

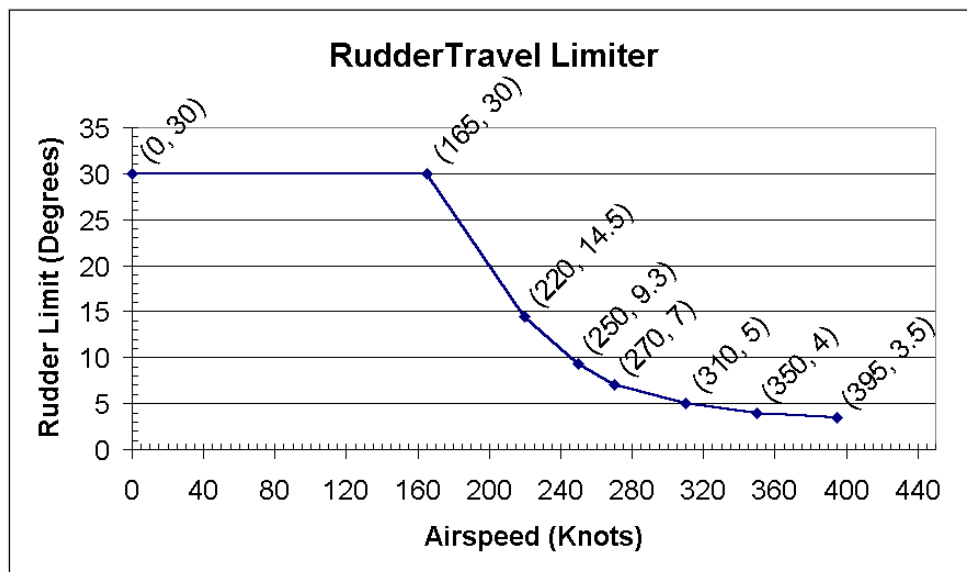
Figure 3. Rudder Travel Limiter

The VSA consists of a screwjack driven by two AC motors. There is a rigid connection between the two motors which drive the screw through a reduction gear and torque limiter. The RTLS is designed to limit the rudder as a function of airspeed as shown in Figure 3.

Each VSA motor is associated with one FLC. FLC 1 is normally the active computer, with FLC 2 in standby. Each FLC receives computed airspeed ( $V_c$ ) data from both air data systems (ADS 1 and ADS 2), and uses the higher of the

The RTLS provides the primary stop for the rudder control system, with a correctly rigged airplane, in flight, under normal circumstances. There are other stops in the system which may limit motion of the components under unusual circumstances such as high pedal loads, a system anomaly, or airspeeds below 165 knots. These stops are as follows:

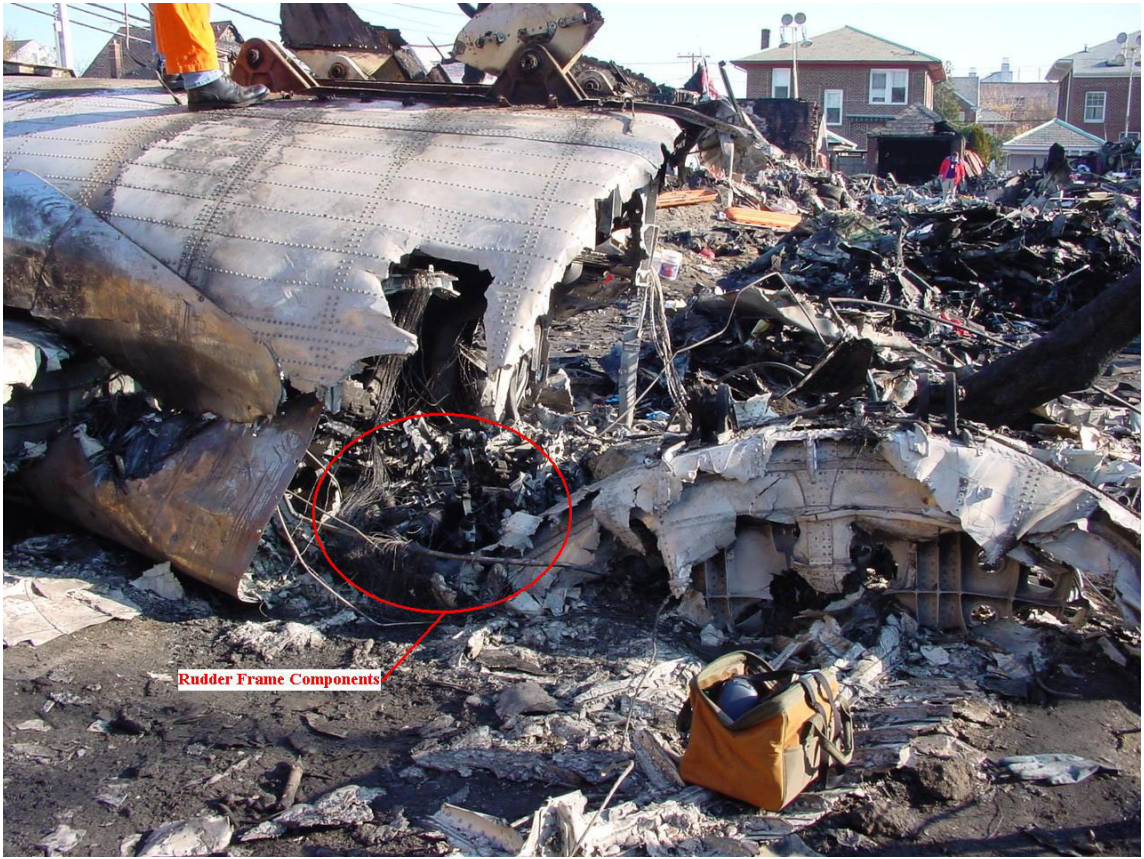
Figure 4. Empennage and Rudder Control Components

At the accident site there were no rudder control components identified forward of the rudder frame installation. The rudder frame installation was found detached from the empennage structure and in a pile at the bottom of the remaining empennage (Figures 4 and 5). Most of the control linkage in the rudder frame was fractured and melted. The AFTU, rudder trim actuator, yaw damper actuator, autopilot yaw actuator, and variable stop actuator were identified in the pile and shipped to the NTSB for possible further investigation. All of the components suffered considerable heat damage.

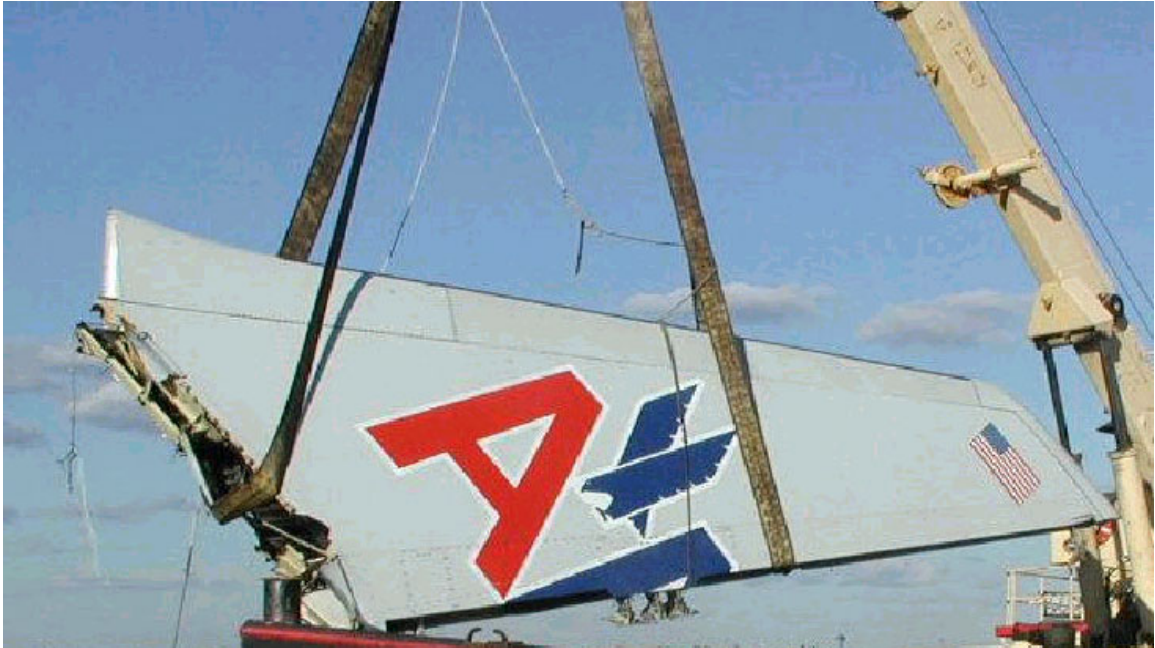
Figure 6. Recovery of Vertical Stabilizer

The vertical stabilizer and rudder were recovered from Jamaica Bay and moved to a hangar (Figure 6). The three rudder servo controls were still attached to the vertical stabilizer and all of the control linkage was intact to the base of the vertical stabilizer (Figure 7 and 8). The lowest control rods, which are normally connected to the output lever of the rudder frame, had the last or lowest approximately six inches missing. The rudder was found detached from the vertical stabilizer. The fittings which attach the servo controls to the rudder and small pieces of rudder structure were still attached to the servo controls. The vertical stabilizer, and the attached system components, were later shipped to NASA Langley for further investigation.
