## Water Operation and Maintenance Bulletin

No. 208

Labor-Saving Debris and Fish Screens

Interim Report – Evaluation and Remaining Service Life of  
Protective Coatings by Electrochemical Impedance Spectroscopy (EIS)

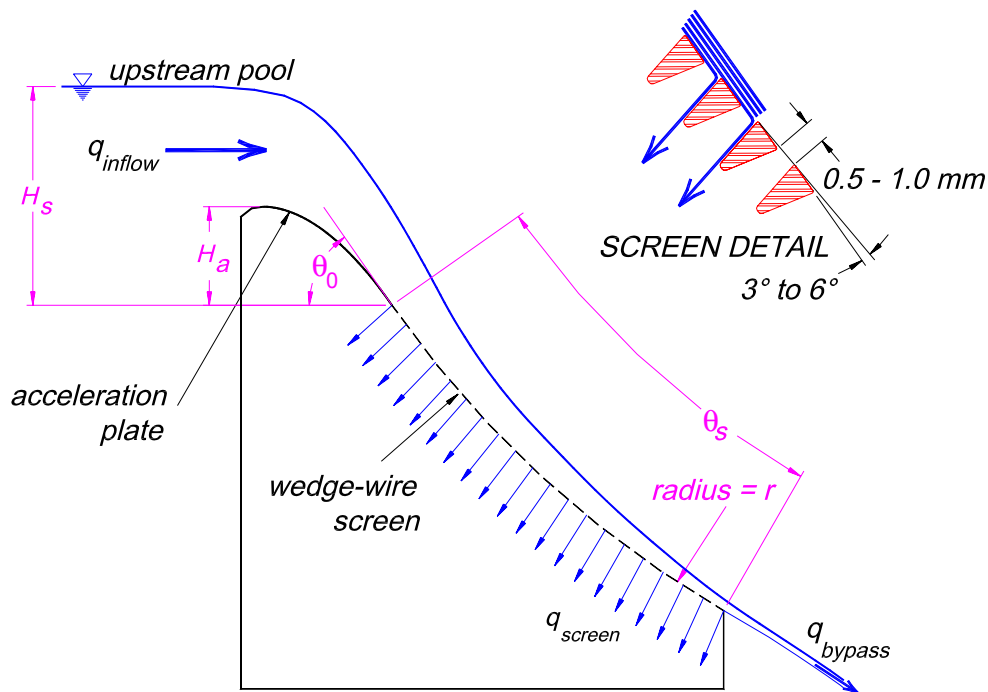
Figure 1.—Features, typical arrangement, and design parameters for Coanda-effect screens.

The primary features of a Coanda-effect screen are illustrated in figure 1. The screen is installed on the downstream face of an overflow weir. Flow passes over an acceleration plate and then across a wedge-wire screen panel. The wires in the panel are horizontal, perpendicular to the flow across the screen. The screen panel may be either flat or concave. Flow passing through the screen (screened flow) is collected in a conveyance channel beneath the screen, while overflow, fish, and debris pass off the downstream end of the screen. Flow velocities across the screen are typically 6.5 to 10 feet per second, increasing toward the toe of the screen. In past hydropower applications, commercially available designs typically had the screen inclined  $60^\circ$  from horizontal at the upstream edge, with a total head drop across the structure of about 4 to 5 feet. However, many of the applications described in this paper use much flatter screen angles and operate with much smaller head loss.

Coanda-effect screens use a unique tilted-wire screen panel. The individual wires are tilted a few degrees downstream (see detail, figure 1) to produce shearing offsets into the flow above the screen. The typical tilt angle is  $5^\circ$ , but angles of  $3^\circ$  to  $6^\circ$  are available from most screen manufacturers. Slot widths between the wires are typically 1 millimeter (mm) (0.04 inch) or less. The shearing action is enhanced by flows that remain attached to the top surface of each wire and are thus directed into the offset created at the next downstream wire. This attachment of the flow to the top surface of each wire is an example of the Coanda effect, the tendency of a fluid jet to remain attached to a solid flow boundary. A detailed discussion of the Coanda effect and its application to tilted-wire screens is provided by Wahl (1995).

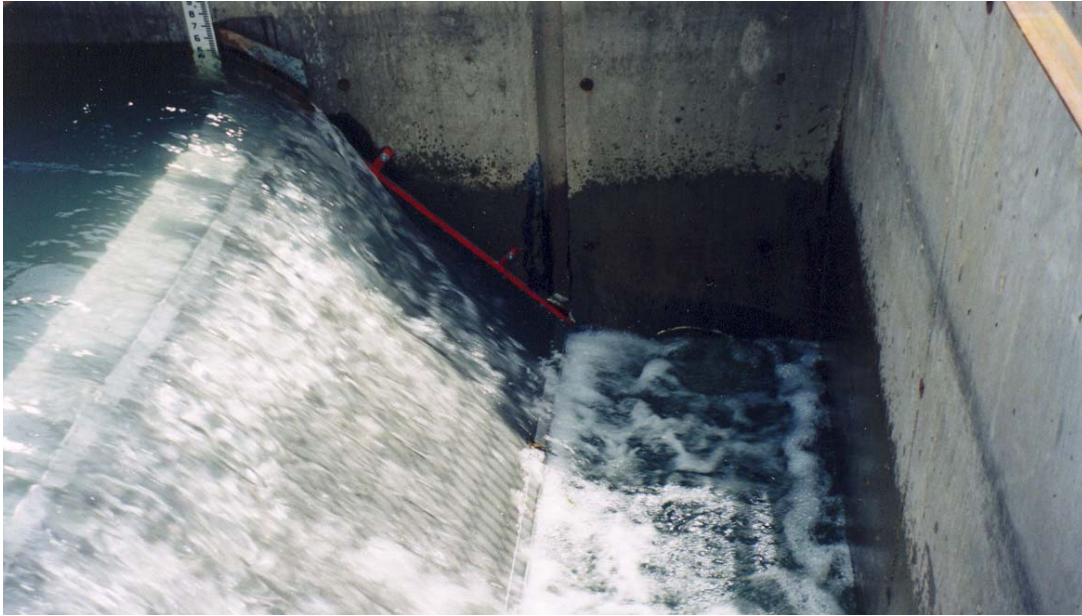
Figure 2.—Coanda-effect screen installed on the Boise Project, Idaho. Clean water drops through the screen section into a conveyance channel beneath the screen. A staff gage and sheet-metal flow deflector are visible at the upstream corner of the screen.

The screen shown in figure 2 was installed on the Boise Project to provide removal of fine debris at a drop structure and flow metering box serving both flood and sprinkler-irrigated farms. The Coanda-effect screen was installed during the spring of 2003. The new stainless steel screen is 3 feet long and 8 feet wide, with 0.5 mm slots. This screen is cleaned a couple of times per week. The Boise Project underwent two minor modifications after the screen was installed. First, small flow deflectors were added near the top edge of the accelerator plate because debris was collecting where the screen met the sidewall of the concrete box. The deflectors successfully keep the edges of the screen clean. Second, a staff gate was added upstream from the weir to allow making a rough estimate of the flow being delivered to the screen. This measurement only approximates the flow actually delivered to farmers on this lateral since a small amount of overflow passes off of the screen into a bypass pipe that leads back to the canal. Downstream from the screen, piped farm deliveries are measured with paddle-wheel-type insertion flow meters, and since the screen was installed, there has been little problem with the meters. This screen was installed as a demonstration project through a 50 percent cost share between the irrigation district and Reclamation's Science and Technology Program.

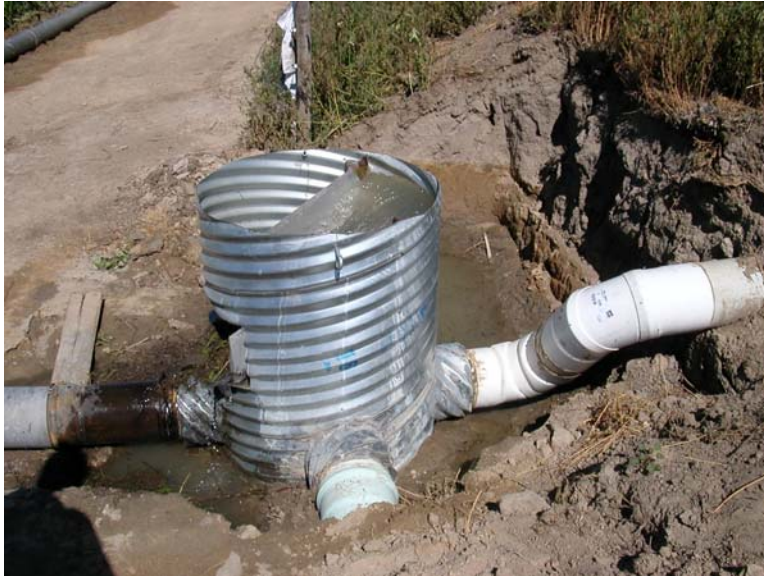
Figure 3.—Coanda-effect screen structure built with corrugated metal pipe. Raw water enters from the right. Clean water is discharged through the center and left-hand pipes, while debris exits onto the ground through the slot in the left side of the structure.

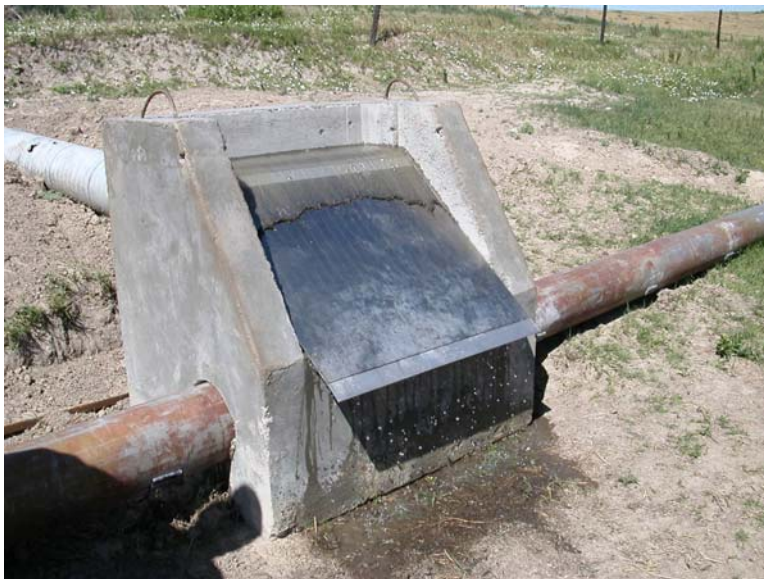
Figure 4.—Coanda-effect screen structure feeding two irrigation pipelines. Raw water enters the back of the structure through the white, polyvinyl chloride pipe. Screened water exits to the right and left. Overflow and debris are discharged onto the ground at the front of the screen.

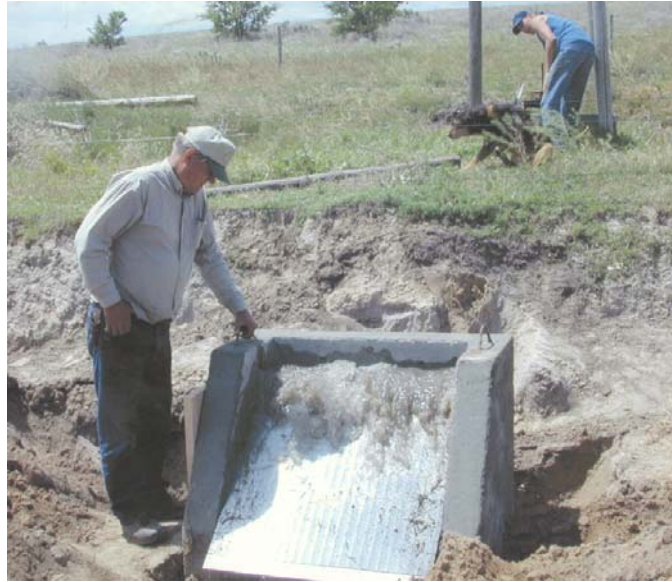
Figure 5.—Coanda-effect screen structure, similar to that shown in figure 4, operating at a relatively high flow rate. All flow still passes through the screen before reaching the toe.

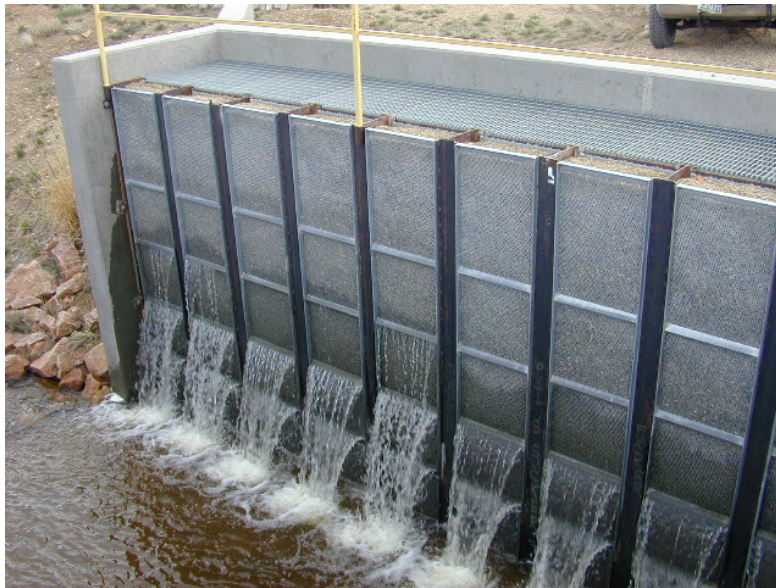
Figure 6.—Sand filter at Lake John. This structure presented some exciting maintenance challenges.

For many years the Colorado Division of Wildlife has tried to limit the entry of carp and sucker eggs and larvae into Lake John in an effort to preserve and maintain a sport fishery there. In the 1990s they constructed a sand filter device (figure 6) like those often used in water treatment applications, but maintenance of the filter was a serious problem. Backwashing and reconditioning of the filter was required on a frequent basis. Cleaning involved lowering a burning cherry bomb held in the jaws of a wrench into the structure, where its detonation disturbed the accumulated fine sediments.

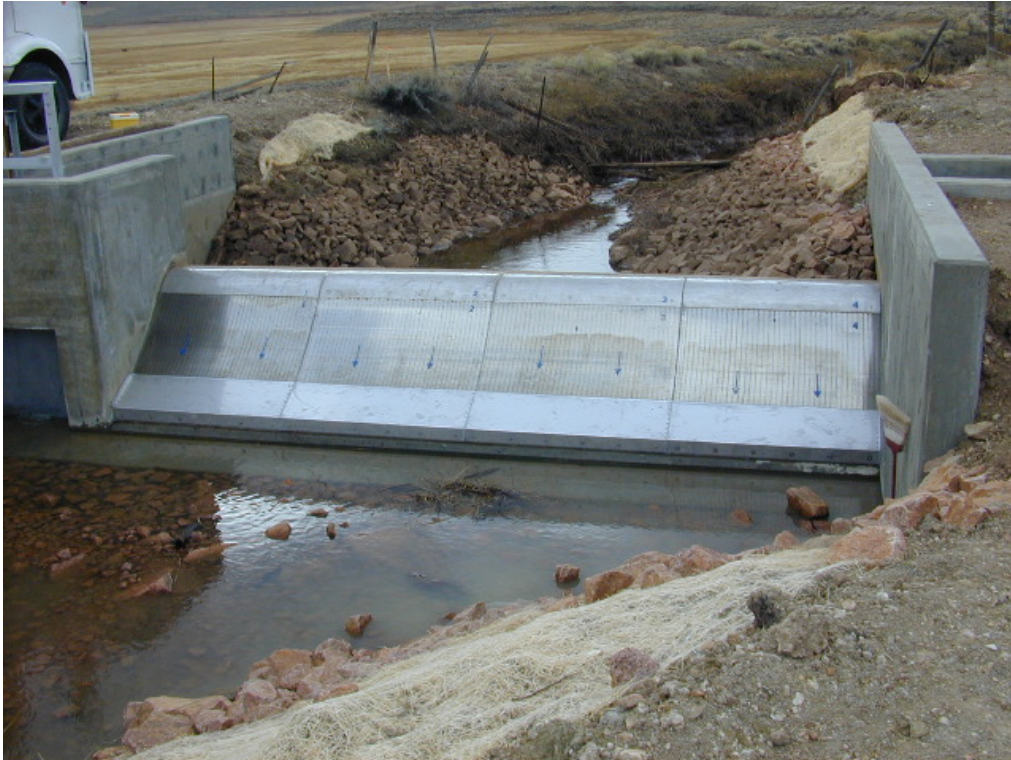
Figure 7.—Coanda-effect screen structure at Lake John, constructed in 2001. This structure replaced that shown in figure 6.

In July 2001, the Division of Wildlife replaced the sand filter structure with four panels of tilted-wire Coanda screens on the irrigation ditch diversion to Lake John. Each panel measured 5 feet wide by 47 inches long. The wire slot opening

was 0.5 mm (0.019 inch), small enough to exclude the undesirable fish and larvae. The design discharge was approximately 30 cubic feet per second ( $\text{ft}^3/\text{s}$ ). To date, the screens have easily accepted the full design flow, but the outlet channel capacity beneath the screens has been somewhat less, preventing screen operations at the full design flow. Despite this problem, the screens themselves have worked well and have significantly reduced the maintenance problems associated with this site. Plans are currently underway to install similar screens on the supply to adjacent lakes.

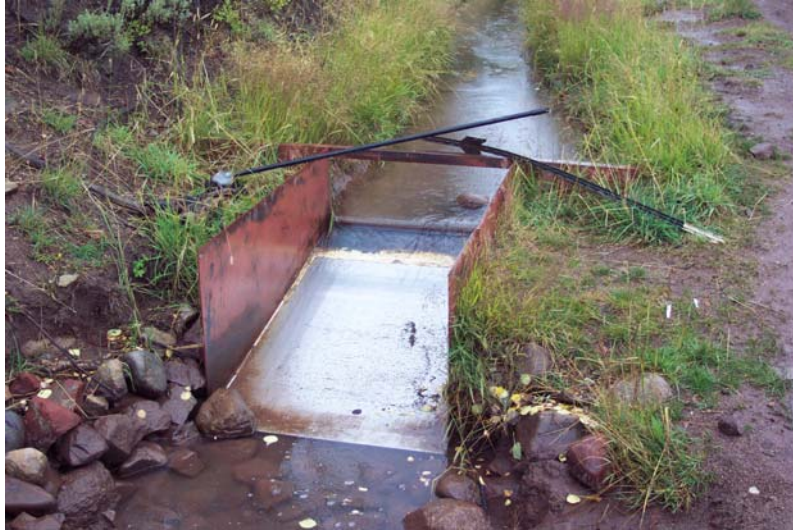
Figure 11.—A small Coanda-effect screen provides water to a sprinkler irrigation system near Carbondale, Colorado.

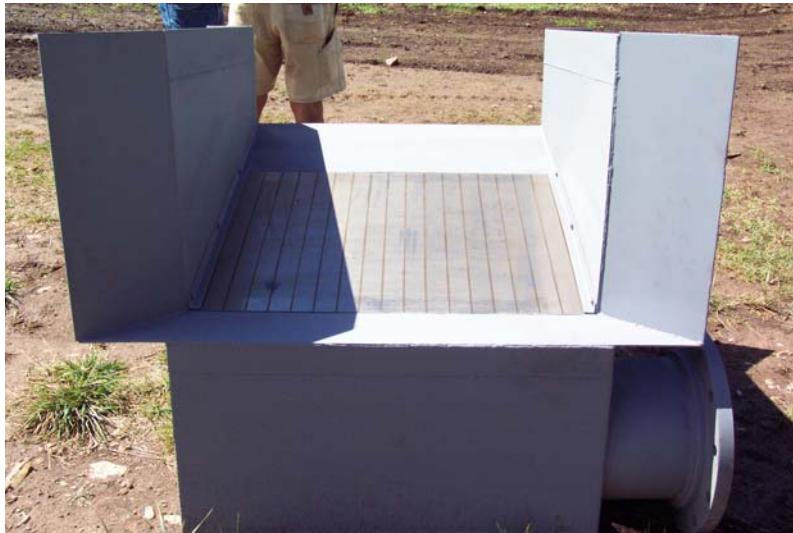
Figure 12. — Modular Coanda-effect screen structure. Flow is toward the reader. Screened flow exits to the right through the flanged pipe connection.

polyvinyl chloride (PVC) pipe. The flow passes through the screen and down the chute into the PVC pipe. The deep vault beneath the screen shown in figure 12 has been eliminated. Note the flap at the bottom of the screen in figure 13. To stop the diversion, check boards are removed to eliminate flow over the screen and the flap is raised to prevent flow entering the screen from the downstream channel. Figures 14 and 15 show plan and elevation views of a typical installation.

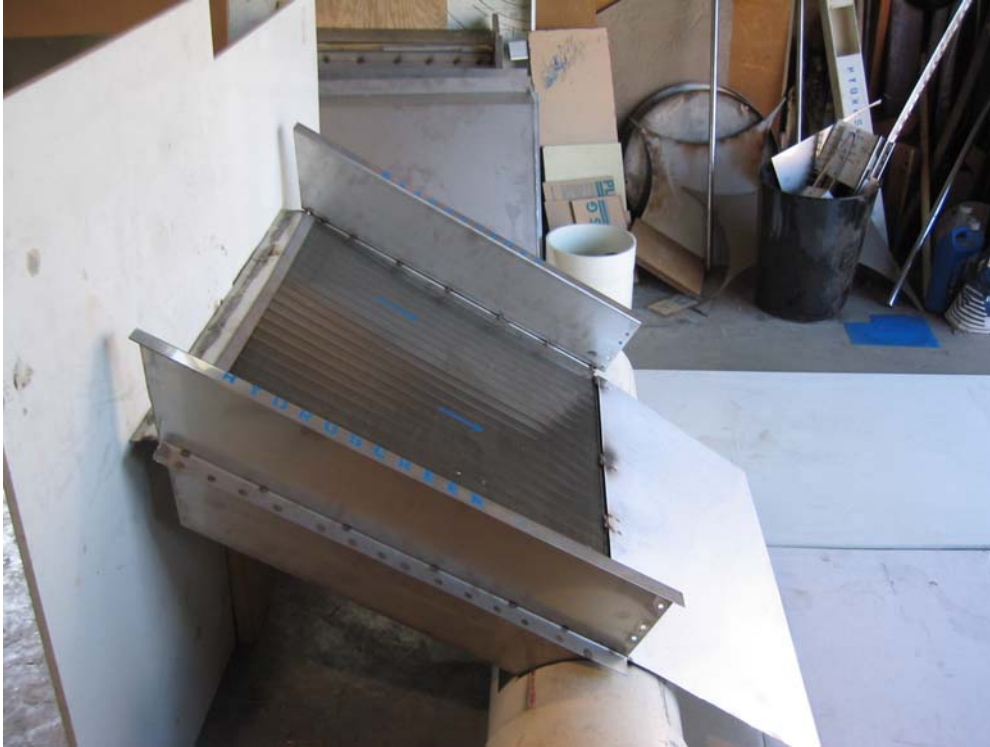
Figure 13.—Coanda-effect screen structure in the shop, configured to discharge directly into a PVC pipe.

At canal check structures, a unique screen structure has been developed that is easily incorporated into an existing check. Figure 13 shows the structure, which contains a wedge-wire screen and an underlying stainless steel chute attached to a

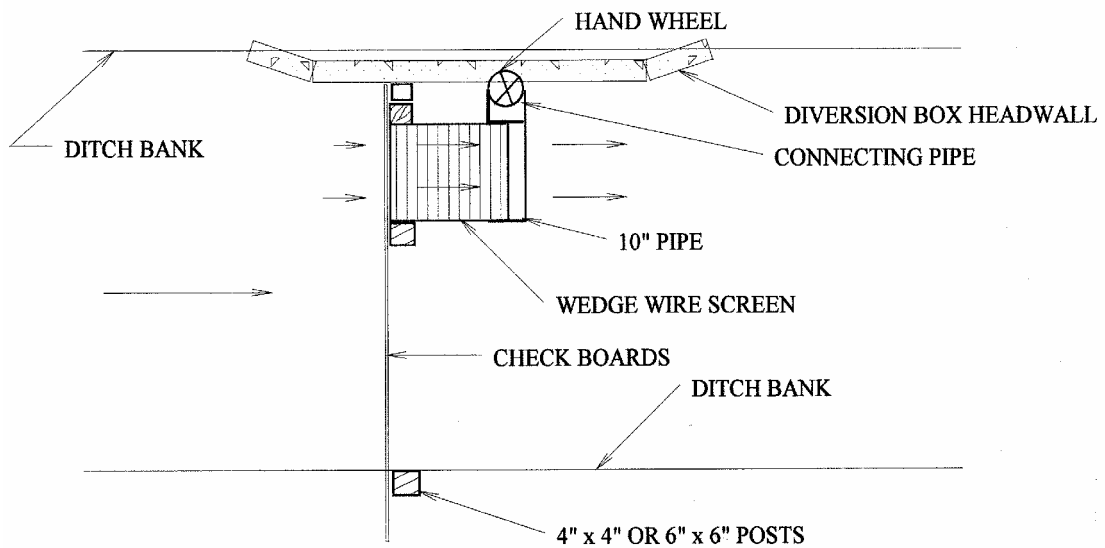
Figure 14.—Plan view of a Coanda-effect screen incorporated into a stoplog check.

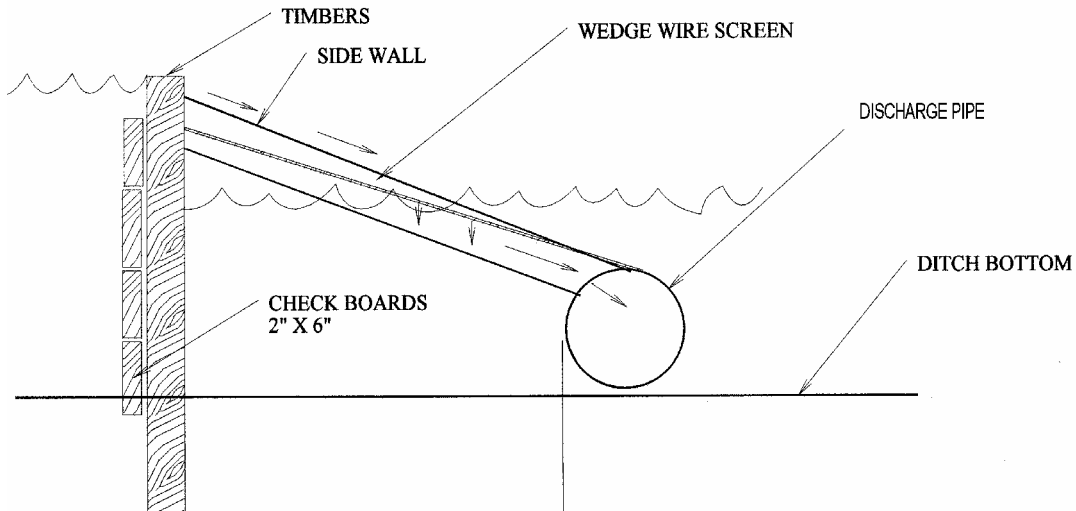
Figure 15.—Elevation view of Coanda-effect screen installation at a stoplog check.

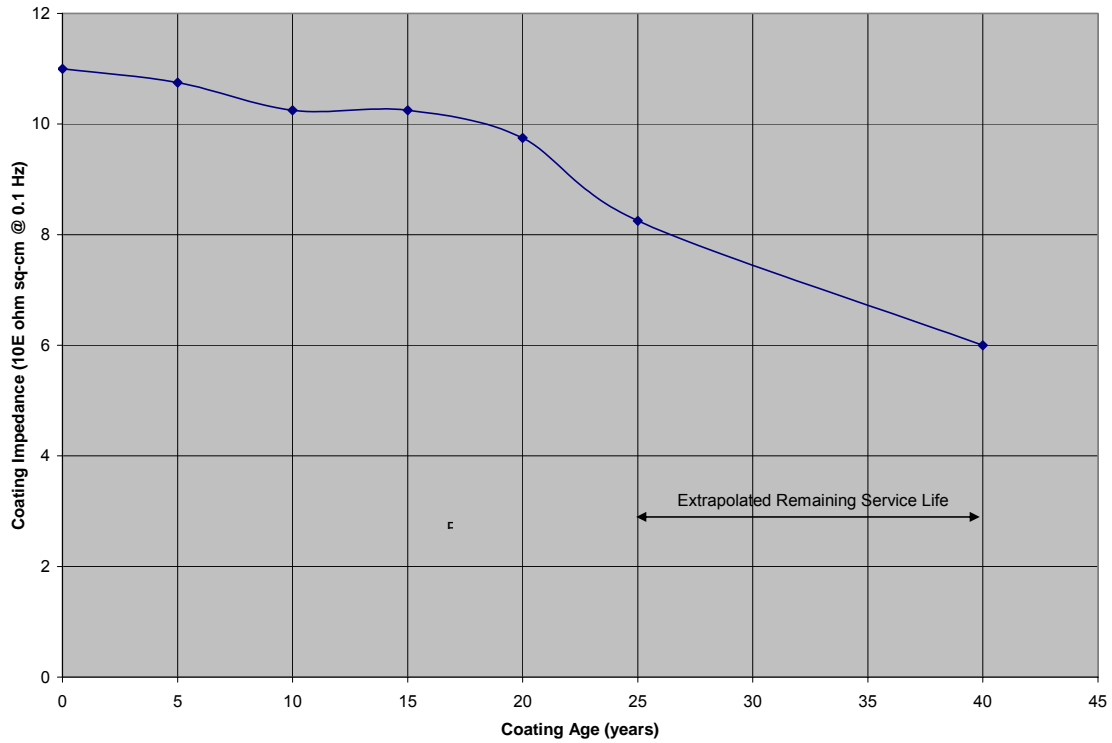
Figure 2.—Example of impedance versus age for a generic coating material with extrapolation after 25 years.

The useful remaining service life of a coating is extrapolated from periodic EIS measurements taken at intervening years. The result is a plot for coating impedance versus coating age. From the plot, the remaining useful service life can be extrapolated.

For example, in figure 2, if EIS measurements were taken initially after application and every 5th year thereafter until the 25th year, the remaining service would be estimated for a further 15 years. After the 40th year, the coatings impedance readings would be expected to be less  $10^6 \Omega\text{-cm}^2$ . This implies work on the coatings would be required at that time.
