Department of the Interior
Bureau of Reclamation

OPERATION AND MAINTENANCE EQUIPMENT AND PROCEDURES RELEASE NO. 41

July, August and September 1962

PRIMING AND PUDDLING CANALS AND LATERALS

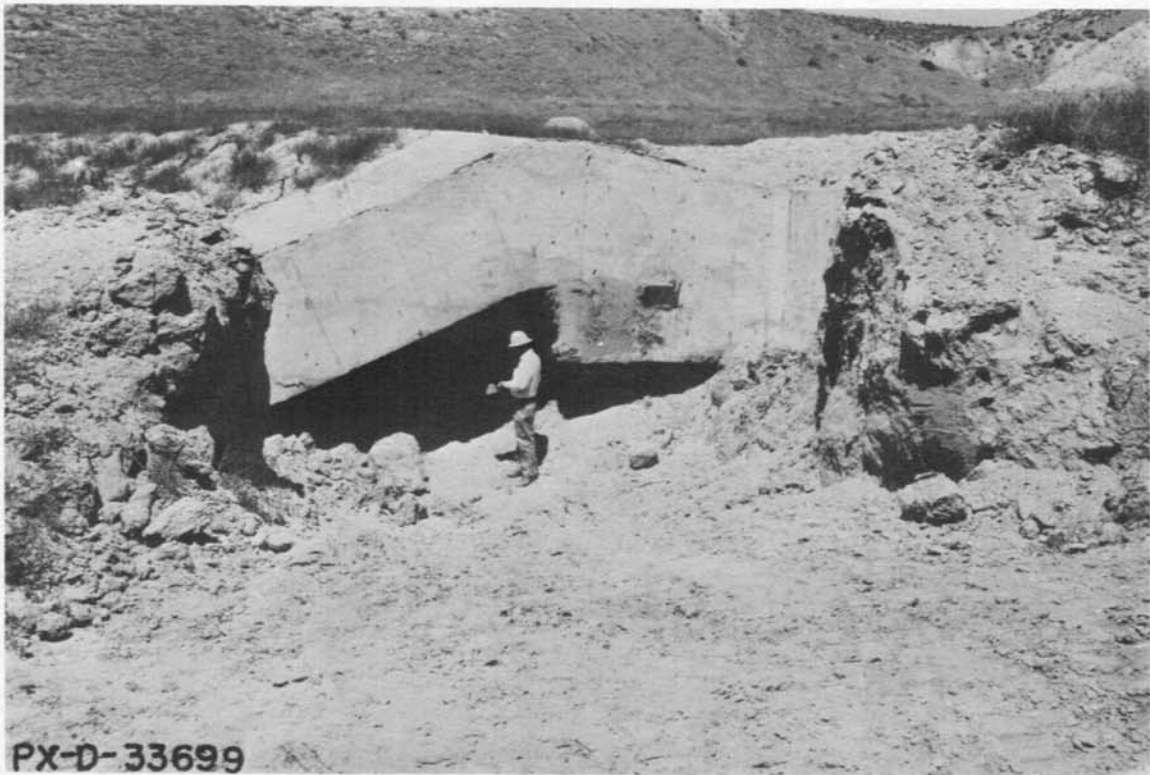
Cover Sheet. Storm water reached this structure one night prior to priming and puddling. Settlement of the banks had occurred 12 hours later, followed by water washing under the upstream cutoff. The left bank was washed out and water washed down under the incline emerging at the opposite side of the bottom as discussed and shown in the article beginning on page 1. Photo No. PX-D-33699.

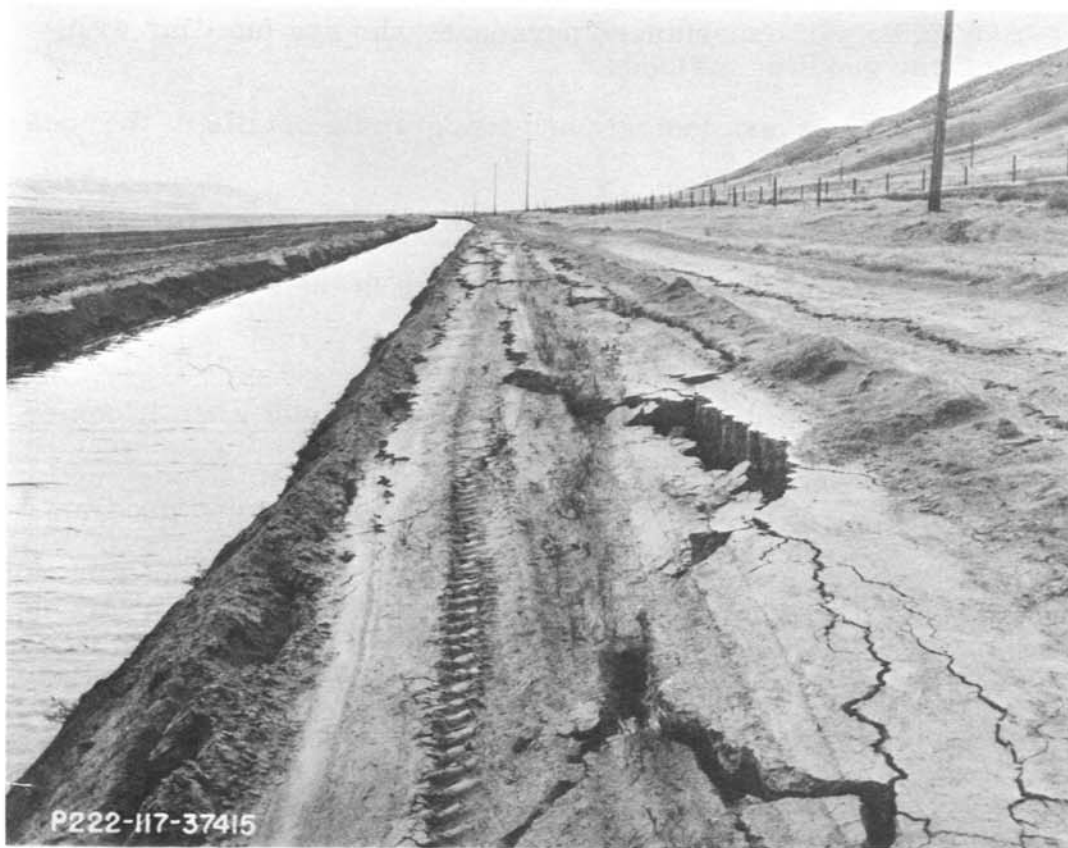
Photo No. 1

The soils, the geology and the topography through which the system is located will have a great deal to do with the difficulties experienced in priming and puddling a system. Light sandy or silty soils can become very unstable when water is first introduced into the channels and the banks become saturated. Serious subsidence of the area adjacent to a large lateral is shown in Photograph No. 1. This is more or less typical of what may be expected in light uncompactd soils.

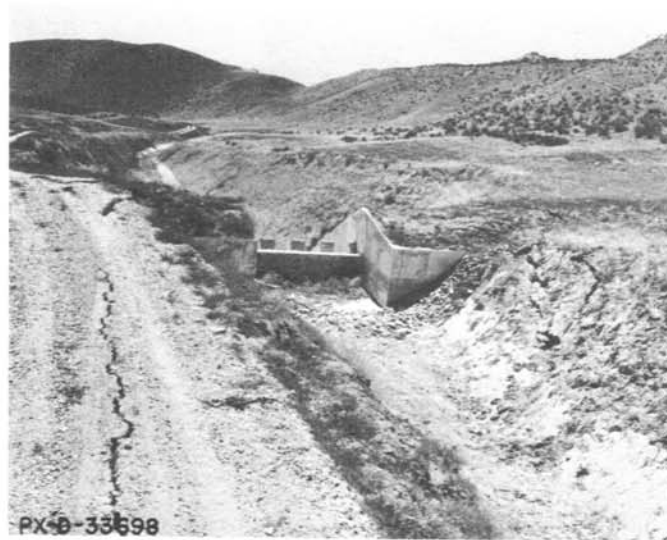
Photo No. 2

Settlement cracks that develop upstream from a structure such as the baffled apron drop, Photograph No. 2, can create a serious problem. In this instance the subgrade material was sand and silt with an underlying gravel strata. Storm water in the channel caused bank settlement and subgrade subsidence with serious damage resulting before the channel had been primed. The photograph on the cover page, and Photograph No. 3 are other views of this same structure. Water washing under the upstream cutoff of the structure, as shown on the front cover, passed along the left side of the inclined section of the drop and emerged at the lower right corner, Photograph No. 3. Only quick action by project forces saved the structure from destruction.

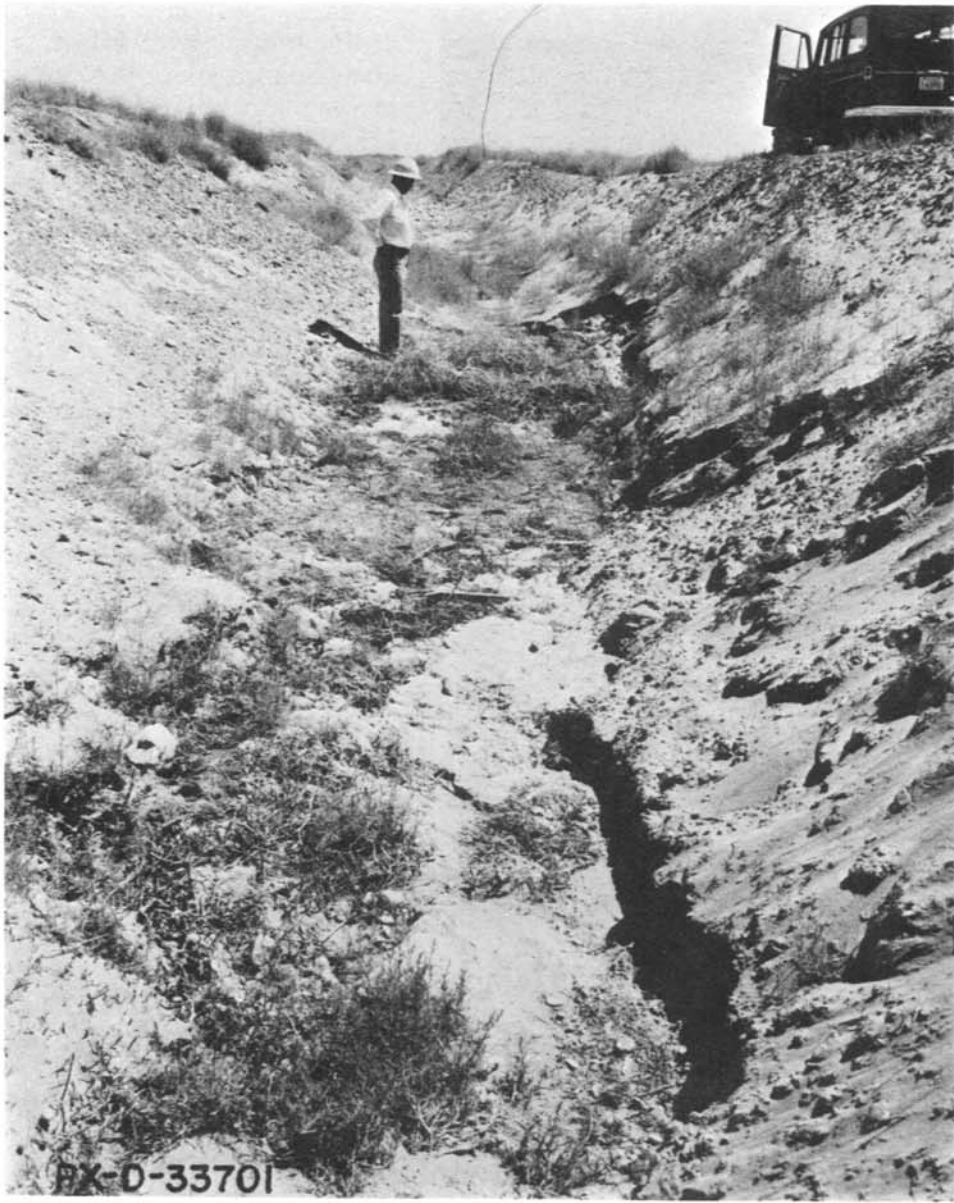
Photo No. 6

Sinkholes in gravels in the bottom of a lateral are shown in Photograph No. 6. Water passing into the underlying gravel strata through

the sinkholes reappeared outside the channel bank, but continued for only a relatively short time.

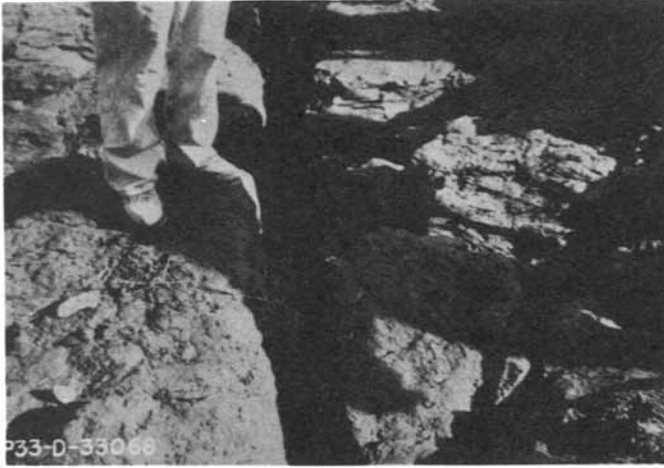
Photo No. 7

Problems have also been encountered where siltstone underlies the canal bottom. Photograph No. 7 shows a large crevice in siltstone that had been filled with permeable material. Seepage from the canal into the crevices caused piping that resulted in washouts and canal bank failures.

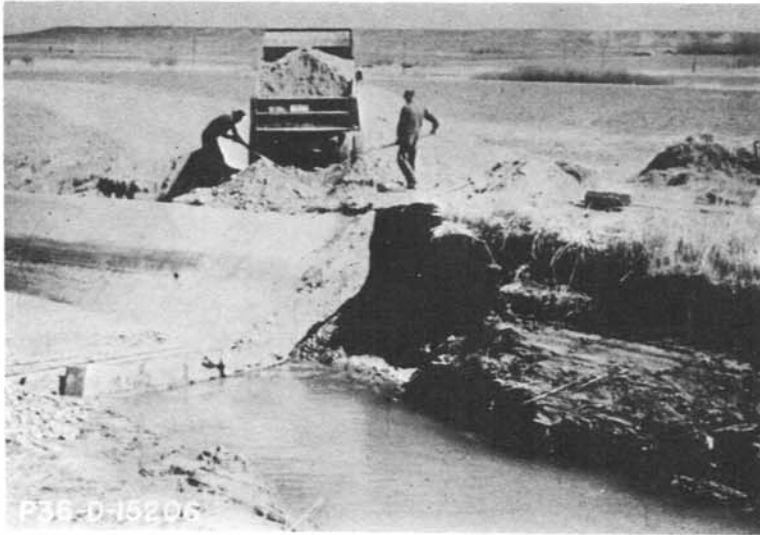
Photo No. 8

The use of fairly well-graded sand-gravel material is favored by many of our project operators for the backfilling of structures which have been washed out, because the coarse particles lend stability. Photograph No. 8 illustrates such a washout on the right side of a drop structure. It is being repaired by backfilling with a silty and sandy gravel. This particular structure had been in operation many years prior to the failure due to piping under a cutoff wall and is typical of such failures.

A favorite procedure among operation and maintenance men in the repair of washed-out structures is to extend the cutoff walls deeper into the banks and into the canal bottom. This is reasonable inasmuch as many such failures are caused by water going around cutoff walls. A failure of this type has been shown in Photographs No. 8 and 10. In some cases

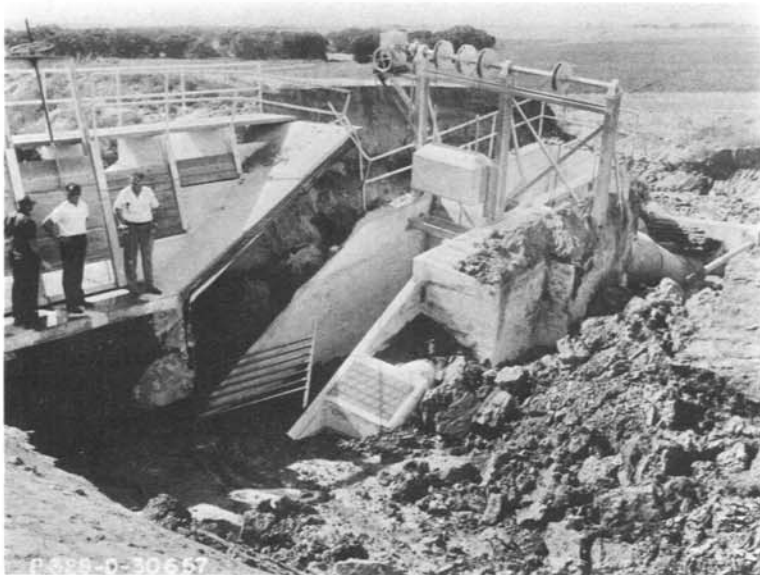
Photo No. 9

performance of surrounding soils, inadequate resistance to percolation may exist at structures and areas of weakness may sometimes develop. This is particularly true in fine sandy and silty soils and soils which subside appreciably upon wetting. The damage to an automatic wasteway structure founded on loessal soil, Photograph No. 9, occurred about 10 weeks after water first reached the

structure and followed what would normally be considered to be an adequate priming procedure. The washed-out structure illustrates the hazards that must be expected when priming a new system.

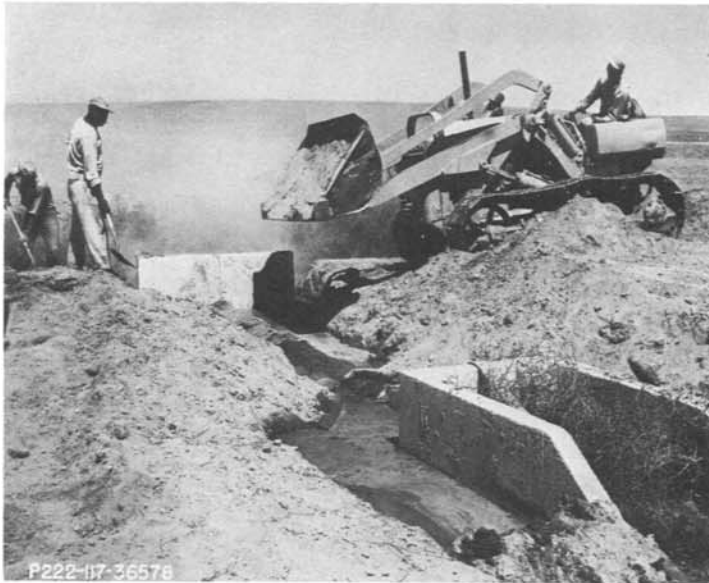
Photo No. 12

Correct procedures for puddling are described in the Earth Manual, 1960, page 302. Figure 12 shows a typical puddling operation around a turnout and weir box structure on a lateral. The occurrence of the break shown in a large canal, Photograph No. 13, at a culvert leads one to suspect that

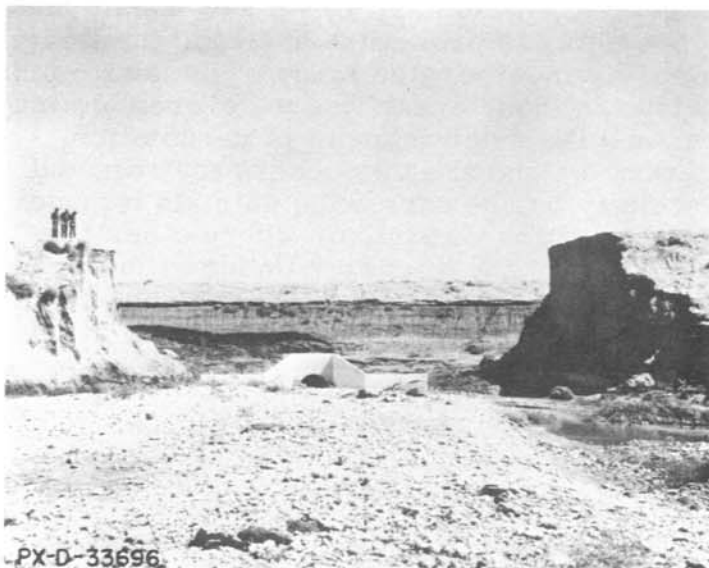
Photo No. 13

pipng along the structure may have had something to do with the failure. Careful puddling and care in placing the backfill is important in such locations.

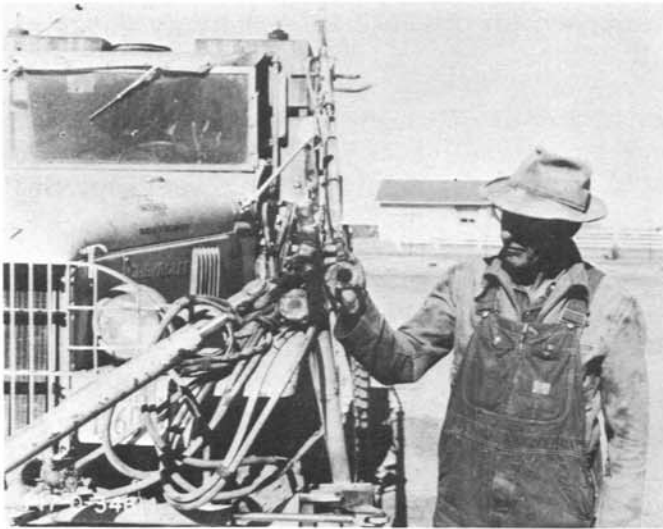
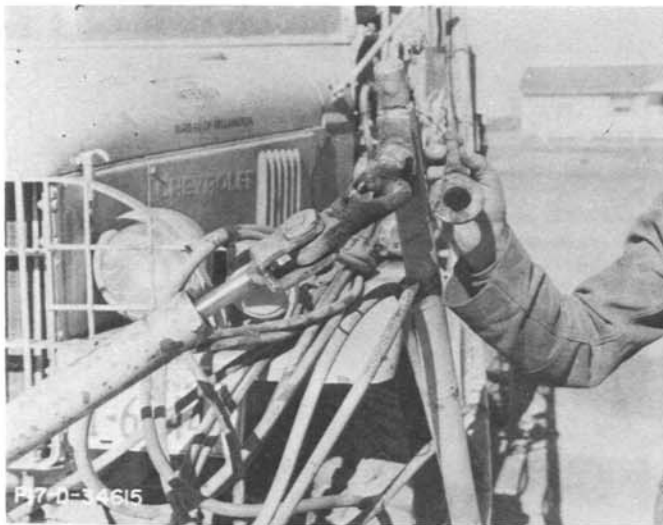
The North Side Irrigation Field Division, Minidoka Project Office, reports less downtime when universal joints replaced the eyebolts on spray rigs. Mr. Charles H. Edwards made the suggestion that the eyebolts installed on the standards on the boom where the hydraulic cylinder is fastened be replaced by universal joints. This installation and the formerly used eyebolt are shown in Figures 1 and 2.

Mr. Edwards states that the eyebolts which were used formerly, crystallized and broke from strain and vibration. An eyebolt would last about 3 or 4 days before it broke, causing the spray rig to lose from 4 to 6 hours field time while it was being repaired at a cost in downtime of about \$10.00 per hour. Mr. Edwards further reports that they get smoother and better operation with less strain on the hydraulic cylinder.

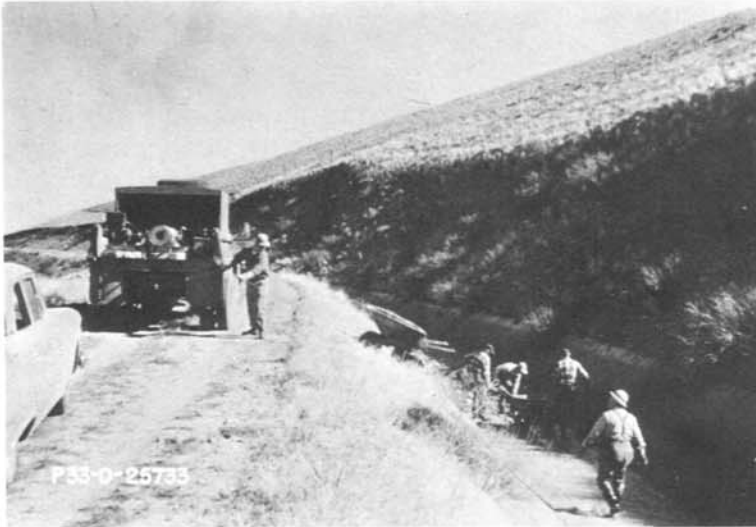
Photo No. 1

The removal of rock from a concrete-lined section of a main canal on the Kittitas Division of the Yakima Project where reaches of the canal are located in sidehill cut, Photo No. 1, cannot be classed as a major maintenance item, but it is one that is awkward to accomplish, becomes time consuming if done by hand, and costly and inefficient, for the amount of work to be done if large equipment is used. The depth of the canal below existing operating roads precludes the use of smaller motorized equipment.

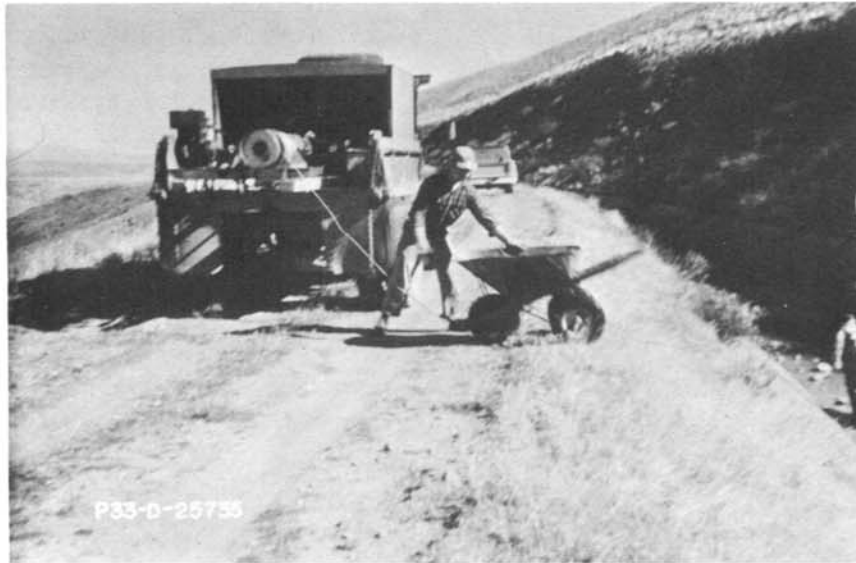
Photo No. 2

Watermaster Adcock has constructed a 3-wheeled wheelbarrow, Photograph No. 2, which is pulled up to the lower canal bank to the operating road by a small gasoline powered winch mounted on the rear of a truck bed. The operation is quite efficient and effective.
