Department of the Interior  
Bureau of Reclamation

# OPERATION AND MAINTENANCE EQUIPMENT AND PROCEDURES RELEASE NO. 45

July, August and September 1963

CATHODIC PROTECTION--A SUPPLEMENTARY REPORT  
All-American Canal System  
Boulder Canyon Project

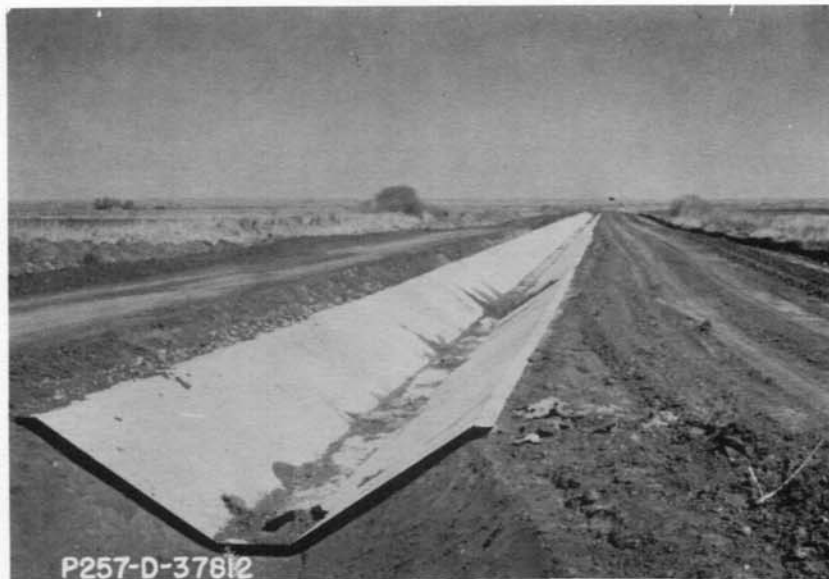
Cover Sheet. A reach of 2-inch-thick, slip-formed, portland cement concrete lining placed by the Arch-Hurley Conservancy District on the Tucumcari Project, New Mexico, as a part of a lateral rehabilitation and betterment program.

In the larger laterals, 10-mil thick polyvinyl chloride plastic is being used as a buried membrane-type lining, following construction practices described in Release No. 40, page 15, of our earlier Operation and Maintenance Equipment and Procedures bulletin. However, it is project policy to place 2-inch thick, slip-formed, portland cement concrete lining with a bottom width of 2 feet in laterals with a capacity of 60 cfs or less. A recently completed section of this slip-formed, concrete lining is shown on the cover page.

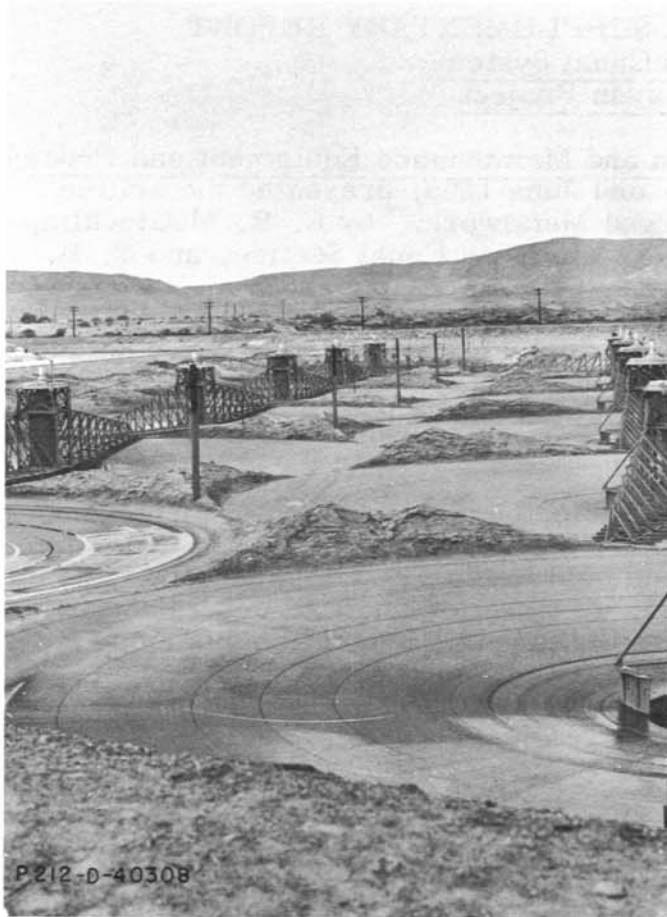
Photo No. 2

influent channel. The south half of one of the dewatered basins is shown in Photograph No. 2. Also shown are the clarifiers and the anodes and supporting line of the cathodic protection system. In addition, there are numerous underground sludge lines, waterlines and metal conduits. The desilting equipment was exposed to the weather for about 9 years before being put into service. The equipment was submerged for about 3 years before experimentation with cathodic protection was begun.

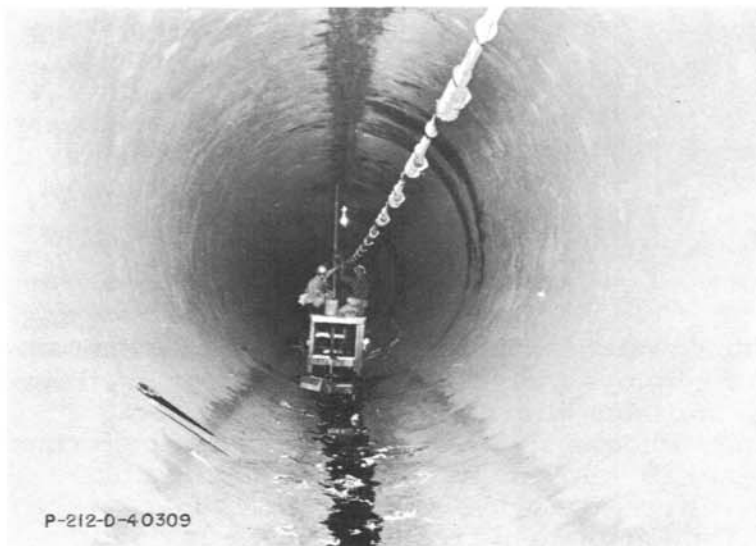
Photo No. 3

cast iron anodes, 2 inches in diameter and 9 inches in length, strung horizontally at 4-foot centers, Photograph No. 3.

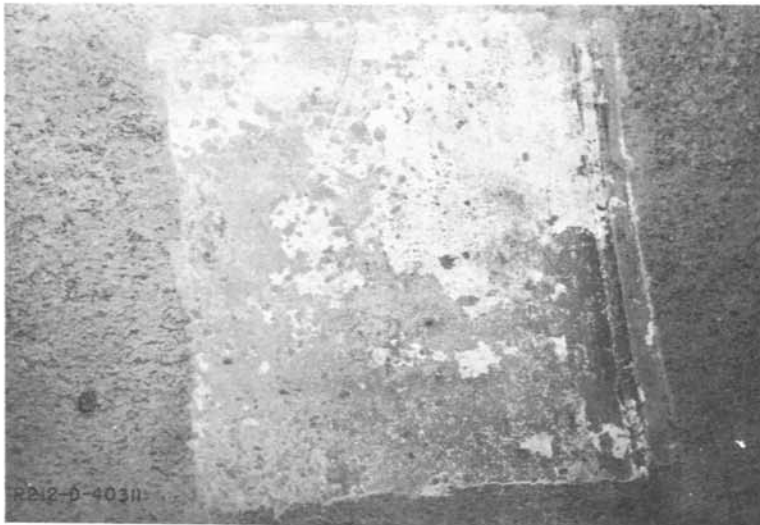
Photo No. 5

anodes or the galvanic system with magnesium anodes is equal and sufficient. A typical view of the excellent protection afforded is shown in Photograph No. 5. However, because of the lower maintenance cost and longer life expectancy of the cast iron anode, and considering that the initial cost for material and installation were nearly the same for both barrels, the District believes the cast iron anode system will prove to be the most economical.

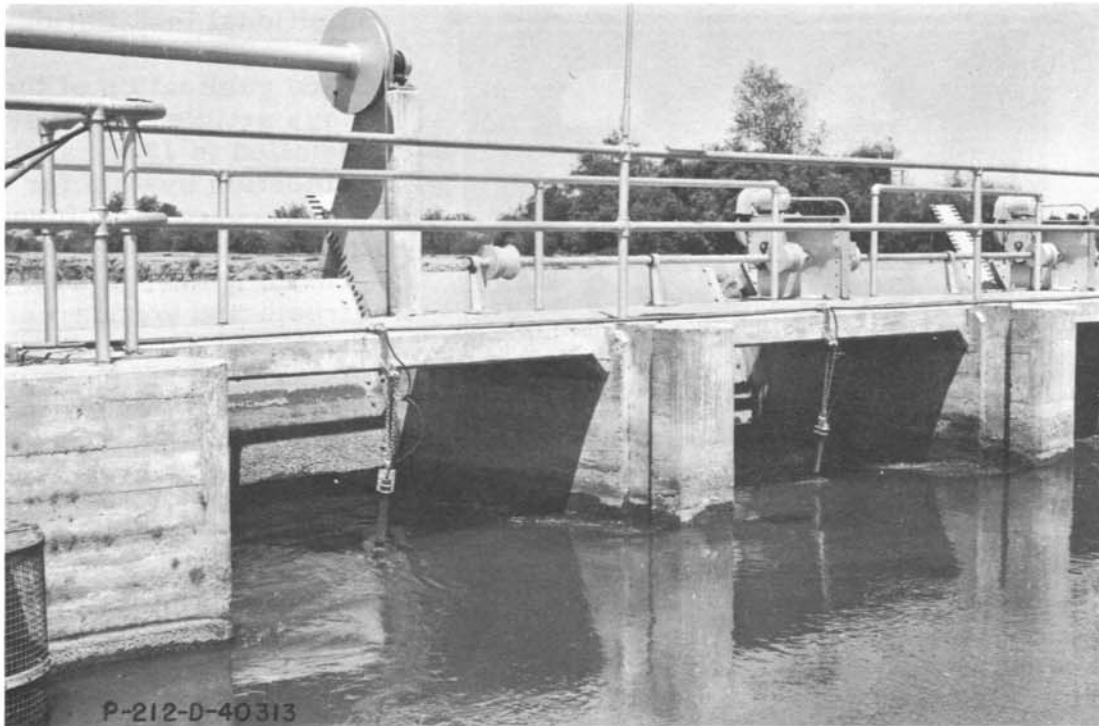
Photo No. 7

Since publication of the previous article, the District installed in 1960, a cathodic protection system for three major check structures on the East Highline Canal, providing anodes both upstream and downstream from the radial gates. A typical installation is shown in Photographs No. 7 and 8 on the following page. These structures have a total of 17 radial gates about 12 feet wide by 10 feet high. The total cost including materials, labor, transportation and miscellaneous was \$2,452 or \$144 per gate.

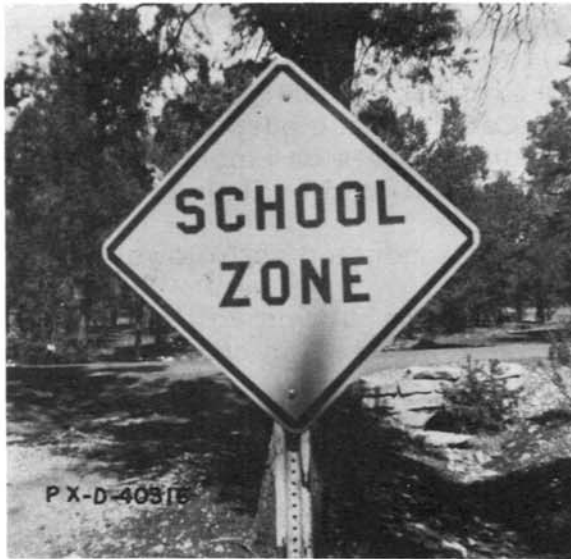
If your park shop has on hand some standard road signs but needs some special lettering, one of the standard units may be easily converted into a clear, professional-looking special version if you use the method worked out by Phillip R. Iversen of Grand Canyon National Park. The picture shows a comparison-- "Winding Road" is a standard sign purchased as such; "School Zone" is a special, prepared on the back of a "Winding Road" sign by the Iversen system.

To follow Phil's method, all you need is some paint thinner or similar nonoily liquid, a roll of black plastic electrical tape, a single-edge razor blade, some clear lacquer or plastic spray, a T-square or drafting triangle, and a pencil.

First, clean with paint thinner the reverse side of a standard sign, selected for the color and size you need. Then make light parallel lines, their distance apart corresponding to the letter height you want. Block in the letters in pencil. (Phil says you can skip this step as you gain experience.) Next, lay the edge of the square or triangle along the outer vertical edge of the first letter to serve as a guide as you apply a strip of tape a little longer than the side of the letter. Place the entire cutting edge of the razor blade firmly where you want the tape to end, then use a slight sawing motion to cut it straight and clean, removing the excess tape. If the letter has horizontal lines, as in E, F, or L, start the horizontal at the outer edge of your vertical piece, leaving no gap.

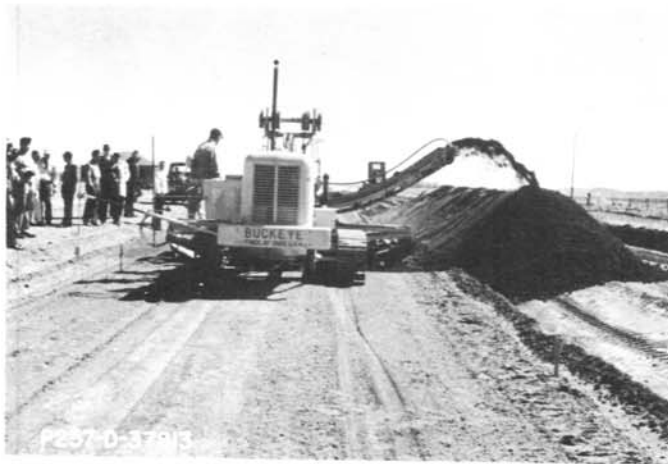
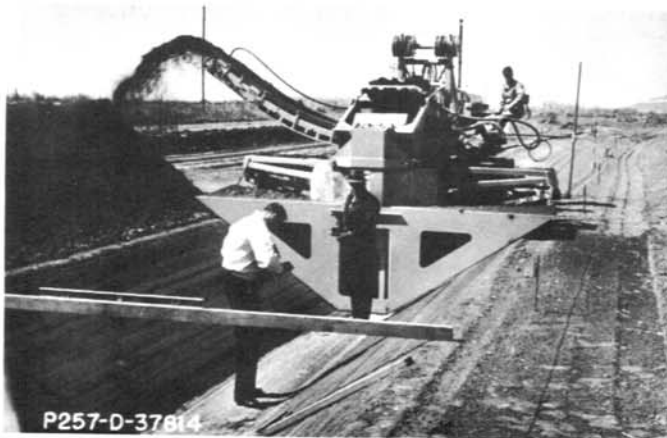
Photo No. 1

by utilizing an indicator arm riding along a taut wire cable set on steel grade stakes, Photographs No. 1 and 2. The finished excavation provides a lateral having a 24-inch bottom, 1-1/2:1 side slopes, and a 42-inch depth. The subgrade prepared for lining is shown in Photograph No. 3. The subgrade guided slip-form used in the placement of the concrete and remodeled for the work by the Conservancy District is shown in the background.

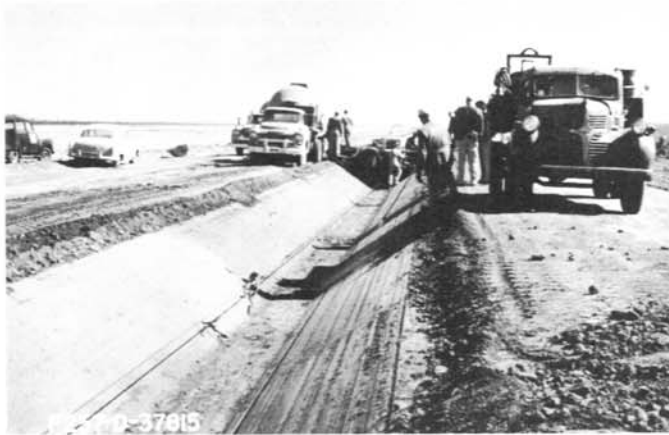
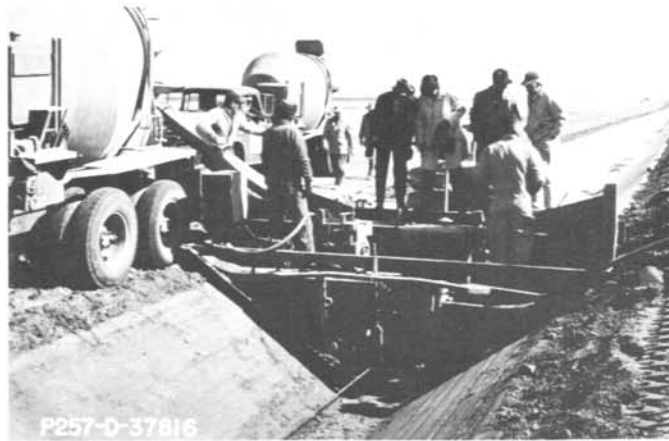
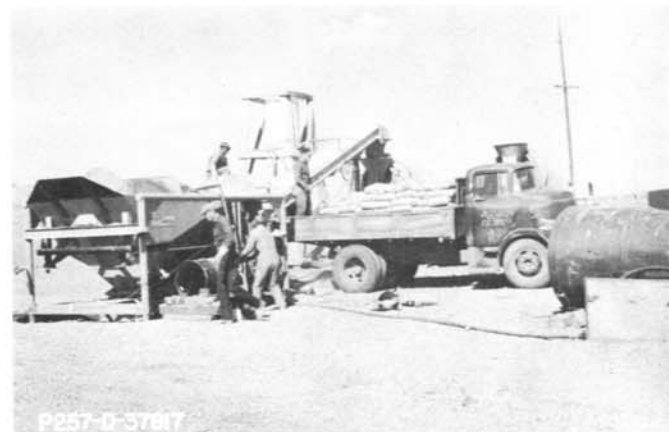
Photo No. 3

Concrete is supplied to the slip-form by transit-mix trucks having a capacity of 4 cubic yards and also purchased for the lining operation by the Conservancy District, Photograph No. 4. The truck-mounted mixers are charged from the Conservancy District's portable batching plant, Photograph No. 6, and the slip form is a standard type commercially available, but remodeled by the District to better fit conditions on the project.

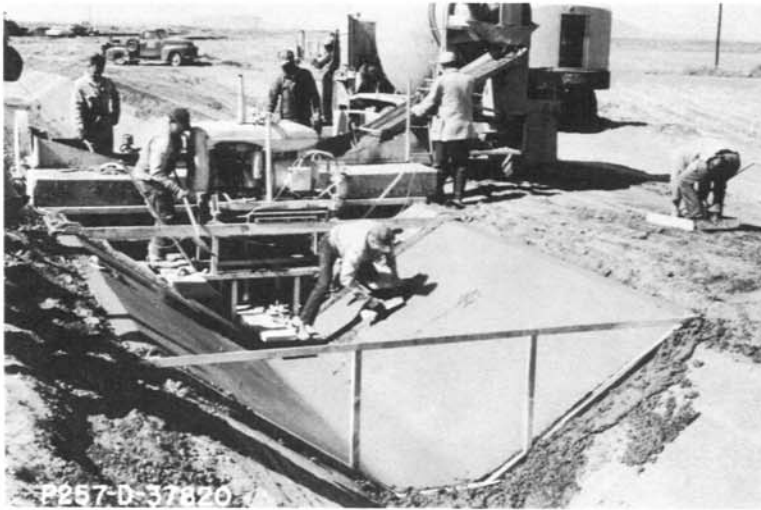
Photo No. 8

Four electric motors are used to power the screw conveyor, the spading equipment, and the electric vibrator on the bottom of the hopper. Current for operation of this equipment is supplied from a portable motor generator set, shown in Photograph No. 8, mounted on the rear of the slip-form. Additional independent generating units operate the immersion-type vibrators that are used to move the fresh concrete and keep it more uniformly distributed in the slip-form hopper, although the screw conveyor does an excellent job in this respect. A view of the hopper filled with fresh concrete is shown in Photograph No. 9.
