# IRRIGATION OPERATION AND MAINTENANCE

**BULLETIN NO. 52**

April, May, June 1965

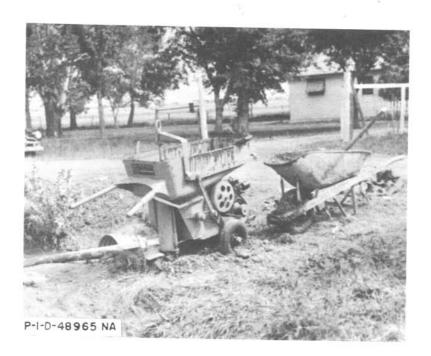
To fill the burrows on the Belle Fourche Project, a lean portland cement-soil grout or slurry, consisting of four parts of top soil to one part of portland cement is pumped into the burrow under 20 to 40 pounds p.s.i. pressure by the mud jack shown in Figure 1 on the following page. Water is added to the mixture until it becomes just fluid enough to flow well through the small diameter hose as shown in Figure 2, also on the following page. During filling, of course, the hose is inserted into the burrow as far as possible.

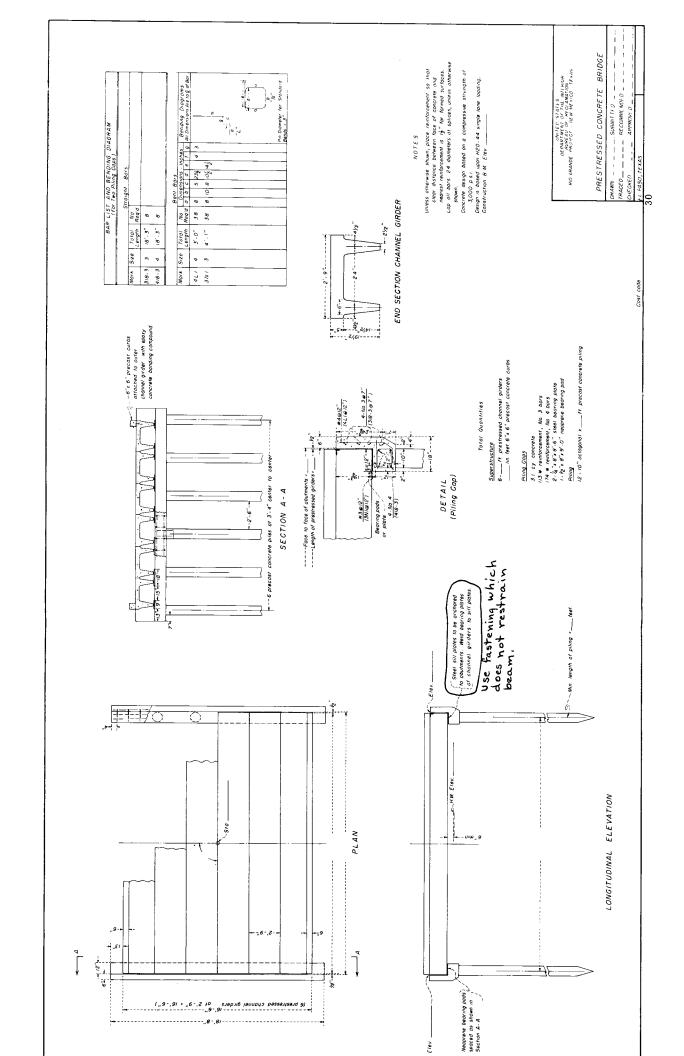
Figure 1

EFFECT OF CREEP IN PRESTRESSED UNITS

Our attention has been called to field observations made of several prestressed concrete highway bridges constructed in the Denver, Colorado, area, and specifically to a problem that has developed in prefabricated units at the fixed ends of spans. As shown in Photographs No. 1 and 2 on the following page, cracks have developed in the fixed ends of the beams and extend from just inside the beam bearing toward the top and near the end of the beam. It appears that failure has been caused by the ends of the units being fixed against rotation about the bearings. Concrete creep could not take place without tension cracking the concrete as illustrated in Figure 1.
