# WATER OPERATION AND MAINTENANCE

BULLETIN NO. 81

SEPTEMBER 1972

WATER LOSS BY SEEPAGE HALTED  
WITH FLEXIBLE LINERS<sup>1</sup>

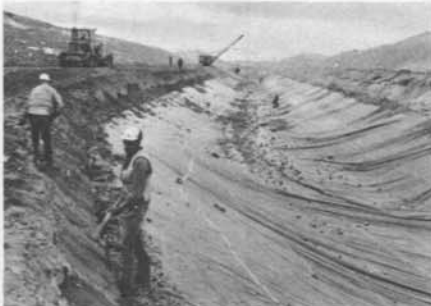
COVER PHOTOGRAPH:

East Bench Canal, Montana - Back-filling of the 18-inch anchor berm is done by hand to hold the PVC lining in place until a blade and dragline complete the 16-inch-deep covering of selected material.

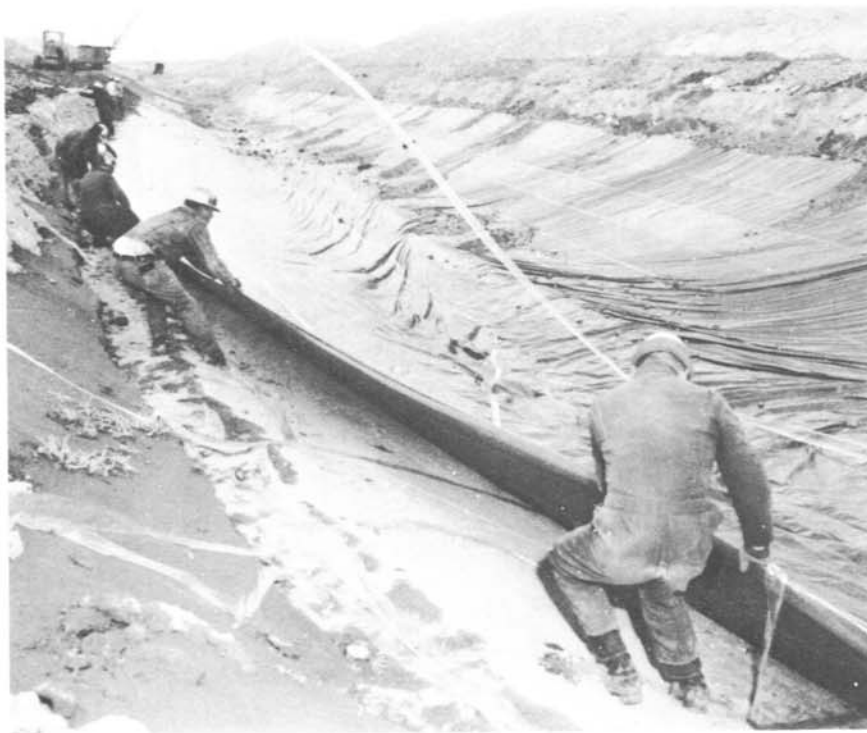
During the fall and winter of 1968, some 68,000 square yds. of vinyl sheeting were laid as an impermeable membrane in the Helena Valley canal. That stopped the leaking there. In Figure 1 below, folds of PVC sheet are loosened before covering sides of the canal slope. The sheet measures 63 feet wide and from 530 feet to 800 feet long.

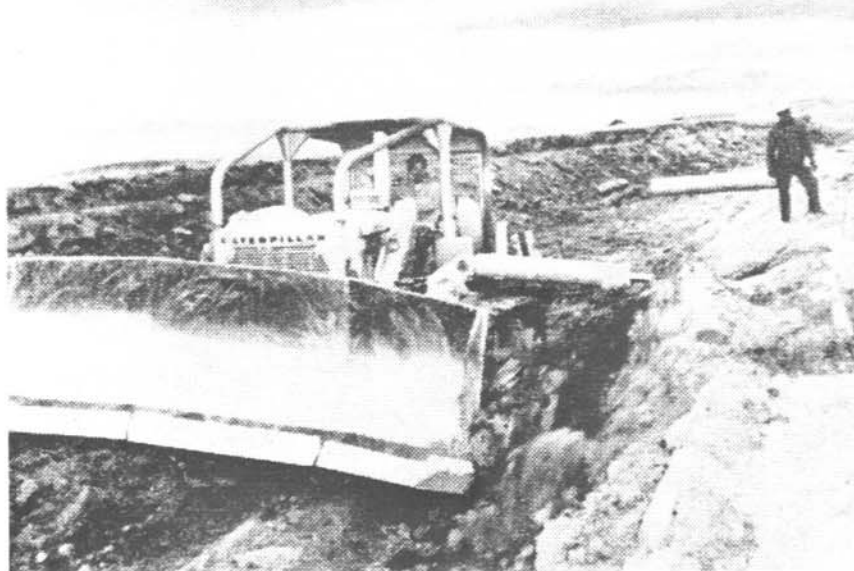
Photo PX-D-71929

At the Dillon project, the dirt was removed and the canal basin cleared. The large vinyl sheets were unfolded from the bottom and laid up the 2:1 slope, one side at a time. Then the loose sides of the material were covered with screened backfill along the berm. More backfill, taken from the canal right-of-way, was placed with a dragline over the entire lining to a depth of 16 inches. See Figure 2 on next page, and note the 18 inch anchor berm for the PVC Membrane on both slopes. Figure 3 shows the back-fill operation. Prior to lining, this stretch of the canal seeped water through breaks in concrete bed at a rate as mentioned above.

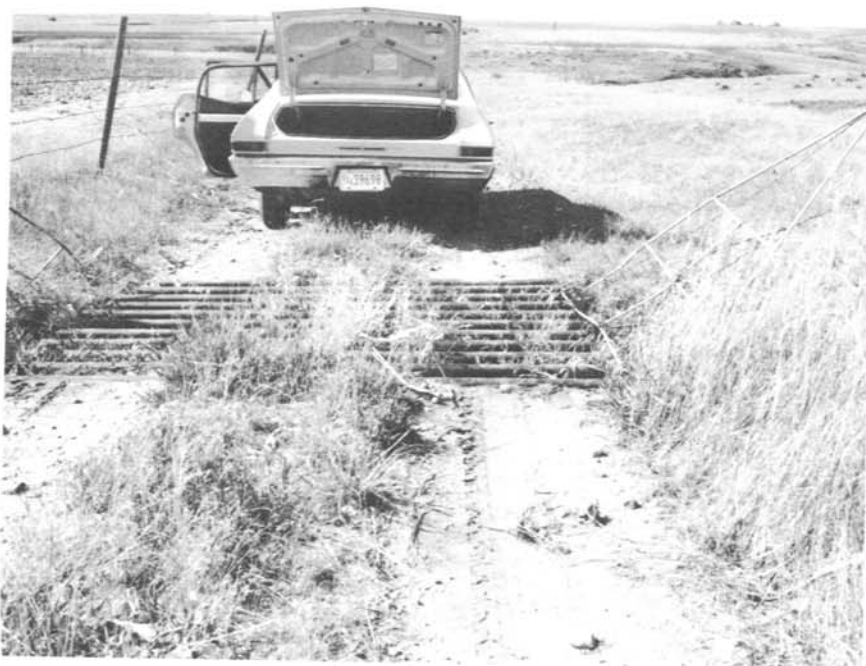
The Kansas-Bostwick Irrigation District, headquartered at Courtland, Kansas, has found through their years of operation, that the cattle guards on their system are too narrow for equipment travel, and that the maintenance of the wing guards was time consuming and costly. Figure 7 below, shows an original cattle guard installation. (Note damage to the wing guards.) To eliminate this problem, the maintenance personnel of the District are utilizing a portion of their time during the winter months to modify the cattle guards.

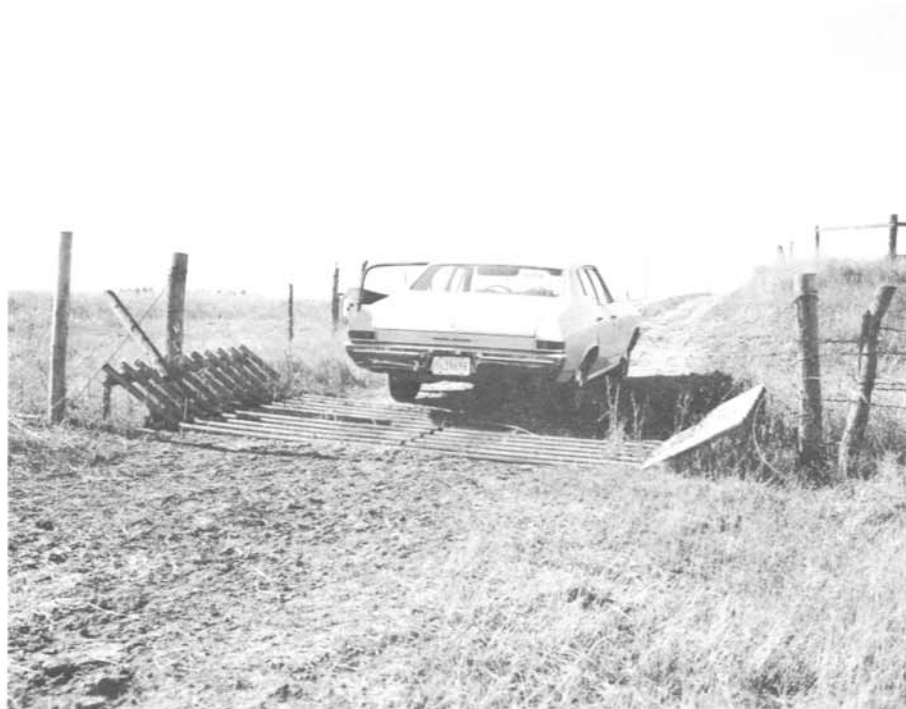
The sketch on page 12, shows in detail the procedure used to bend the pipe deck ends to form the wing guards, and Figure 9 on next page below shows a cattle guard installation after it has been modified.

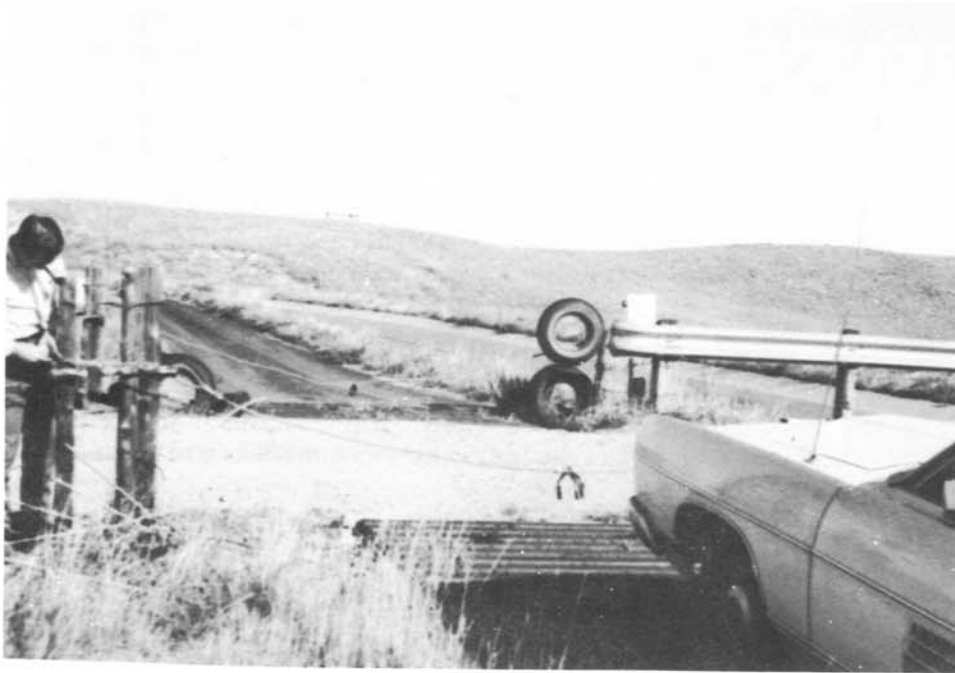
district maintenance personnel has been attaching automobile tires to the wing guard support posts to form the wing. See Figure 10 below, showing the tires attached to the support posts.

The tires are bolted to the wing guard support posts, and if hit by maintenance equipment, the tires are flexible enough to allow passage of the equipment and then return to their original position. The tires used for this purpose are unfit for other uses; therefore, the material cost to modify the wing guards is negligible.

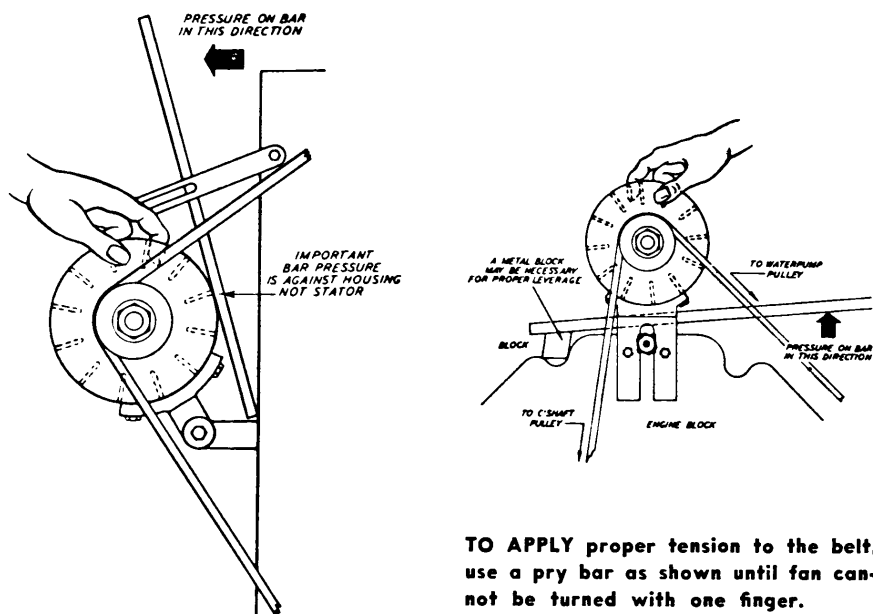
**TO APPLY** proper tension to the belt, use a pry bar as shown until fan cannot be turned with one finger.

1. Loosen the lug or spindle bolts only enough to pivot the alternator.
2. Loosen the adjusting arm bolts so it pivots freely. (Do not unseat the belt, however, if this can be avoided).
3. Use a pry bar as shown in Figure 11 above, to tighten the belt until the alternator fan cannot be turned with the pressure of one finger.

Care should be used with the pry bar so that pressure is brought to bear on the casting portion of the alternator frame and the stator laminations are not damaged.
