# WATER OPERATION AND MAINTENANCE

BULLETIN NO. 82

DECEMBER 1972

## CONCRETE STRUCTURE REPAIRS WITH EPOXY

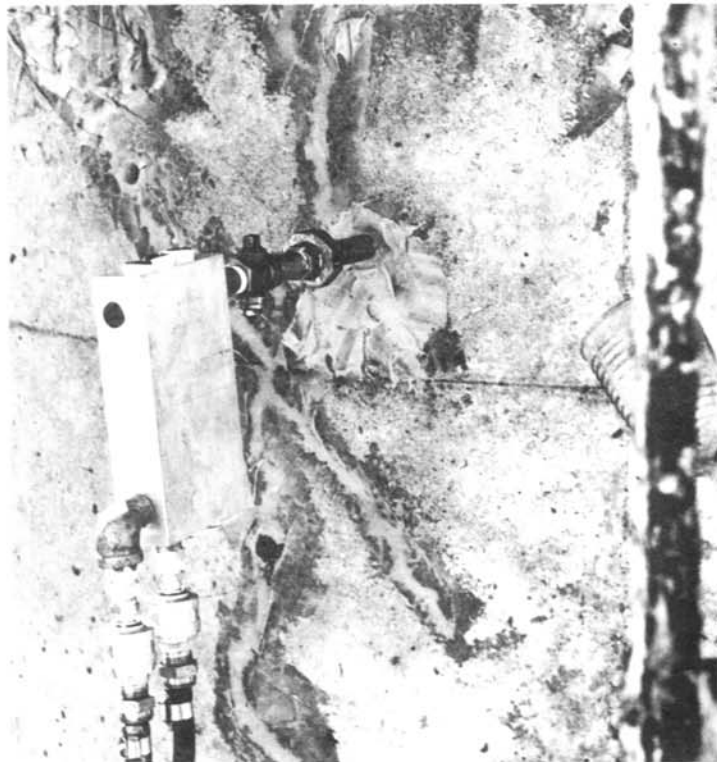
The epoxy mixing gun with pipe nipple is secured to the tapped hole and concrete adhesive epoxy is then injected into the crack. See Figure 5 on page 5, showing cracks in concrete pedestal being pressure filled with epoxy using the epoxy injection gun. The operator activates the epoxy pump with pushbutton switch to bring pressure up to 200 psi and as pressure diminishes, the pump is reactivated and brings

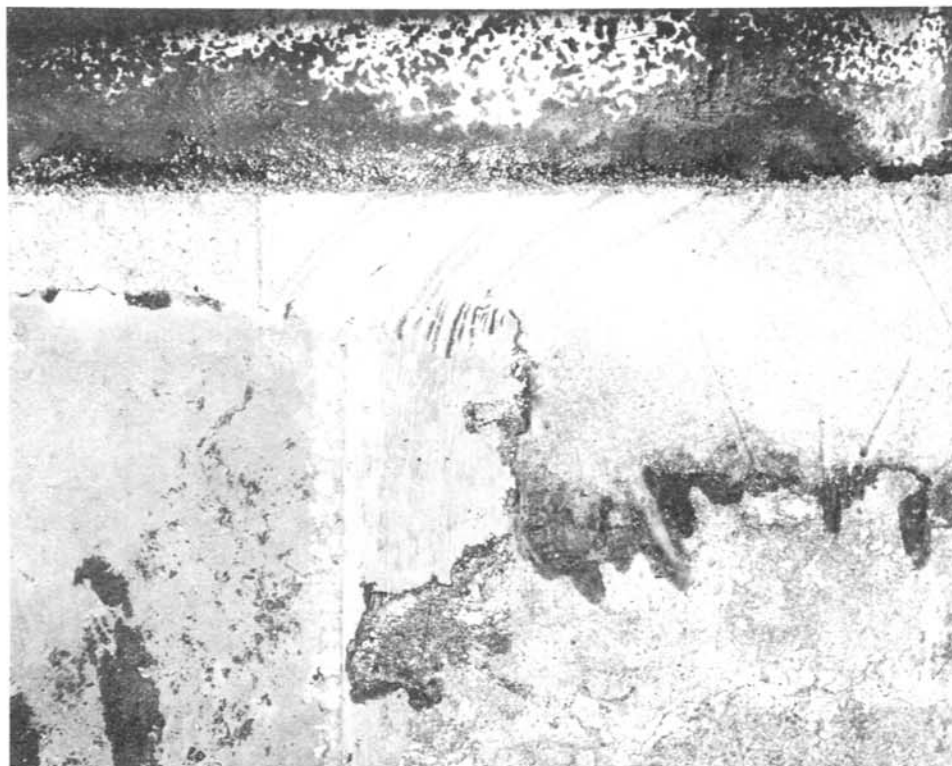
The pipe nipple and gun are removed from the filled hole and a cork is inserted to retain the epoxy until it solidifies. The cork is later removed and the hole filled with paste epoxy. The process is repeated until all prepared holes and cracks have been treated. Figure 6 on page 5, shows the repaired section with the epoxy-silicon and epoxy grout between pedestal and clarifier base.

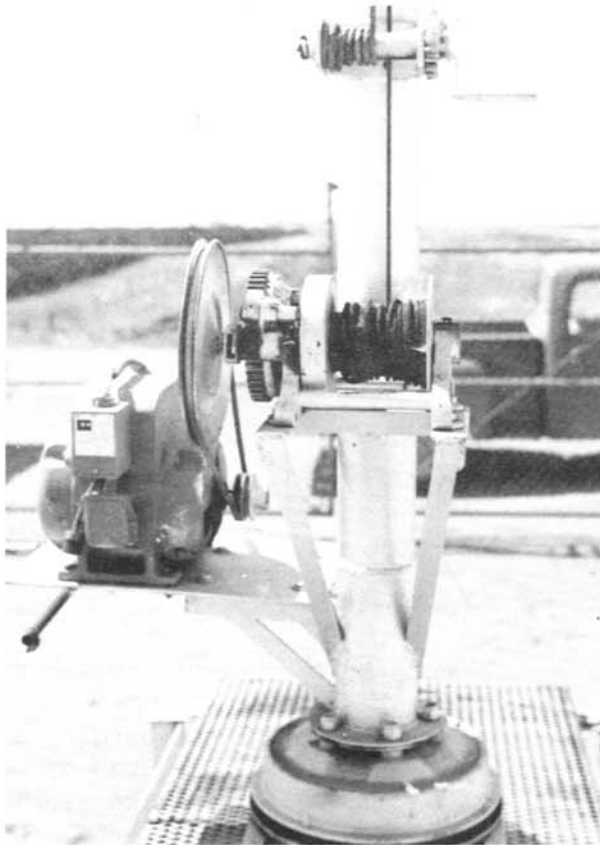
Figure 10 Photo P214-D-72388

reduction-gear-driven cable drum to which is attached a 3/8-inch-diameter stranded steel wire cable. The motor and reduction gear setup is mounted on the main support approximately 2 feet above the base. The gear ratio from the motor pulley to the cable drum is 88:1. Also Figure 10 shows a closeup view of the motor and cable drum setup.

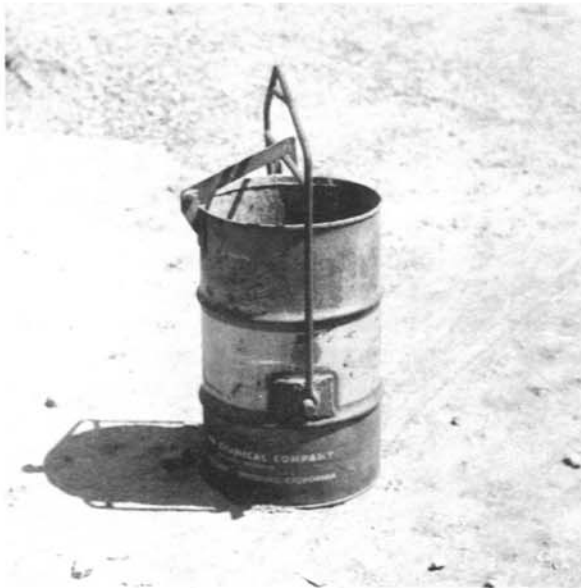
Figure 11 Photo P214-D-72389

The barrel used to carry the mud and silt hold approximately 30 gallons and has been modified so that it can be easily lifted and emptied out into the dump truck. Figure 11 shows a closeup view of the barrel and the modification.
