WATER OPERATION AND MAINTENANCE

BULLETIN NO. 85

SEPTEMBER 1973

CHEMICAL GROUT EXPEDITES TUNNEL REPAIR¹

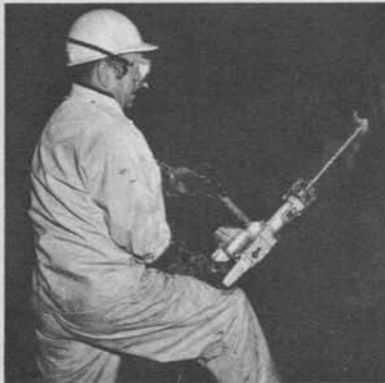
COVER PHOTOGRAPH:

Drilling grout hole with electric percussion drill. Three-fourths-inch-diameter carbide-tipped bits gave excellent results with relatively low wear. Carter Lake Pressure Tunnel, Loveland, Colorado. Photo P245-713-5243 NA

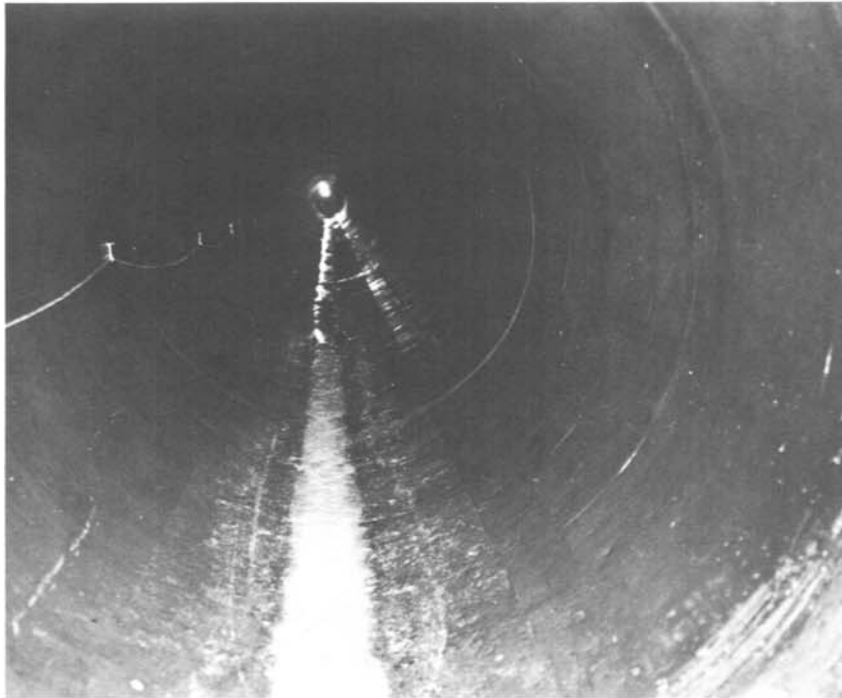
Figure 1 below, shows a general view of the tunnel lining after completion of grouting in this area. Wall is essentially dry as compared with numerous seeps before grouting with AM-9 Chemical Grout.

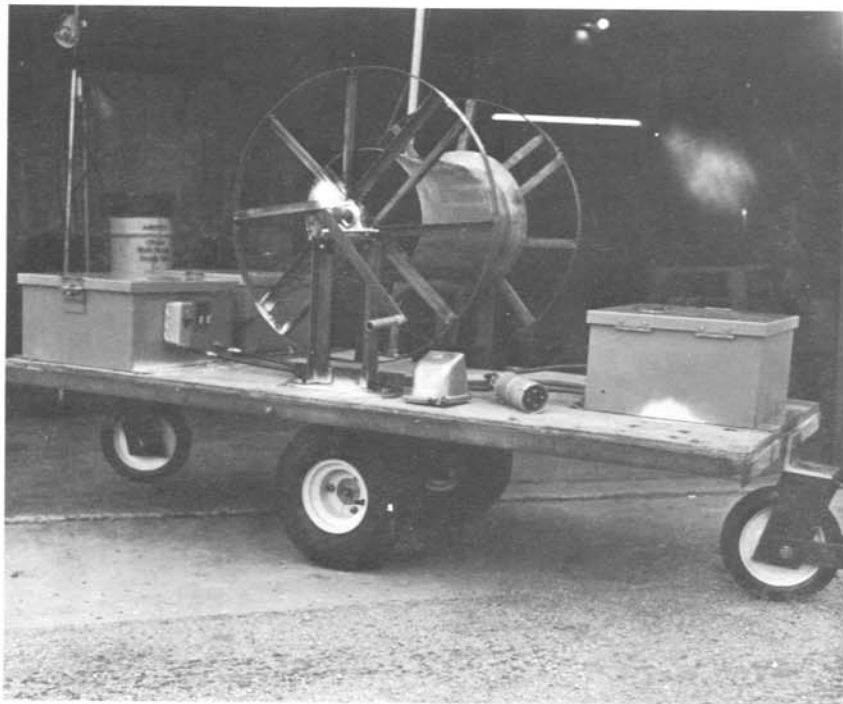
Figure 2 on next page, shows a closeup view of reel cart used in Carter Lake Pressure Tunnel repair. All items in this cart and reel can be broken down to be inserted through 19-inch diameter manhole. Box at left contains transformers and ground fault detectors for protection

of personnel. Box at right may be used for storage of small tools and other items. Cart will travel in either direction by switching the tongue shown on the small wheel to the right, and Figure 3 on page 5, shows a view of grout packer in hole with chemical grout pump at lower left corner of the photograph. All work was done by Project Operation and Maintenance personnel.

The grout pump, electric transformer, distribution panel, and ground fault interrupters are manufactured equipment. All other items, such as cable rails, transformer and pump carts, grout packers, special hand tools and others, were made in the Flatiron Powerplant machine shop. Portable insulated cables carried 440-volt power into the tunnel with the stepdown transformer at the grout point providing 115-volt power for tools and lights.

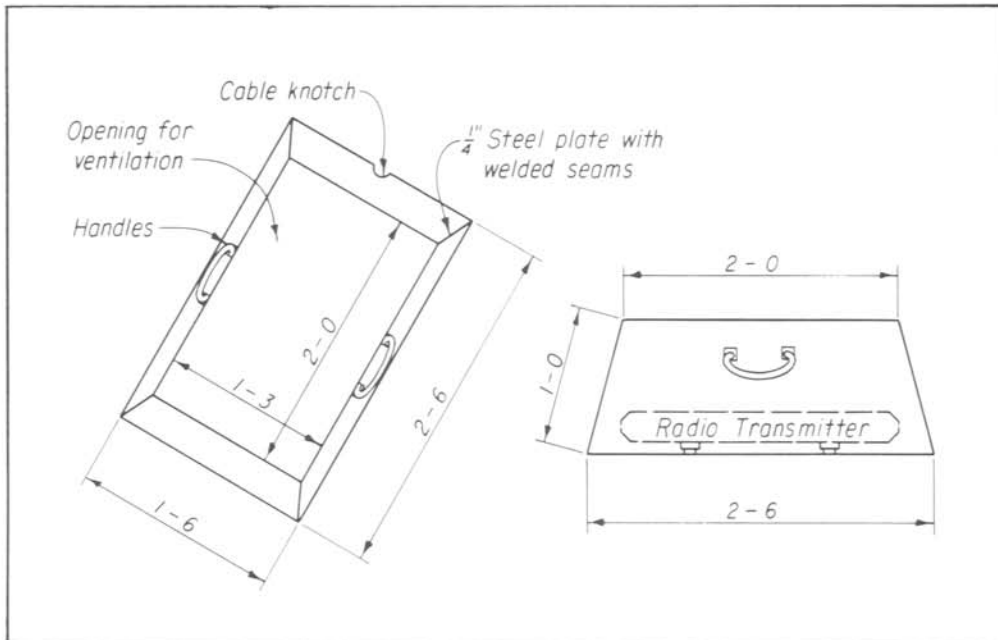
Figure 5

To protect this equipment, project personnel have incorporated the use of a specially designed quarter inch steel frame that fits around the radio transmitter, as shown in drawing (Figure 5) on the next page. These protective frames have been in use for six years and have proven to be very effective protection.

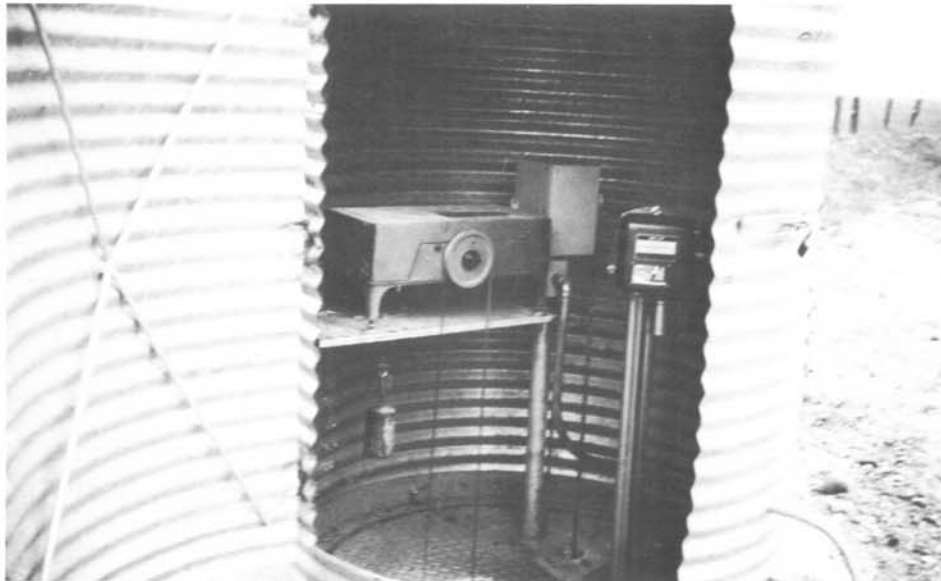
Figure 6

A typical corrugated steel gaging station that shows the stream gage recorder can be seen in the photograph (Figure 6) on the following page. Personnel of the North Platte Project, reports that these gages can also be successfully protected. A very simple method is used. A quarter inch steel plate 14 inches high is installed around the inside of the gage house at the recorder level.

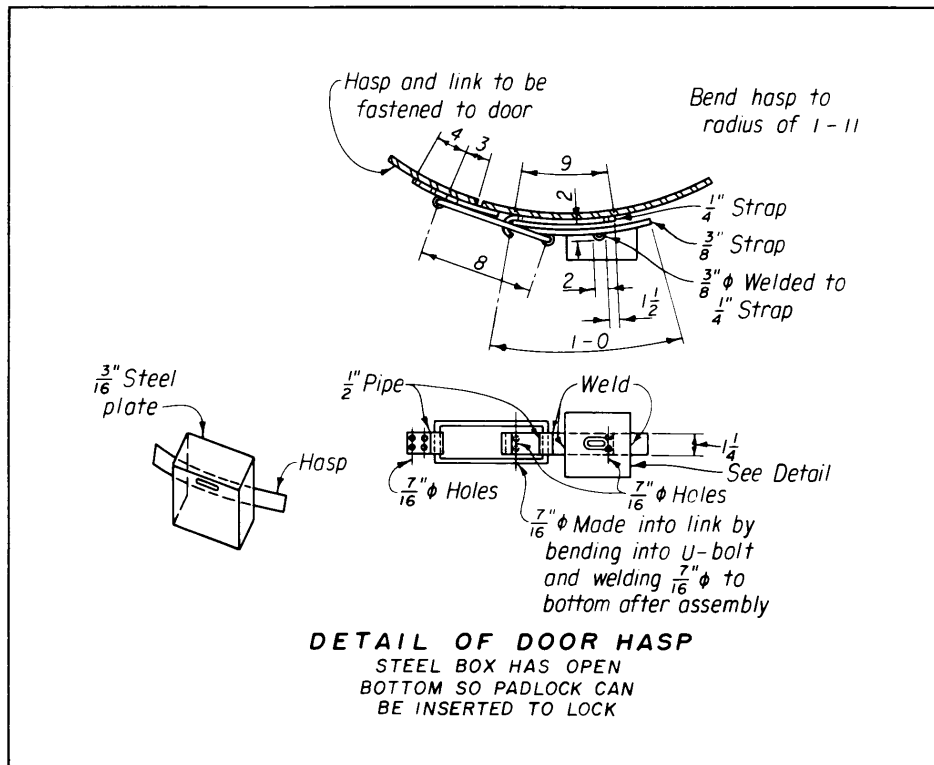
The locks take a little longer for authorized personnel to open, but operating personnel overlook this inconvenience because of the effectiveness of this device. A detailed drawing of the protective steel box is shown in Figure 7 below.

Vandals have no respect for property of any kind when they are bent on destruction, and the doors of some of these current-meter gaging stations have been broken open on numerous occasions and the equipment destroyed. Therefore, to prevent further destruction, maintenance personnel designed a unique steel plate box to cover exposed padlocks, and it has proven instrumental in preventing the locks from being pried open with a bar or tire iron.

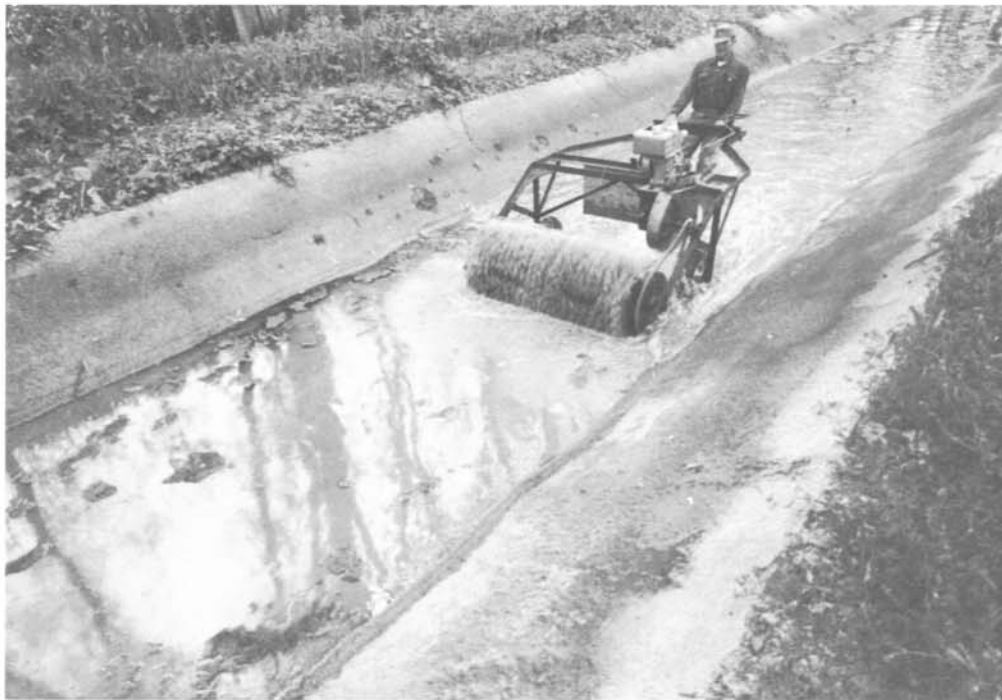
Figure 9 below, shows a full view of this unique cleaning machine at work; note the algae and silt in the foreground that was scrubbed loose by the rotation of the brush. Figure 10 on next page shows a rear view of the machine. It is light enough to be handled by one man wearing hip boots working in the canal with the machine as shown in the photograph.

The cleaning machine shown in a series of photographs in this article was designed and fabricated in the maintenance shop by personnel of the Orland Unit Water Users' Association, Orland, California. This inexpensive machine is driven by a gasoline engine that propels a chain-driven nylon brush. The nylon brush scrubs the algae and silt loose from the concrete lining and floats it harmlessly down the canal. This is a one-man operation and it was reported to be a very easy machine to handle.

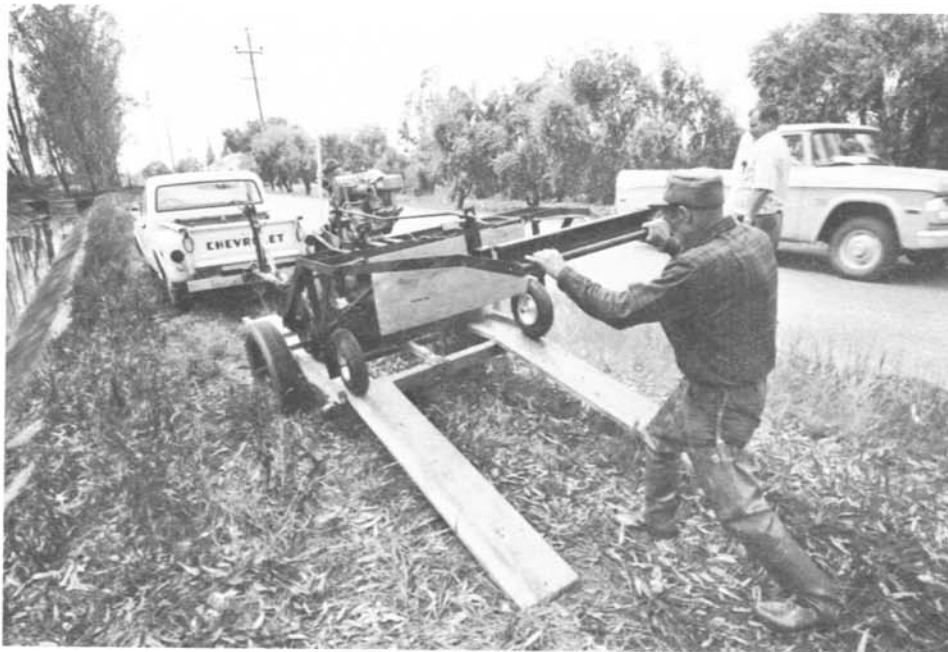
Figure 11 shows the cleaning machine being loaded aboard a light frame trailer hooked to a pickup truck for transporting, and Figure 12 on the next page, shows how the machine looks when loaded ready to be moved to a new location.

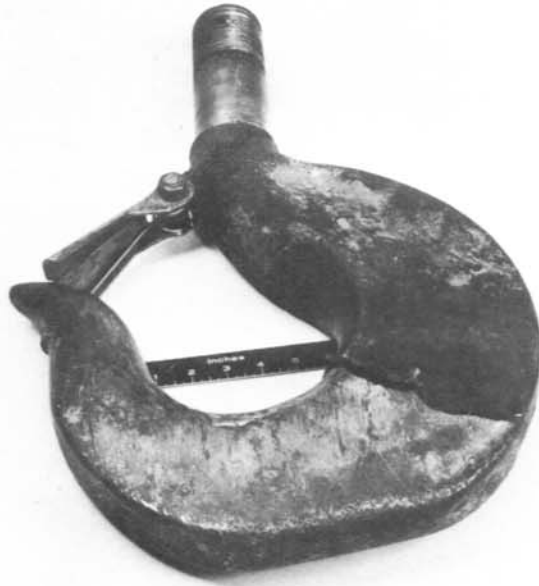
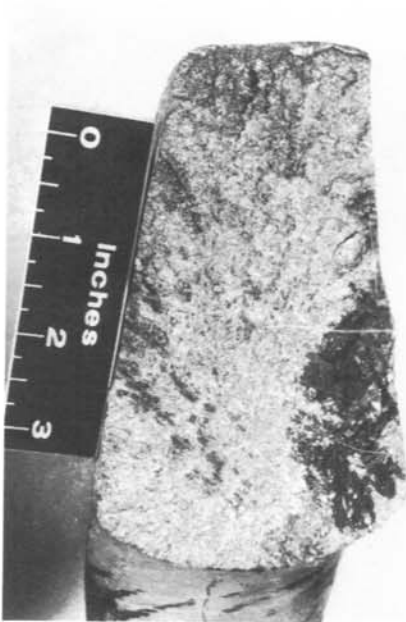
CRANE HOOK FAILURE!

The crane hook shown on the following page was in normal use for only a few months when it failed under a partial loading. The two lower pictures are closeup views of the broken ends and graphically illustrate the reason for failure. The two pieces fitted together in the center photograph show the relative failure point.

Similar hook failures can be prevented with a good sound inspection program as outlined in the following regulations.

Section 1910.179, Overhead and gantry cranes (j)(3)(ix): "Crane hooks. Magnetic particle or other suitable crack detecting inspection should be performed at least once each year."

1. Discontinue the practice of painting crane hooks and remove the paint from existing hooks to facilitate visual inspection.
2. A visual inspection of each crane hook should be made prior to any heavy lifting and on a monthly basis.
3. Crane hooks should be measured annually and discarded if the throat measurement has increased 15 percent from the original dimension.
4. Incipient cracks are not always visible. Each hook should therefore be checked annually for cracks by being subjected to a Magnaflux, Zyglo, or some other suitable nondestructive crack detection test. If equipment for these tests is not available in the Region or from local test equipment rental sources, this office will aid in locating such equipment upon request.
