WATER OPERATION AND MAINTENANCE

BULLETIN NO. 93

SEPTEMBER 1975

QUICKLIME STABILIZES CANAL LINING

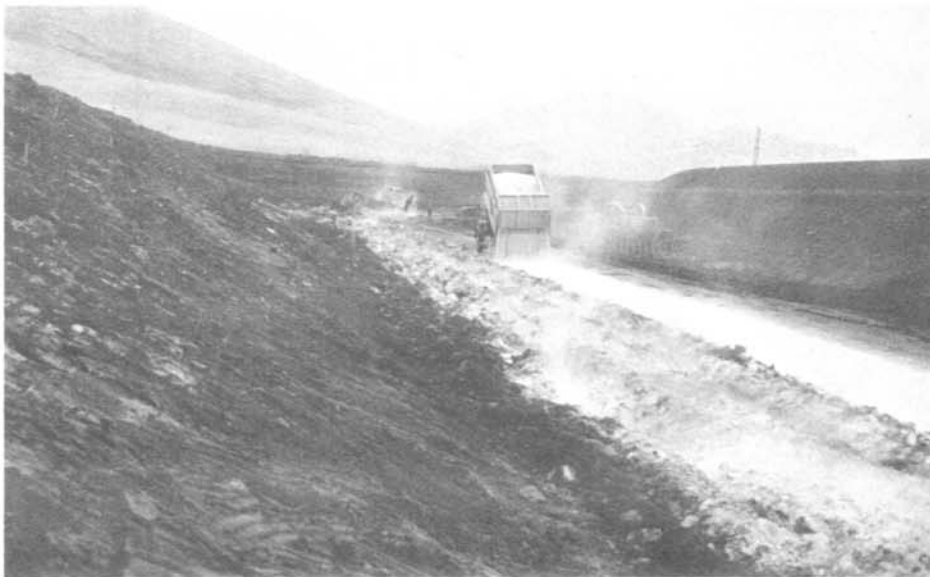
Bank lining material could not be processed in place, so it was peeled off and pushed to the canal bottom for mixing with lime. Figure 1 shows how granular quicklime was spread in long windrows in the bottom of the empty canal.

Dump trucks were used for lime-spreading with the lime being spread to close tolerance from the tailgates, (See figure 1). This method of spreading ordinarily is not recommended for hydrated lime because of its poor flowability, but was satisfactory for the free-flowing granular quicklime. Its gradation was substantially minus 6 mesh plus 100 mesh in size. The tailgate opening and truck speed were closely controlled to attain the 2 percent application in one pass.

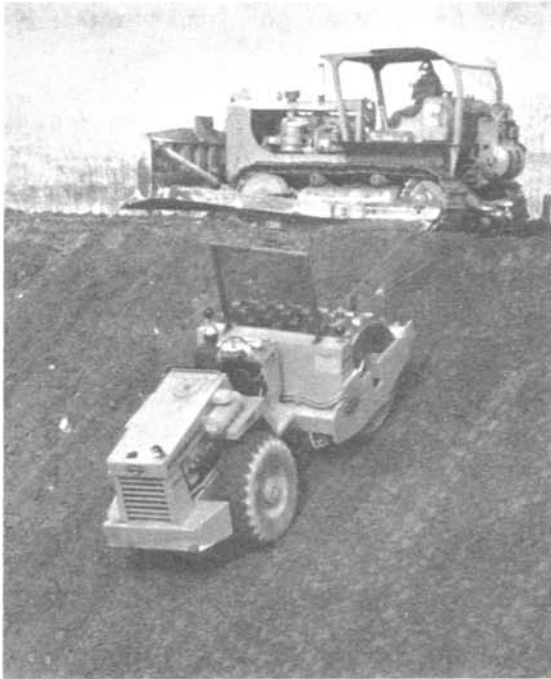
Then, after mixing, the treated soil was pushed back and compacted in several lifts, the compactor being yo-yoed up and down the bank with a winch. Figure 2 shows the vibrating roller being winched up the steep slopes.

After a brief curing period the treated materials were remixed to assure adequate pulverization and water added as needed for compaction. The soil was then replaced on the canal bank in three equal lifts. Each lift was compacted to 95 percent standard Proctor density with a Dynapac CR 25 vibrating roller, which was winched up and down the slope by a crawler tractor, as shown in figure 2.

Compaction was initially carried out with a heavy sheepsfoot roller and, in the case of bank compaction, the roller was winched up and down by the dragline. Later the contractor switched to the vibrating pad-type roller previously shown.

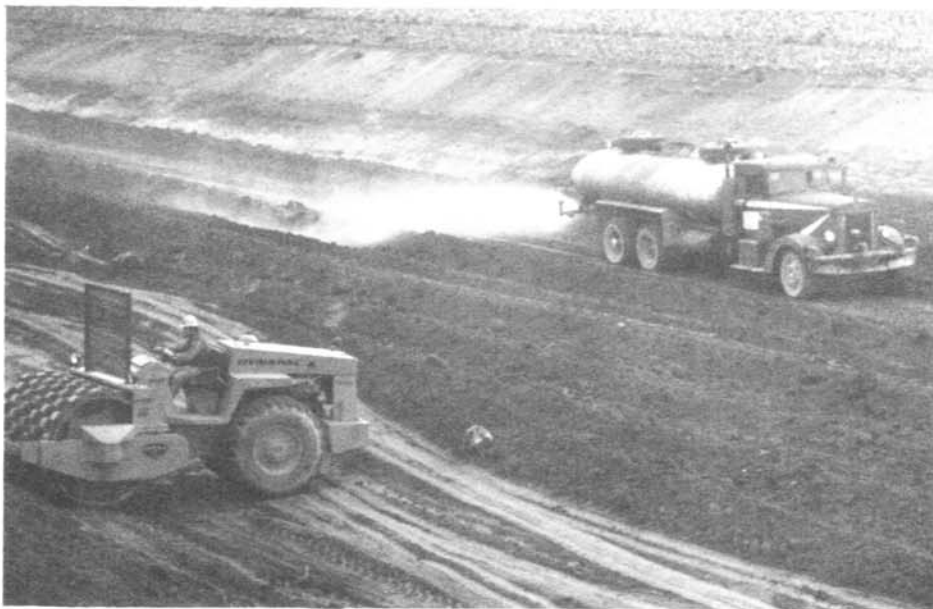
Water for slaking came mostly from the soil itself during mixing, although it was often necessary to add sprinkling water to complete the reaction as well as for compaction. The heat of hydration was especially advantageous in helping counteract the winter temperatures, which normally would have impeded the lime-clay cementing reaction. Figure 4 shows how the water was applied to the lime-soil mixture for the next lift of material to be placed.

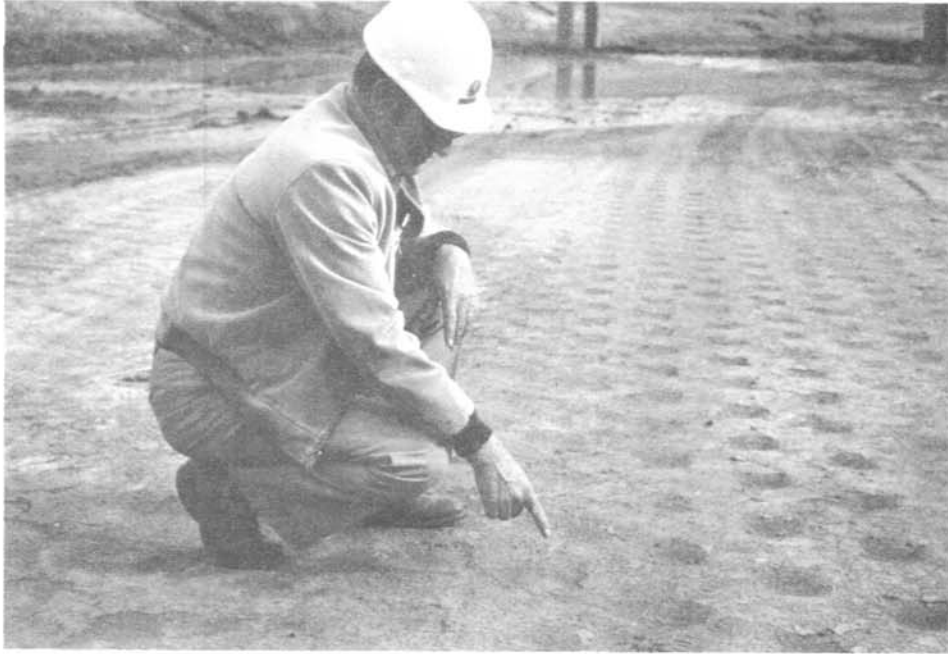
Figure 6

None of the stabilized lining suffered any failure during the period. There was no cracking, sliding or detectable erosion. In fact, sheepsfoot roller impressions made during construction were still evident on the canal bottom. See figure 6 on the next page, showing the sheepsfoot roller indentations which were still evident nearly a year later after the canal had been in full flow. If the layer had not been stabilized the indentations would have been obliterated. In the unstabilized sections, bottom and side slopes were soft and yielding.

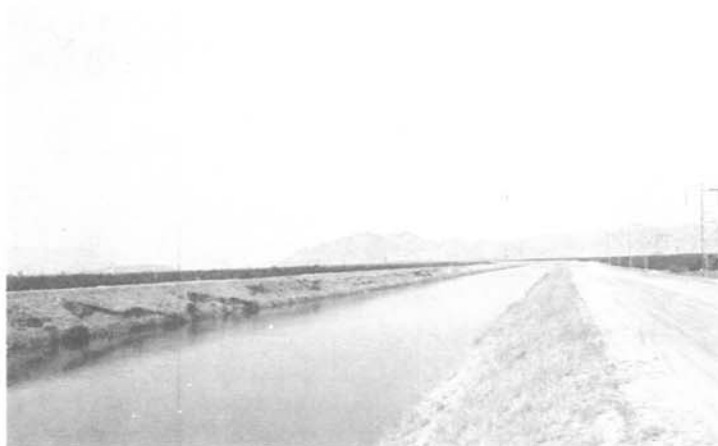
In an effort to prevent canal bank erosion, personnel of the Fresno Field Division, Fresno, California, designed and built a most unique conveyor for spreading gravel on unlined canals. The gravel blanket was uniformly spread about 10 feet wide and 12 inches thick. Figure 8 shows the Friant-Kern Canal and part of the eroded section on the left bank due to wave action.

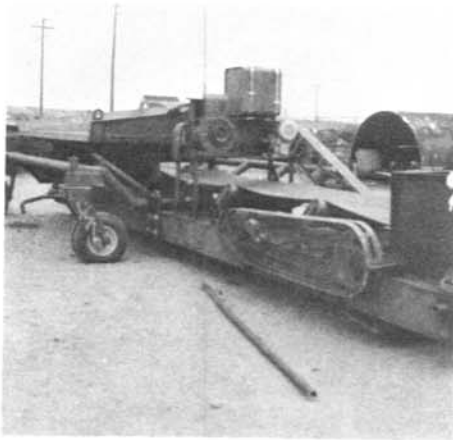
A Bureau Engineer, Mr. Glen Richardson, of the Fresno Field Division, Operation Branch, undertook the task of designing a conveyor. By exchanging ideas and searching out suitable components he was able to build a very satisfactory machine. The machine was fabricated and assembled by personnel in the Division Maintenance shop, at little cost to the project. Figure 9 on page 11 shows the partially completed conveyor prior to the first trial operation and figure 10 shows the completed assembly prior to being placed in operation.

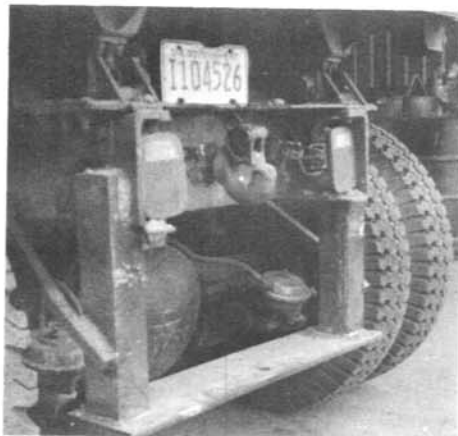
The conveyor was adapted so an 8-yard dump truck could be easily and quickly coupled and uncoupled by the operator. Figure 11 shows the conveyor hookup arrangement on back of the dump truck, and Figure 12 shows tail gate extension that is added on to the truck for discharging material into the conveyor hopper.

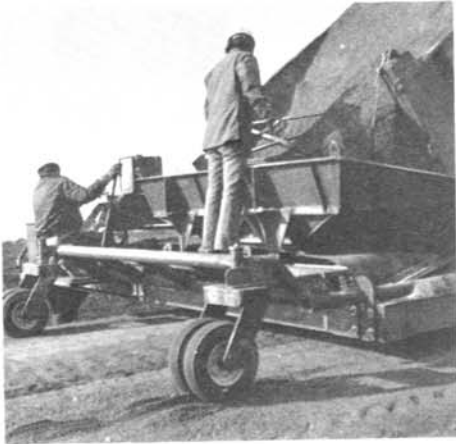
Figure 13 on page 12 shows a closeup view of the conveyor in operation. Beach belt material is being dumped into the conveyor hopper and it also shows the operator at left of conveyor.

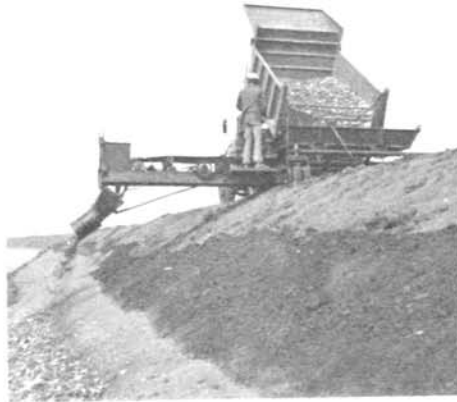
Figure 16 shows rock being spread over the previously placed sand, and Figure 17 on the next page was taken on the Friant-Kern Canal looking downstream, and water at the normal elevation. This photograph also shows how the canal bank looked when job was completed.

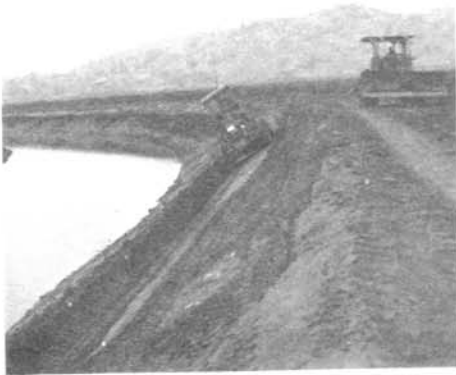
Figure 14 shows the grader cutting a slot for the beach belt material and it also shows how the grader was supported from the canal bank. A rigging was attached from a D-8 caterpillar to the grader working along the slope of the canal.

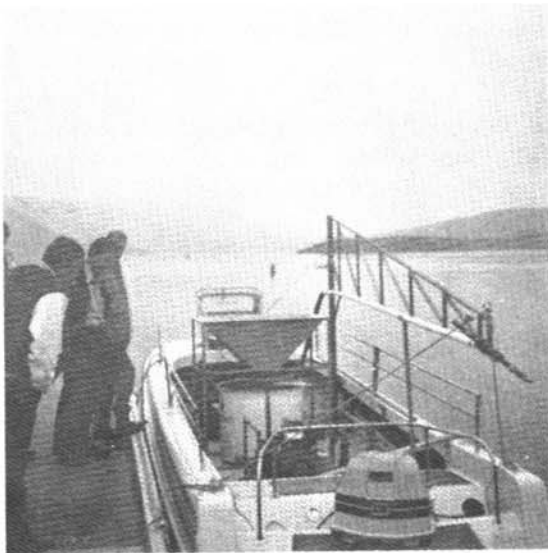
Figure 18 shows one of the Whalers fitted out in its copper sulfate gear. Designed by Mr. Verne Haller, of support engineering, this equipment consists of the following: a swinging boom, a chemical hopper and tank, and two special pumps. The boom is made of a conduit stiffened with other lengths of pipe welded parallel and at angles, to form a girderlike arm 12 feet long. At the end of this arm is a cap with cross pipes forming a T-shaped nozzle equipped with four jets. The boom moves in pivots of steel pipe clamped on the bottom and side of the boat.

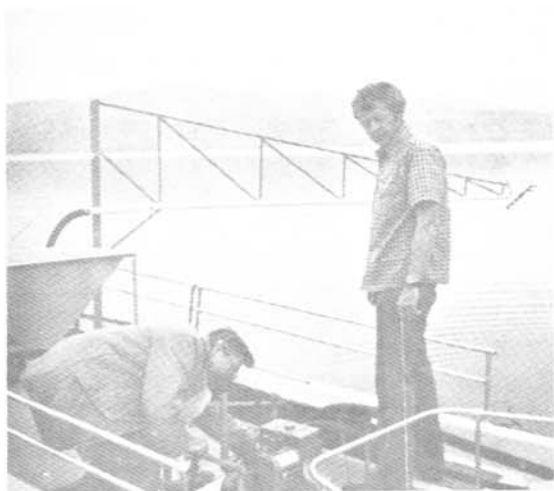
Figure 21 shows the pump engine about to be started. Even moving slowly, the boat can cover a lot of territory in a few hours.

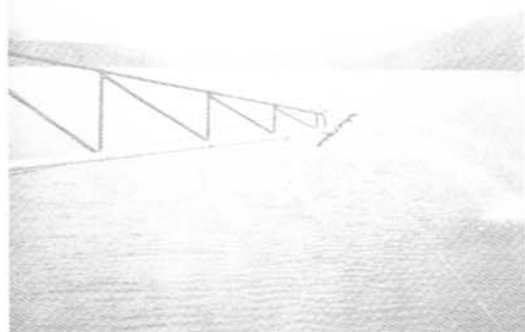
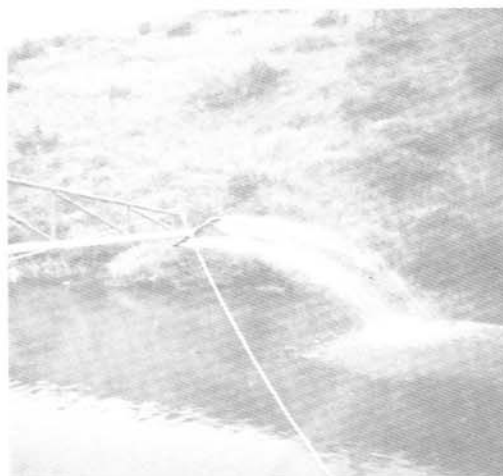
Figures 22 and 23 give some idea of how the nozzle can be used on floating weeds or along the shoreline.
