WATER OPERATION AND MAINTENANCE

BULLETIN NO. 103

MARCH 1978

EMERGENCY DROUGHT RELIEF ON THE FRIANT-KERN CANAL
ELECTRICAL SAFETY - IRRIGATION SYSTEMS
A WAY TO SERVICE STEEL, ROLL-UP DOORS AT HALF
THE COST
BENTONITE SEALS PONDS AND DITCHES
A SAFETY LADDER FOR CLIMBING ONTO UNITS AT
BUENA VISTA
SOME SPRAYS CAN DAMAGE POLYCARBONATE HATS

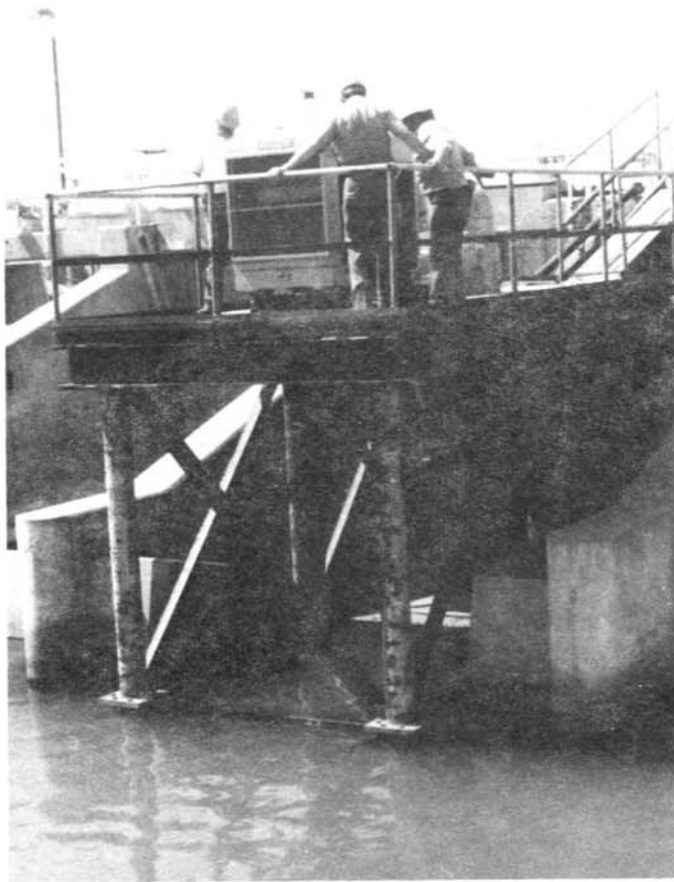
Figure 2. - View looking upstream at pump and platform installed between the gate arms at the Equalizing Reservoir check.

After much research, personnel from the Engineering Branch, Fresno Office (CVP), were able to locate two large vertical lift pumps that could be adapted to pump the water over the Shafter and reservoir check gates. These two pumps, rented on a monthly basis, were driven by large LP gas engines through an angle-drive gear box. The optimum capacity of these pumps was $1.7 \text{ m}^3/\text{s}$ ($60 \text{ ft}^3/\text{s}$); however, the head conditions available reduced the output. The platforms on which the pumps, gearheads, and engines were mounted were designed by the Engineering Branch, Fresno Office (CVP), and were built in the shops of the Orange Cove and Lindsay Field Branches. The platform at the Shafter check was built 5 m (16-1/2 ft) high, 6.1 m (20 ft) long, and 2.7 m (9 ft) wide. It consisted of six 200-mm (8-in) diameter pipes, properly braced with angle iron for stability on which a frame made from 300-mm (12-in) wide flange beams were mounted and solidly welded. The whole structure rested on large wooden pads to protect the concrete structure from damage.

The other platform placed downstream of the reservoir check was similar in size and design, except that it was 6.3 m (20-1/2 ft) high; the difference being due to larger gates being installed at the reservoir check. The total cost for design, materials, and labor for these two platforms was about \$20,400. Photographs of the completed pump and installations are included at the end of this report.
